Report on  
Stability Assessment

Proposed Residential Subdivision  
South Creek West, Precinct 5, Cobbitty

Prepared for  
JJ Cobbitty Development Pty Ltd

Project 92225.06  
October 2025

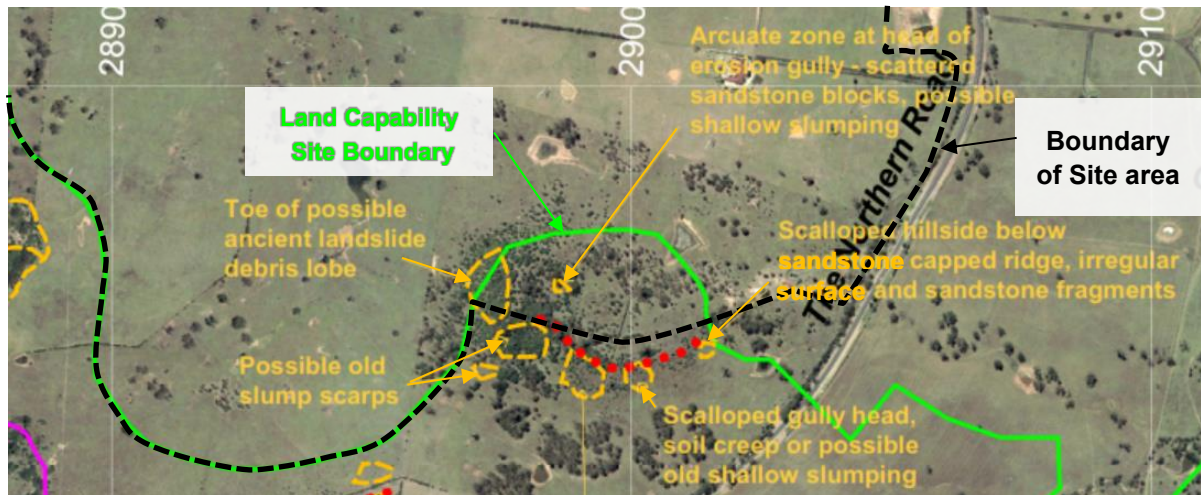
**Figure 2: Excerpt of slope instability mapping from DP's Land Capability Study (DP, 2007).**

- deep-seated hillslope instability affects the upper slopes of the ridgeline (near the southern site boundary), which is considered to be a major constraint to development;
- observed or inferred surficial soil creep, and possible ancient slumping of residual soils, was present in over-steepened gullies and steeper ridgelines below mapped (or interpreted) un-named sandstone members of the Bringelly Shale geological formation (outcropping to the south of the site area: denoted using red dotted lines in Figure 2);
- potential soil creep, shallow slump instability of soil, and erosion features are likely to impose constraints to development (minor to intermediate), including for residential and infrastructure development in both current landslide (movement-affected) areas, and bordering areas with equivalent topography and stratigraphy.

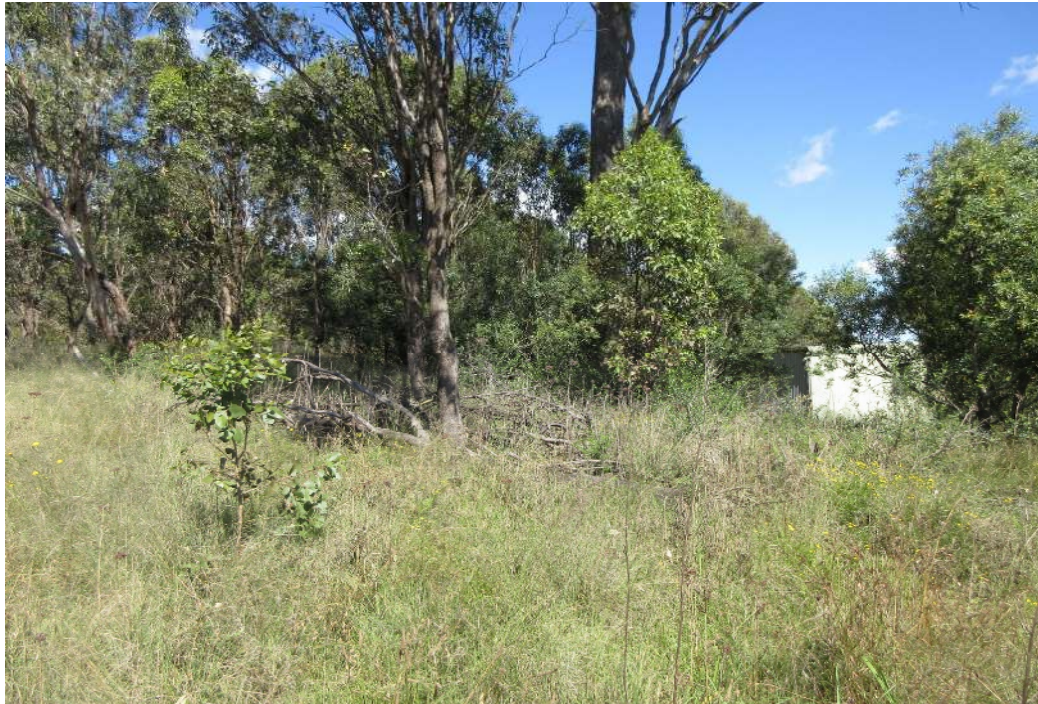
Photo 1 - View towards the west near Test Pit 301, near the crest of the ridgeline.

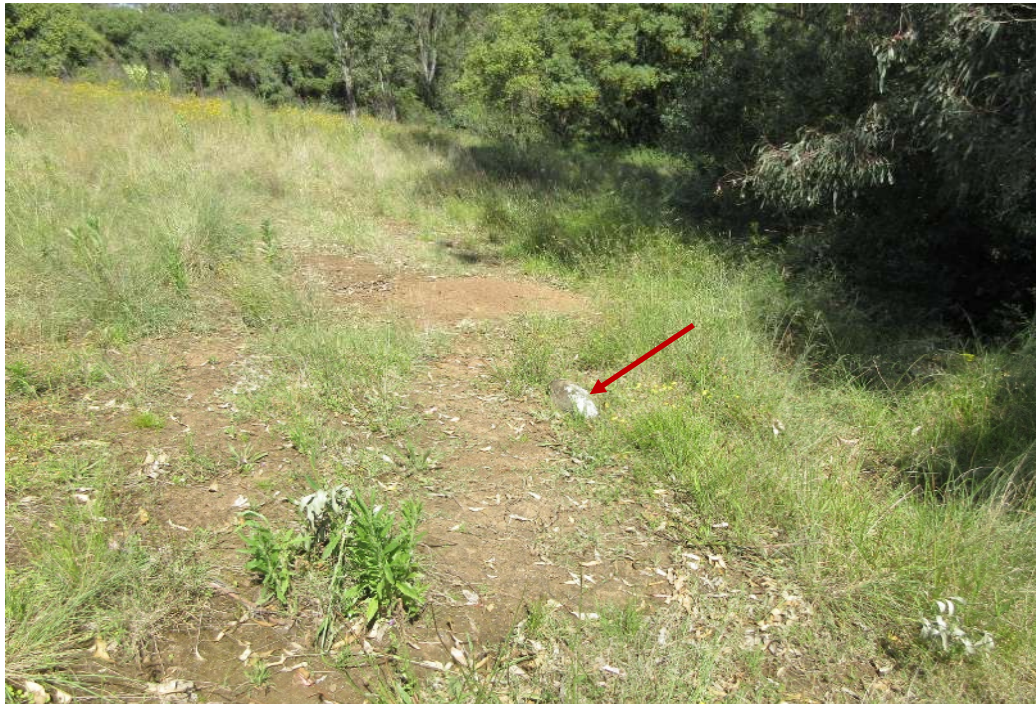
Photo 6 - Sandstone boulders partially buried within the slope (inferred colluvial soil).

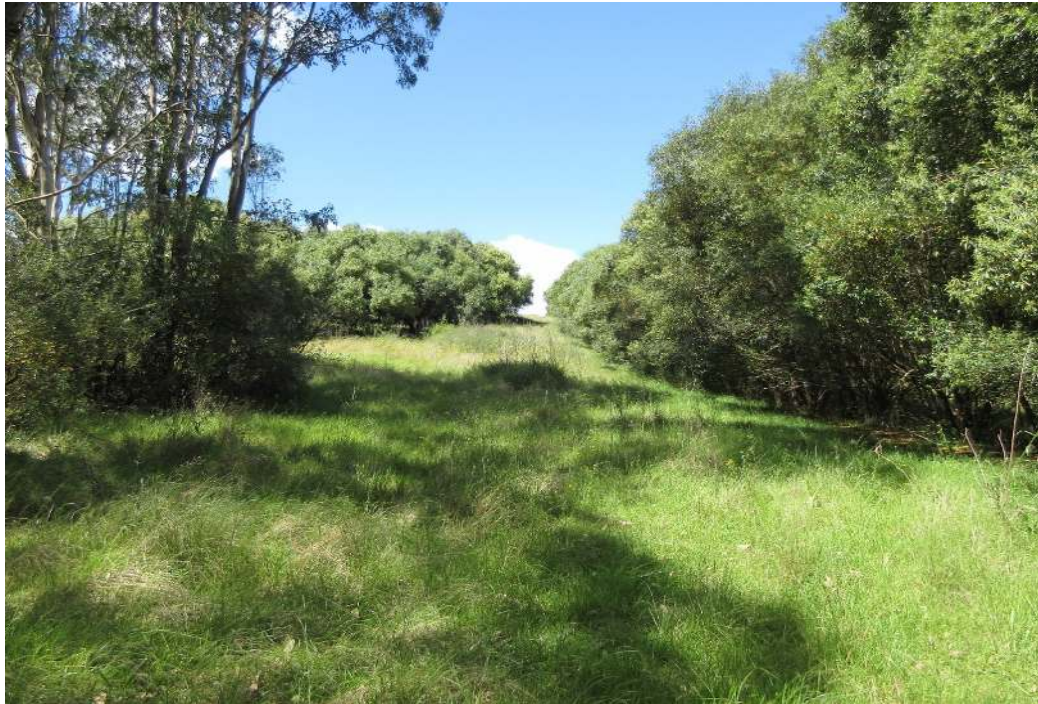
Photo 7 - View towards the south, upslope along a fenceline obscured by wild olives, west of Test Pit 302.
