Report on  
Preliminary Site Investigation (Contamination)

Proposed Rezoning  
Sub-Precinct 5, South Creek West, NSW

Prepared for  
Boyuan Bringelly Pty Ltd

Project 92225.04  
December 2022

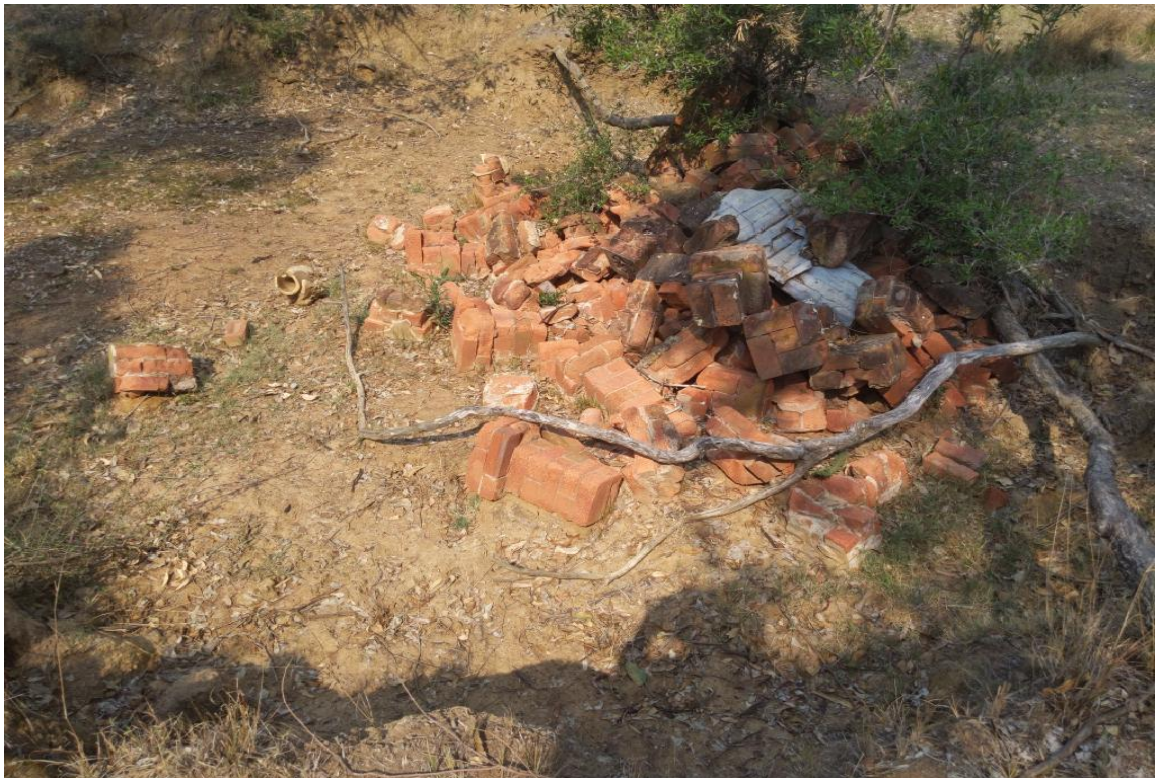
Photo 4 - Observed Fly Tipping
