# Arboricultural Development Assessment Report

206 West Dapto Road  
Kembla Grange NSW 2526  
Lot 1 DP 588139

December 2018  
Updated June 2020

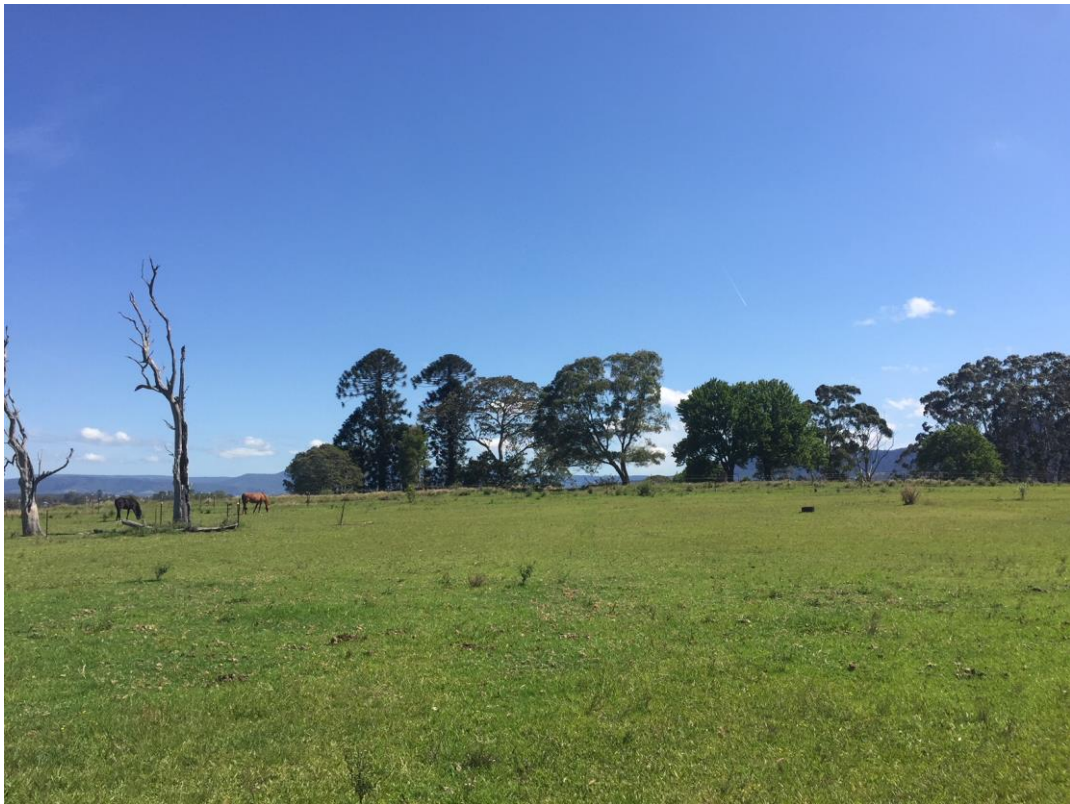
- 3.9 The site has previously been utilised for farming purposes and, as such, has been extensively cleared of the majority of vegetation (Plate 1). Along the western boundary is a large, dense cluster of trees. Not far from Paynes Road is Heritage item 6326. This item is listed as; *Group of Bunya Pines, Moreton Bay Figs and Hills Figs*. This group of trees is numbered as 1-20 and appear to be associated with an old homestead that would have been located in this area. Since the 2019 site inspection, Tree 11 is almost

**Plate 1:** Image showing the general layout of the site.  
Heritage item 6326 can also be seen in this image. P. Vezgoff.

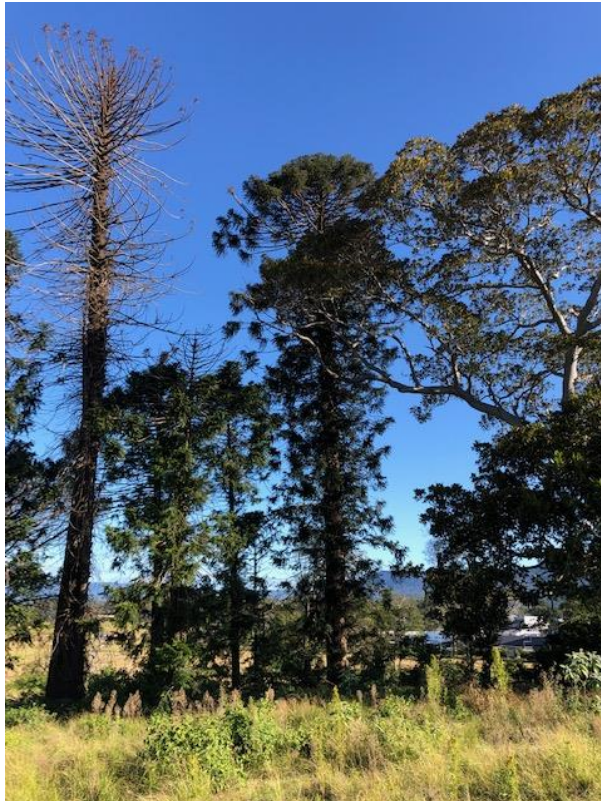
dead and Tree 8 has gone into decline (Plate 1a). Plate 1b shows the extensive borer damage however this will be a secondary issue and not the cause of the decline.

**Plate 1a:** Image showing the almost dead Tree 11 in June 2020. **Plate 1b:** The base of Tree 11 had extensive borer damage. P. Vezgoff.

**3.25** Due to the sudden death of Tree 11, which is unusual as this species can live for hundreds of years, further scientific testing has been recommended. This group of trees (1-13) being a Heritage item would normally be required to be retained. However, if there is a detrimental soil pathogen such as Australian honey fungus (*Armillaria luteobubalina*) or *Phytophthora cinnamomic* it will impact on the long term plans for these trees. Soil and tissue samples have been taken and sent to the Royal Botanic Gardens Pathology unit to determine the diagnosis.

- 4.2** Design around this Heritage item should be put on hold until the pathogen results from Royal Botanic Gardens Pathology unit are returned.
- 4.3** Consideration to retain Tree 152 is recommended as Council has required smaller specimens of the same species to be retained on similar developments in the area.

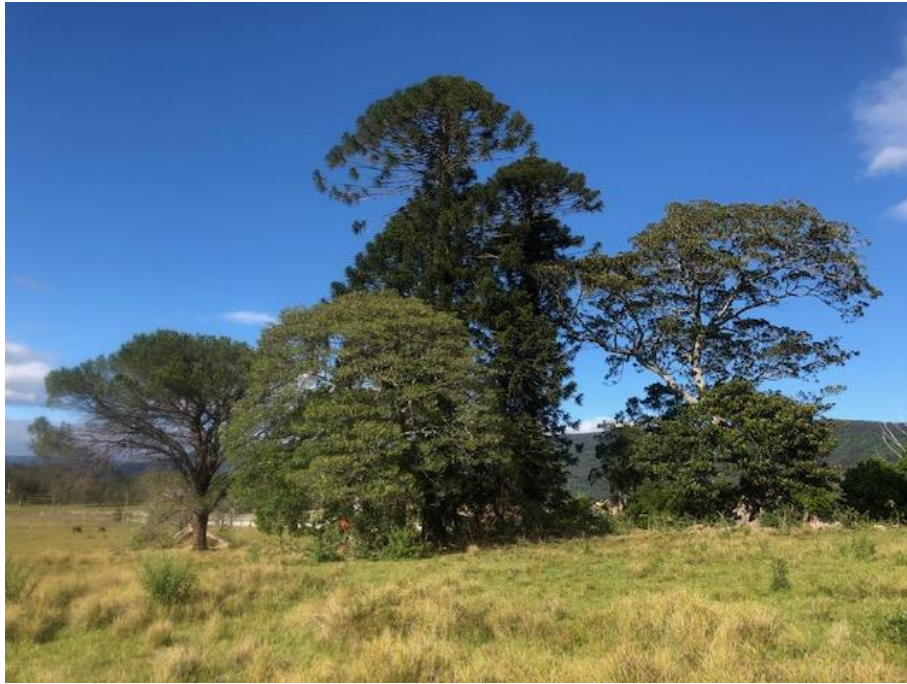
**3.10** Trees 4 and 11 are large Bunya Pines (Plate 2). These are large trees and may eventually reach heights of 30 – 50 metres. The species has a broad conical with a dome shaped upper crown and has long been cultivated within the urban environment. The proportions of this tree are often statuesque and emergent specimens become prominent within the landscape due to their unique shape. Mature specimens can be found in established gardens, as individual specimen plantings, or small stands on large properties and in older public parks. Many of these trees in NSW may be heritage listed as individual items or as a component of the curtilage of a significant building. They are often reminders of old farming homesteads that have long since vanished as is the case at this site.

**Plate 2:** Image showing heritage item 6326 in 2019. P. Vezgoff.

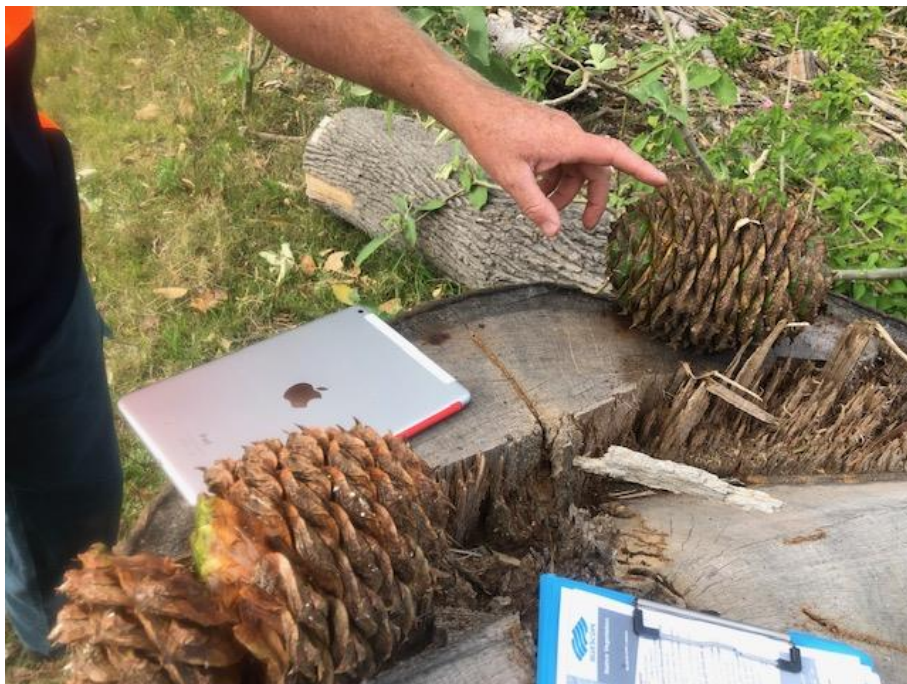
**3.11** Trees 4 and 11 did have large portions of fruit within the canopy of these trees at the time of inspection (Plate 3). Although fruit growth of this species is usually encountered on a cycle of 2-3 years, a reduced volume or an absence of fruit production has been recorded in the intermittent years. On most occasions when the fruit falls it breaks apart and it falls through the tree's canopy.

**Plate 3:** Image showing the size of cones present at the time of inspection. P. Vezgoff.

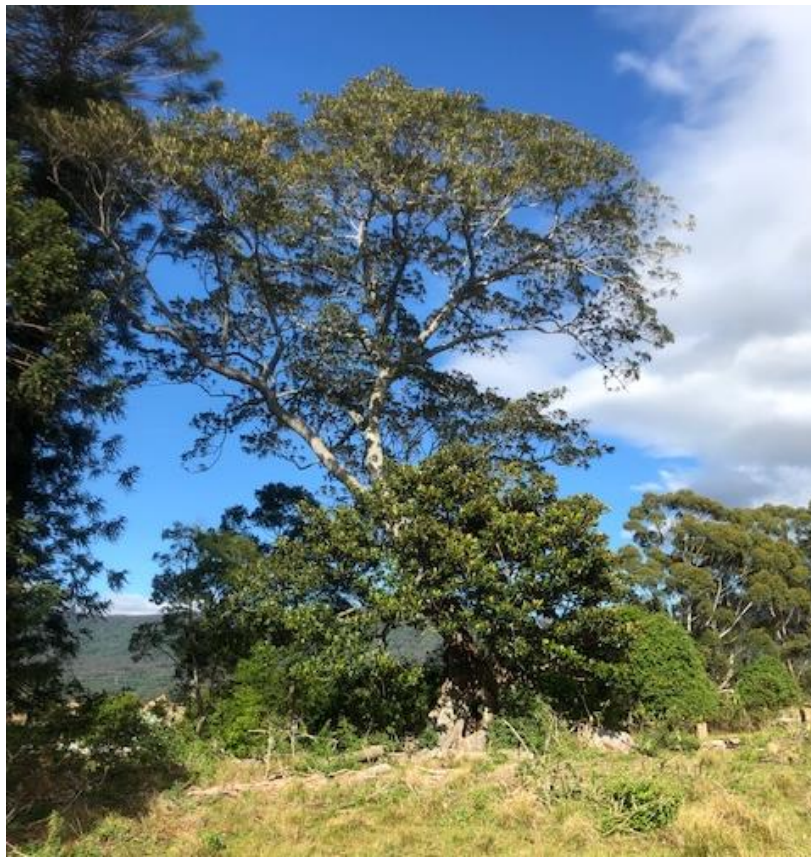
**3.12** Tree 1 is a large mature Moreton Bay Fig. Although associated with a heritage group of trees, the form of this tree is poor due to the loss of one of the main stems, most likely due to storm damage (Plate 4). Due to the loss of a large portion of the canopy, a secondary canopy is forming around the lower portion of the tree. This tree is generally in good health however the cavity within the basal area and the asymmetrical canopy create a tree that is not a particularly good long term specimen to retain in a public open space.

**Plate 4:** Image showing Tree 1. The cavity can be seen at the base of the tree and the poor form of the upper canopy is apparent. P. Vezgoff.

| Tree | Species | Height (m) | Spread (m) | DBH (m) | Live canopy % | Defects | SULE | Condition | Age | Comments | TPZ (m) | SRZ (m) |
|---|---|---|---|---|---|---|---|---|---|---|---|---|
| 1 | Moreton bay fig (Ficus macrophylla) | 19 | 15 | 3 | 80 | Open cavity with evidence of decay | 2c removed for more suitable planting | Good | Mature | Large sections of dead wood cavity at bas | 36 | 5.1 |

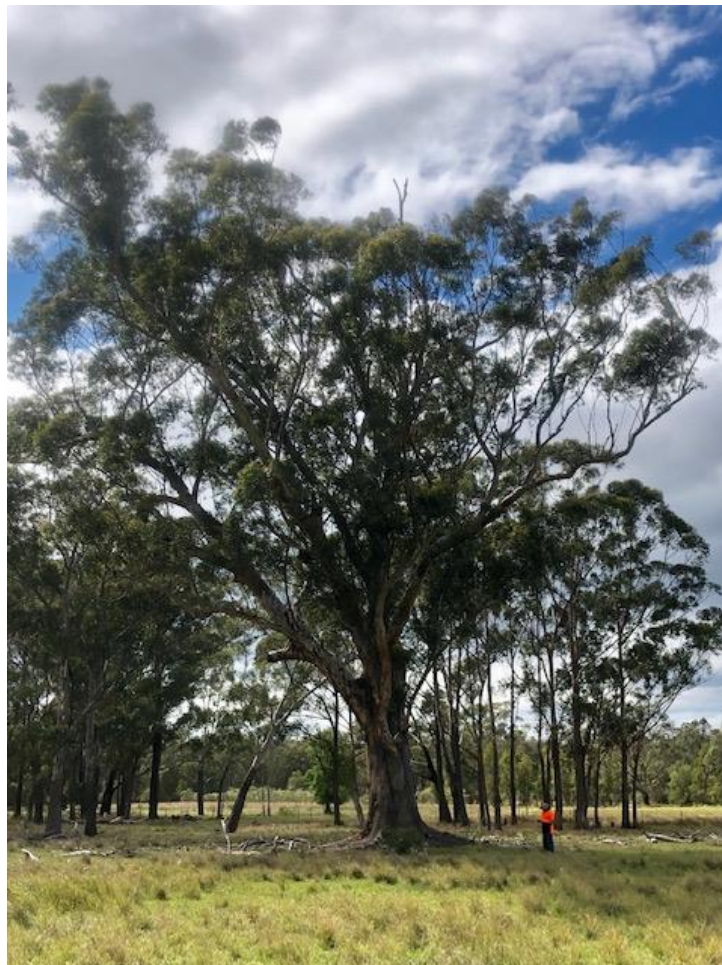
- 3.14** Other large remnant trees assessed within the study area include Trees 63, 64 and 65 along with Tree 60, near Paynes Road. As with Tree 65 shown in Plate 5 these remnant trees have many old fractures and hollows that take decades to form, with the trees themselves likely to be well over 180 years old.

**Plate 5:** Image showing Tree 63 that would be considered a remnant specimen. P. Vezgoff.

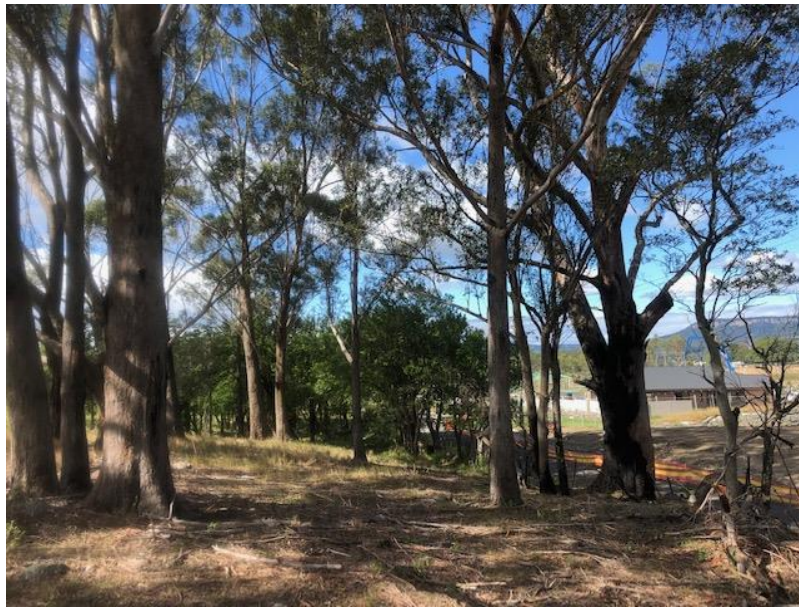
**3.15** Majority of the site trees are Forest red gum (*Eucalyptus tereticornis*), Blackbutt (*Eucalyptus pilularis*) along the Paynes Road boundary. There are also scattered specimens of Cheese tree (*Glochidion ferdinandi*). Most of the understory in this area has been cleared (Plate 6). Since the 2019 inspection Trees 14, 50 and 55 have suffered large diameter limb failure due to storm damage. It is possible a micro storm event occurred in this location as the damage appears to have occurred at around the same time.

**Plate 6:** Image showing the vegetation along the Paynes Road boundary. P. Vezgoff.

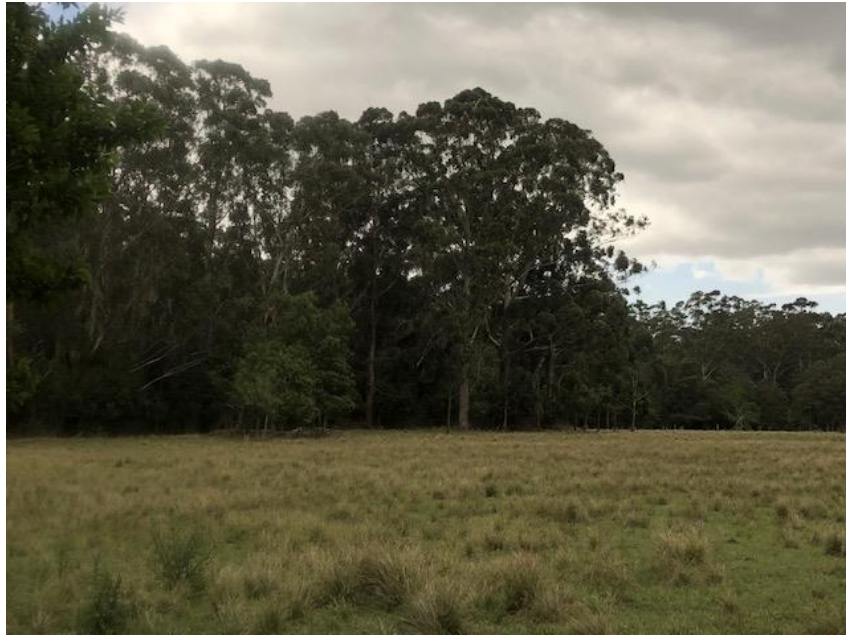
**3.16** The creek along the northern boundary has many native trees and shrubs however it is heavily weed infested, mostly with *Lantana camara* (Plate 7). This area is within the E3 zoned area. Also growing around this area *Melaleuca styphelioides*, Forest red gum (*Eucalyptus tereticornis*) with scattered specimens of *Acacia maidenii* and *Acacia mearnsii*, Willow Bottle brush (*Callistemon salignus*) and Cheese tree (*Glochidion ferdinandi*).

**Plate 7:** Image showing the E3 vegetation along the northern boundary creek. P. Vezgoff.

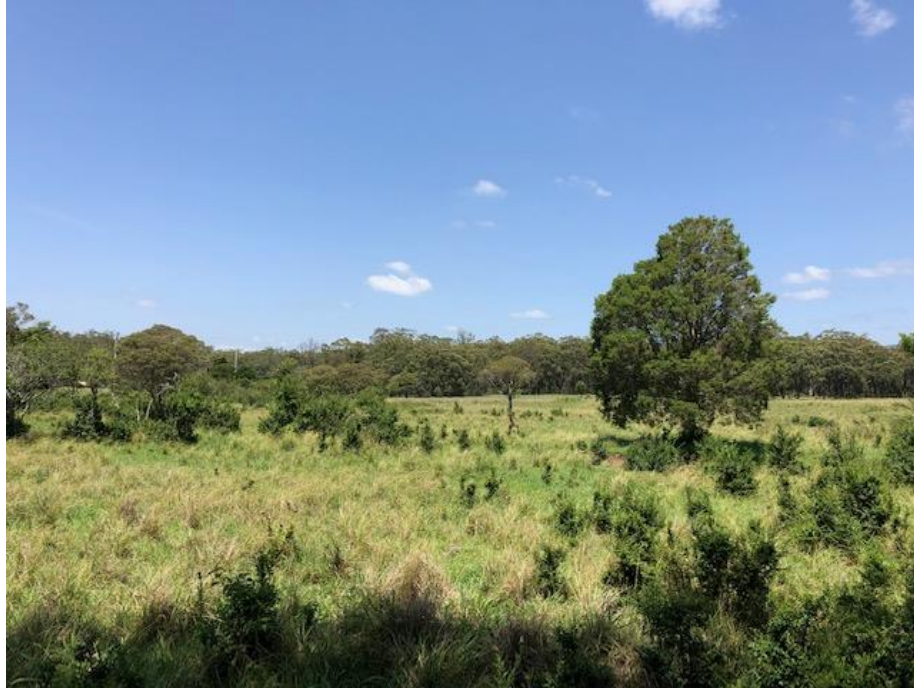
**3.18** Between the Industrial area and West Dapto Road are scattered specimens of *Acacia maidenii*, and Cheese tree (Plate 9). Within this area is a collapsed old residential dwelling that is surrounded by mixed species being Camphor laurel (*Cinnamomum camphora*), Port Jackson fig (*Ficus rubiginosa*), Cockspur coral tree (*Erythrina cristagalli*), Cheese tree (*Glochidion ferdinandi*), White stringy bark (*Eucalyptus globoidia*). Tree 152 is a large specimen of Moreton Bay fig (*Ficus macrophylla*) that was most likely planted in association with the cottage. This tree has grown into a large

**Plate 9:** Image showing the open area in the eastern section of the site. P. Vezgoff.

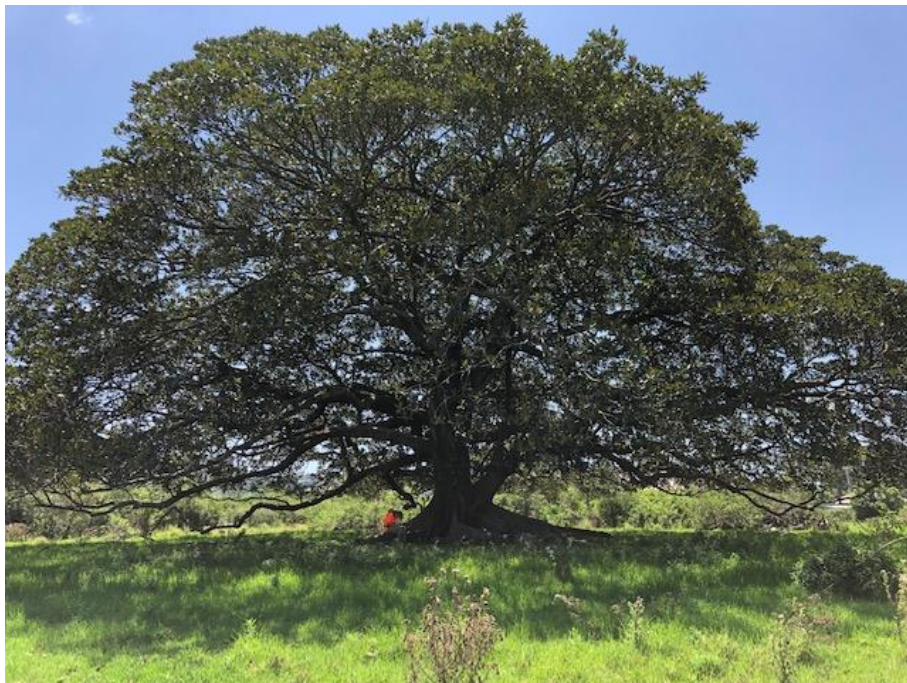
significant tree that can be seen from West Dapto Road (Plate 10). This vegetation surrounds an old dwelling that can be seen in Diagram 5. Based on Diagram 5, Tree 152 will be approximately 100 years old.

**Plate 10:** Image showing Tree 152 that, although not remnant, would be considered a significant specimen. P. Vezgoff.

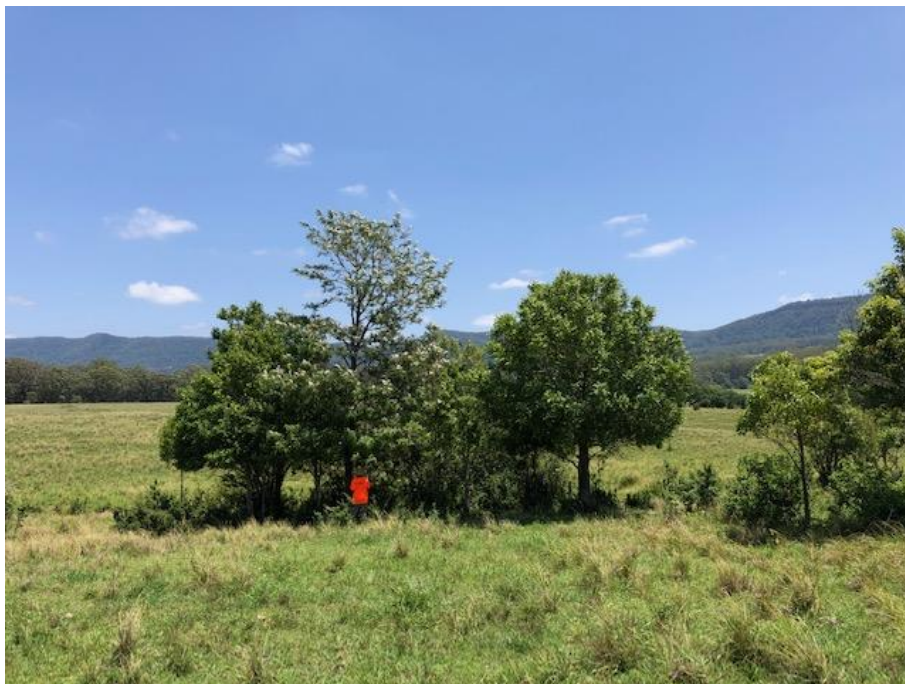
- 3.19** Plate 11 shows Tree group 156 that consists of sapling regrowth containing mixed species of Silky oak, Cheese Tree, Privet, Pittosporum. This group is similar to the other groups numbered as 164-168 located along the northern boundary and a small stream that was not flowing at the time of inspection.
- 3.20** Two (2) of the larger trees along West Dapto Road are numbered as Trees 148 and 149 near west Dapto Road (Plate 12). These trees are large specimens of White stringy bark (*Eucalyptus globoidia*). These trees are not remnant specimens but were most likely planted in association with a small dwelling that was once in this location.

**Plate 11:** Image showing Tree group 156.  
This group is similar to the other groups numbered as 164-168. P. Vezgoff.

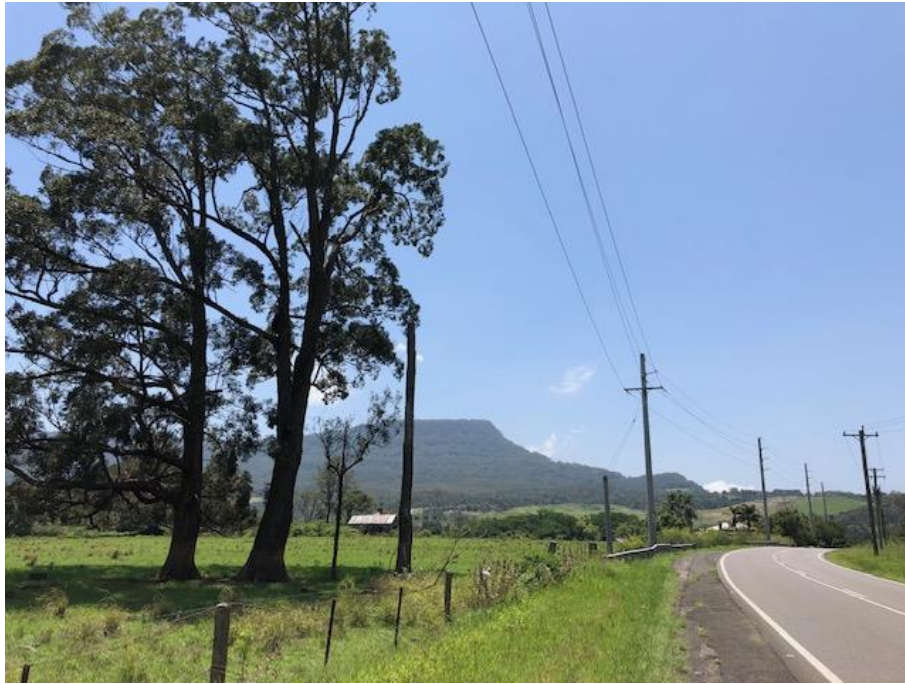
**Plate 12:** Image showing Trees 148 and 149 near west Dapto Road. P. Vezgoff.

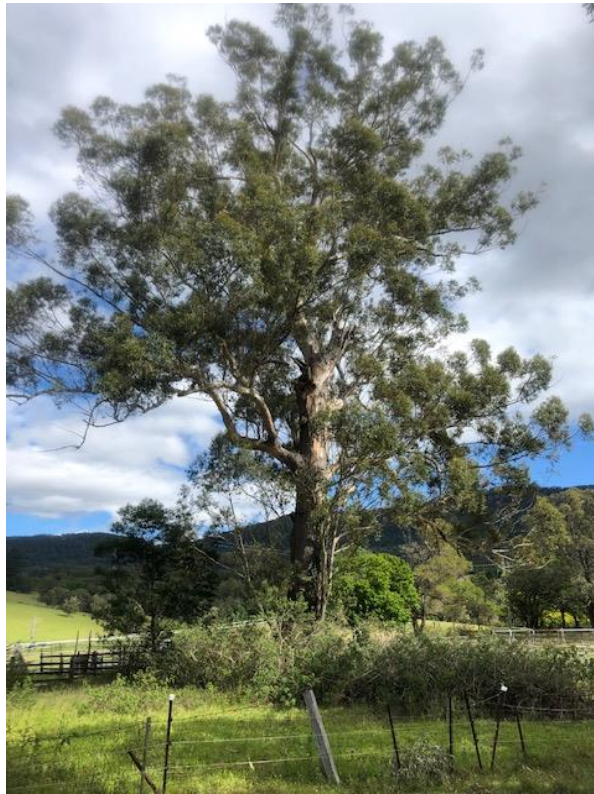
Hollow bearing trees were noted as being Trees 60, 63, 65, 76, 105, 106, 107, 108, 120-123. These hollows were observed from ground level thus not possible to determine if any habitat was present.

**Plate 9:** Image showing Tree 60 one of the several remnant trees on site. P. Vezgoff.

| Tree | Species | Height (m) | Spread (m) | DBH (m) | Live canopy % | Defects | SULE | Condition | Age | Comments | TPZ (m) | SRZ (m) |
|---|---|---|---|---|---|---|---|---|---|---|---|---|
| 60 | Blackbutt (Eucalyptus pilularis) | 28 | 15 | 1.5 | 90 | No visual defects | 2c removed for more suitable | Good | Mature | Likely habitat hollows | 18 | 4.3 |
