**ADE**  
CONSULTING  
GROUP

**Re: Proposed Little Bay Development – Review of Site Contamination**  
**Ref: MER-04-16399/LTR/v1 final**

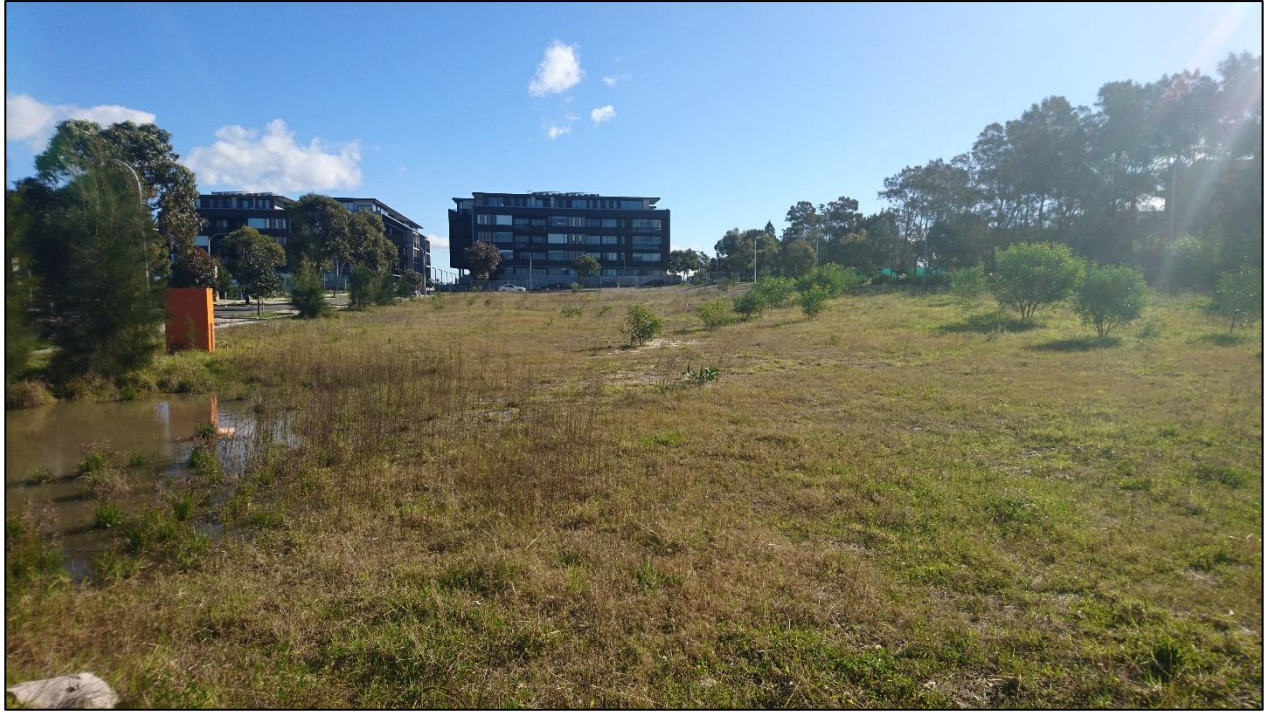
**Photograph 1:** Proposed Lot A (former construction compound area) – facing west. Dated 12.07.2019.

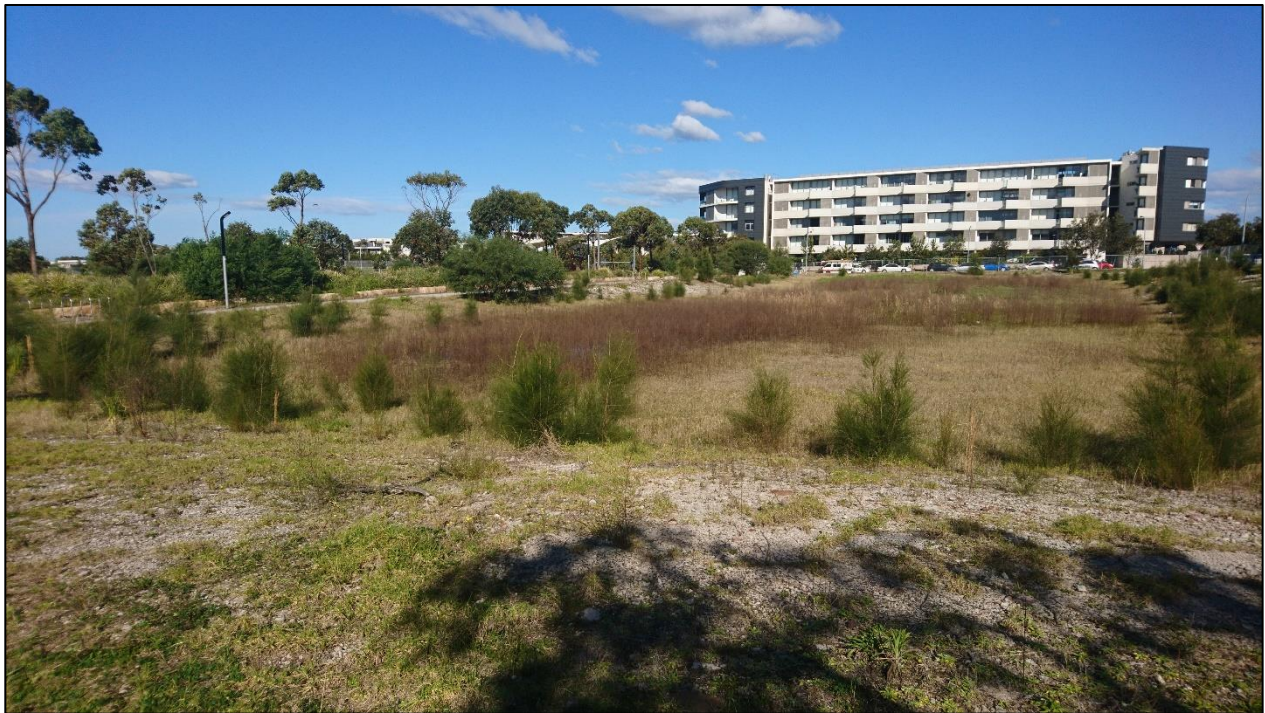
The proposed Park adjacent Lot C appears to have been underwater at various stages during and since the remediation works. It is unclear what the purpose of this dam area was.

**Photograph 2:** Proposed park area. Evidence of former dam use – facing south. Dated 12.07.2019.

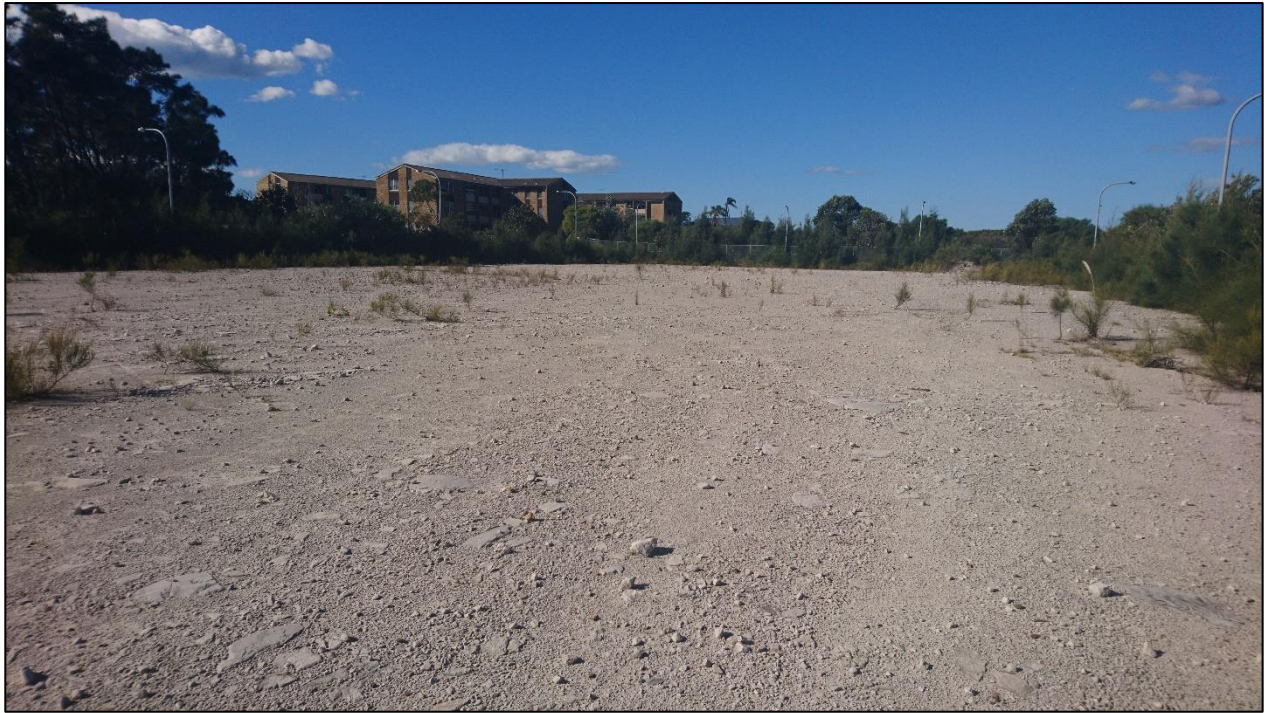
**Photograph 3:** Proposed eastern Lot – sandstone material throughout surface – facing east. Dated 12.07.2019.

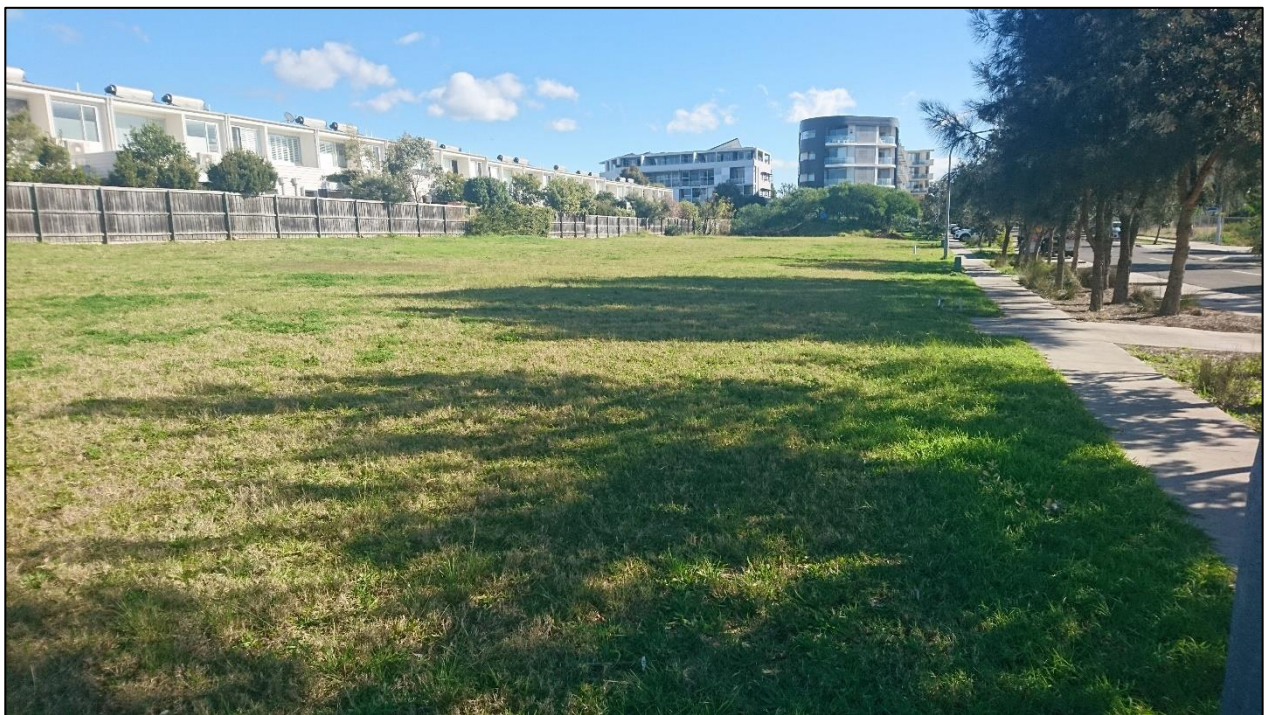
**Photograph 4:** Proposed southern lots (lot C) – facing west. Overgrown stockpile present at far end. Dated 12.07.2019.
