## ***PRELIMINARY CONTAMINATION AND URBAN CAPABILITY ASSESSMENT***

***LOT 12 DP 192526,***

***14 BURBANK CRESCENT, SINGLETON***

***PROJECT 39661***

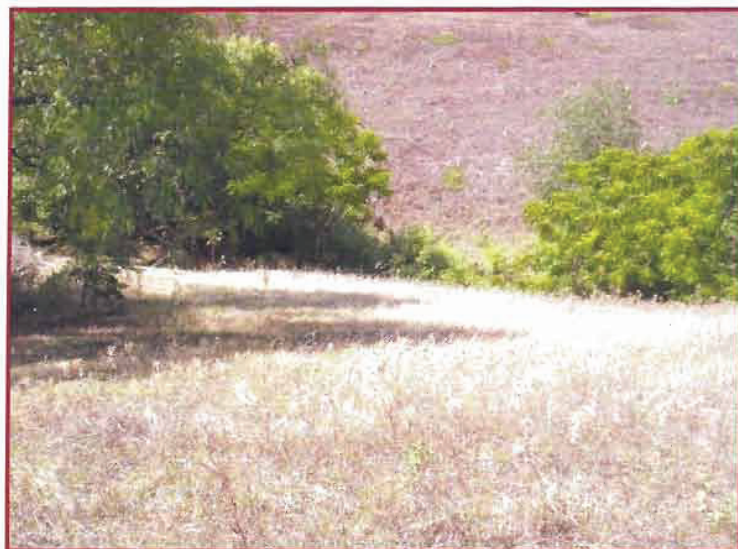
**Photo 1 – Typical section of the gully, looking south-east**

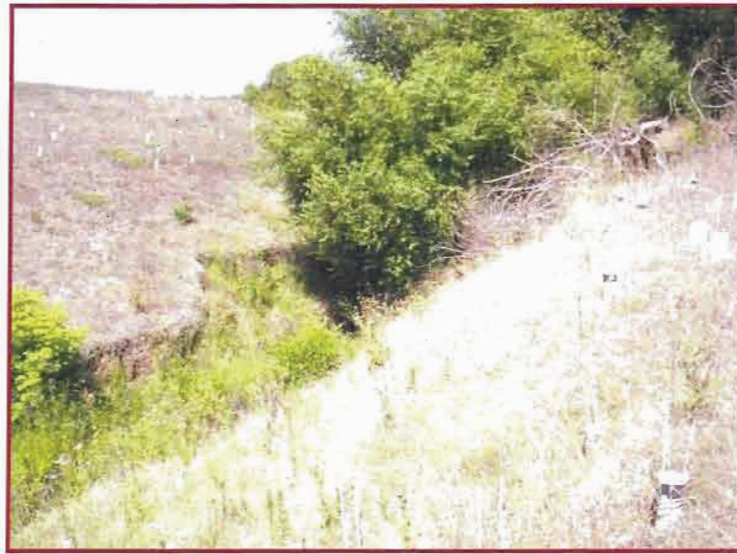
***Photo 2 – Typical section of the gully, looking west. Some erosion scarring is visible along the southern side of the gully.***

Slopes in the vicinity of the major gully are generally in the order of 30° to 40°, with some localised steeper slopes associated with erosion within the gullies. Further assessment of slope stability (including set back requirements for the proposed residential development) by an experienced geotechnical engineer or engineering geologist is recommended.

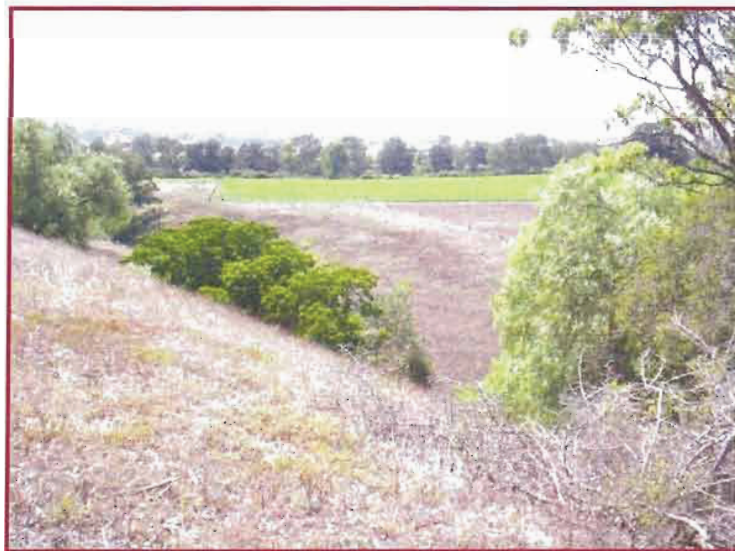
***Photo 3 – View along the gully looking east***

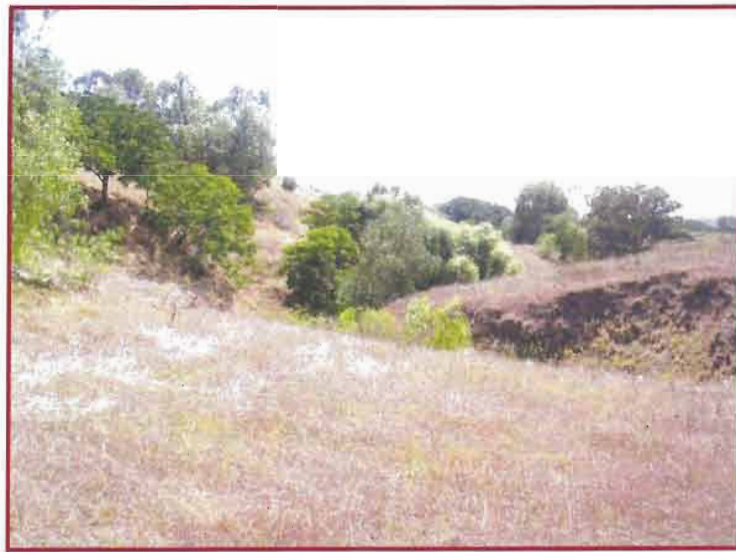
***Photo 4 – View along the gully looking east***

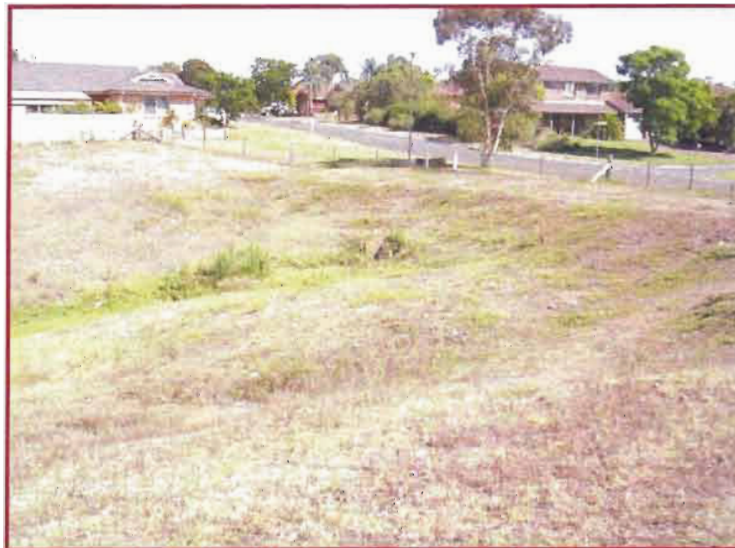
The upper reaches of the gully system within the site originate from suburban run-off onto the site, specifically a stormwater culvert draining into a farm dam located in the north-eastern corner of the site (photos 5, 6 and 8). The dam was observed to be turbid and contained some reeds and surface vegetation at the time of investigation.

***Photo 5 – Stormwater culvert draining onto site looking north-west***

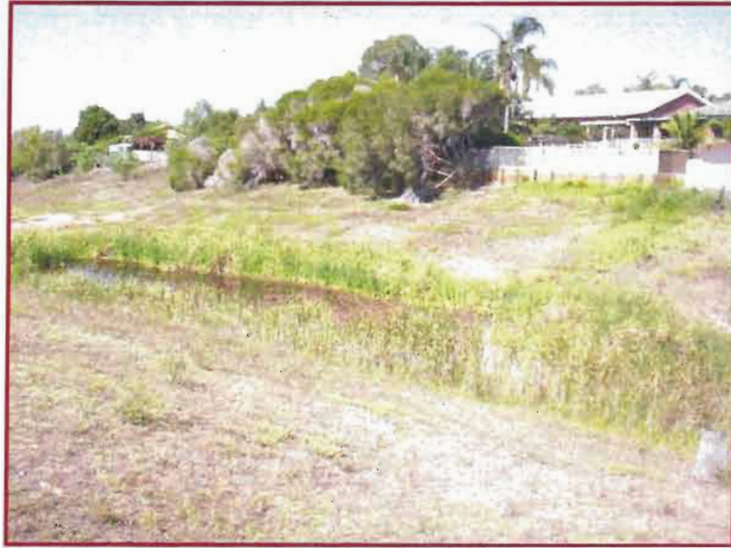
***Photo 6 – Farm dam located in the north-western portion of the site, looking south-west.***

Soils in the immediate vicinity of the farm dam were observed to contain some wet to saturated surface soils and some ponded water. The presence of soft / wet or poorly drained soils would not necessarily preclude development but would require some form of ground treatment, depending on the nature of the development. Further investigation is required in this area to determine the most appropriate treatment for future foundation and pavement design.

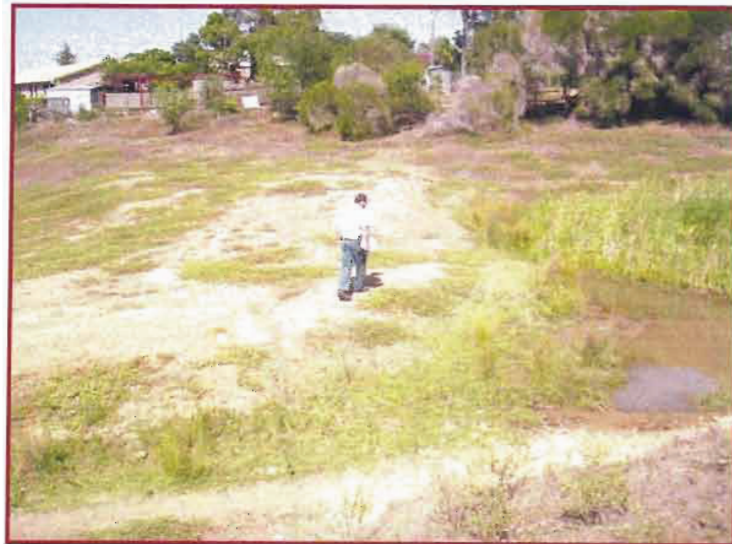
The southern end of the dam within the gully contained some fill at the time of investigation (photos 7 and 8) comprising clayey sand and gravel (generally 100mm diameter or less) at the surface.

***Photo 7 – Fill located at the southern end of the fill batter, looking west.***

- The fill pad found next to the dam contained brown clayey sand and gravel at the surface and was sourced from the excavation of nearby swimming pools, however the chance of opportunistic dumping in this area cannot be discounted;

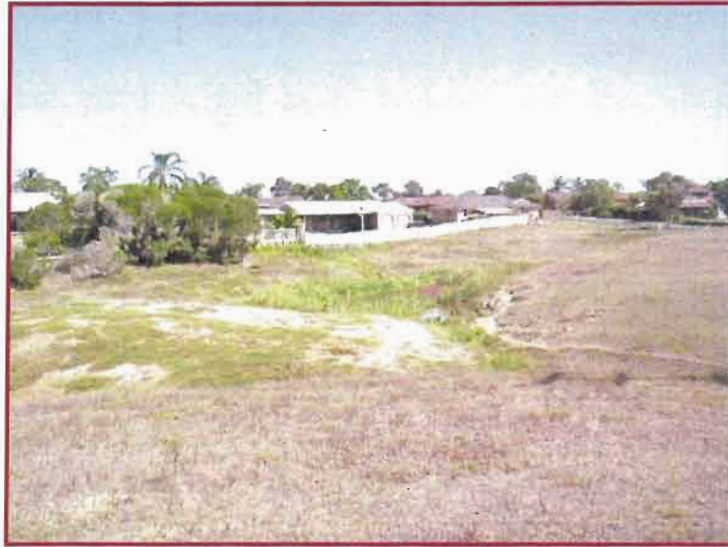
***Photo 8 – Upper reaches of the gully system showing open unlined drainage channel, dam and fill area, looking north-west.***

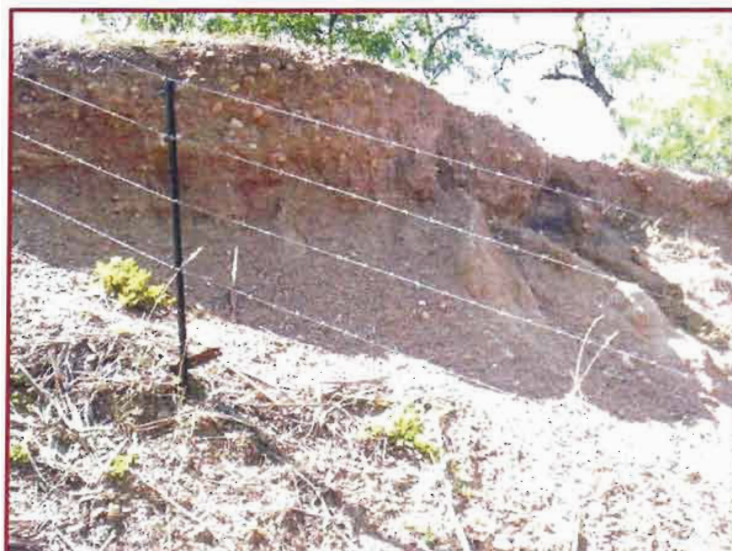
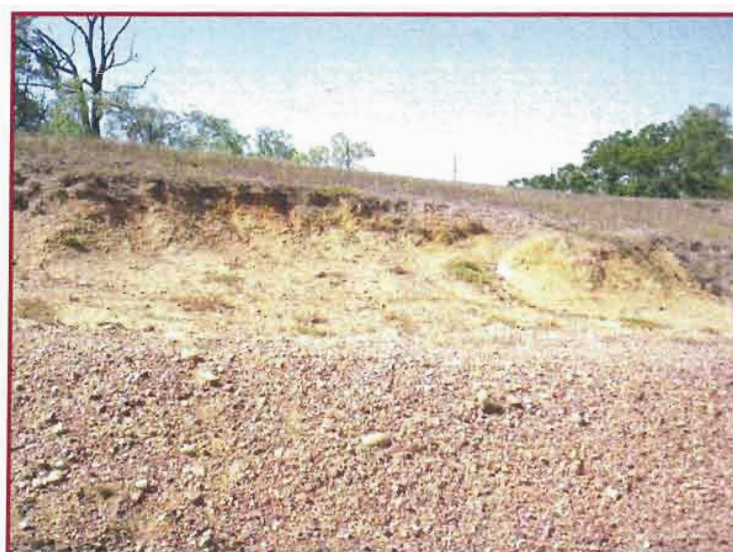
***Photo 9 – Erosion scarring along the gully banks***

***Photo 10 – Erosion scarring along the gully banks***

Near surface soils within the site were observed to be erodable where vegetation was sparse predominantly in the vicinity of the gully system. Further assessment including laboratory testing of soils is required to assess erosion potential of soils on site.

Provision of an adequate vegetation cover would aid in preventing large scale erosion at the site. It should also be noted that erosive soils are readily amenable to standard mitigation measures during and following construction.

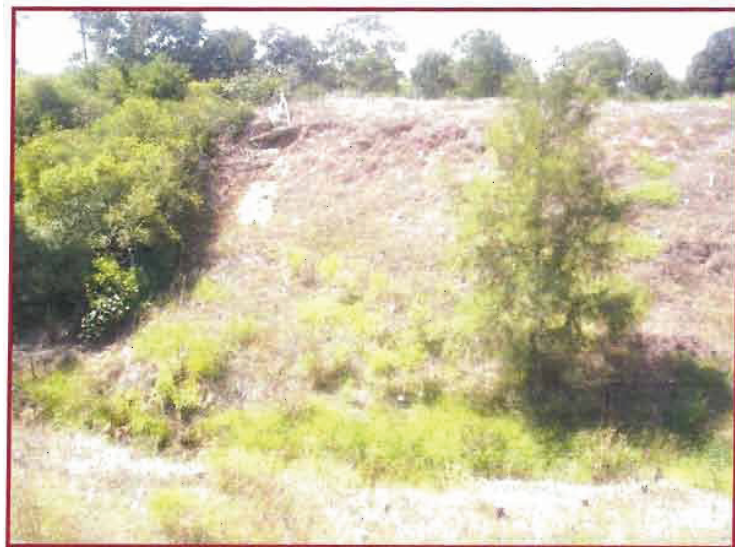
***Photo 11 – Semi mature trees and along the major gully line***

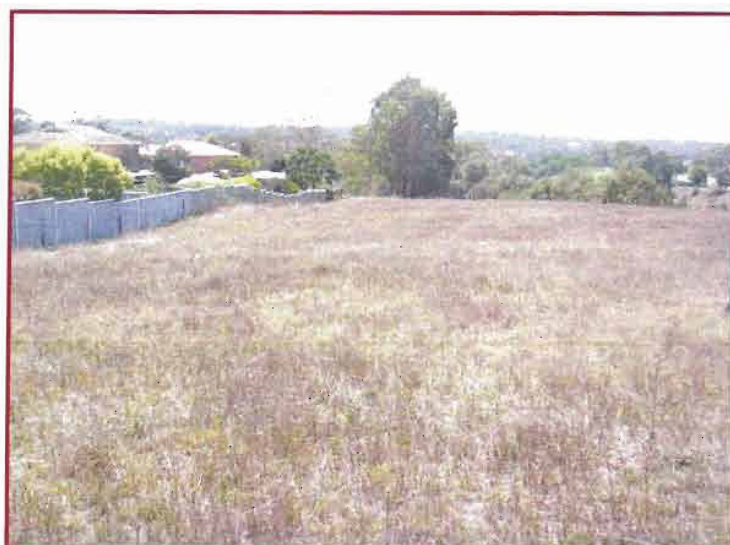
***Photo 12 – Open former pasture land at the northern end of the site, looking east.***

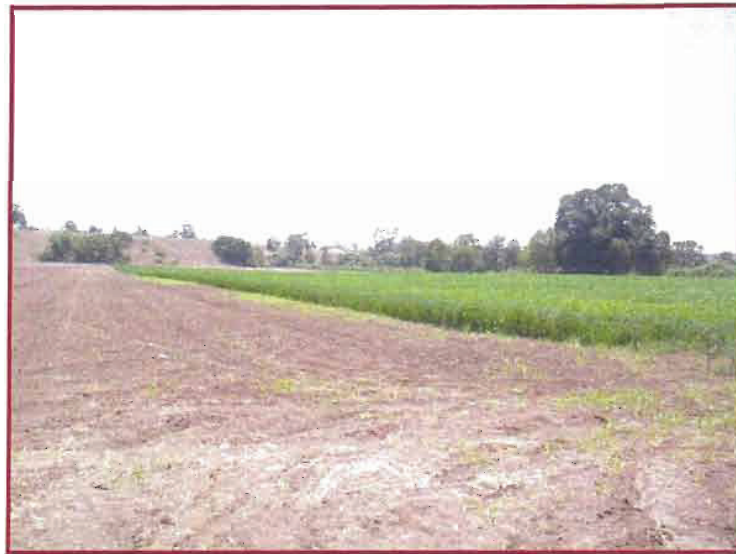
***Photo 13 – Crop land in the southern section of the site looking north-east***

- Possible pesticide use in the southern section of the site may have caused contamination, however given that this area of the site is proposed to remain agricultural, further assessment is not required at this stage;

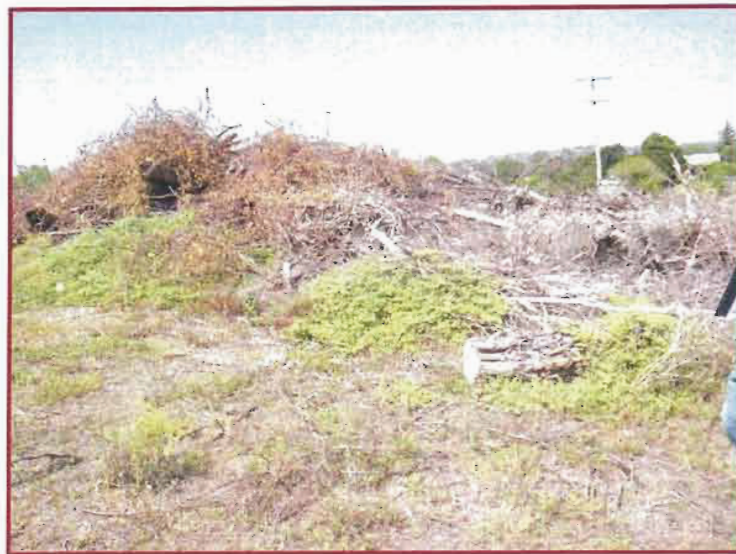
A fill stockpile containing timber and green waste, (previously containing building demolition materials) was located south-east of the dam in the western section of the site (photo 14). A further fill stockpile to the south of the dam contained clayey sand and gravel, glass, timber, plastic, PVC, brick and concrete up to 500 mm in diameter (photos 16 and 17). A small area of disturbed ground (possible rubbish burial area) was located in the western section of the site near the timber and green waste stockpile (photo 15).

***Photo 14 – Timber and green waste fill stockpile in the western section of the site, looking south.***

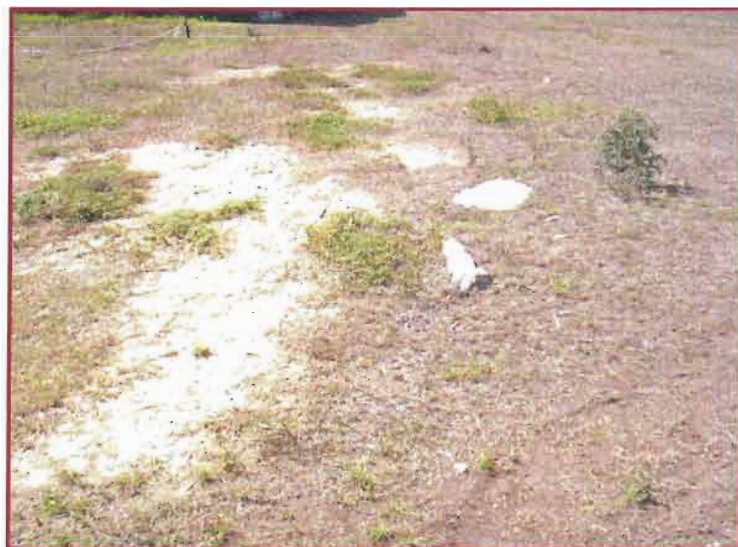
***Photo 15 – Small buried fill area in the western section of the site looking east.***

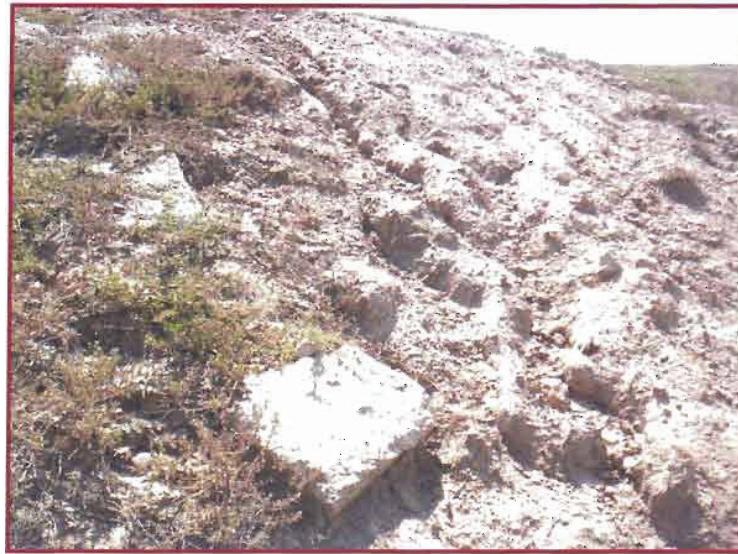
***Photo 16 – Fill stockpile in the western section of the site containing various materials, looking south-east.***

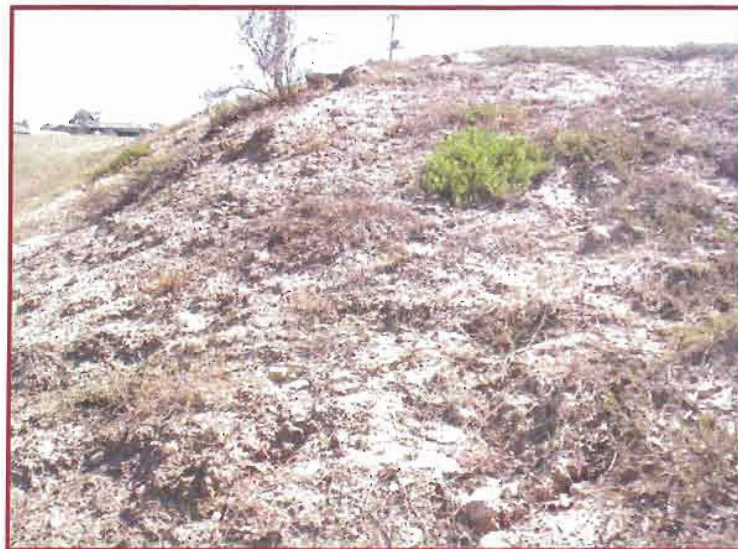
***Photo 17 – Fill stockpile in the western section of the site containing various materials, looking north.***

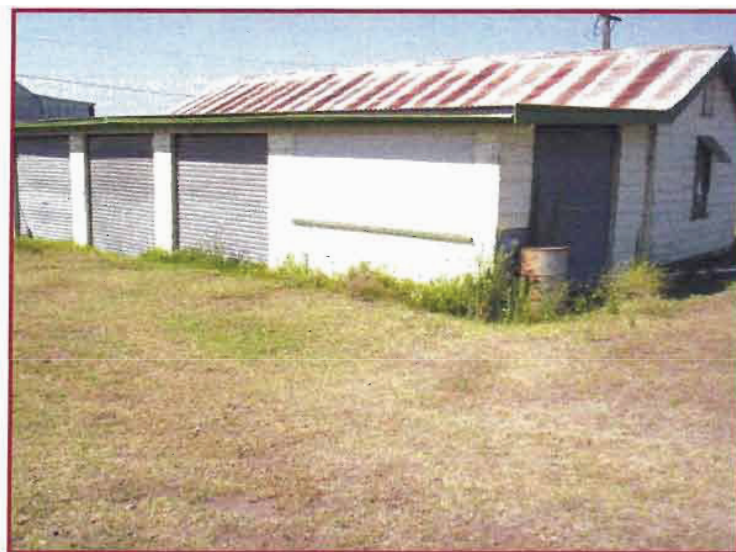
At the time of investigation, three sheds were located on-site as well as the site dwelling. The northernmost shed comprised timber, sheet metal and masonry construction on a concrete slab (photo 18). It is understood that this shed housed a dairy.

**Photo 18 – Former dairy shed, looking south-east.**

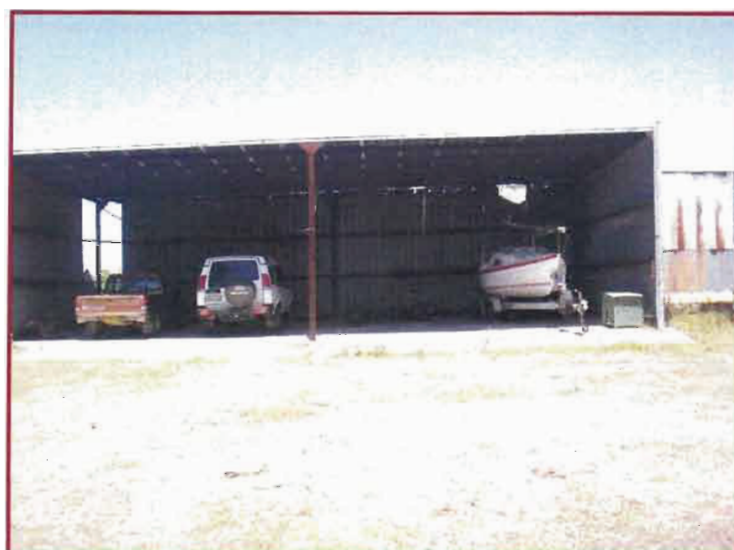
**Photo 19 – vehicle storage shed, looking south.**

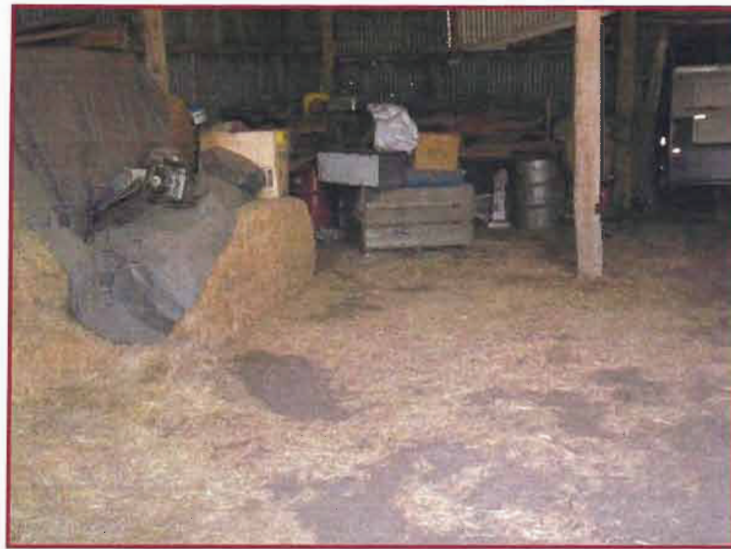
The southernmost shed was of timber and sheetmetal construction on a concrete slab, and at the time of investigation was used for vehicle storage. The third shed, also of timber and sheetmetal construction, was on bare ground and was used for storage of hay bales, empty 44 gallon drums, a caravan, timber and building materials.

***Photo 20 – inside the southernmost storage shed***

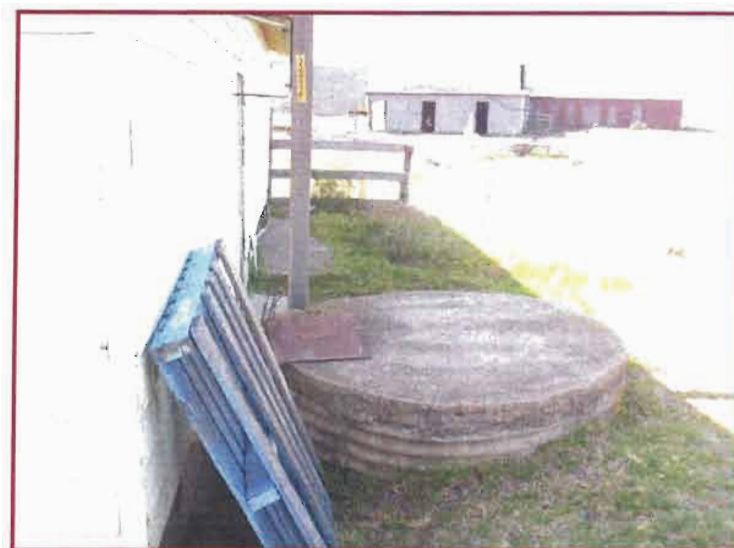
A water tank located adjacent to the dairy shed appears to collect stormwater from the roof of the shed and has not been used since 1971 (photo 21). No surface staining was observed in the vicinity of the shed at the time of investigation.

***Photo 21 – Stormwater collection tank next to the dairy shed. Looking east toward the storage shed.***

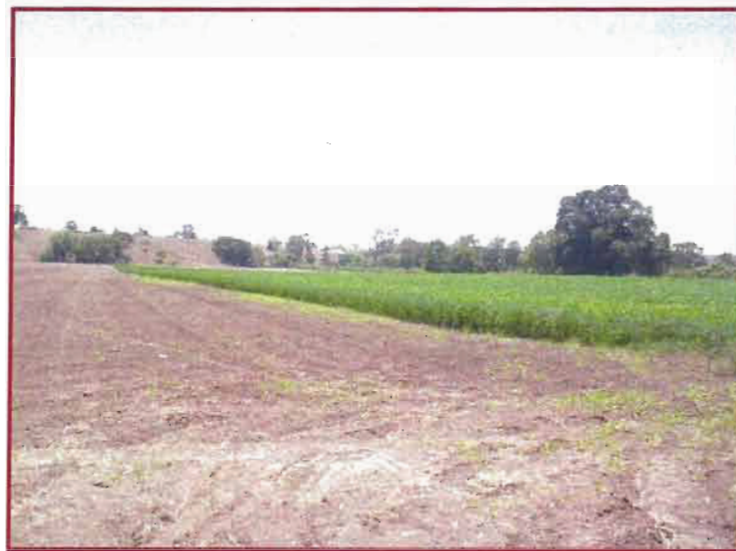
***Photo 22 – Ploughed fields for cropping purposes.***

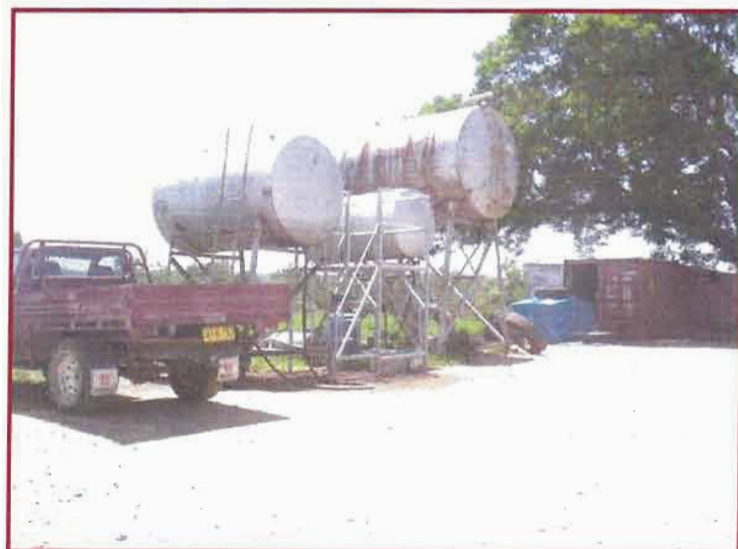
The southern section of the site contained large ploughed fields for cropping purposes (photo 22). Above ground fuel storage tanks were observed on the southern boundary of the site (photo 23). Some localised staining was observed at the base of the tanks.

***Photo 23 – Above ground fuel storage tanks located on the southern boundary of the site.***
