Urbis Pty Ltd  
Doyalson Wyee RSL Structure Plan  
Preliminary site investigation - FINAL REPORT

May 2018

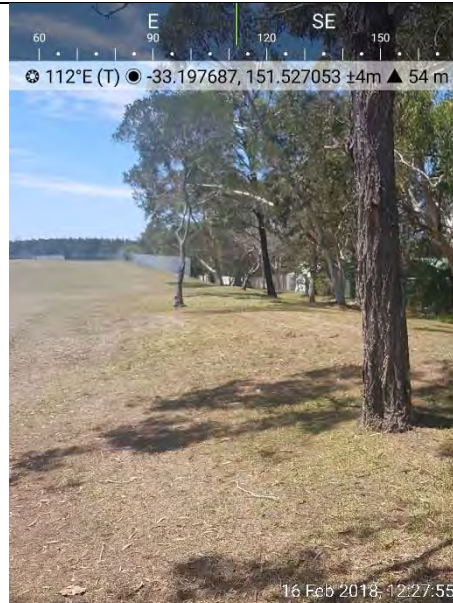
View looking east over 80-90 Pacific Highway.

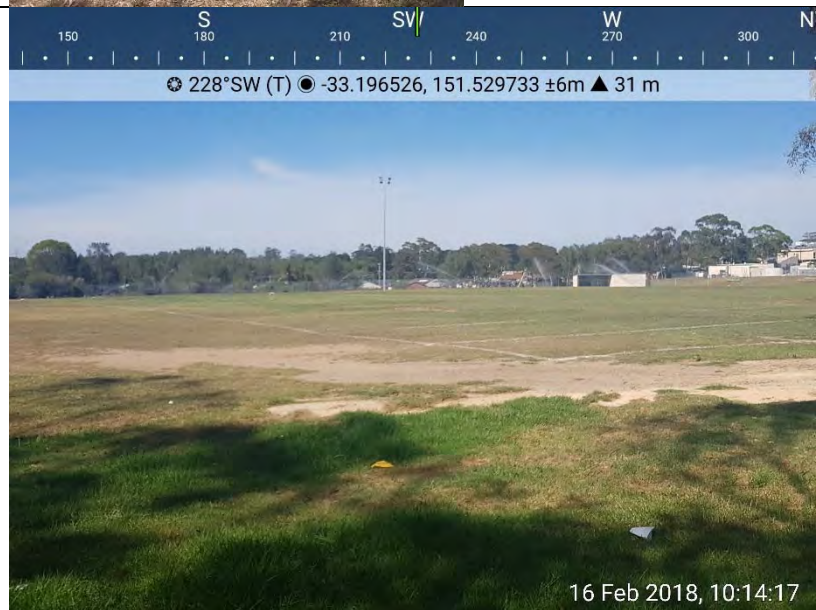
View over playing fields located at 100 Pacific Highway

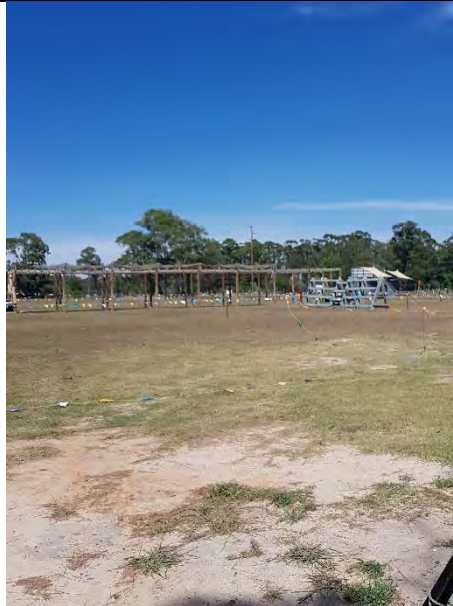
Example of built obstacles  
located 110 Pacific Highway

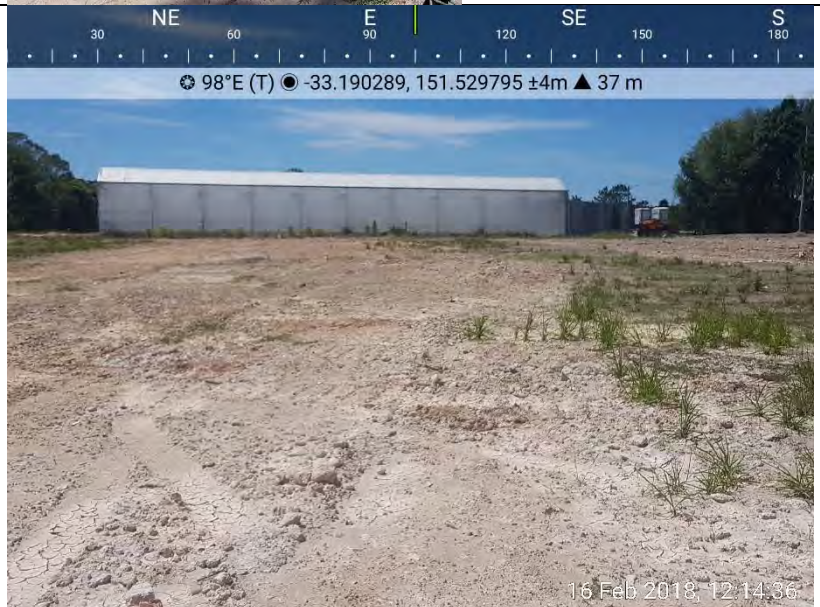
Eastern-most greenhouse  
located at 120 Pacific  
Highway. Image taken  
looking eastwards.

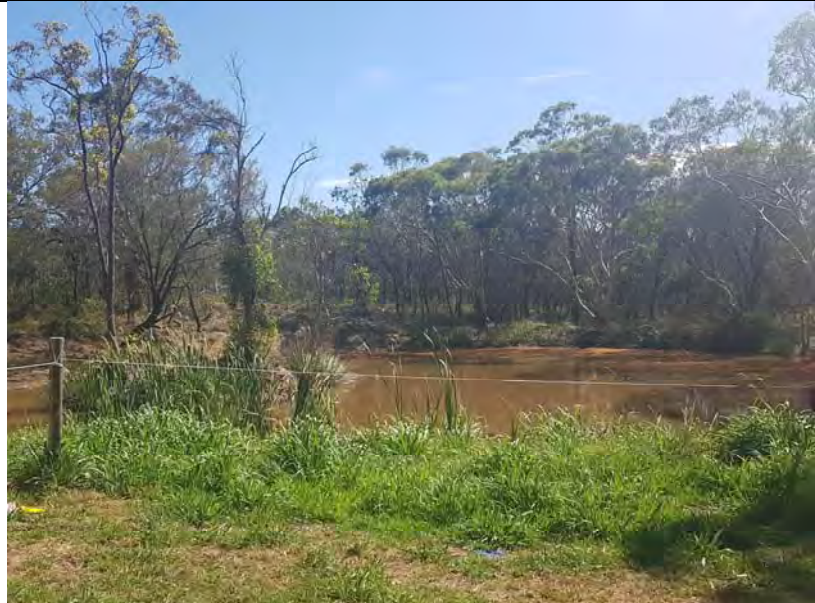
Surface water body located at 100 Pacific Highway.

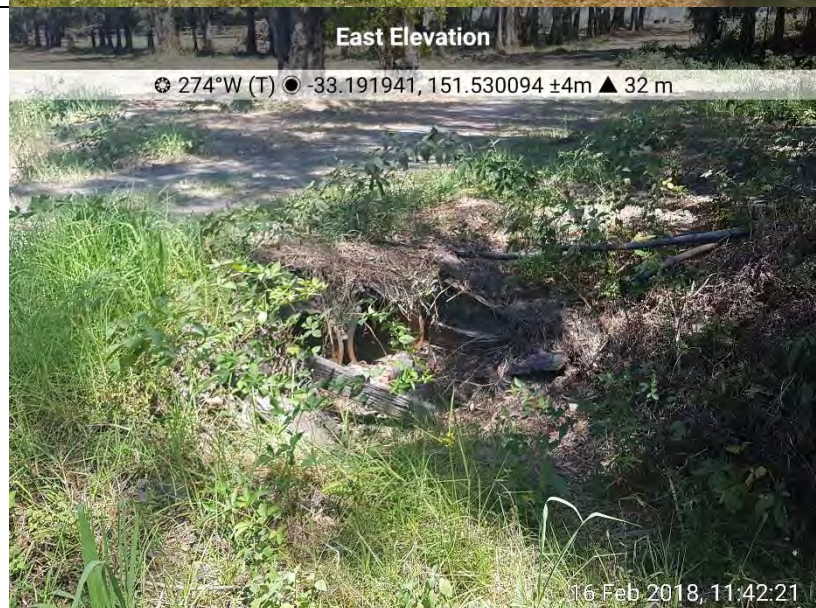
Culvert of dry, unnamed creek which traverses both 110 and 120 Pacific Highway before entering Colongra Lake.

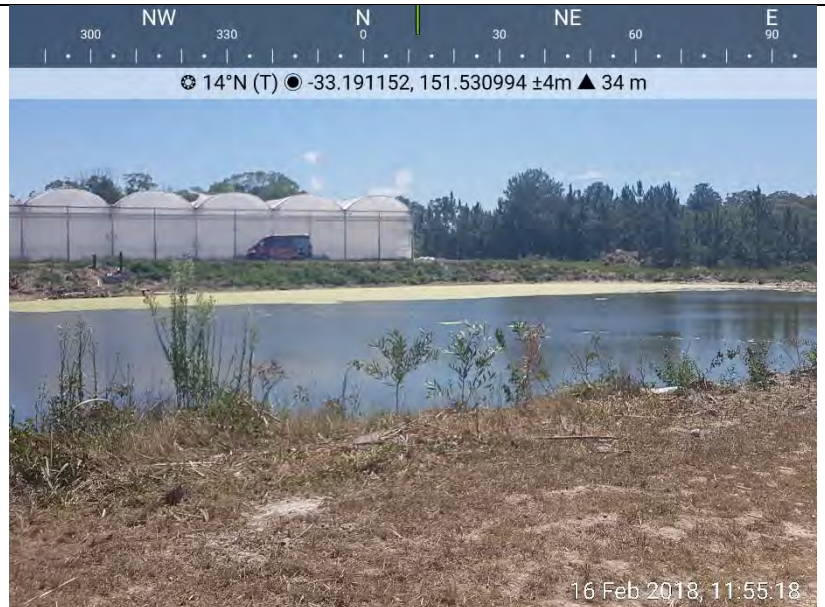
Dam located at 120 Pacific Highway adjacent to greenhouses.

Algal growth adjacent to the greenhouses may indicate high nutrient load resulting from fertiliser runoff or discharge.

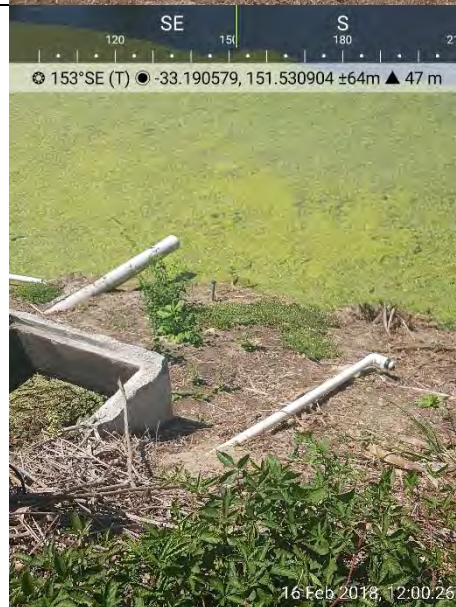
Potential outflow pipes into dam. Algal growth in this area may indicate high nutrient load in discharge water.

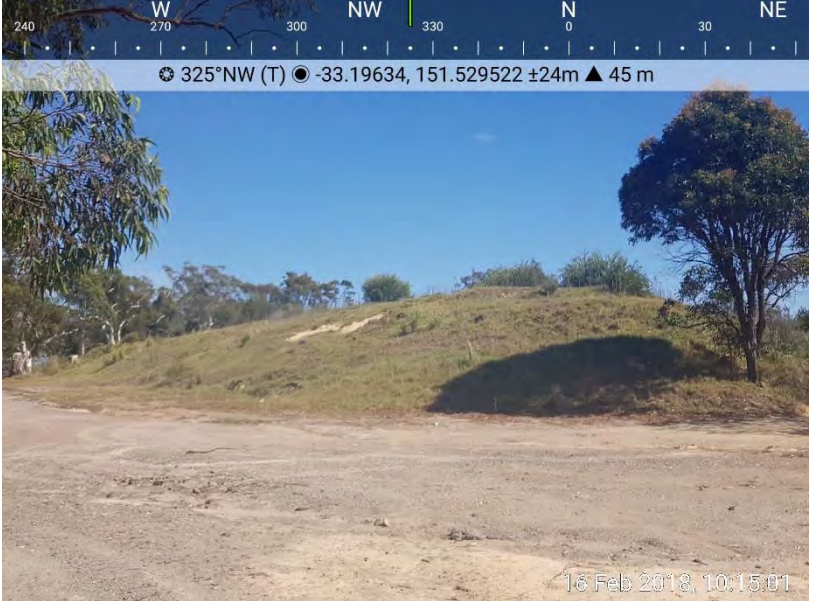
Stockpile ID	Location (latitude / longitude)	Description
A	-33.196319° / 151.529012°	Located at 100 Pacific Highway, north of the central playing field, the stockpile covers an area of approximately 2000 m <sup>2</sup> and ranging in height from 1-3 metres. Based on discussions with site personnel, GHD understands that the stockpile contained mostly fill material and garden refuse, however some construction rubble was observed on top of the stockpile including blocks of concrete, bitumen, gravel and wood.
B	-33.195647° / 151.529137°	Located approximately five metres north of Stockpile A, this stockpile appeared to contain mostly garden refuse in a conical pile approximately 60 m <sup>2</sup> and two metres tall.
C	-33.195662° / 151.528515°	A mixed stockpile abutting the northwest flank of Stockpile A containing garden refuse and demolition waste including concrete blocks, scrap metal and bricks. Approximately 120 m <sup>2</sup> in area and ranging from 1.0 to 1.5 metres tall.

<p>Stockpile A seen facing northwest</p>

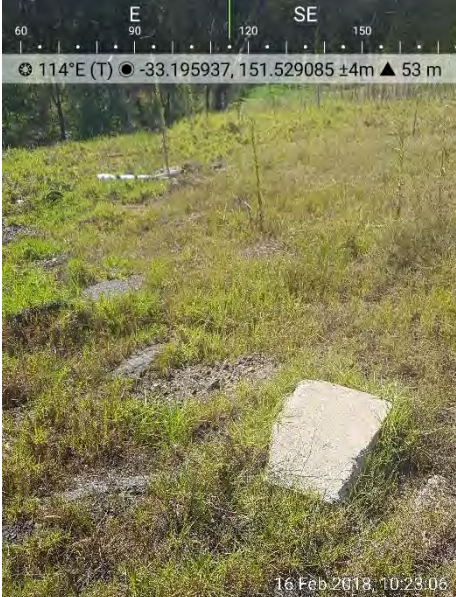
<p>Building rubble including concrete and bitumen on top of Stockpile A</p>

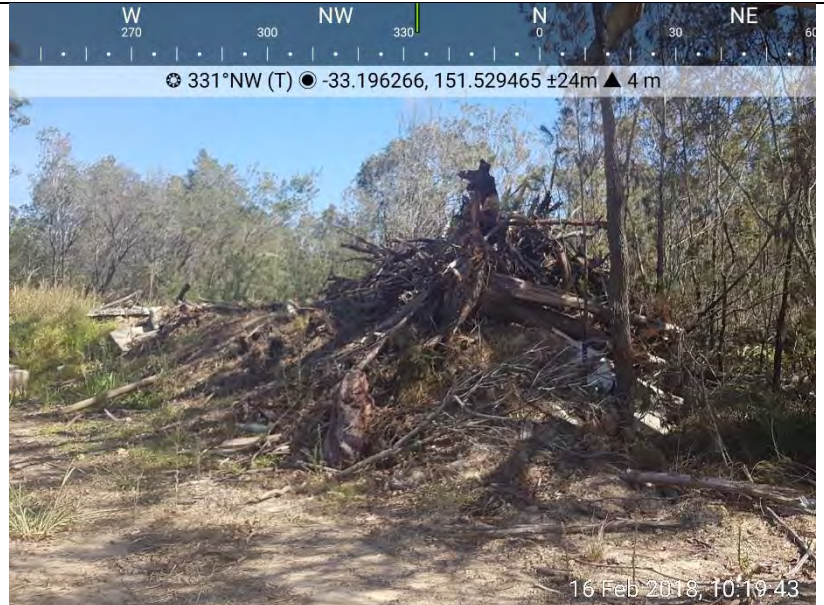
Stockpile B containing garden refuse

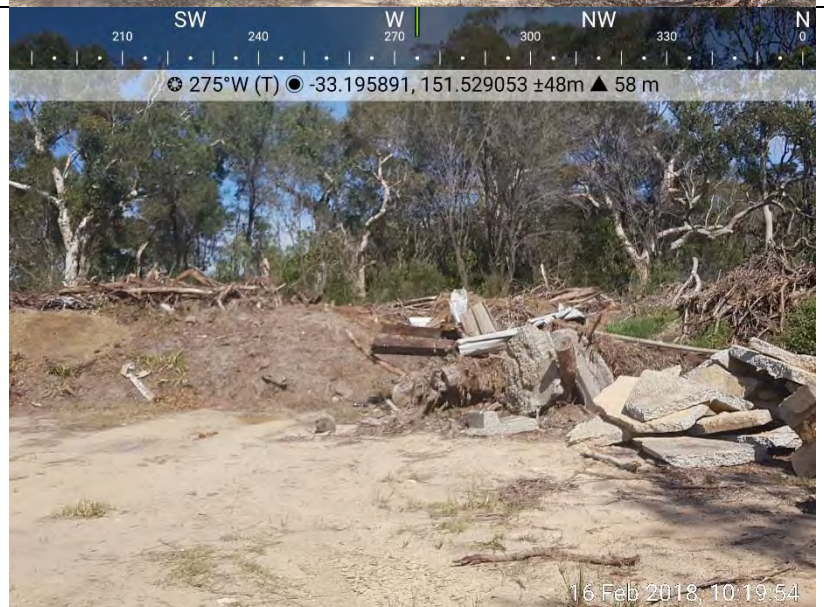
Stockpile C containing garden refuse and demolition waste.

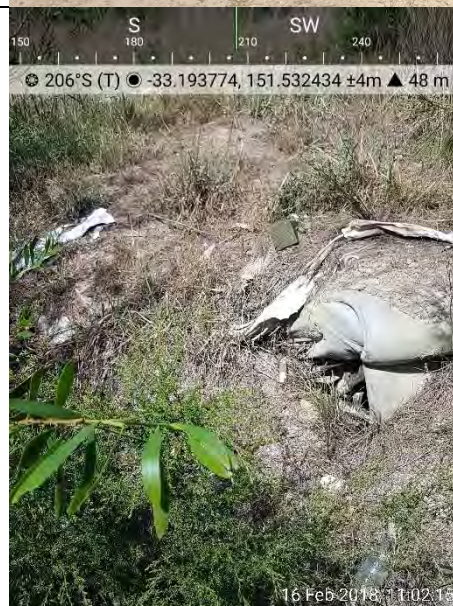
Stockpile C continued

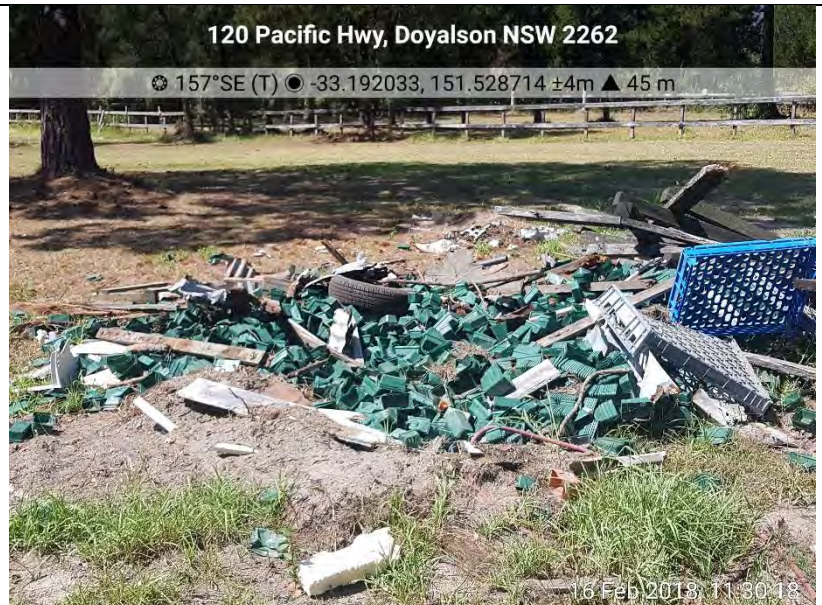
Area of uncontrolled dumping identified as Stockpile E located at 120 Pacific Highway. Materials appeared to be associated with the nursery operations at the site.

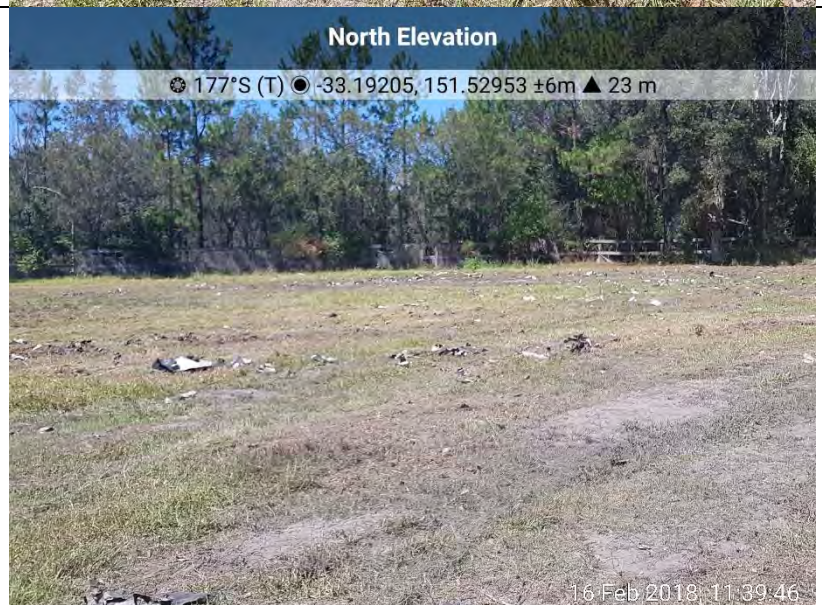
Area of uncontrolled dumping identified as Stockpile F at 120 Pacific Highway. Material comprises scraps of plastic laminated webbing, empty fertiliser sacks, plastic pots, cardboard, string, pallets, jute bags, fish scales (nutrients).

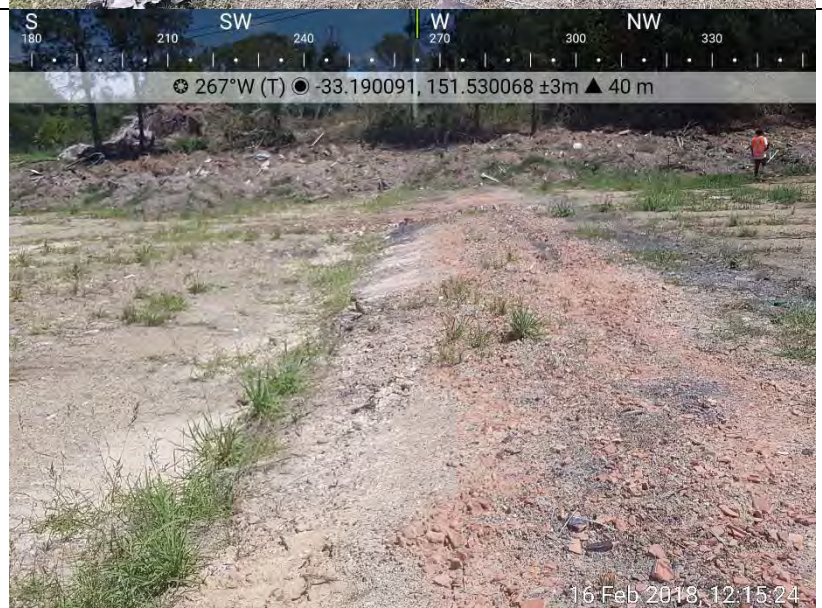
Area identified as Stockpile G. Former outside propagation area. All infrastructure has been demolished. Waste in this area includes broken ceramic pots and tiling, brick, concrete cobbles, broken plastic irrigation pipes

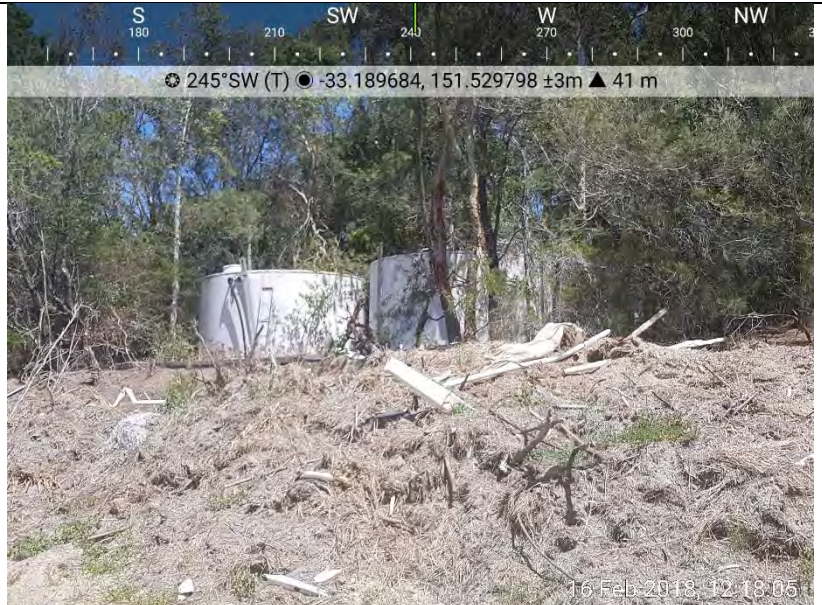
Area identified as Stockpile G. Stockpiled vegetation waste as well as plastic and metal irrigation pipes and treated timber.

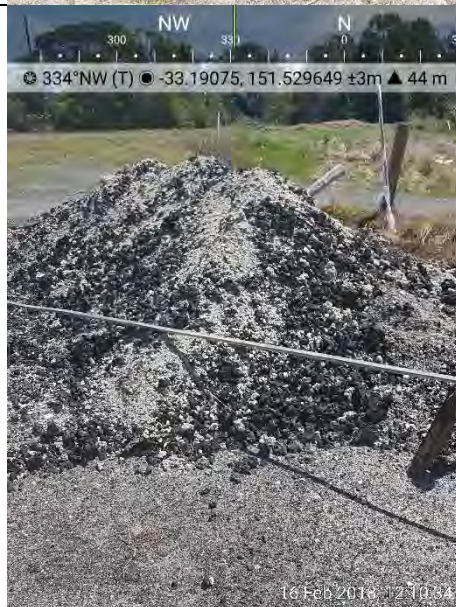
An incinerator is located at 120 Pacific Highway. Surrounding its concrete footings are deposits of ash and coke, and nearby was a stockpile of ash and coke of 5 m<sup>3</sup>. A coal bunker is located adjacent to the incinerator and during the site inspection was observed to contain approximately 5 m<sup>3</sup> of coal.

Stockpile H adjacent to the incinerator located at 120 Pacific Highway, Doyalson.

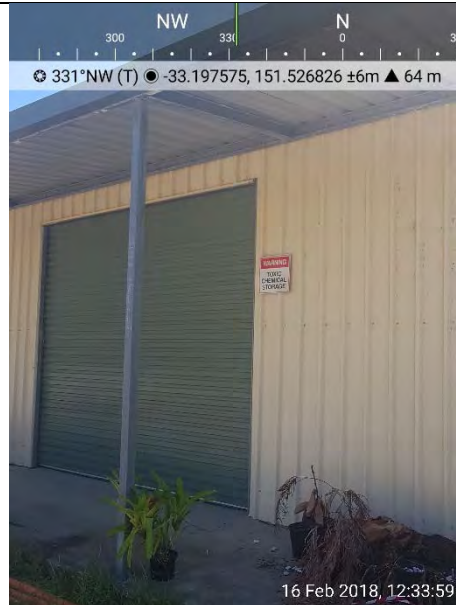
Signage indicating chemical storage at 80 Pacific Highway.

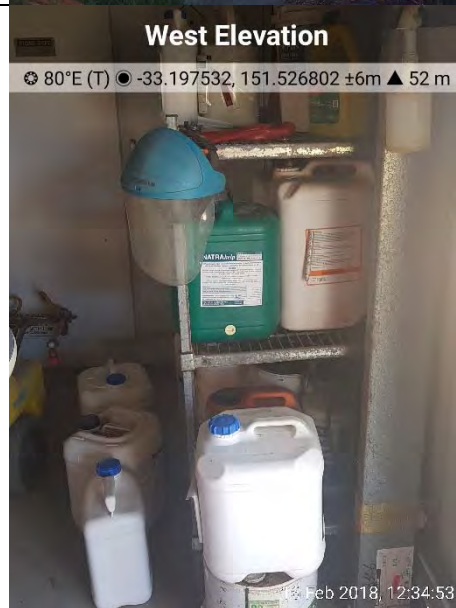
Within the chemical storage sheds at 80 Pacific Highway. Chemicals included herbicides, pesticides, and plant nutrients.

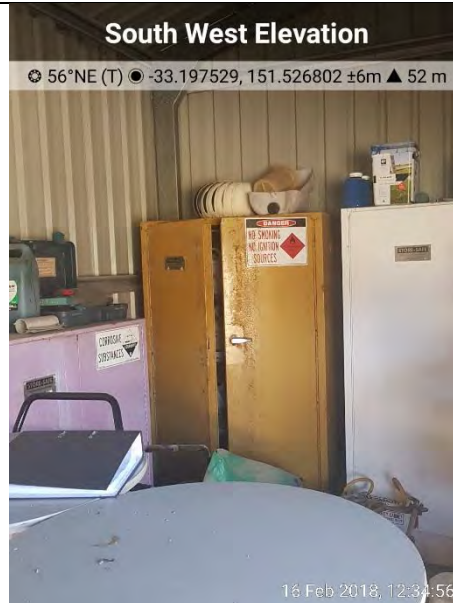
Within the chemical storage sheds at 80 Pacific Highway. Un-banded cupboards indicating storage of flammable and corrosive chemicals. Access to these was prevented by stored furniture.

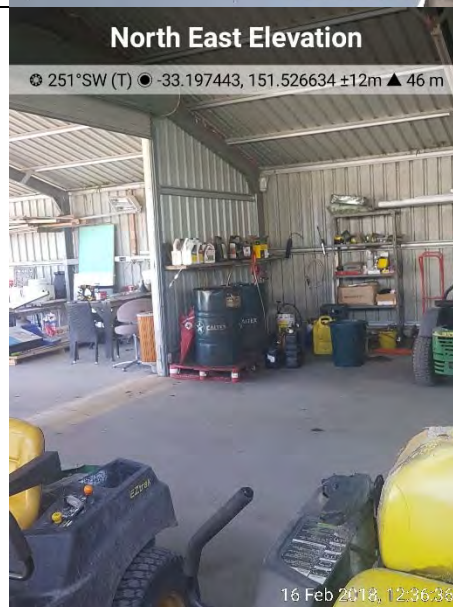
A small amount of staining was observed in the vehicle maintenance shed located at 80-90 Pacific Highway. The staining appeared relatively new and covered an area of less than 0.5 m<sup>2</sup> and was located adjacent to stored motor oils. This area was generally clean and tidy and concrete surfaces were in good condition. There is a sump on the concreted forecourt which is connected to an oil/water separator.

Stored motor oils in the vehicle maintenance shed located at 80 Pacific Highway.

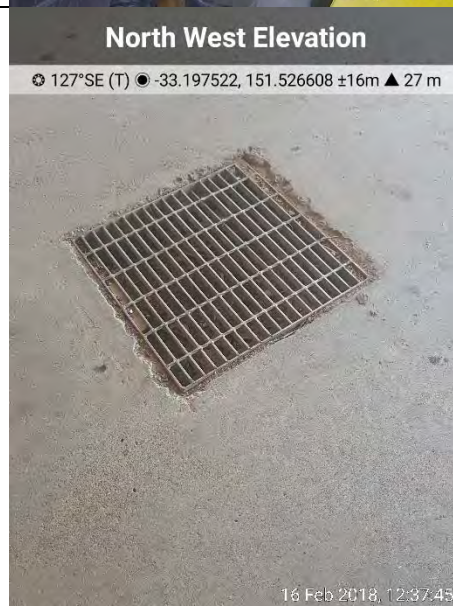
Grate covering sump outside the roller door to the vehicle maintenance shed at 80 Pacific Highway.

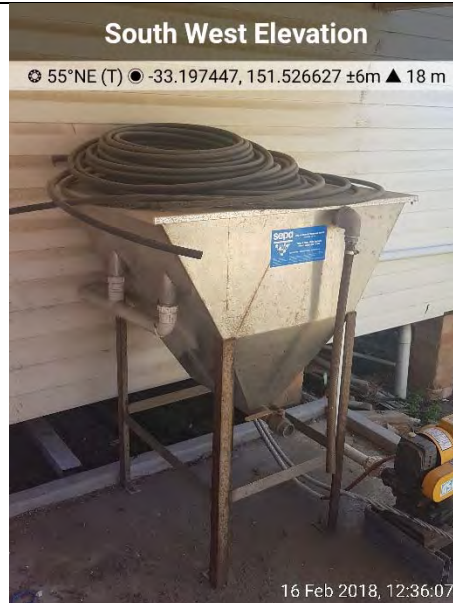
Oil water separator adjacent to the vehicle maintenance shed at 80 Pacific Highway.

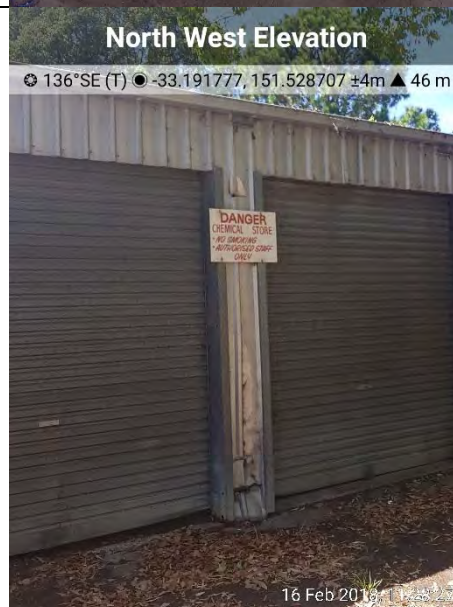
Storage shed located in the southwest of 120 Pacific Highway with signage indicating chemical storage. Access to the shed was possible through the back, however there was no indication of chemical storage in the area that was accessible, and the adjoining door between rooms was locked.

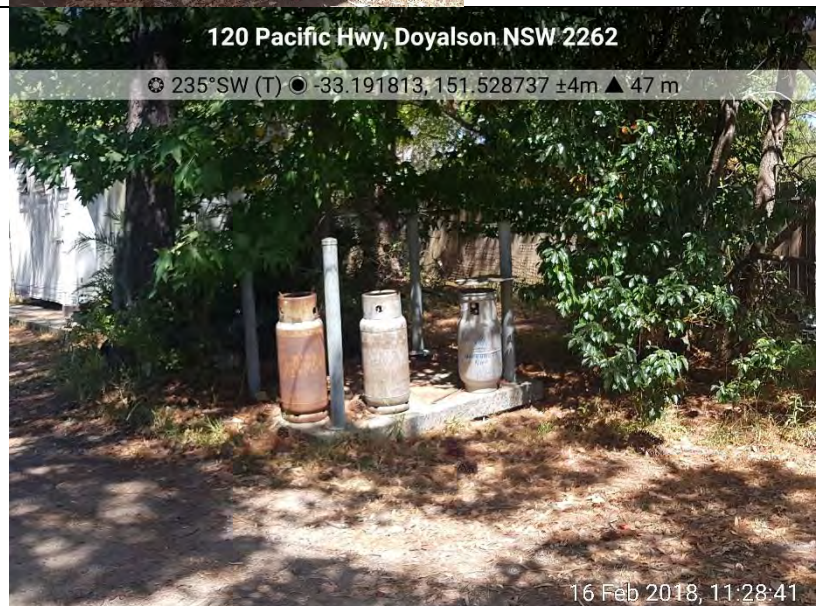
Storage of gas bottles at  
120 Pacific Highway  
Doyalson.

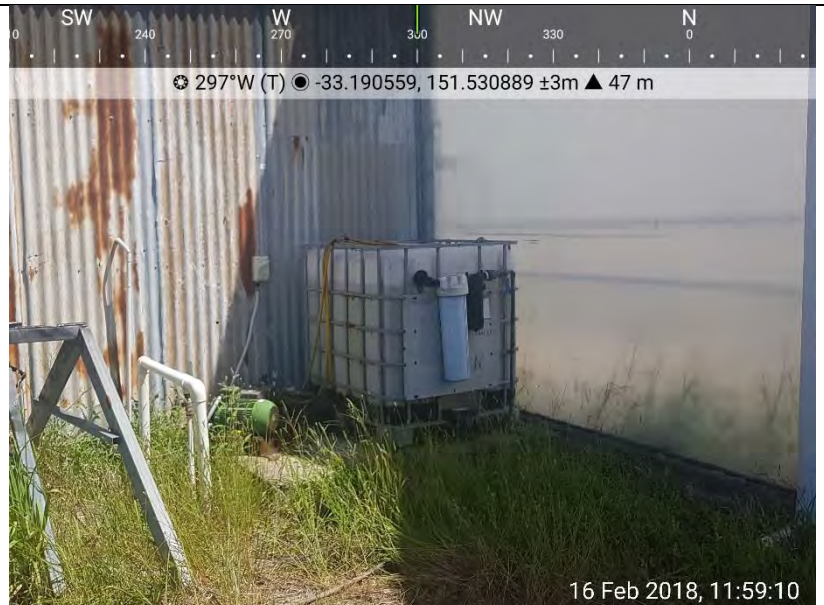
An intermediate bulk container (IBC) and pump adjacent to the northern-most nursery at 120 Pacific Highway.

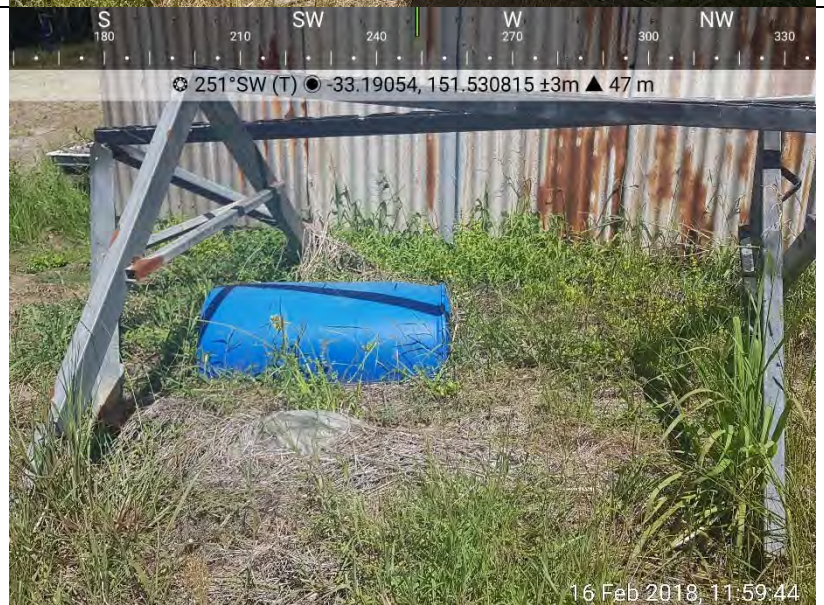
Partially buried plastic drum (empty) located near IBC and pump at 120 Pacific Highway. The drum was not labelled and its former contents unknown.

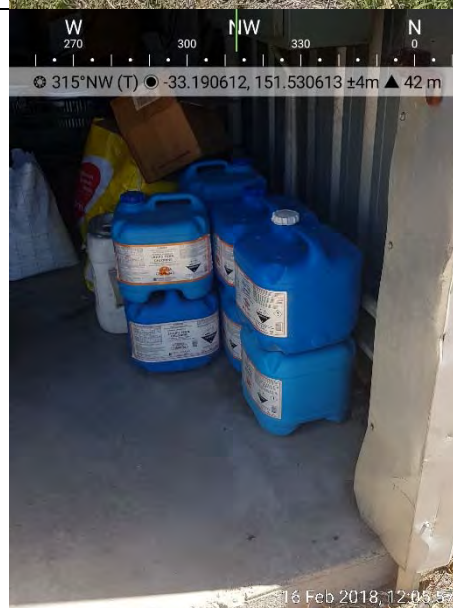
Storage of approximately 100 L of liquid pool chlorine within chemical storage sheds at 120 Pacific Highway.

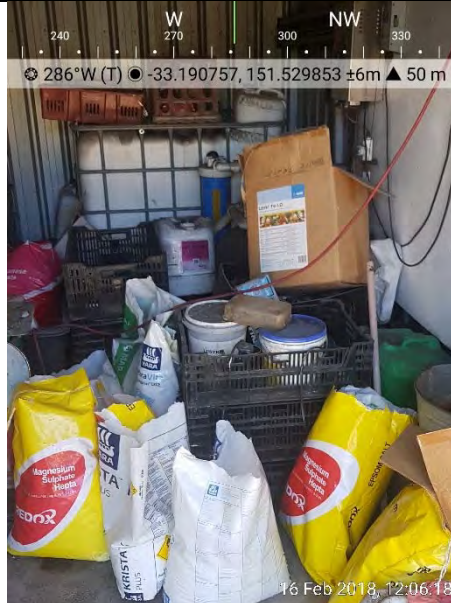
Storage of open bags of miscellaneous nutrients within chemical storage sheds at 120 Pacific Highway.

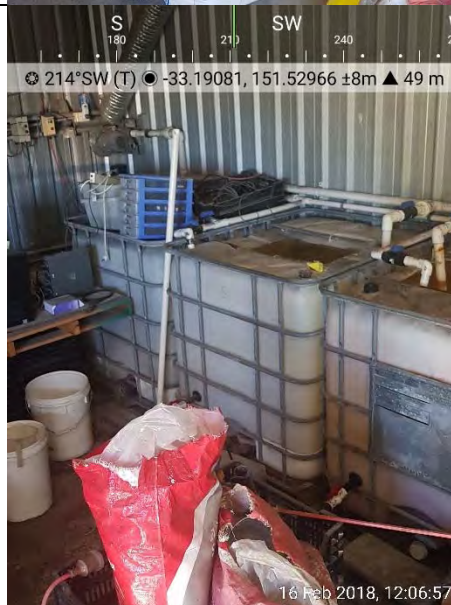
Open IBCs with irrigation pipes exiting the shed within chemical storage sheds at 120 Pacific Highway.

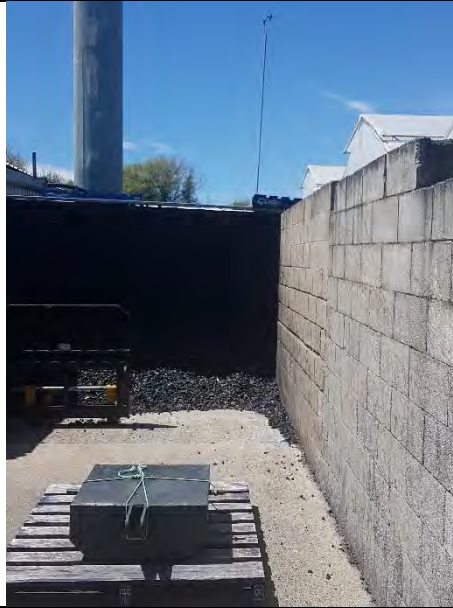
Coal bunker adjacent to the incinerator. Incinerator stack is visible in the background.
