Report on
Preliminary Site Investigation

Site 1 - Lake Munmorah Rezoning
Lake Munmorah and Crangan Bay

Prepared for
Darkinjung Local Aboriginal Land Council

Project 83115.00
September 2017

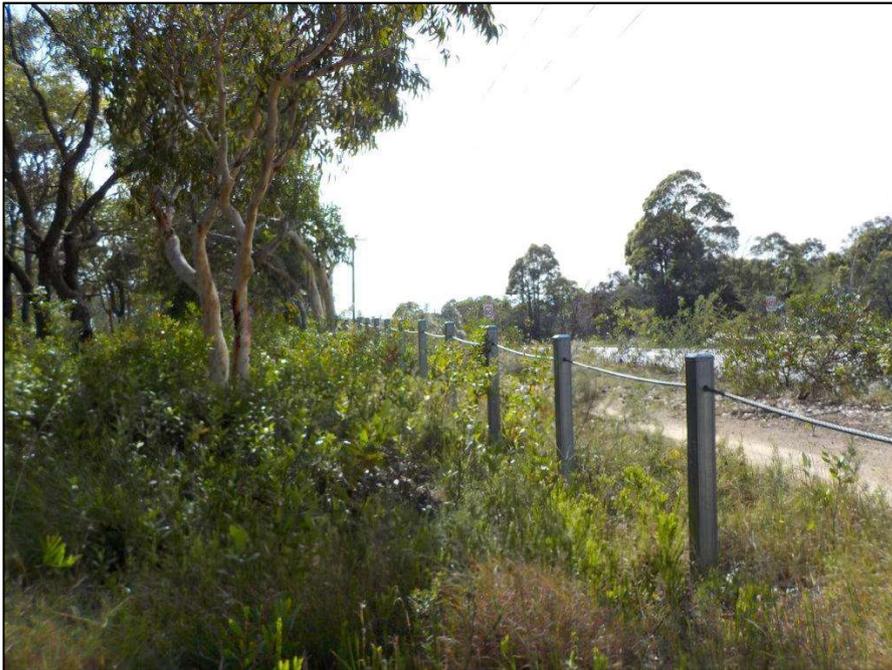
Photograph 1: View along southern boundary of Lot 642 with Pacific Highway on right.

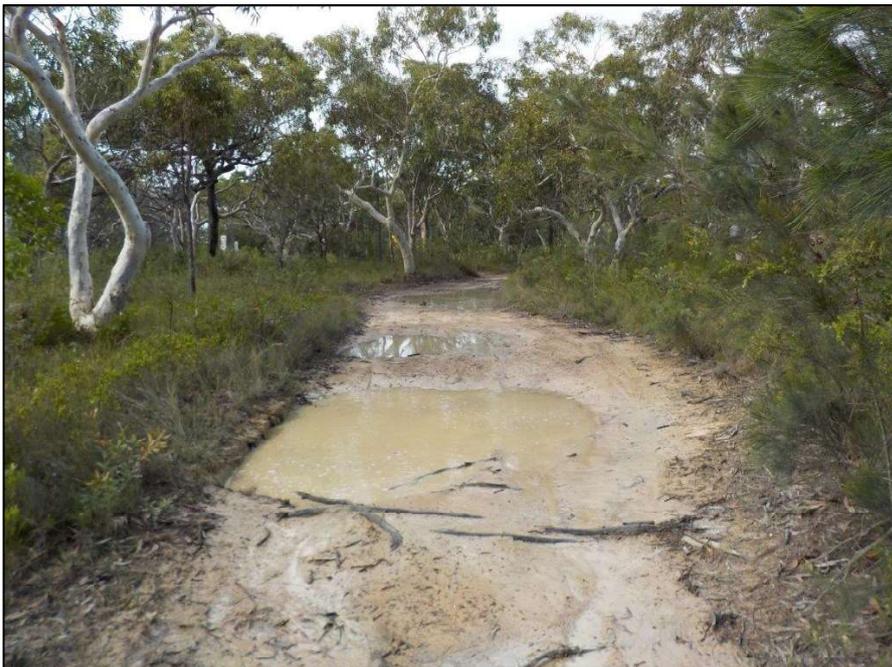
Photograph 2: Access track in southern portion of Lot 642 (facing north). Walkover of the site was restricted by dense vegetation.

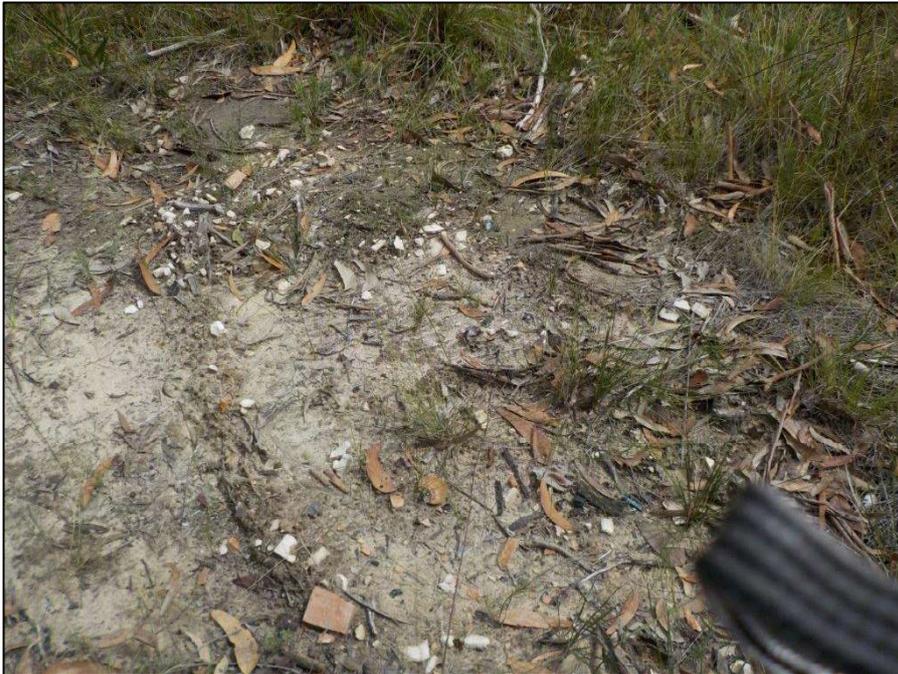
- A number of fragments of asbestos-containing material (ACM) were observed amongst tile and demolition debris in the central portion of Lot 642 (Reference Point 10 on Drawing 1, Appendix A). Additionally, the south-western portion of Lot 100 comprises a cleared area of approximately 1 hectare, where a number of ACM fragments were observed on the ground surface (refer Photograph 4). The approximate locations of these and other areas where ACM fragments were observed are shown on Drawing 1, Appendix A;

Photograph 3: ACM fragments and demolition debris observed in central portion of Lot 642 (Reference Point 10 on Drawing 1, Appendix A).

These investigations should include an assessment of site soils for chemical and physical characteristics to confirm the perceived low to moderate risk of contamination. The investigations should also target the areas where ACM and/or PACM have been observed on the ground surface to evaluate the vertical and lateral extent of ACM contamination (if any) at the site. Should the results of the intrusive investigations identify the need for remediation, then an adequate remediation and validation programme will need to be implemented to render Site1 suitable for the proposed residential development.

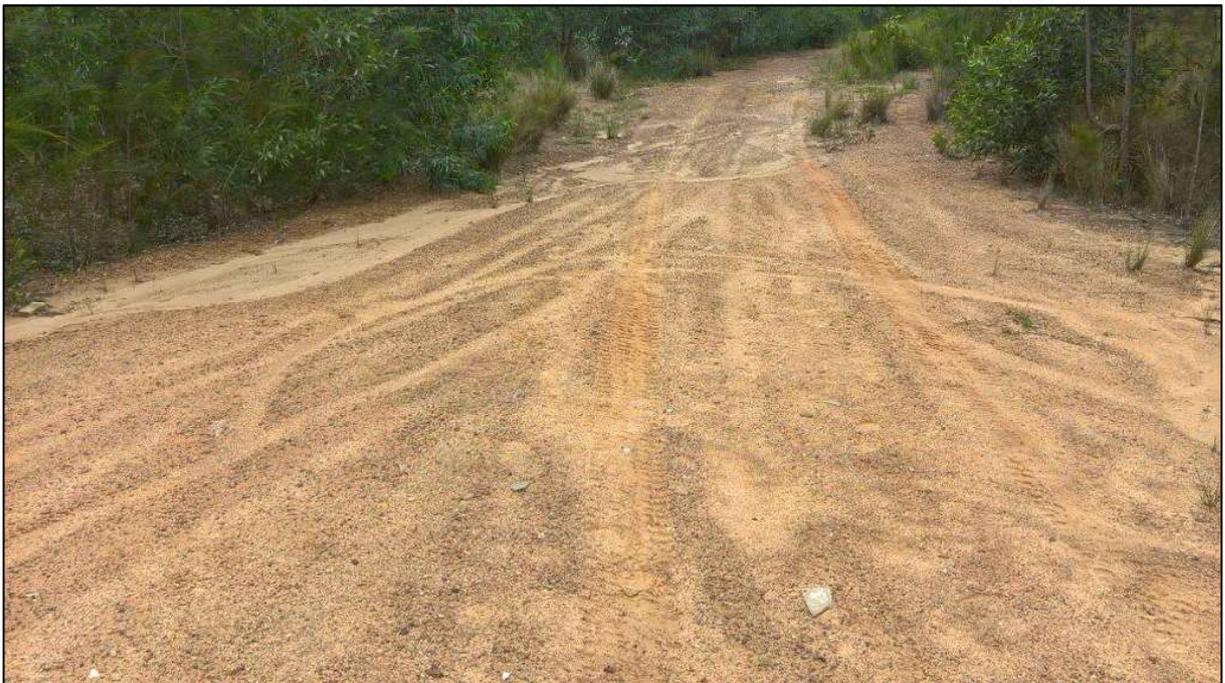
Photograph 4: Cleared area and access path in south-western portion of Lot 100 where ACM fragments were observed on the ground surface (Reference Point 16 on Drawing 1, Appendix A)

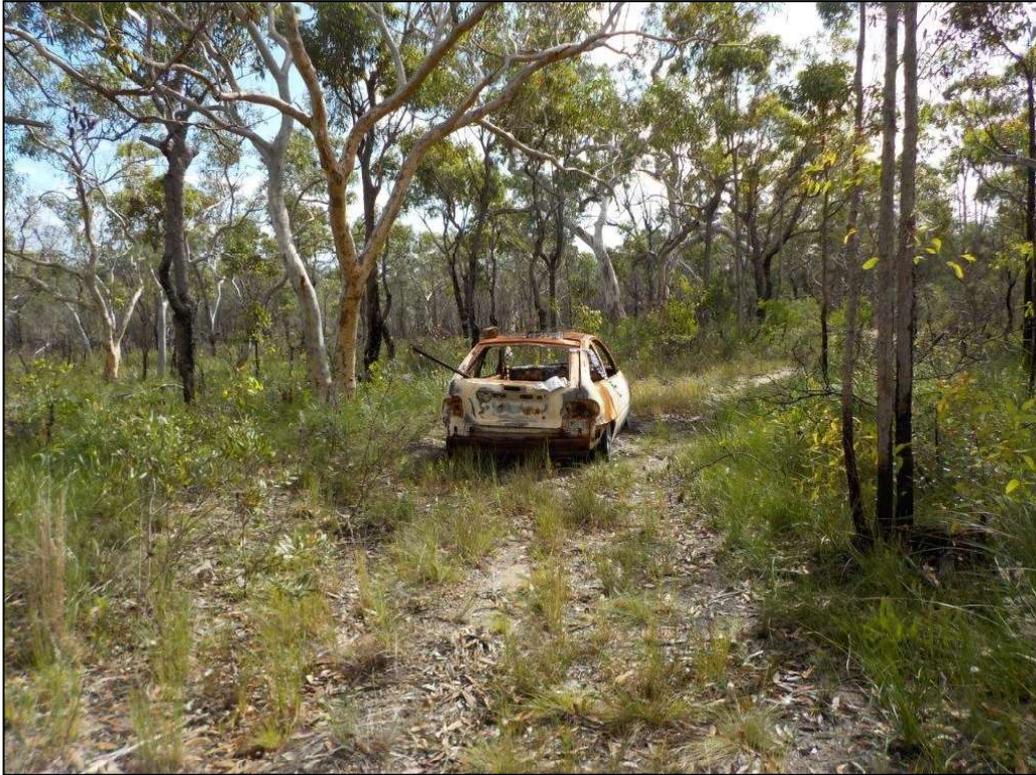
- Small quantities of rubbish, derelict car bodies and suspected fly-tipped materials comprising demolition debris (bricks, concrete, potential asbestos-containing materials (PACM) and metal scraps) were observed in southern and central portions of the site (refer Photographs 5 and 6). Whilst the fly-tipped materials were observed to predominantly be present in areas generally bordering the site boundaries or adjacent to tracks bisecting the site, given the access restrictions associated with dense vegetation, the potential for such materials to be present in other areas of the site cannot be completely ruled out. The approximate locations of the identified fly-tipped materials are shown on Drawing 1, Appendix A;

Photograph 5: Derelict car body in Lot 642 (Reference Point 1 on Drawing 1, Appendix A).

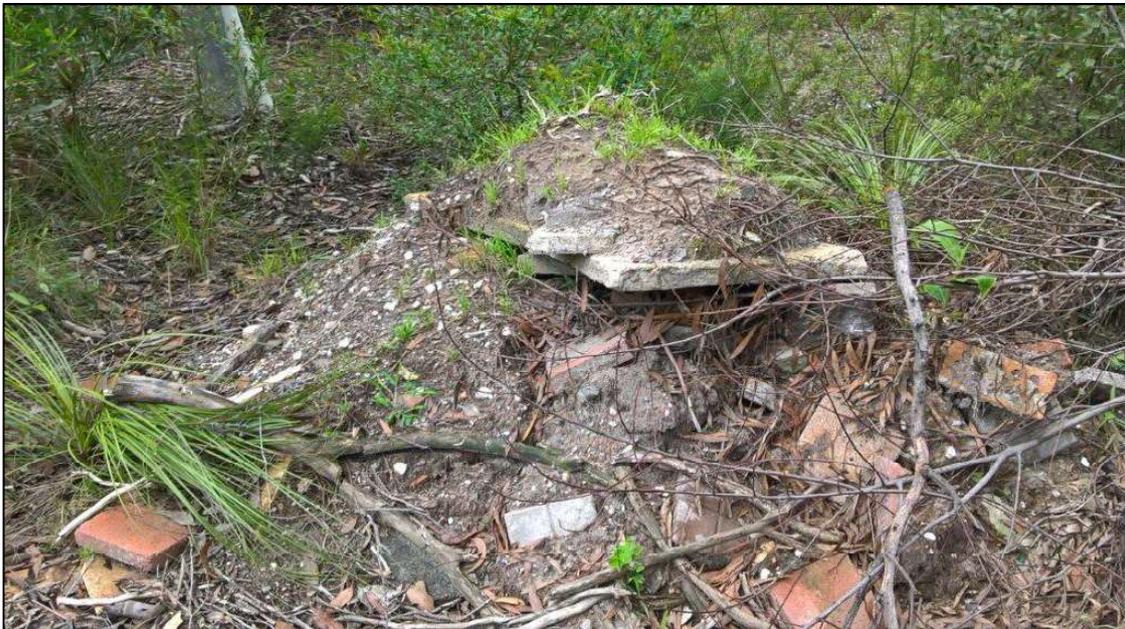
Photograph 6: Fly-tipped waste comprising demolition debris in Lot 100 (Reference Point 18 on Drawing 1, Appendix A).

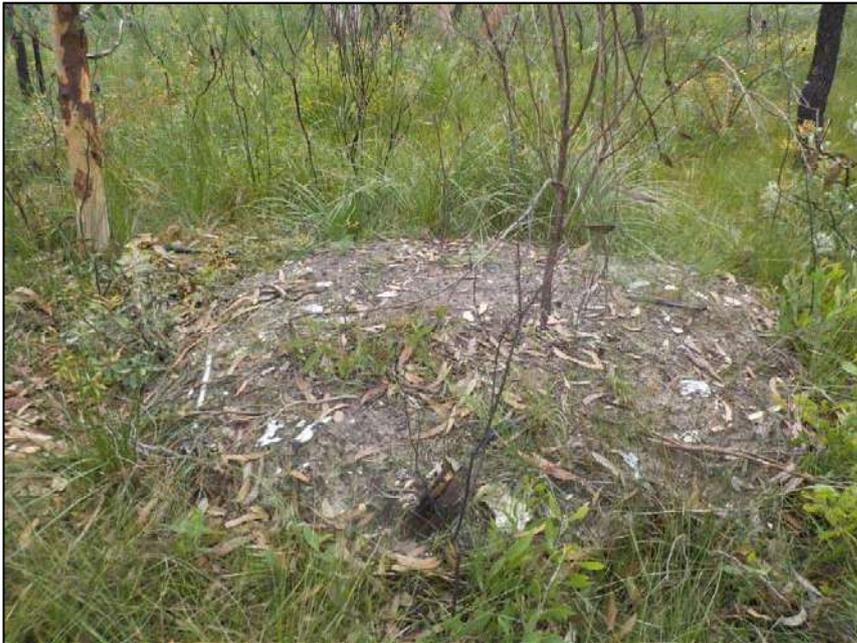
- Small stockpiles ranging between approximately 5 m³ to 10m³ of suspected imported fill were observed in the south-eastern section of Lot 642 and the western portion of Lot 100 (refer Photographs 7 and 8). The approximate locations of these stockpiles and other areas where fill stockpiles were observed are shown on Drawing 1, Appendix A.

Photograph 7: Fill stockpile observed in south-western portion in Lot 642 (Reference Point 3 on Drawing 1, Appendix A).

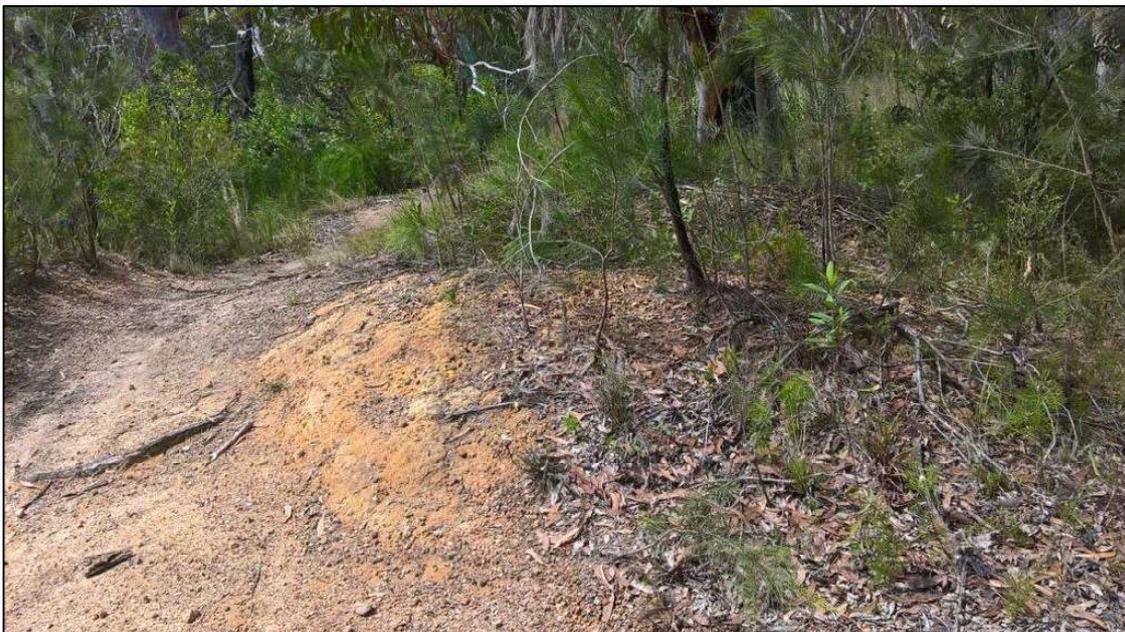
Photograph 8: Possible fill stockpile observed in western portion in Lot 100 (Reference Point 17 on Drawing 1, Appendix A).

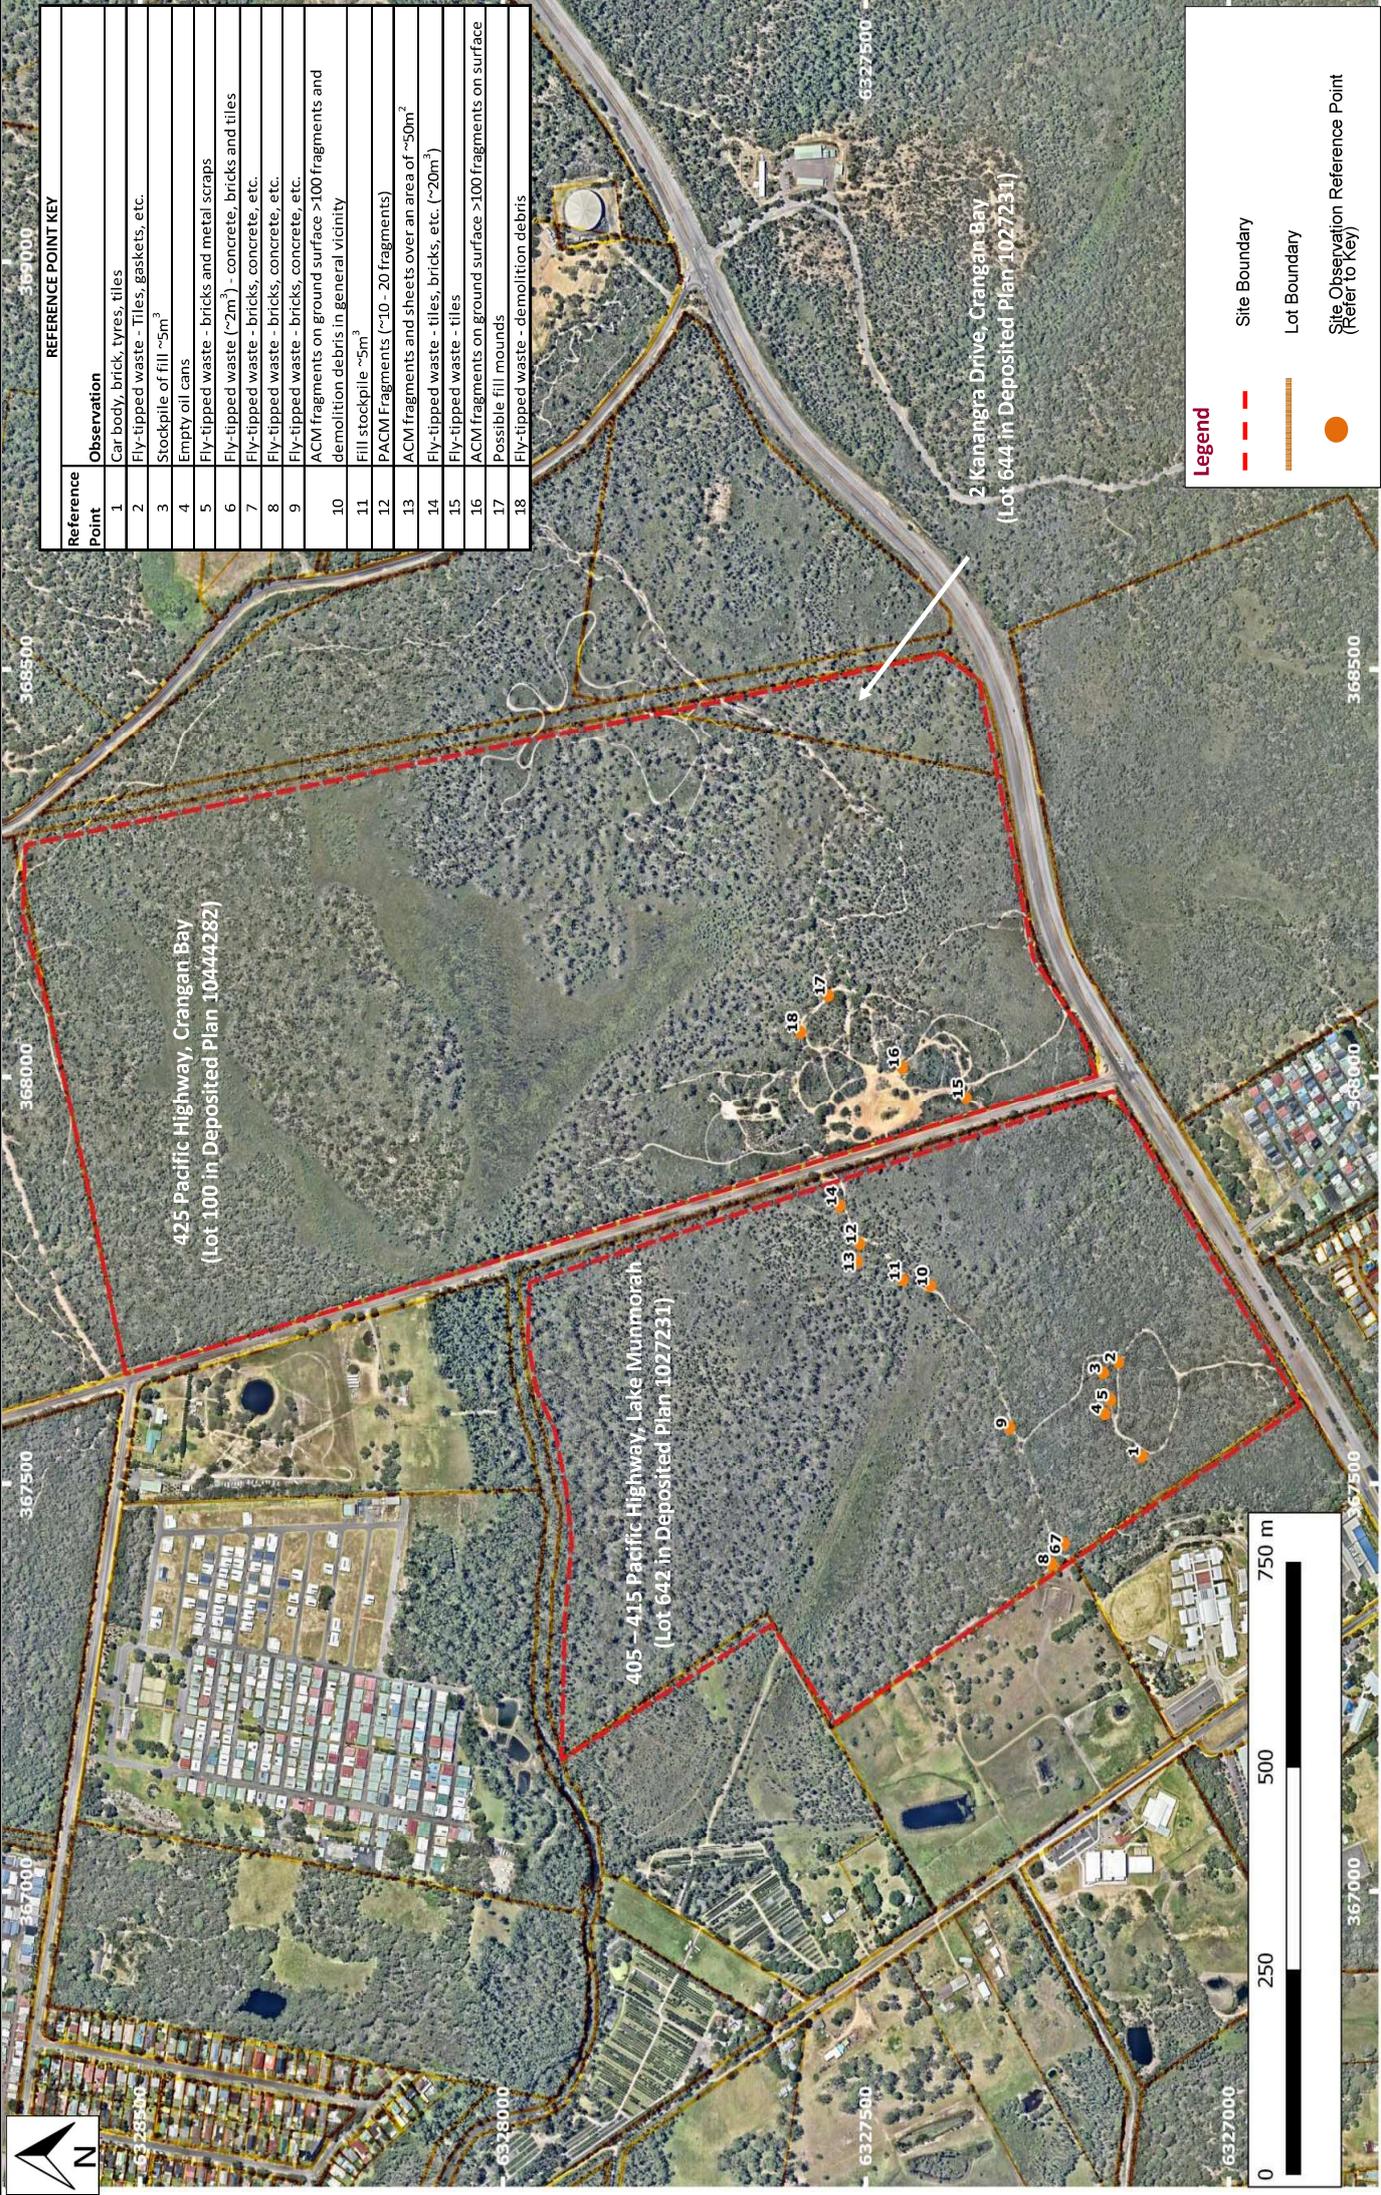
REFERENCE POINT KEY	
Reference Point	Observation
1	Car body, brick, tyres, tiles
2	Fly-tipped waste - Tiles, gaskets, etc.
3	Stockpile of fill ~5m ³
4	Empty oil cans
5	Fly-tipped waste - bricks and metal scraps
6	Fly-tipped waste (~2m ²) - concrete, bricks and tiles
7	Fly-tipped waste - bricks, concrete, etc.
8	Fly-tipped waste - bricks, concrete, etc.
9	Fly-tipped waste - bricks, concrete, etc.
10	ACM fragments on ground surface >100 fragments and demolition debris in general vicinity
11	Fill stockpile ~5m ³
12	PACM fragments (~10 - 20 fragments)
13	ACM fragments and sheets over an area of ~50m ²
14	Fly-tipped waste - tiles, bricks, etc. (~20m ³)
15	Fly-tipped waste - tiles
16	ACM fragments on ground surface >100 fragments on surface
17	Possible fill mounds
18	Fly-tipped waste - demolition debris
