SCHEDULE OF CONSERVATION WORKS

"The Wattles"
245 Great Western Highway, South Wentworthville
October 2021

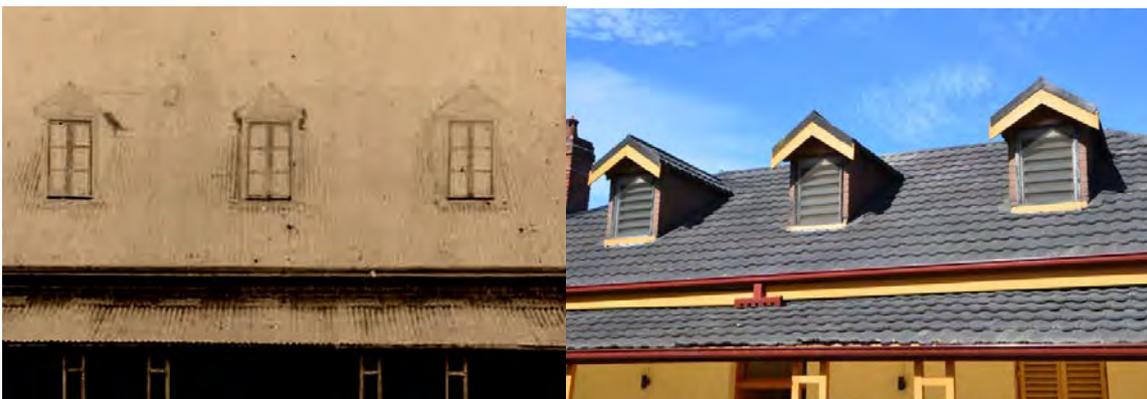
The three window sashes on the eastern side of the attic level are not original. Multi-paned window sashes in dormers that appear in early photographs have been replaced by glass louvres.

Figure 2.7 | Window sashes in the dormers, circa 1905, which were probably casement sashes. (left); louvres in dormers, 2021 (right).

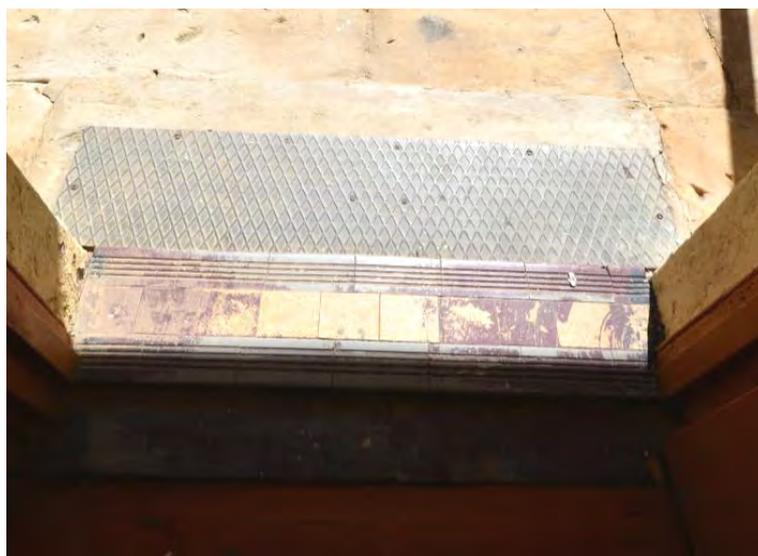
The tiled threshold at the front door appears to have been laid during the interwar period. An earlier threshold is located beneath the tiling.

Figure 2.8 | Tiled threshold at the front door.

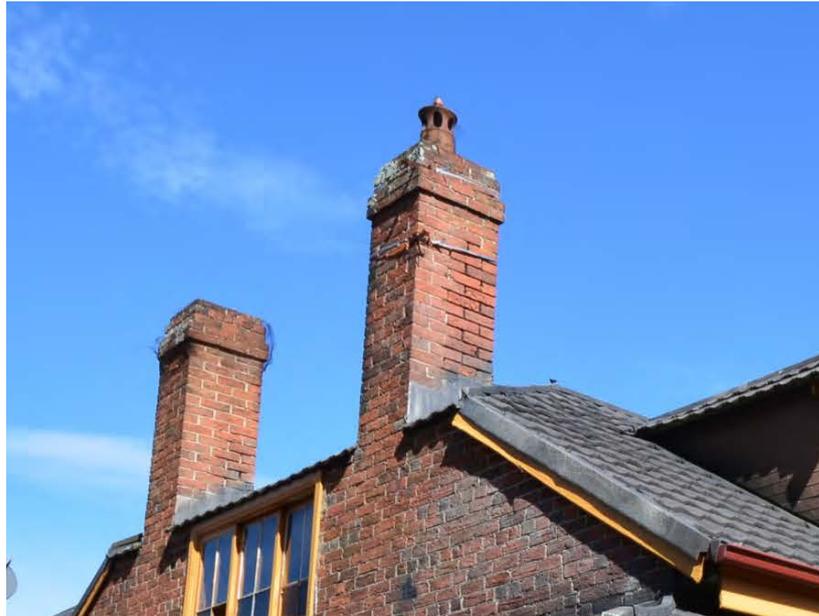
The four brick chimneys associated with the main roof and the two chimneys associated with Rooms 6 and 7 are an original part of the house. The chimneys are generally in fair condition but pointing has eroded on their western side. Metal straps have been installed the north-east chimney, which suggests that it may have needed stabilising in the past.

Figure 2.10 | Deteriorating brick pointing in the northern chimney on the eastern side of the house.

Check chimneys are stable. Carefully dismantle and relay bricks in exactly the same locations. Remove metal straps. Replace damaged bricks where the brick has deteriorated to the point where it cannot be reversed; new bricks are to match the existing bricks. Repoint brickwork where eroded using a lime mortar to match the sound mortar in the brickwork. Remove

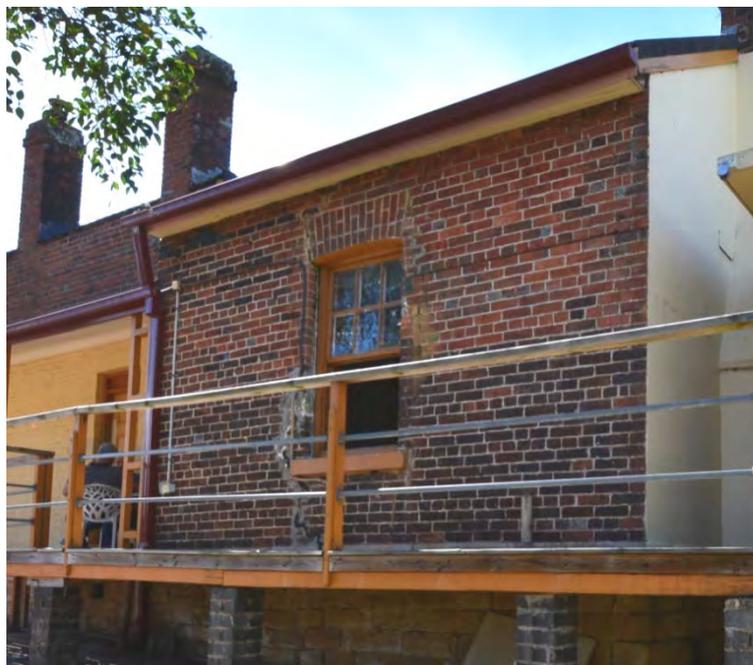
Figure 2.11 | Cracking in the western wall at the rear of the building has been an ongoing problem. Attempts to repair it in the past has been carried out crudely.

Cracking in brick walls should be inspected by a qualified structural engineer that has experience with heritage listed buildings. The advice from the structural engineer regarding works required to remedy cracking should be followed.

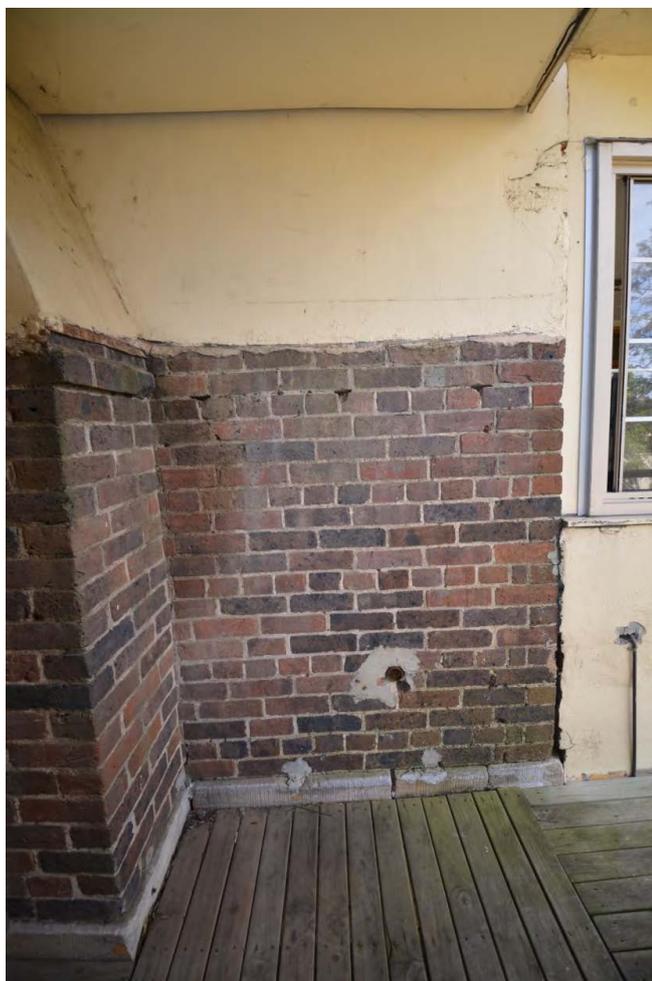
Figure 2.12 | Brickwork on the southern side of the southern wings (Rooms 6 and 7) requires repairs to mortar, replacement of new bricks where holes have been formed and careful removal of cement patching.

Brickwork should be repointed where necessary. This is most evident in the northern elevations of the place. Pointing and mortar repair should be undertaken using mortars to match existing mortar composition and appearance. Early mortars are generally richer in lime content and should be repointed like for like. Replacement mortar should be of a "softer" composition to allow moisture passage through the pointing instead of through brickwork.

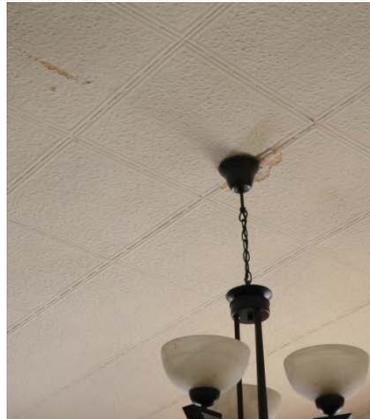
<p>Room 7</p>	
<p>Ceiling</p> <p>Retain pressed metal ceiling. Evidence of what may be water damage around the central light fitting. If water ingress has been occurring, wiring in this part of the building must be checked. Check condition of ceiling generally</p> <p>Remove paint layers back to a sound surface and repaint.</p>

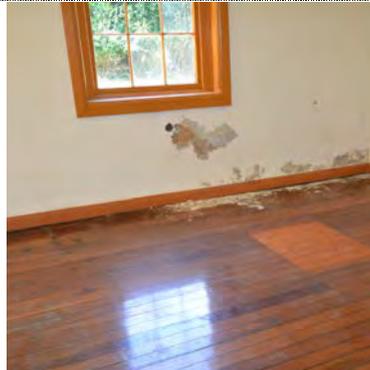
<p>Walls</p> <p>Investigate potential causes of damp in eastern and western walls where painted surface has deteriorated. Remedy any damp using approved methodology to minimise damage to brickwork.</p> <p>Hammer tap all wall surfaces to identify drummy areas of plaster. Replace areas of unsound or damaged/cracked plaster.</p> <p>Remove paint layers back to a sound surface and repaint walls.</p>

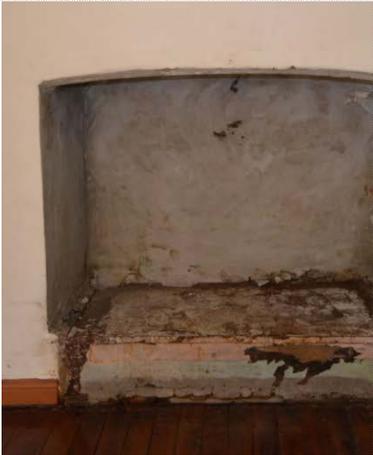
Room 7	
Fireplace	<p>Retain fireplace.</p> <p>Ensure chimney is clear of any debris.</p> <p>Clean back floor of firebox and carefully repair vertical edge where the lining has broken away.</p> <p>Add matching section of skirting board on the western side of the firebox to match the skirting on its eastern side.</p>
