REPORT TO
THE DEPARTMENT OF PLANNING, INDUSTRY AND
ENVIRONMENT – DEVELOPMENT AND TRANSACTIONS

ON
GEOTECHNICAL ASSESSMENT

AT
FORMER MANLY HOSPITAL, 150 DARLEY STREET,
MANLY, NSW

Date: 9 September 2020
Ref: 31233YJrpt3

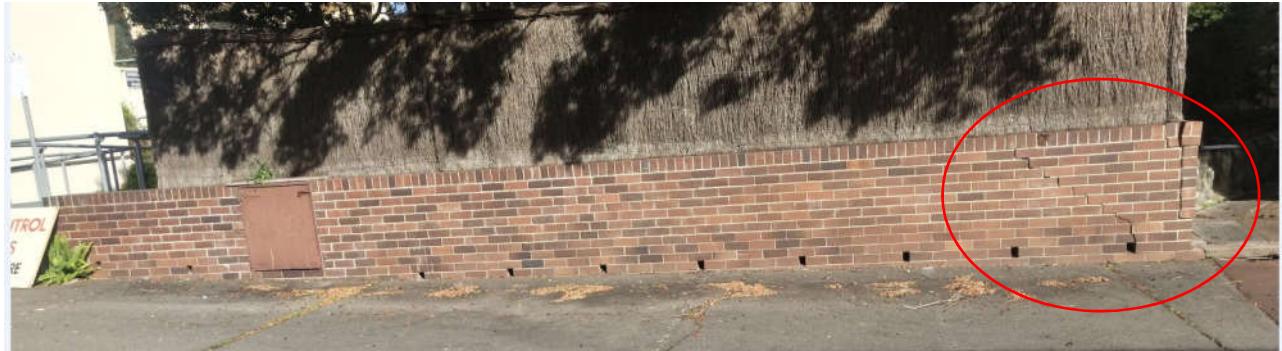
Plate 1: Photograph of 1.2m High Brick Wall Assessed to be in Poor Condition

- Brick retaining wall, 1.2m high with 30mm wide vertical cracking and approximately 2° tilt at north-western end, as shown on Figure 4a and Plate 1 below.

- The identified retaining walls are to be replaced with new engineered walls.
- The thin plinth of rock along the cliff-line should be removed during construction. Until removed an exclusion zone that extends a perpendicular distance of 4m out from the cliff line and for the full length of the plinth, plus an additional 1.5m at either end, should be formed. The geotechnical engineer should indicate to the builder, prior to them establishing to site, the required extent of the exclusion zone. During removal of the plinth we recommend that a geotechnical engineer be present to provide advice on the required extent of removal. Care must be taken to avoid damaging the retaining wall (brick rendered) above the cliff-line that is about 0.4m high. Some support or underpinning of this wall may be required. Alternatively, consideration could be given to providing long term support to the plinth of rock, which may include the installation of permanent rock bolts, shotcrete and mesh. General recommendations regarding inspections of cut faces during construction are provided in Section 5.2.

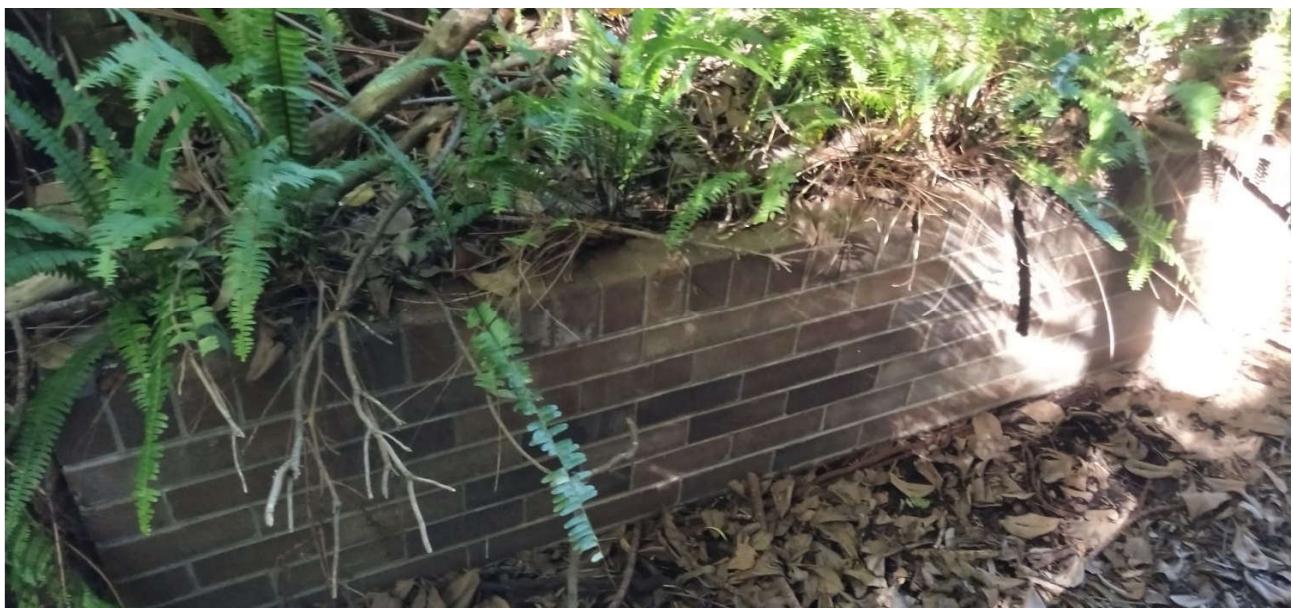
Plate 2: Photograph of 0.7m High Brick Wall Assessed to be in Poor Condition

- Brick retaining wall, 0.7m high with 10° tilt over extents of wall (about 7m in length), as shown on Figure 4e and Plate 2 below.

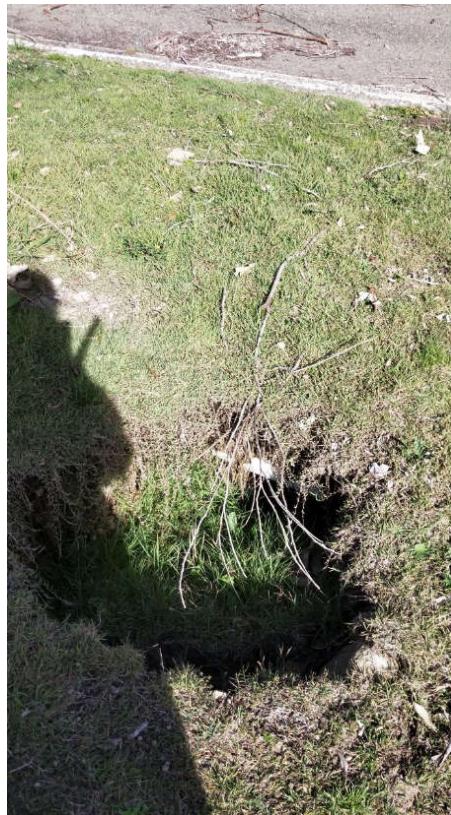
Plate 3: Photograph of Sinkhole

A relatively small sink hole was observed around buried water services to the north of a car park area as shown on Figure 4e and Plate 3 below. The sink hole was about 0.9m diameter and about 0.9m deep.

- The sinkhole has likely developed due to the existing buried water service pipe leaking. We recommend that the following works be completed in this area:

- The buried services should be pressure checked for leaks. Any leaky services should be repaired.
 - The area should be backfilled with engineered fill as recommended below in Section 5.3. If no buried services are found to be leaking and the cause of the sinkhole cannot be determined further advice should be sought from this office.

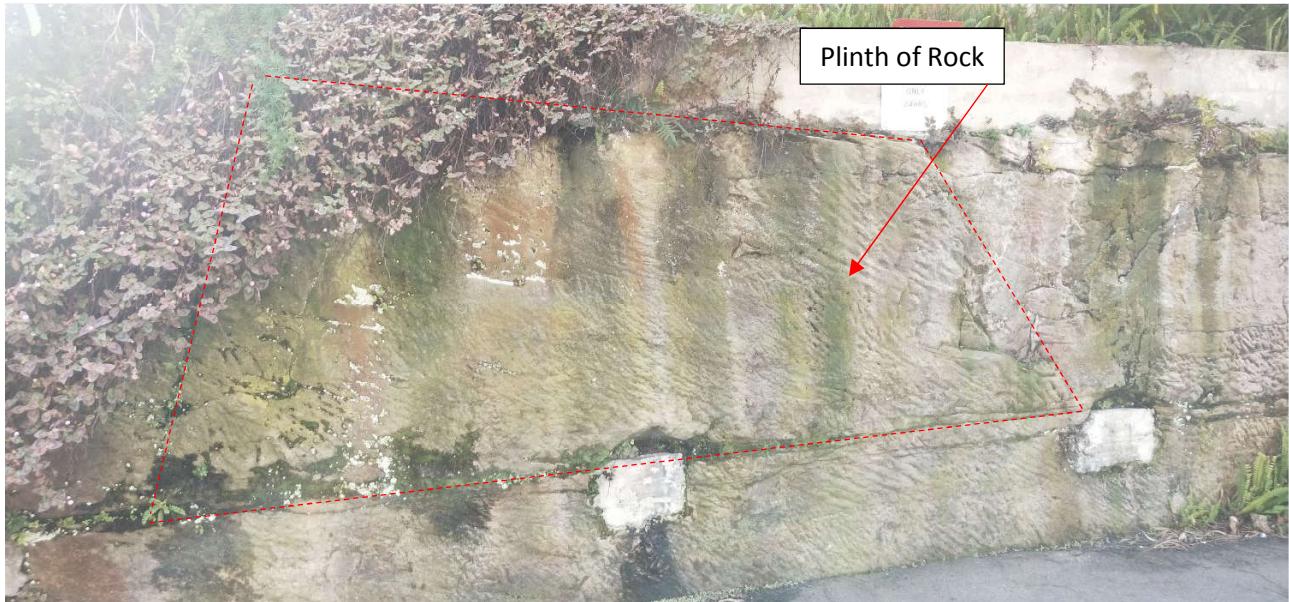
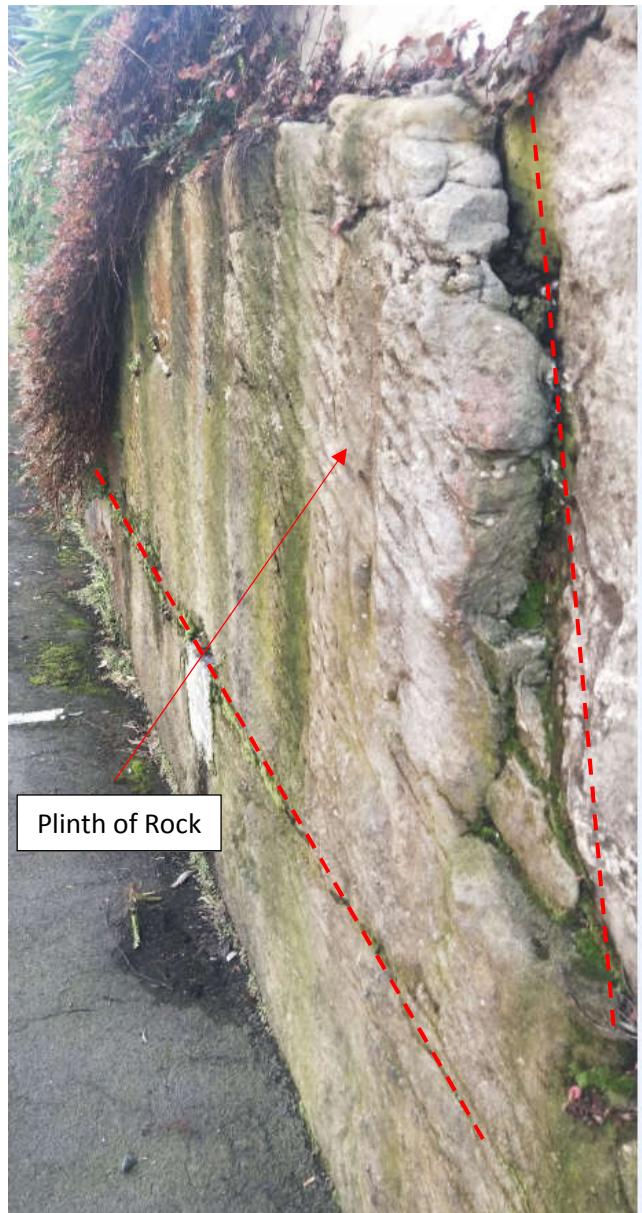
Plate 4: Photographs of Plinth of Bedrock That May Detach from Cliff-Line

Along a cliff-line at the north-western end of the site near the Darley Road entrance we observed a plinth of bedrock that appears likely to dislodge from the face. The plinth was about 100mm thick over an area of about 1.1m (vertical) x 3.2m (horizontal), as shown in Plate 4.

- BA-Near car parks and access roads. Hazard BA3 includes a plinth of rock that appears likely to detach.
 - BB-Near buildings.
 - BC-Embankment below car park.

Sandstone bedrock of better than low strength may be cut vertically and left unsupported provided it contains no adverse defects such as joints, clay seams bedding partings etc. Where adversely orientated defects are present, such as the identified plinth of rock, remedial measures such as rock bolts, drainage, shotcrete and mesh will be required to provide support to the excavated bedrock. Alternatively, the plinth may be removed but the geotechnical engineer must reinspect the plinth to confirm the extent of removal required and that its removal will not destabilise other structures. In this regard, the geotechnical engineer may request that part, or all of the plinth be removed whilst they are on site.
