### **Summary of Contamination Status**

Watagan Park Residential Subdivision **Precinct South**

Watagan Park Development Unit Trust Pty Ltd 27 Patrick Drive Cooranbong NSW 2265

30 May 2023

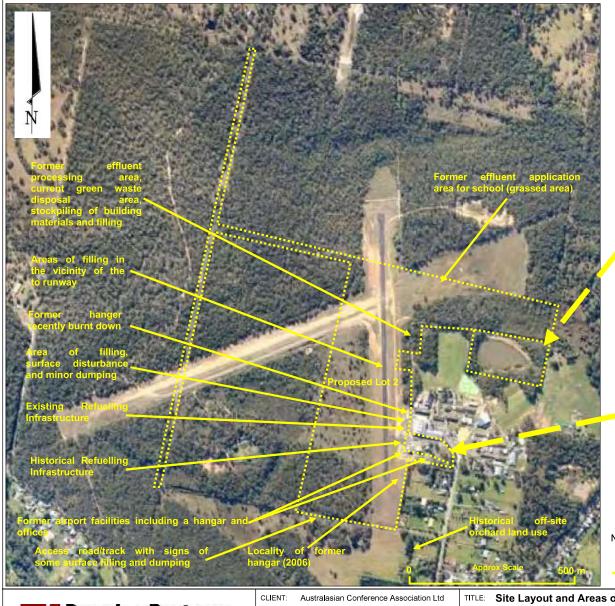
PROJECT No:	75250.00
DRAWING No:	1
REVISION:	A

The investigation findings indicated there was a low to medium risk of contamination across the Site broadly however with areas of environmental concern (AECs) presenting a higher risk. AECs identified within the Site included the two former hangars and existing and former refuelling infrastructure. The location of these AECs was on the southeastern boundary of the Site adjacent the former runway. The report recommended a Phase 2 Contamination Assessment be undertaken to address the identified AECs.

A figure showing the site location and AECs is presented in Figure 1 in Appendix C.

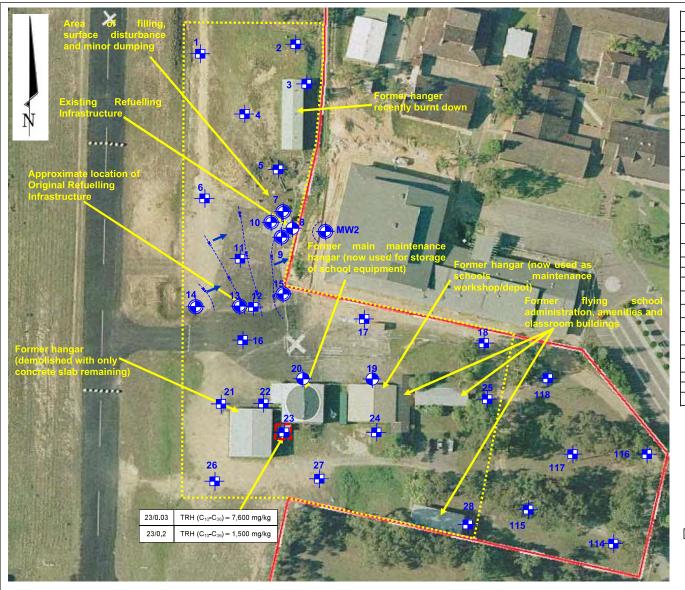
-		
	PROJECT No:	75250.01
	DRAWING No:	2
	REVISION:	В

A total of 28 boreholes were undertaken in the former airport, a further 47 boreholes were undertaken in and around the former runway. Evidence of filling was observed around the former runway, the fill comprised sandy clay or clayey silt with asphalt inclusions as well as minor quantities of brick and concrete. A fragment of asbestos was observed in one of the test pits adjacent the former runway however no buried asbestos fragments were identified and asbestos wasn't considered to be present within fill materials at the Site. Additionally, one sample exceeded the adopted ecological criteria for benzo(a)pyrene however the sample was subsequently tested for leachable concentrations and testing showed low leachability. It is likely associated with asphalt inclusions within the fill at the Site and not considered to present a risk to onsite ecological receptors.

- Decommissioning of the existing refuelling infrastructure.
- Excavation and disposal of the benzo(a)pyrene contamination identified in one of the test pits.

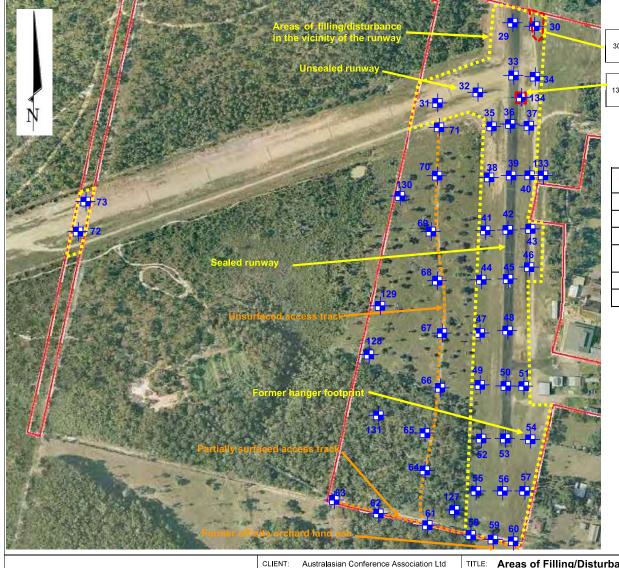
PROJECT No:	75250.01
DRAWING No:	3
REVISION:	В

30/0.1	BaP- 23 mg/kg
30/0.1	PAH – 443.8 mg/kg

134/0.1	BaP- 2.8 mg/kg
134/0.1	PAH – 47.2 mg/kg

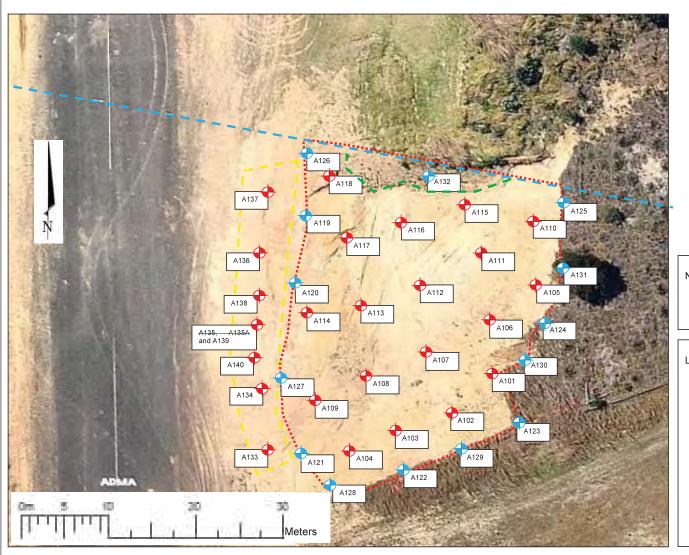
TITLE: Remediation Area A

Area A – The 'fly tipping' material comprised asbestos contaminated fill covering an area of approximately 1,200  $\,$  m $^2$  that was excavated and removed from the Site between 28 February 2013 and 5 March 2013. A total of 39 validation samples were collected from the Site and the results were below the adopted remediation criteria and considered acceptable.

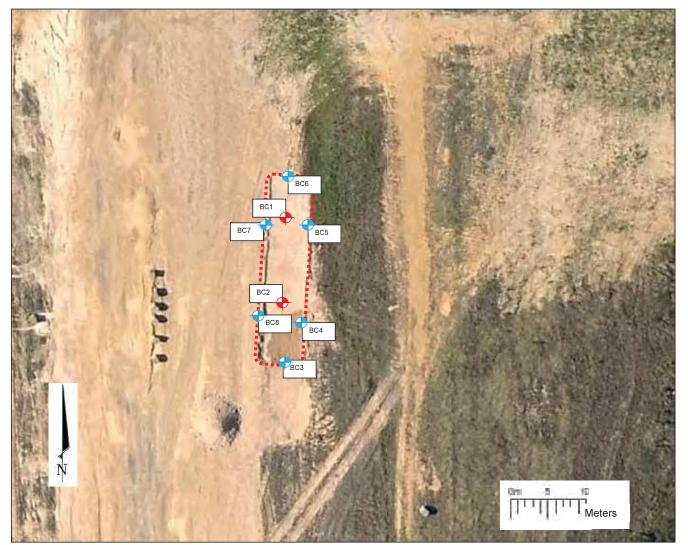
TITLE: Remediation Area B
119 Avondale Road, Cooranbong
Proposed Stage 2 Subdivision Works

Area B – Soils that were previously identified within as being impacted by PAH. These soils were excavated and stockpiled on site. The excavated spoil was pre-classified as 'General Solid Waste' and removed from the Site, eight validation samples were collected from the excavation walls and base and the results of the testing were below the adopted remediation criteria.

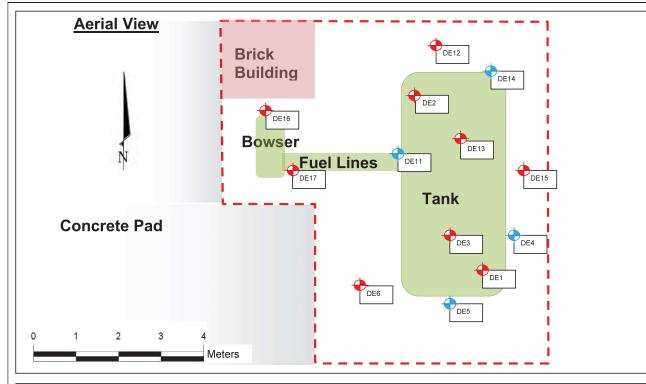
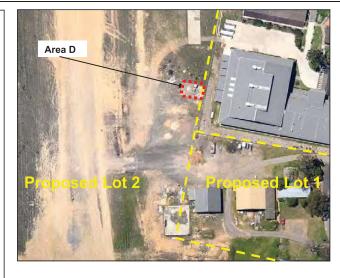
TITLE: Remediation Area D

Area D – The refuelling infrastructure was excavated and removed from site on 7<sup>th</sup> and 8<sup>th</sup> January 2013. The refuelling infrastructure included a 20,000 L fiberglass storage tank, a bowser and interconnecting fuel/vent lines. The excavated spoil comprising clay and granular bedding material were used to backfill the excavation area once all validation samples had been collected. A total of 15 validation samples were collected and the results of the testing were below the adopted remediation criteria.

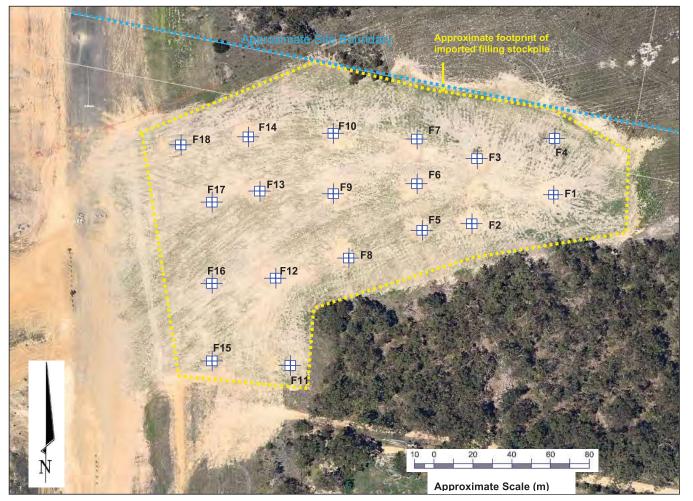
Remediation Area F
119 Avondale Road, Cooranbong
Proposed Stage 2 Subdivision Works

Area F – Visual inspection identified an area understood to comprise an estimated 60,000 m³ of imported Virgin Excavated Natural Material (VENM). Test pitting, soil sampling, screening and subsequent laboratory testing for the contaminants of concern was undertaken with respect to the recommendations of the RAP. The results of the validation/verification testing were below the adopted remediation criteria.
