Report on  
Preliminary Geotechnical Assessment

Rosalind Park Planning Proposal  
Medhurst Road, Menangle

Prepared for  
Leda Holdings Pty Ltd

Project 205817.05  
August 2022

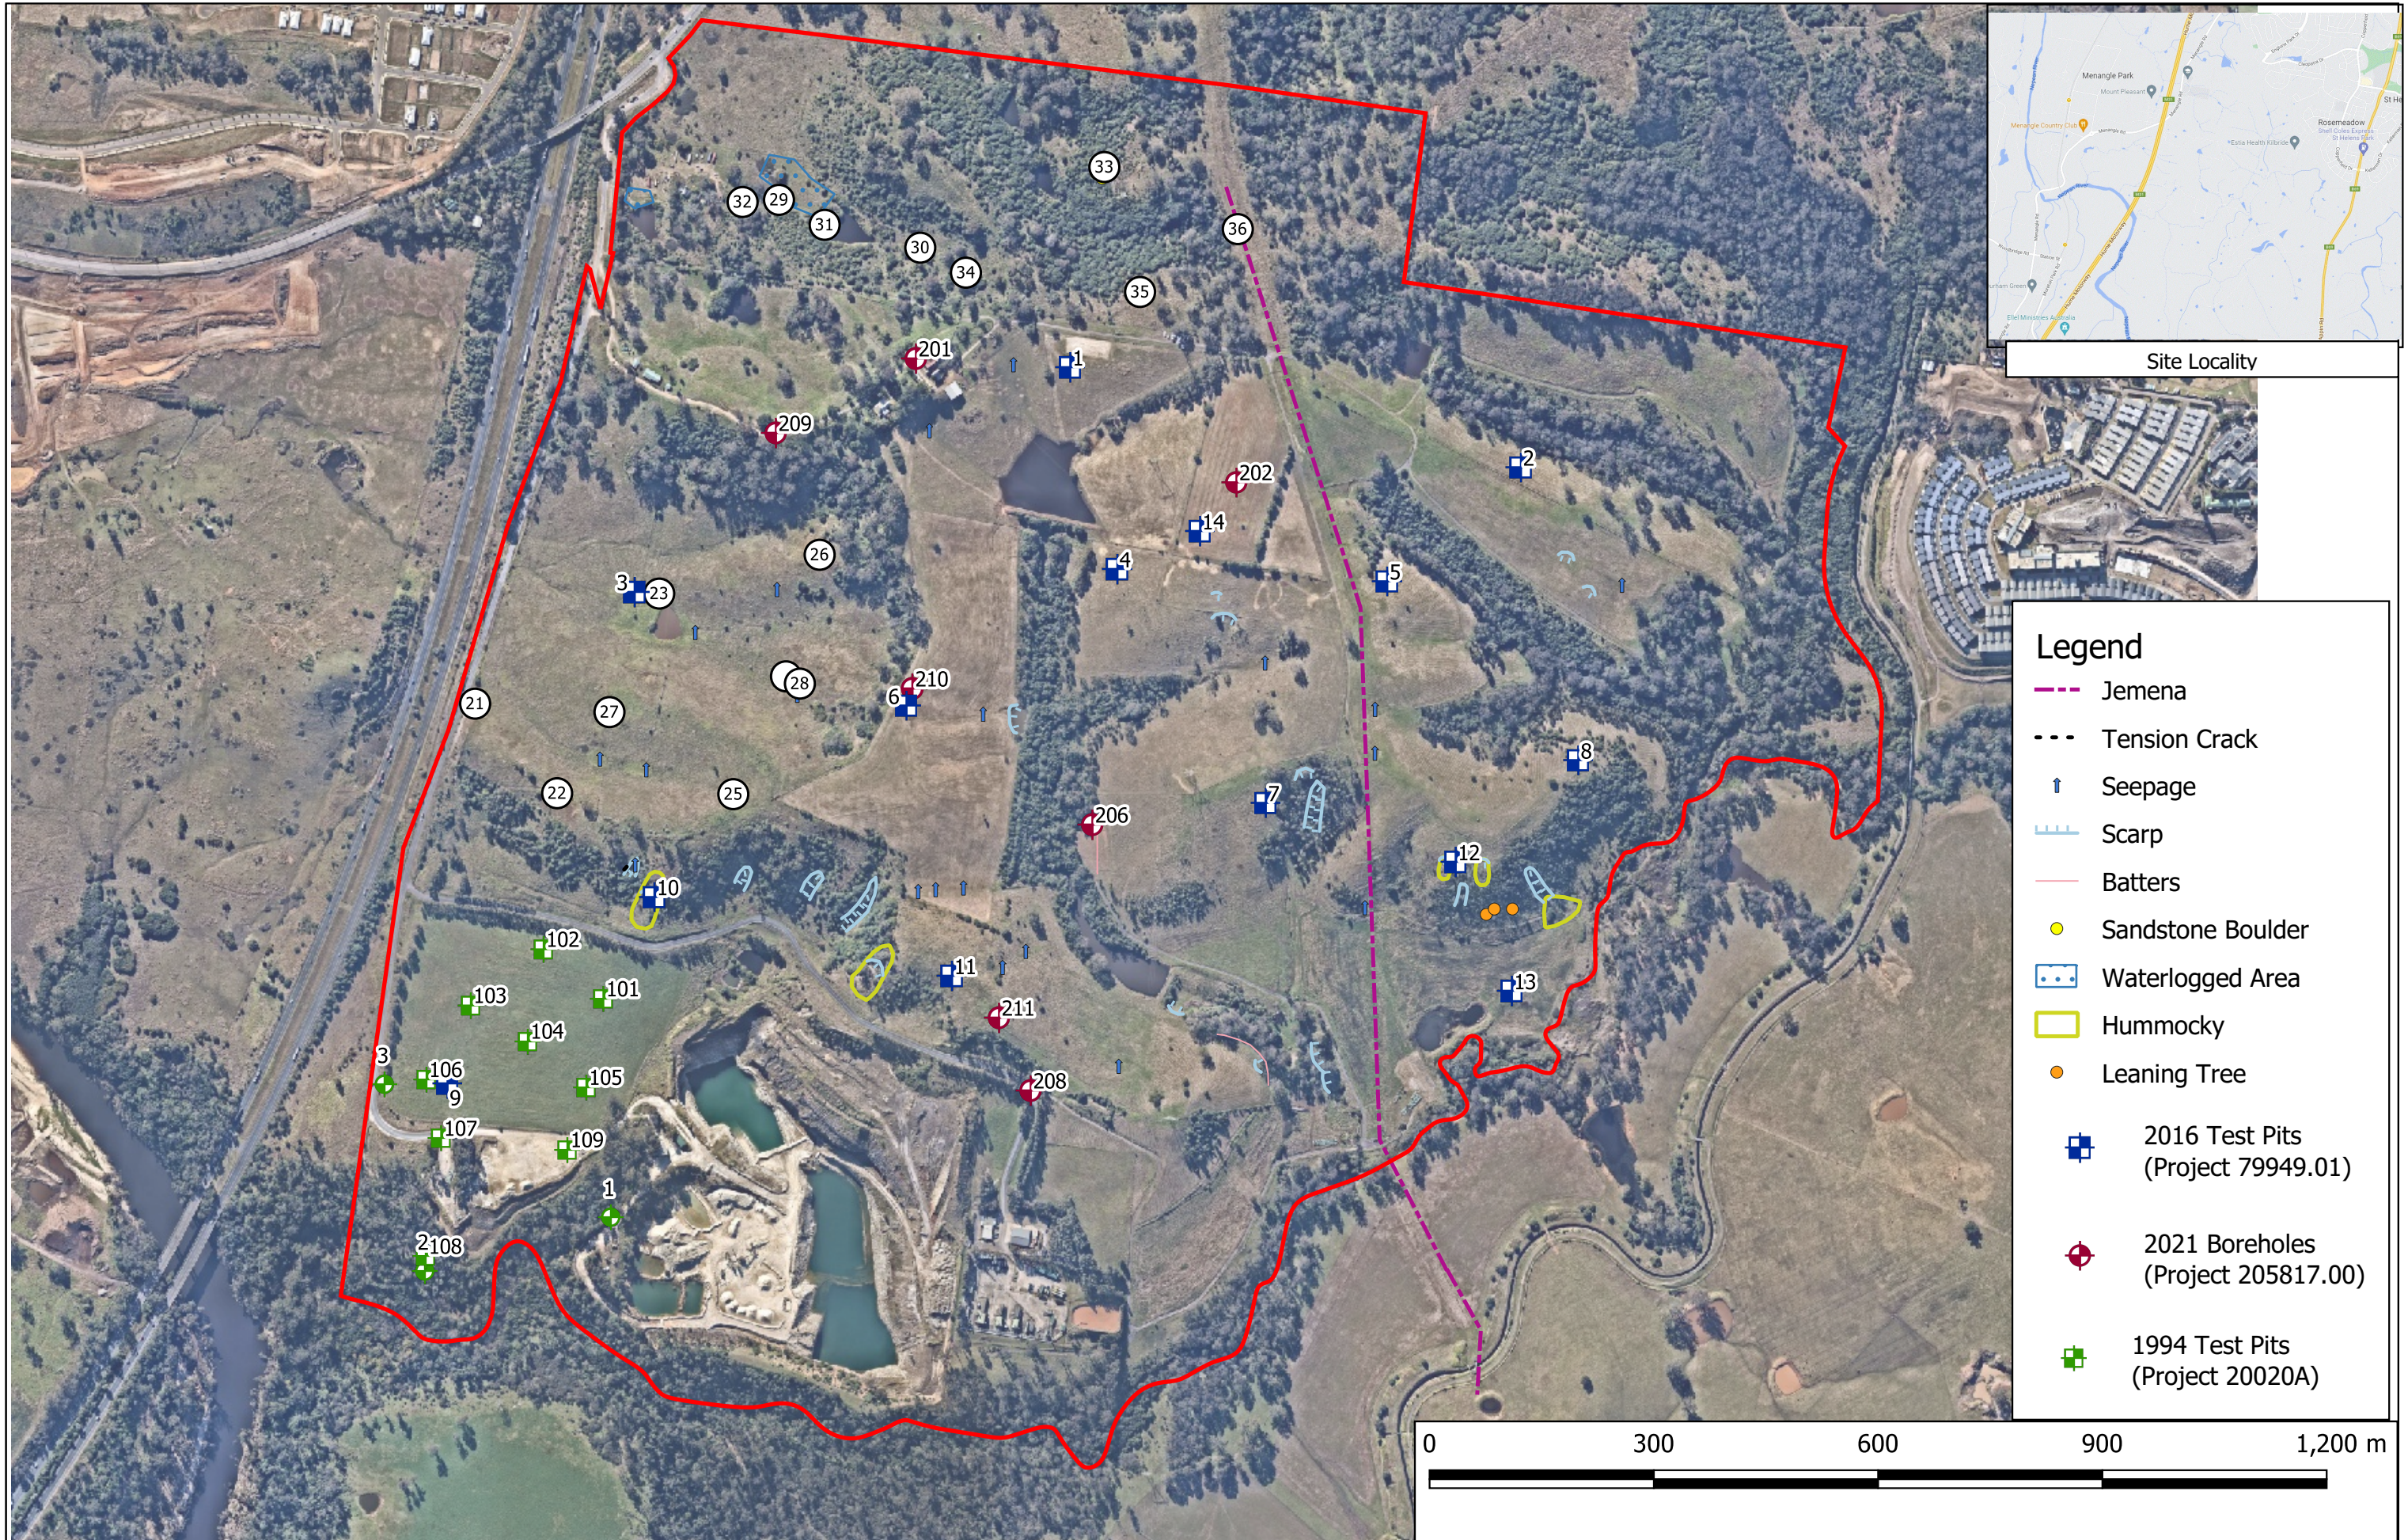
Site Locality

Inspection of the north eastern portion of the site was carried out by a senior engineering geologist in May 2022. The main features observed during the inspection are summarised below and selected items are additionally shown on Drawing 1 and Photos 29 - 32.

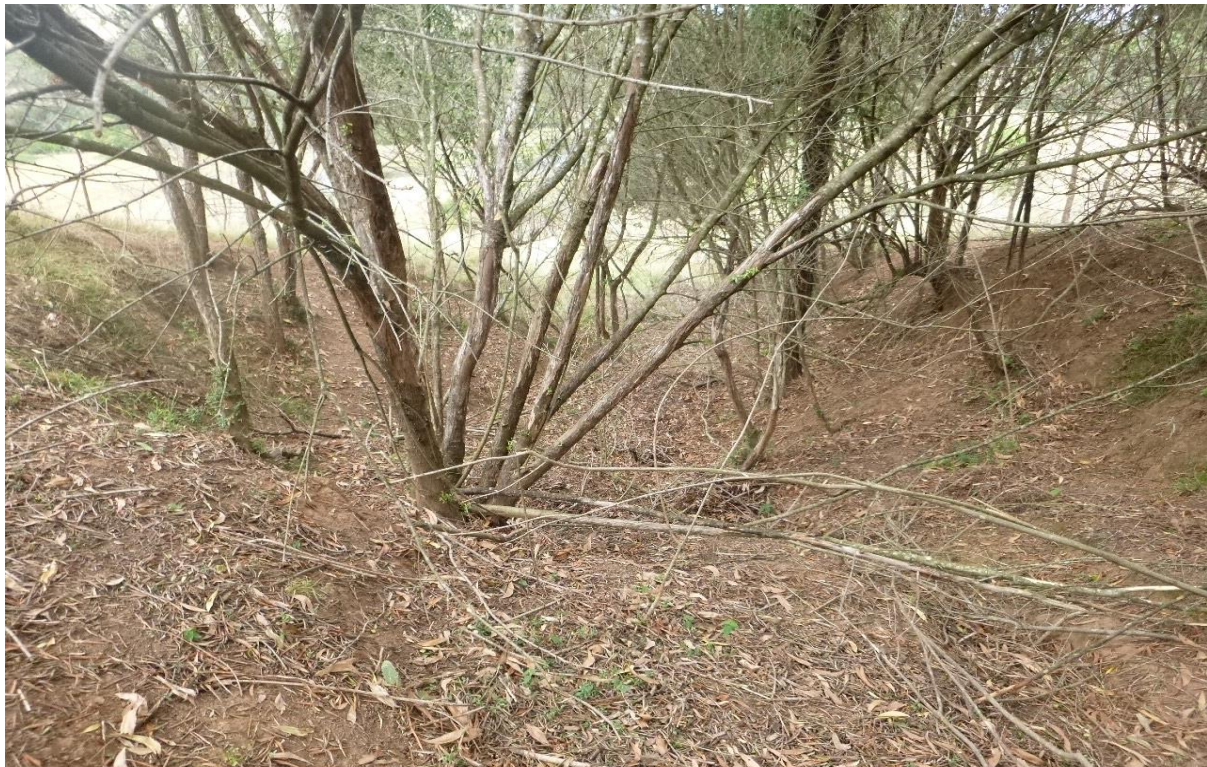
- Gully erosion and entrenchment of perennial creek lines including over-steepened batters and near-vertical faces exposing bedrock were observed within the very steep, southerly facing hillsides in the central and southern parts of the site (refer Photo 6).

Photo 6: View looking downslope of entrenched gully below Pit 12 (Project 76649.01).

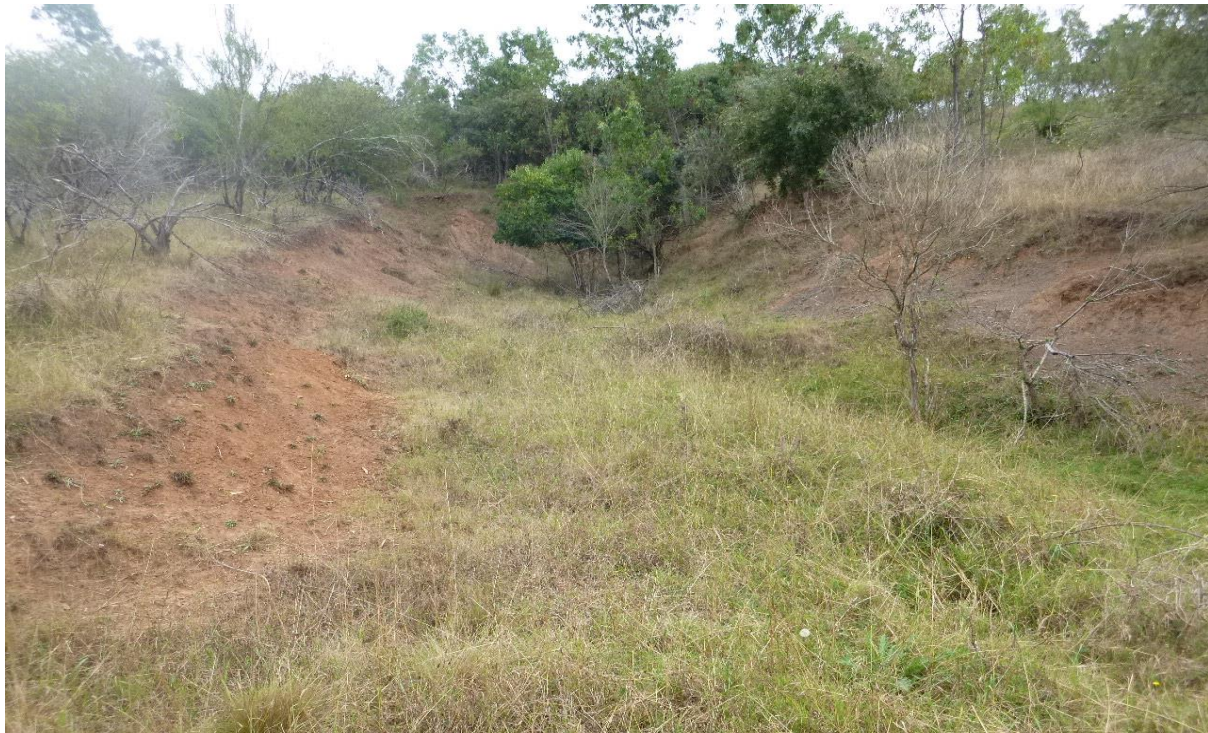
Photo 7: View looking upslope at an entrenched gully and the toe of a slump in the south-eastern part of the site (Project 76649.01).

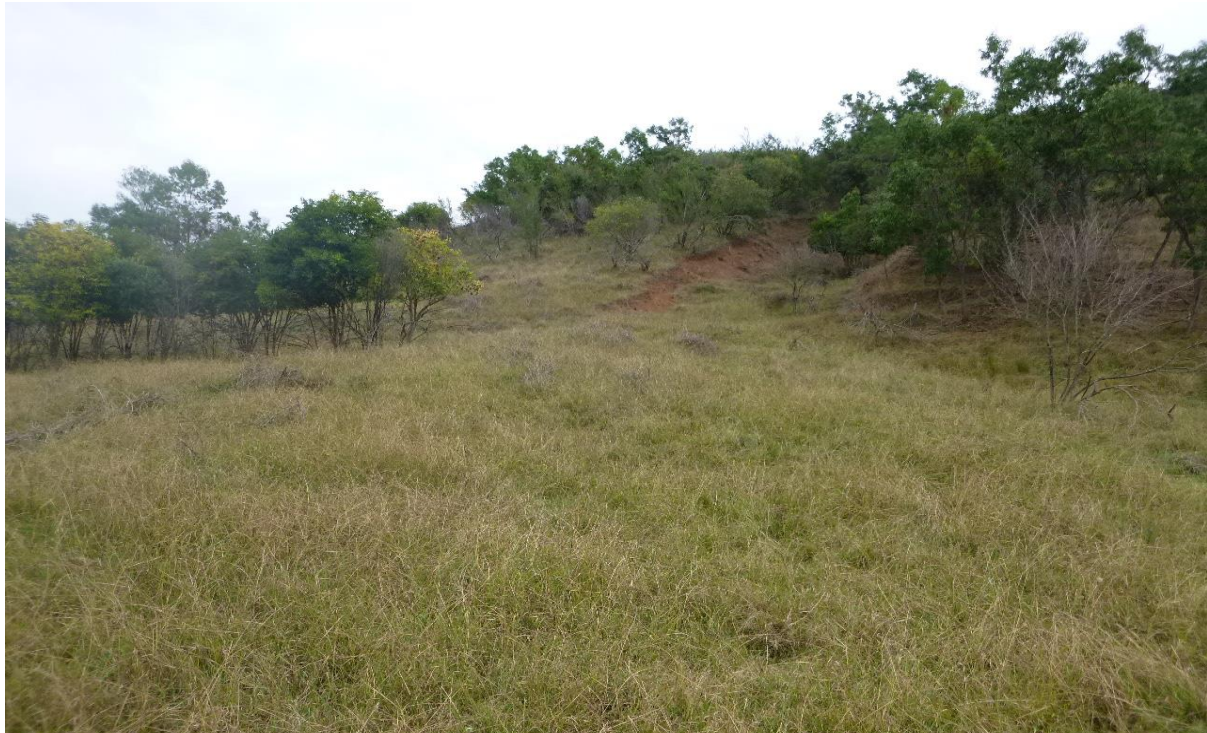
Photo 8: View looking upslope at the toe of slump in the south-eastern part of the site (Project 76649.01).

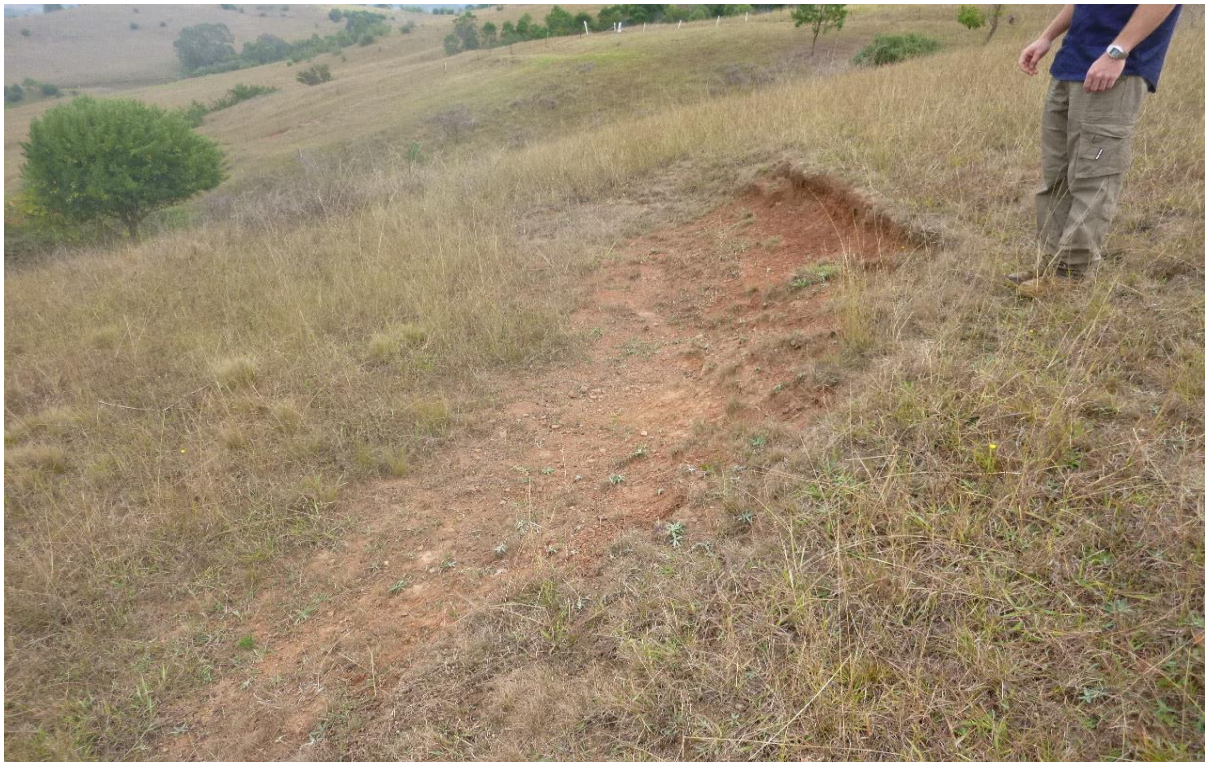
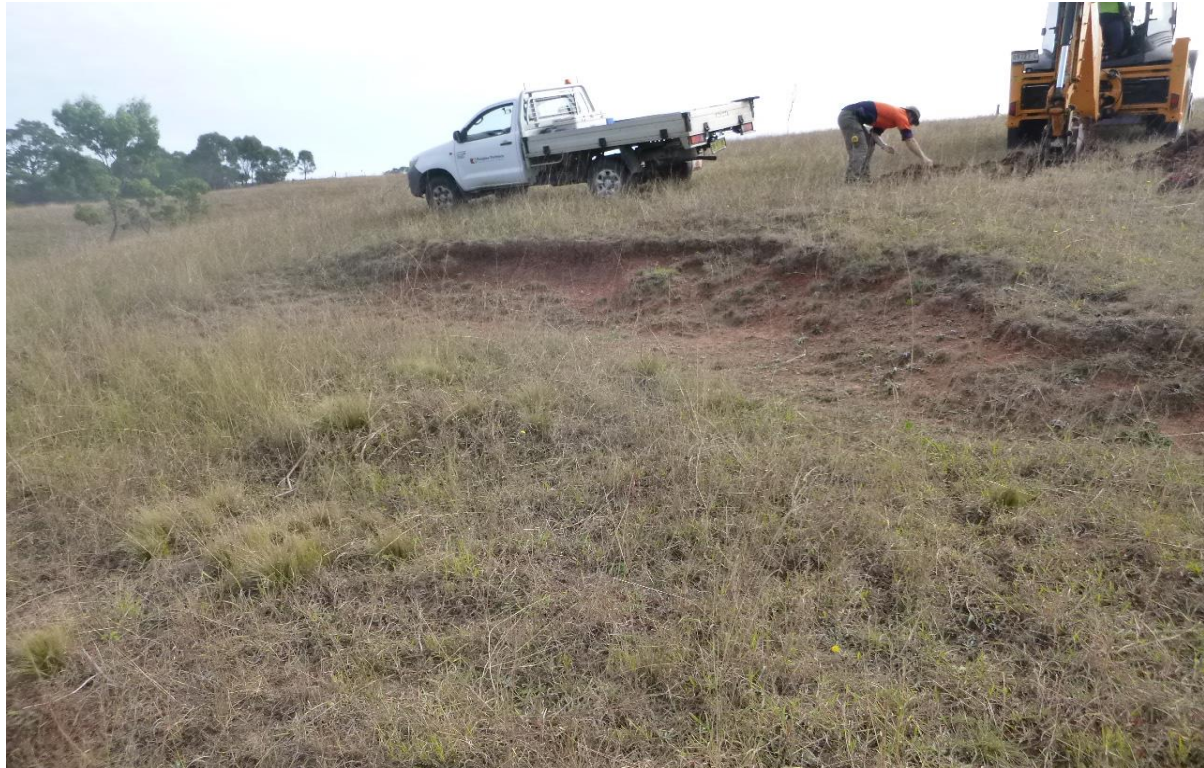
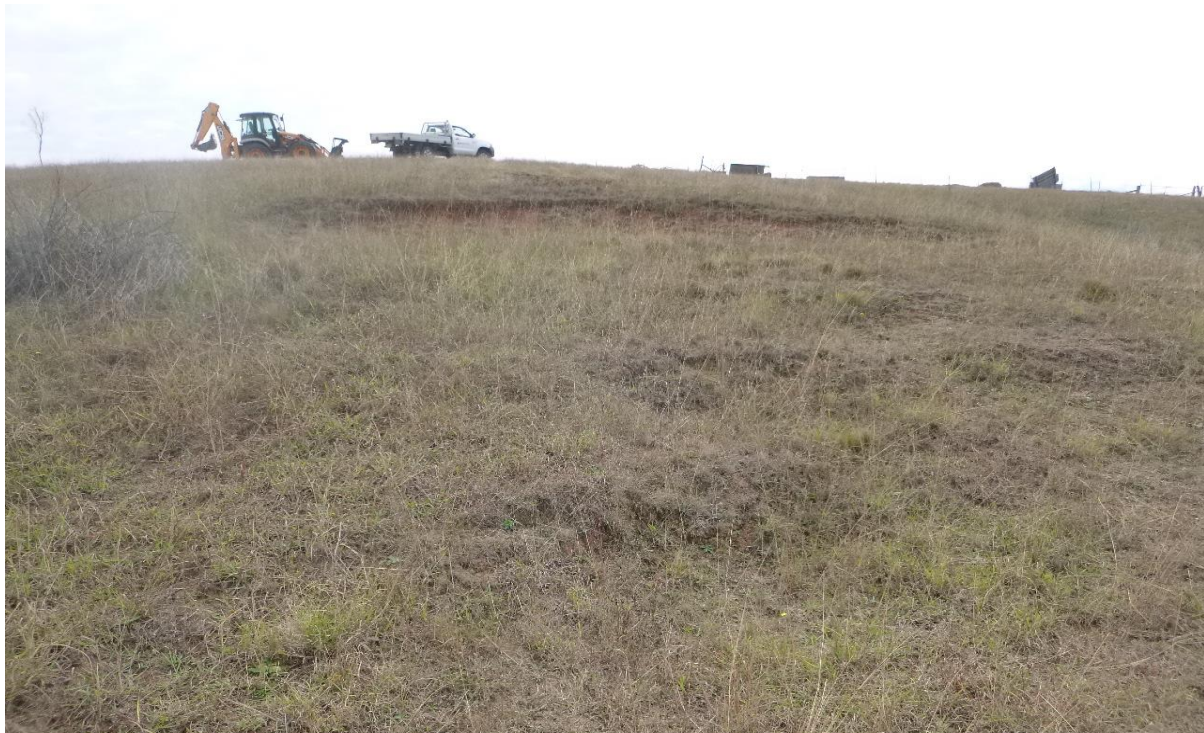
- Tension cracking was observed on the bare slope adjacent to gully erosion and near rabbit burrows in the south-western part of the site.
- Surficial slump-flow slides and soil terracing with back-scarps up to 1 m high were observed on the very steep hillsides adjacent to gully erosion (refer Photos 9 – 11).

Photo 9: View looking at back scarp in the very steep hillside at Pit 12 (Project 76649.01).

Photo 10: View looking at back scarp in the very steep hillside at Pit 12 (Project 76649.01).

Photo 11: View looking at back scarp in the very steep hillside at Pit 12 (Project 76649.01).

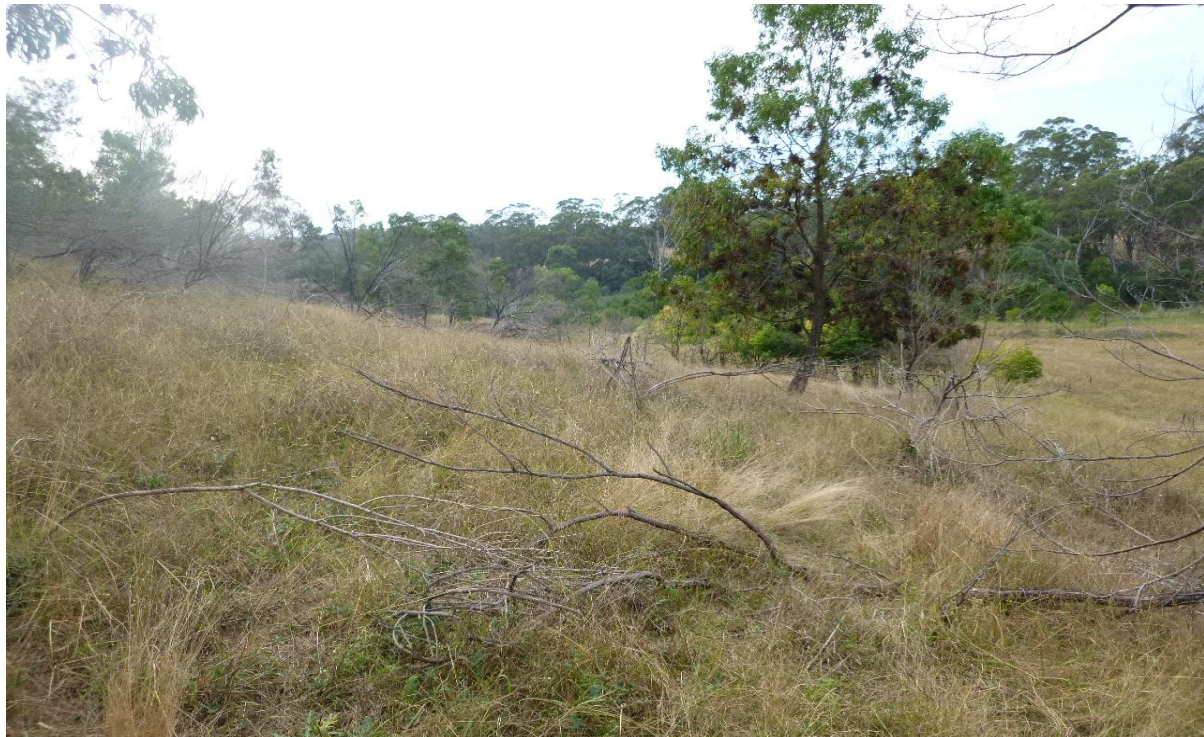
- Trees with downslope bows in the base of the trunks were observed in the very steep hillsides in the central and southern parts of the site (refer Photo 12) indicative of soil creep.

Photo 12: View looking at tree with downslope bow in the base of the track in the lower slope below Pit 12 (Project 76649.01).

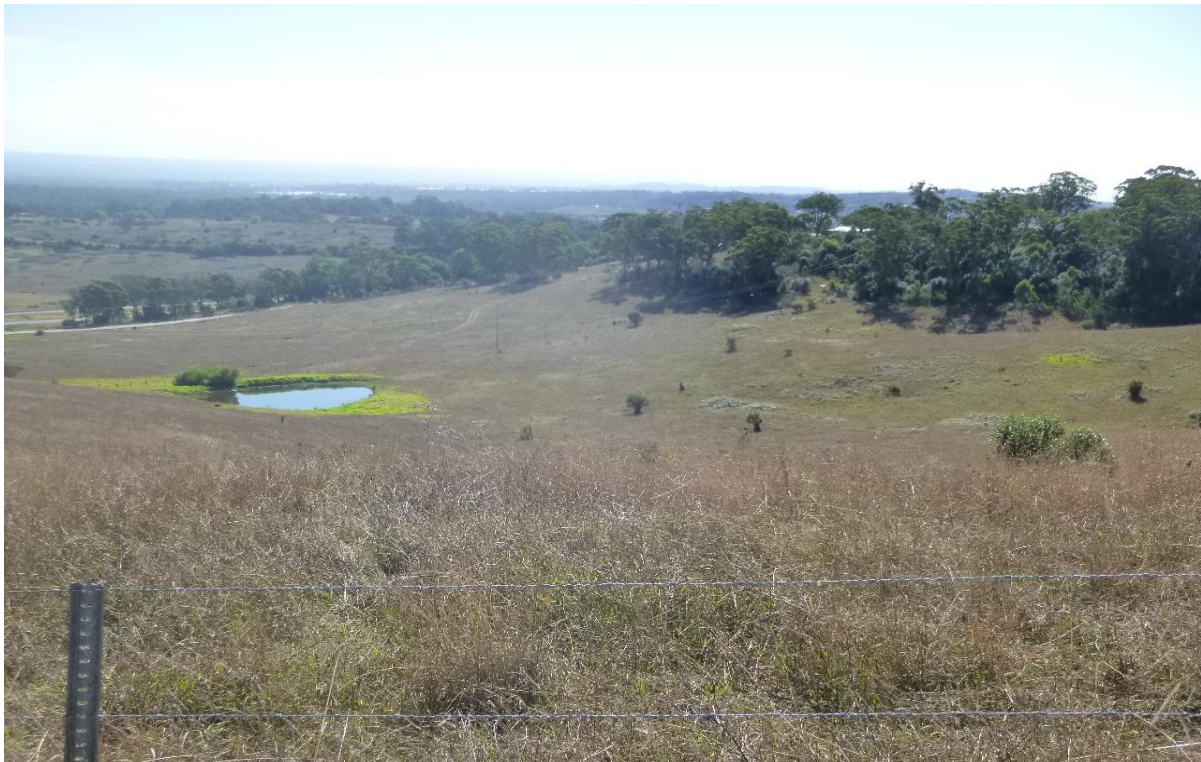
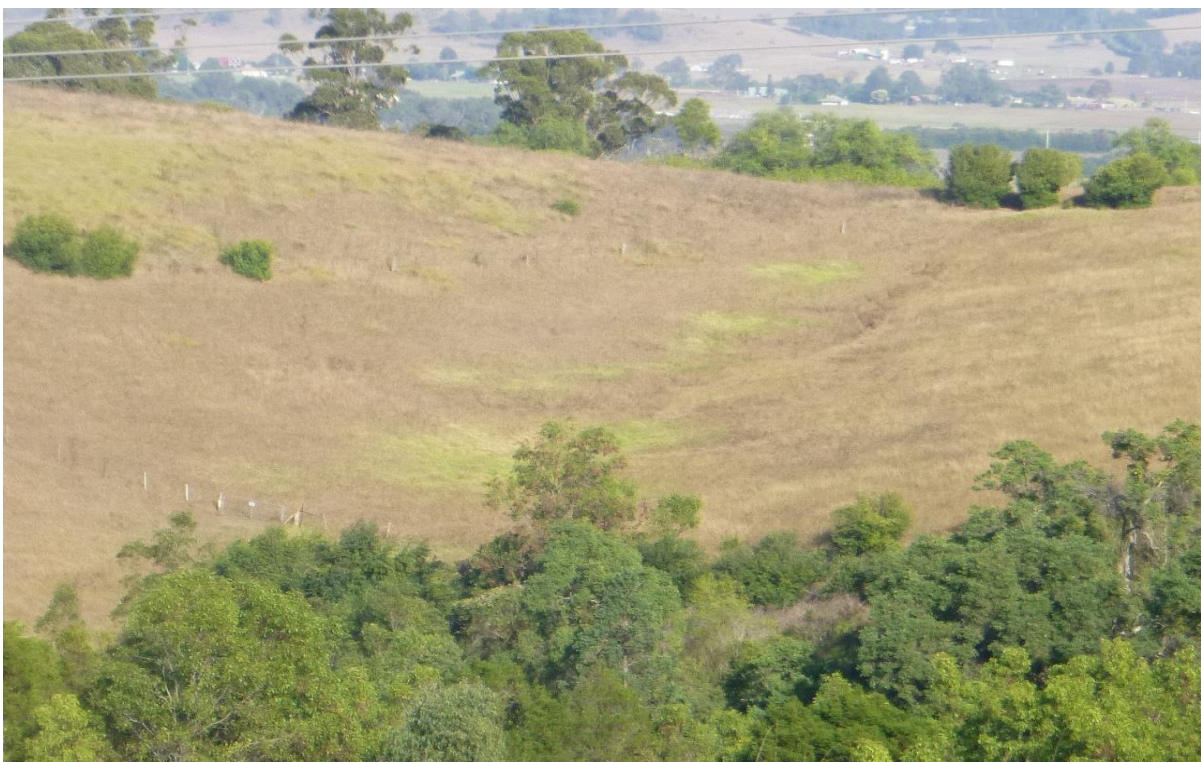
- Lush, green areas of grass were noted in many of moderate and steep hillside around the site (refer Photos 13 and 14), typically associated with local depressions and perennial watercourses which can be indicative of groundwater seepage.

Photo 13: View looking west at break in the slope and trees leaning in various directions (Approximate Chainage 3860) (Project 76649.01).

Photo 14: View looking west at break in the slope and trees leaning in various directions (Approximate Chainage 3860) (Project 76649.01).

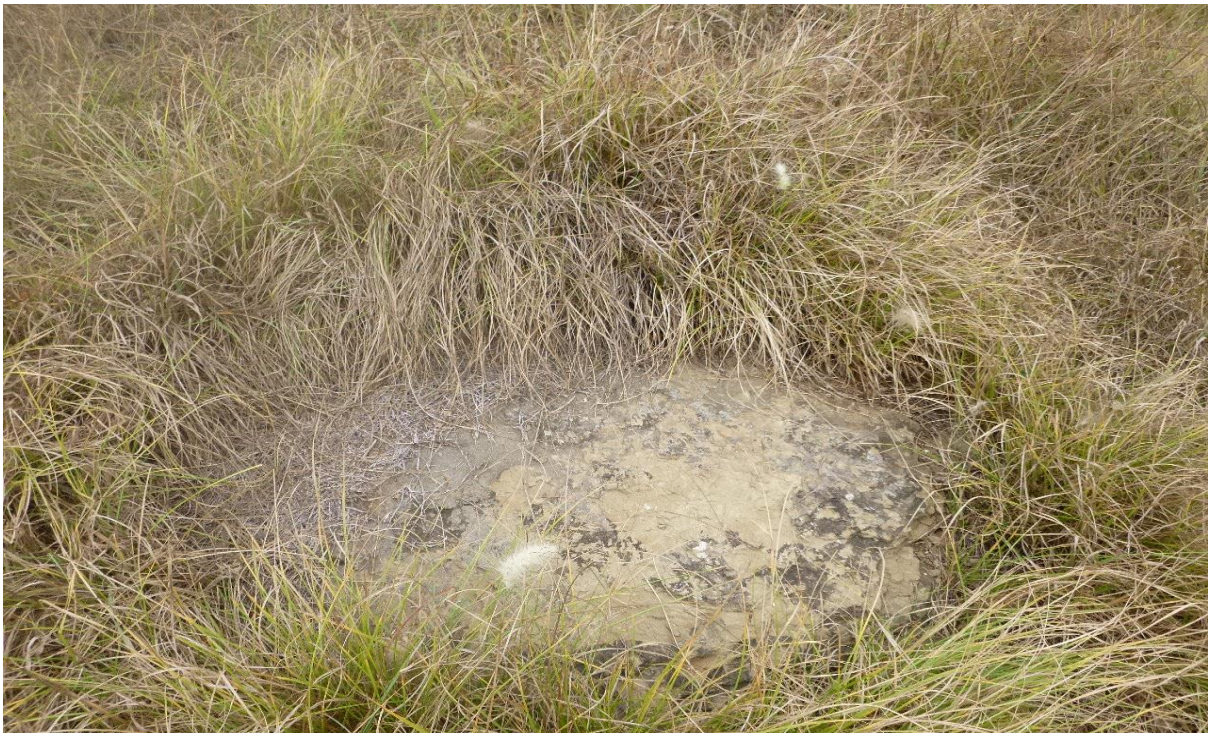
- Sandstone boulders (including tabular slabs) were observed at a number of locations around the site. Tabular slabs located in the central eastern hillside appear to be from an erosion-resistant sandstone band close to the expected location of the Minchinbury Sandstone Member (refer Photo 15) which marks the boundary between the Ashfield Shale and Bringelly Shale.

Photo 15: Sandstone slab at the surface near Pit 5, probably related to a sandstone ledge in the hillside (Project 76649.01).

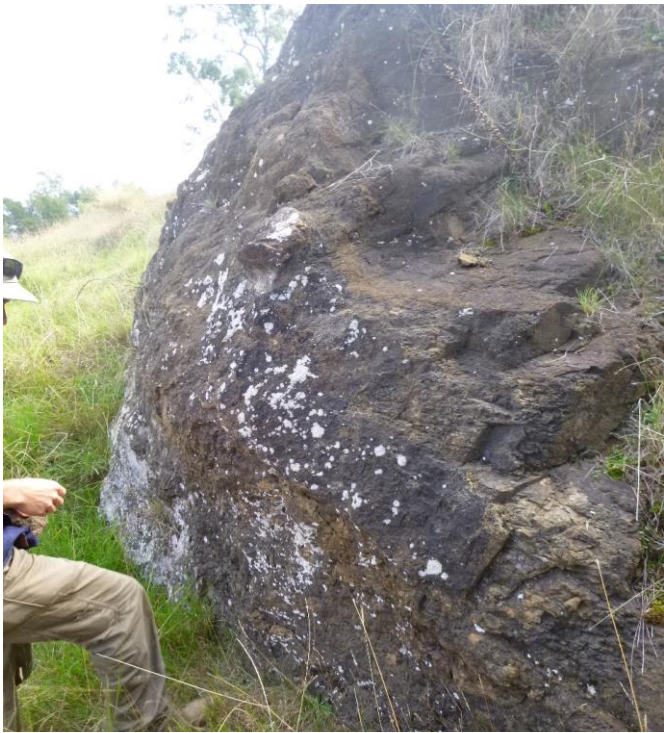
Photo 16: Dolerite exposed in a small roadside quarry in the southern part of the site (Project 76649.01).

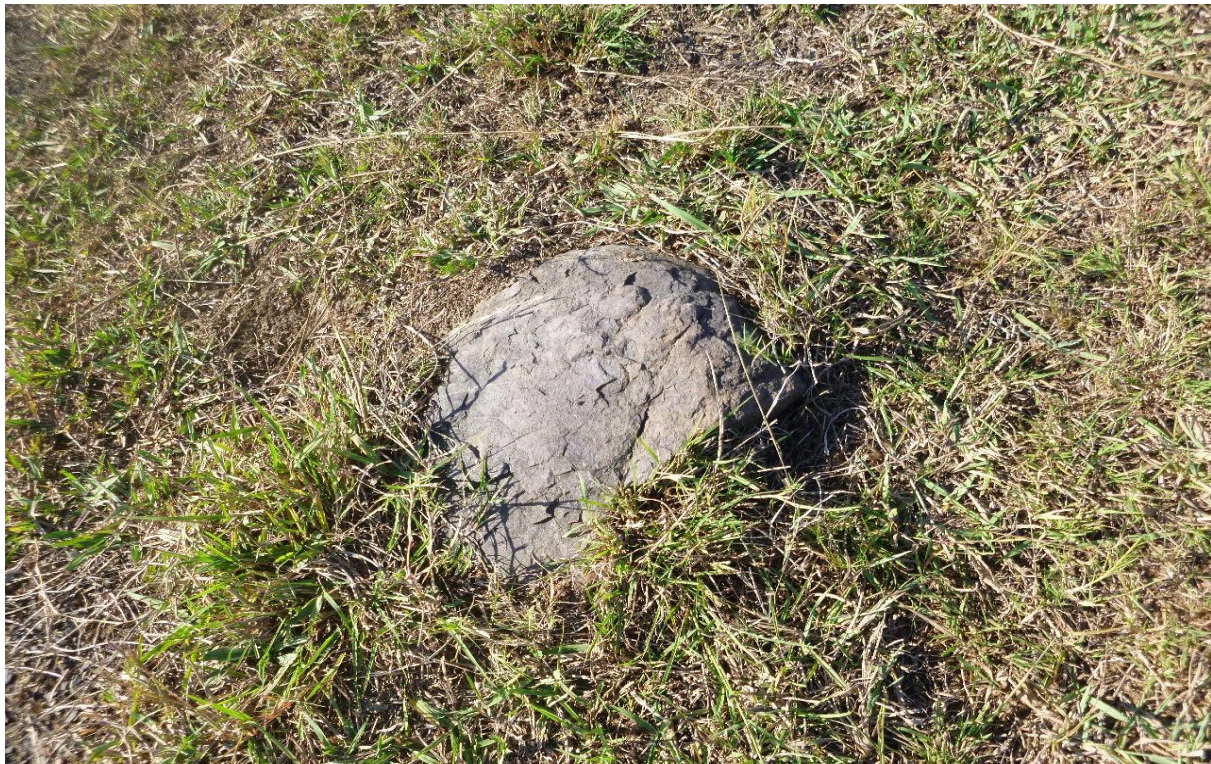
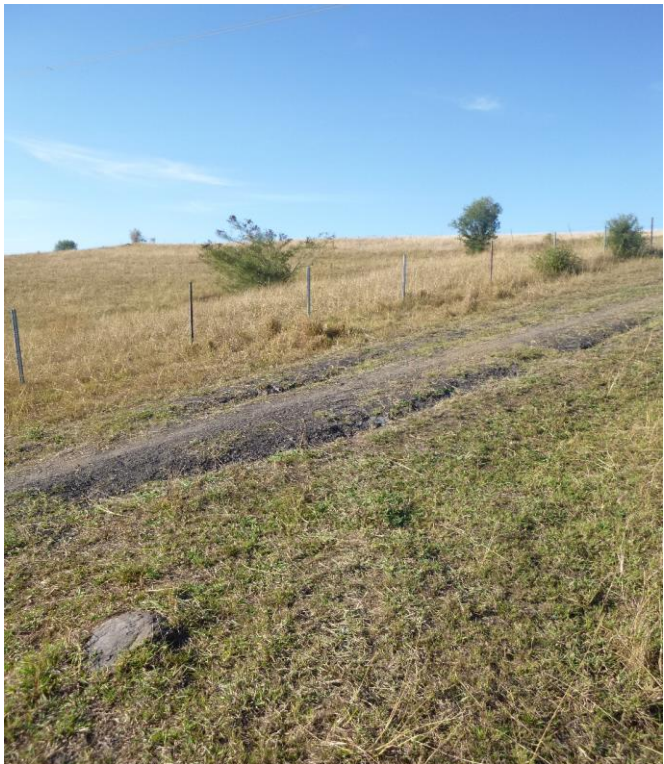
- Surficial slumping was also observed in many of the moderate to steep hillsides and watercourse embankments within the site.
- A small quarry within a dolerite diatreame is located in the southern part of the site (example of exposed rock shown in Photo 16). A dolerite boulder/core stone was also observed within the hillside in the central northern part of the site (refer Photos 17 and 18).

Photo 17: View looking at dolerite boulder/corestone embedded in the surface of the hillside (Project 76649.01).

Photo 18: View looking at dolerite boulder/corestone embedded in the surface of the hillside (Project 76649.01).

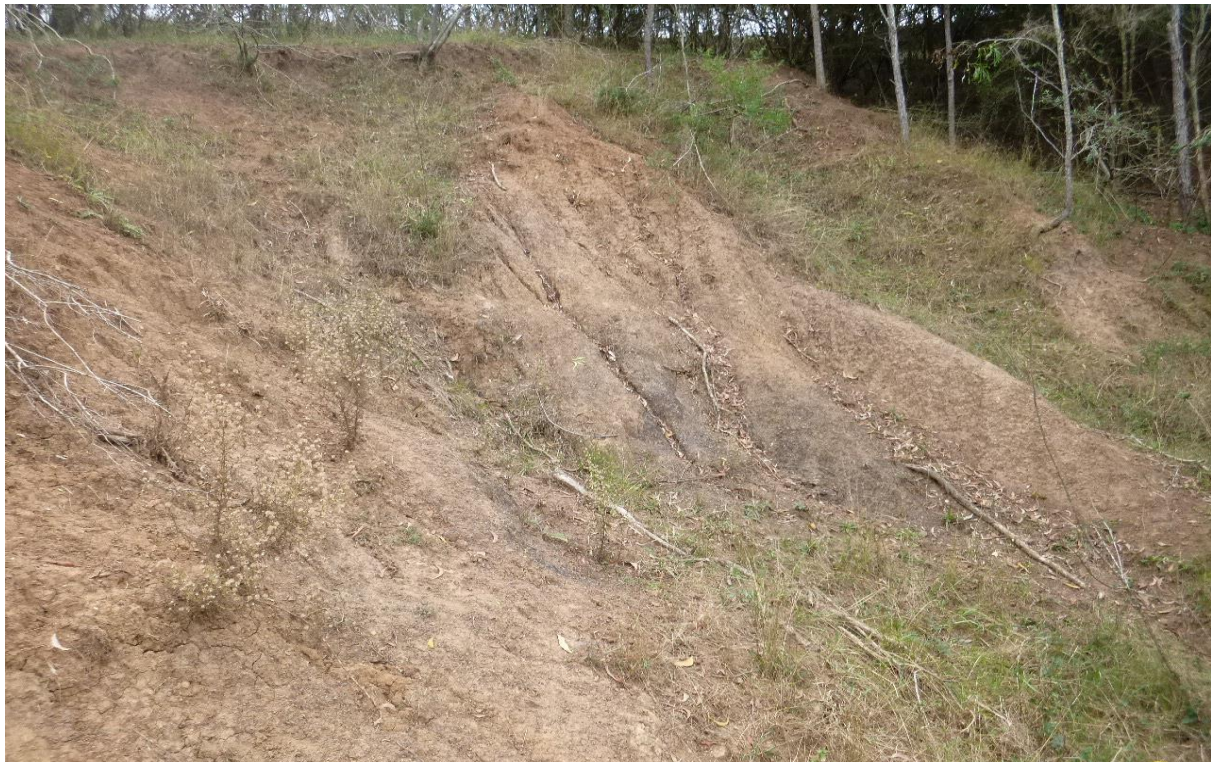
Photo 19: View looking at erosion rills in over-steepened erosion gullies (Project 76649.01).

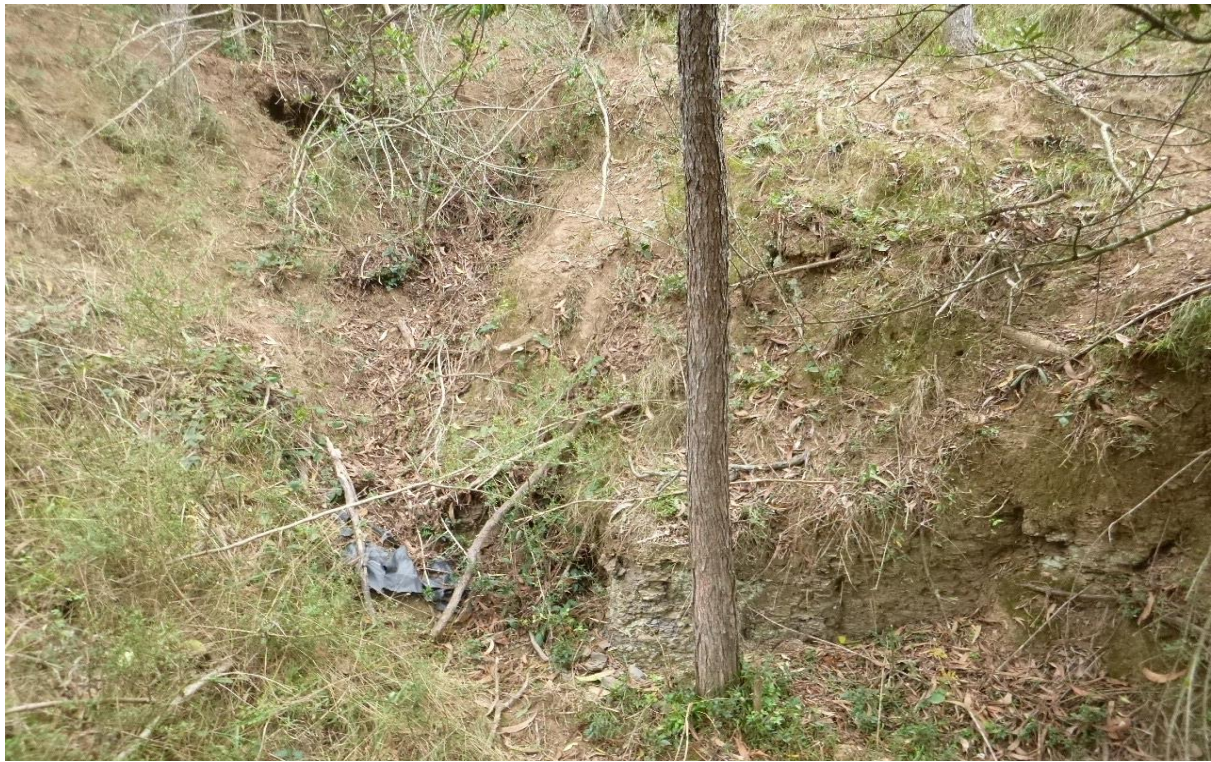
Photo 20: View looking at siltstone exposed in one erosion gully (Project 76649.01).

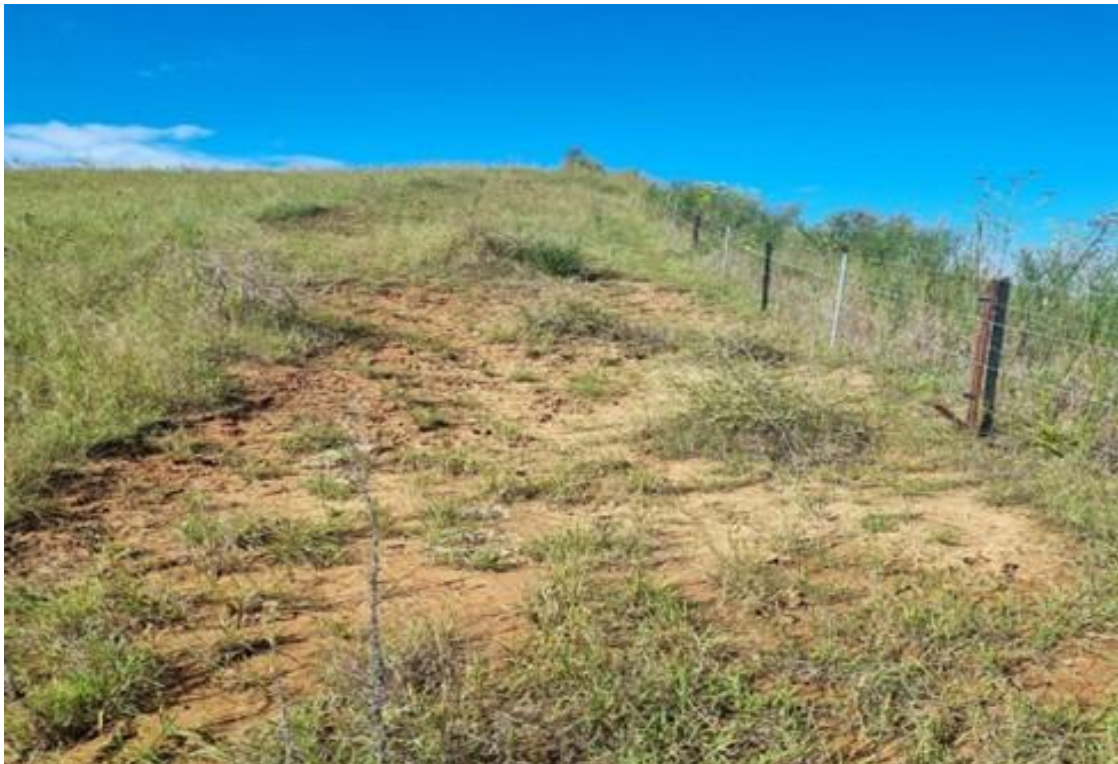
Photo 21 - Eroded ground above Medhurst Road batter

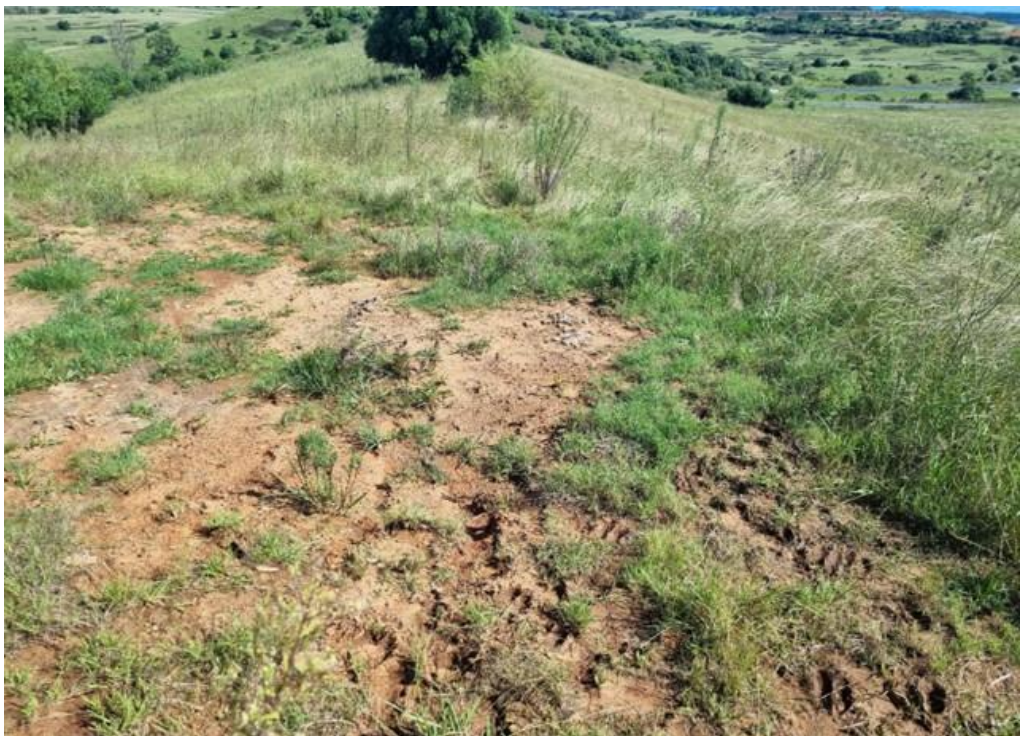
Photo 22: Eroded ground on southern ridge line

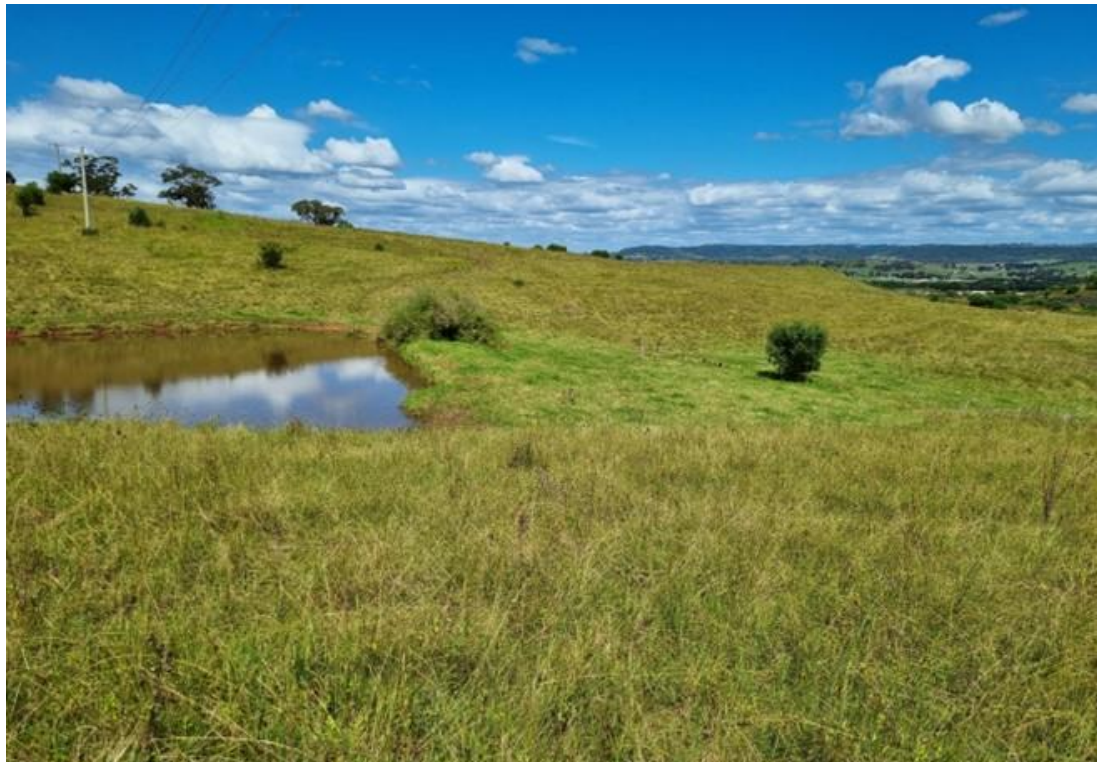
Photo 23: Fill placed downslope of dam wall

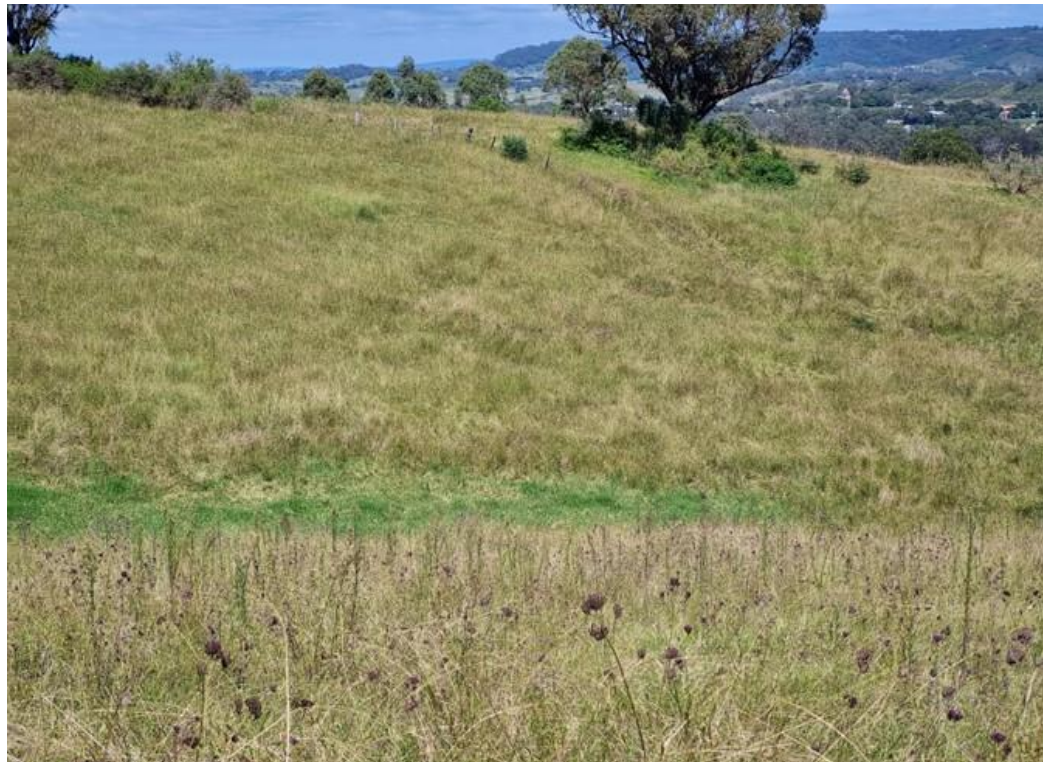
- Waterlogging was noted and is typically associated with local depressions and perennial watercourses which is indicative of groundwater seepage (Photo 27). Areas of groundwater seepage have also been identified on Drawing 1.

Photo 27: Seepage areas in midslope

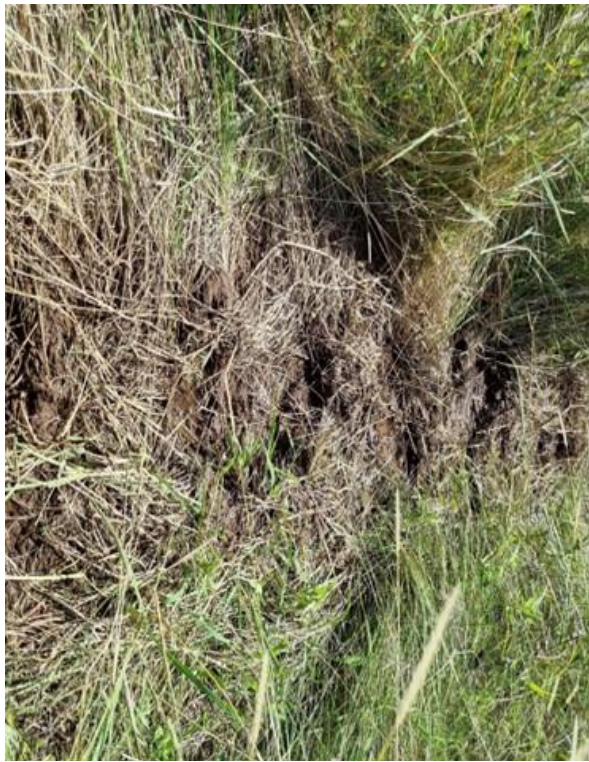
Photo 28: Detailed view of seepage midslope

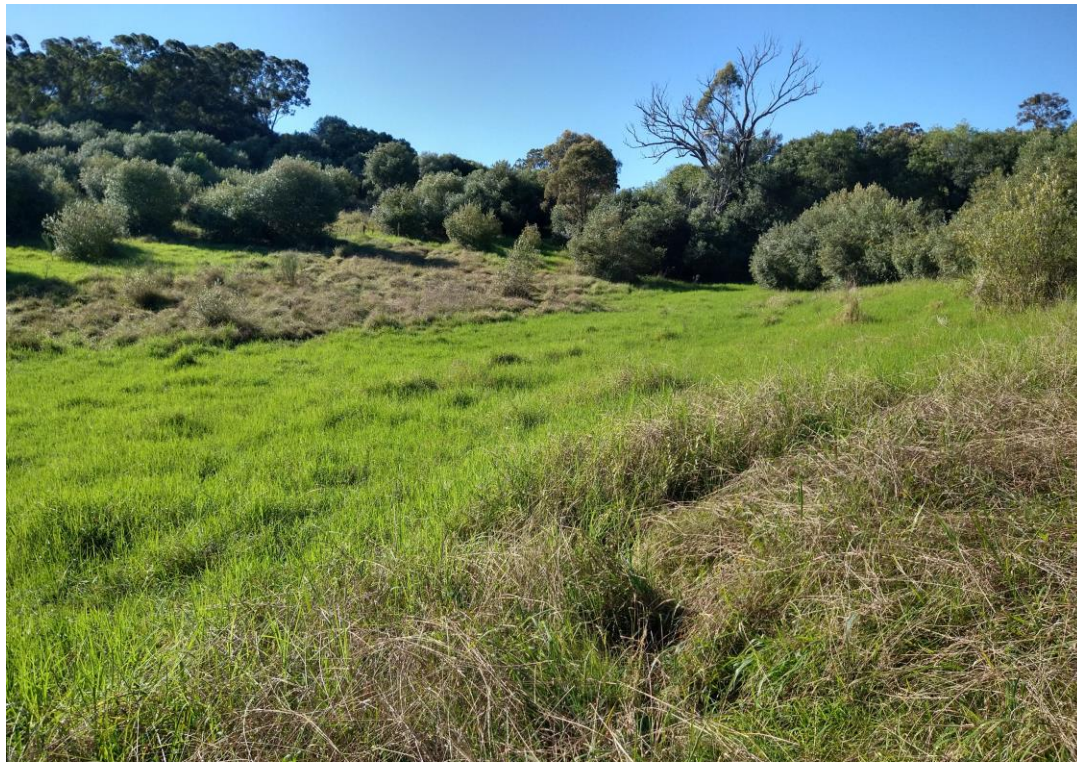
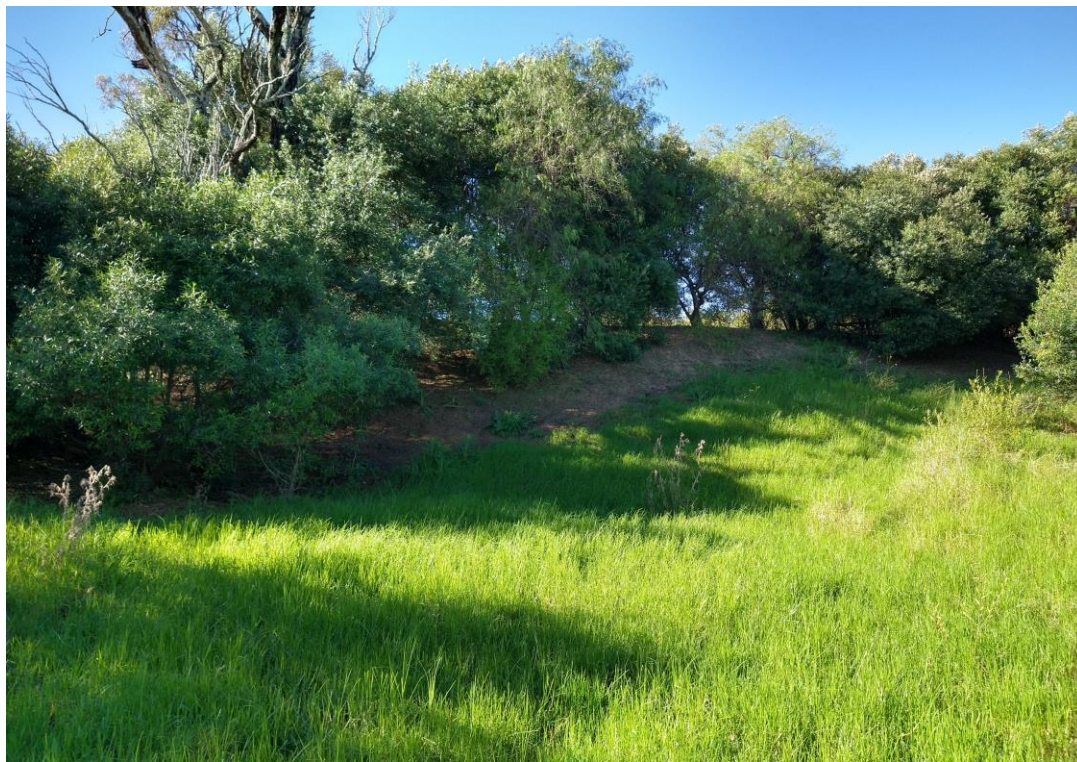
- The various farm dams typically comprise a filled embankment on one side up to 3 m in height with batter slopes up in the range 2H:1V to 4H:1V (Photos 29 and 31).
- Water logged areas were noted downstream of the farm dams and in flat areas with poor drainage
- Sandstone boulders and gravel were noted at the surface of the slopes below the power line easement (Photo 33);
- A collapsed rabbit warren indicated topsoil thicknesses of about 400 mm (Photo 34);
- The steeper portions of the site were heavily overgrown with African olive shrubs which prevented detailed observations of the slopes (Photo 30).
- High voltage power lines and high pressure gas mains traverse the site (Photos 35 and 36);
