Report on  
Preliminary Geotechnical Assessment

Rosalind Park Planning Proposal  
Medhurst Road, Menangle

Prepared for  
Leda Holdings Pty Ltd

Project 205817.05  
August 2022

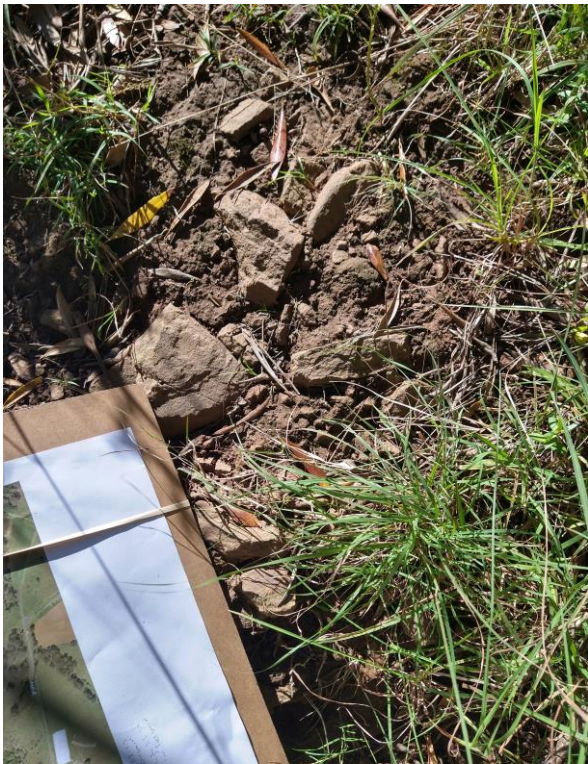
Photo 33: Sandstone at surface in midslope

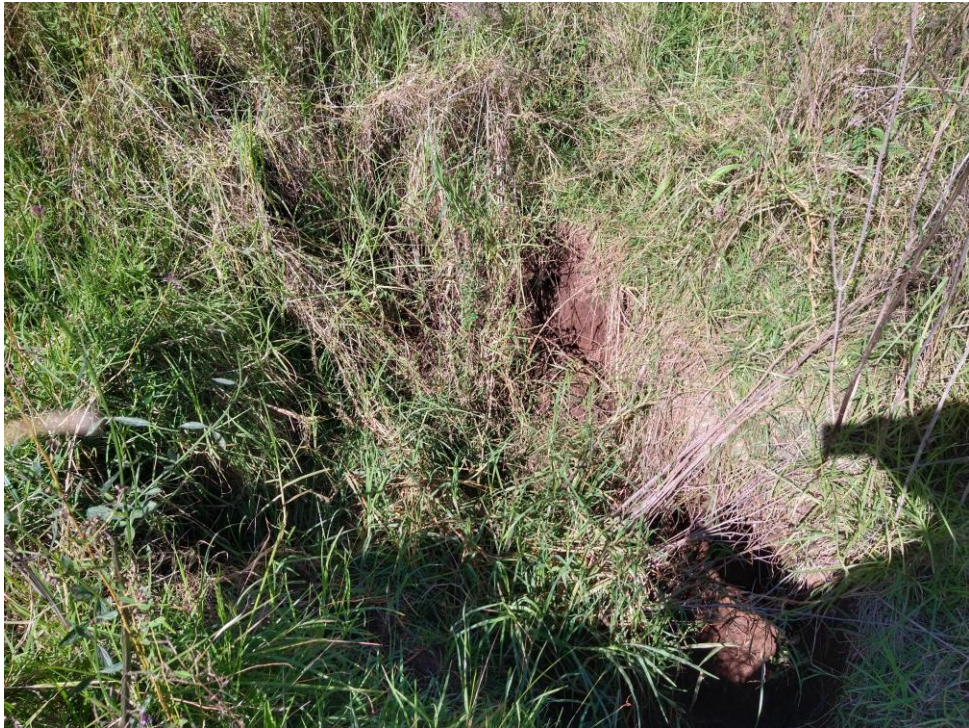
Photo 34: Collapsed rabbit warren showing topsoil depths
