**Preliminary Geotechnical Assessment**

**Proposed Commercial / Residential Subdivision**

**1055 Bruxner Highway, Goonellabah**

Report No. RGS33375.1 - AA

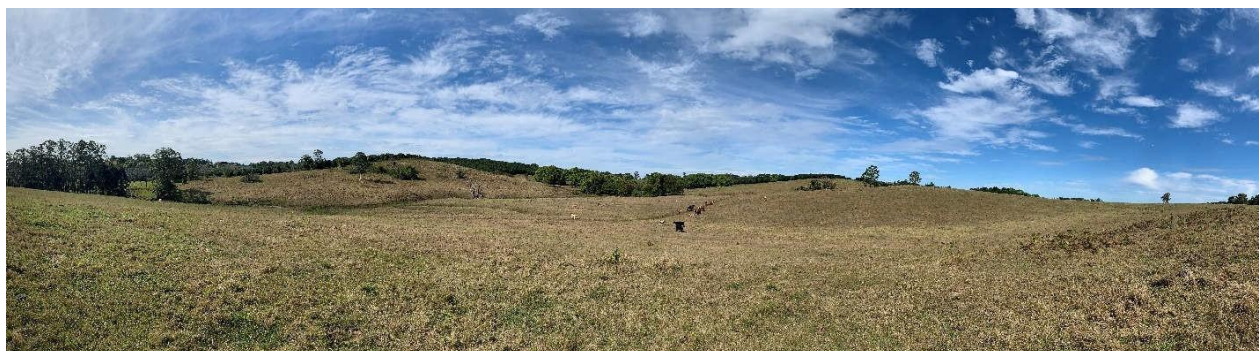
*A panoramic view looking northeast illustrating undulating rolling hills which typifies the site.*

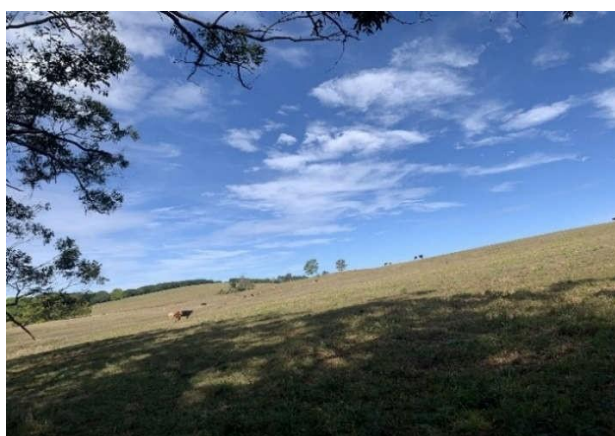
*Looking southeast illustrating site slopes.*

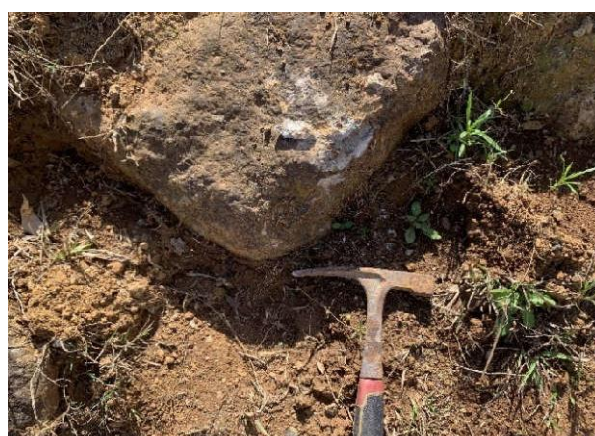
*Outcropping basalt boulders were estimated to be of at least high strength.*

Basalt boulders and outcrops were observed across the site with larger flow type deposits found in the topographically lower portions of the site e.g creek lines. In situ strength tests conducted on out cropping rock were high to very strength in nature.

It should be noted that high strength basalt will likely require ripping and tynes or rock hammers. The use of rock hammers may be required in detailed excavations such as service trenches, or to avoid overbreak in detailed excavations.

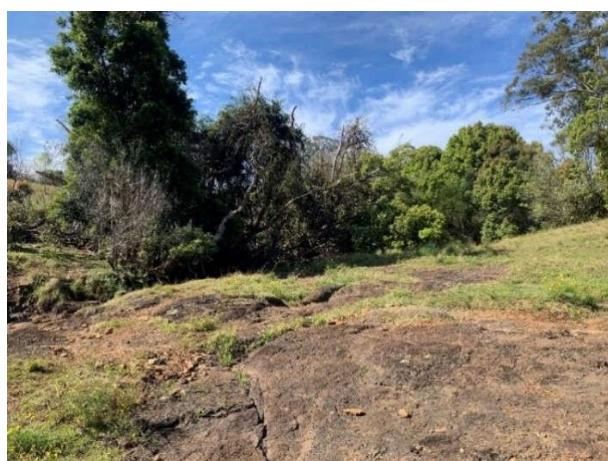
*Out cropping basalt bedrock prevalent in creek lines.*

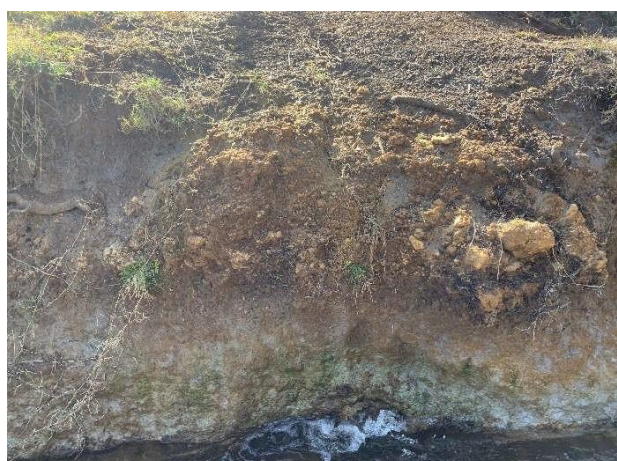
*A creek incision reveled a soil profile of residual clay soils and weathered basalt.*
