Proposed “Bunderra” Residential Subdivision
Boolaroo

Geotechnical Slope Risk Assessment

Report No. RGS01611.1-AB

10 August 2017

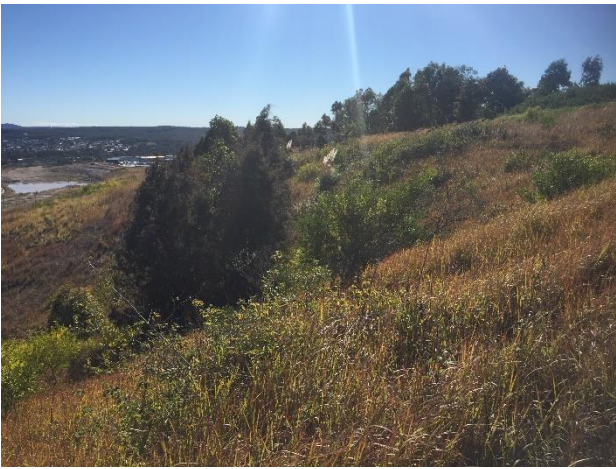
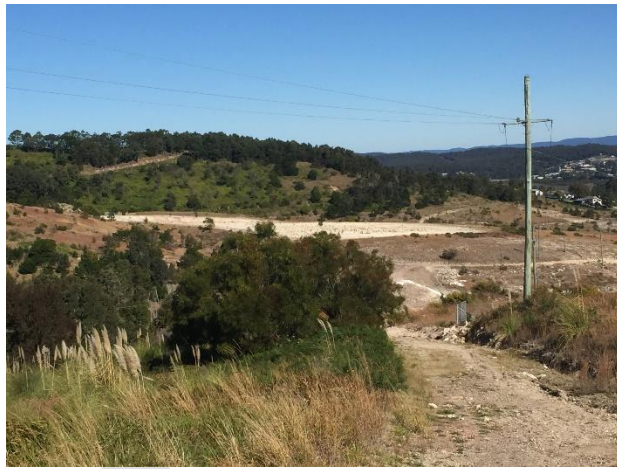
<p><i>Zone 2 terrain, near highest point of proposed development area. Steep slopes, some evidence of movement noted in separation of conglomerate blocks and disturbed bedding.</i></p>	<p><i>Looking across majority of Zone 2 area from the north to south. Steep slope in background (outside but above development area) shows evidence of numerous small scale landslides.</i></p>

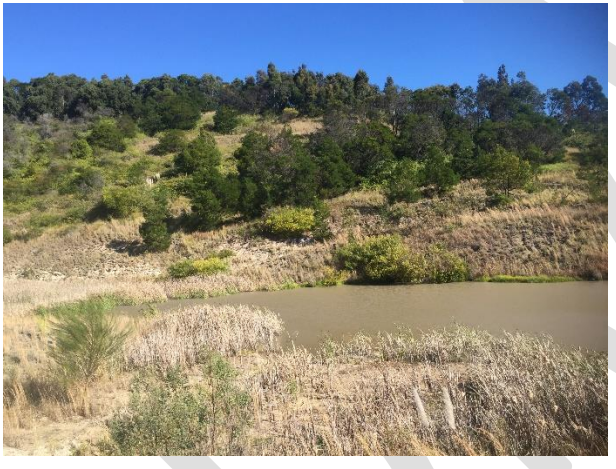
<p><i>Looking across Zone 2 area at southern end of site. Revegetated hill slope in rear of image shows evidence of past small scale rotational failures.</i></p>	<p><i>Seepage from sandstone joints and beds near boundary between Boolaroo sub group and Moon Island Beach Sub-Group at southern end of site</i></p>

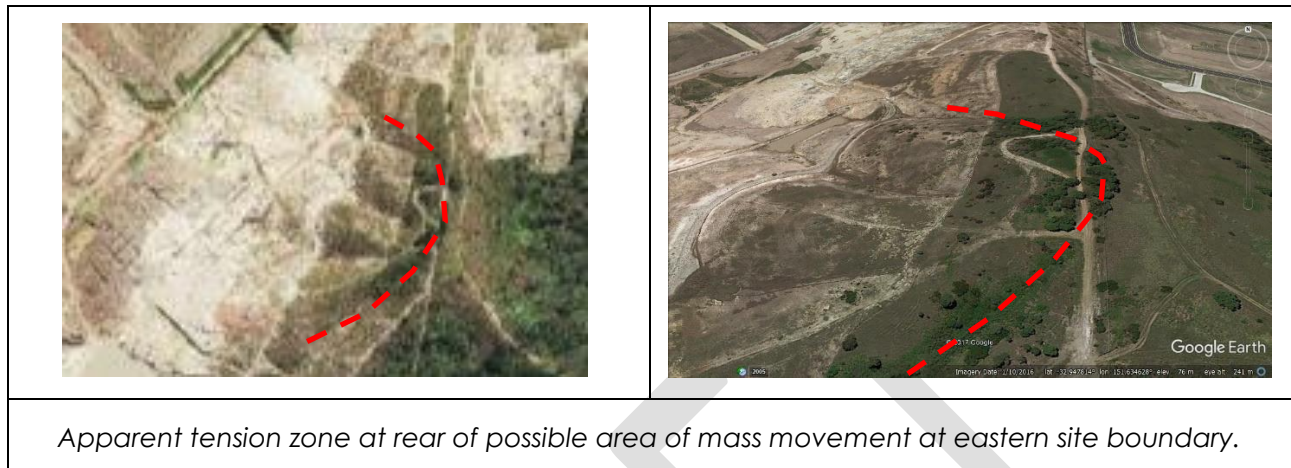
In the Zone 2 terrain, evidence of slope instability was observed in two areas, as shown on Figure 2. At the eastern site boundary, an area of apparent former large scale instability is evidenced by the separation and disturbance of conglomerate blocks over thinly bedded disturbed siltstone and claystone. This area is visible on aerial images and appears to be a large scale lateral movement of the crest and upper slopes of a ridge spur, towards the west. Laterally oriented drainage courses

and an area of lush vegetation at the rear of the spur appear to indicate a tension zone caused by the gradual lateral migration of conglomerate blocks over an underlying slide plane. There is no evidence of debris flows below the area of apparent movement, however, this may have been present prior to the extensive disturbance of the site during the Pasmenco remediation earthworks. Aerial images of the area of concern are shown below.

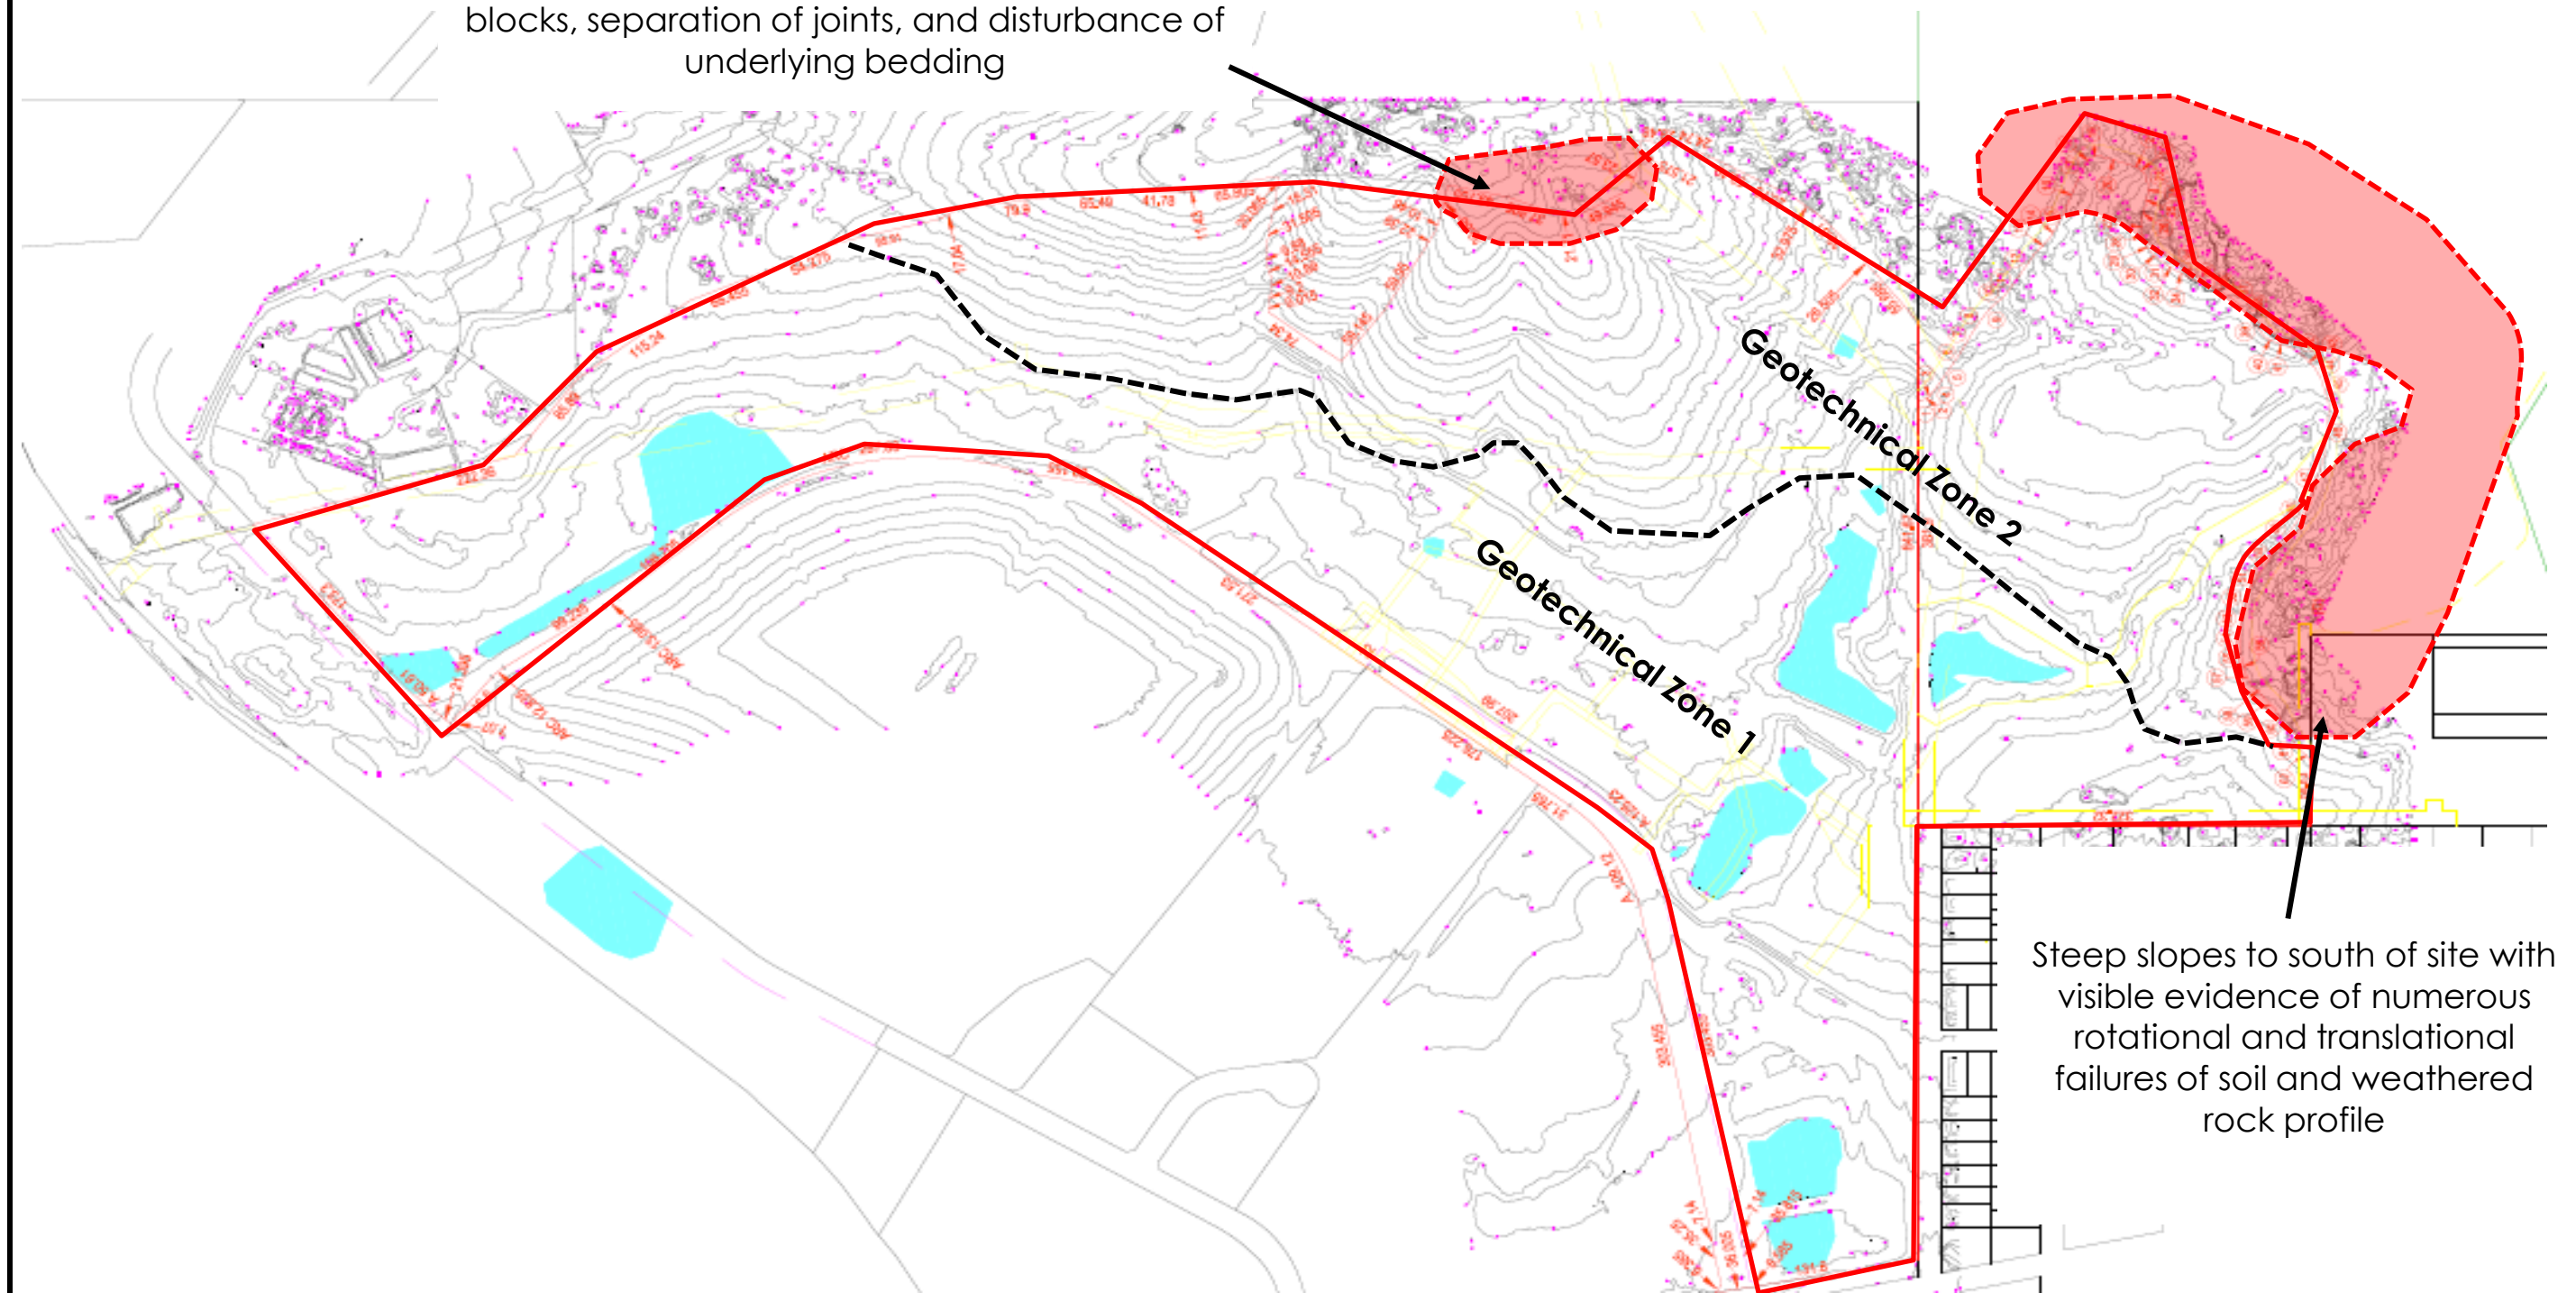
Client	HDB Town Planning and Design	Job No.	RGS01611.1
	Residential Subdivision Geotechnical Assessment	Drawn By:	SRM
	"Bunderra" site, Main Road Boolaroo	Date:	11-Aug-17
	Geotechnical Zones and Areas with Evidence of Slope Instability	Drawing No.	Figure 2

The second area of past instability is located at the southern site boundary where there are visible scars of multiple translational and rotational slides in the steep slope just outside the site boundary. There is some evidence of these areas, and the debris from these slides, extending across the site boundary onto the proposed development area. There is also some visible seepage and separation of sandstone blocks on the mid to lower slopes of the ridge spur in the southern corner of the site. Brief observation of some adjacent residential development that appears, from the style of house present, to be over 50 years old, did not reveal visible evidence of damage attributable to lateral ground movement.

Area showing evidence of slope instability in the form of large conglomerate and sandstone blocks, with apparent lateral movement of blocks, separation of joints, and disturbance of underlying bedding

Steep slopes to south of site with visible evidence of numerous rotational and translational failures of soil and weathered rock profile

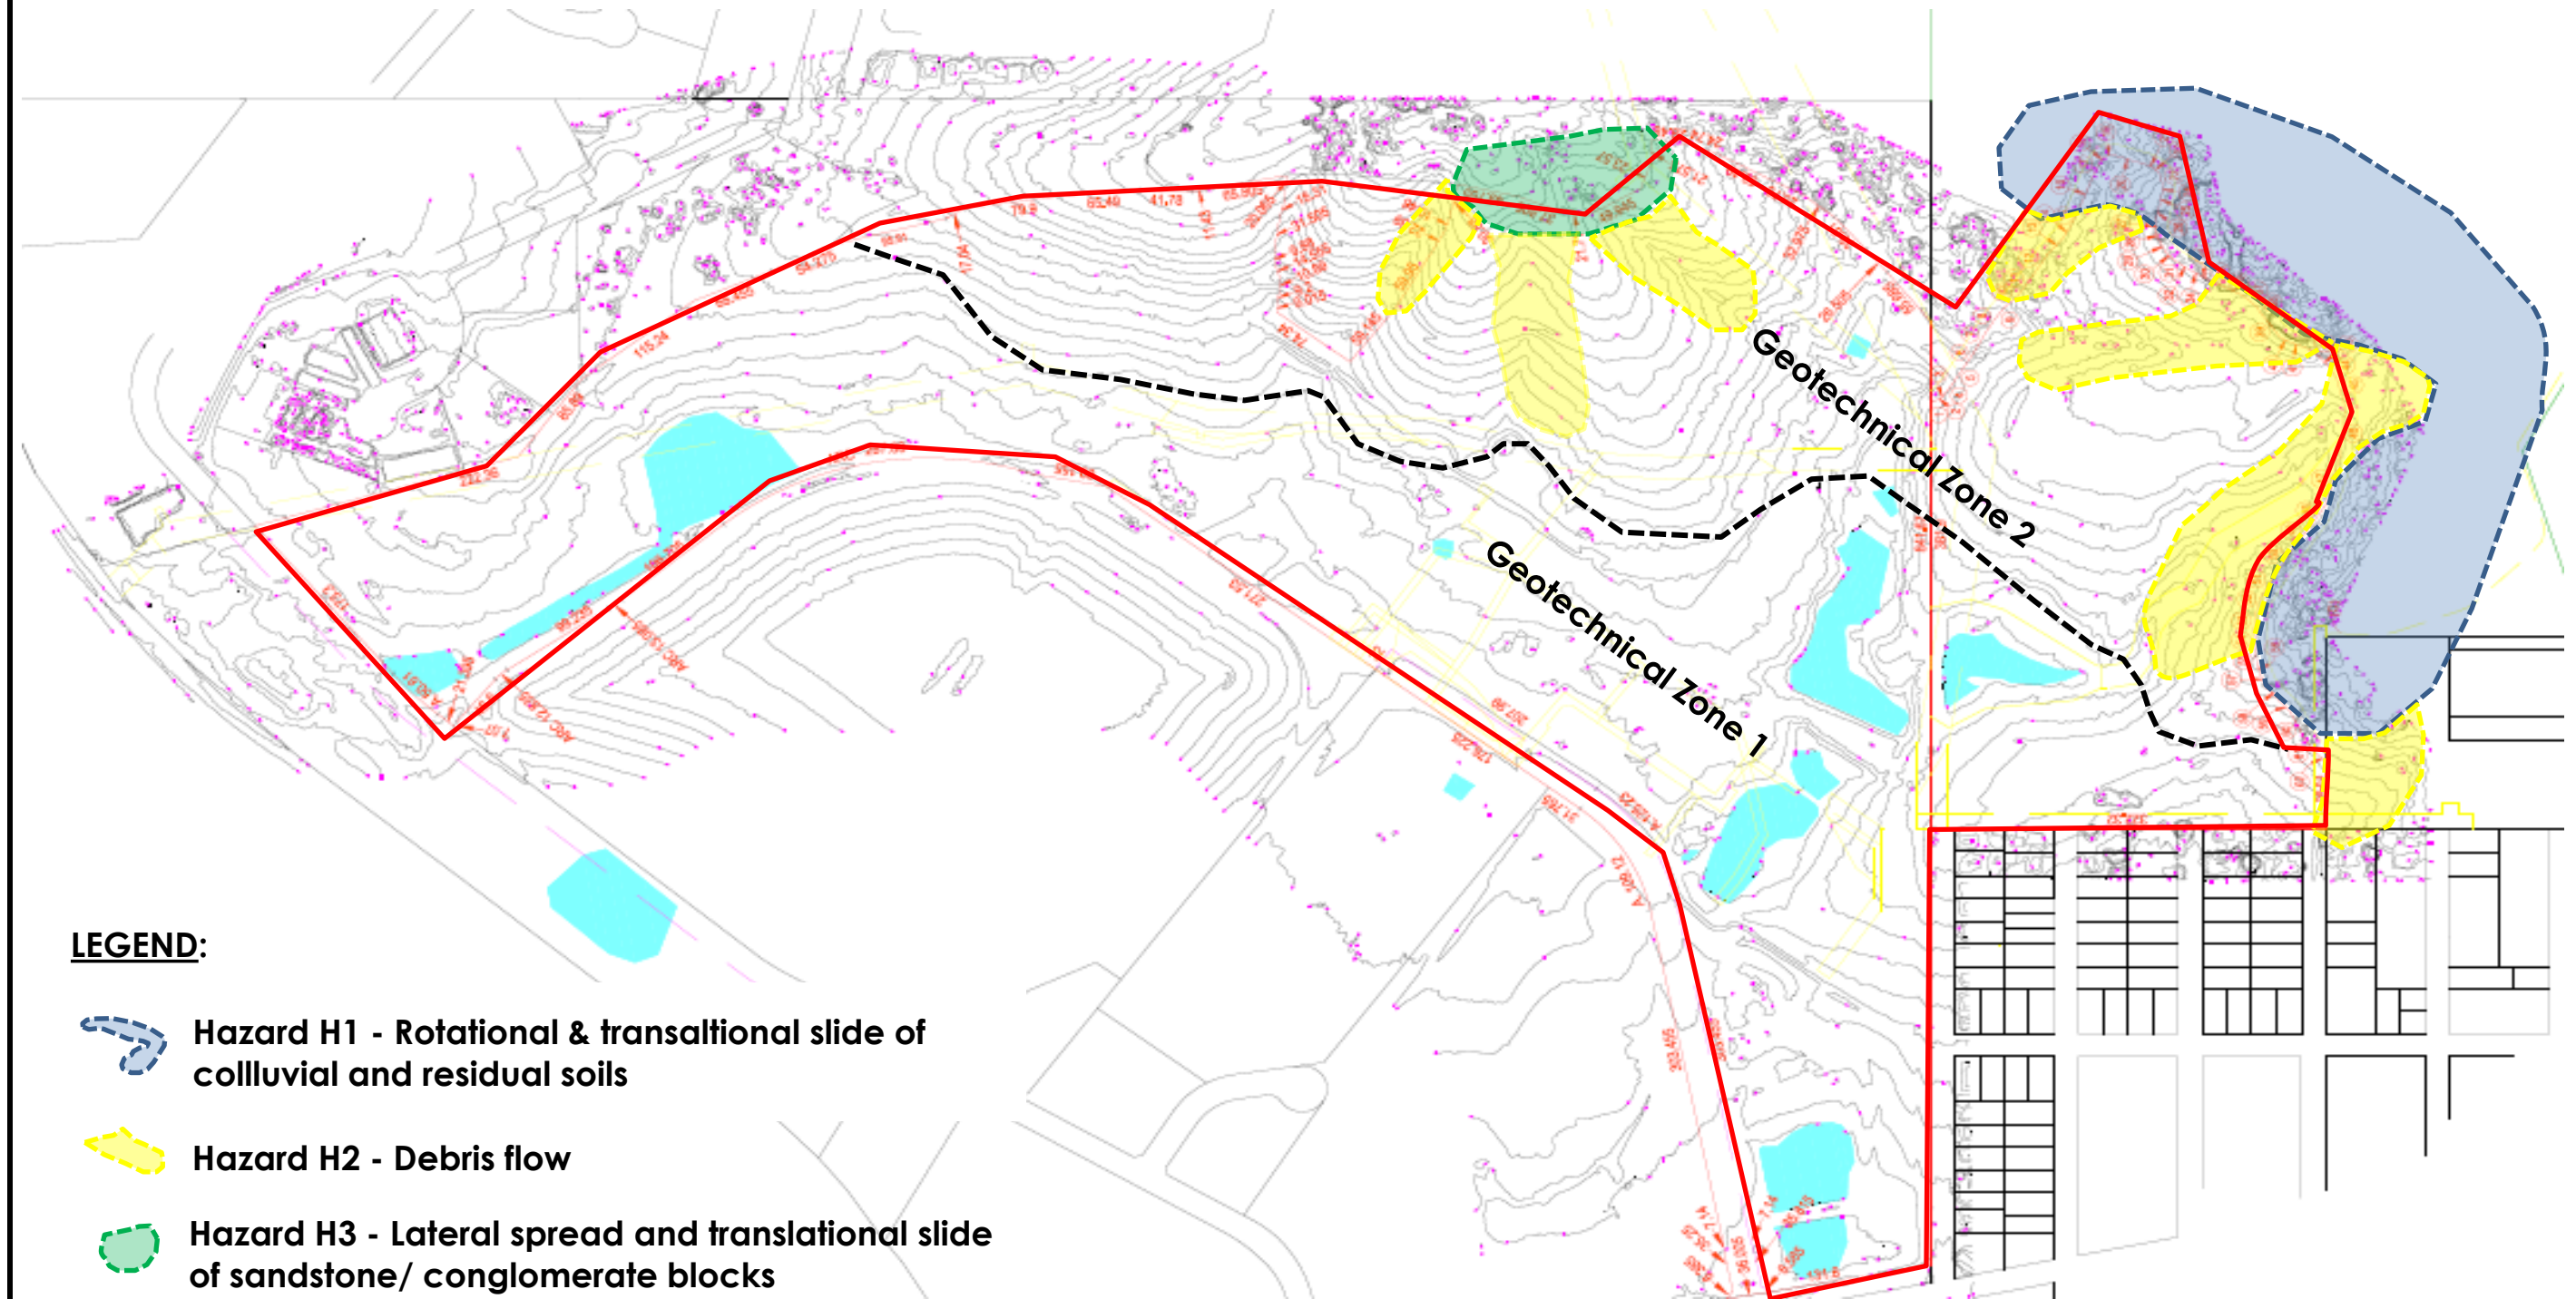
The areas potentially affected by Hazards 1, 2 and are illustrated on Figure 4. Hazards 4 and 5 could affect any part of Zone 2.

Hazard H1 - Rotational & translational slide of colluvial and residual soils

Hazard H2 - Debris flow

Hazard H3 - Lateral spread and translational slide of sandstone/ conglomerate blocks
