Report on
Preliminary Site Investigation

Proposed Appin (Part) Precinct
Appin, NSW

Prepared for
Walker Corporation Pty Ltd

Project 76589.06
October 2022

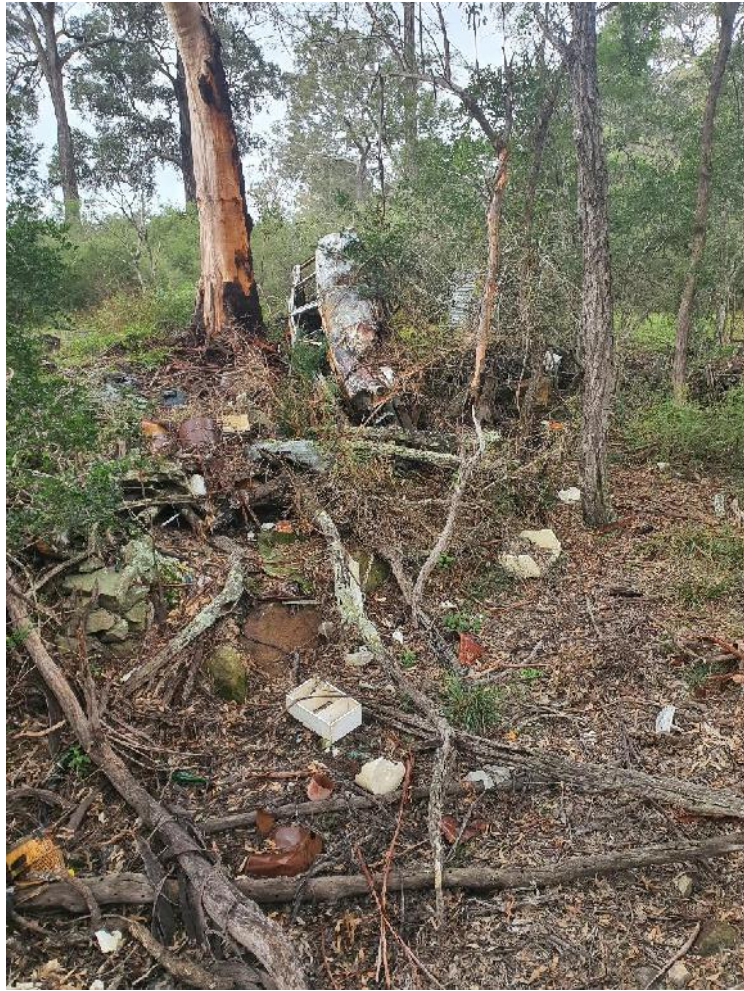
Photo 21 - Refuse (MRP16)

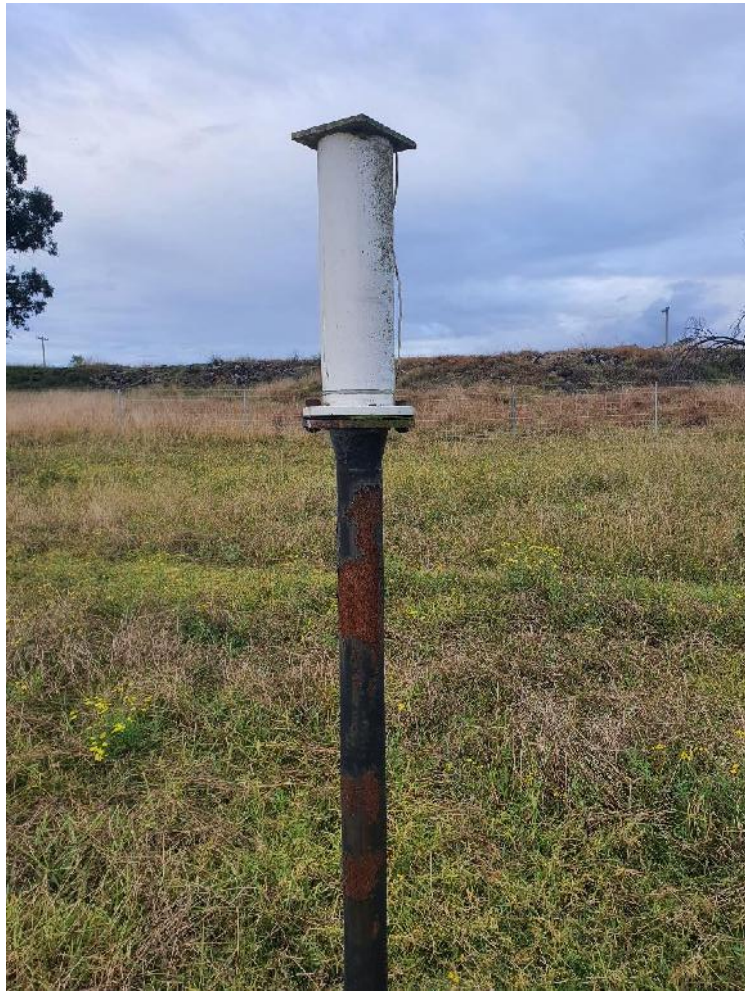
- Three monitoring bores belonging to BHP Billiton or South32 were observed on this portion of the site (MRP 8; plates 8 and 9, MRP28; plate 33 and MRP 53; plate 60).

Photo 33 - BHP Monitoring Well (MRP28)

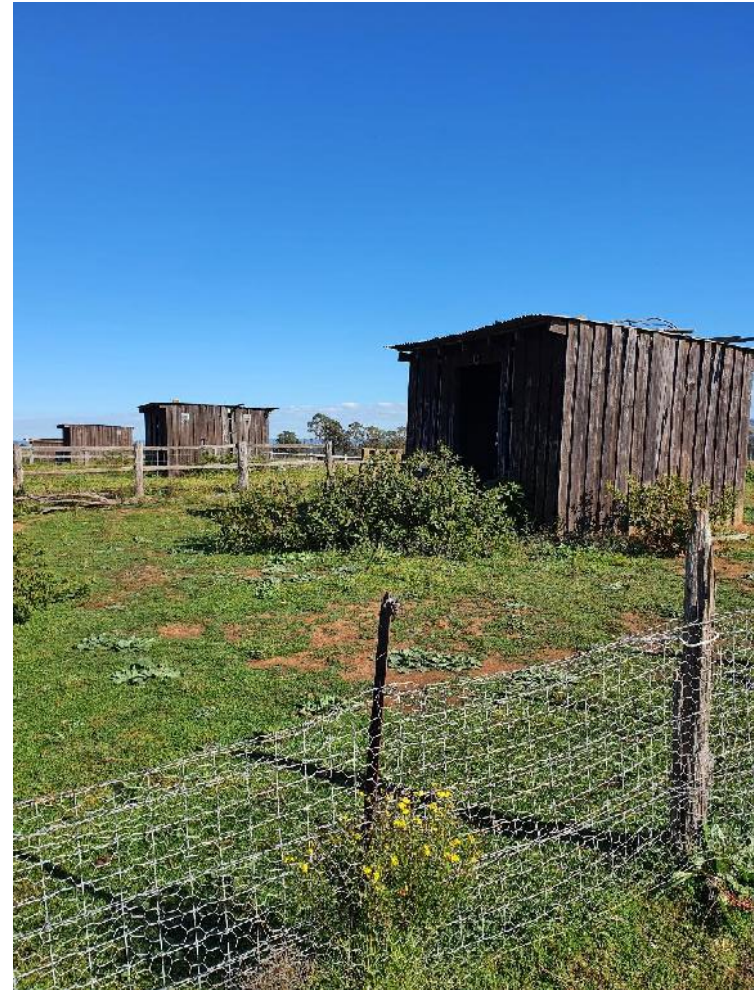
Photo 36 - Timber Structures (MRP32)

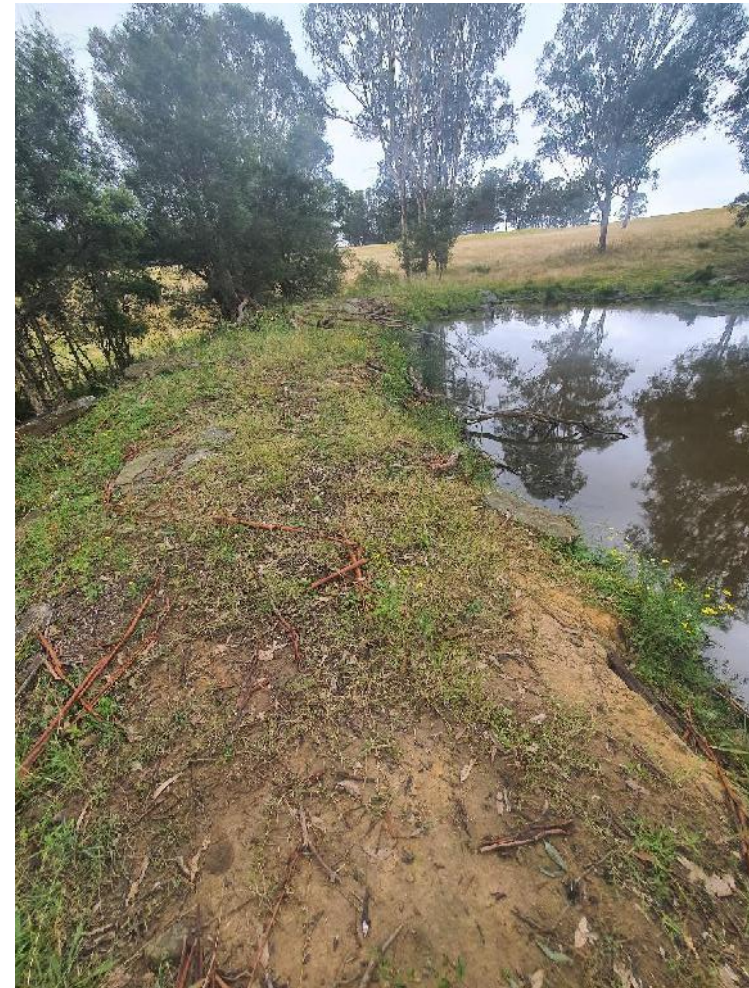
Photo 44 - Dam Embankment (MRP37)

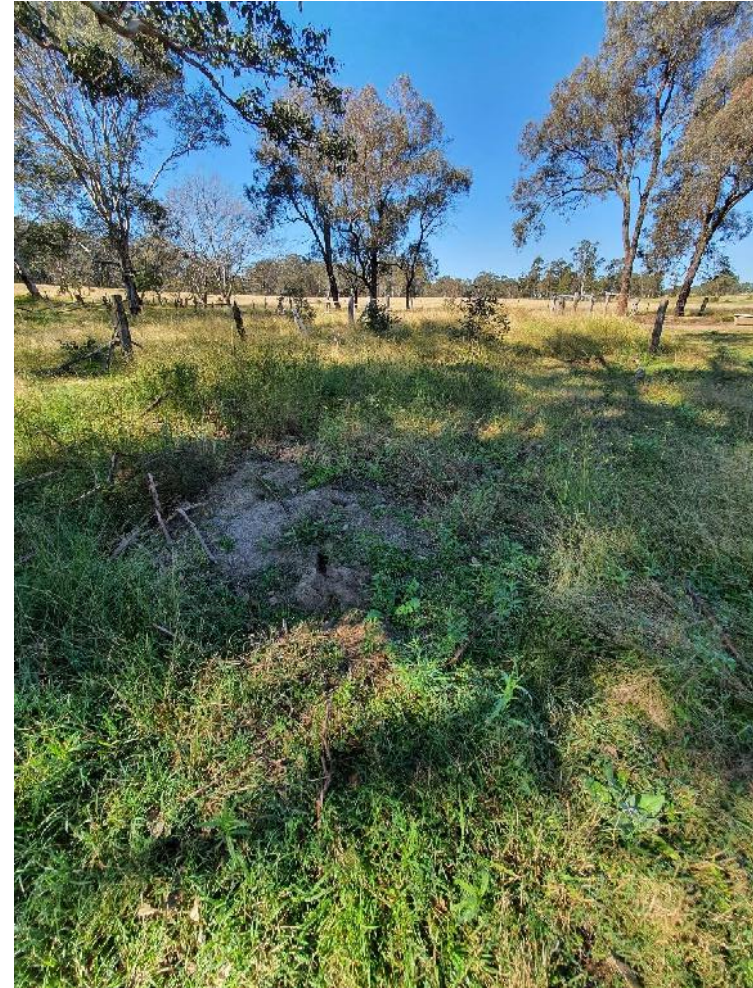
Photo 46 - Minor Sand Stockpile (MRP39)

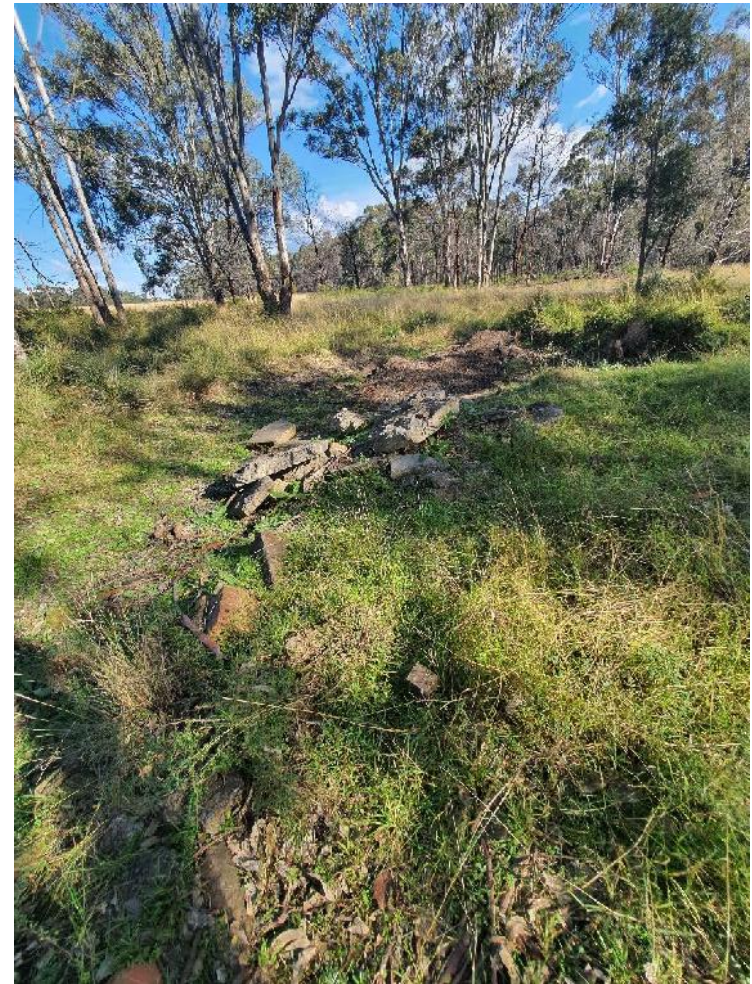
- Systematic dumping was observed along Elladale Road including construction and demolition materials (MRP 65; plates 74 to 76, MRP 67; plate 78, MRP 70; plate 81 and MNP 76; plates 86 to 88).
- Several stockpiles were noted along Elladale Road (MRP 59; plate 67, MRP60; plates 68 and 69, MRP 61 to 63; plates 71 and 72).
- Farm dams were scattered throughout the area, the majority of which were observed to have embankments constructed from locally derived material. One dam embankment was noted to contain building rubble.
- Several timber power pole alignments were encountered.
- There were several houses in this area (i.e. along Brooks Point Road) some of which may be derelict and many of which were of the age which would indicate that hazardous building materials may be present.

Photo 74 - Dumped Building Rubble (MRP65)

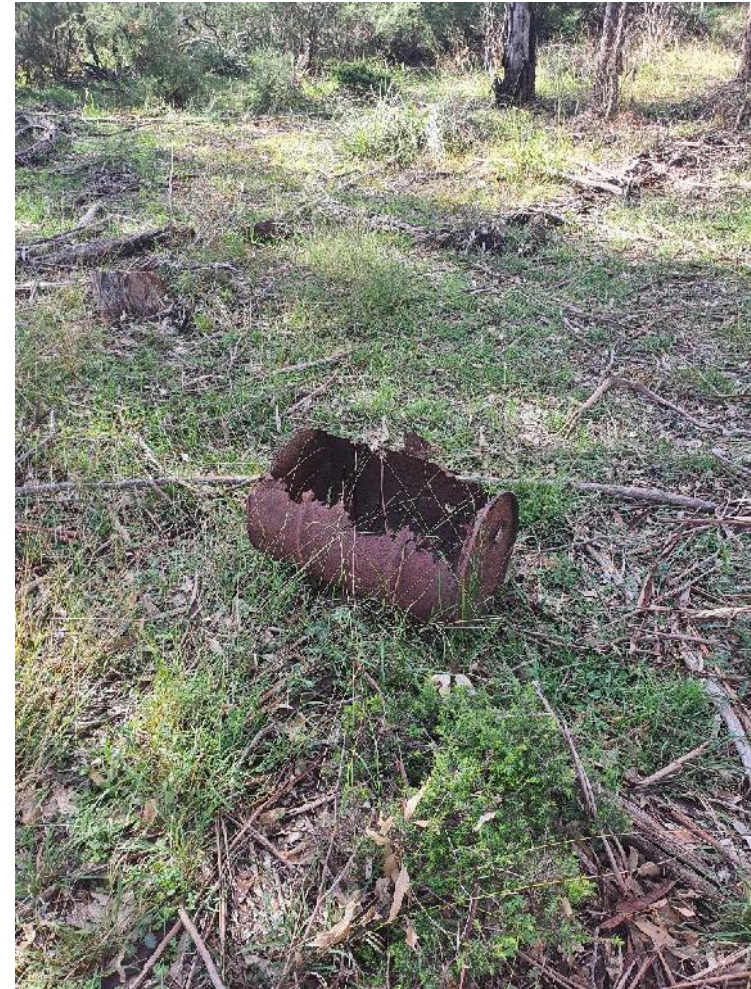
Photo 78 - Occasional Minor Refuse in Trees (MRP67)

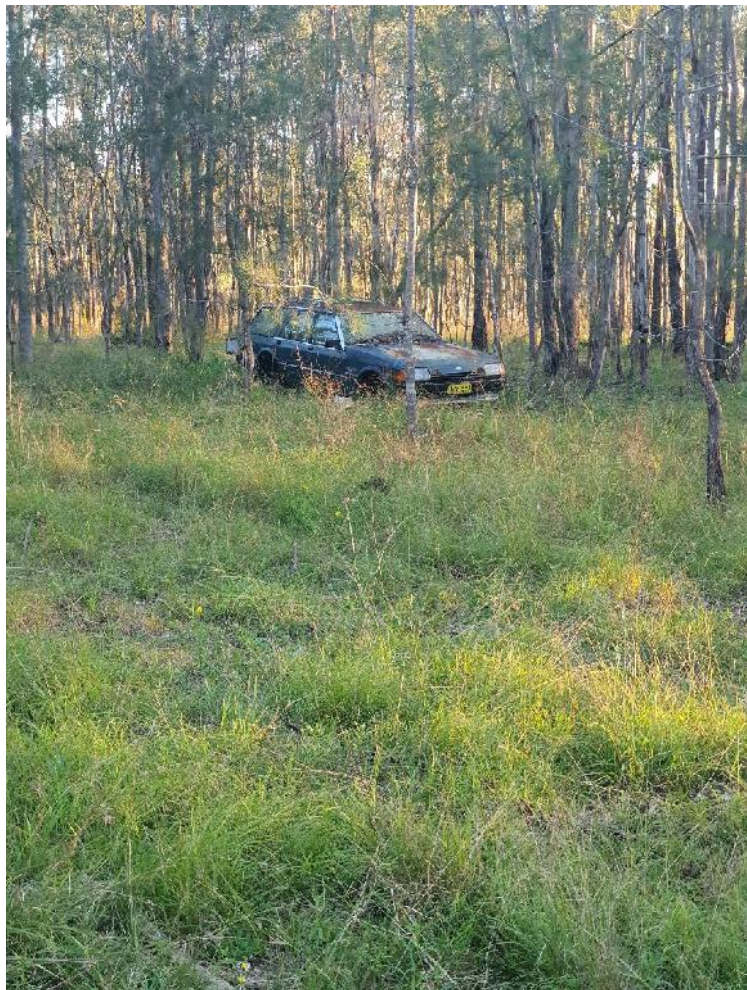
Photo 87 - Dumped Cladding and Car (MRP76)

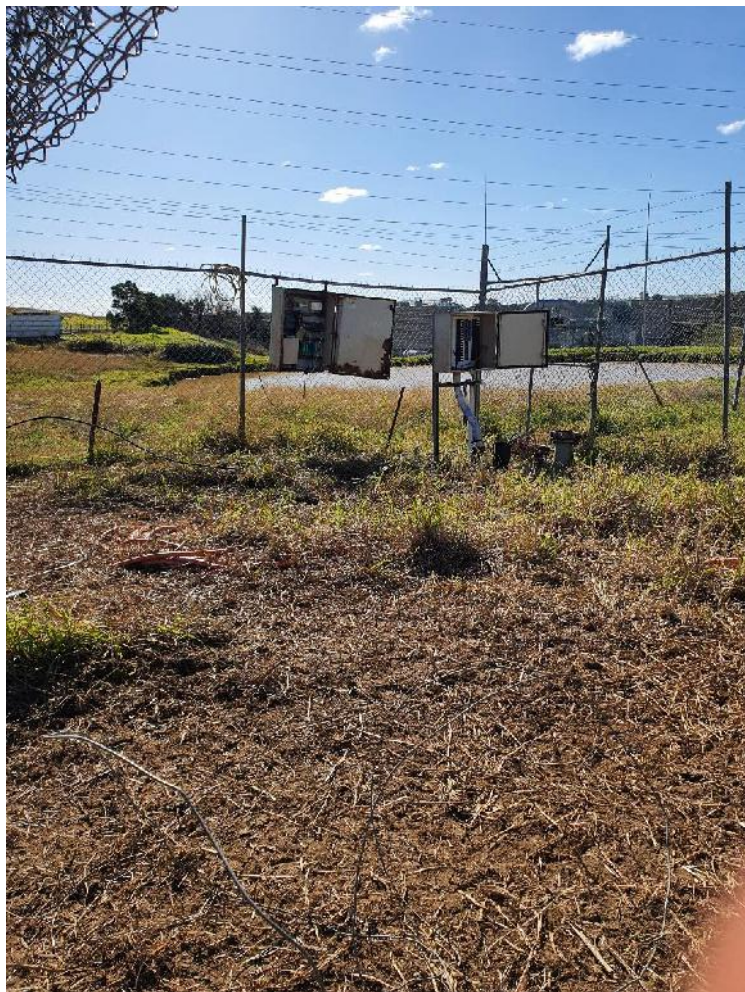
- A coal seam gas well network was observed in the west (MRP 93; plates 103 to 105) near Appin Colliery) centre (MRP 94; plate 106) and south of the site (MRP 98 and 99; plates 113 and 114) and a pipeline extending towards the south west (MRP 101; plate 116, MRP 102; plate 117) adjacent to the creek in the south west portion of the site. A mine communication antenna was also observed (MRP 100; plate 115).
- As with the remainder of the site, several timber power pole alignments were encountered throughout.

Photo 103 - Gas Wells (MRP 93)

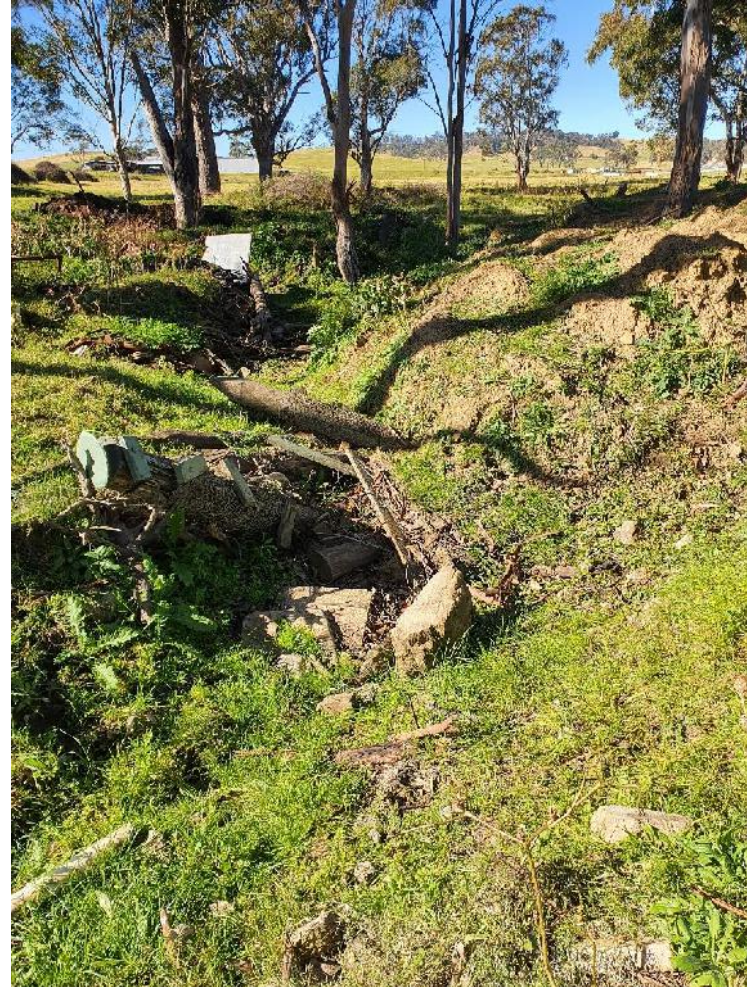
- Localised dumping was observed in some gullies largely minor refuse (MRP 83; plate 93) and cars and machinery (MRP 105; plate 121) with the exception of MRP 96 (plates 108 – 111) and 97 (plate 112) where dumping appeared to be widespread and systematic. An area of waste tyre dumping was noted at MRP 111 (plates 125 to 127).

Photo 108 - Dumping in Creek (MRP96)

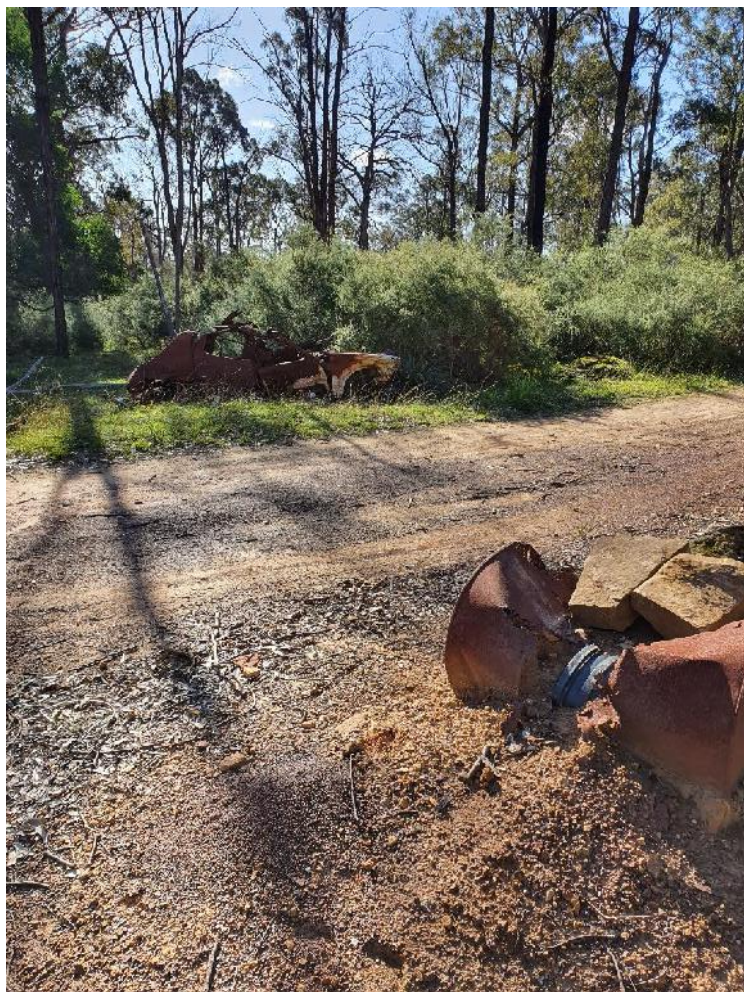
Photo 121 - Dumped Cars and Machinery (MRP105)

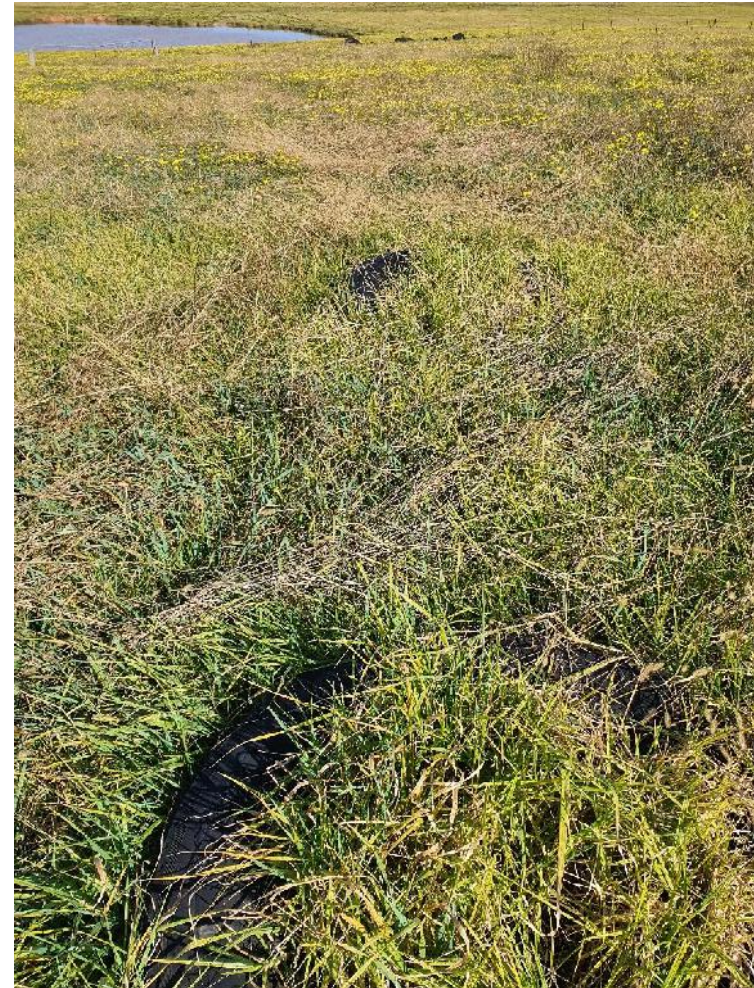
Photo 126 - Waste Tyres (MRP111)

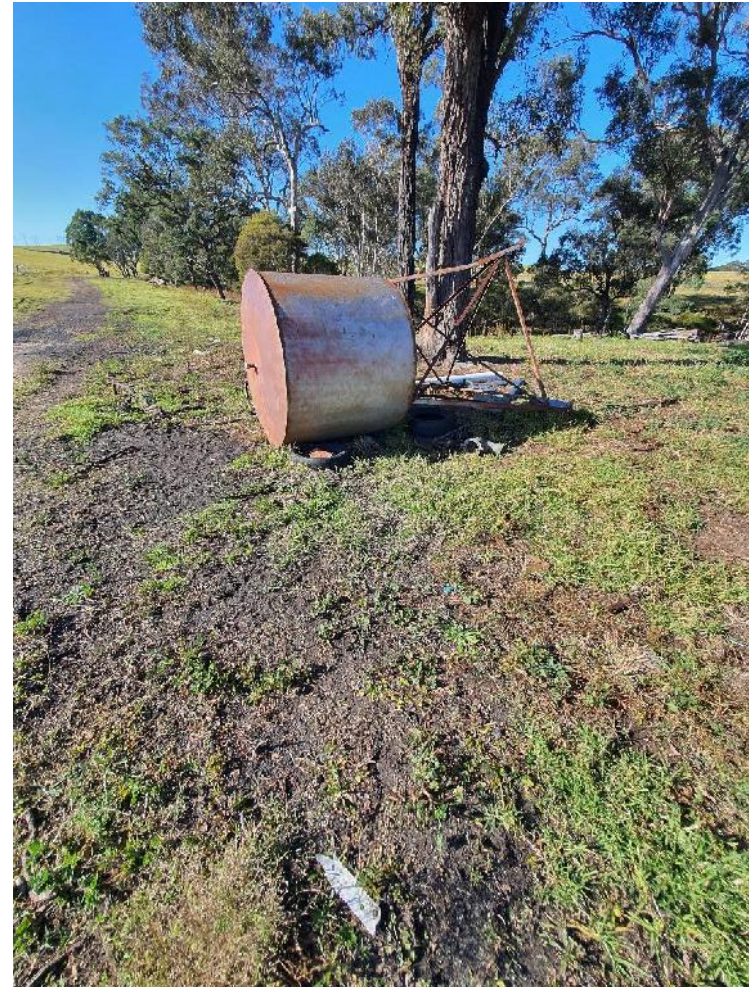
- An area of possible livestock burial was observed (MRP 103; plates 118 and 119).
- Fuel storages were noted in above ground storage tanks at water pumps, specifically MRPs 89, 108 and 115 (plates 130 and 131). A discarded AST was also noted at MRP 112 (plate 128).

Photo 128 - Disarded AST (MRP112)

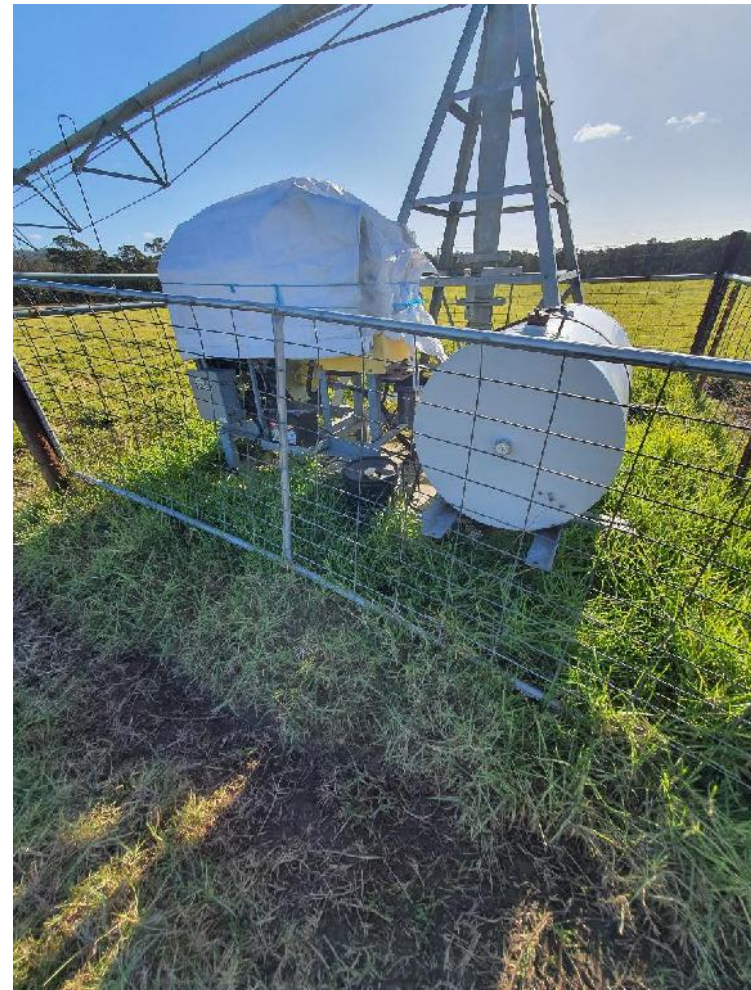
Photo 130 - Fuel Storage for Irrigation Pump (MRP114)
