Report on
Preliminary Site Investigation (Contamination)

Proposed Mixed Residential and Commercial
Development
34 Queen Street, Campbelltown NSW 2560

Prepared for
H&R Properties Pty Ltd
C/o Arben Management Pty Limited

Project 222594.00

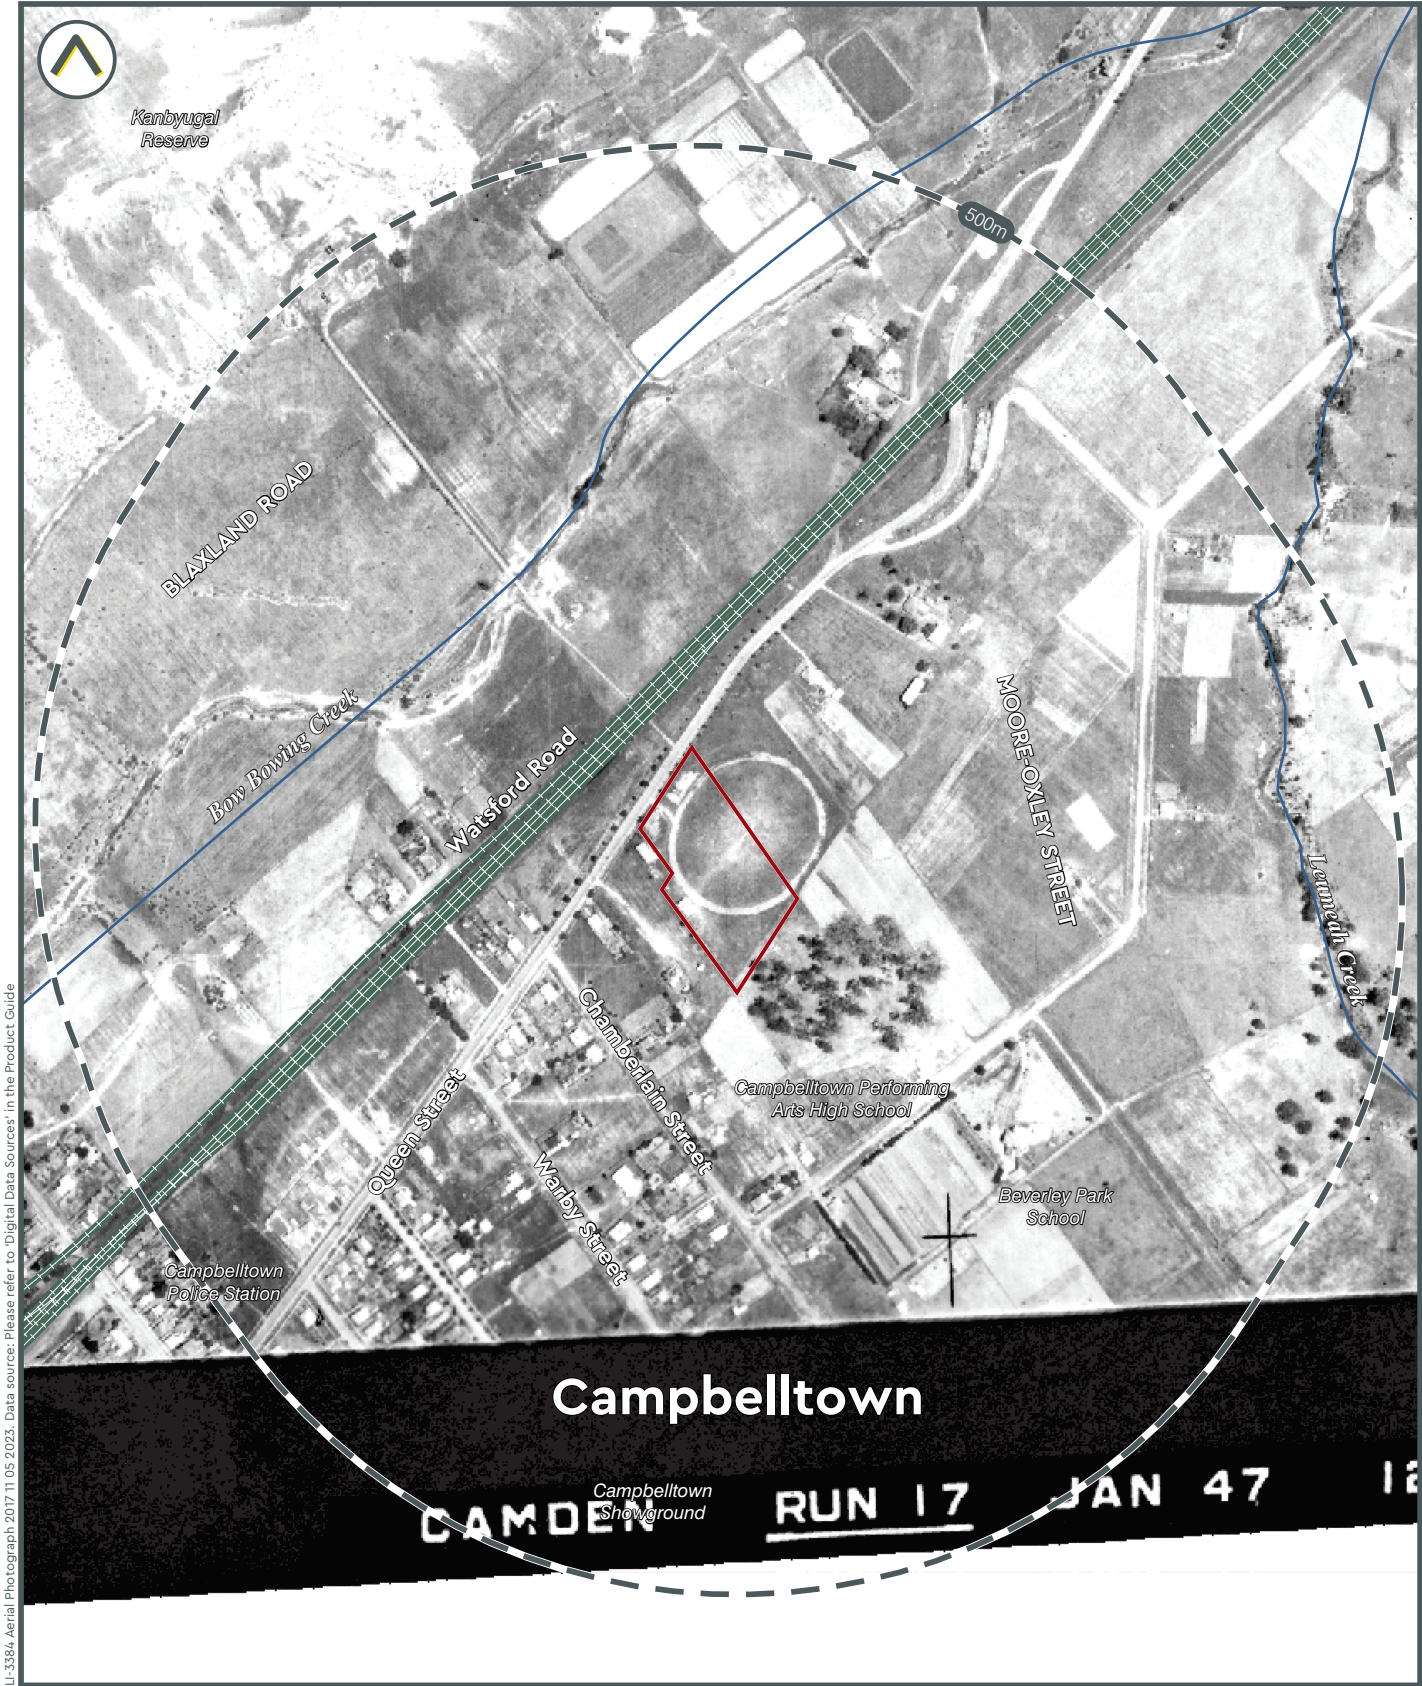
Historic Aerial Photograph - 1947

Year	Site	Surrounding Land Use
1947	Part of a race track/oval runs through the majority of the site. Small structures are present in the northern and western sides of the site.	Potential residential development observed to the southwest. A part of the race track/oval observed to the east of the site. A small structure with possible commercial use is present to the north west of the site. The land on the southern side observed to have few trees.
1956	The northern structure has been removed. A small structure or possible material storage observed in the north-western side of the site.	More residential houses constructed on the western side. Campbelltown Performing Arts School buildings are present and the trees have been removed south of the site. A few buildings have been constructed beyond the track/oval.
1969	The structure on the western side has been demolished and the shape of the oval track appears to have changed. One or two buildings have been constructed in the southern corner of the site. Some material storage or possible small structures (stands) are present around the oval track.	Residential development observed to the east beyond the remainder of the track/oval and south beyond the Campbelltown Performing Arts School. Potential commercial development under construction to the north of the site following the railway tracks.

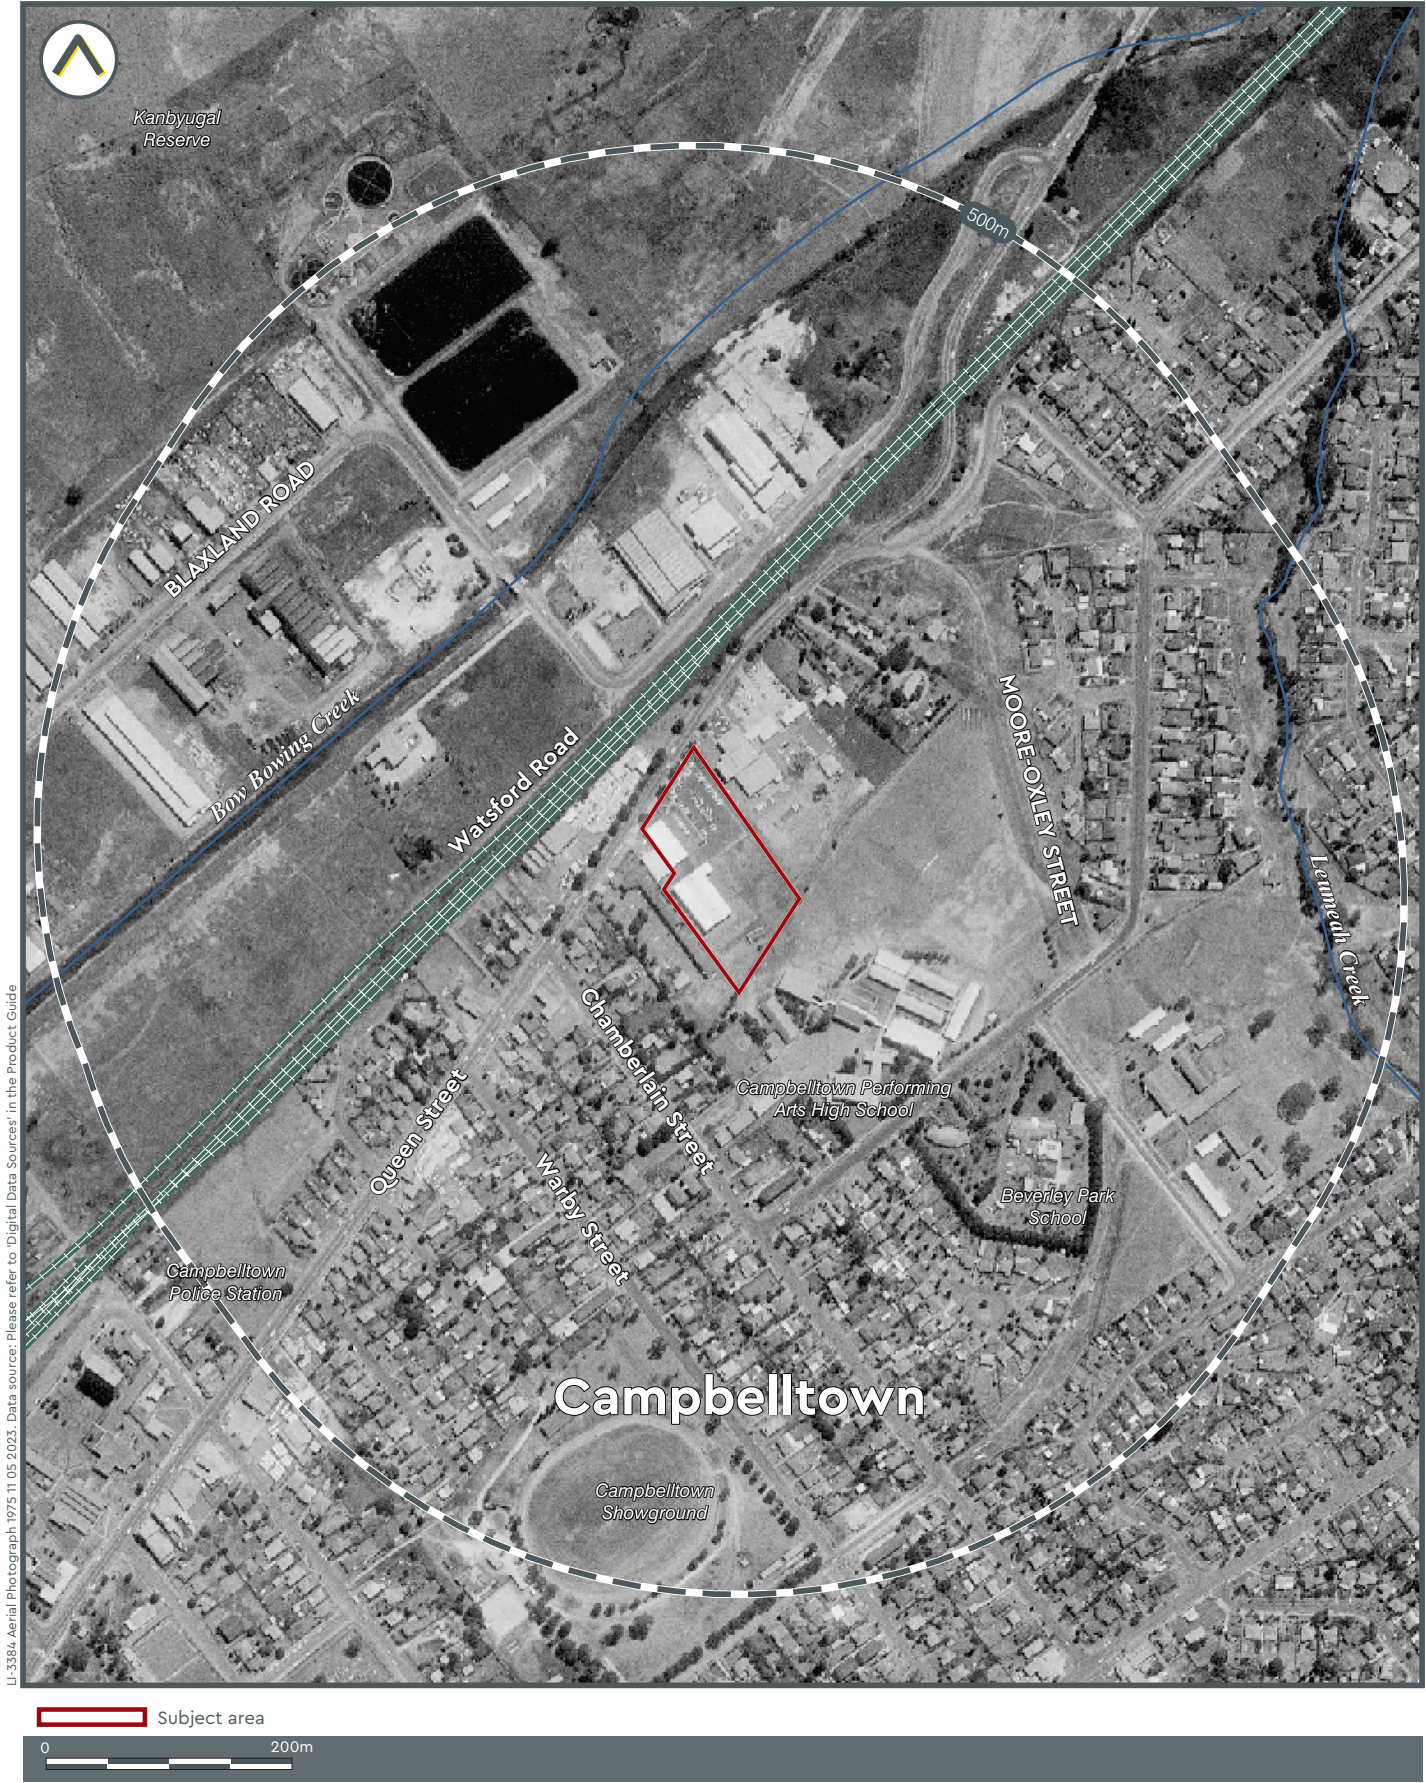
Historic Aerial Photograph - 1975

1975	Site use has changed from recreational use to possibly commercial use. The building, currently occupied by Officeworks, has been constructed in the central portion along the western boundary. Another commercial / industrial style building has been constructed in the north-western corner.	More commercial development observed north and immediately east of the site. Part of oval track has been replaced by buildings (possibly commercial use). No significant changes observed on the other sides.

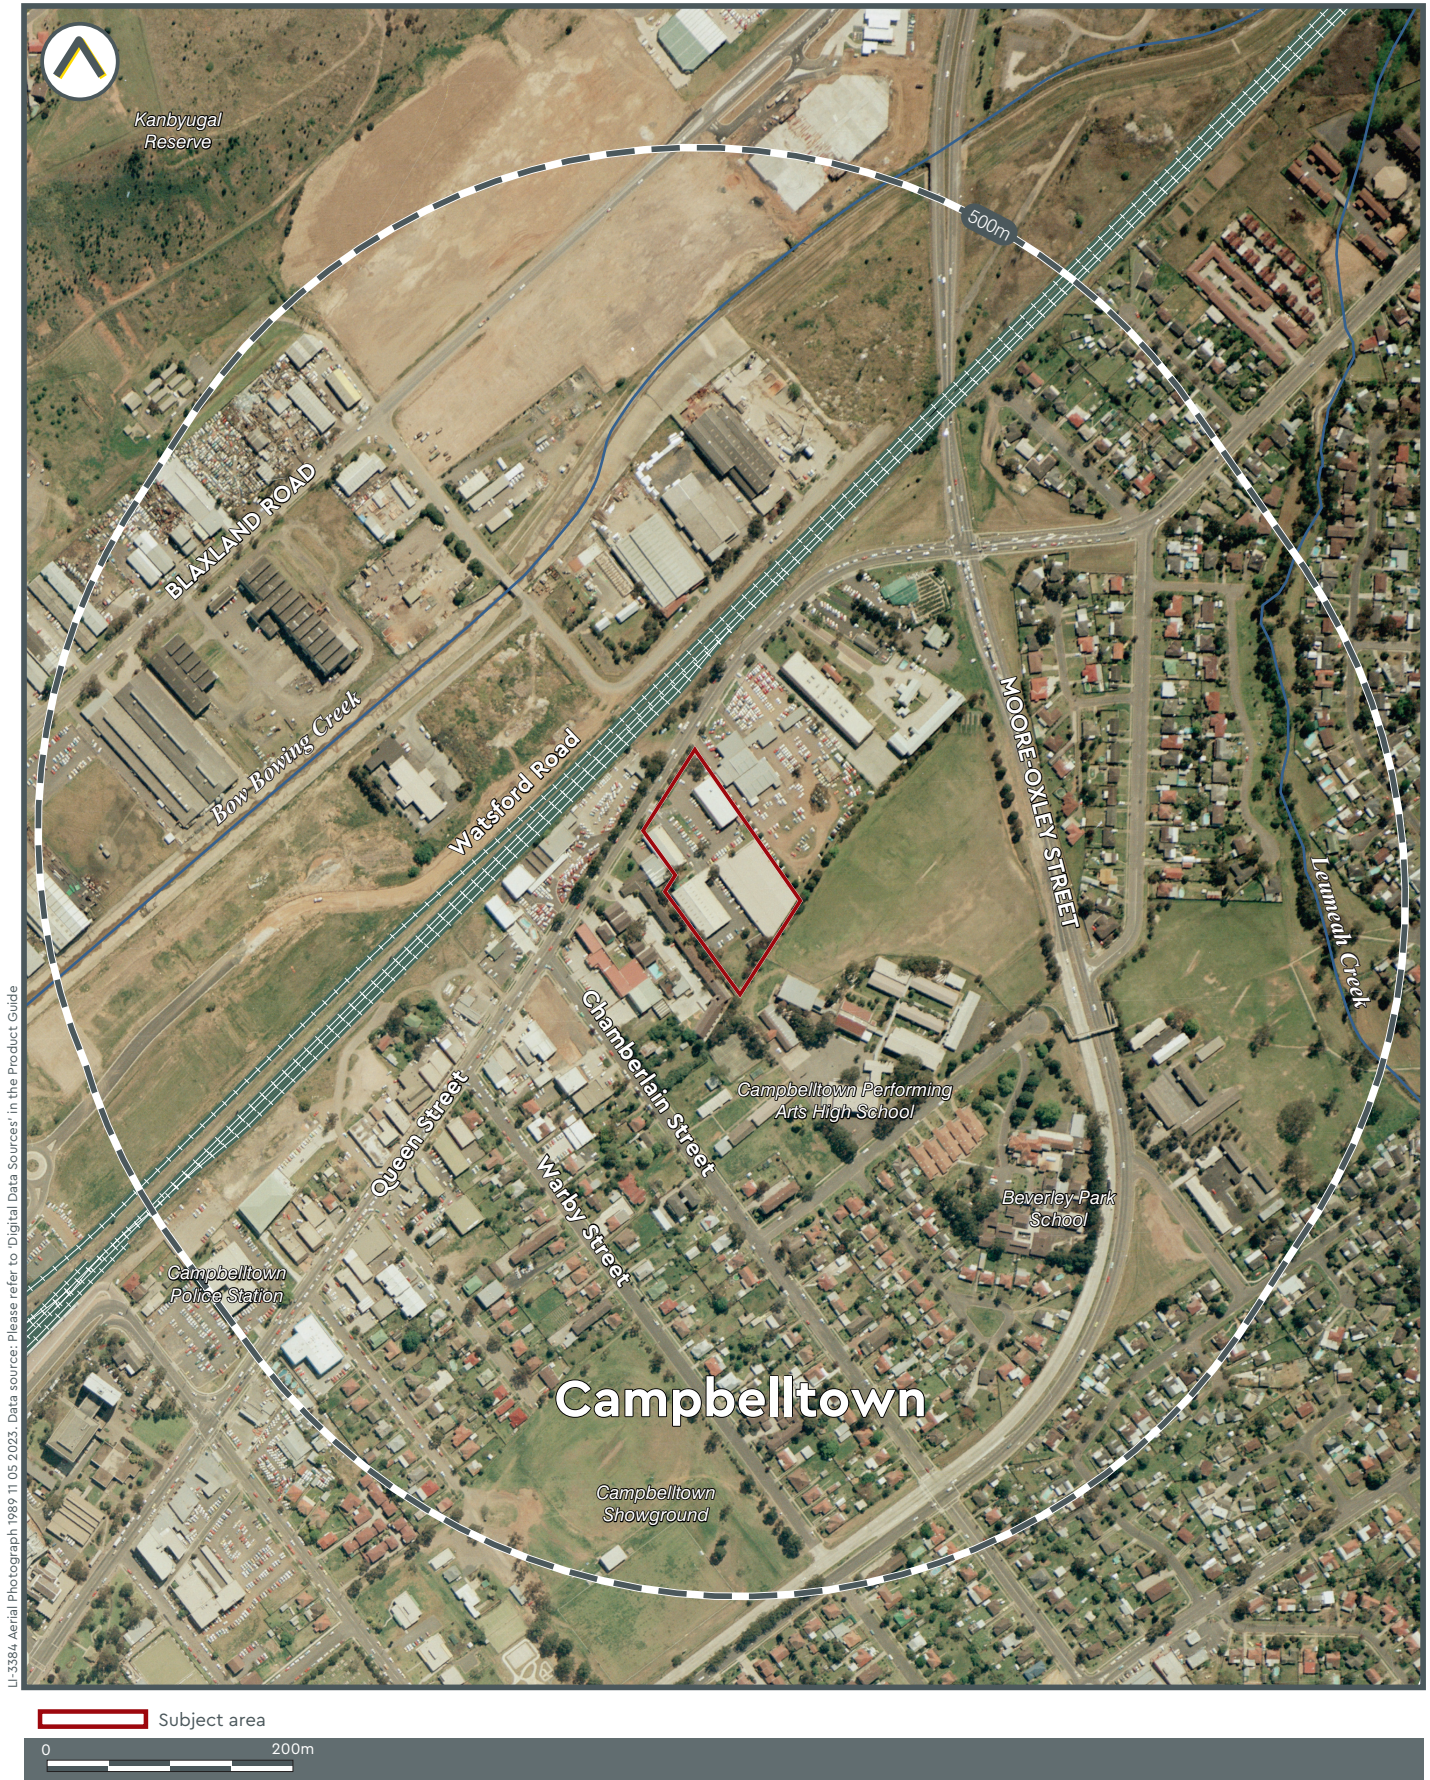
Historic Aerial Photograph - 1989

Year	Site	Surrounding Land Use
1989	Addition of two other commercial buildings, currently used as the pharmacy and motorcycle accessories store in the eastern portion of the site.	No significant changes observed.
1998	No significant changes since 1989.	More dense commercial development in the northern side. No significant changes observed on the other sides.
2008	Building at the north-western corner has been demolished. The layout of the buildings within the site resembles the current (2023) layout.	Addition of few more commercial buildings in the northern side. No significant changes observed on the other sides.
2014	No significant changes since 2008.	No significant changes since 2008.
2023	No significant changes since 2014.	Residential apartment building observed immediately north of the site. No significant changes observed on the other sides.

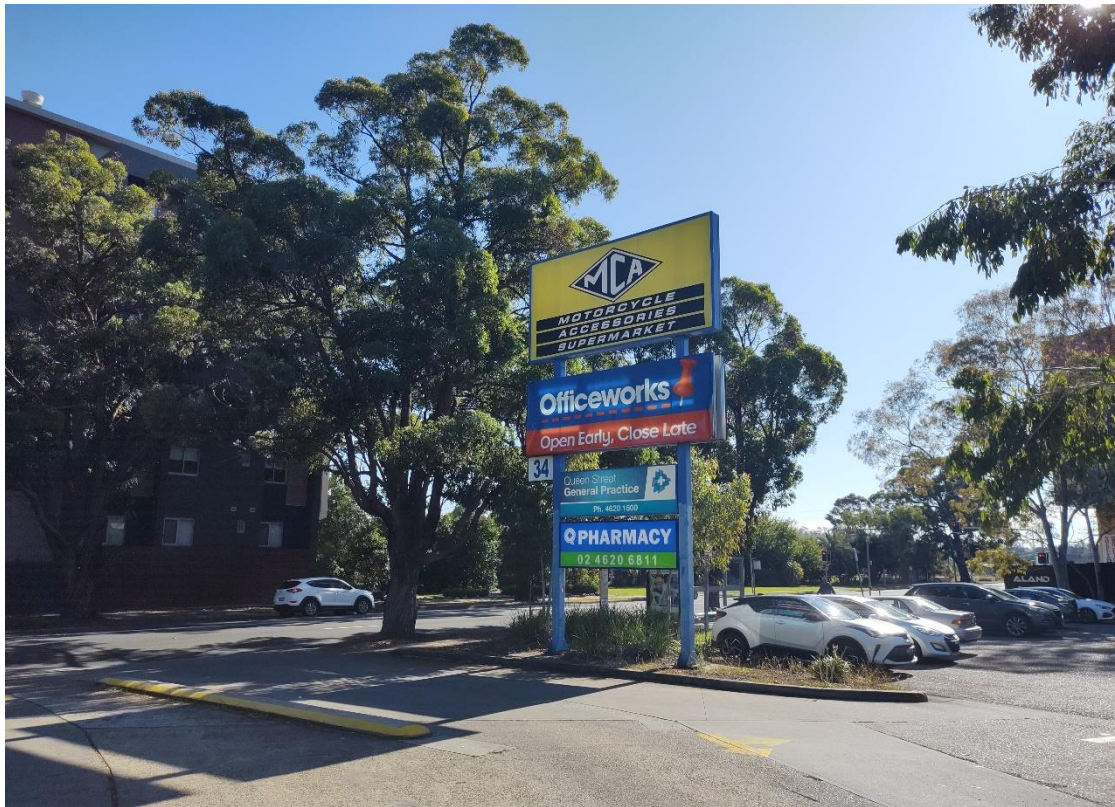
- Three buildings are present at the site. The building on southern side is occupied by Officeworks. The building on the northeast corner is occupied by Pharmacy on Queen and building on the southeast corner is occupied by Motorcycle Accessories Supermarket (MCAS) (Photograph 1, Appendix C);

Photo 1: Businesses on site

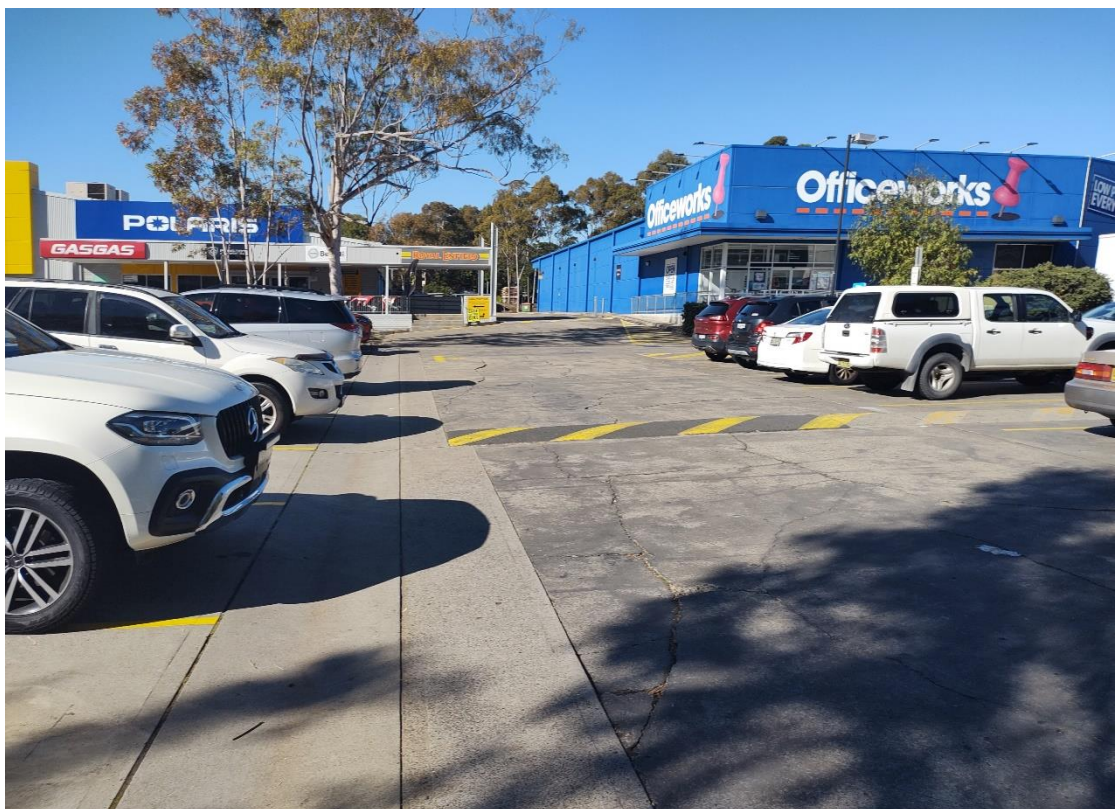
- All three buildings are primarily brick and concrete structures with some minor areas comprising metal walls. At the time of the inspection, the buildings appeared to be in reasonable condition (Photograph 2 and 3, Appendix C). Potential Asbestos containing material (PACM) was observed to be present in the lower wall of MCAS at the southern side (Photograph 4, Appendix C);

Photo 2: Officeworks and MCAS on site

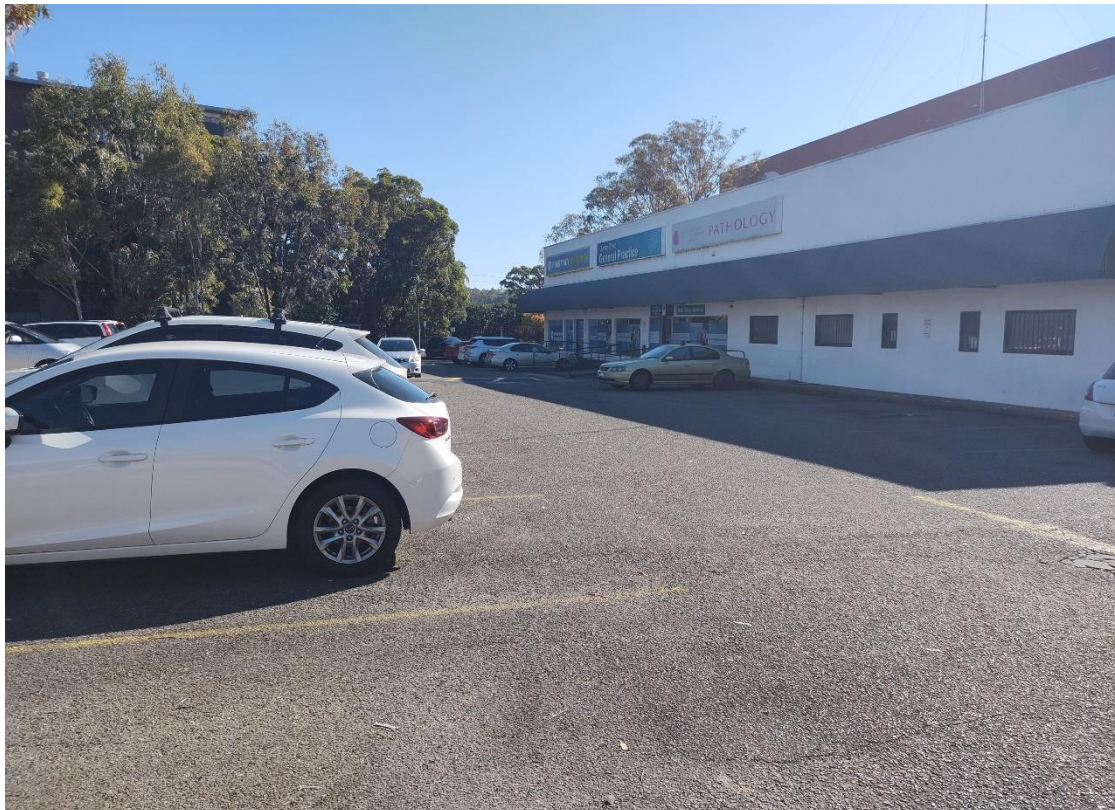
- The carpark area west of the pharmacy (Photograph 3, Appendix C) and behind Officeworks, in the southern corner of the site, has sealed bitumen pavements. The carpark north of Officeworks and the driveway between MCAS and Officeworks comprises a sealed concrete pavement (Photograph 2, Appendix C). At the time of the inspection, minor cracking was observed on the concrete pavement (Photograph 5, Appendix C);

Photo 3: Pharmacy on Queens on site

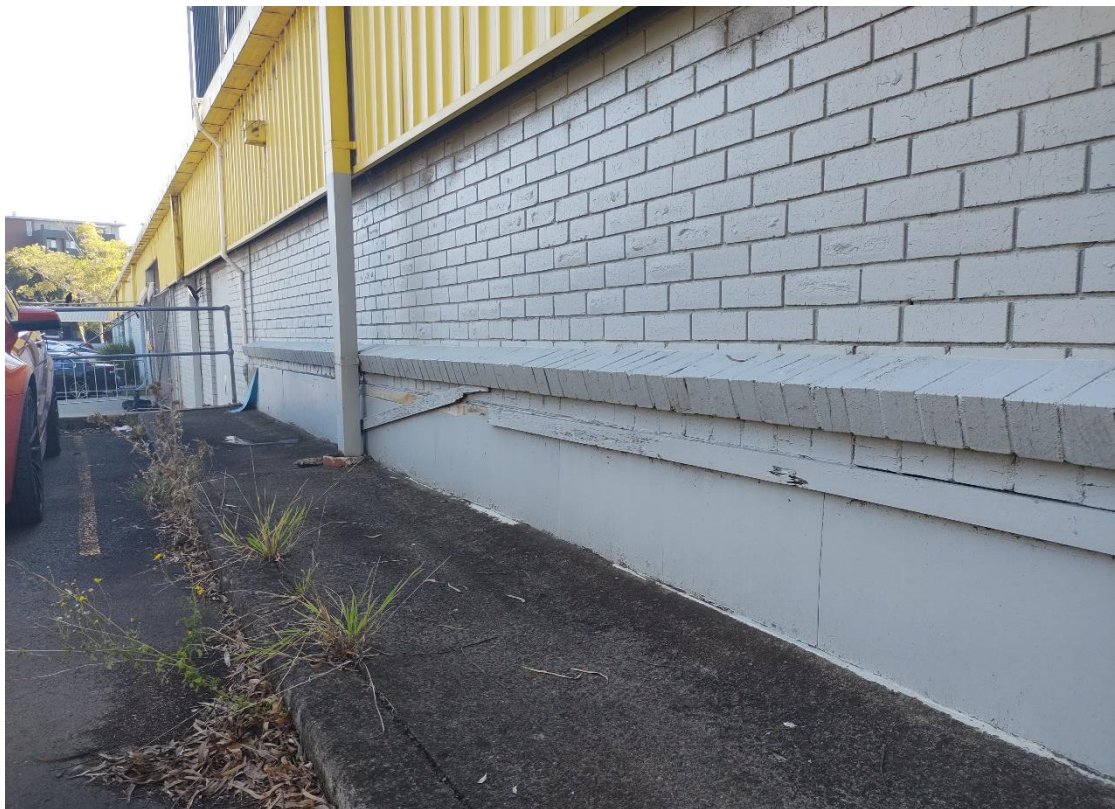
Photo 4: Lower wall in MCAS suspected ACM

A hazardous building materials survey of the current buildings on the site is also recommended to assess the presence or otherwise of hazardous building materials which will require specific management.

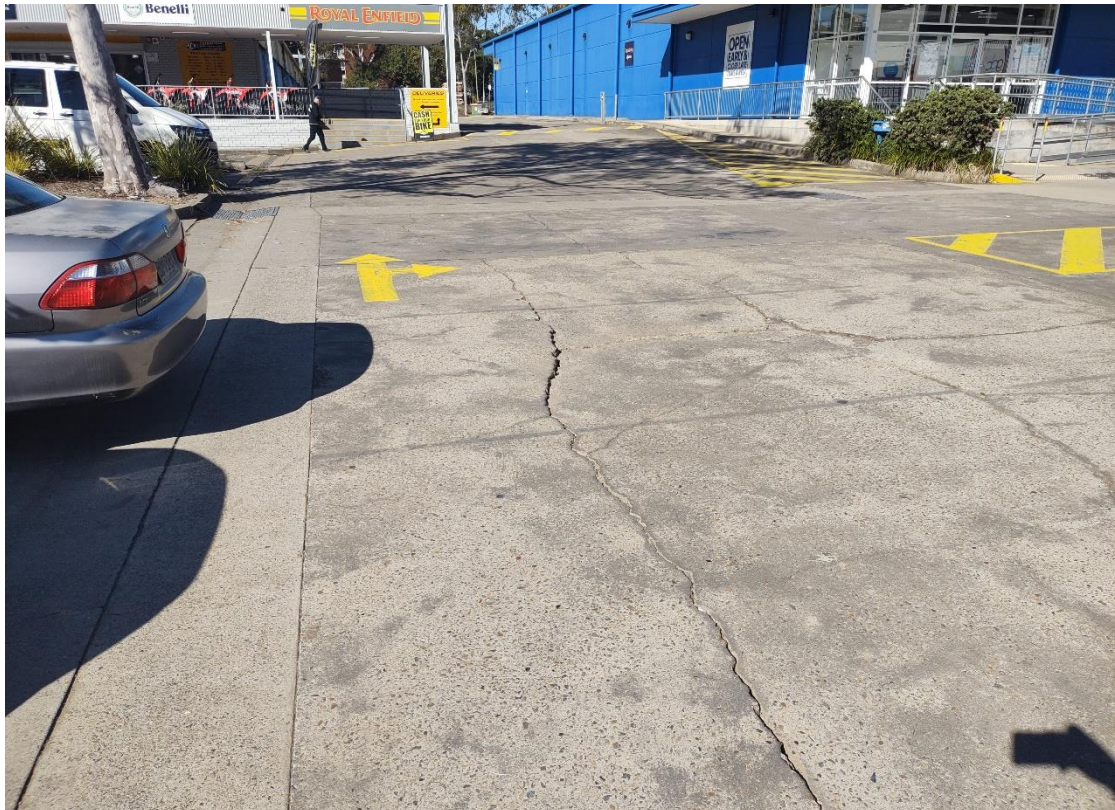
Photo 5: Cracks on concrete pavement

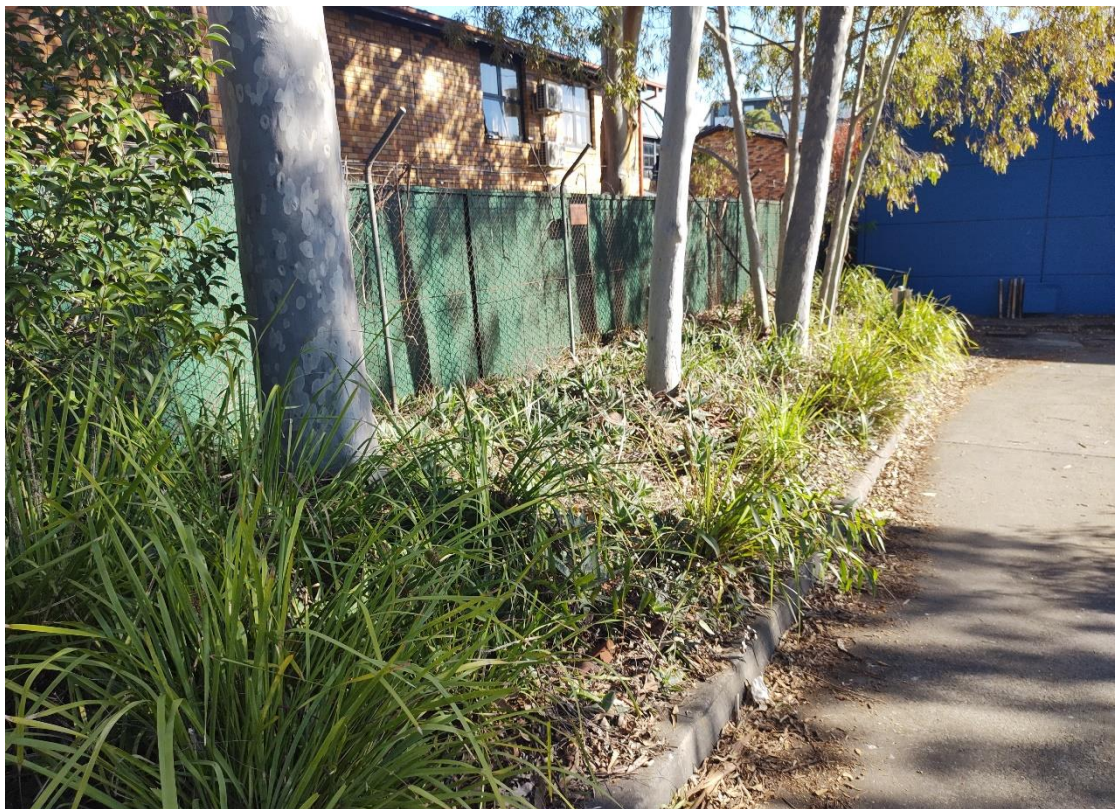
- Garden beds with trees, vegetation and mulch are present in the southern side of the site, along the site perimeter and in parts of carpark area (Photograph 6 and 7, Appendix C);

Photo 6: Garden bed with trees and vegetation

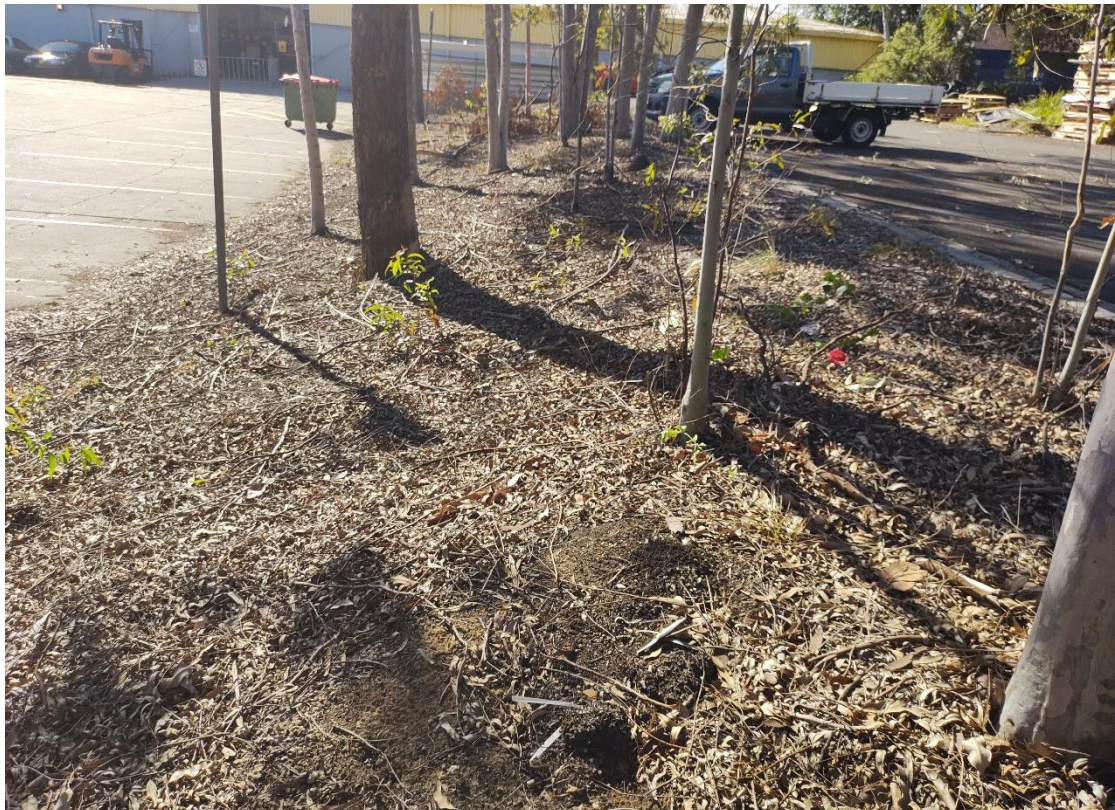
Photo 7: Garden bed in the southern side of site

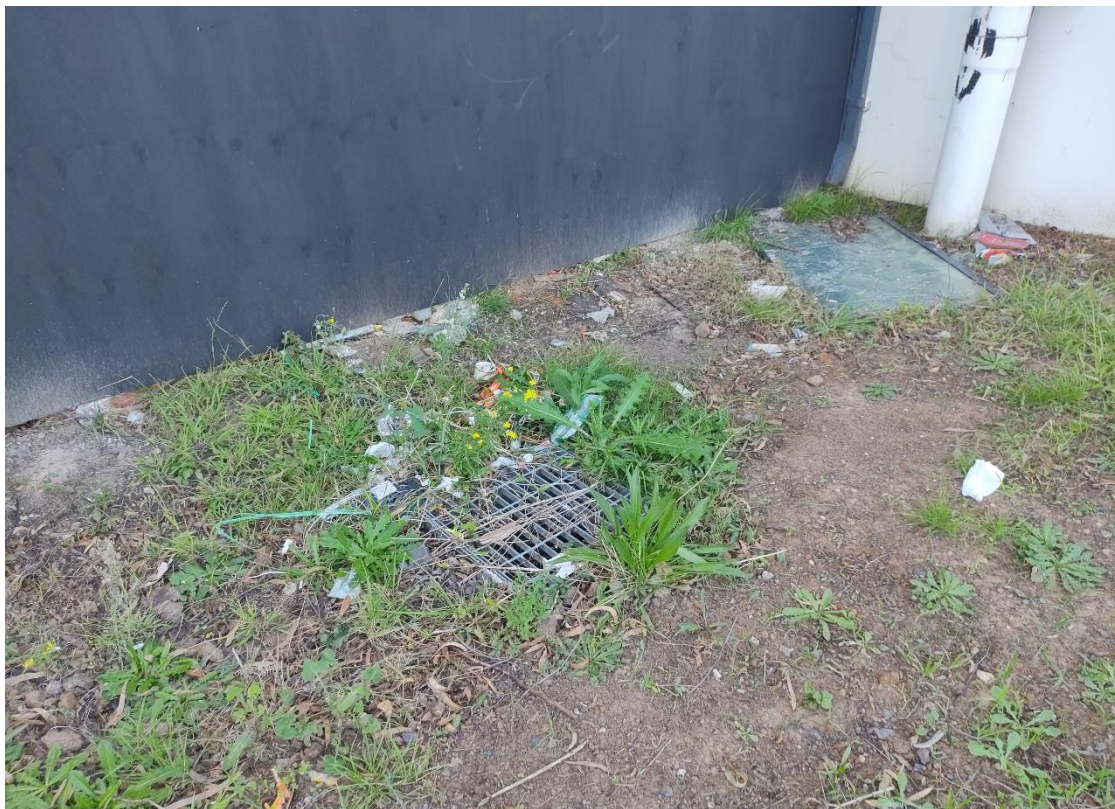
- Plastic, glass, and a car door was observed on the garden bed in the north-eastern side of the site (Photograph 8, 9 and 10, Appendix C). Some rubber tyres were observed in the garden bed in the southern side of the site (Photograph 11, Appendix C);

Photo 8: Plastic and glass waste observed on garden bed

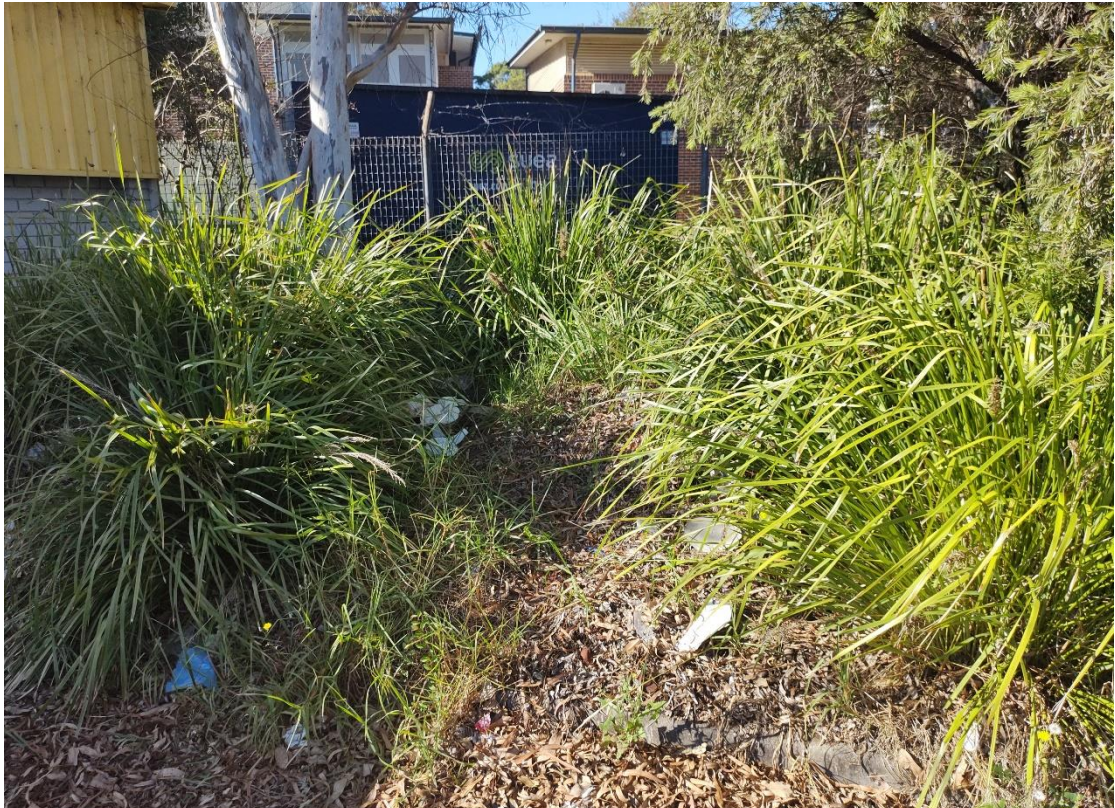
Photo 9: Plastic waste on garden bed

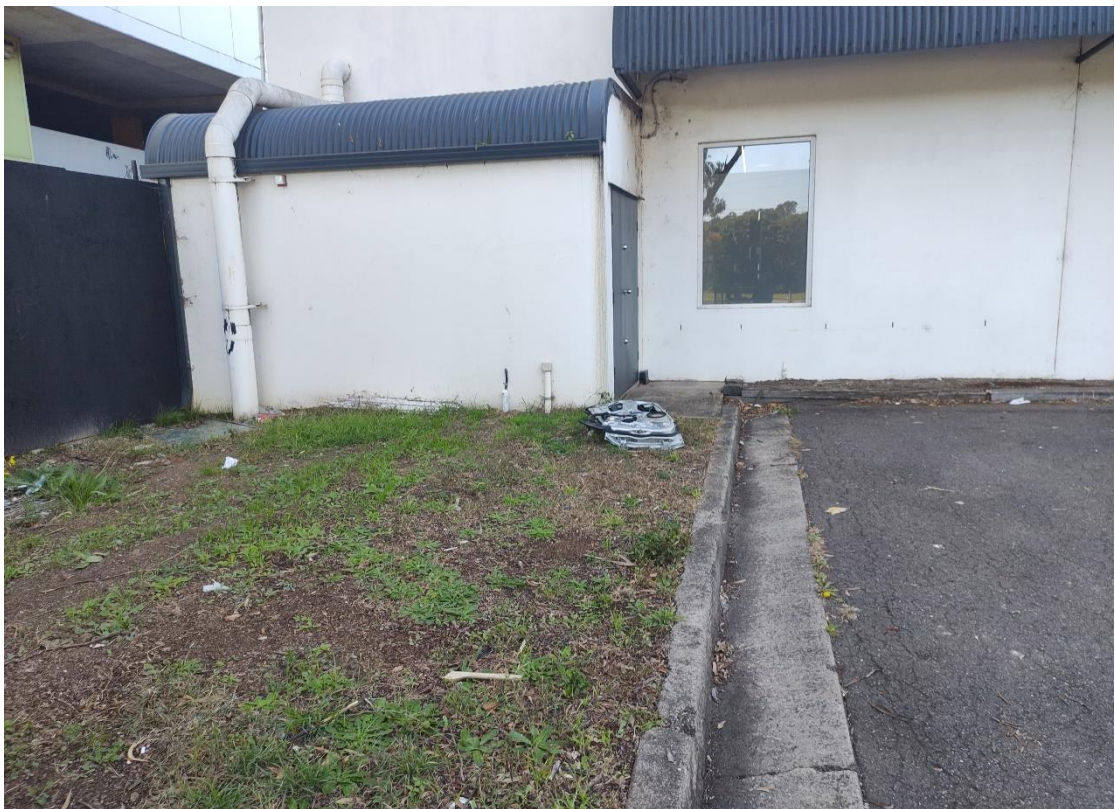
Photo 10: Car door observed in garden bed

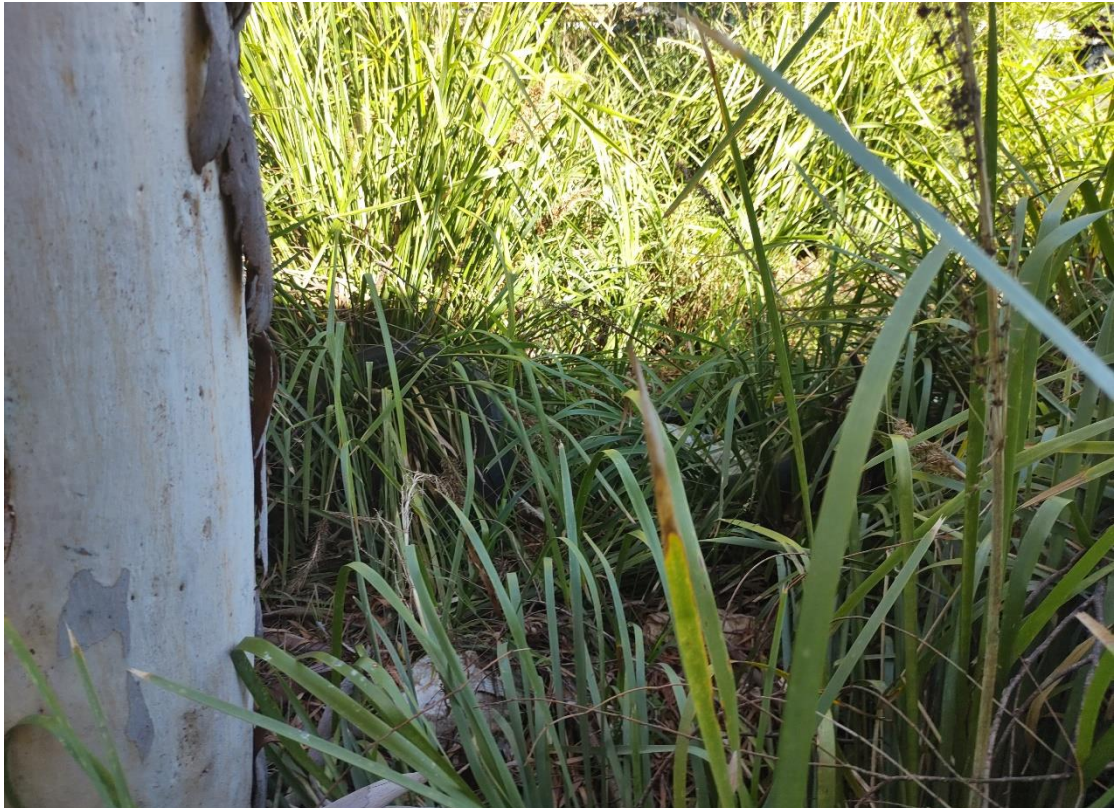
Photo 11: Rubber tyres observed in the garden bed

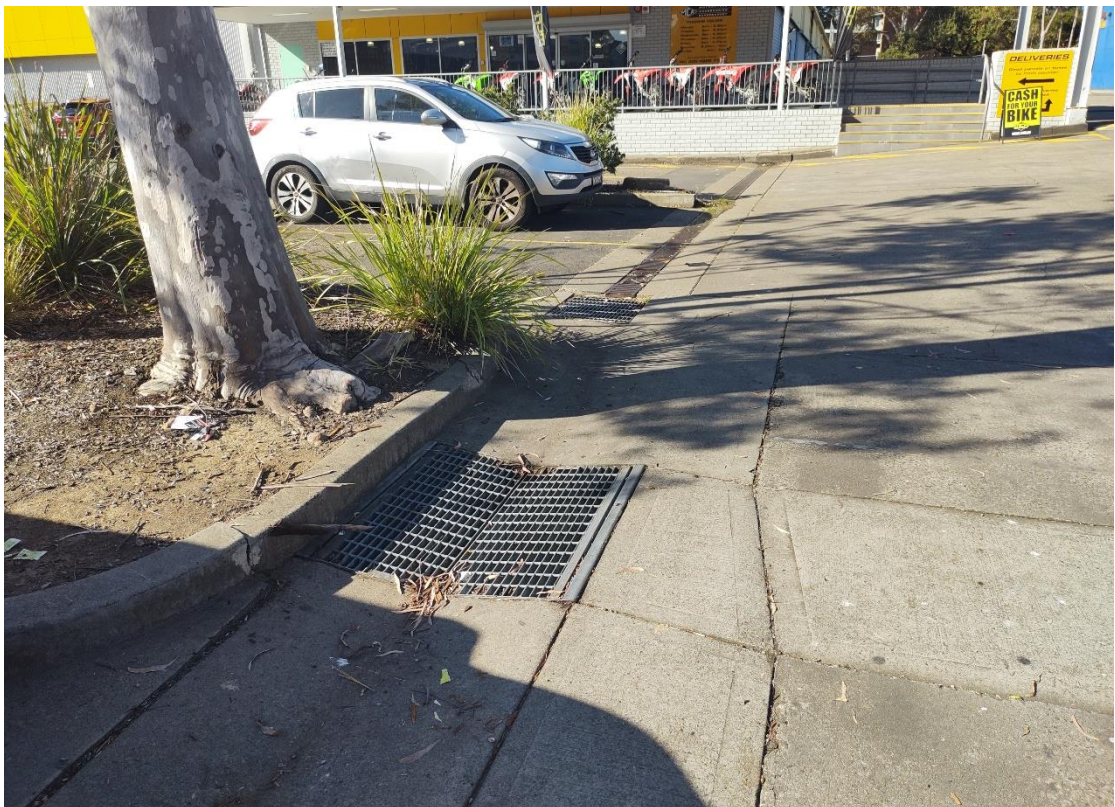
- Stormwater runoff and drainage pits were observed in the carpark areas and driveway (Photograph 12);
- Whilst access into the buildings was not made available to DP, chemicals are suspected to be stored inside the pharmacy and MCAS; and

Photo 12: Stormwater drainage on the ground surface

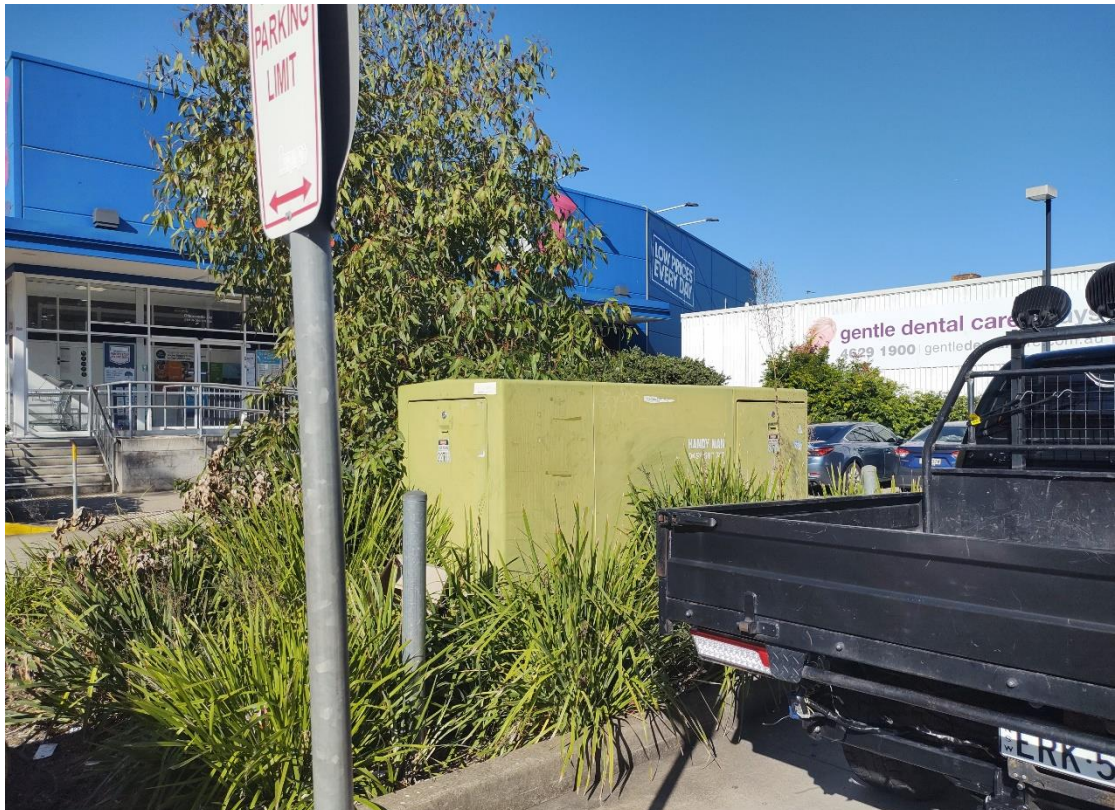
- A substation identified as 22755 is present in the carpark on the northern side of Officeworks (Photograph 13, Appendix C).

Photo 13: Substation 22755 in the carpark area
