Preliminary Site Investigation Proposed Rezoning Planning Proposal

Lot 261 DP 1262316 & Lot 11 DP 807867
Rankin Drive Bangalow

HMC2022.1062.01

June 2022

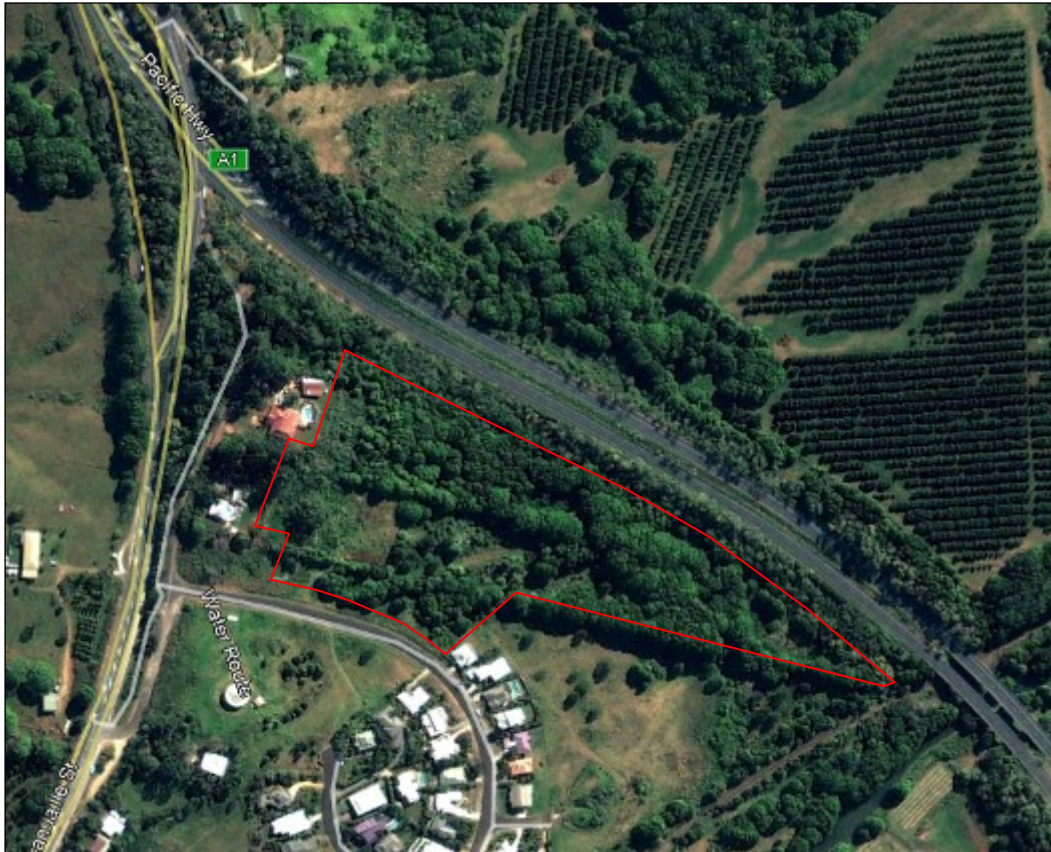
| Year | Source | Comments | Areas of Potential Concern Yes/No |
|---|---|---|---|
| 2009 | Google Earth | Land heavily vegetated, surrounding residential development. | NO |

Figure 6 – 2009 (Aerial Extract)

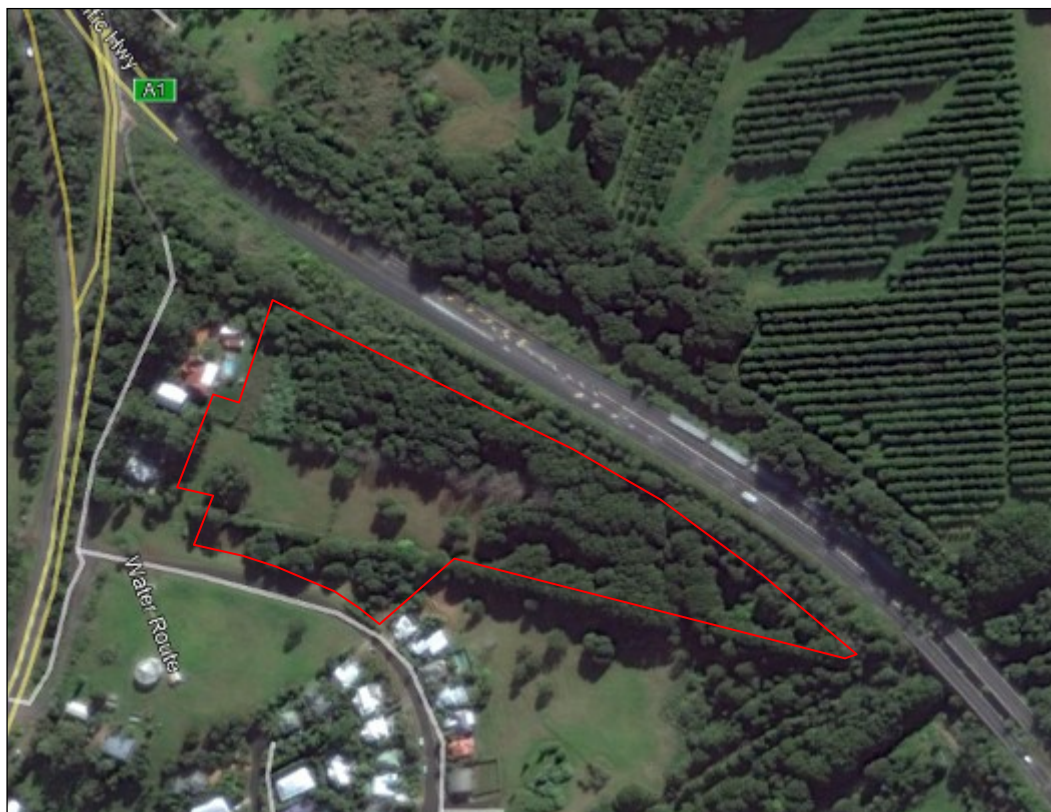
Figure 7 - 2014 (Aerial Extract)

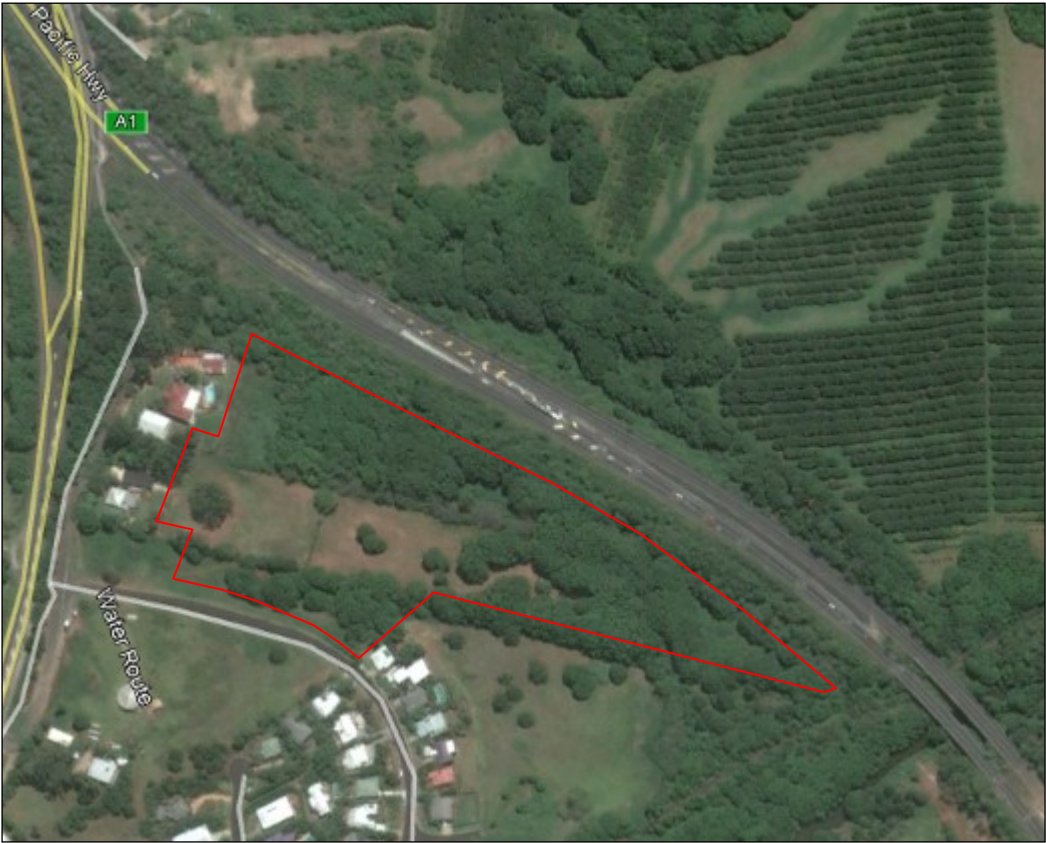
Figure 8 – 2015 (Aerial Extract)

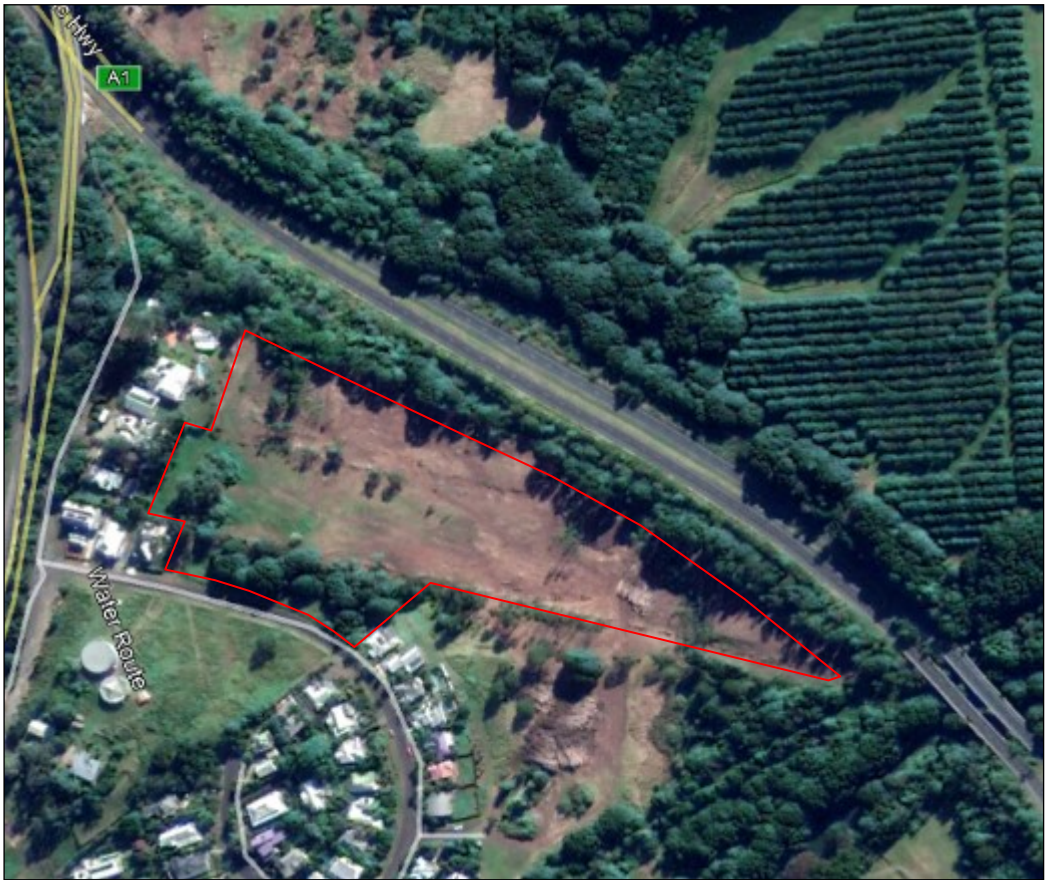
| 2019 - Present | | Land heavily vegetated, surrounding residential development. | NO |

Figure 9 – 2019 (Aerial Extract)

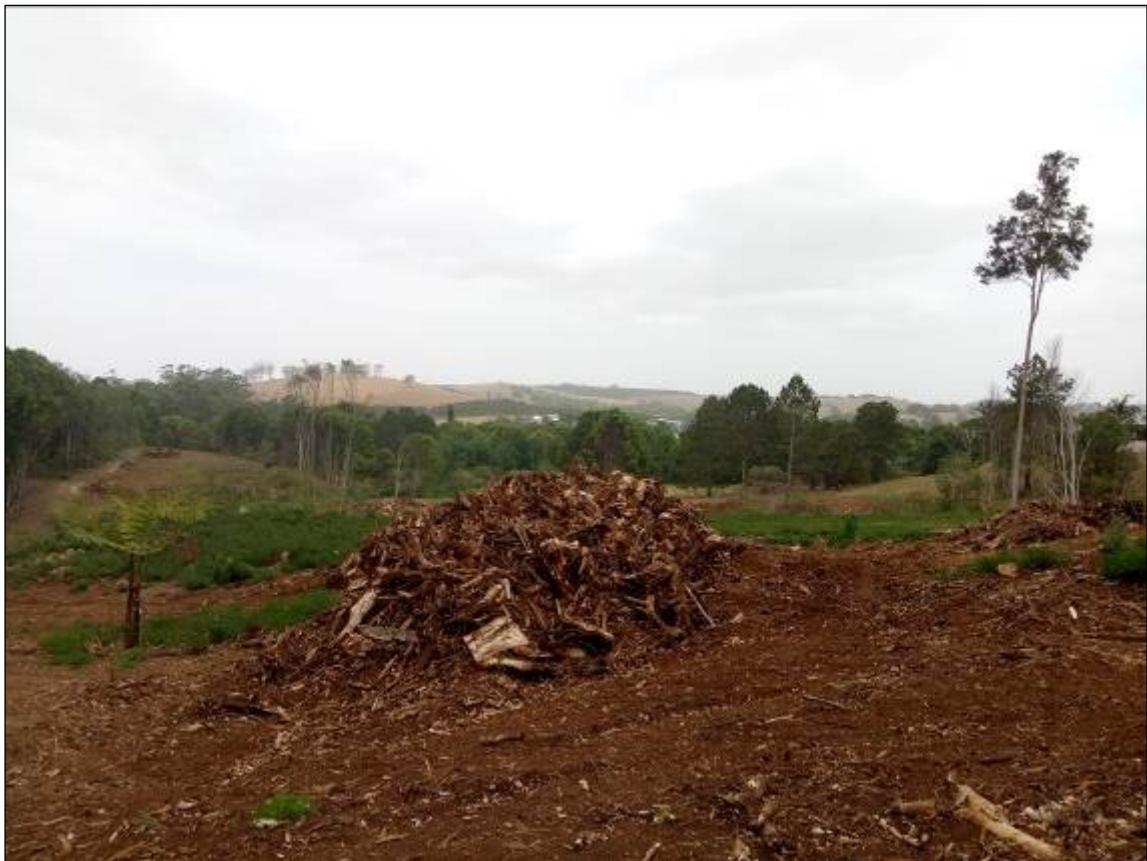
Photo 4 – View south-east showing stockpile of camphor laurel tree logs.

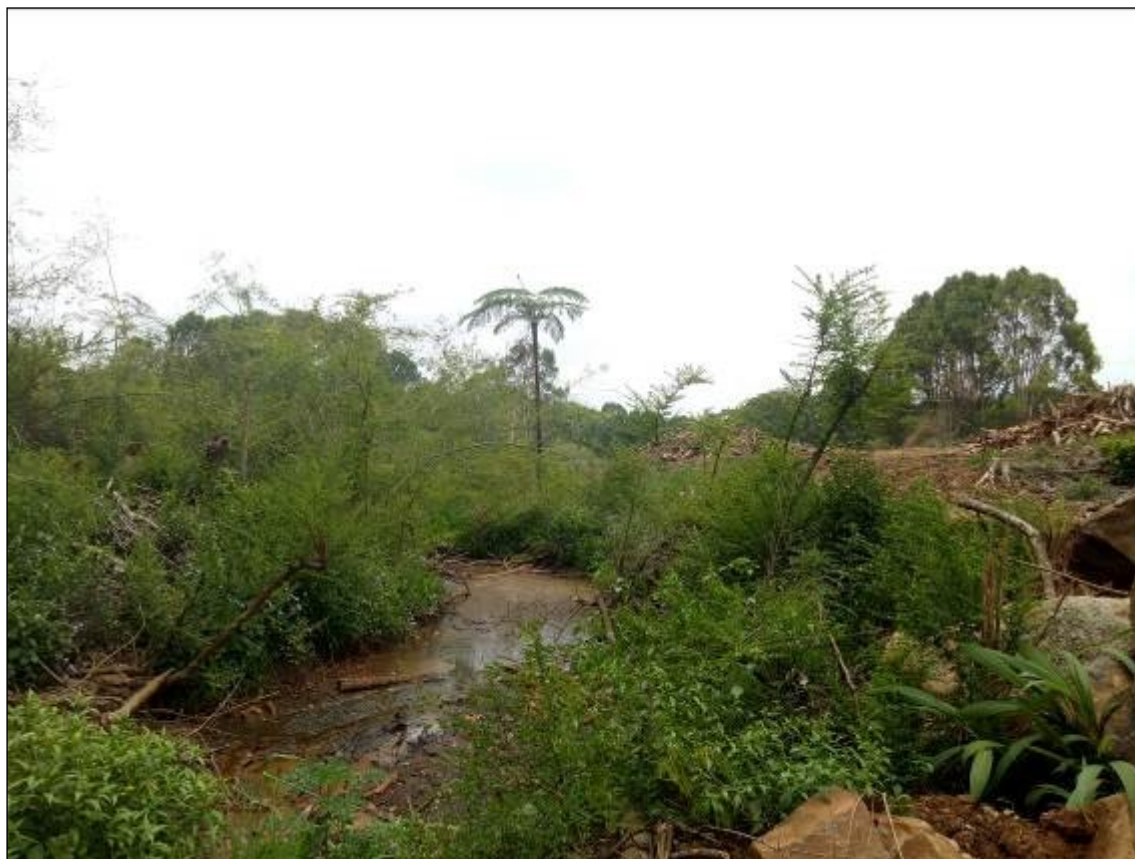
| Features of Contamination | Comments |
|--|--|
| Surface water quality | Elevated, undulating site. Surface water present, un-named stream, flowing southeast towards Byron Creek. The quality of surface water was not tested. A visual inspection of the stream was carried out during site inspection, no algal growth was observed. |

Photo 5 – View south-west showing un-named stream.

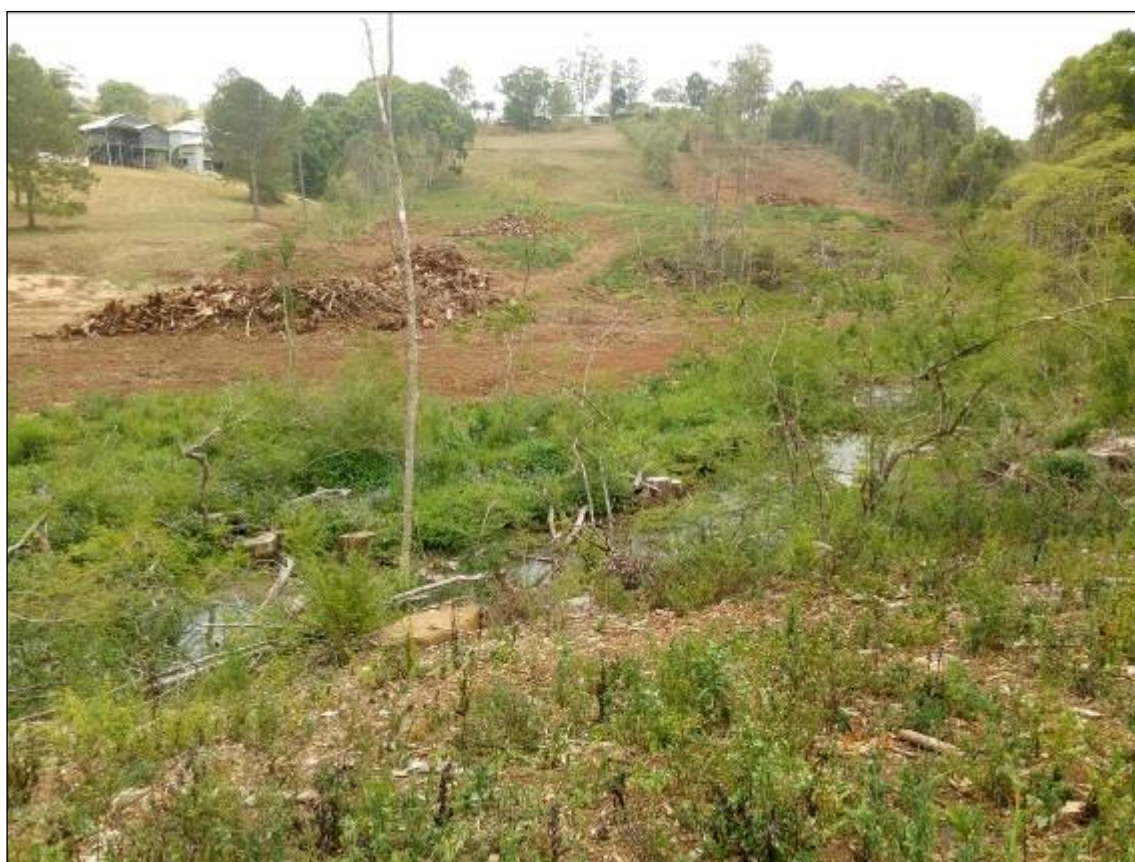
Photo 6 – View west showing un-named stream and subject site.
