# **Flood Impact Assessment Report**

**21-23 Victoria Avenue, Castle Hill**

**Prepared for Blueprint Australia Planning Development Management / 29 July 2022**

191928 CAAB

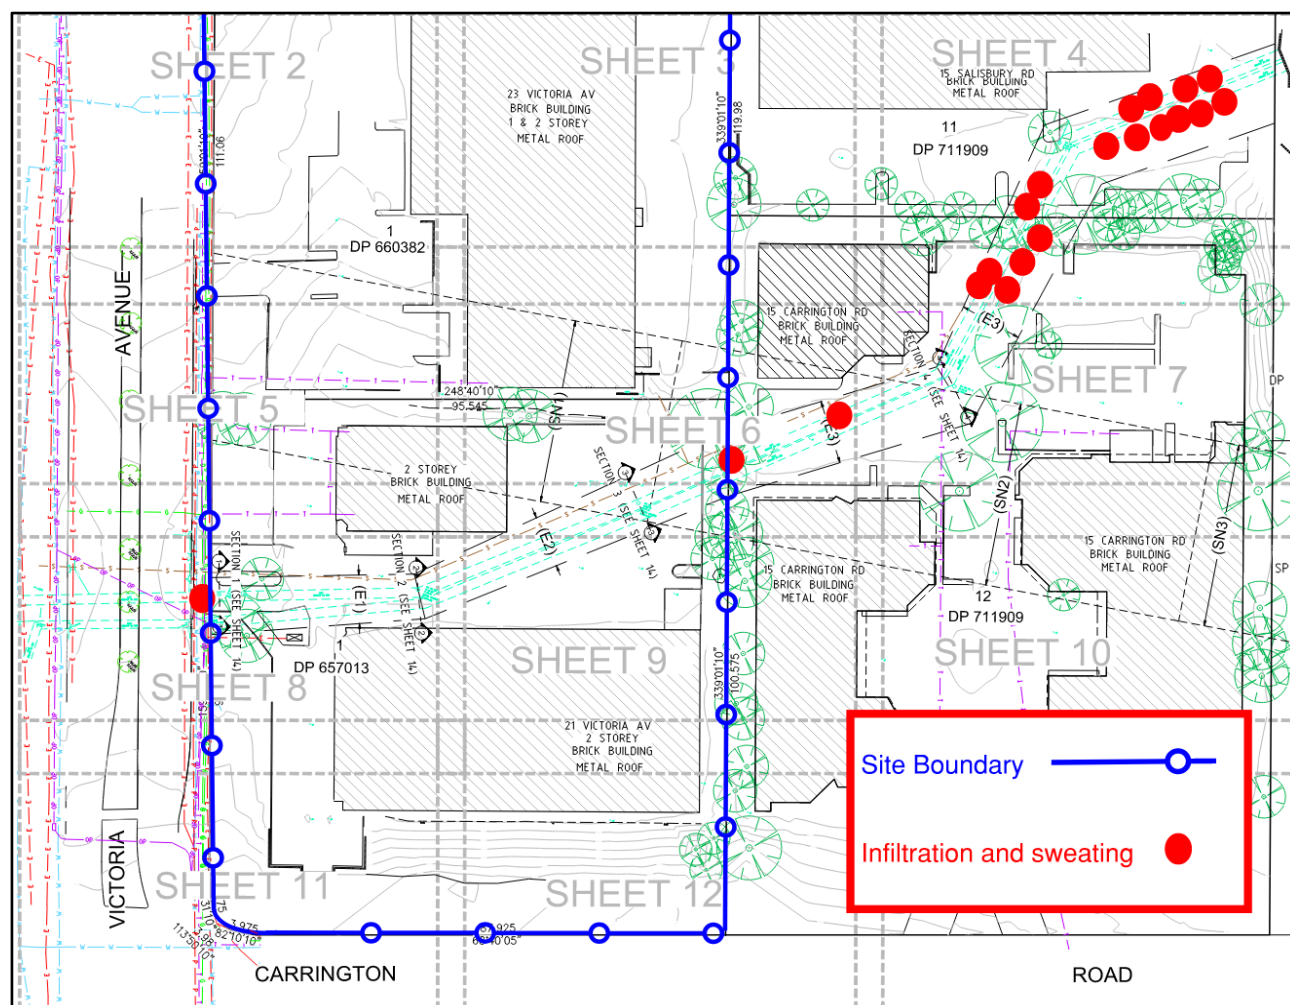
Figure 1. Infiltration and sweating

Infiltration and sweating defects have been detected in 20 locations along the stormwater pipe all of which are outside of the development site boundary. These issues are considered as minor damage/cracking. Attached below is a photo of the locations detected on the stormwater pipe.

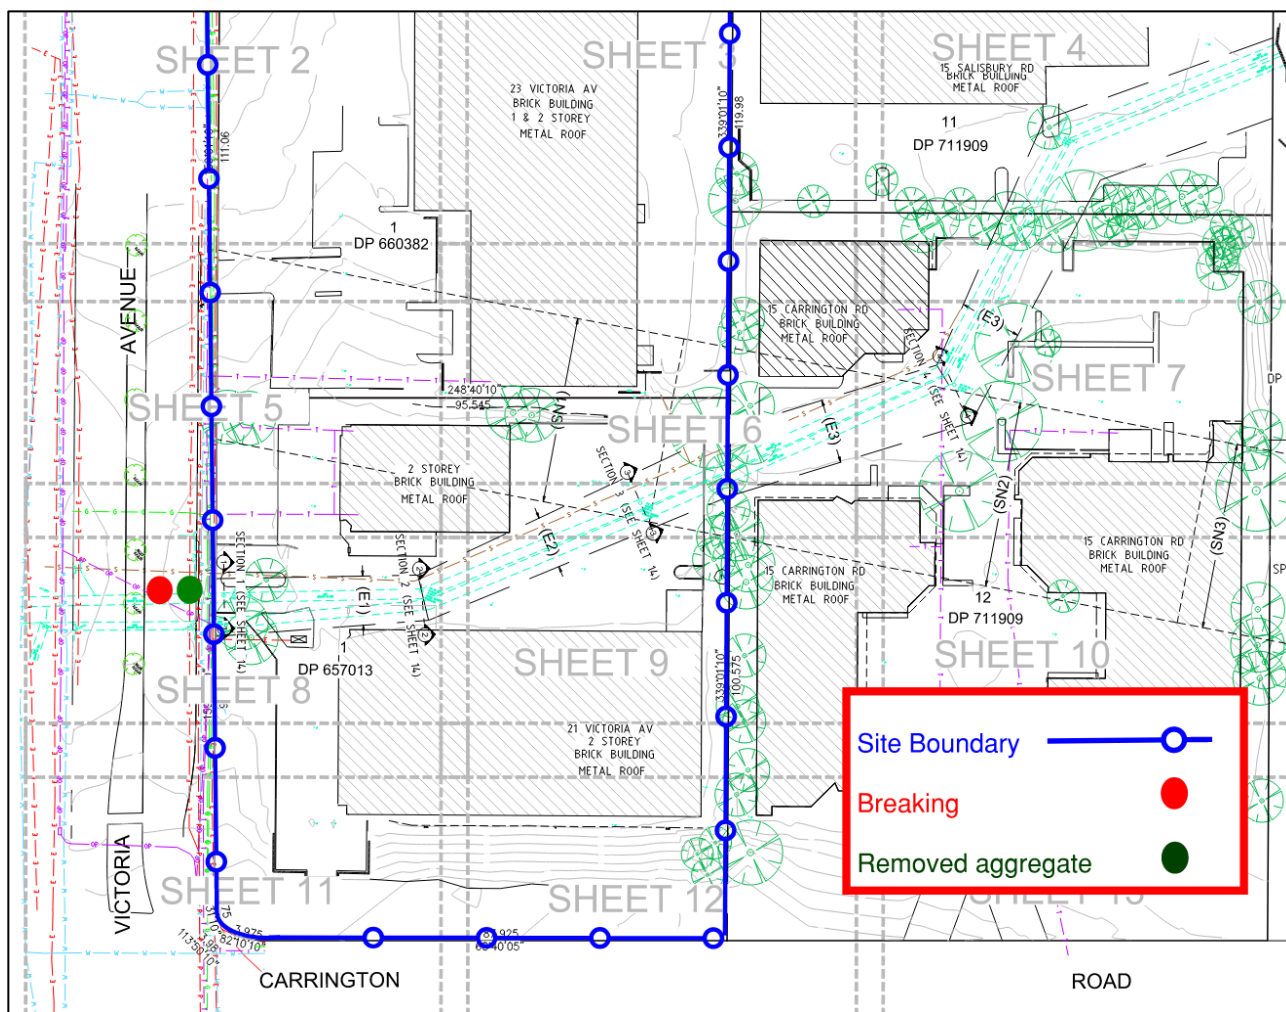
Figure 3. Breaking and removed aggregate

One occurrence each of a breaking and removed aggregate occur upstream of the development site as identified on figure 3.

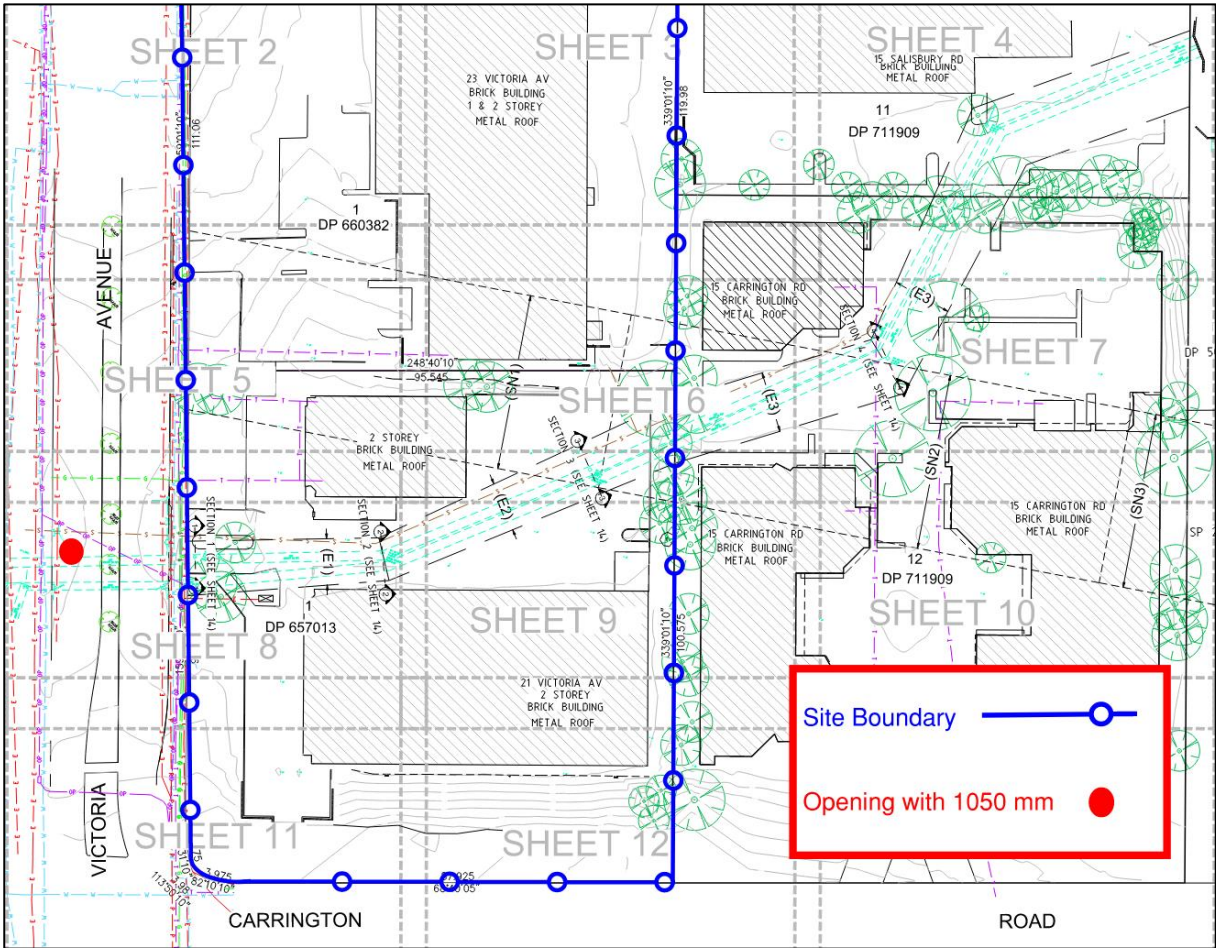
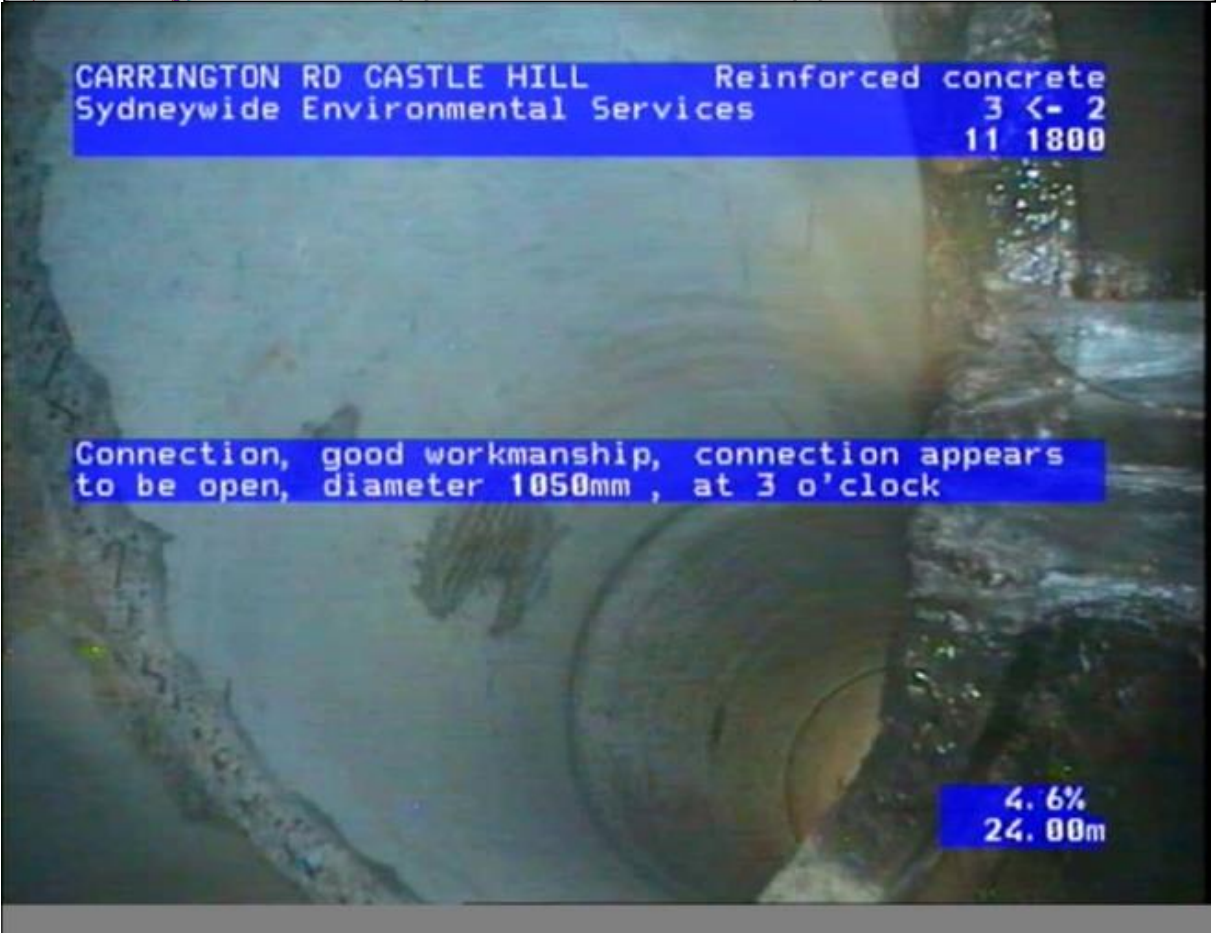
Figure 5. Open connections 1050 mm diameter

Please see the appendix E (Open Connections on Small Pipes <300mm dia Sheet) and (Open Connections on 1050mm Pipe) for more details.

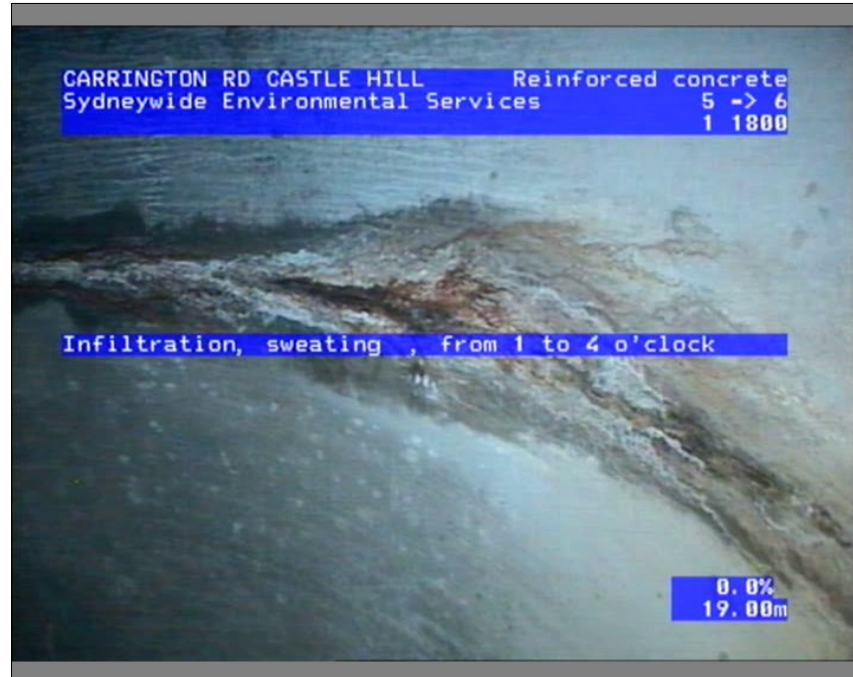
Photo: 075134\_18022022\_A.JPG, Media No.: LTS LOCKLEY,\_0, 00:01:30  
19m, Infiltration, sweating , from 1 to 4 o'clock

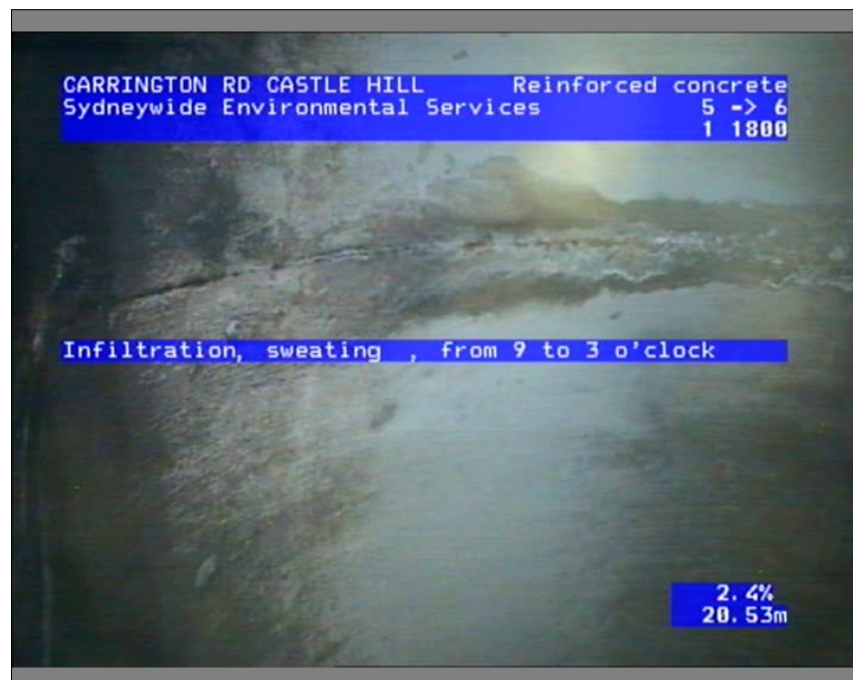
Photo: 075222\_18022022\_A.JPG, Media No.: LTS LOCKLEY,\_0, 00:02:13  
20.53m, Infiltration, sweating , from 9 to 3 o'clock

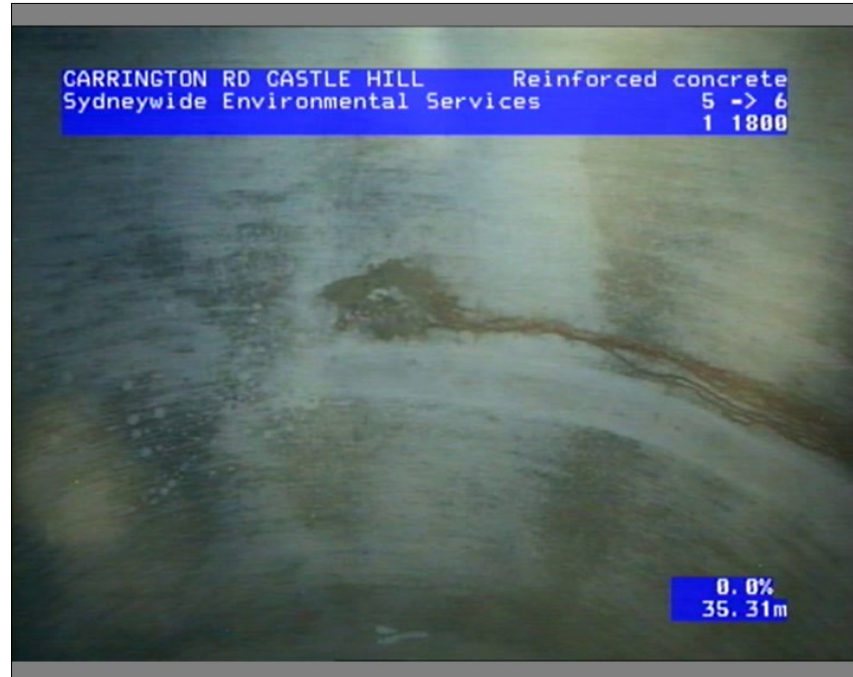
Photo: 075327\_18022022\_A.JPG, Media No.: LTS LOCKLEY,\_0, 00:03:11  
 35.32m, Infiltration, sweating , at 12 o'clock

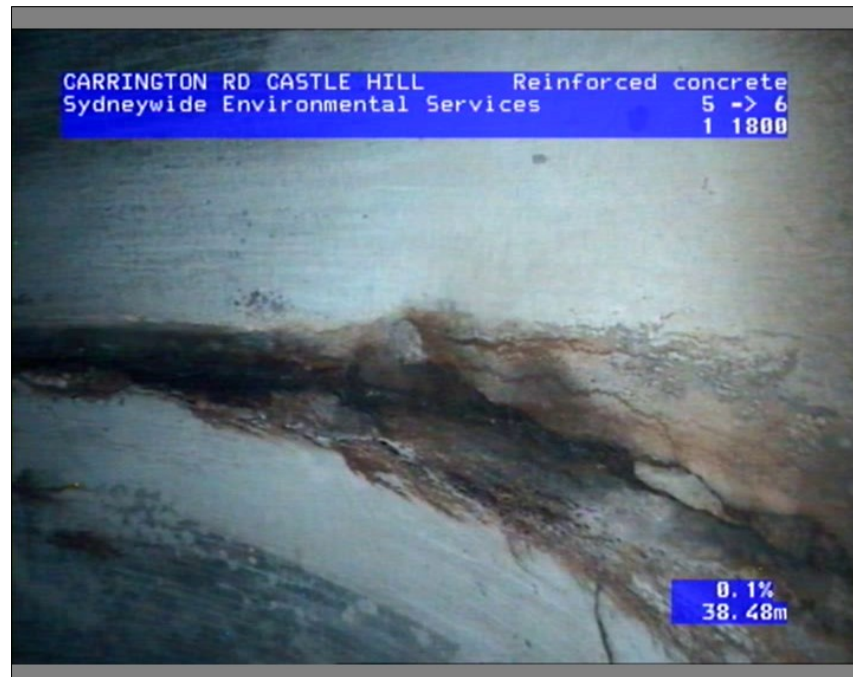
Photo: 075414\_18022022\_A.JPG, Media No.: LTS LOCKLEY,\_0, 00:03:46  
 38.48m, Infiltration, sweating , from 2 to 5 o'clock

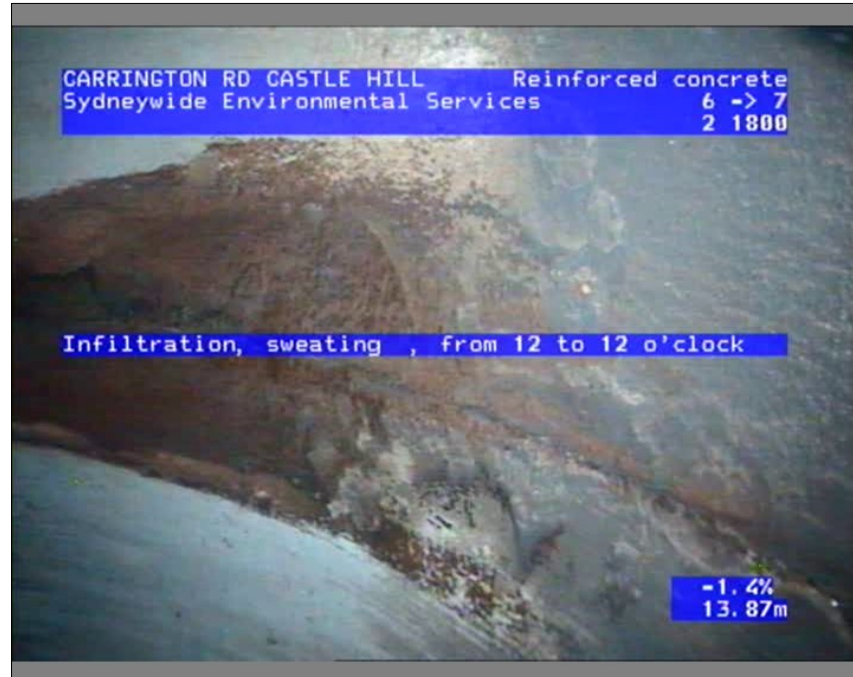
Photo: 075845\_18022022\_A.JPG, Media No.: LTS LOCKLEY,\_0, 00:01:07  
 13.87m, Infiltration, sweating , from 12 to 12 o'clock

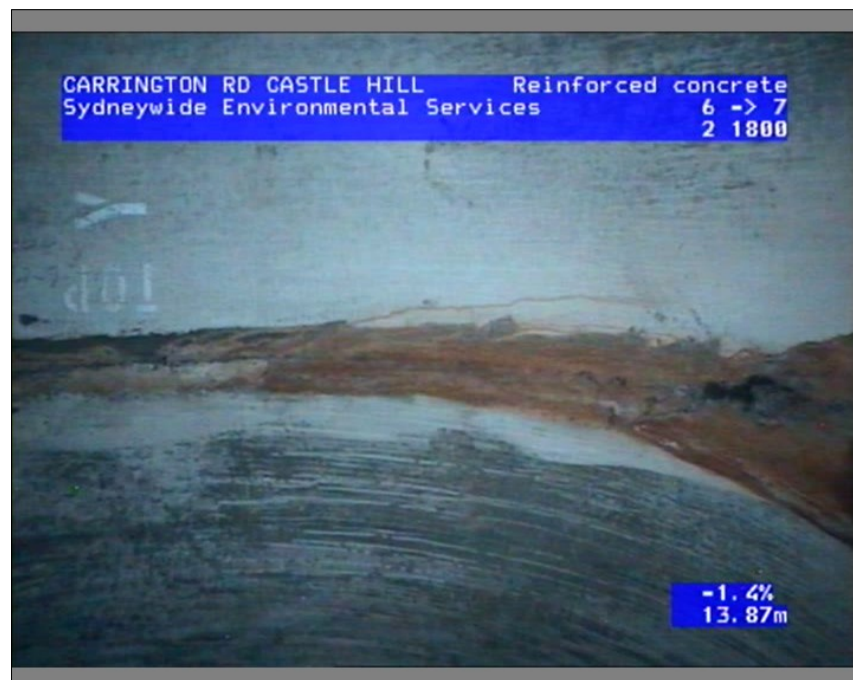
Photo: 075851\_18022022\_B.JPG, Media No.: LTS LOCKLEY,\_0, 00:01:07  
 13.87m, Infiltration, sweating , from 12 to 12 o'clock

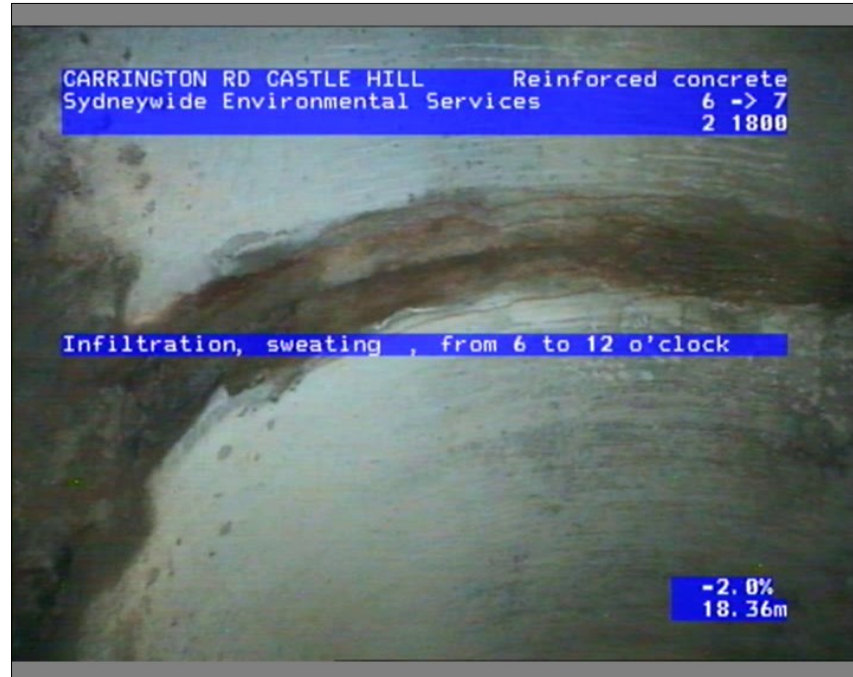
Photo: 075920\_18022022\_A.JPG, Media No.: LTS LOCKLEY,\_0, 00:01:37  
18.16m, Infiltration, sweating , from 6 to 12 o'clock

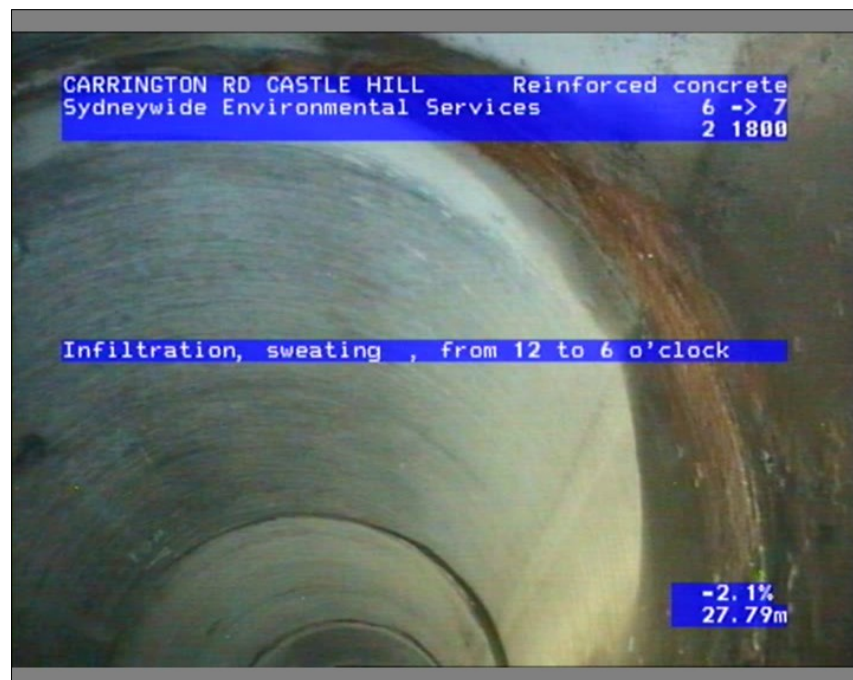
Photo: 080015\_18022022\_A.JPG, Media No.: LTS LOCKLEY,\_0, 00:02:21  
27.73m, Infiltration, sweating , from 12 to 6 o'clock

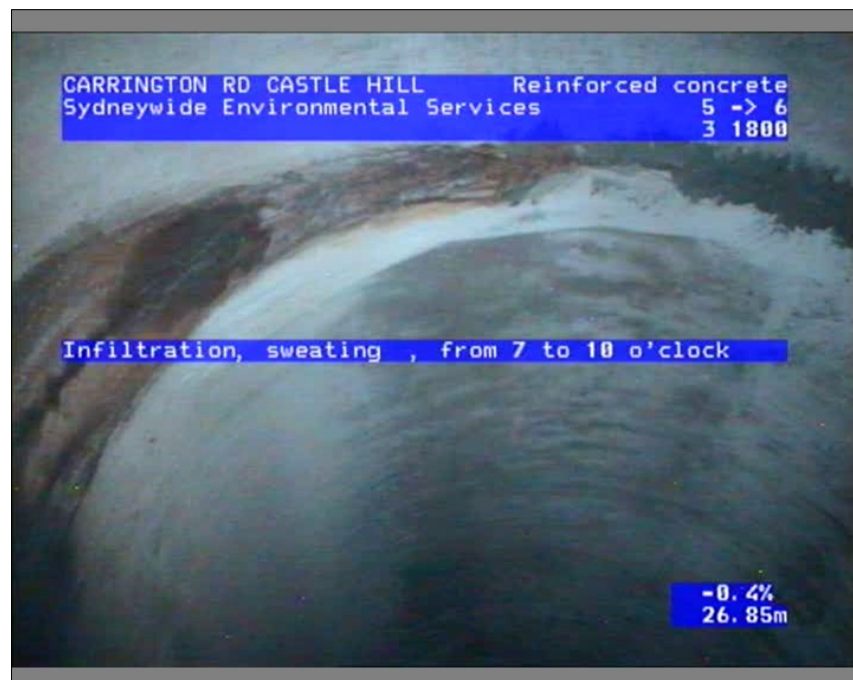
Photo: 081521\_18022022\_A.JPG, Media No.: LTS LOCKLEY,\_0, 00:01:58  
26.85m, Infiltration, sweating, from 7 to 10 o'clock

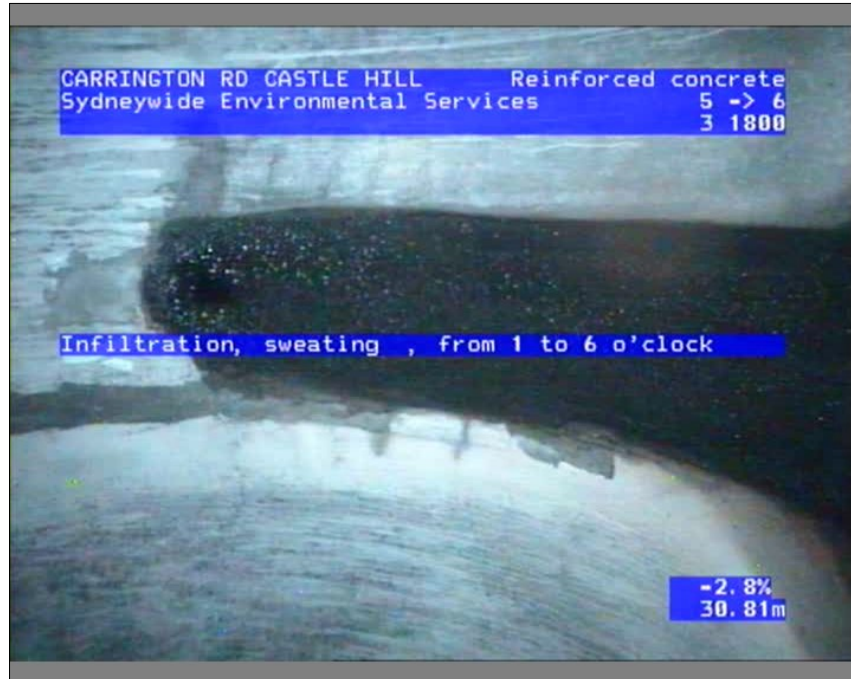
Photo: 081554\_18022022\_A.JPG, Media No.: LTS LOCKLEY,\_0, 00:02:21  
 31.09m, Infiltration, sweating , from 1 to 6 o'clock

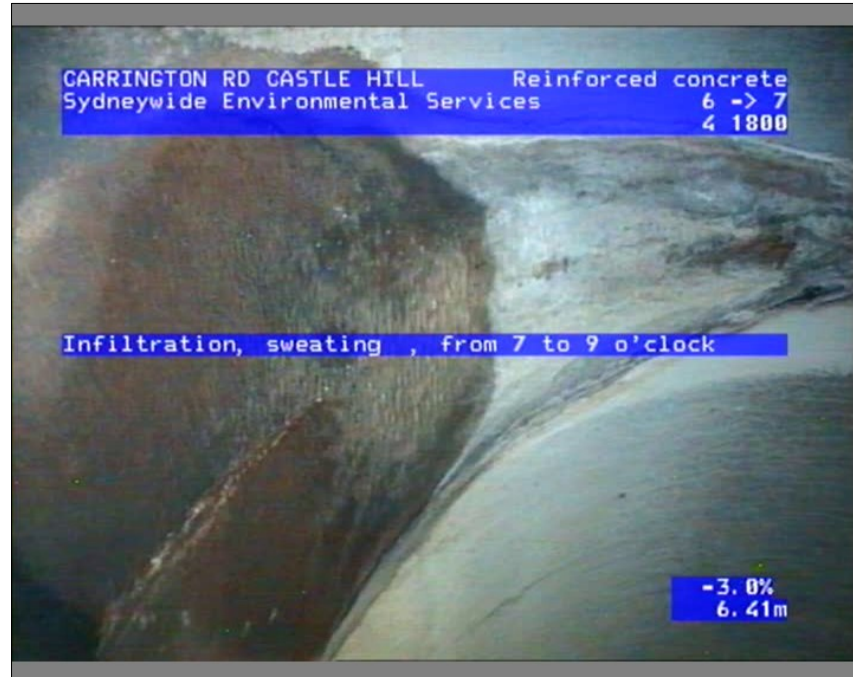
Photo: 081936\_18022022\_A.JPG, Media No.: LTS LOCKLEY,\_0, 00:00:39  
6.41m, Infiltration, sweating , from 7 to 9 o'clock

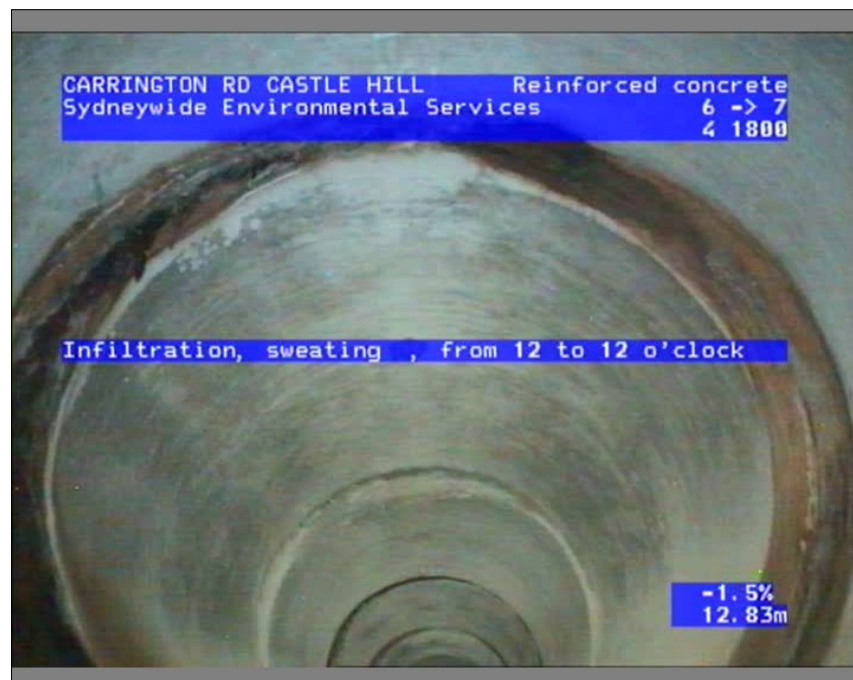
Photo: 082006\_18022022\_A.JPG, Media No.: LTS LOCKLEY,\_0, 00:01:06  
12.8m, Infiltration, sweating , from 12 to 12 o'clock

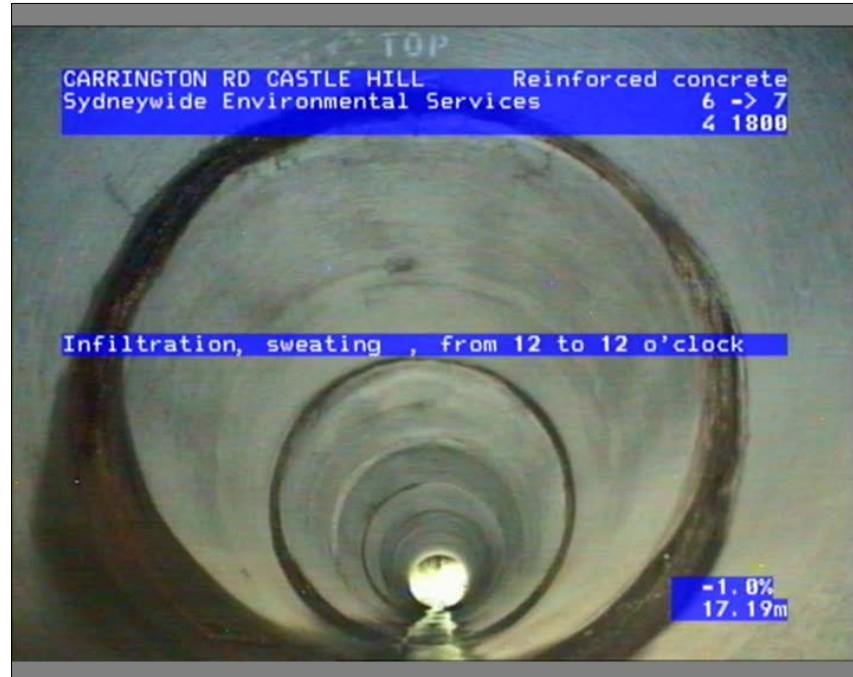
Photo: 082026\_18022022\_A.JPG, Media No.: LTS LOCKLEY,\_0, 00:01:24  
17.06m, Infiltration, sweating , from 12 to 12 o'clock

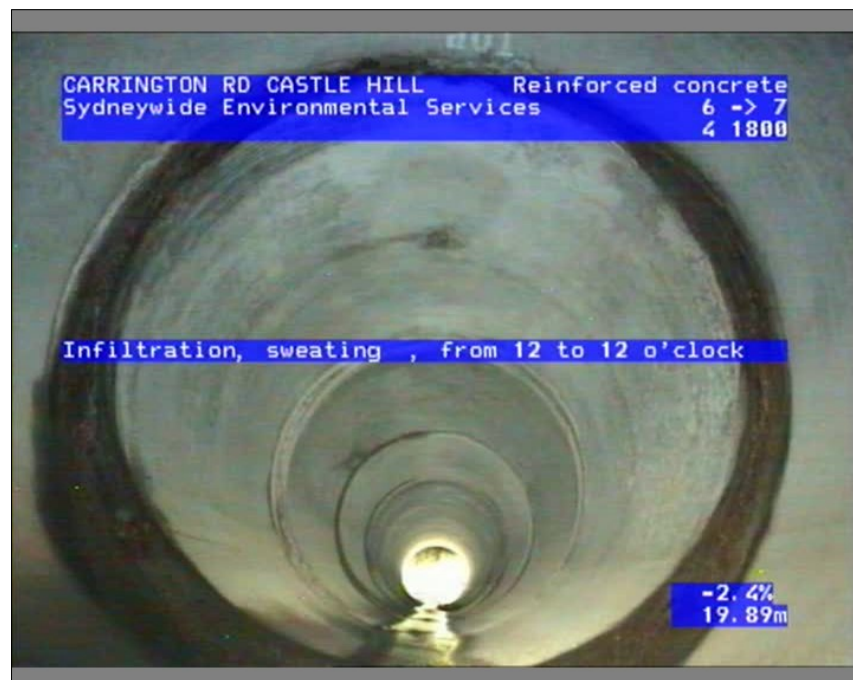
Photo: 082041\_18022022\_A.JPG, Media No.: LTS LOCKLEY,\_0, 00:01:35  
19.77m, Infiltration, sweating , from 12 to 12 o'clock

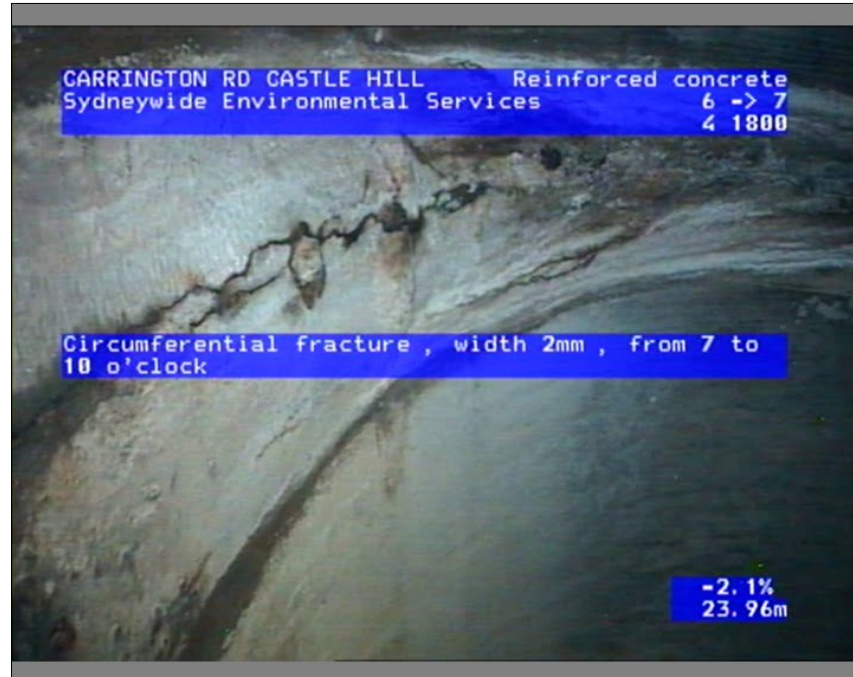
Photo: 082125\_18022022\_A.JPG, Media No.: LTS LOCKLEY,\_0, 00:02:03  
23.96m, Circumferential fracture , width 2mm , from 7 to 10 o'clock

**Solution for circumferential fracture:**  
As the pipe is large diameter, it is suggested to use **epoxy injection/filling** to fill the crack from internally and rely on calcification/autogenous healing. Seal and review in 12 months.

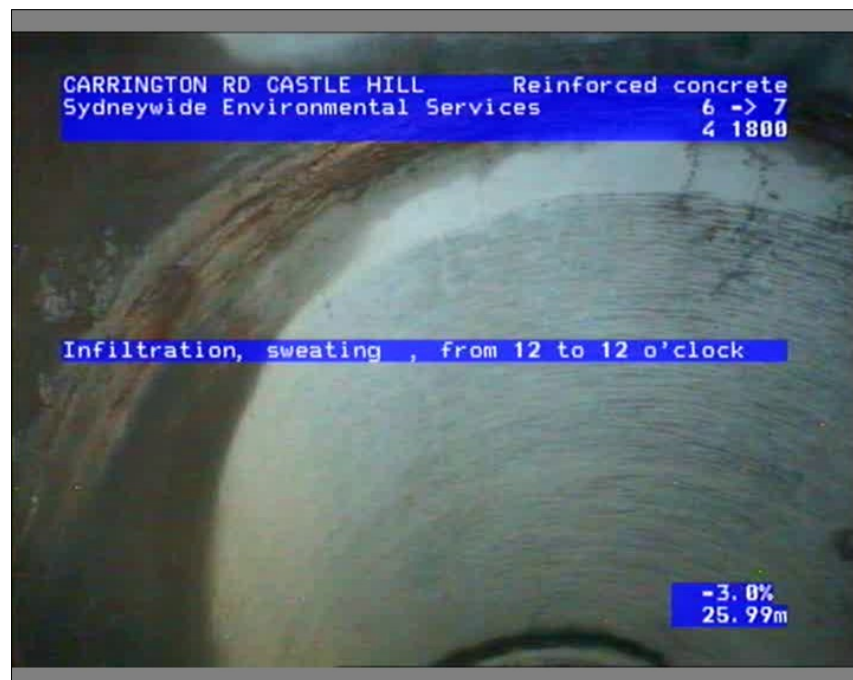
Photo: 082506\_18022022\_A.JPG, Media No.: LTS LOCKLEY,\_0, 00:02:25  
25.99m, Infiltration, sweating , from 12 to 12 o'clock

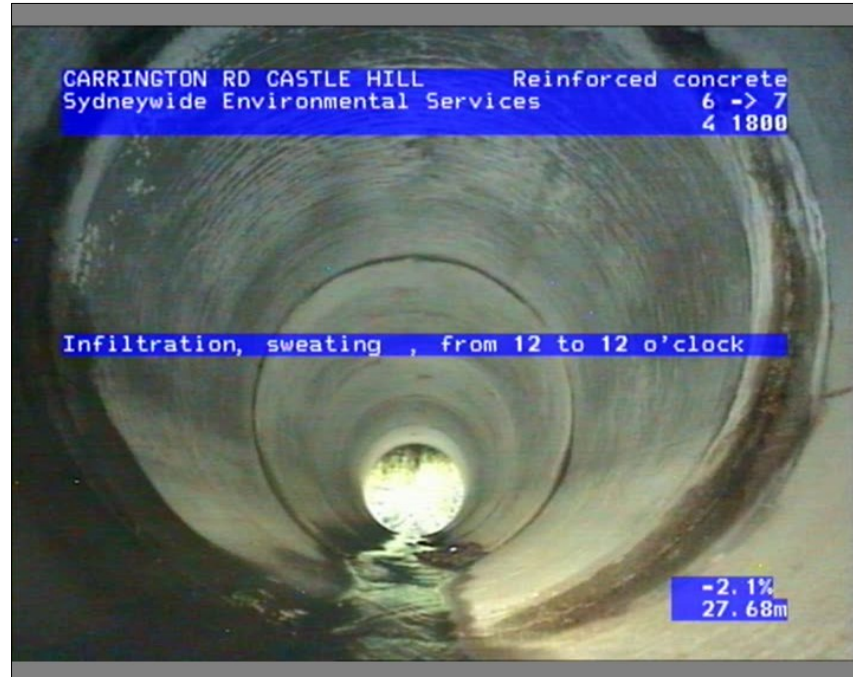
Photo: 082521\_18022022\_A.JPG, Media No.: LTS LOCKLEY,\_0, 00:02:38  
27.66m, Infiltration, sweating , from 12 to 12 o'clock

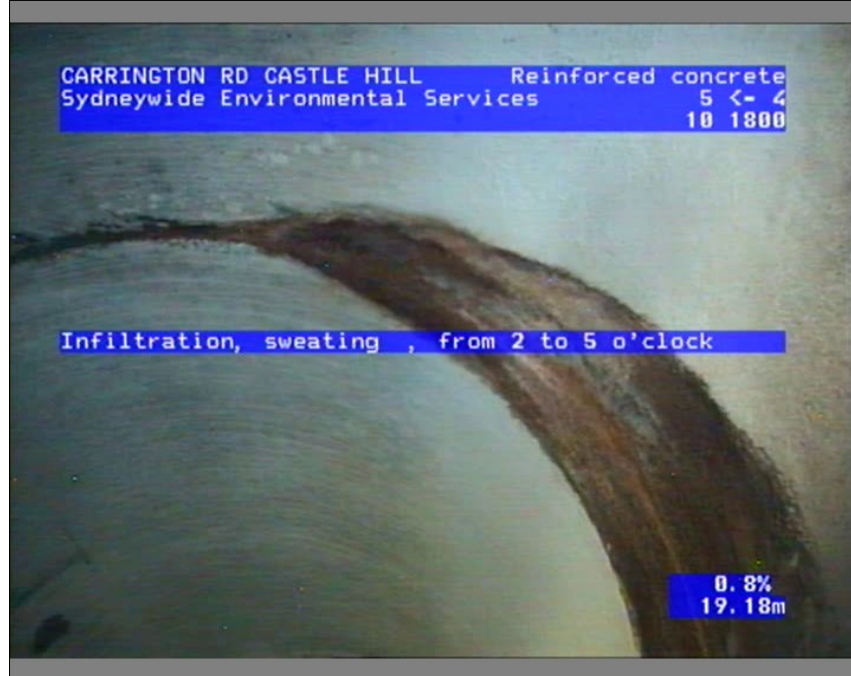
Photo: 093357\_18022022\_A.JPG, Media No.: LTS LOCKLEY,\_0, 00:00:58  
 19.18m, Infiltration, sweating , from 2 to 5 o'clock

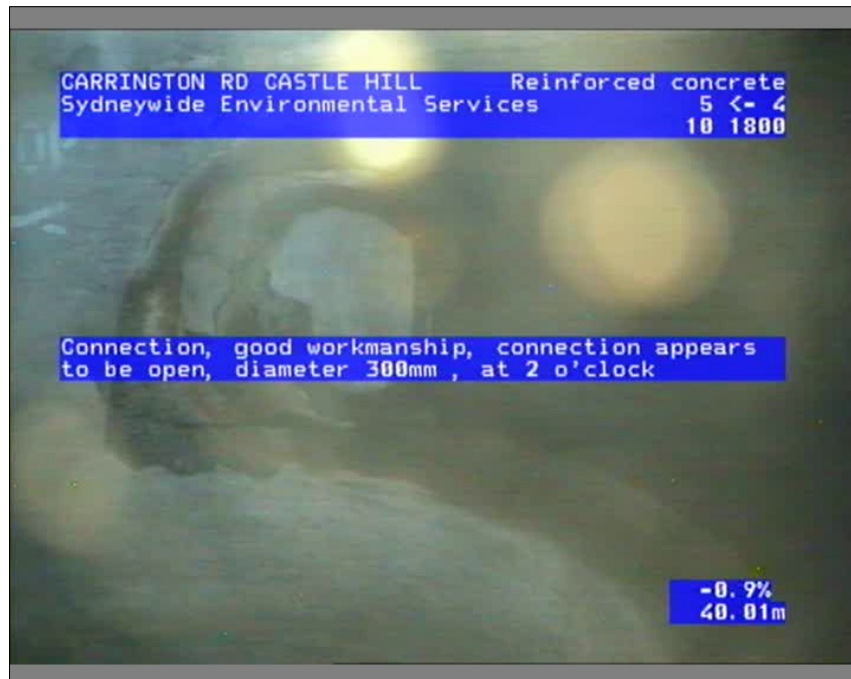
Photo: 093503\_18022022\_A.JPG, Media No.: LTS LOCKLEY,\_0, 00:01:58  
 40.01m, Connection, good workmanship, connection appears to be open, diameter 300mm , at 2 o'clock

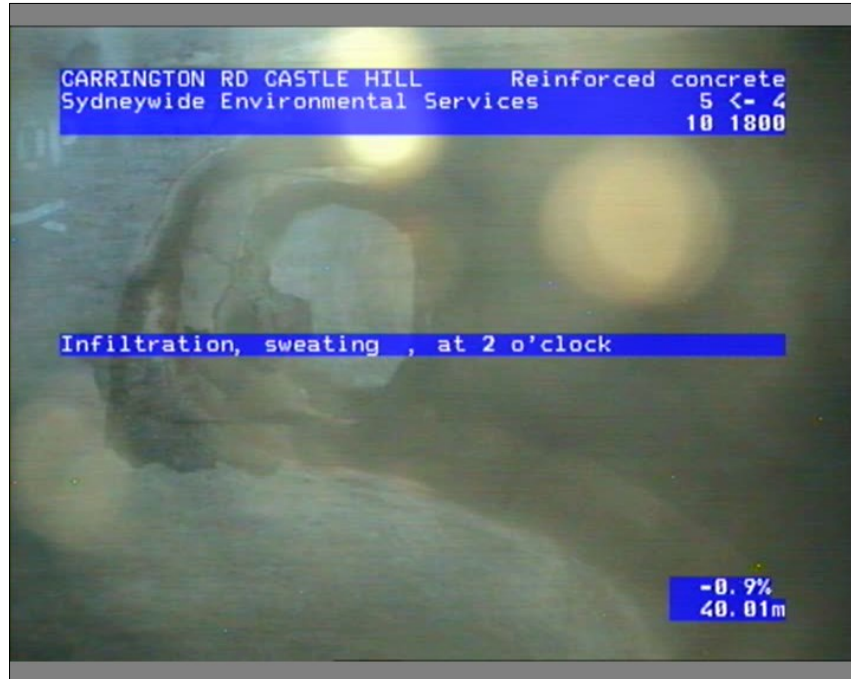
Photo: 093513\_18022022\_A.JPG, Media No.: LTS LOCKLEY,\_0, 00:02:02  
 40.01m, Infiltration, sweating , at 2 o'clock

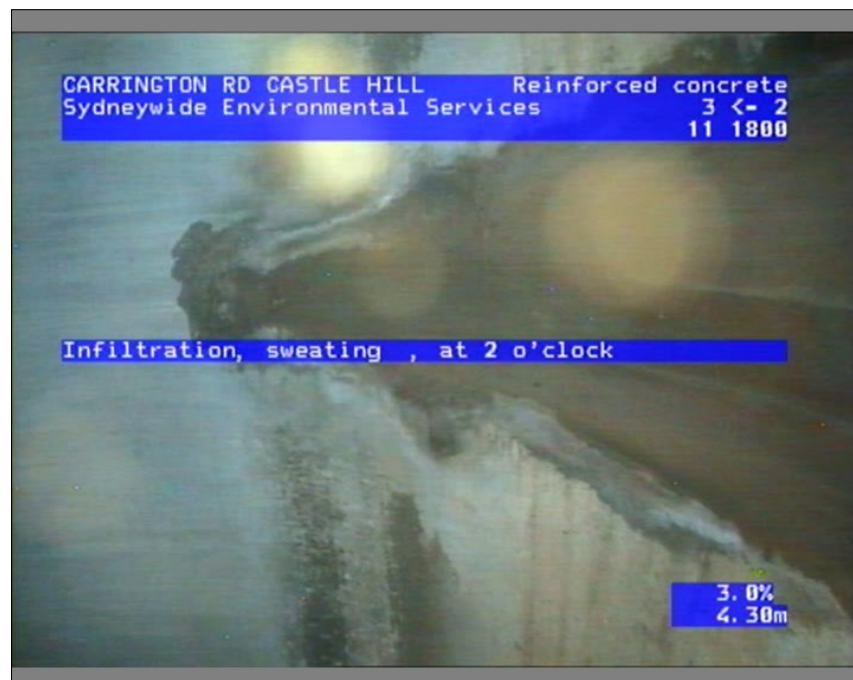
Photo: 094754\_18022022\_A.JPG, Media No.: LTS LOCKLEY,\_0, 00:00:42  
4.3m, Infiltration, sweating , at 2 o'clock

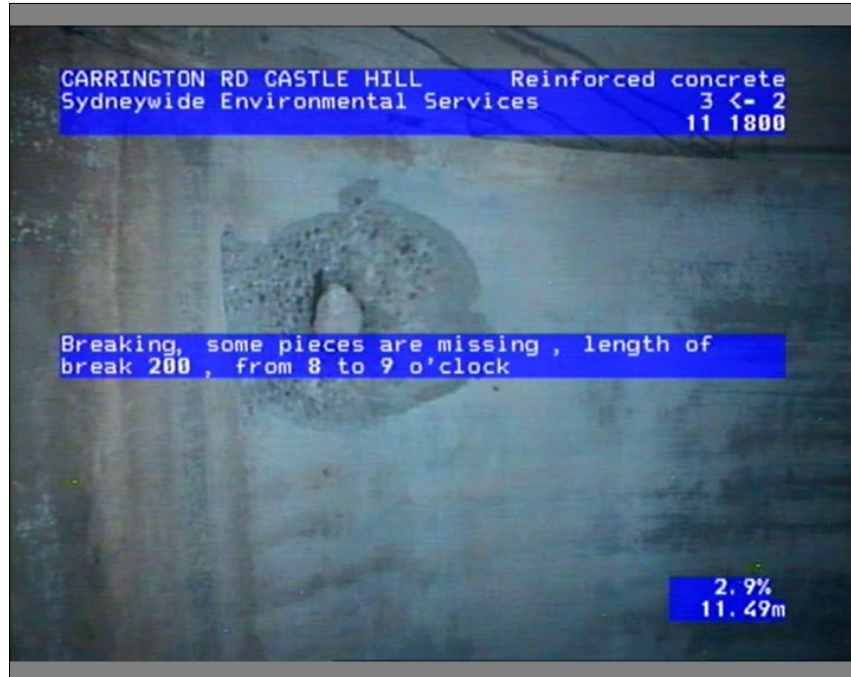
Photo: 094946\_18022022\_A.JPG, Media No.: LTS LOCKLEY,\_0, 00:01:50  
 11.49m, Breaking, some pieces are missing, length of break 200, from 8 to 9 o'clock

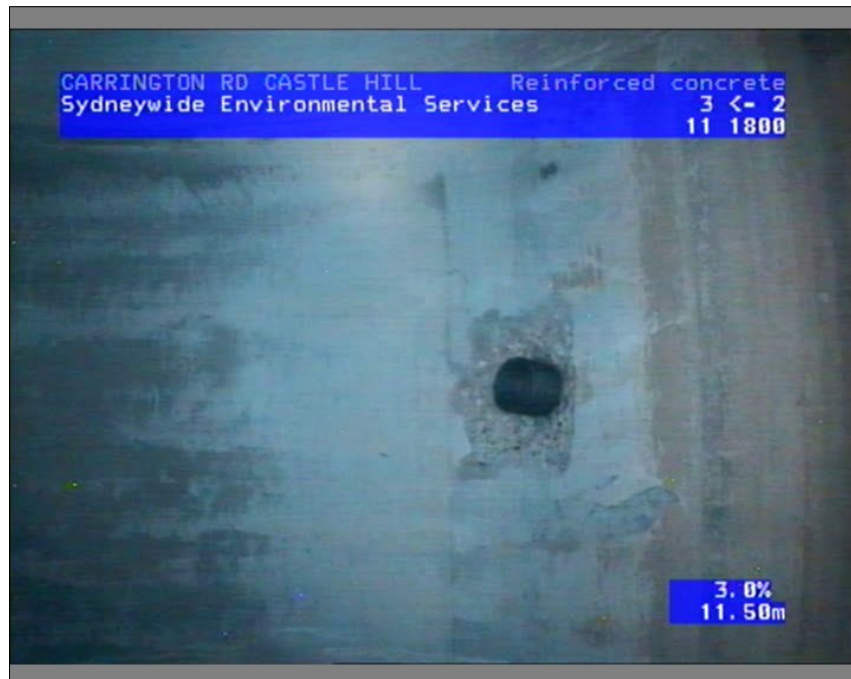
Photo: 095021\_18022022\_A.JPG, Media No.: LTS LOCKLEY,\_0, 00:02:07  
 11.5m, Connection, good workmanship, connection appears to be open, diameter 50mm, at 3 o'clock
