Tree Report – 21- 23 Victoria Ave, Castle Hill Park

Prepared for Masters Home Improvement

19 February 2013

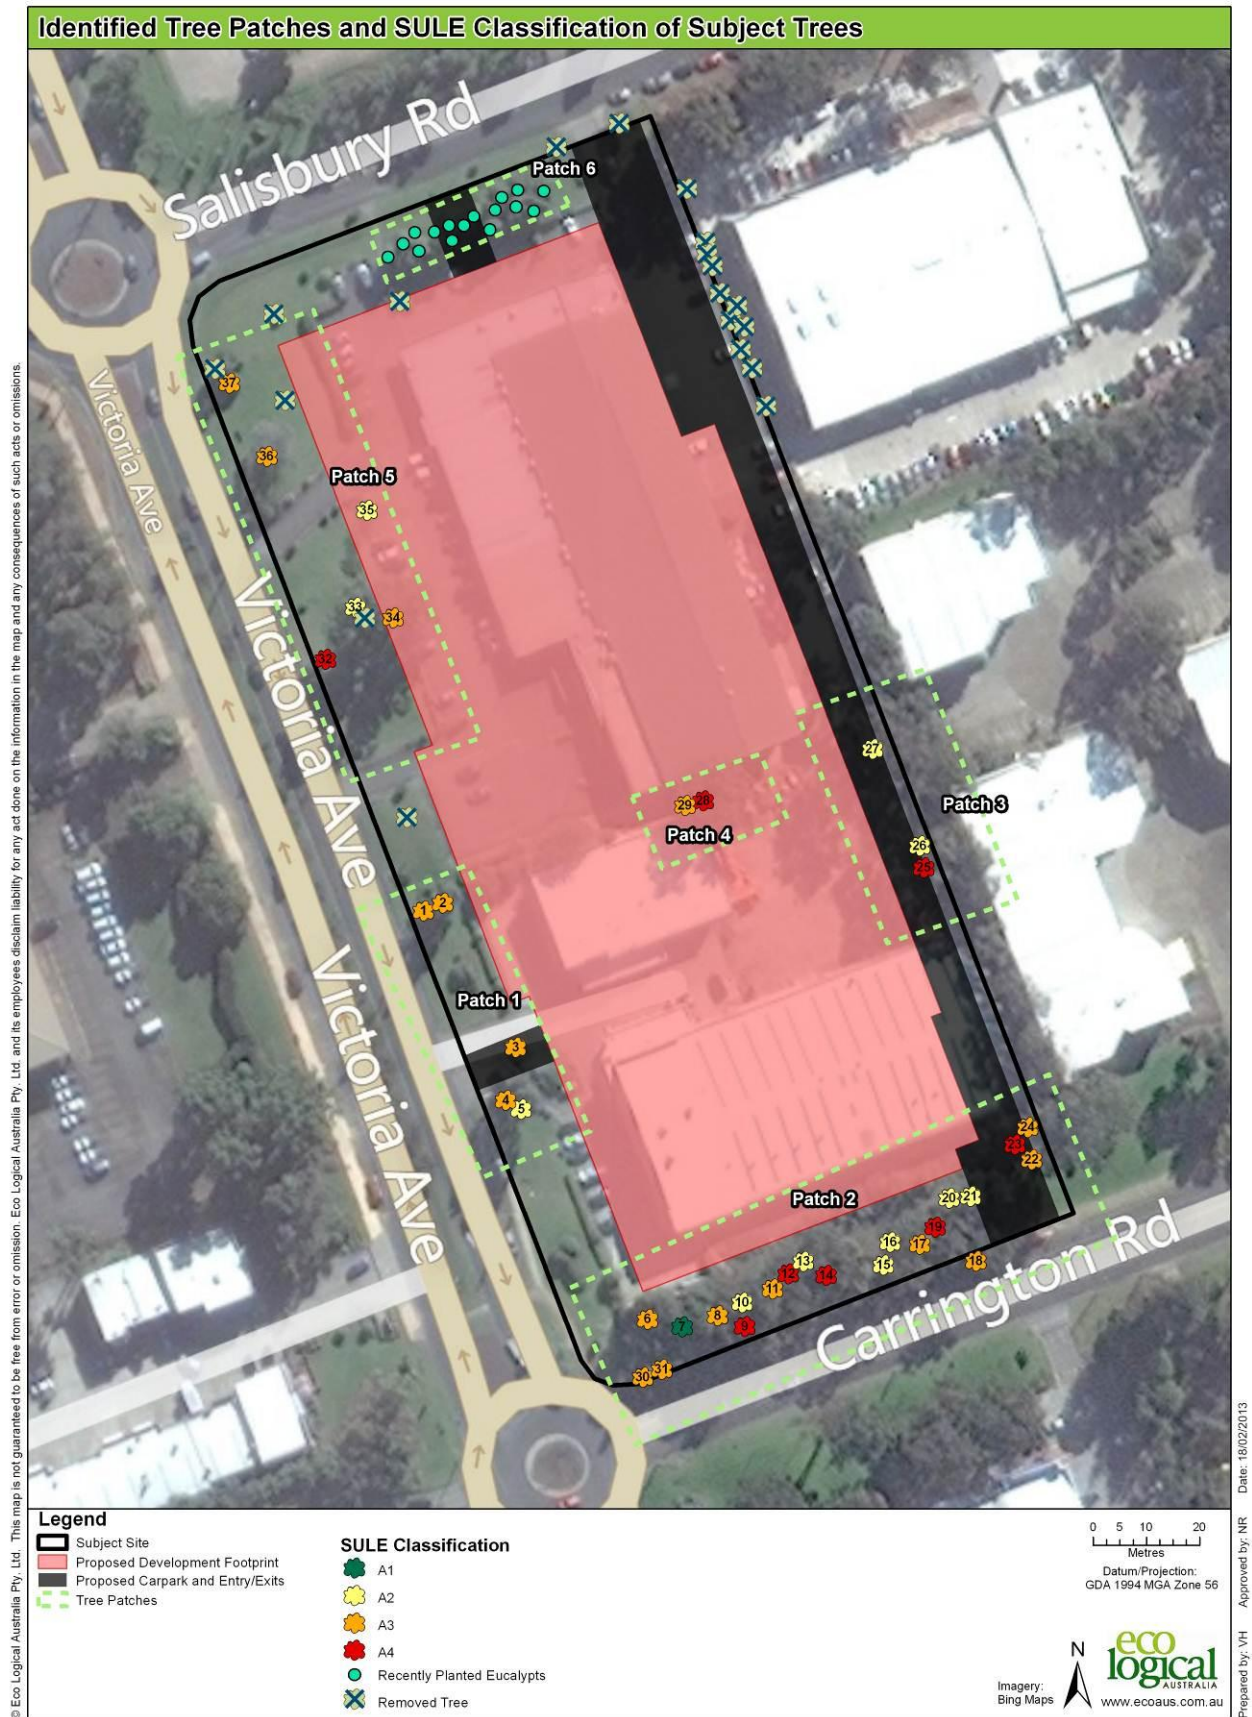
Using the SULE classification, 8 trees (22% of all trees observed) were identified to have a SULE Class of 4, i.e. recommended for removal either due to the tree's poor health, instability and/or poor structure, or, trees that could live for more than 5 years but may be removed to prevent interference with more suitable individual. An additional 17 trees (46% of all trees observed) were classified into SULE Class 3, i.e. have a SULE of 5 to 15 years. Thirty per cent (11 trees) of the existing tree cover was considered retainable for the medium term (15-40 years; SULE 2) and 3% (1 tree) retainable for the long-term (>40 years; SULE 1) (**Figure 3**). **Appendix C** provides a complete list of all trees assessed and their corresponding SULE rating, tree retention value and TPZs.

Figure 3. Subject site depicting the 6 tree patches and the SULE classification.

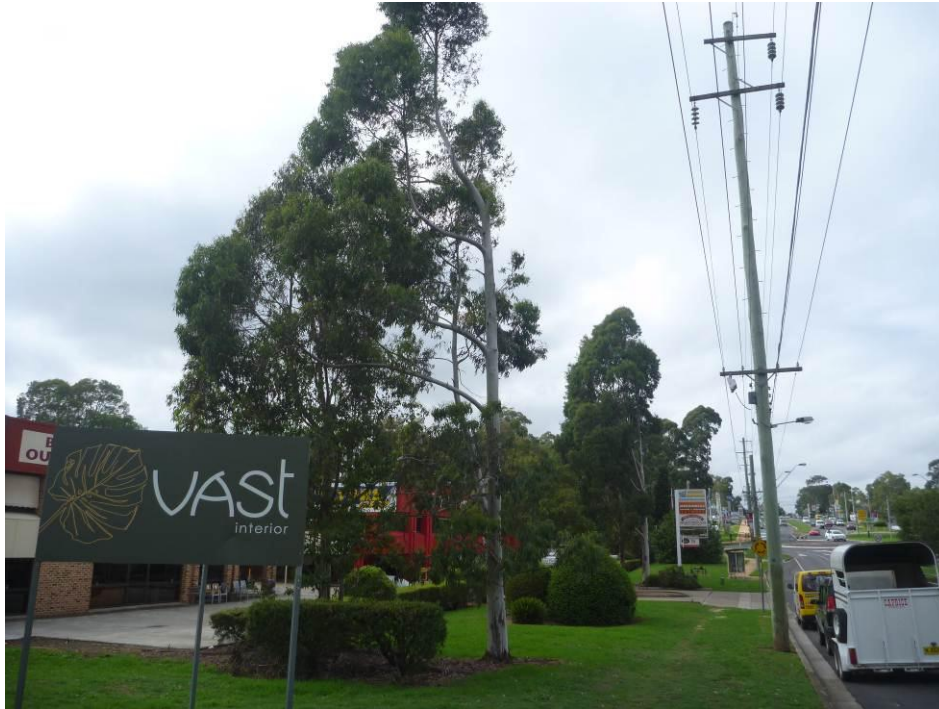
Patch 1 is located along Victoria Avenue. It consists of five trees (# 1 - 5) located in a turf area along Victoria Avenue. Trees #1 to 4 were assessed to have a SULE 3 rating (i.e. SULE of 5 to 15 years), while tree # 5 (*E. punctata*) received a SULE 2 rating (SULE of 15 to 40 years) (Figure 4, Figure 5).

Figure 4. Tree # 1 (large) and tree # 2.

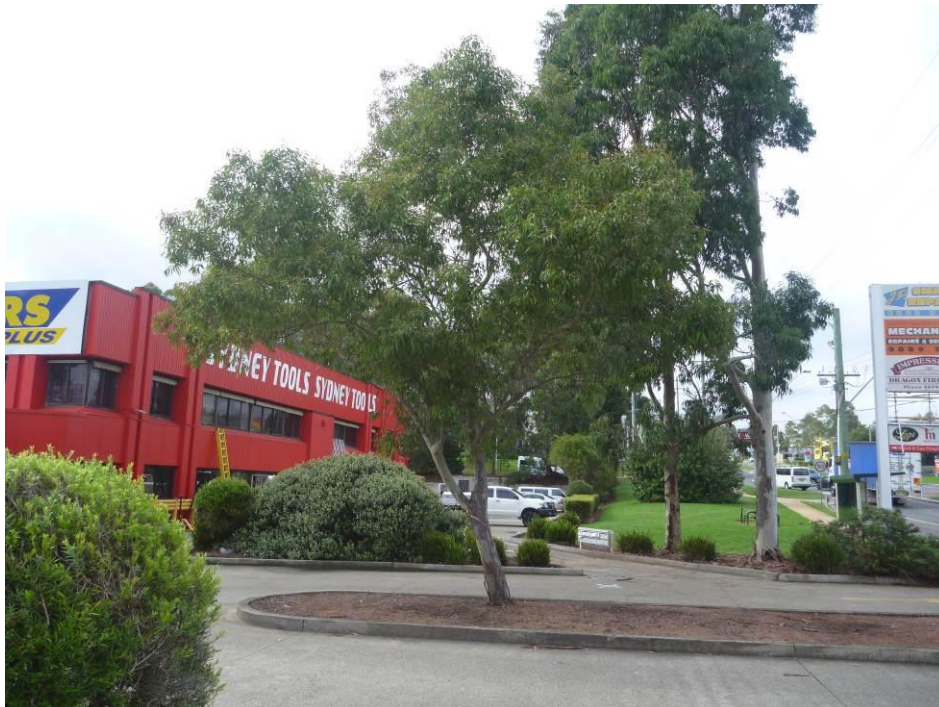
Figure 5. Tree # 3 (in foreground) to 5.

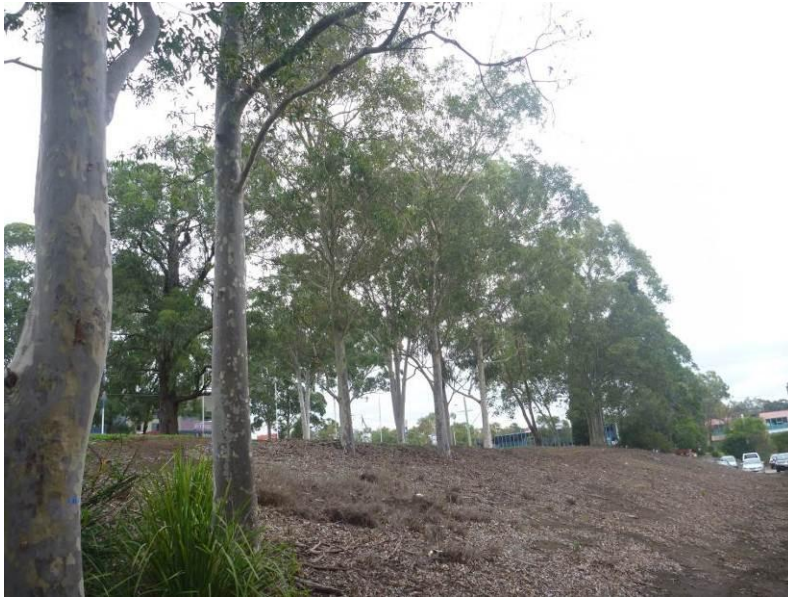
Patch 2 is located along Carrington Road and consists of 21 trees predominately made up of *C. maculata* (**Figure 6**). This patch currently acts as a screen and holds a high amenity value for the proposed development.

Figure 6. Showing Patch 2 (looking southwards).

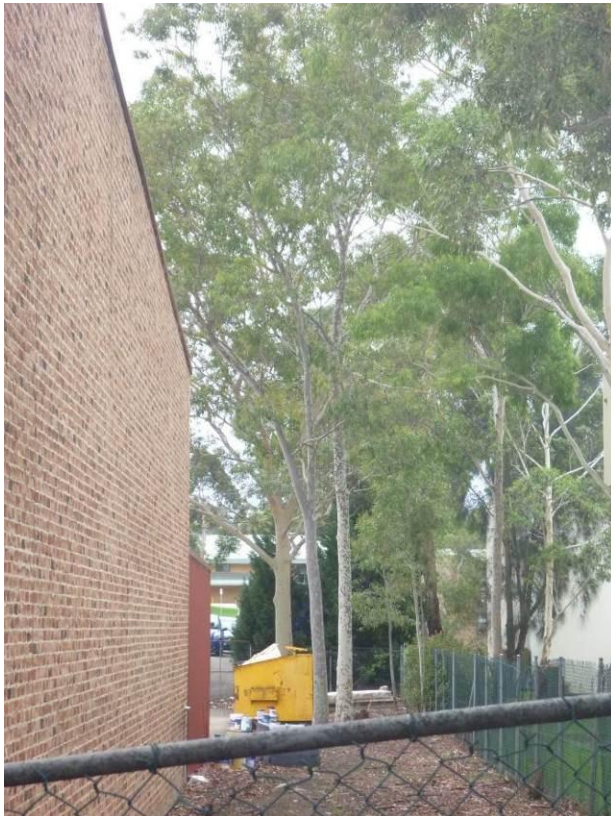
Patch 3 contains three trees (all *C. maculata*). This patch is located along the northern boundary adjacent to a car park (**Figure 7**).

Figure 7. Patch 3 showing the three *C. maculata* trees.

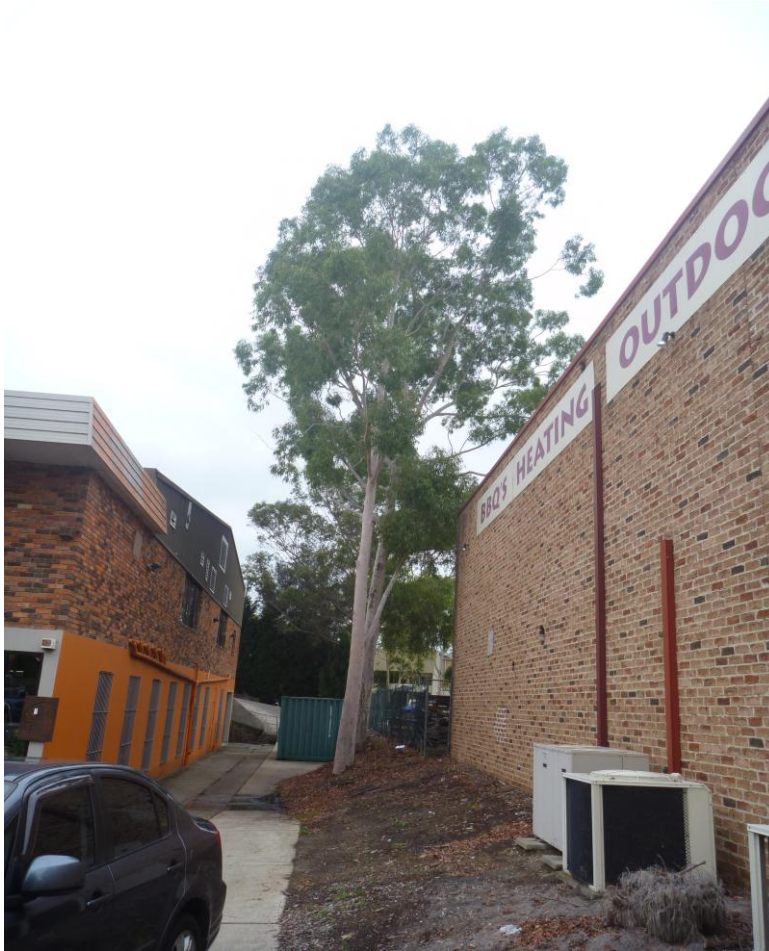
Patch 4 consists of two *C. citriodora*. They are located between two buildings in the centre of the subject site (**Figure 8**).

Figure 8. Patch 4 showing the two *C. citriodora* trees.

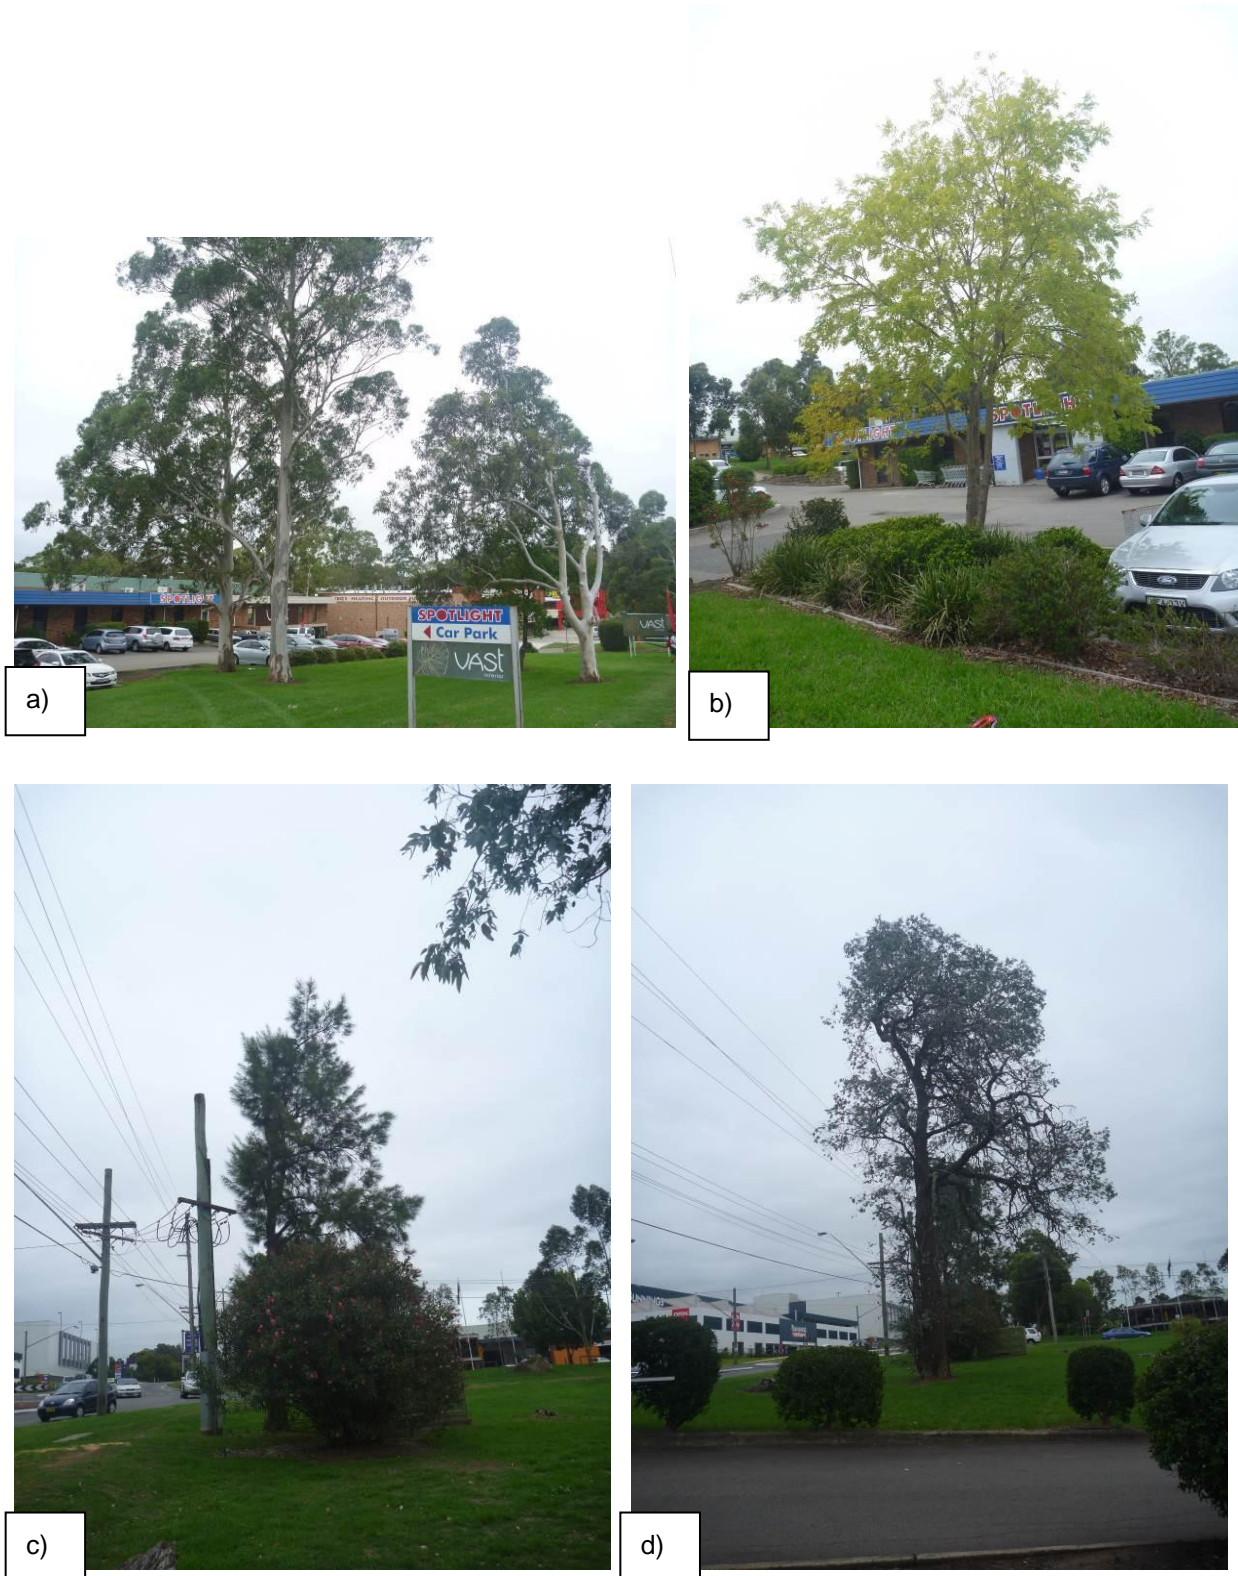
Patch 5 is made up of six trees, four Eucalypts, one *Robinia pseudoacacia* 'Frisia' and one *Allocasuarina* species (Figure 9). This patch is located between Victoria Avenue and a car park.

Figure 9. Patch 5. a) Showing three Eucalypts within turf area. b) Showing Robinia in garden bed adjacent to car park. c) Showing *Allocasuarina* adjacent to a power line and Victoria Avenue. d) Showing *Eucalyptus cinerea* adjacent to a power line and Victoria Avenue.

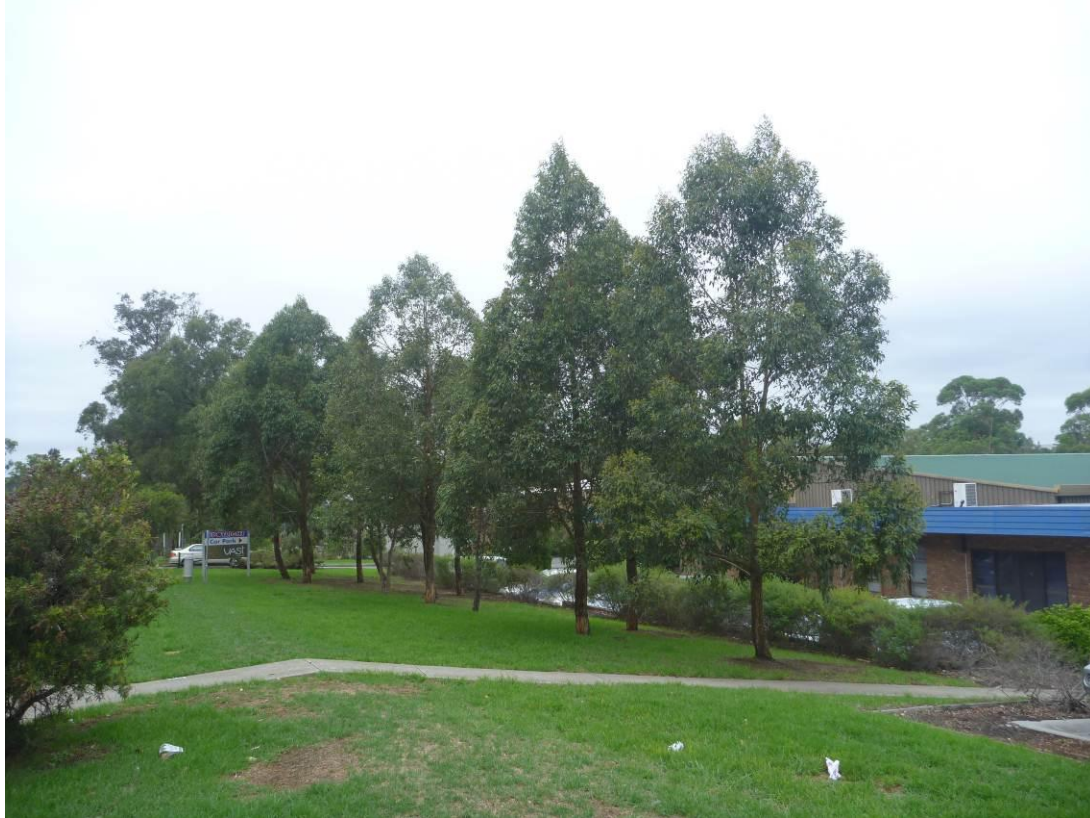
Patch 6 is located along Salisbury Road and is made up of recently planted Eucalypts (predominantly *E. microcorys* (Tallow Wood)). Trees are estimated to be approximately 10 years old (**Figure 10**). Trees within this patch were not individually assessed due to their young age. Overall, condition and structure of the trees ranged between fair to good.

Figure 10. Patch 6 made up of immature planting.

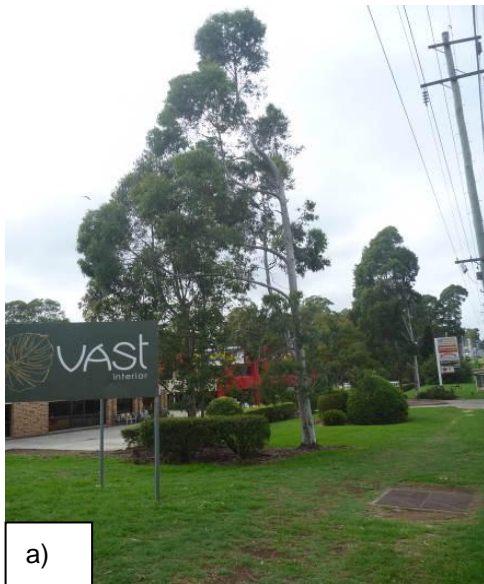
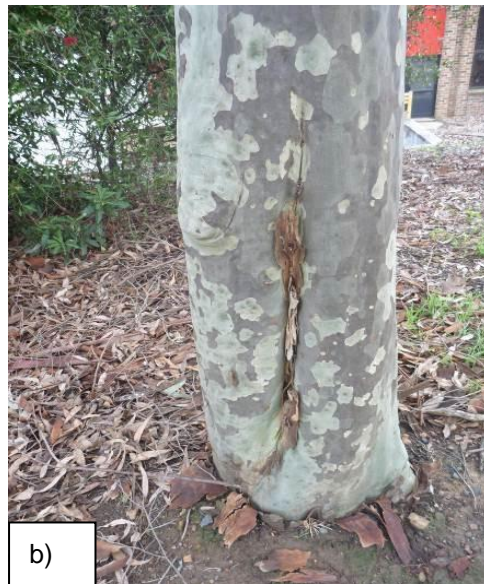
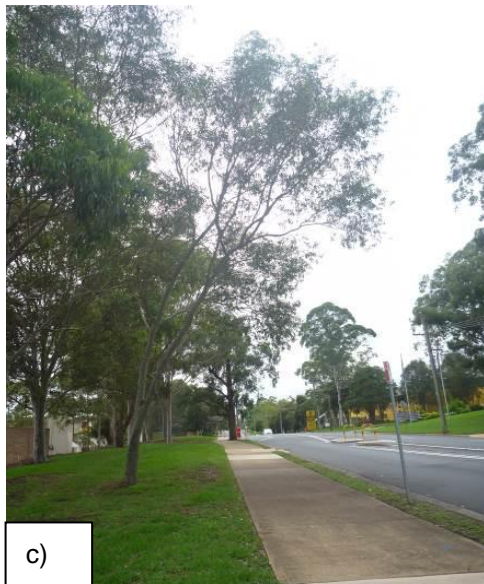
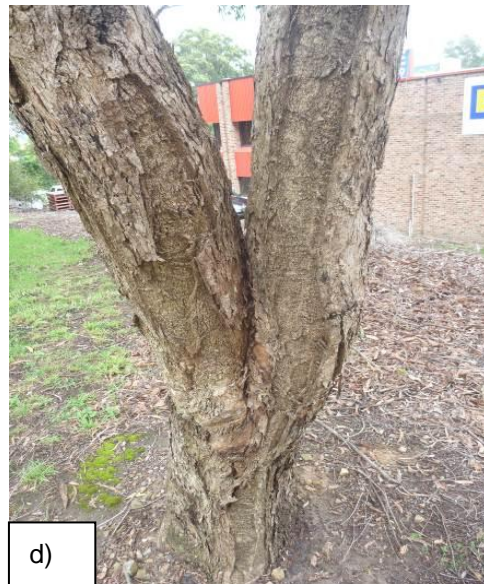
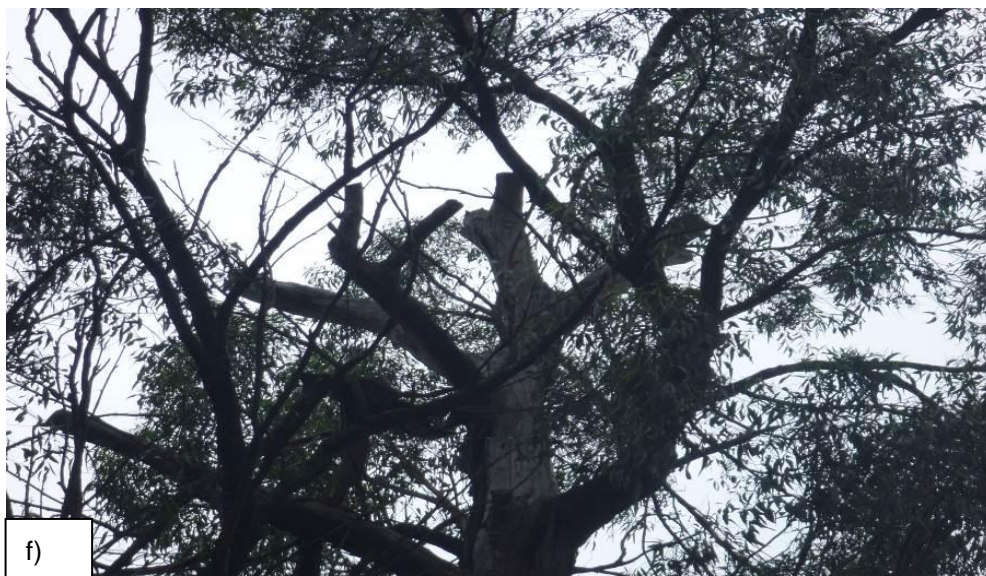
The contributing factors that resulted in 25 (68%) trees' short SULE ratings (SULE 3 and 4) included the following:

- Contain wounds
- Contain uneven tree crowns
- Contain heavy horizontal branches (end weight)
- Experienced detrimental pruning of trees for power line clearance
- Are leaning/suppressed
- Comprise major branch or trunk forks (i.e. are co-dominant) (**Figure 11d**). Narrow branch/stem junctions can result in trees enclosing bark which in turn results in a weakened junction/twin stems attachment (Mattheck and Breloer, 1994). Advanced cases of included bark show a split at the fork junction or show severe reaction wood grown at the fork junction (overgrowing an existing crack).

- Have thin crowns
- Contain large amounts of dead wood/dieback
- Contain epicormic growth
- Are suppressed

Figure 11 below depicts some of the subject trees that received a SULE 3 or 4 rating.

Figure 11. a) Poorly structured tree due to heavy pruning for power line clearance. b) Old wound partially overgrown (potential internal decay). c) Leaning / suppressed tree. d) Co-dominant stems with included bark. e) Over-mature senescent tree.

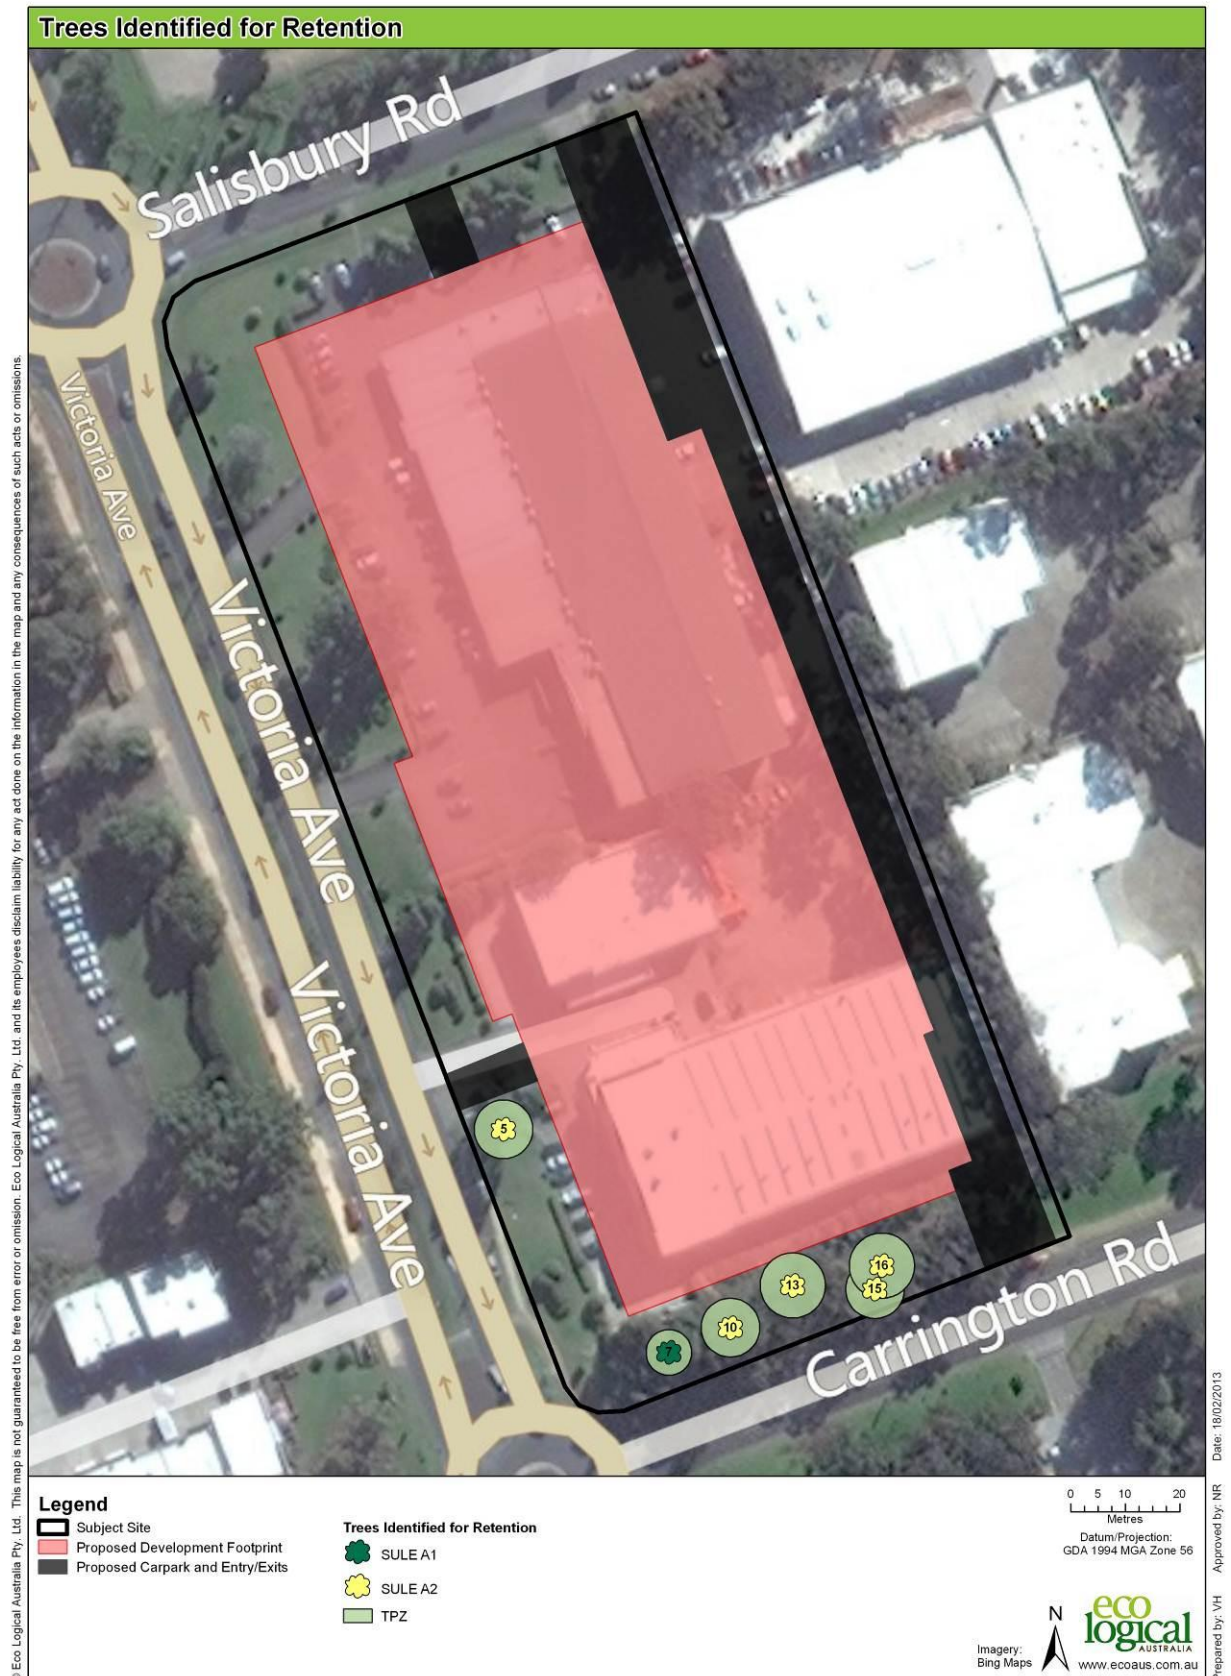
Figure 12. Trees identified for retention including their associated TPZ (indicative locations).

Trees identified for retention should be re-inspected by a more in-depth assessment and remedial work prescribed where necessary to reduce the risk to people and property. Remedial work may include:

- Pruning of canopy for development and construction access;
- Pruning of dead limbs (dead-wooding);
- Corrective pruning;
- Thinning of crown;
- Weight reduction of heavy branches; and / or
- Removal of diseased branches (e.g. bracket fungi) or poorly attached branches.
