## TREE ASSESSMENT REPORT

## ArborSite Report Summary for Forestry Corporation NSW – Cumberland State Forest

Assessment commenced: 25 March 2024

Location: 121-131 Oratava Avenue, West Pennant Hills NSW

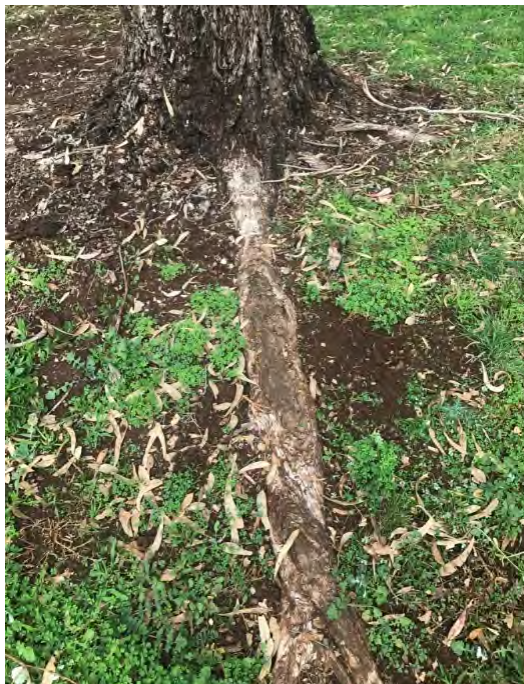
Figure 3. An example of damage to tree roots caused via mowing. (Luke Dawson, June 2017).

Another advantage to mulching around the trunk and root crown is that it limits damage to both parts from mowing equipment. This in turn reduces mechanical damage and compaction.

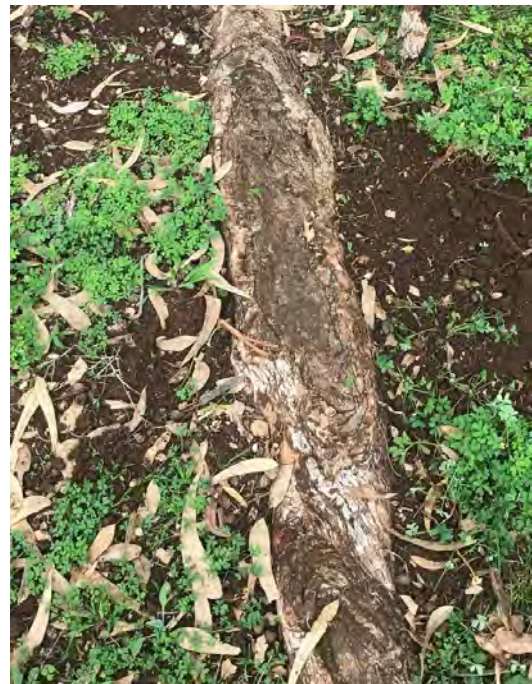
Figure 4. Image showing wound caused to upper portion of surface root by mower. (Luke Dawson, June 2017).
