Detailed Site Investigation

407 & 457 Crookwell Rd, Kingsdale, NSW

Reference No:	DSI2022-218
Survey Date:	24 November 2021
Prepared by:	CSH Consulting PTY LTD

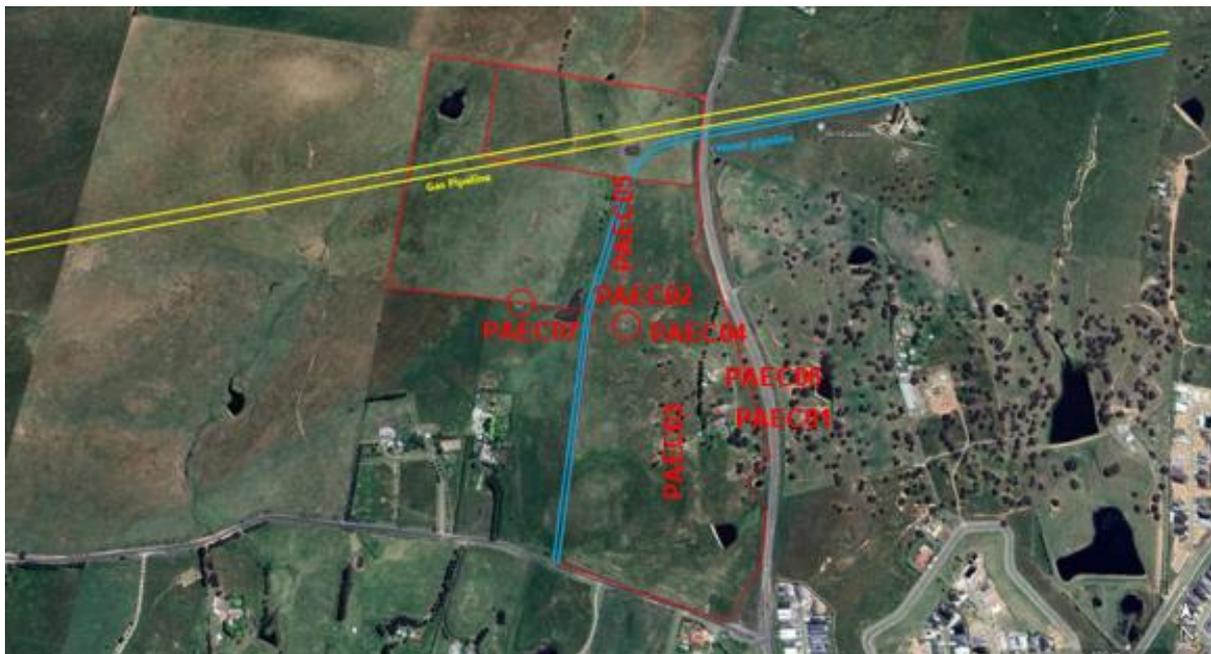
Figure 3: Approximate locations of potential areas of environmental concern (PAEC).

Table 3: Potential areas of Environmental Concern (PAEC) identified during investigation of site		
PAEC No	Area descriptor	Potential contaminants
PAEC01	Residential building and garage	Asbestos, SMF, lead (paint) and polychlorinated biphenyls (PCB)
PAEC02	Pump sheds associated with onsite groundwater bores – broken with just housing.	Metals; total recoverable hydrocarbons (TRH); benzene, toluene, ethylbenzene, xylene (BTEX); polycyclic aromatic hydrocarbons (PAHs)

PAEC03	Three piles of fill and building rubble approx. 100m to West of residential building running along the fence line approximately 50m apart	Asbestos and lead (paint)
PAEC04	Rock formation approx. 100m East of central dam – contains miscellaneous materials like steel and buried and cremated animal carcasses.	Surveying of effectiveness of disposal of animal carcasses.
PAEC05	Fill along Eastern side of gully from Northern central section of site down to central dam – contained building rubble, concrete, tyres and some plastic	Metals; TRH; BTEX; PAH; PCB; OCP; phenols and asbestos
PAEC06	Sheds to North of residence contained weed killer chemicals including a 20-litre container of glyphosate.	TRH; BTEX; PAH; OCP; Glyphosate and other herbicides
PAEC07	An old fuel tank on the neighbouring paddock on the boundary approx. 100 m West of and up gradient from central dam	Metals; TRH; BTEX; PAH.

Table 1: Area of concern analysis		
PAEC No	Findings	Further requirements
PAEC01	It was advised that the house and garage will continue to be occupied and will be removed prior to works commencement on site.	A hazardous materials survey, including sampling, is to be carried out and a remedial action plan is to be developed for the safe demolition and removal of any contaminated waste.
PAEC02	Further investigation of the material associated with the pump sheds indicated that only the housing was left onsite. No evidence of potential hazardous causing materials could be seen to initiate further investigation.	Housing was removed from site. No further investigation required
PAEC03	The 3 piles of fill contained brick, timber and other anthropogenic materials. The timber was untreated and contained no lead paint. There was no evidence of fibre cement sheeting and the fill was able to be scrapped down to virgin land with no evidence of hazardous materials that would cause harm to human health or the environment	Fill was removed from site. No further investigation required

PAEC04	The carcasses were disposed of in a pit.	No further investigation required.
PAEC05	Similarly to PAEC03, the fill contained concrete blocks, tyres and some plastic. As the fill was dug into and scrapped, there was no evidence of any hazardous materials that would cause harm to human health or the environment. The concrete blocks and tyres have been used as erosion inhibitors.	Fill was removed from site. No further investigation required.
PAEC06	The sheds are to remain and will be demolished at the same time as the house and garage.	Sampling of this area to be conducted prior to demolition and will be included in the remediation action plan with PAEC01
PAEC07	The old fuel tank on the neighbouring property has a berm around the tank to direct any runoff from the tank to remain on the property and not seep into the Property 407.	No further investigation required.

By reviewing the Preliminary Site Investigation (PSI) report, Sampling and Analysis Quality Plan (SAQP), findings from site visit and information provided by the owner and developers, the extent of potential contamination on this site has been reduced to 2 locations:

- PAEC01 – House and garage
- PAEC06 – sheds

A remediation action plan is to be written up and accompany this document in order to define the testing required of these areas and how to manage the site during demolition and removal of contaminated waste.
