Brou Landfill Post Bushfire Expansion

Geotechnical Investigation Report

Public Works | Department of Regional NSW

Reference: 754-CBRGE301356-R01

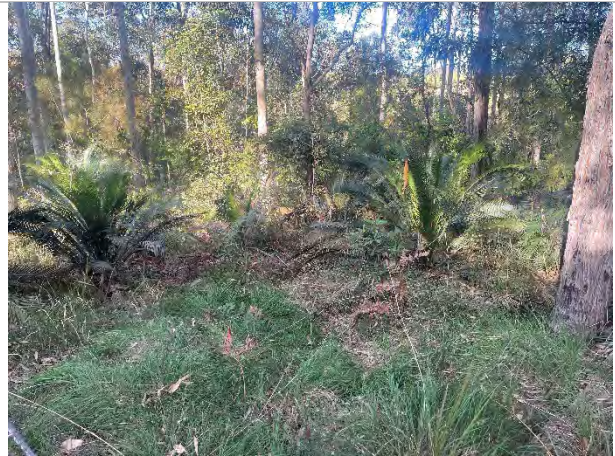
Photo 2: View of the Phase 1 development area with dense vegetation near BH03.

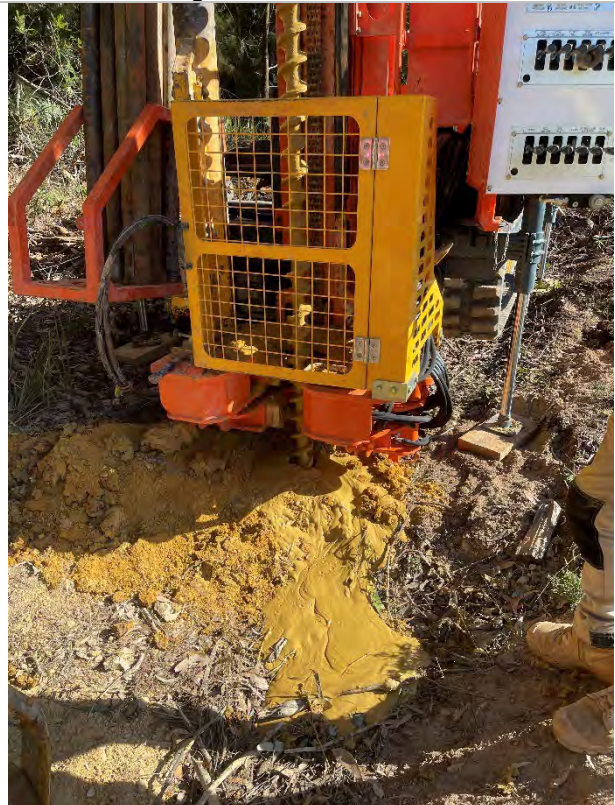
Photo 4: Groundwater encountered in the Phase 1 development area at BH12.

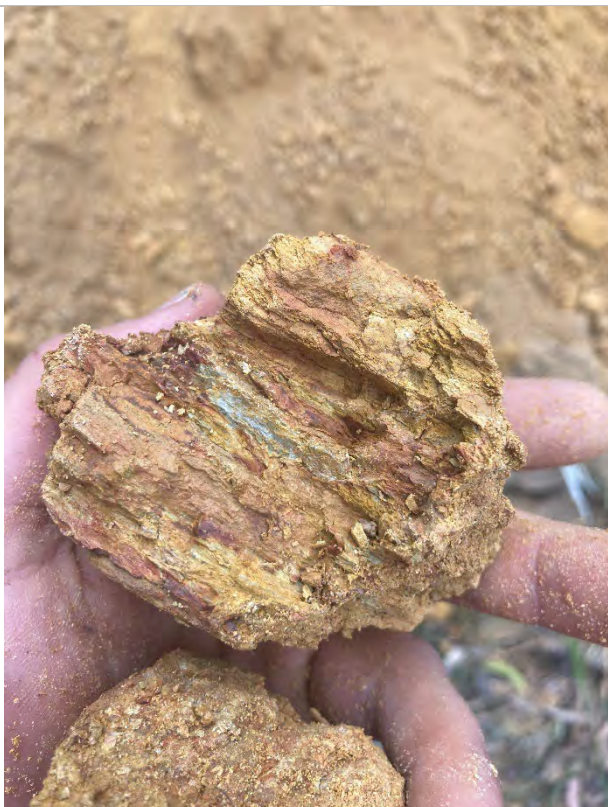
Photo 9: Extremely weathered siltstone recovered from test pit TP02.

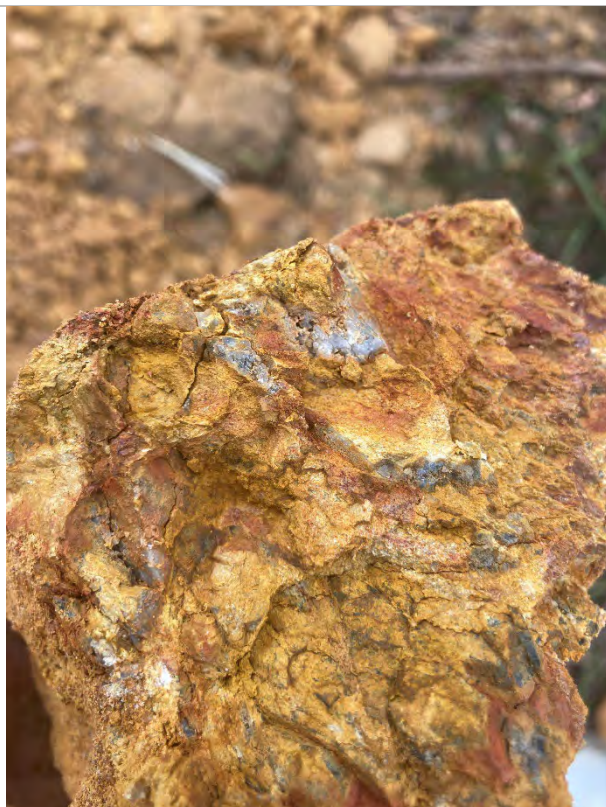
Photo 10: Extremely weathered sandstone recovered from test pit TP06.

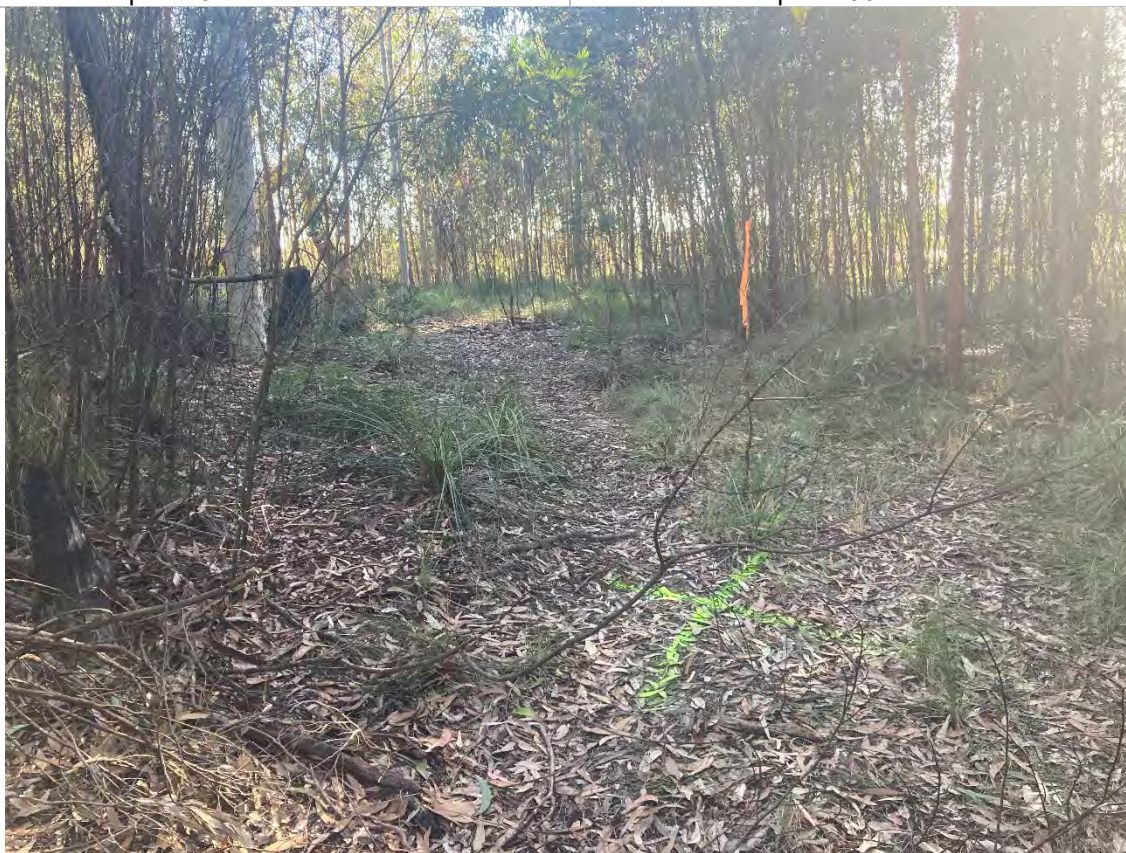
Photo 11: View of dense vegetation, test pit TP07 and access trail in the Phase 2 development area.
