## Preliminary Tree Assessment Report

**Site address:** 921 Punchbowl Rd  
Punchbowl NSW 2221

**Prepared on:** 22<sup>nd</sup> September 2023

**Report number:** CD2516

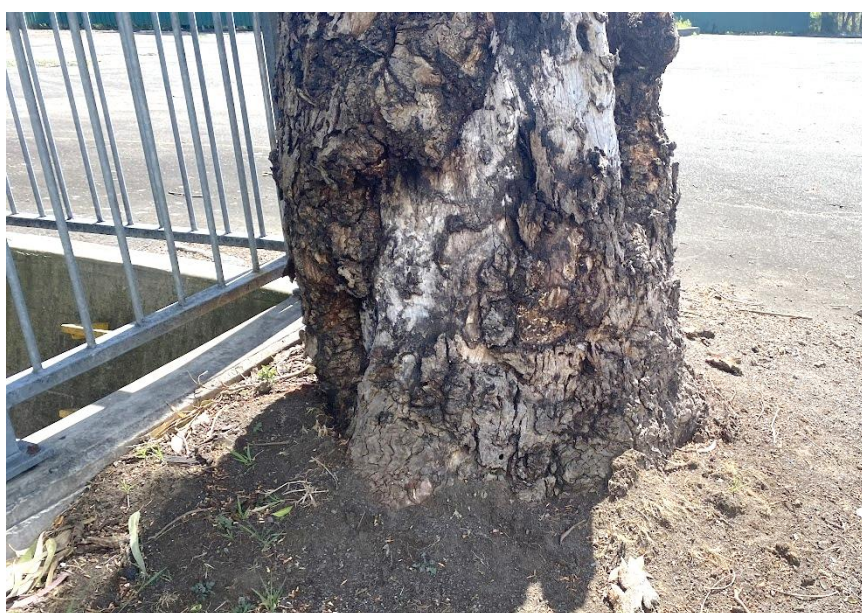
This is a tree about sixty years old and is growing in a small opening surrounded by bitumen. It is less than 20 cm from a concrete drainage culvert. It has a basal wound on the southern side covering about 25-35 per cent of the circumference and a second large stem wound about a metre above ground on the southern side.

Image 3: The stem on Tree 1 has a basal wound and is very close to the culvert

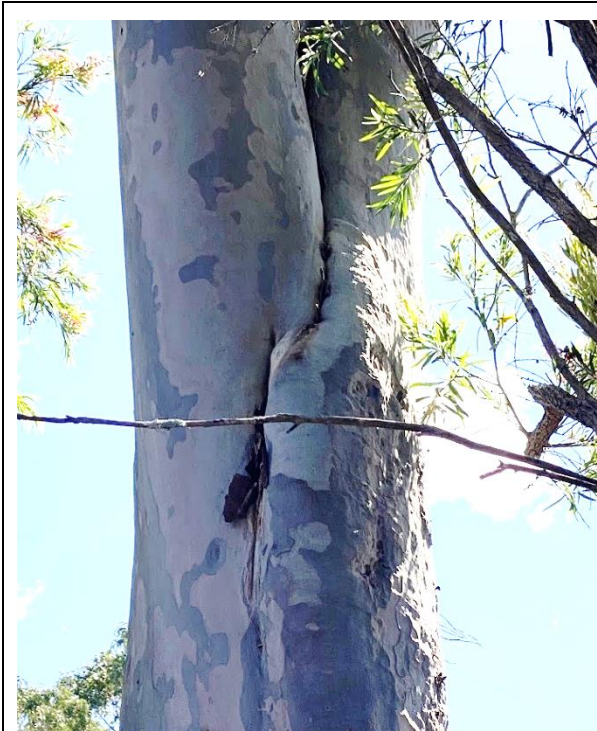
This tree is around 40 years old. It is in a narrow landscape planting. The tree bifurcates into two stems at about 3 metres above ground and has large amounts of included bark above this point. In response, the southern stem has started to engulf the northern stem with woundwood.

**Image 4:** The southern side of the inclusion on Tree 2

The structural issues with both Tree 2 and Tree 5 suggest that their retention may not be the best option, particularly considering the young age of these trees. A better option would be to replace these trees with sufficient new trees to compensate for the canopy loss within a decade or two.

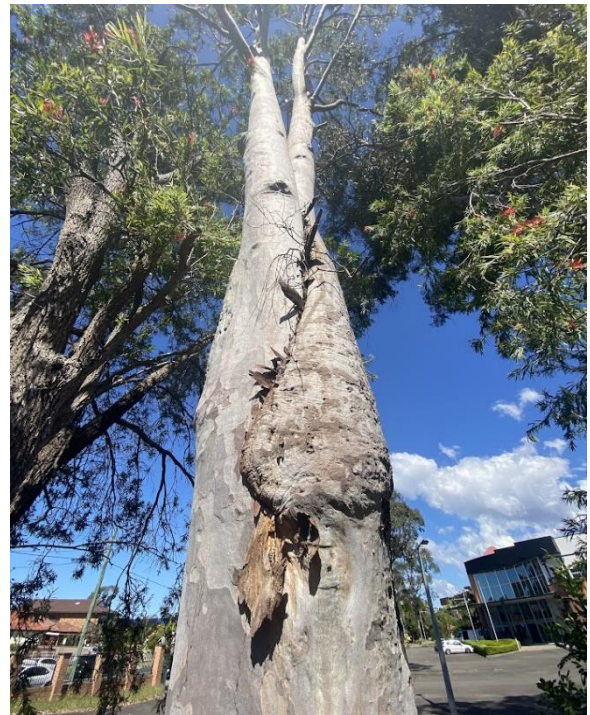
**Image 5:** The north side of the inclusion on Tree 2

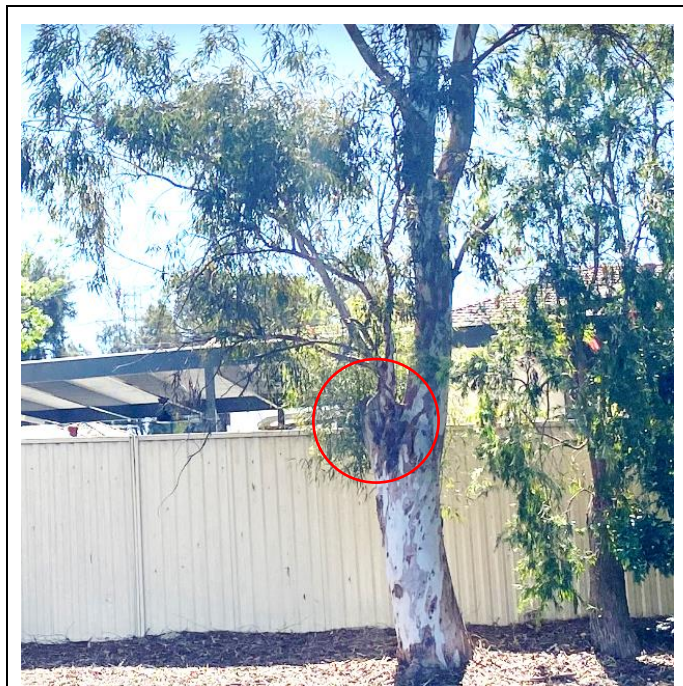
This is a tree that is under forty years old. It is growing in a narrow landscape garden near the boundary, and its canopy is suppressed by the spotted gum growing on either side. In the last year or so, the tree has had a codominant stem removed, which removed around half the canopy. There appears to be an old failure point in the same area as the pruning cut.

The tree had low levels of active Winter Bronzing Bug (*Thaumastocoris peregrinus*).

**Image 6:** The location of the stem removal on Tree 3

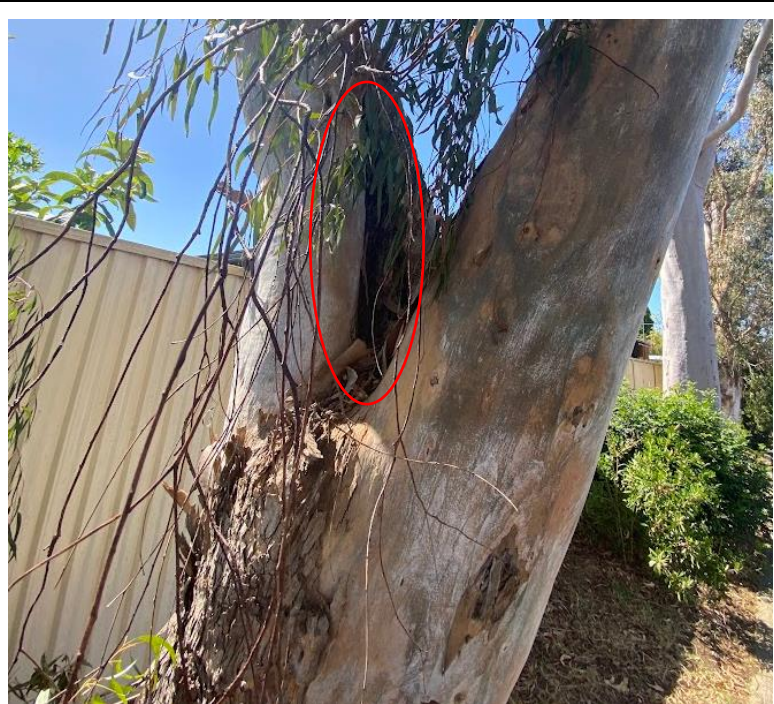
This tree is less than 40 years old and is growing in the same landscape garden bed. The tree is codominant at about 1.6 metres from the ground. Included bark is present. The side unions of the two stems were nicely rounded. The northern stem has a large wound just above the fork on the southern side of the stem. There was evidence of recent pruning, including poor cuts and the use of climbing spikes.

There were low levels of active Winter Bronzing Bugs (*Thaumastocoris peregrinus*).

**Image 7:** Location of the stem wound on Tree 3

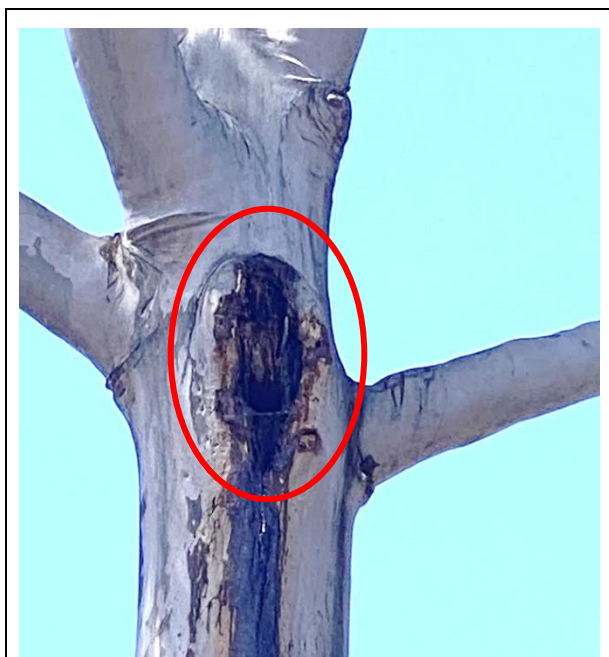
This tree is at the southern end of the property and is growing in a landscape mound. It is less than a metre from the boundary fence, and the boundary fence has cracked and rotated towards the public path. The tree has had at least one and possibly two limbs fail.

**Image 8:** A branch failure on Tree 6 at about 10 metres

While the retention of Tree 6 seems possible, several issues need to be weighed. The first is the need to interface any new works with the mound. The second issue is the need to repair the boundary fence without causing significant damage to the roots less than 50 cm from the base of the tree.
