## Contaminated Land Preliminary Site Investigation

### **Proposed rezoning of 70 Manifold Rd, North Casino (Lot 21 DP601461)**

REPORT NO: 2310-04.CL Rev 3

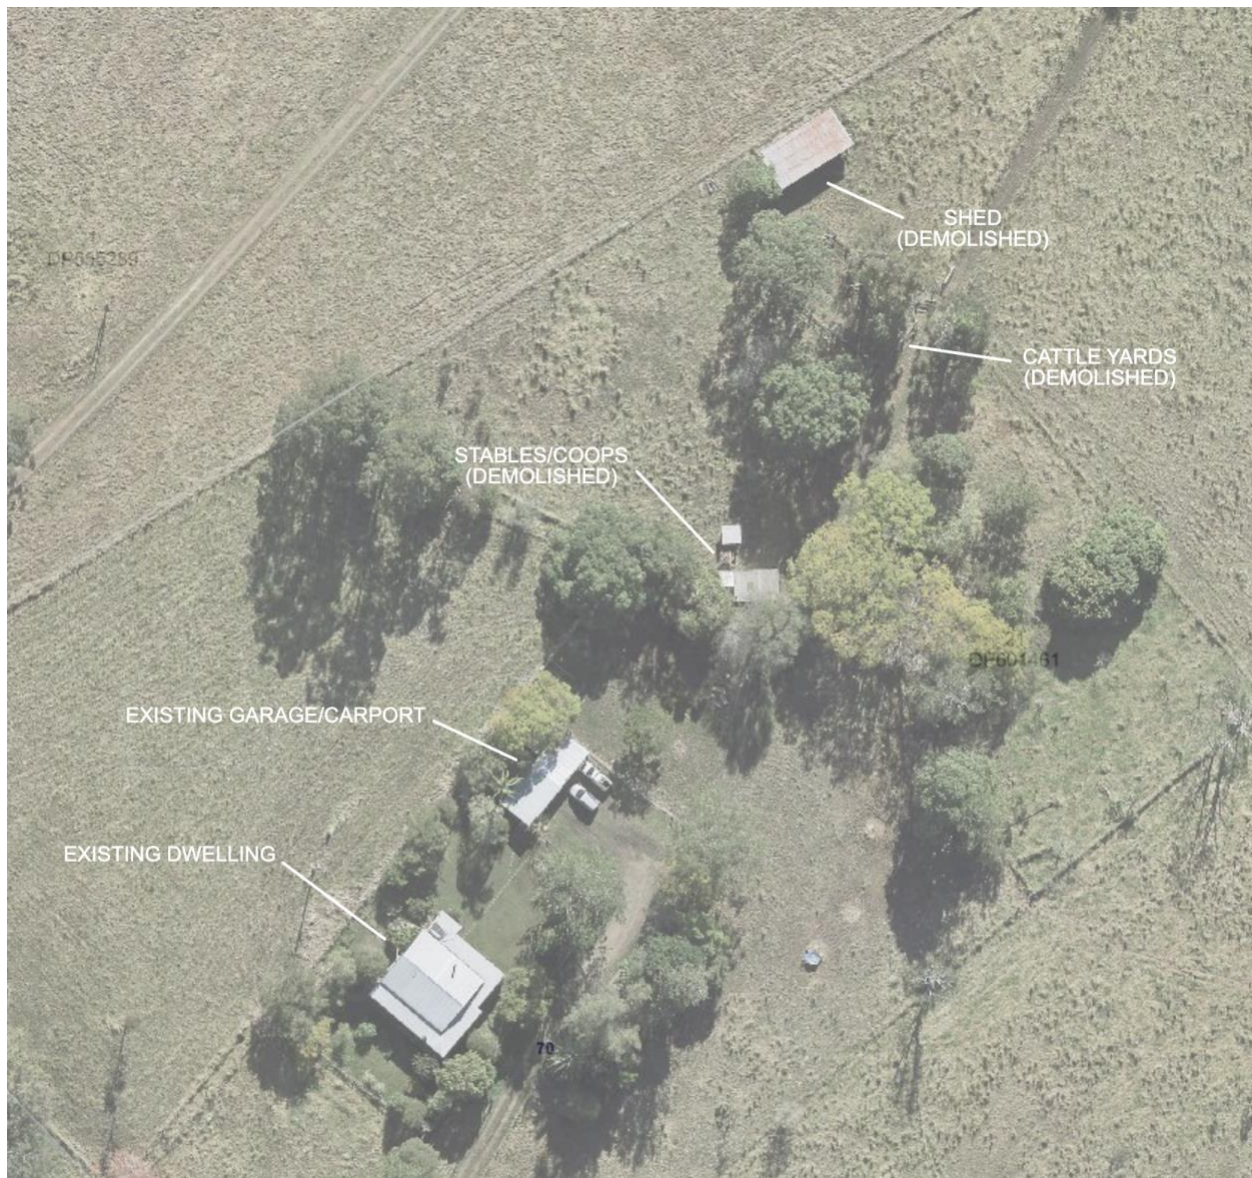
Figure 2 – Plan of existing and recently demolished buildings (source: RVC Intramaps)

An existing dwelling and garage/carport were identified on the southern end of the subject property access from Manifold Rd as shown in Figure 2 below.

The dwelling is of timber construction with metal roofing and is likely to have been constructed between 1920-1950. The garage/carport was constructed in the 1970s with timber frame and metal sheet cladding.

Other structures including a shed, cattle yards and stables/chicken coops previously located north of the dwelling had recently been demolished. These structures appear to have been constructed in the 1960s and 1970s. Traces of demolished materials including bricks, concrete, timber, steel wire and electrical conduits were identified on the subject property.

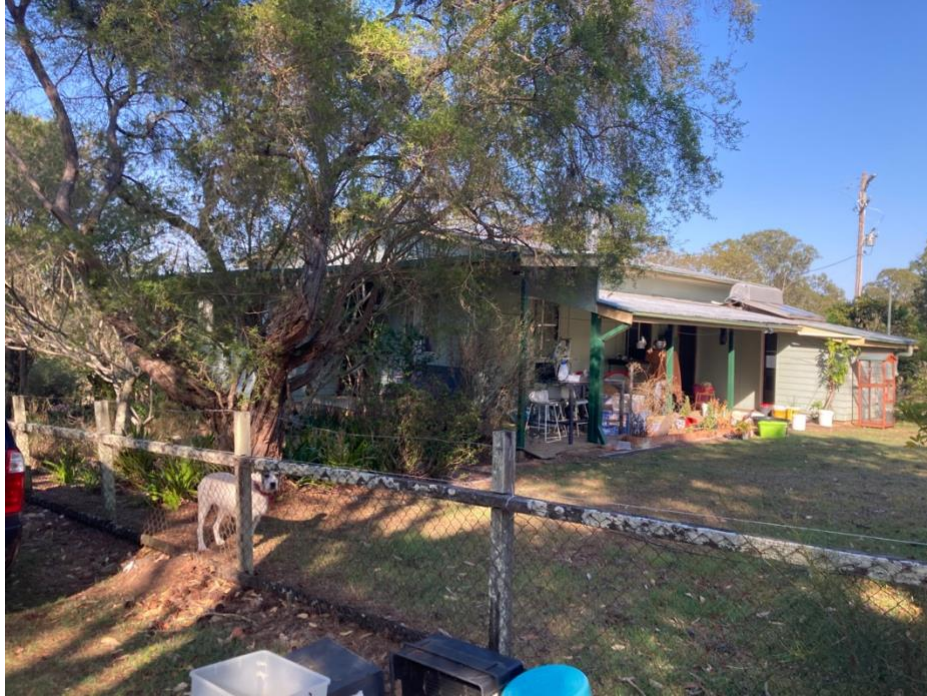
Existing dwelling

| <b>Condition of buildings and roads</b> | The dwelling, garage/carport and driveway were in good condition and well maintained. Paint coatings were in good condition. |

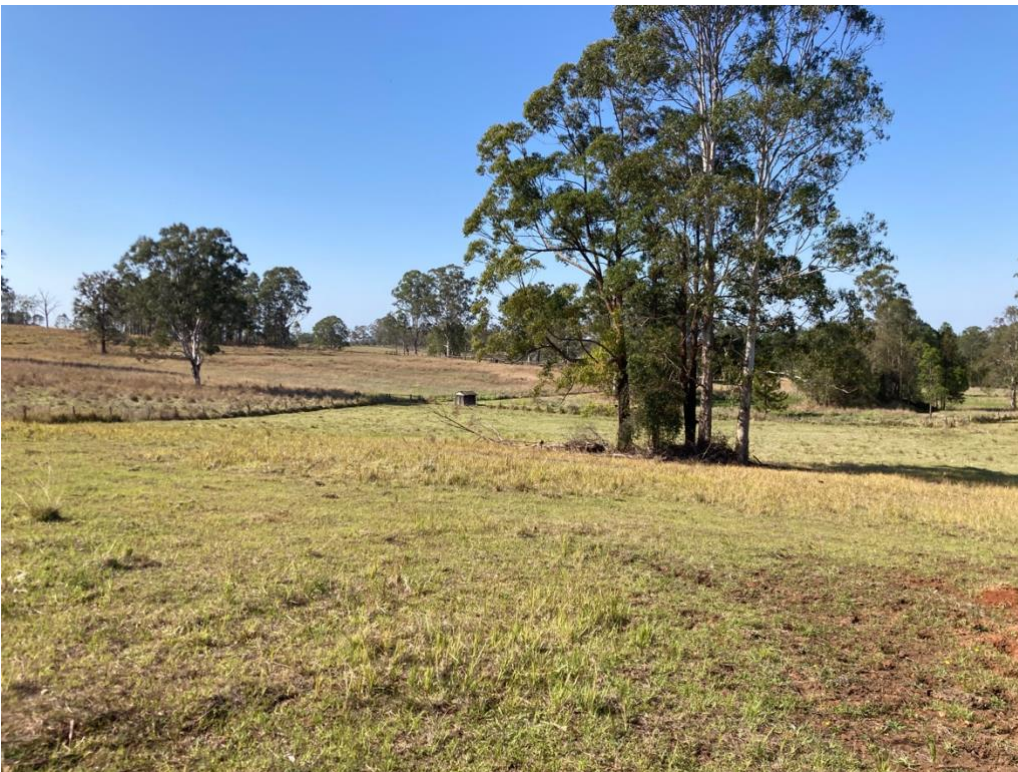
| <b>Quality of surface water</b> | Water in farm dams adjoining subject property was observed be good quality with no signs of contamination. |

Subject property – looking east towards gully/dam

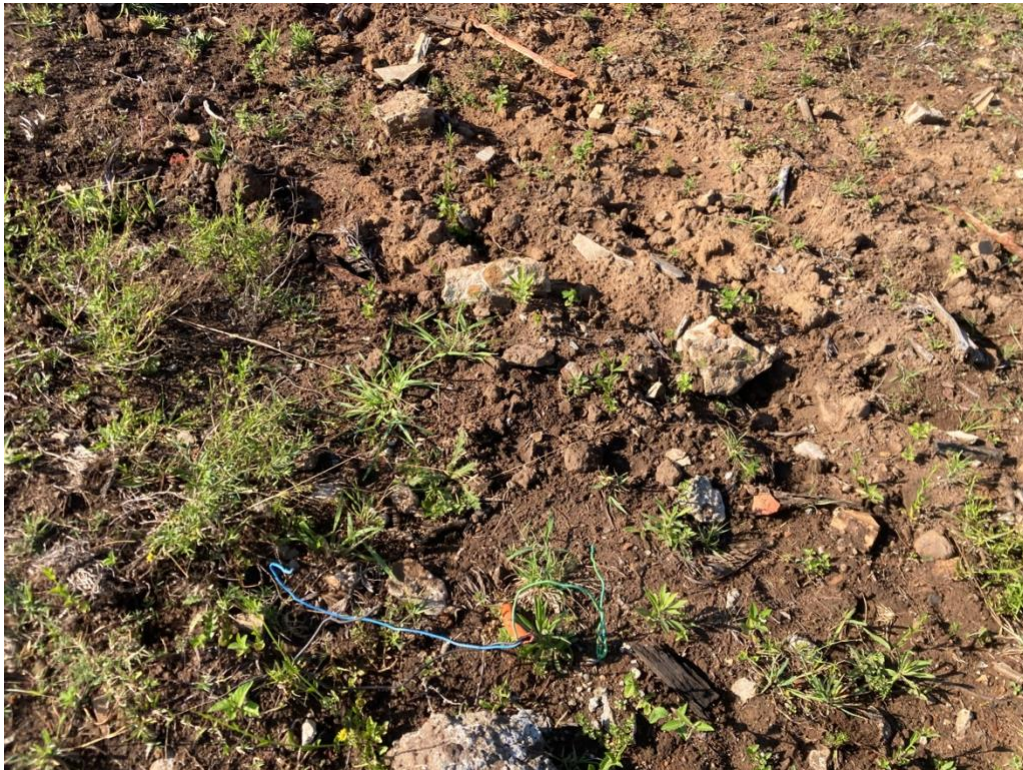
| Site Feature | Description |
|---|---|
| <b>Presence of drums, wastes and fill material</b> | General waste associated with the recent demolition of sheds, stables/coop and cattle yards was observed on the subject property. The wastes included brick and concrete rubbles, timber, steel wire, poly pipe and electrical conduit. The waste was thoroughly inspected and there |

| | were no visual signs of any asbestos containing material. |

Minor rubble from demolition of structures

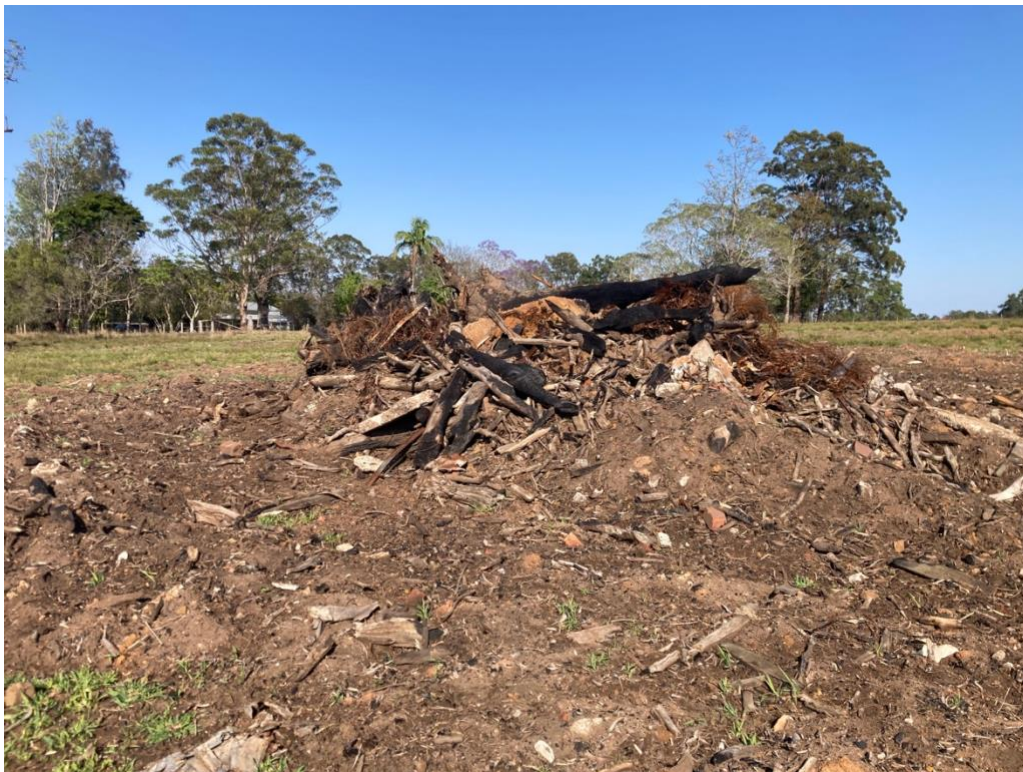
Burn pile of materials from recent demolition of structures
