Arborist Report

Project **1380 Pacific Highway
Turramurra NSW 2074**
Ref: 2023-1089
Job: 67154

Client **Rebel Property Group**
1380 Pacific Highway
Turramurra NSW 2074

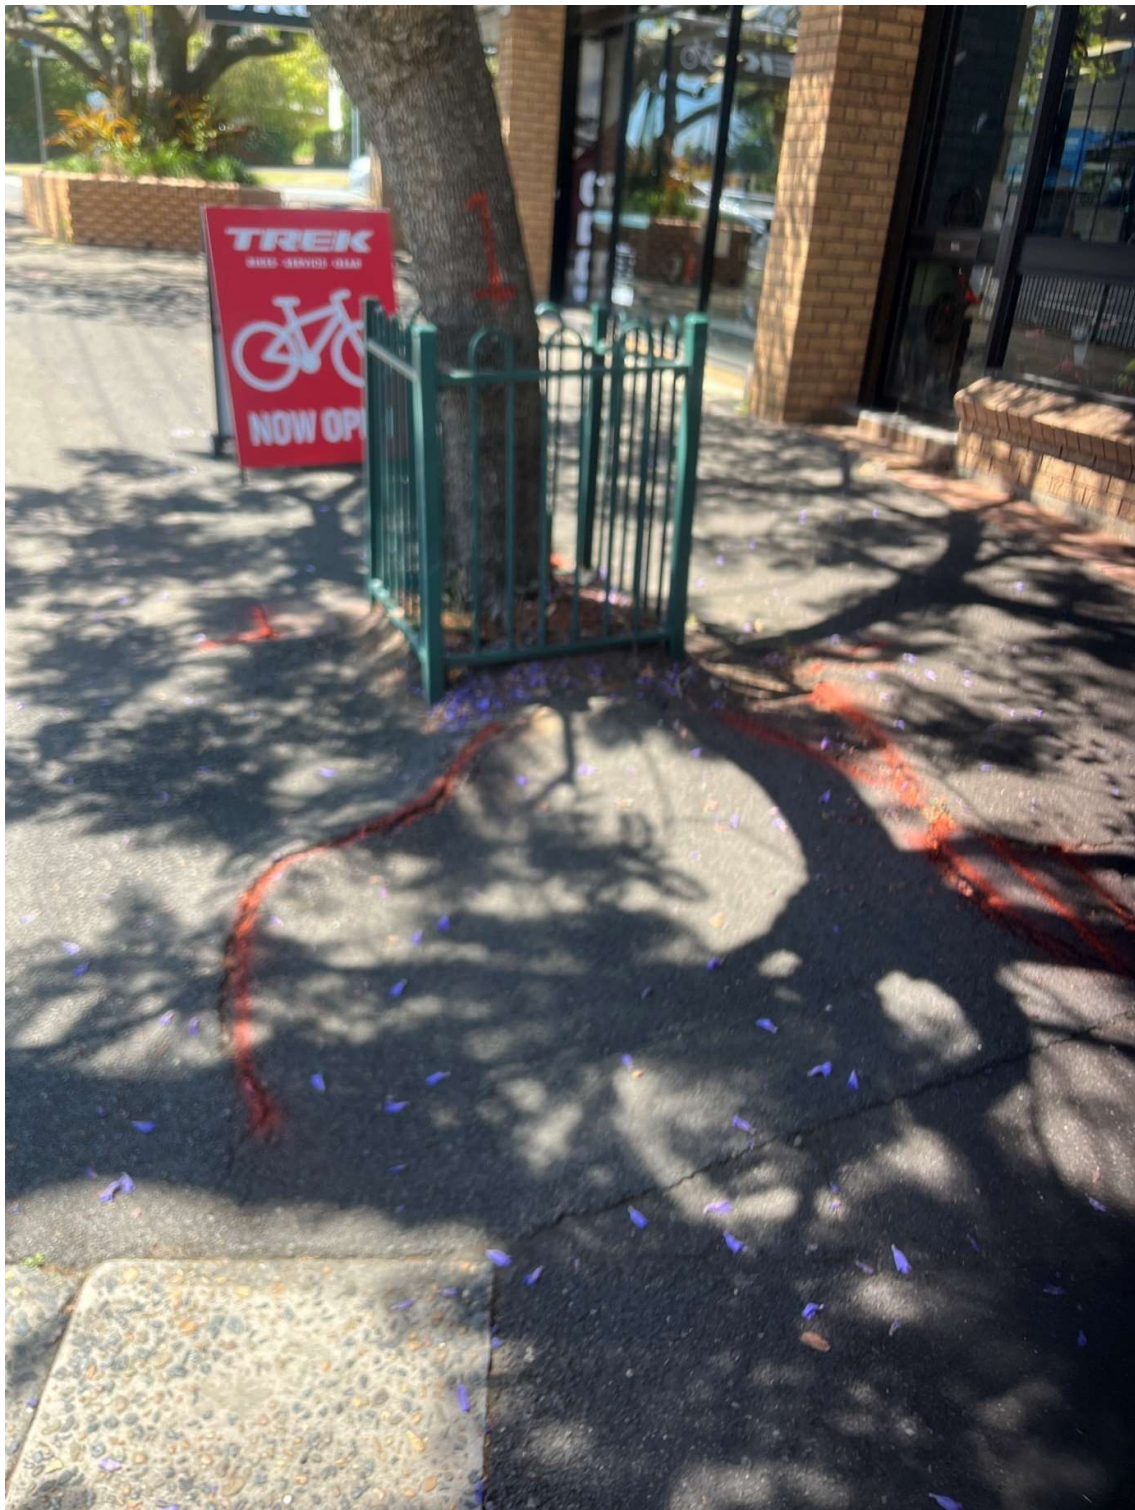
PHOTO 2 (B) Date – 23/10/2023

Tree 1 – Jacaranda mimosifolia - Lifted pathways due to root impact.

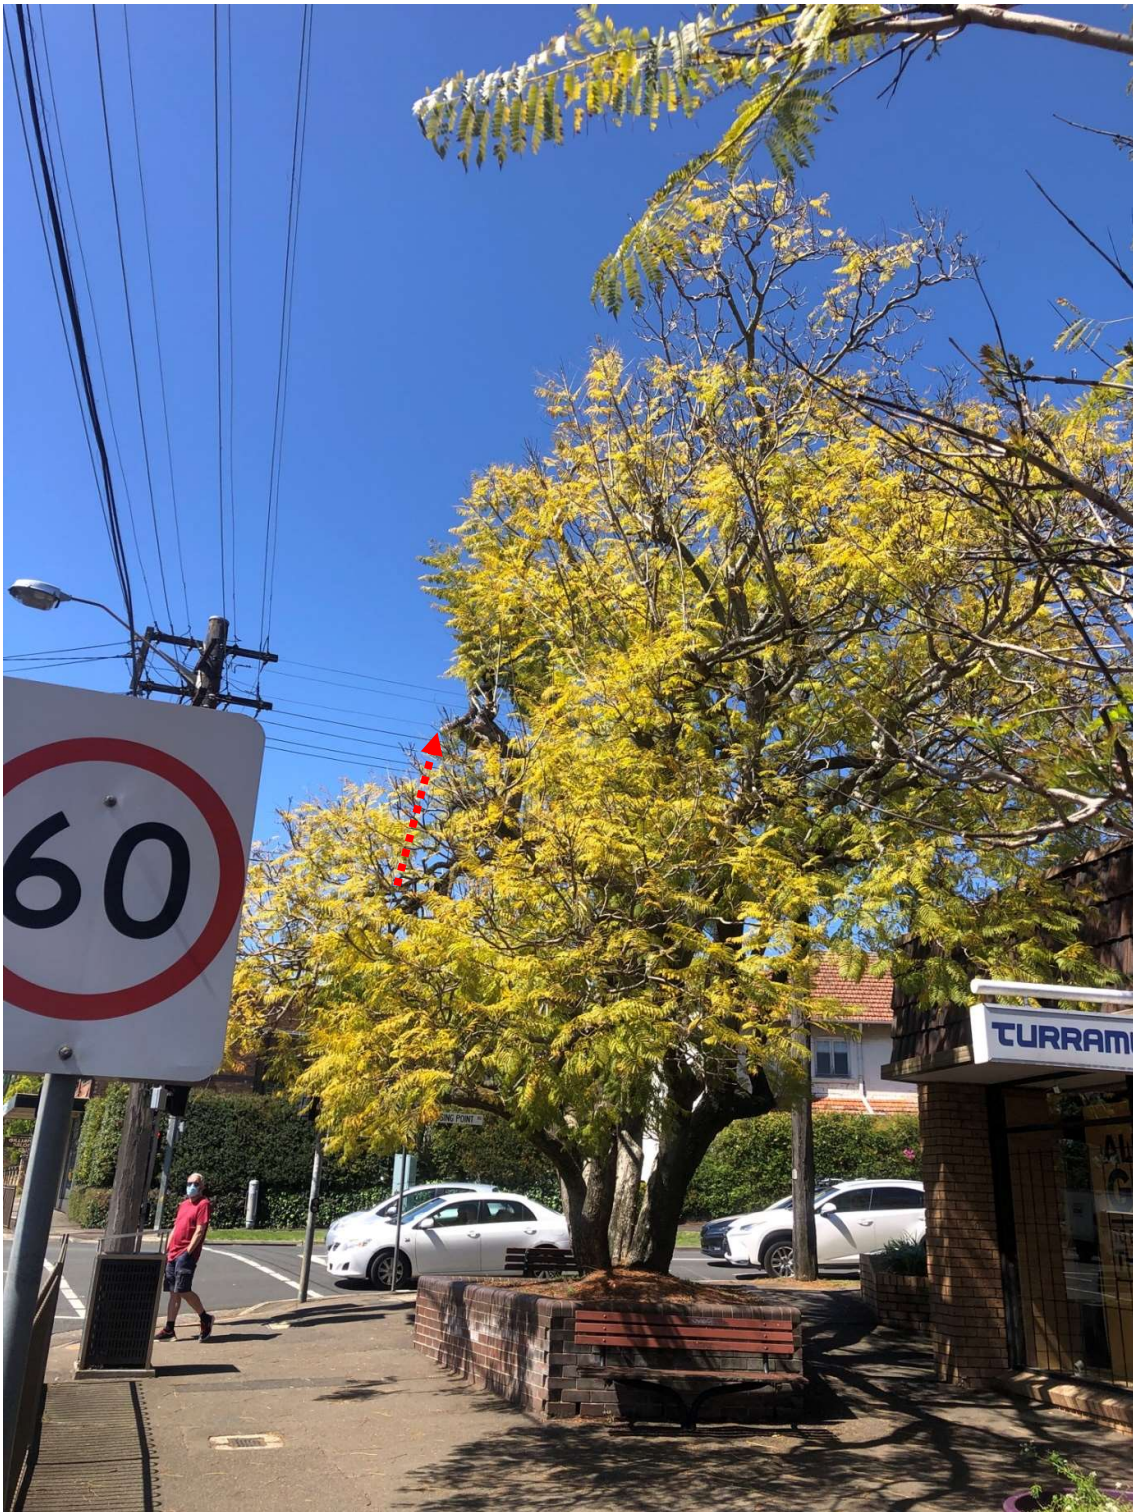
PHOTO 3 (A)

- 4.3 Tree 2 - *Jacaranda mimosifolia*- is a multiple trunk specimen growing in the raised garden bed where the base of trunks has been buried. The tree has a height of 8 metres with a canopy spread of 8 metres and is mature in age. It has a health rating of 5 out of 5 and a structure rating of 4 out of 5. The tree has a dominant crown class with 70% canopy cove. This canopy is misshapen due to powerline clearance. The tree has a TPZ of 4.8 metres.

Tree 2 – Jacaranda mimosifolia - canopy is modified for high-voltage power lines. Notation no trunk flair at base of the tree tree more than likely has been buried.

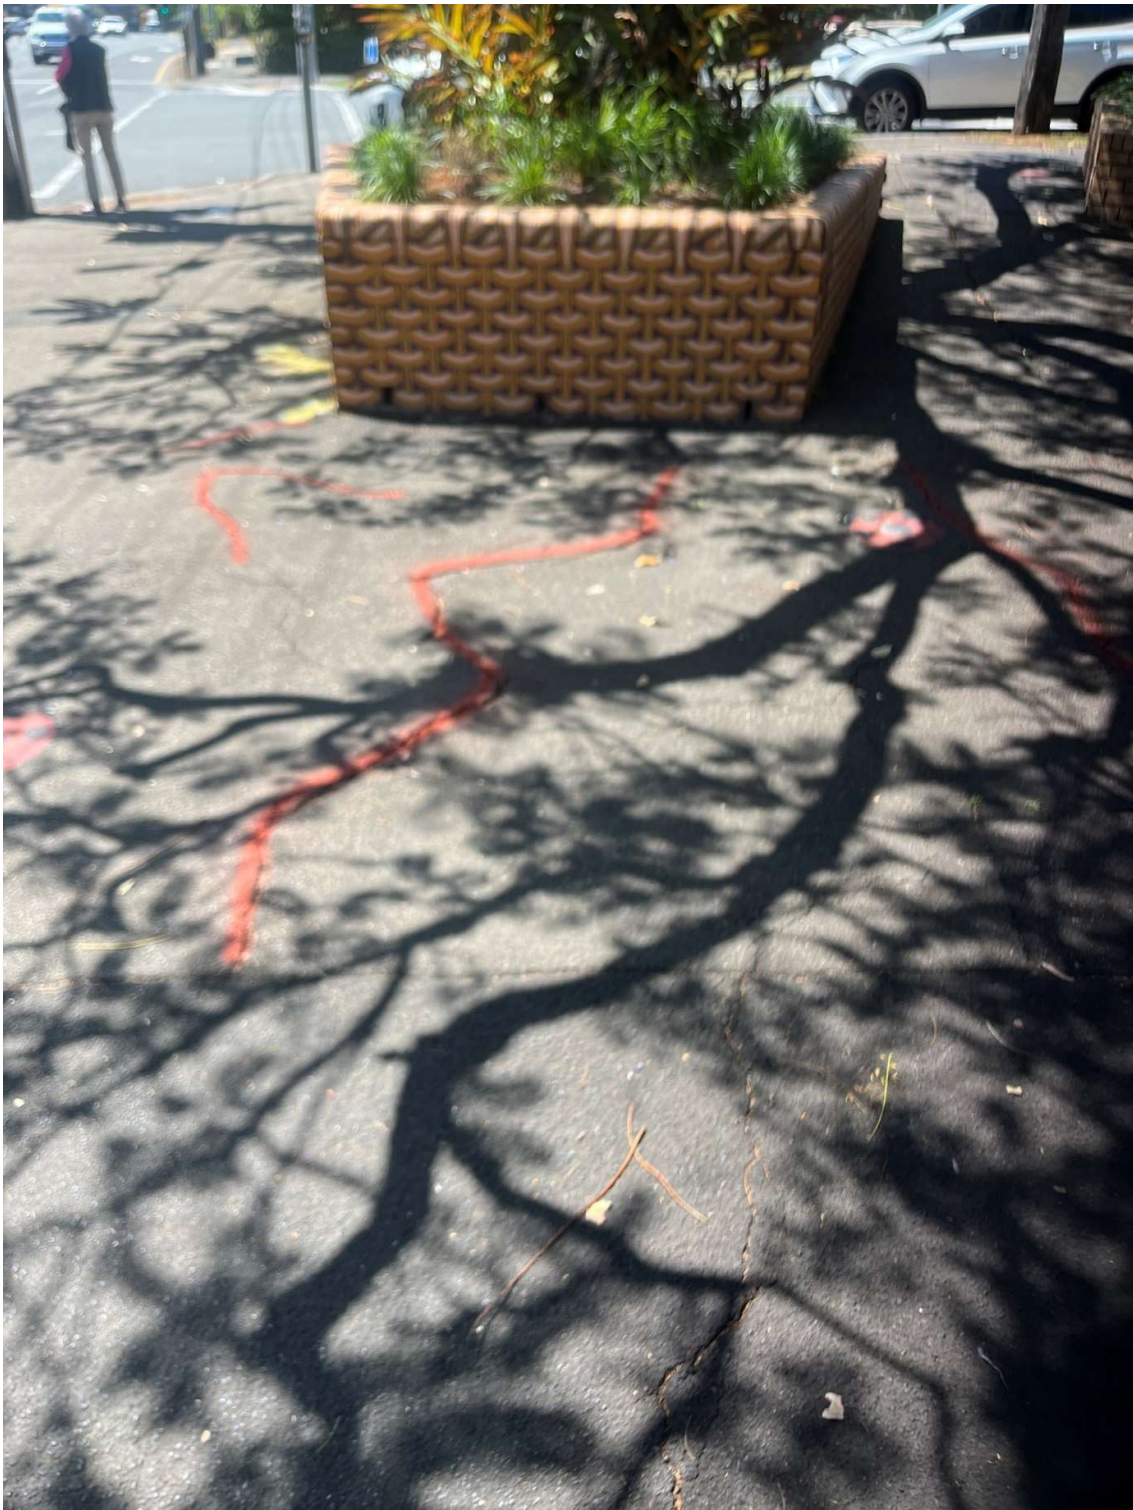
PHOTO 5 (C) Date – 23/10/2023

Tree 2 – Jacaranda mimosifolia - root impact to pathway

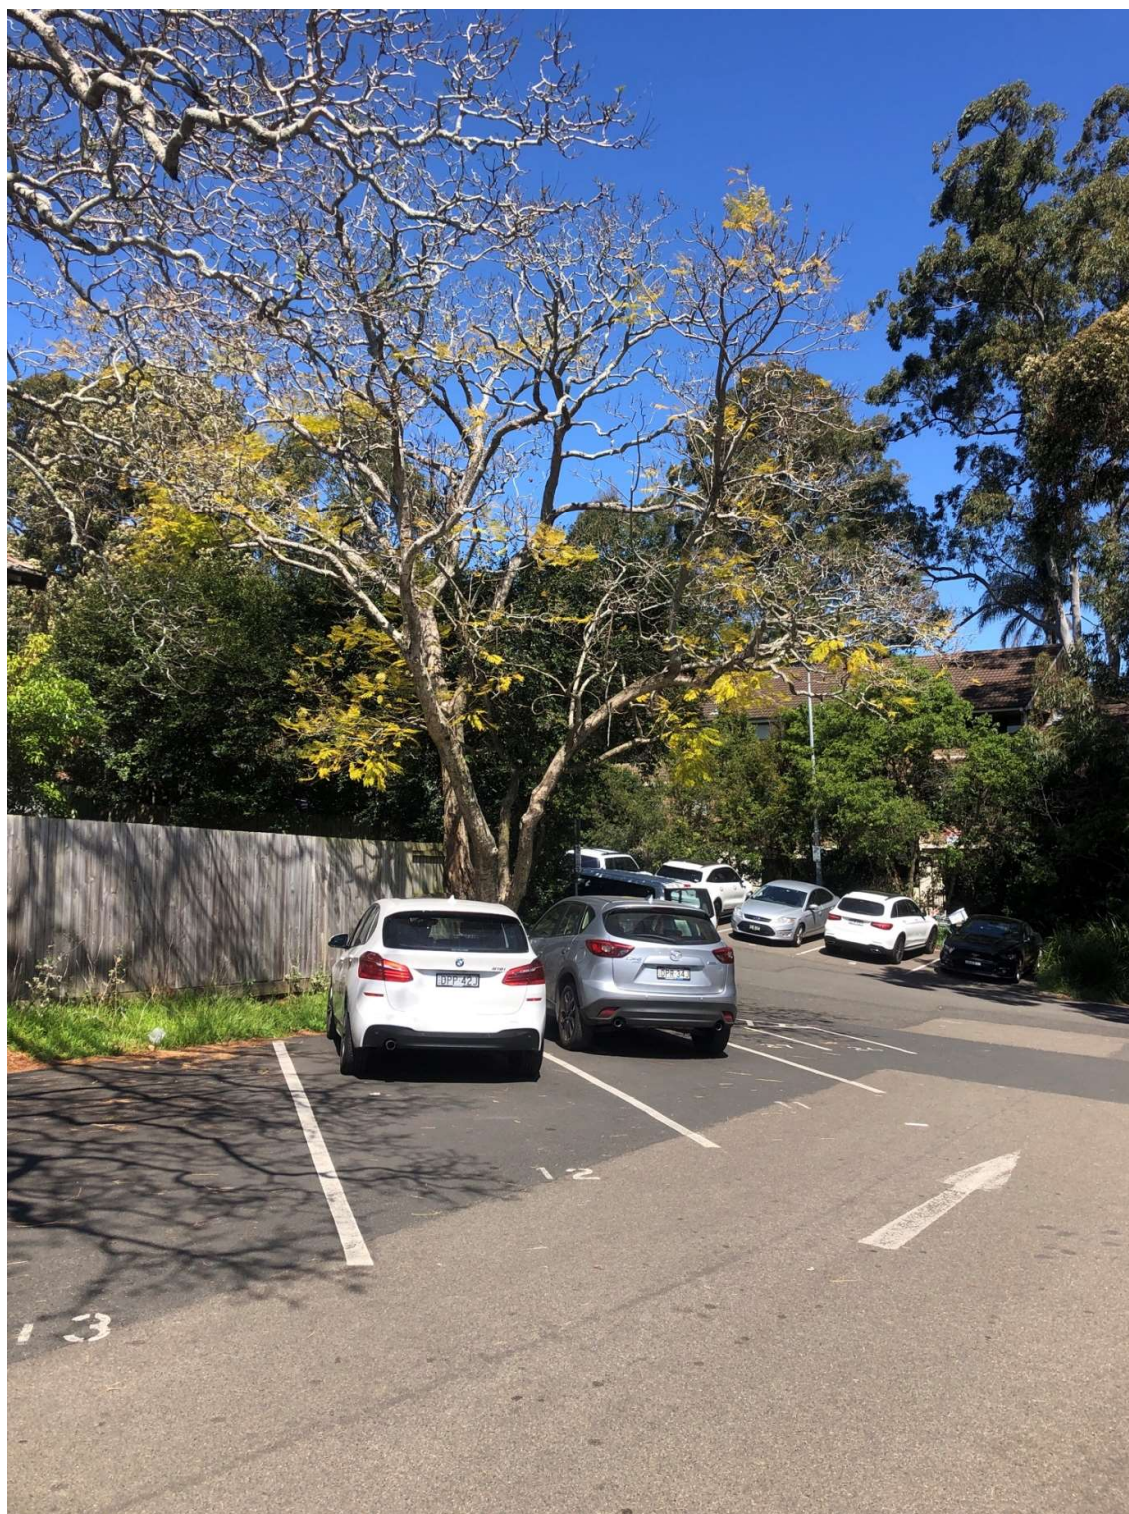
PHOTO 11 (A)

- 4.7 Tree 6 – *Jacaranda mimosifolia* – is a multiple trunk specimen with a height of 9 metres, width of 8 metres and has an age classification of overmature. The tree has a health rating of 4 out of 5 and a structure rating of 3 out of 5. It has a dominant crown class with 50% canopy cove. This tree has major cambium damage to all three trunks. This cambium damage would be impacting 60% of the trunk diameters.

Tree 6 – *Jacaranda mimosifolia* - Cambium damage on east and trunk.

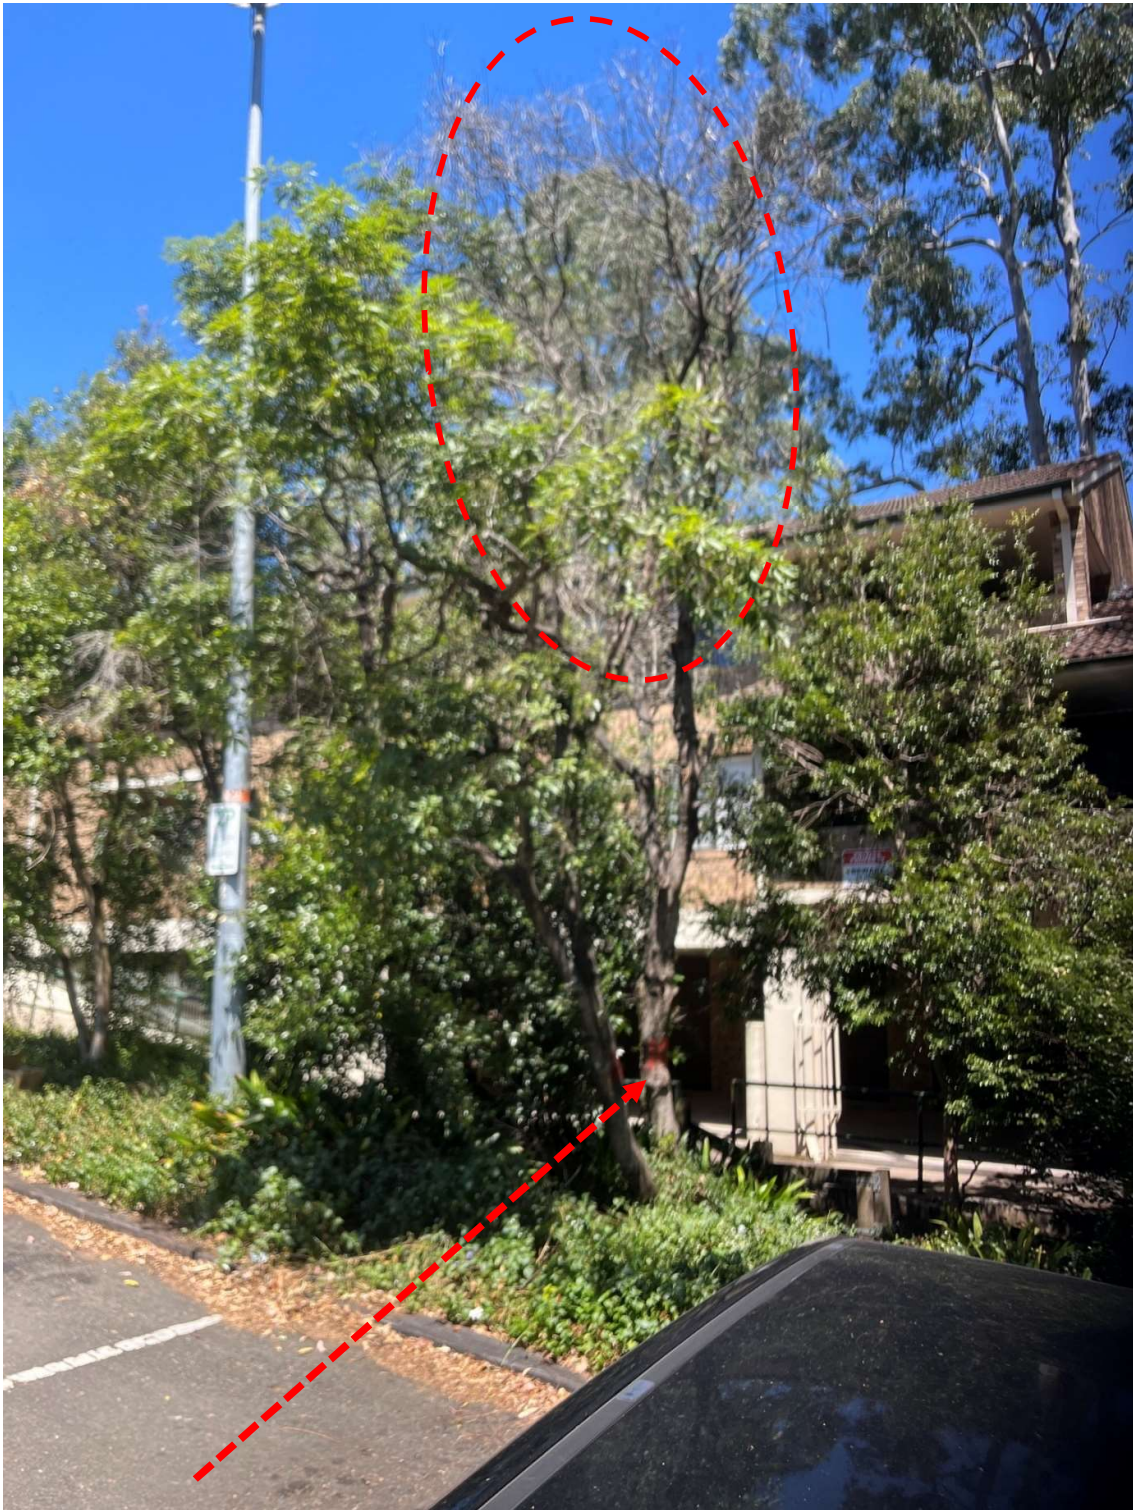
PHOTO 18 (A) Date – 23/10/2023

Tree 10 – Pittosporum undulatum - dieback in the upper canopy.

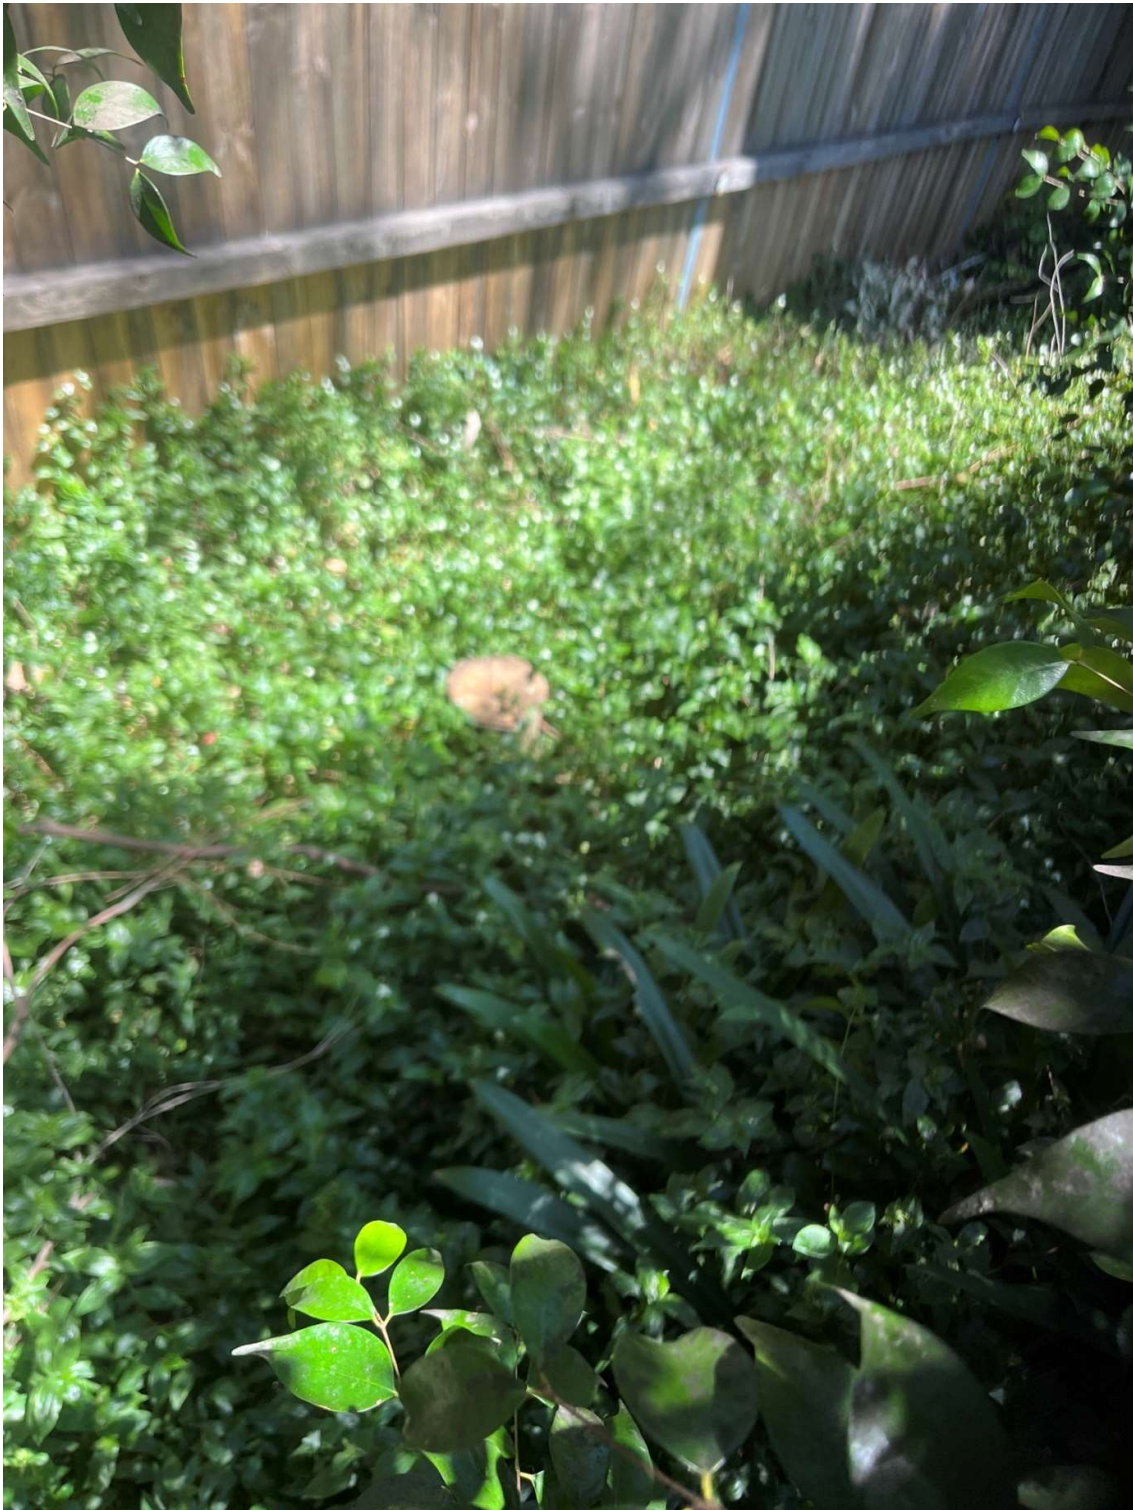
PHOTO 21 (B) Date – 23/10/2023

Tree 11 – *Pittosporum undulatum* - has been removed.

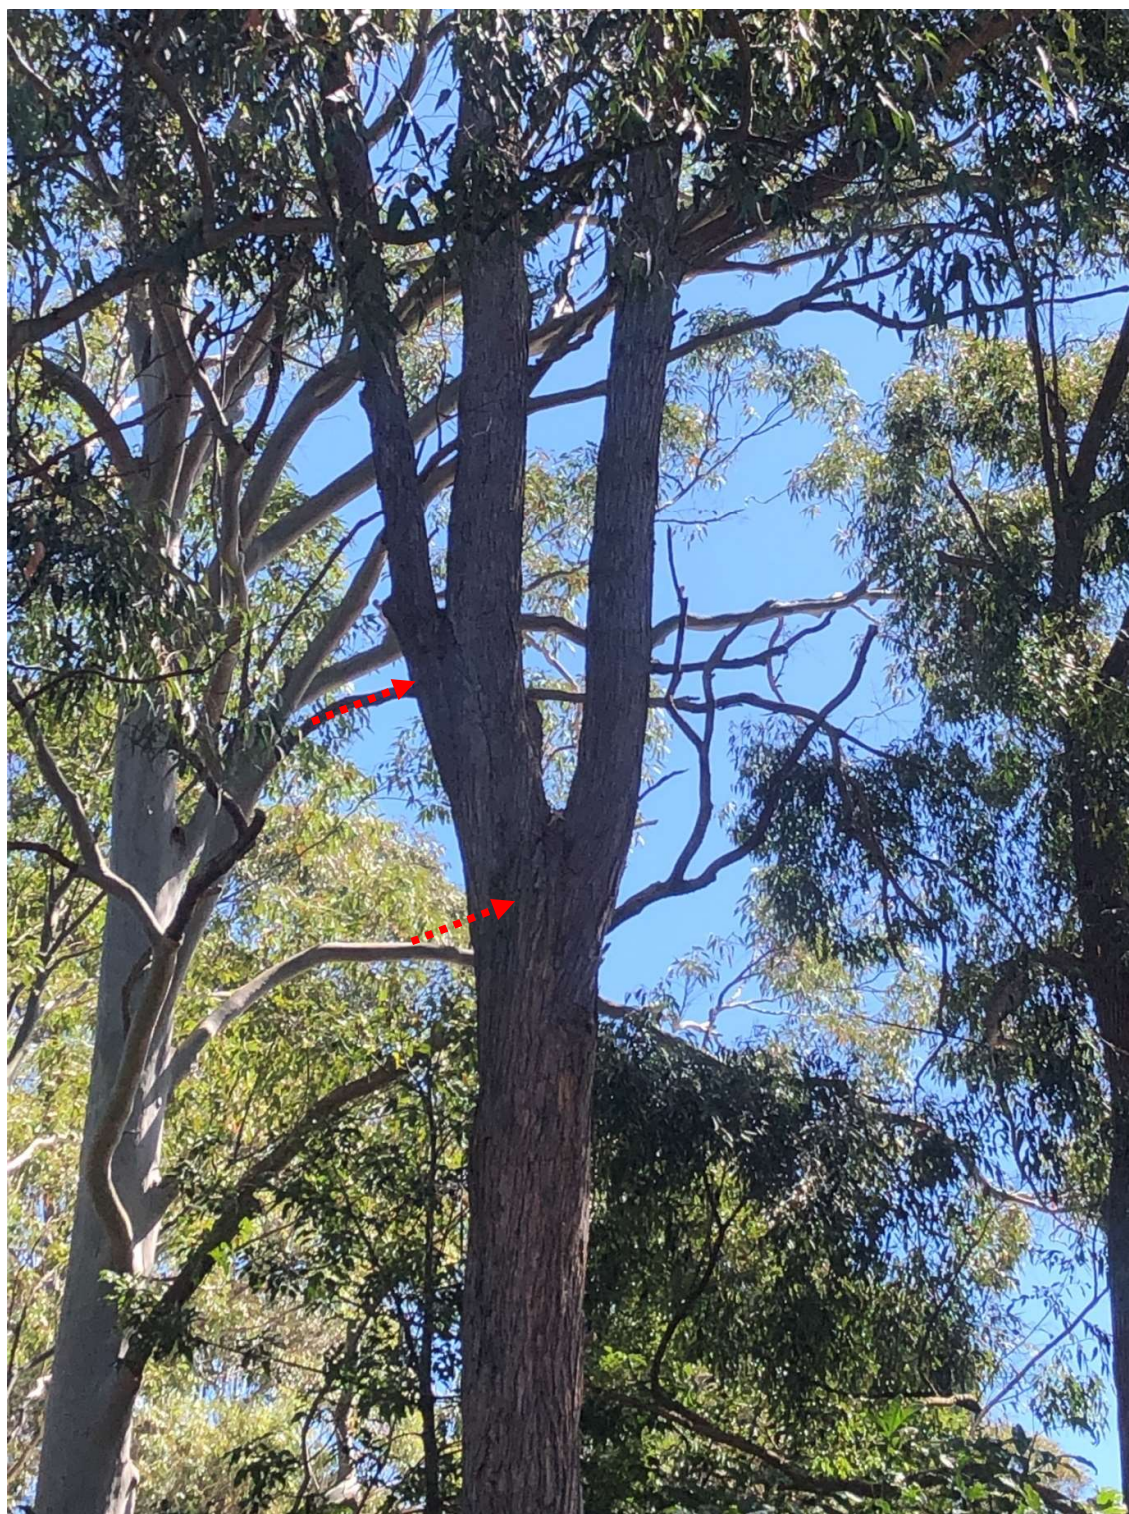
PHOTO 23 (A)

- 4.14 Tree 13 - *Eucalyptus microcorys* - has a height of 16 metres with a canopy spread of 8 metres and is mature in age. The has a health rating of 5 out of 5 and a structure rating of 3 out of 5. It is a dominant tree with 50% canopy cover. The trunk has inclusions at 6 metre mark and the 10-metre mark. It has a TPZ of 7.2 metres.

Tree 13 – *Eucalyptus microcorys*. Trunk inclusion at 6 metres.

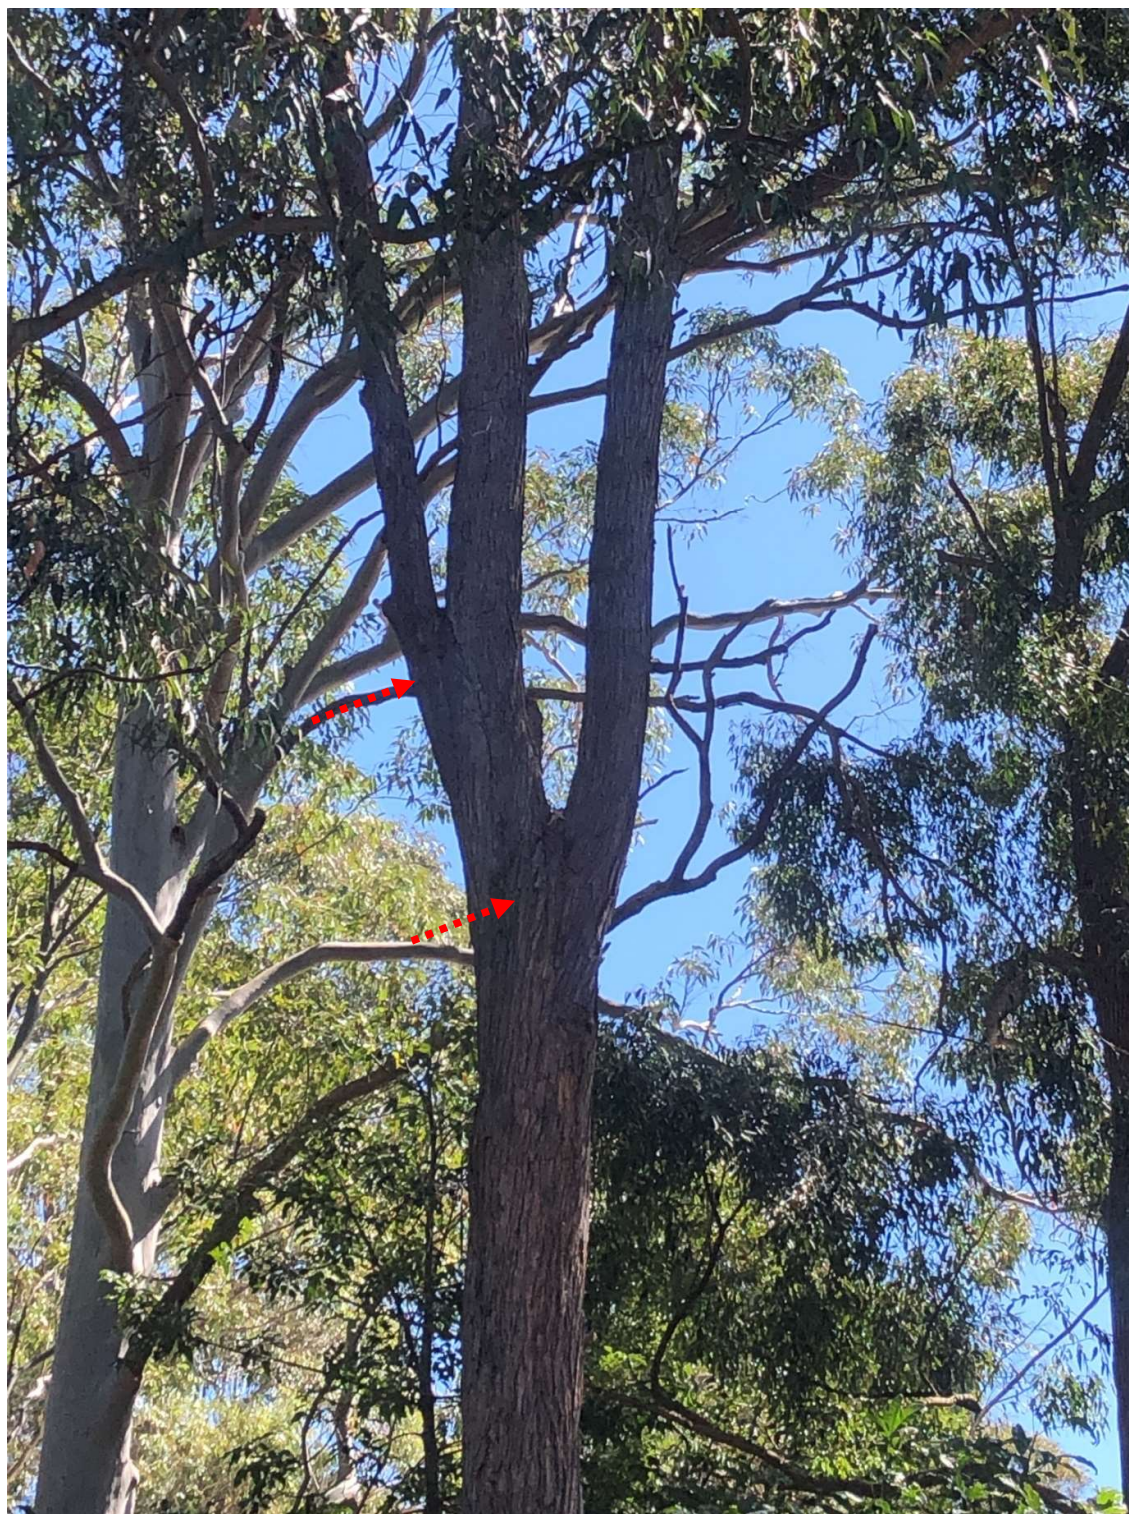
PHOTO 26 (D)

Tree 13 – *Eucalyptus microcorys* - Trunk inclusion at 6 metres.

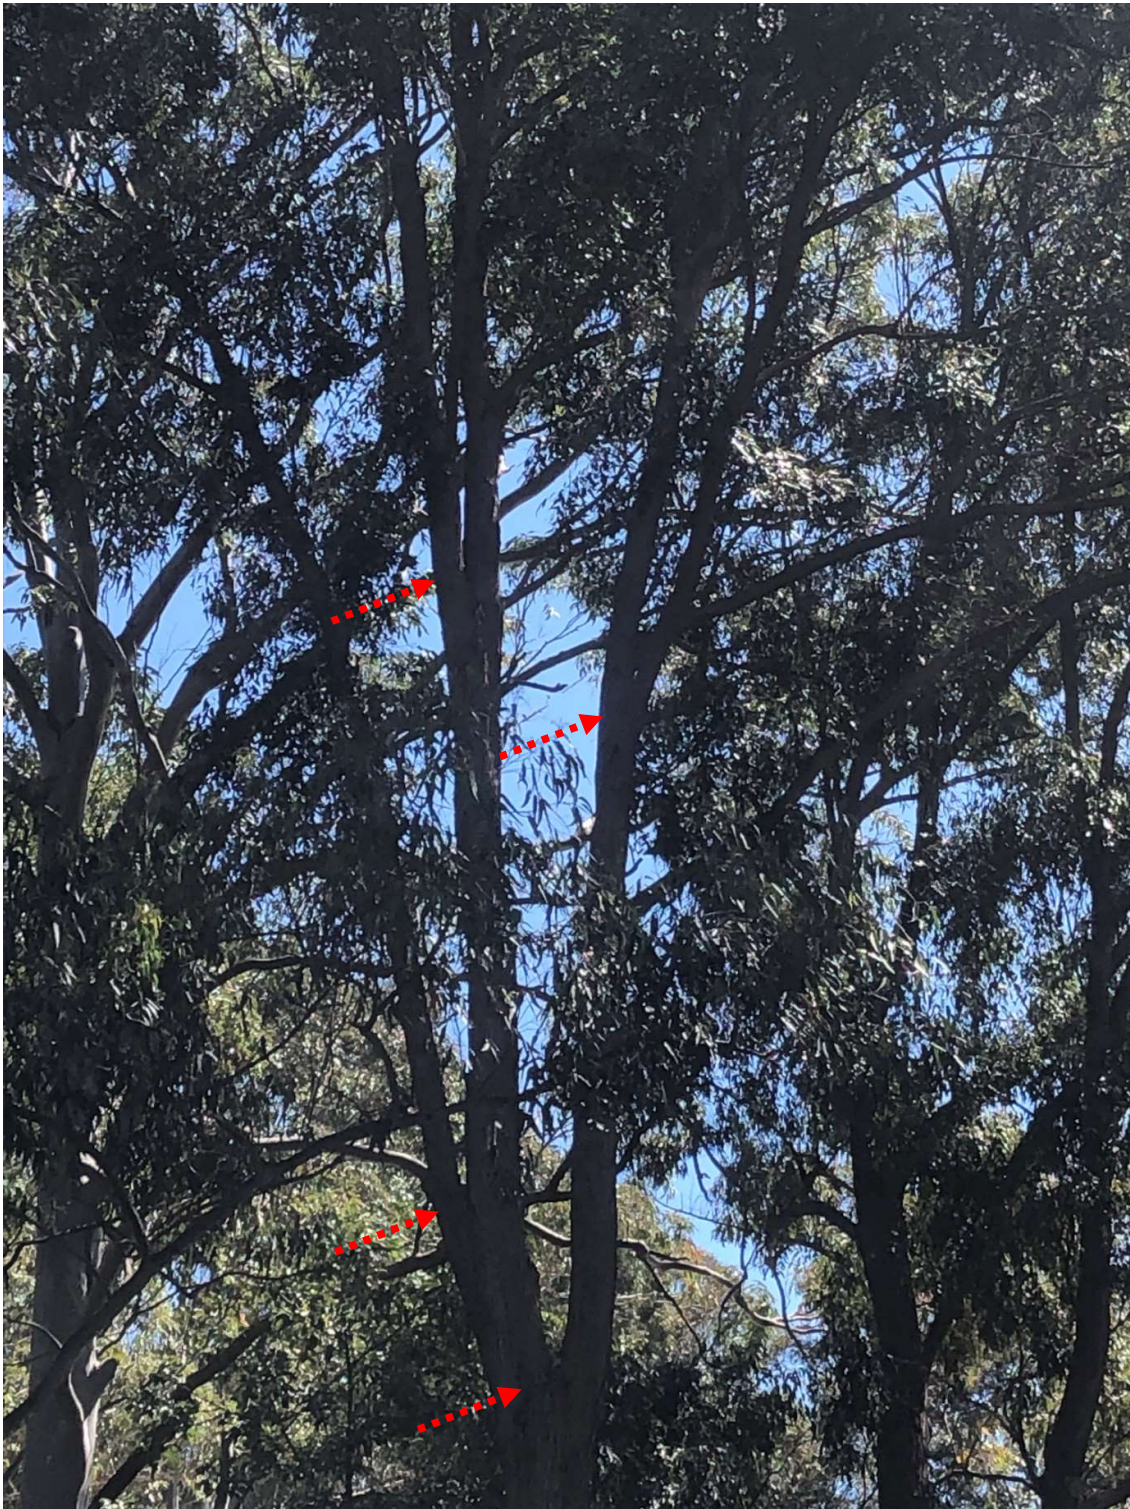
PHOTO 27 (E)

Tree 13 - Eucalyptus microcorys - trunk inclusions at 6 metres and 10 metres.
