# DR. TREEGOOD

## Arborist Report

*Project* **1380 Pacific Highway  
Turramurra NSW 2074**  
Ref: 2023-1089  
Job: 67154

*Client* **Rebel Property Group**  
1380 Pacific Highway  
Turramurra NSW 2074

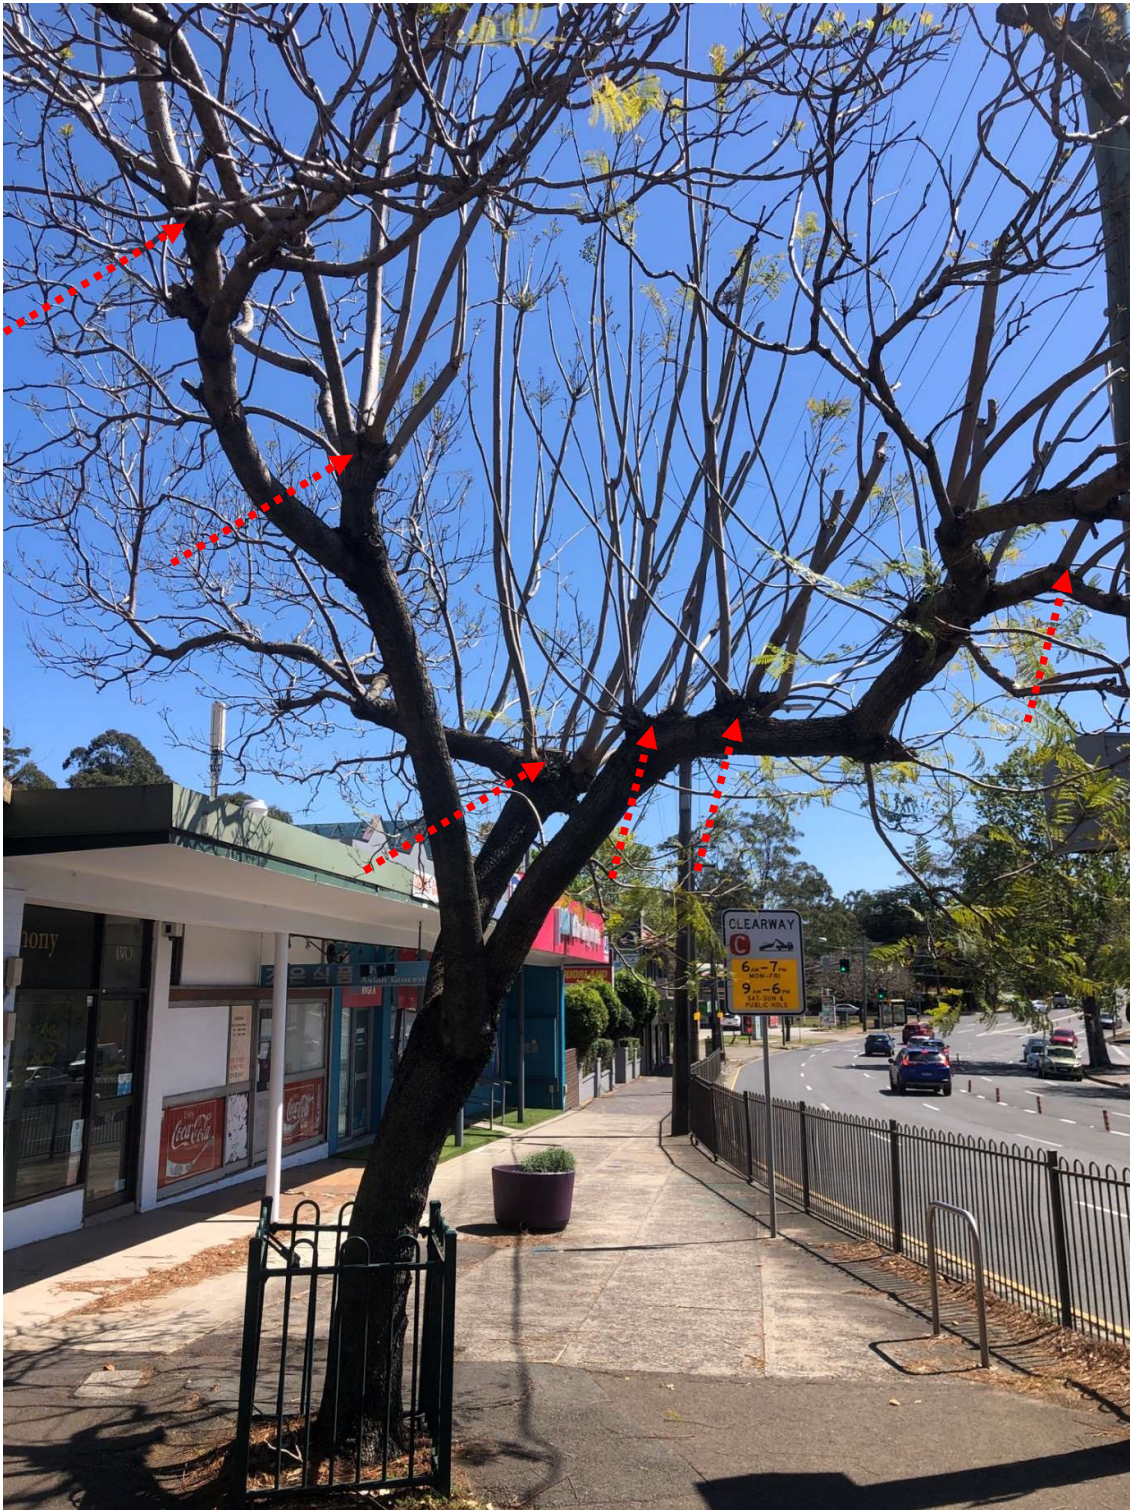
PHOTO 1 (A)

- 4.2 Tree 1 – *Jacaranda mimosifolia* - has a height of 6 metres with a canopy spread of 6 metres and is mature in age. The tree has a health rating of 5 out of 5 and a structure rating of 4 out of 5. It has a dominant crown class with 50% canopy cover and has a TPZ of 3.6 metres. The canopy has become misshapen due to significant powerline clearing. The central leaders have been removed, possibly for powerline clearing.

Tree 1 Jacaranda mimosifolia – Half of the canopy is epicormic growth. Main leaders has been removed

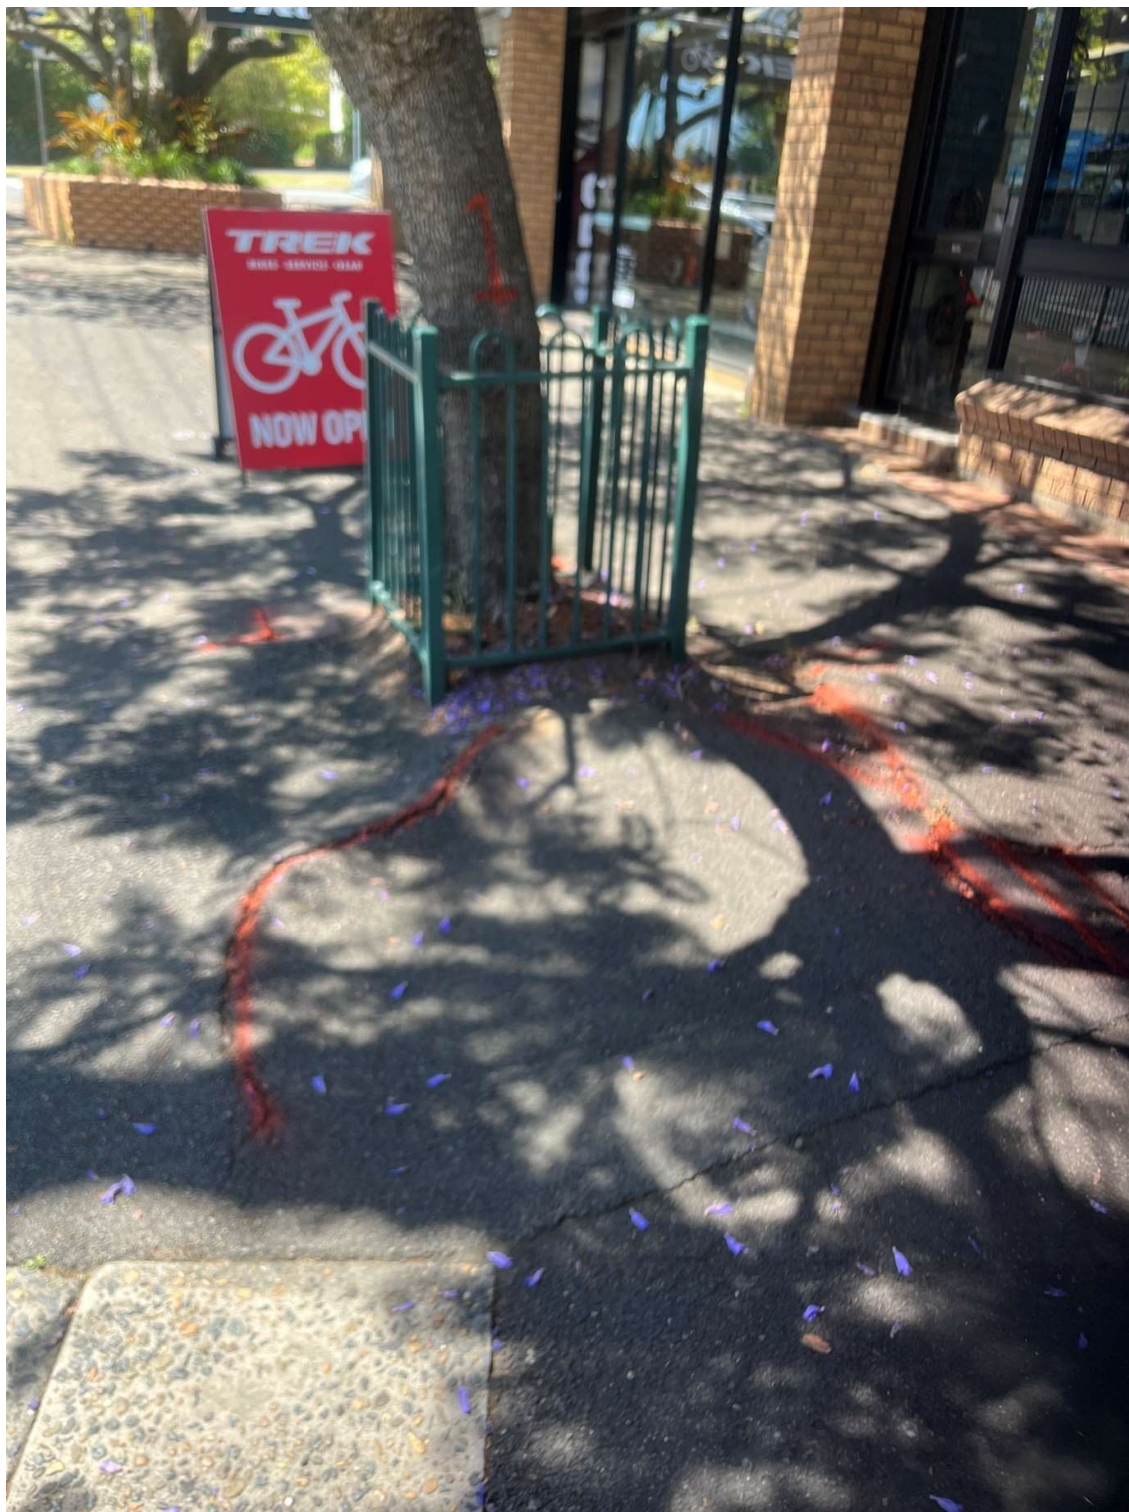
PHOTO 2 (B) Date – 23/10/2023

Tree 1 – *Jacaranda mimosifolia* - Lifted pathways due to root impact.

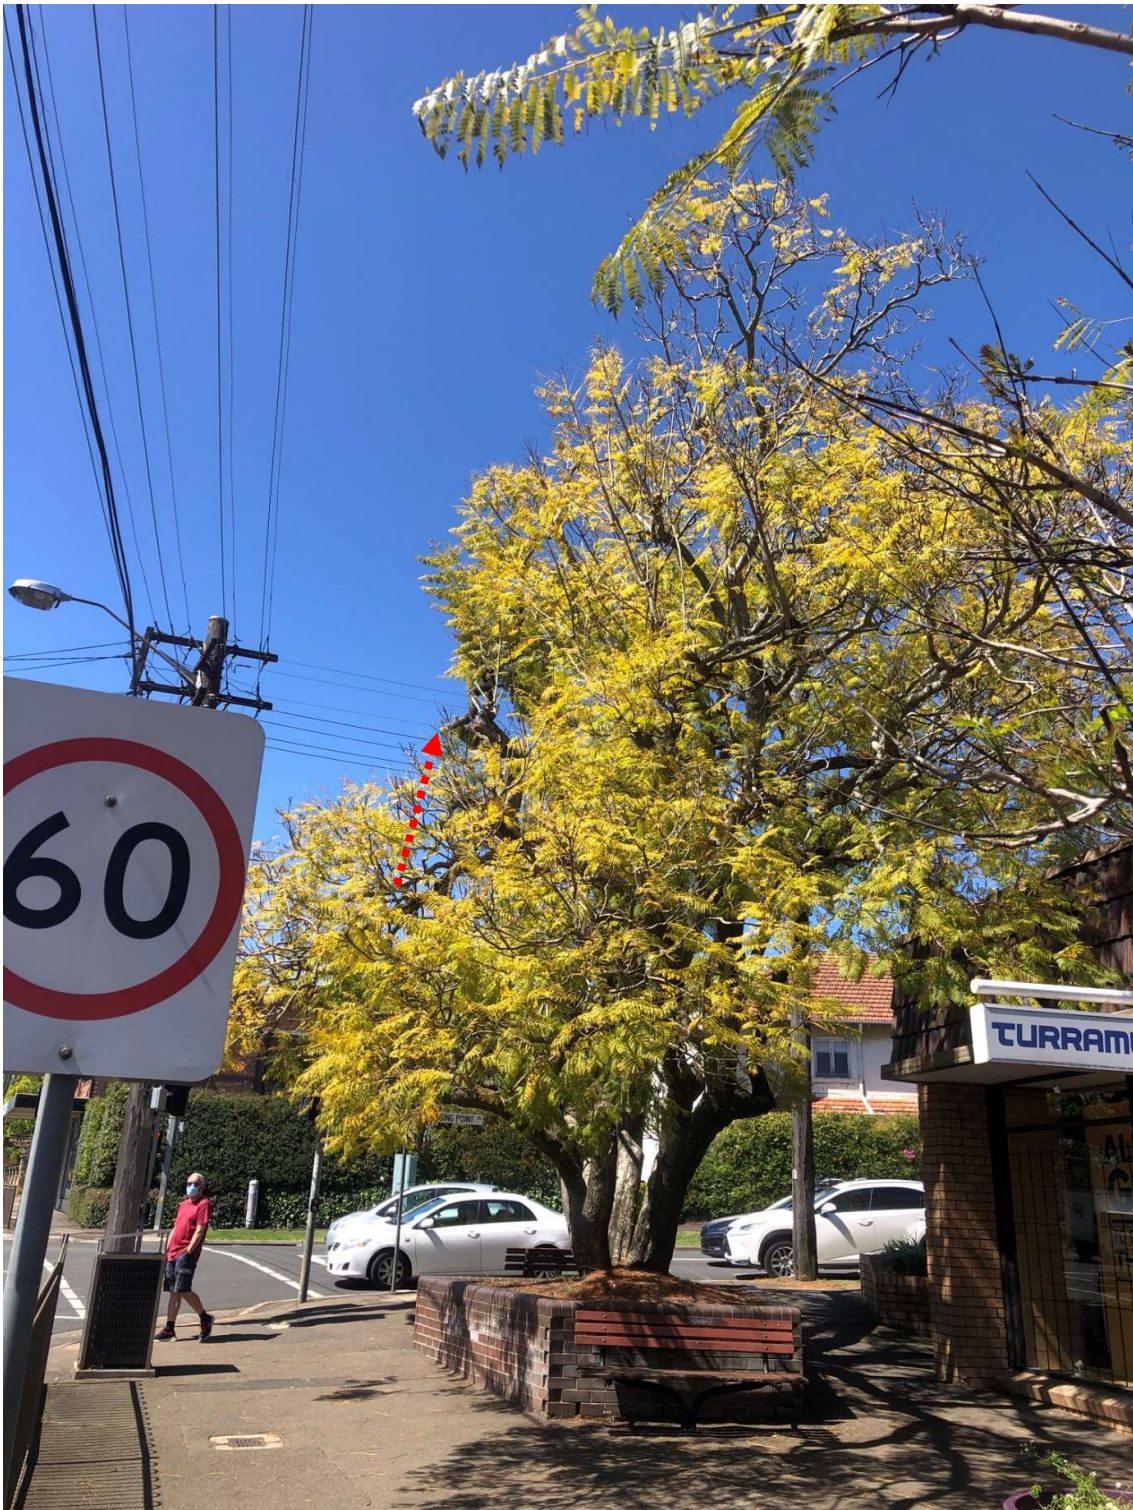
PHOTO 3 (A)

- 4.3 Tree 2 - *Jacaranda mimosifolia*- is a multiple trunk specimen growing in the raised garden bed where the base of trunks has been buried. The tree has a height of 8 metres with a canopy spread of 8 metres and is mature in age. It has a health rating of 5 out of 5 and a structure rating of 4 out of 5. The tree has a dominant crown class with 70% canopy cove. This canopy is misshapen due to powerline clearance. The tree has a TPZ of 4.8 metres.

Tree 2 – Jacaranda mimosifolia - canopy is modified for high-voltage power lines. Notation no trunk flair at base of the tree tree more than likely has been buried.

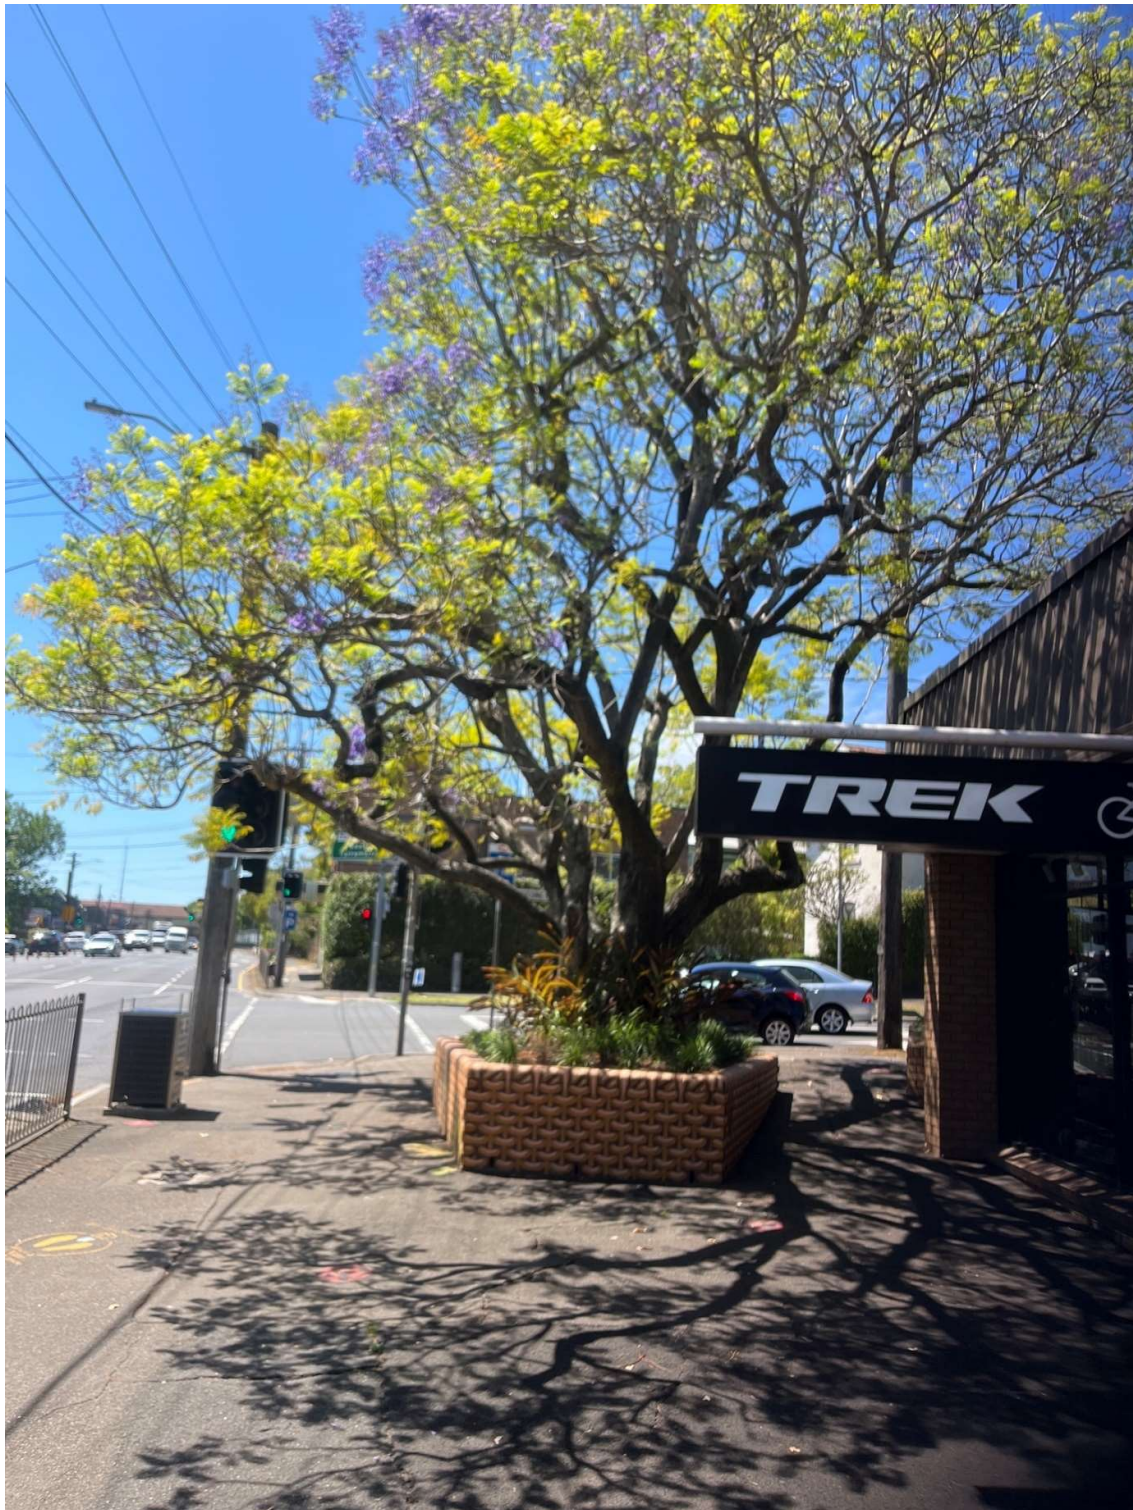
PHOTO 4 (B) Date – 23/10/2023

Tree 2 – Jacaranda mimosifolia - misshapen canopy from power lines.

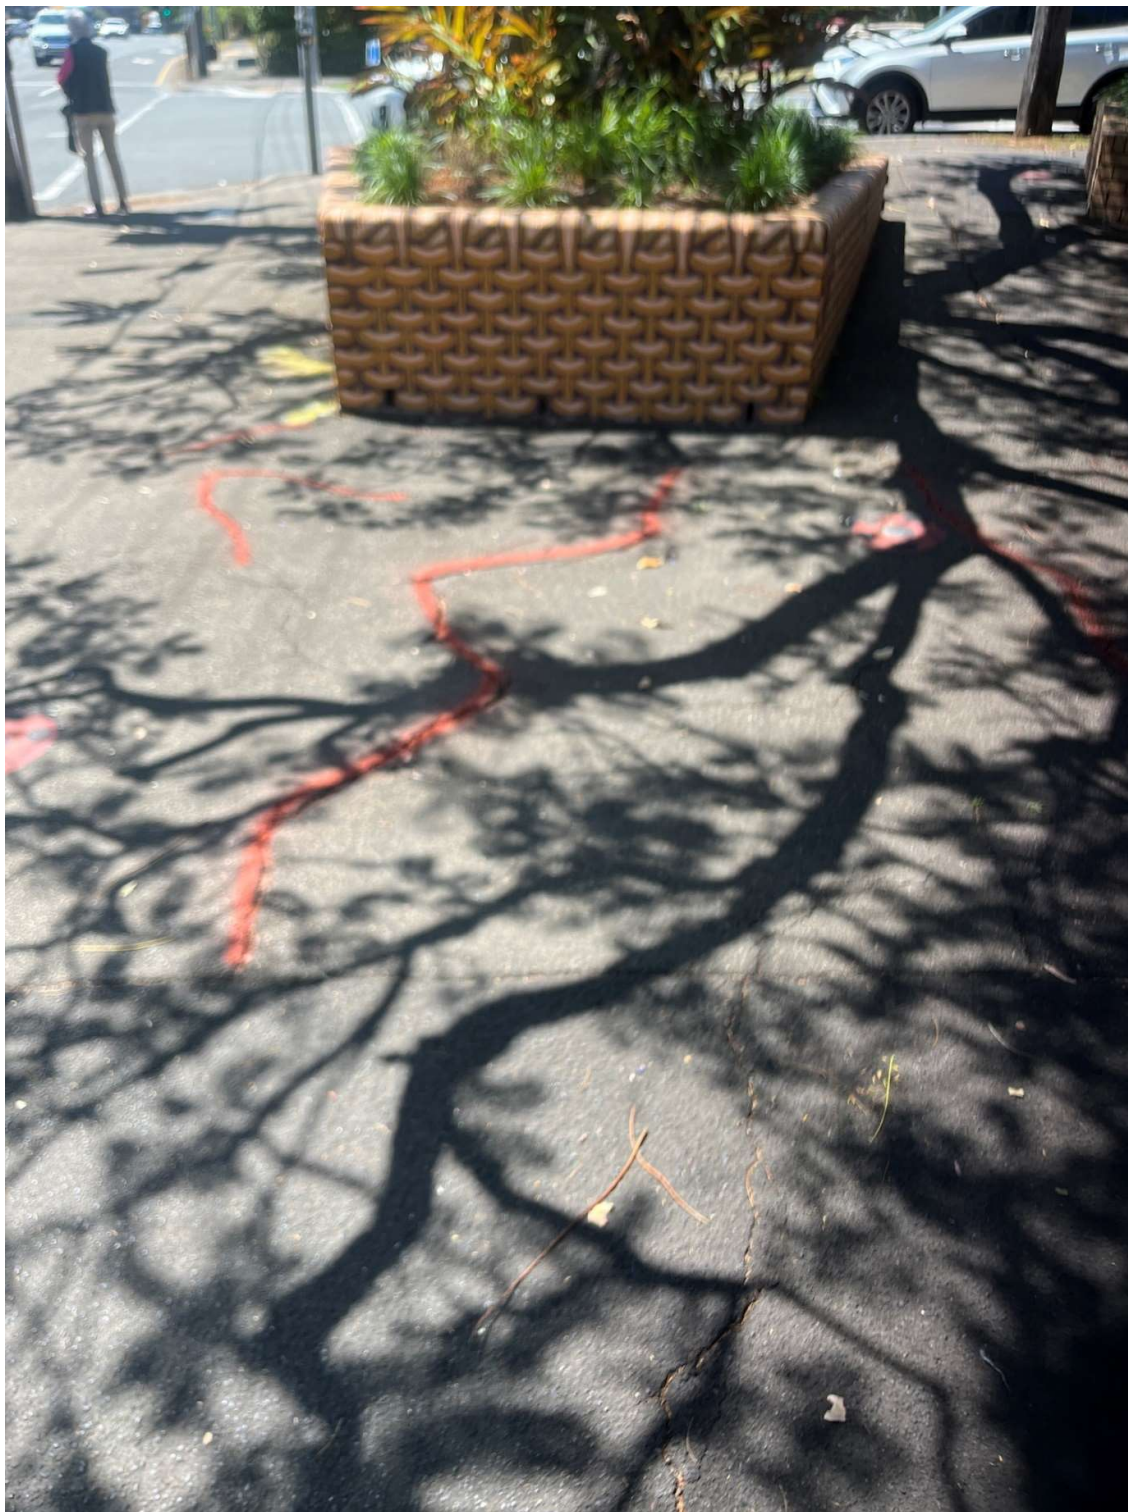
PHOTO 5      (C) Date – 23/10/2023

Tree 2 – Jacaranda mimosifolia - root impact to pathway

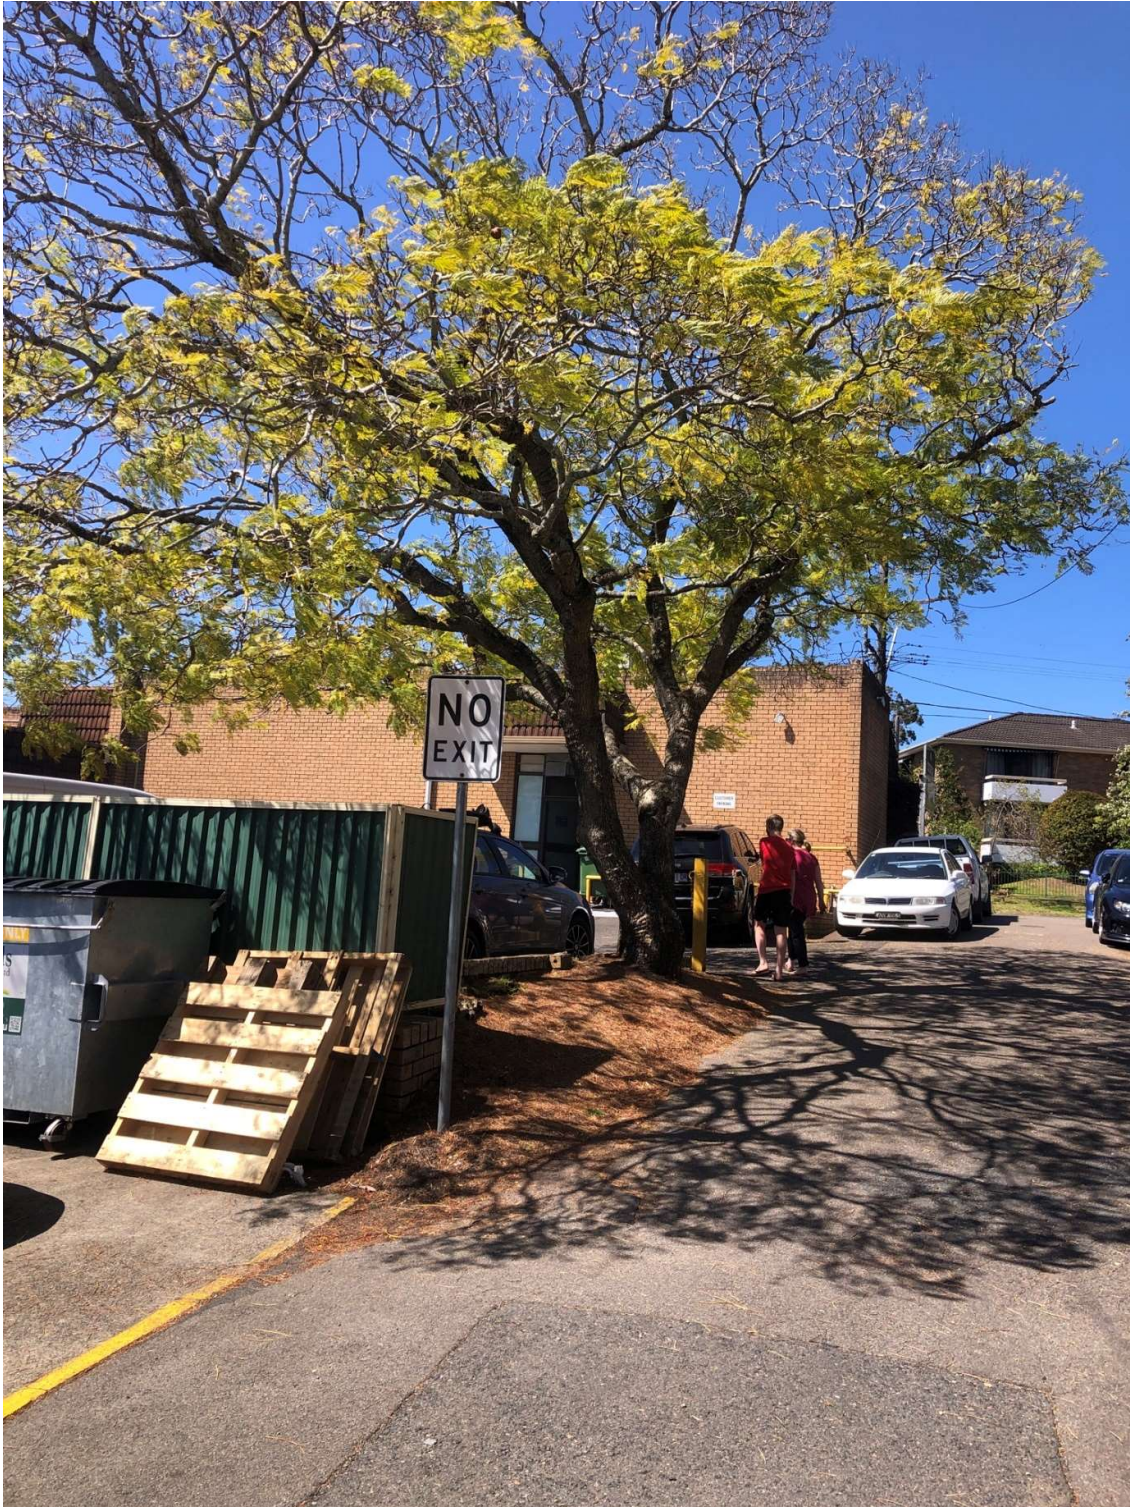
PHOTO 6     \_(A)

- 4.4 Tree 3 - *Jacaranda mimosifolia* - has a canopy height of 6.5 metres with a canopy width of 9 metres and is mature in age. The tree has a health rating of 5 out of 5 and a structure rating of 5 out of 5. It has a dominant crown class with 70% canopy cover. The tree has a TPZ of 6 metres.

Tree 3 – *Jacaranda mimosifolia* - raised soil levels at the base of the tree root are impacting on the small wall.

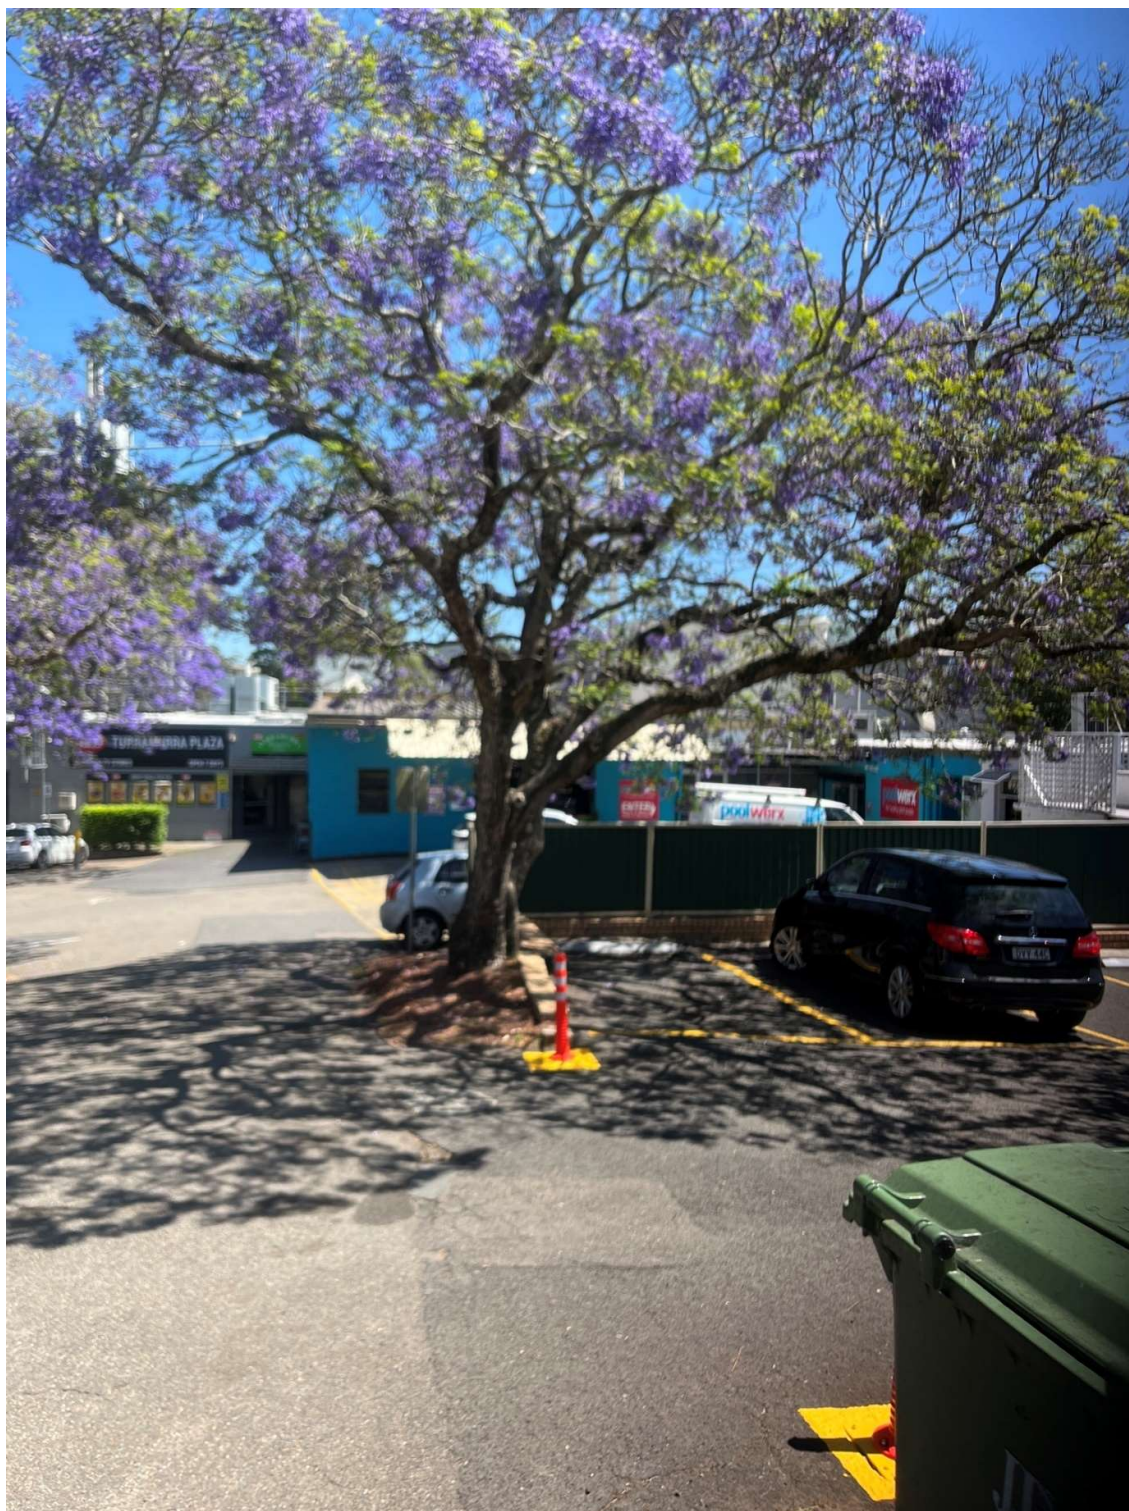
PHOTO 7      \_ (B) Date – 23/10/2023

Tree 3 – Jacaranda mimosifolia - root impact to the retaining wall.

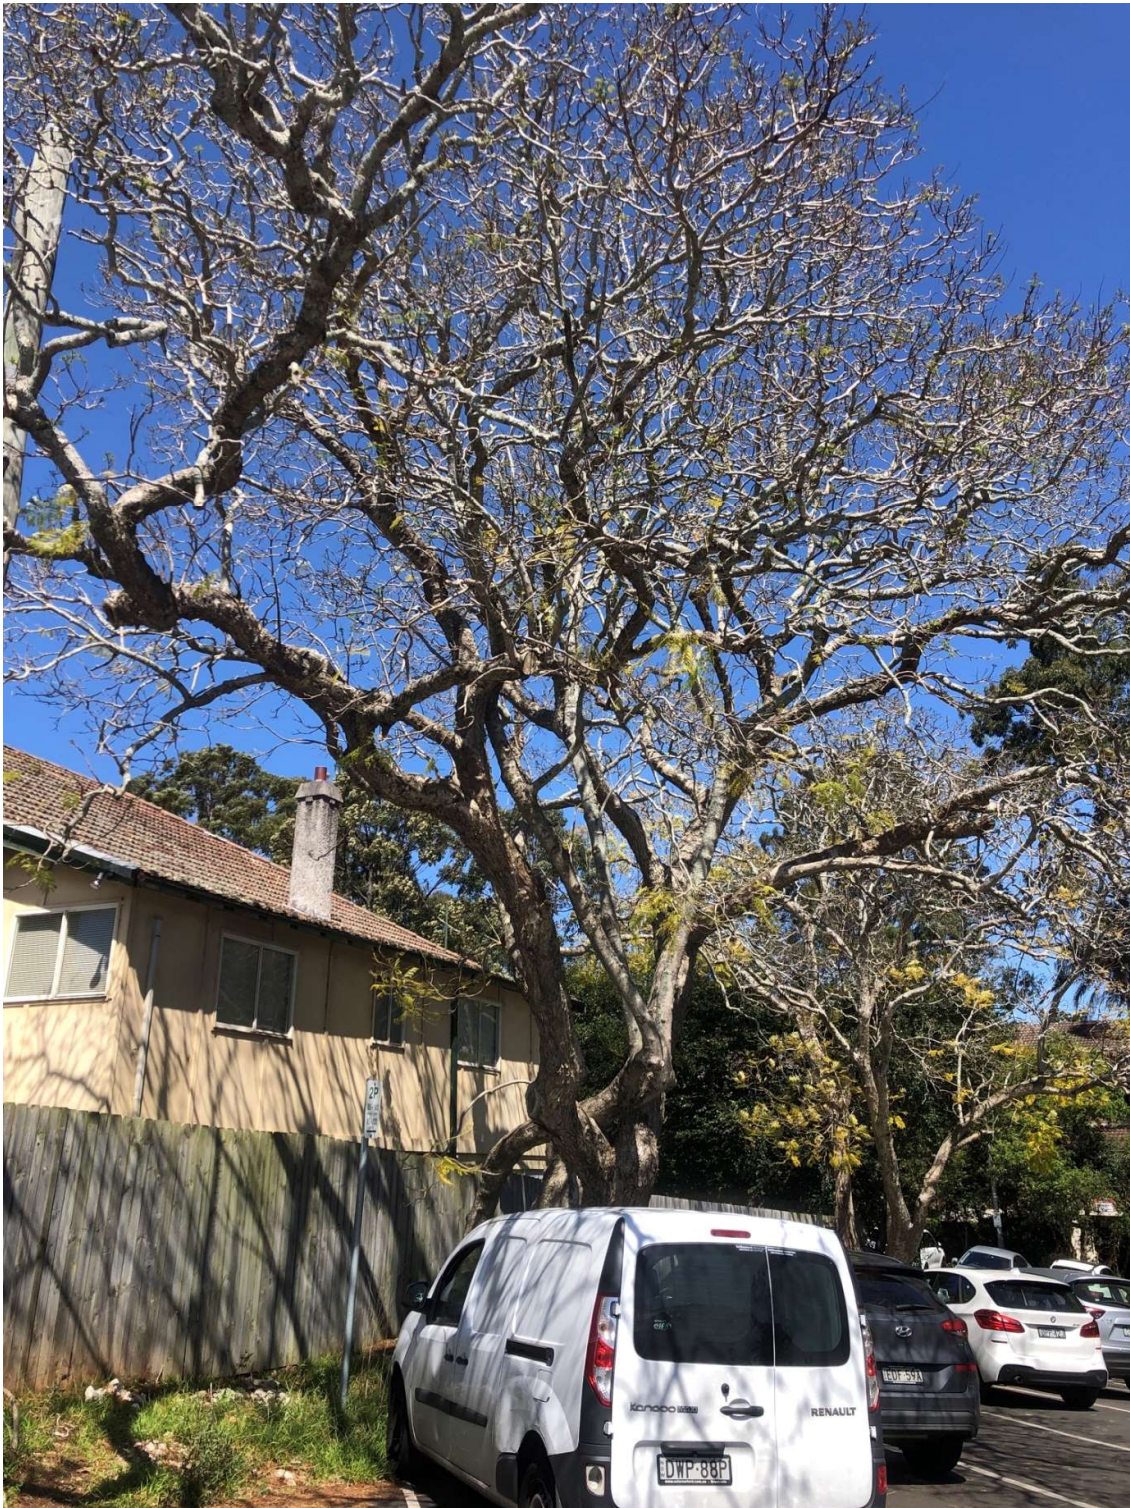
PHOTO 8     .(A)

- 4.5 Tree 4 -*Jacaranda mimosifolia* - has a height of 10 metres with a canopy spread of 10 metres and is mature in age. The tree has a health rating of 5 out of 5 and a structure rating of 5 out of 5. It has a codominant canopy with 60% canopy cover. The tree has a TPZ of 8.4 metres.

Tree 4 – Jacaranda mimosifolia - multiple trunk specimen

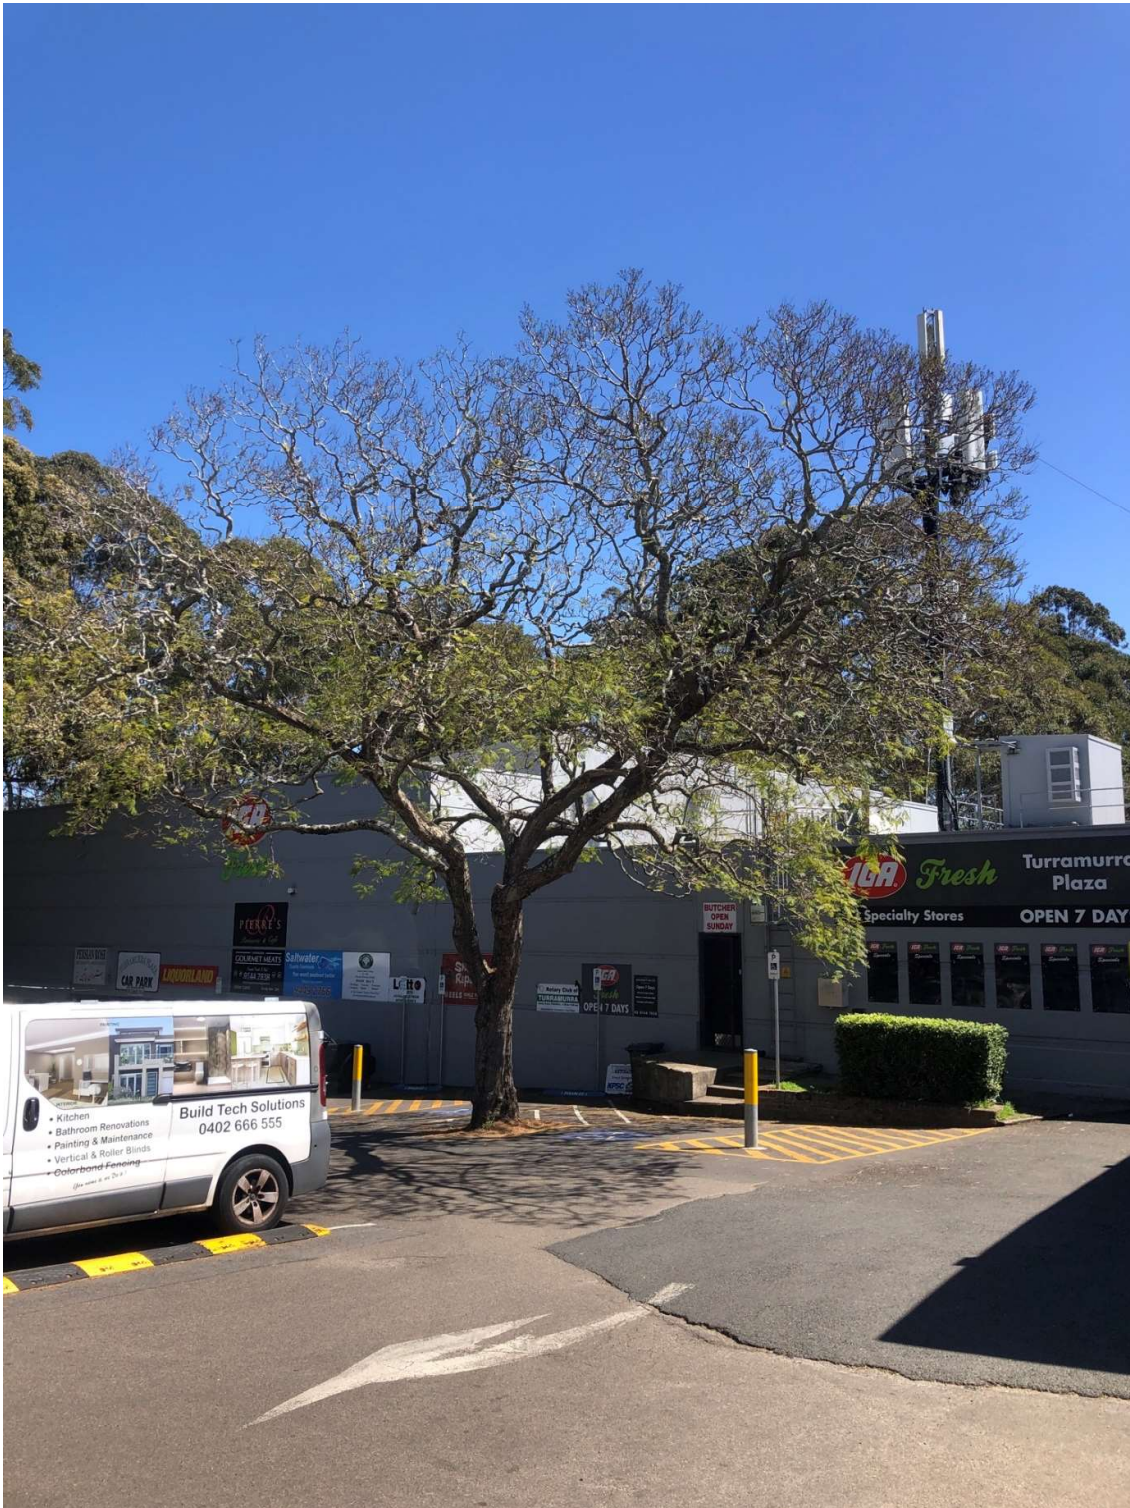
PHOTO 9 (A)

- 4.6 Tree 5 - *Jacaranda* - has a height of 10 metres with a canopy spread of 10 metres and is mature in age. The tree has a health rating of 5 out of 5 and a structure rating of 5 out of 5. It has a codominant canopy with 70% canopy cover. The tree has a TPZ of 7.2 metres.

Tree 5 – Jacaranda mimosifolia - well-shaped canopy.

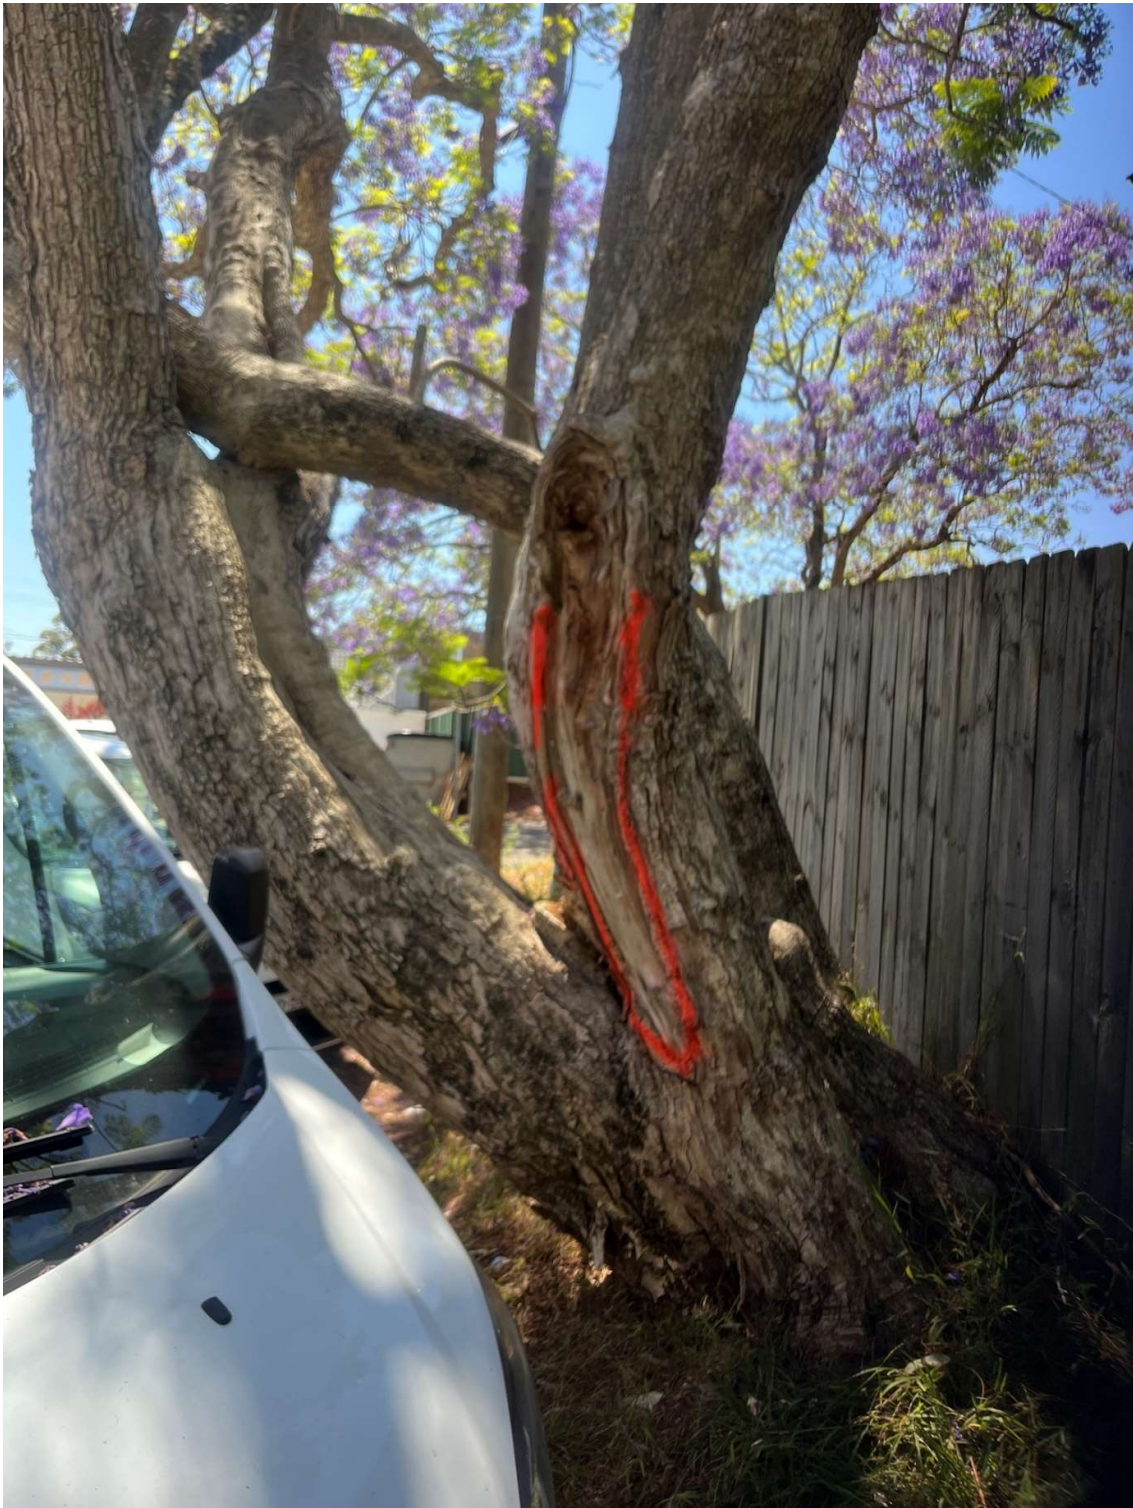
PHOTO 10 (B) Date – 23/10/2023

Tree 5 – Jacaranda mimosifolia - branch failure on the southern side. note rubbing crossing branches at rear of photograph.

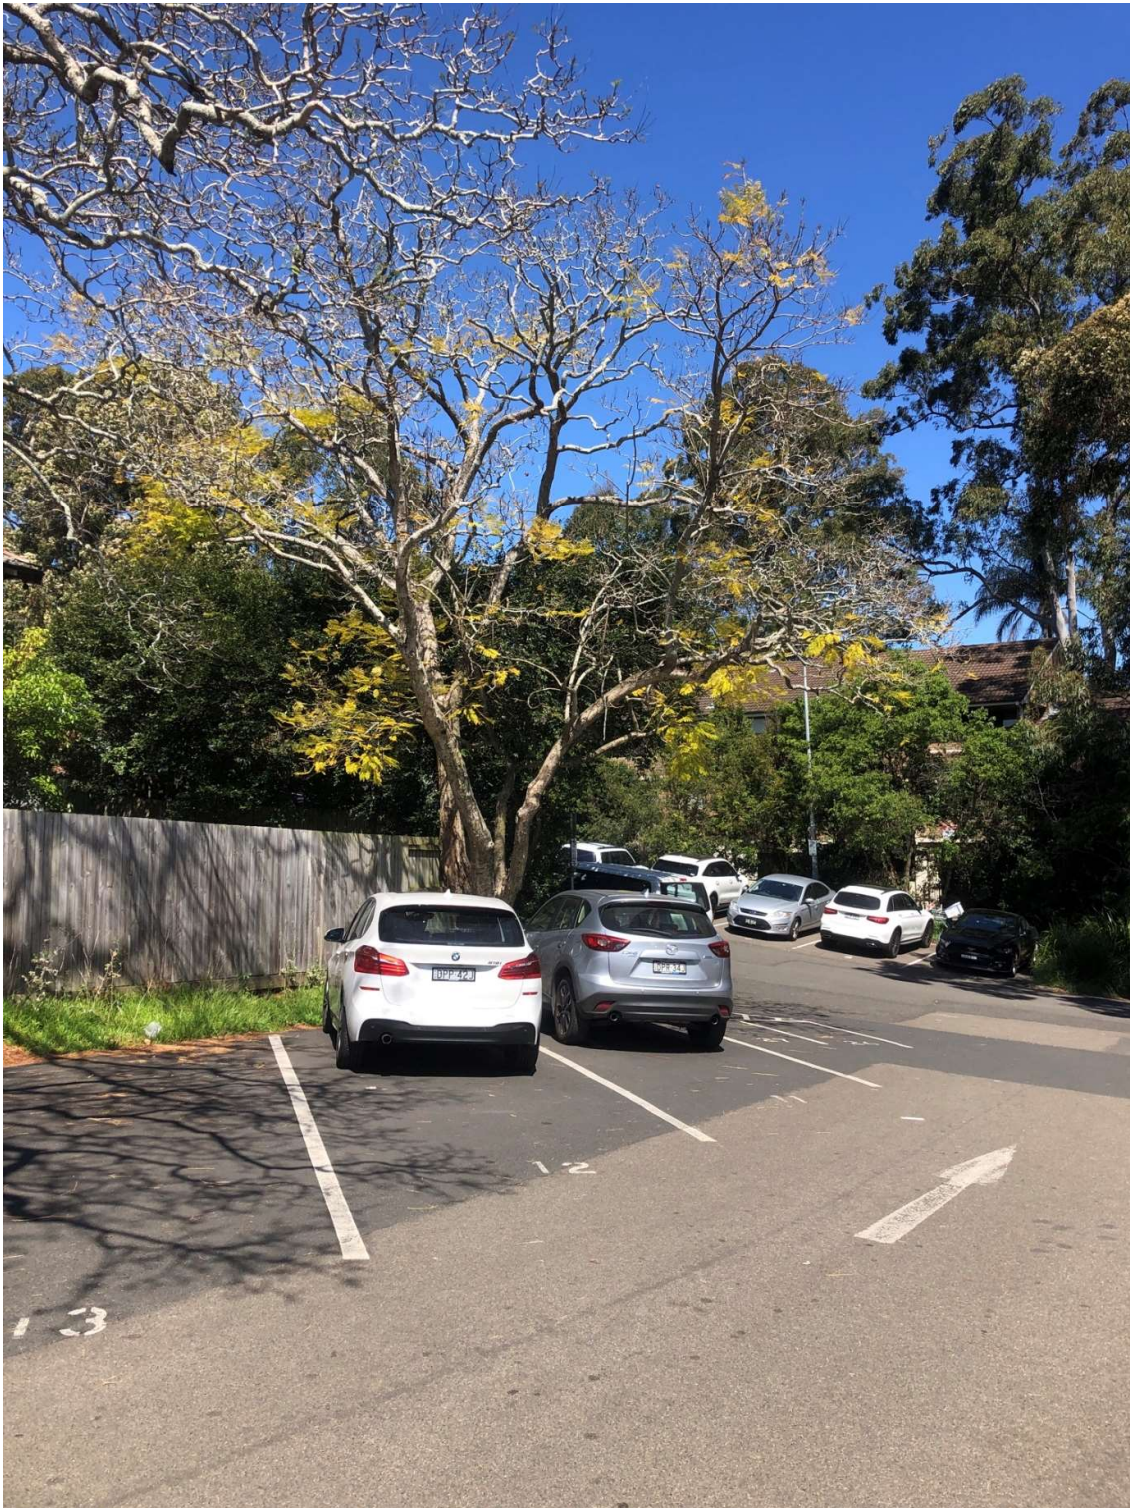
PHOTO 11 (A)

- 4.7 Tree 6 – *Jacaranda mimosifolia* – is a multiple trunk specimen with a height of 9 metres, width of 8 metres and has an age classification of overmature. The tree has a health rating of 4 out of 5 and a structure rating of 3 out of 5. It has a dominant crown class with 50% canopy cove. This tree has major cambium damage to all three trunks. This cambium damage would be impacting 60% of the trunk diameters.

Tree 6 – *Jacaranda mimosifolia* - Cambium damage on east and trunk.

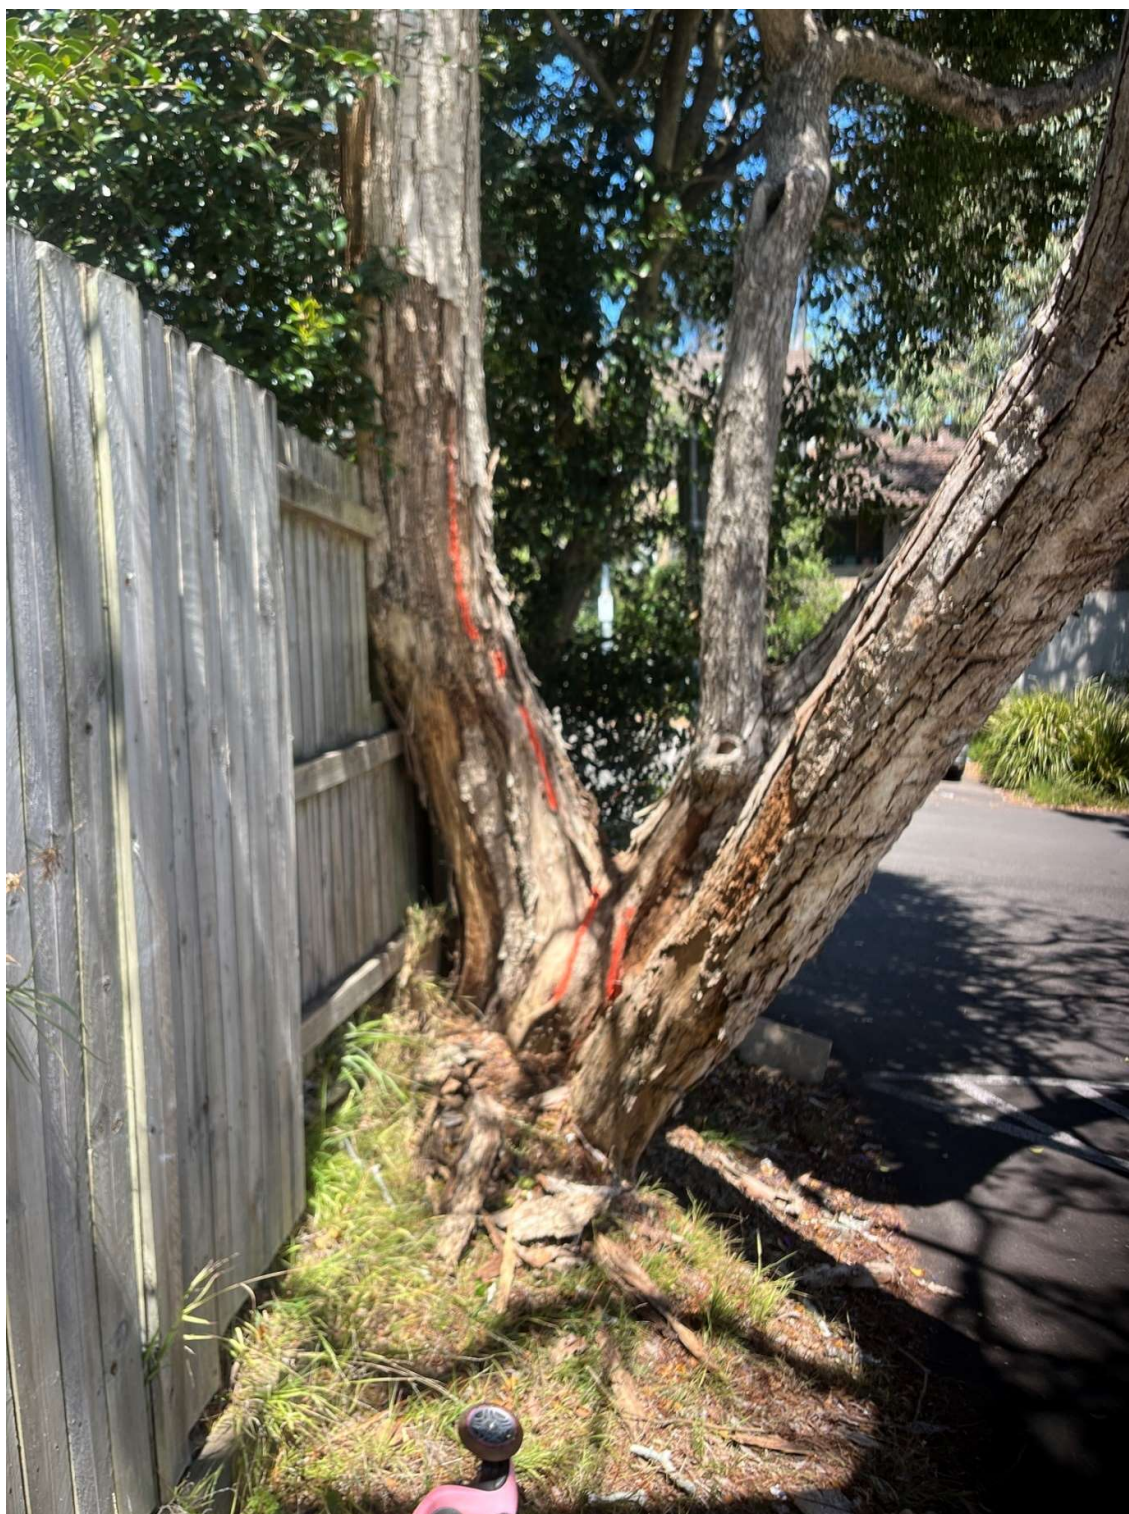
PHOTO 12 (B) Date – 23/10/2023

Tree 6 – *Jacaranda mimosifolia* - has major cambium damage.

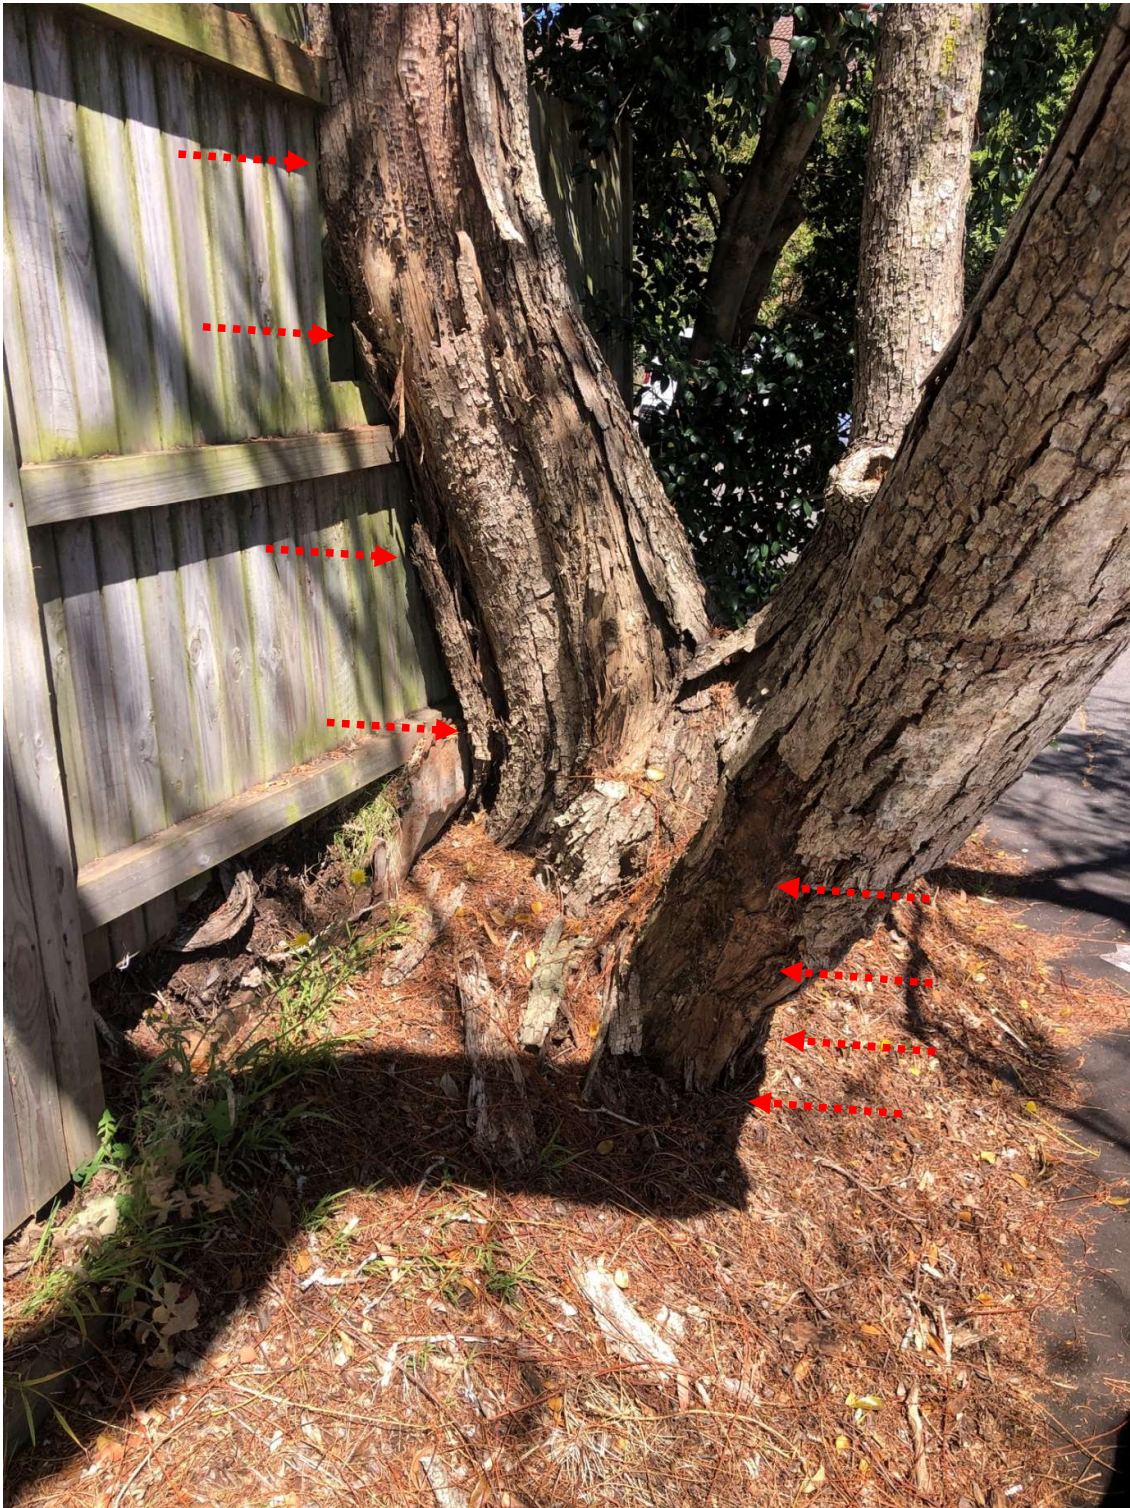
PHOTO 13 (C) Date – 23/10/2023

Tree 6 – Jacaranda mimosifolia - Major cambium damage to trunk.
