# DR. TREEGOOD

## Arborist Report

*Project* **1380 Pacific Highway  
Turramurra NSW 2074**  
Ref: 2023-1089  
Job: 67154

*Client* **Rebel Property Group**  
1380 Pacific Highway  
Turramurra NSW 2074

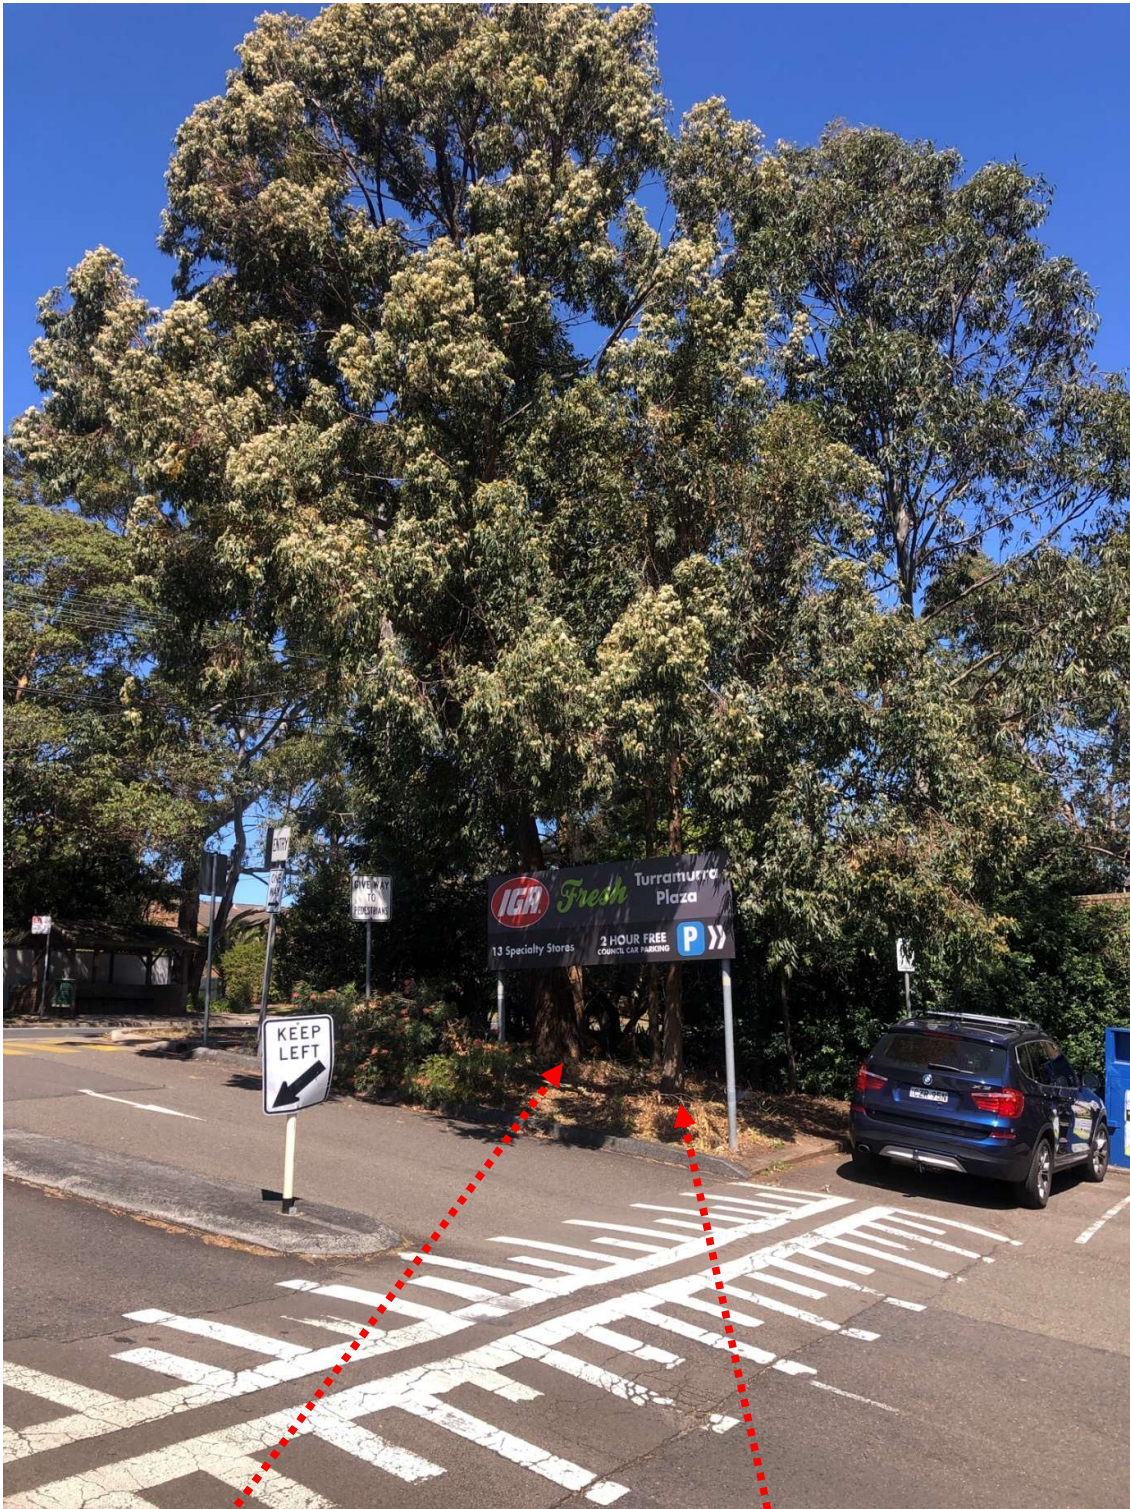
PHOTO 14 (A)

Tree 7 - *Eucalyptus robusta*- dominant tree , Tree 8 - *Eucalyptus robusta* – small specimen growing next to dominant Tree 7.

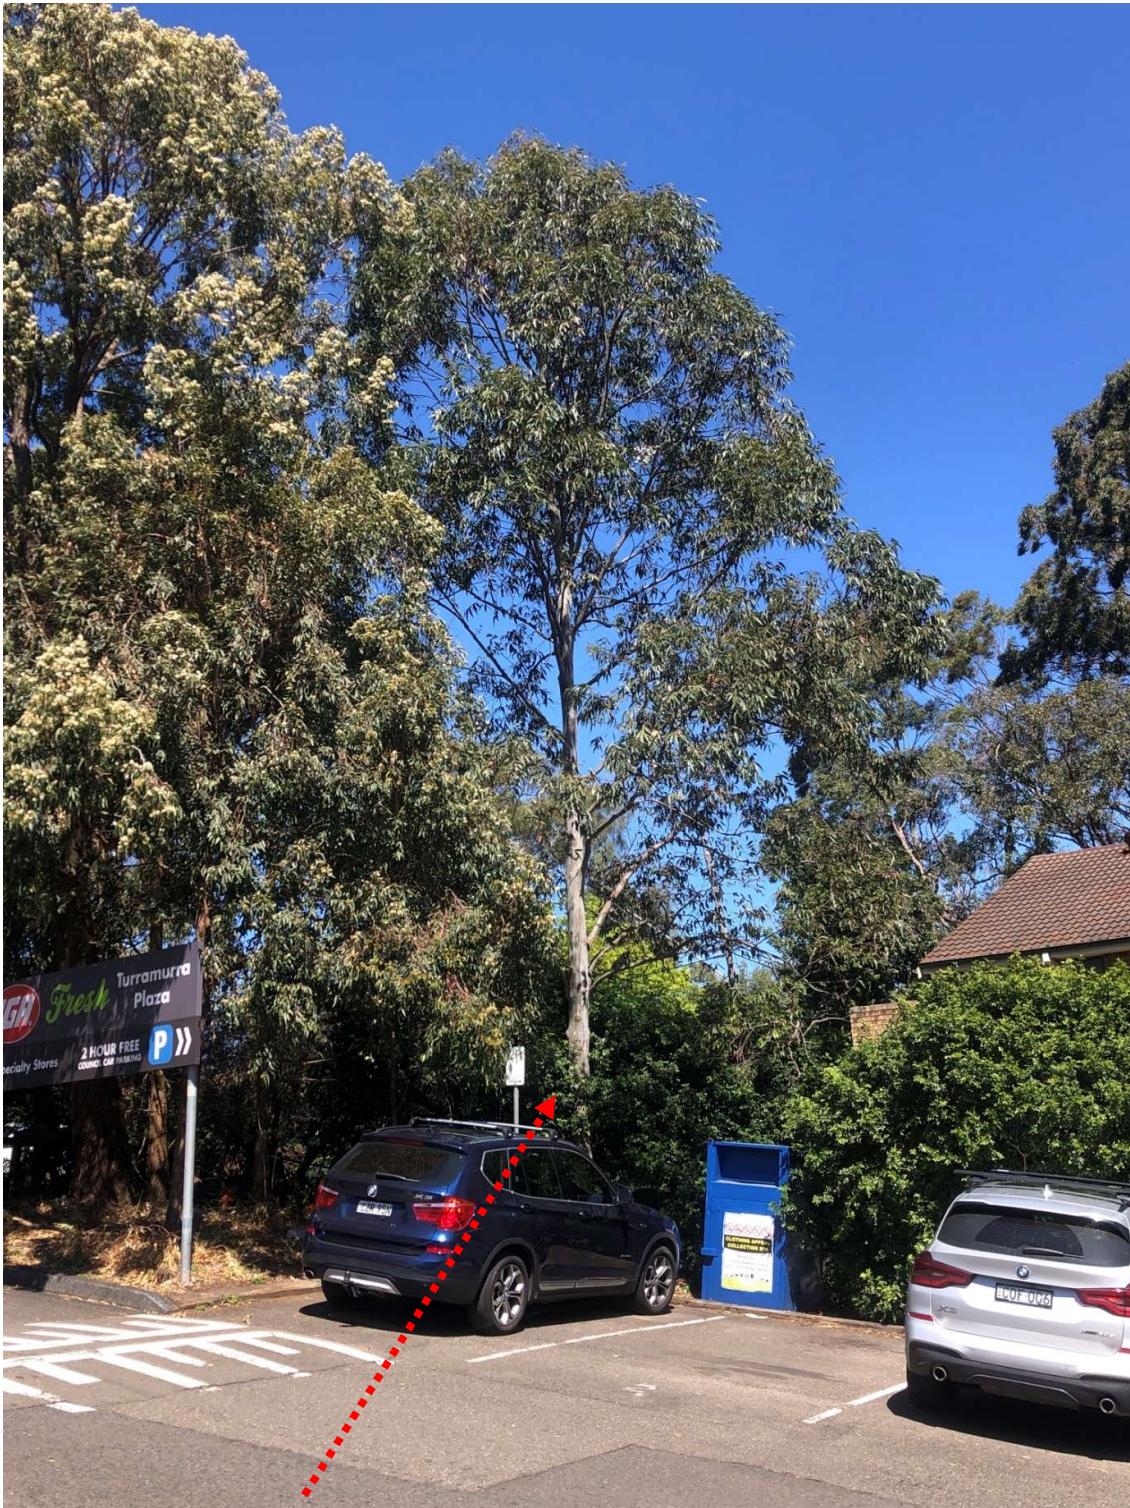
PHOTO 16

- 4.10 Tree 9 - *Eucalyptus pilularis* - has a height of 10 metres with a canopy spread of 6 metres and is mature in age. The tree has a health rating of 5 out of 5 and a structure rating of 5 out of 5. It has a codominant canopy with 60% canopy cover.

Tree 9 – *Eucalyptus pilularis* - this tree is to be removed.

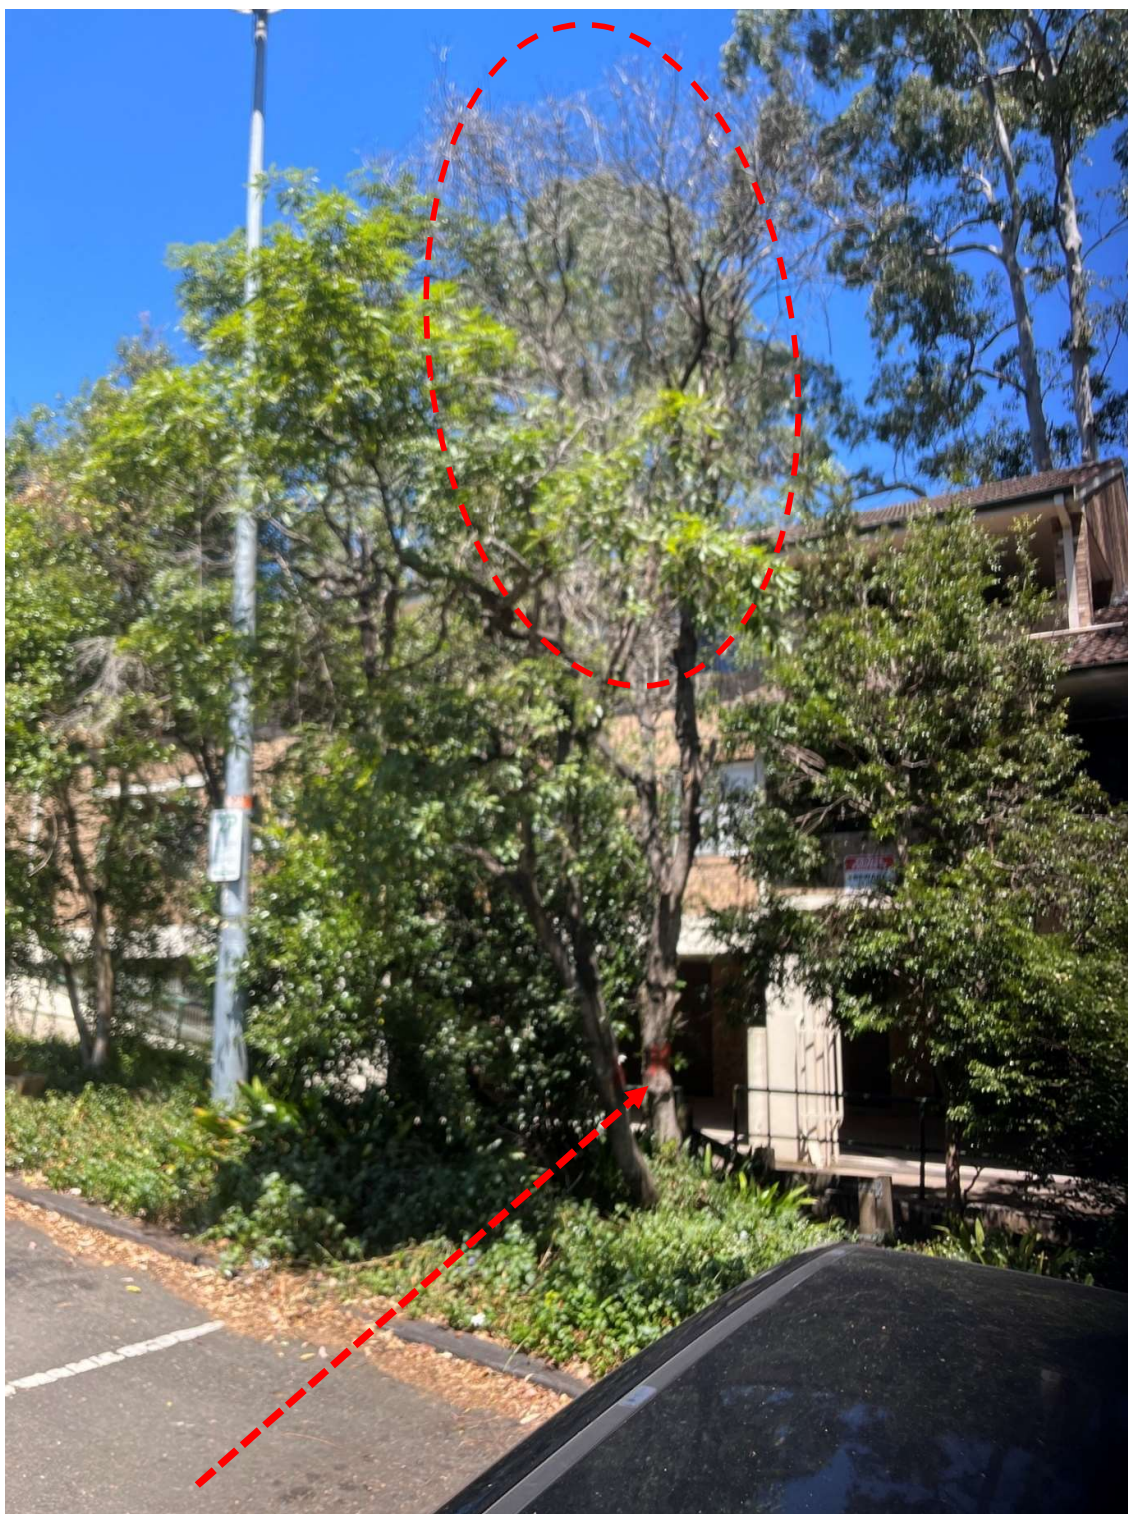
PHOTO 18 (A) Date – 23/10/2023

- 4.11 Tree 10 - *Pittosporum undulatum* - has multiple trunks with a height of 8 metres and a canopy spread of 6 metres and is mature in age. The tree has a health rating of 5 out of 5 and a structure rating of 4 out of 5. It has a dominant canopy with 50% canopy cover. There has been a vehicle impact to the canopy cover. The tree has a TPZ of 2.4 meters.

Tree 10 – *Pittosporum undulatum* - dieback in the upper canopy.

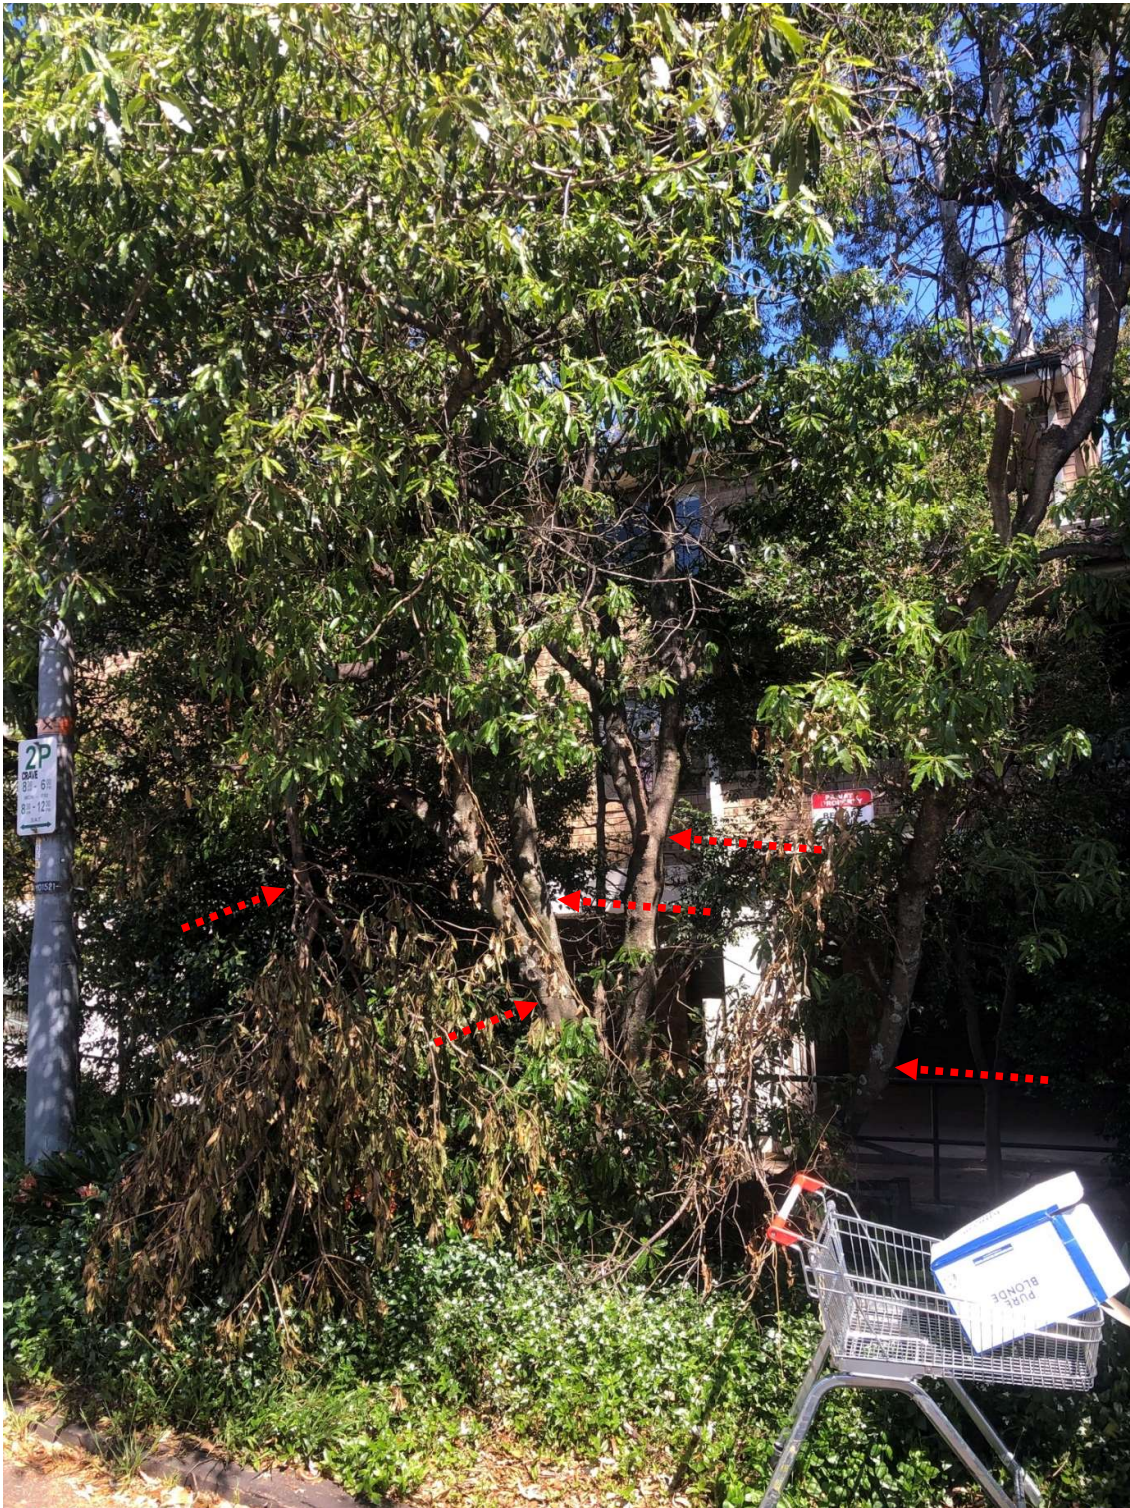
PHOTO 19 (B)

Tree 10 – *Pittosporum undulatum* - multiple trunk specimen which has suffered branch failure.

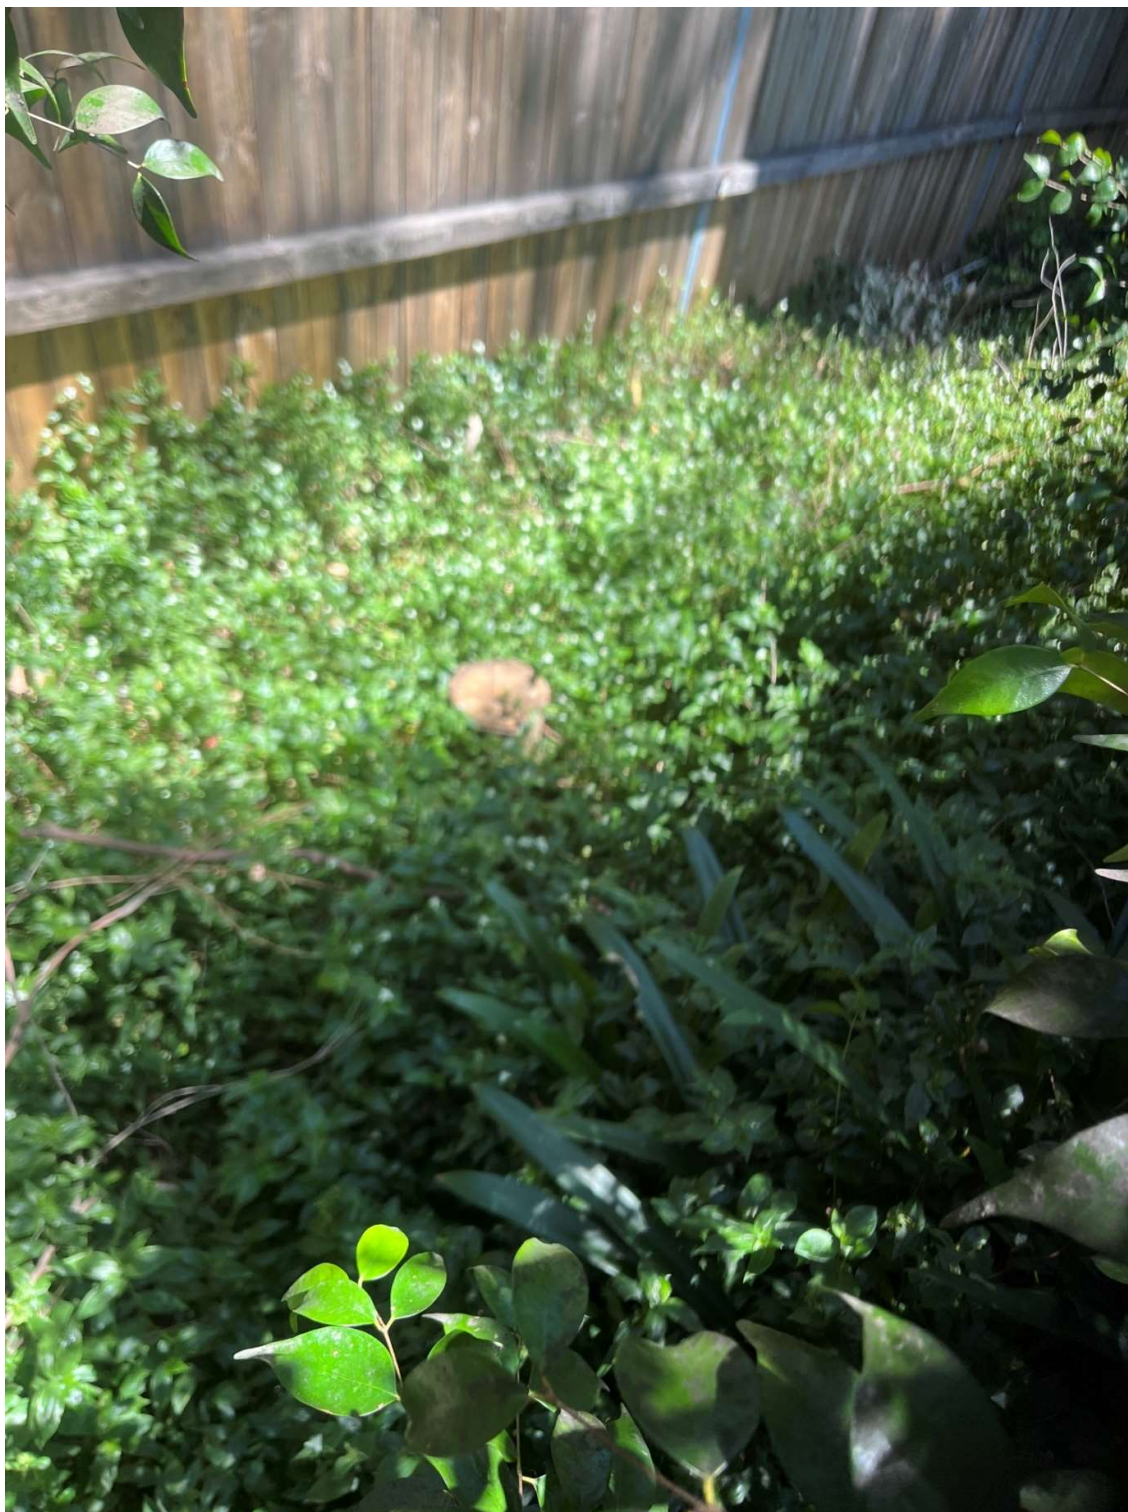
PHOTO 21 (B) Date – 23/10/2023

Tree 11 – *Pittosporum undulatum* - has been removed.

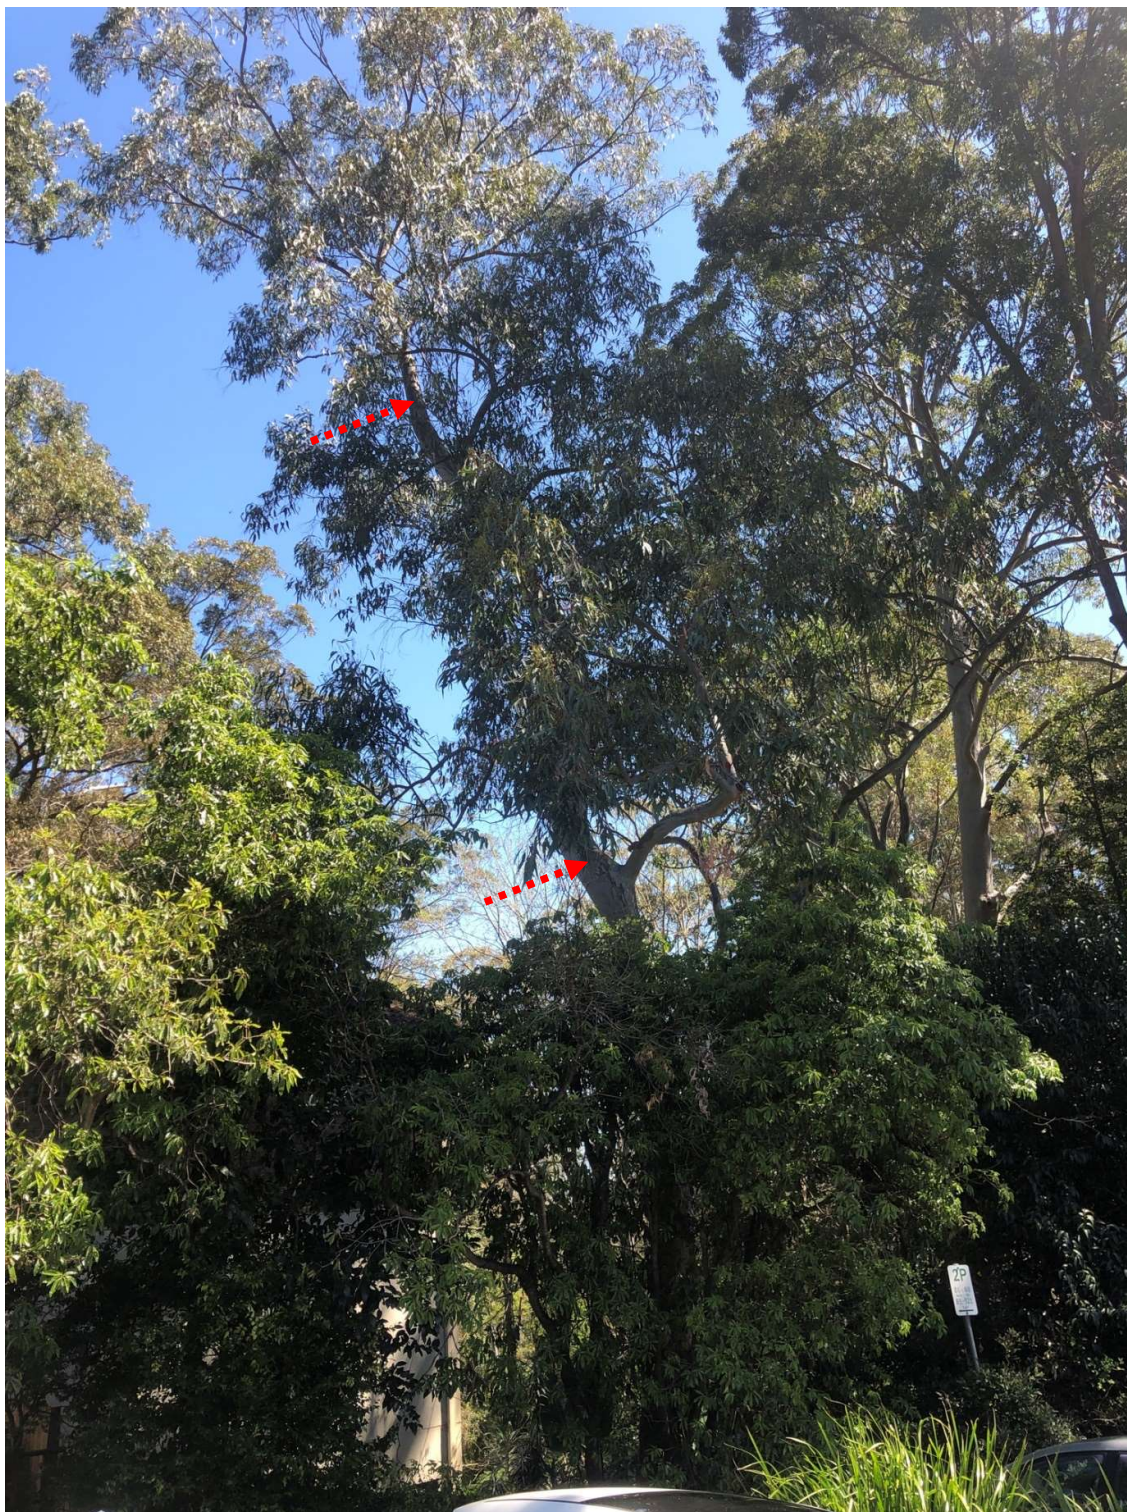
PHOTO 22 (A)

- 4.13 Tree 12 - *Eucalyptus acmenoids*- has a height of 12 metres with a canopy spread of 8 metres The canopy is predominantly growing over neighbouring house. The tree is mature in age with a health rating of 5 out of 5 and a structure rating of 4 out of 5. It has a codominant canopy with 70% canopy cover. There is a major bend in the trunk and the canopy cover is uneven. The tree has a TPZ of 8.4 metres.

Tree 12 – Eucalyptus acmenoids - canopy predominantly growing over neighbours building.

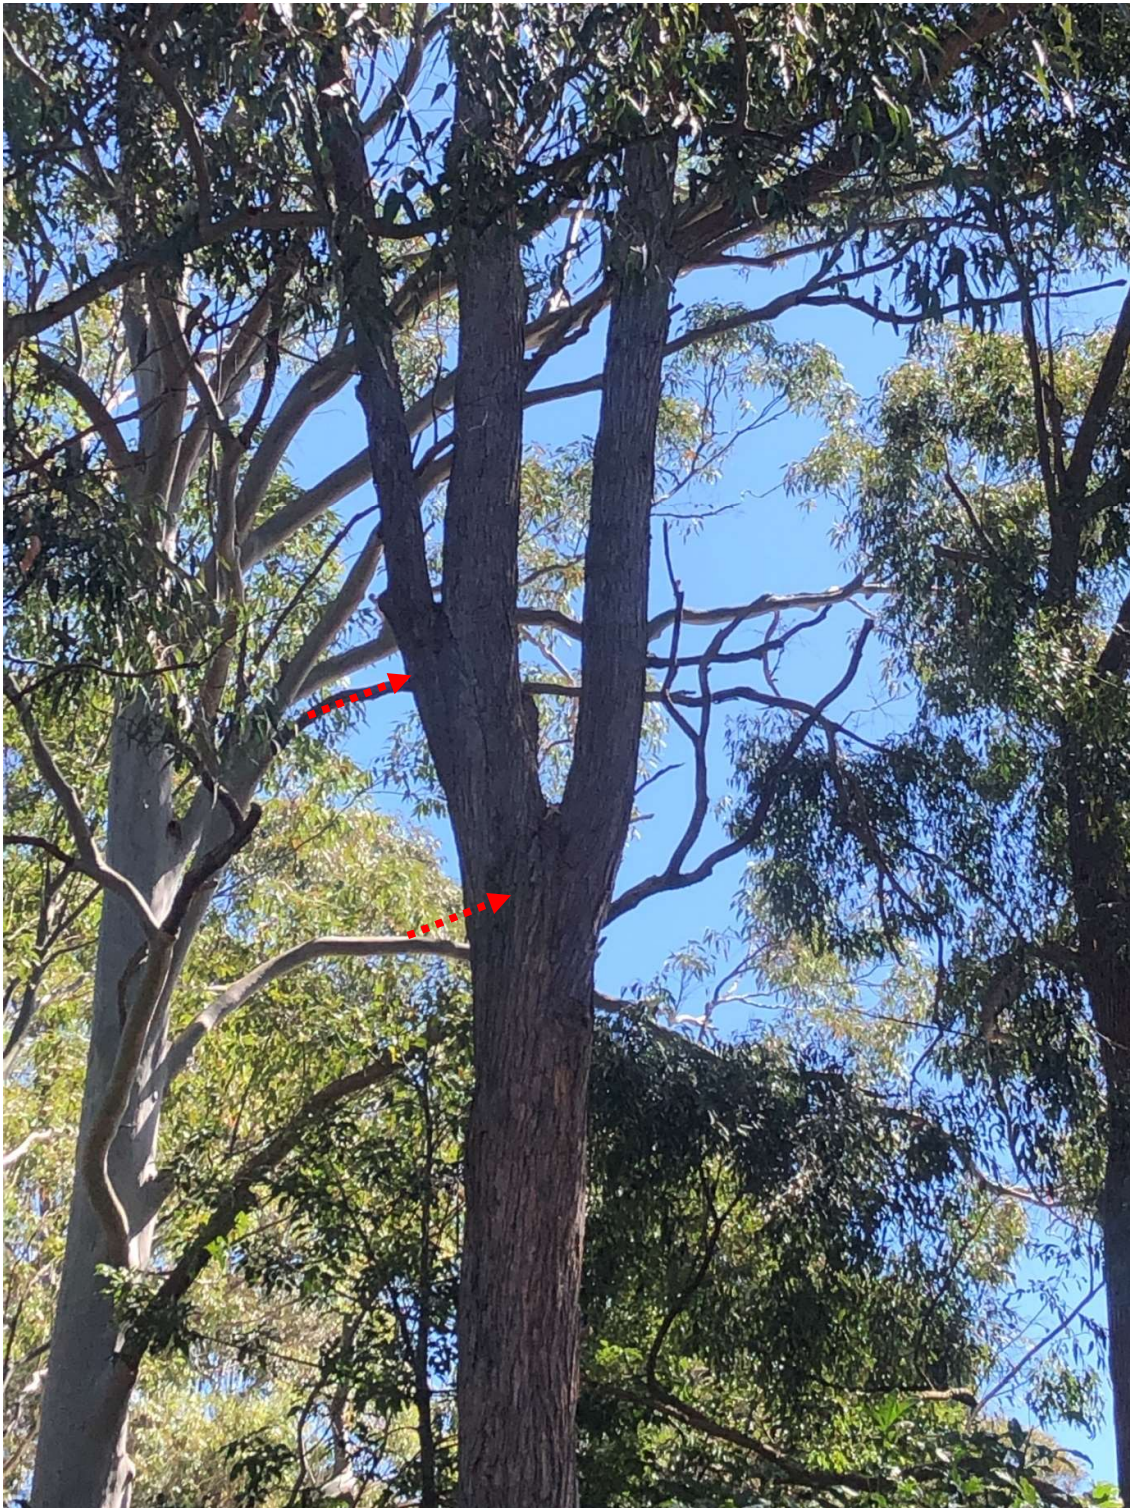
PHOTO 23 (A)

- 4.14 Tree 13 - *Eucalyptus microcorys* - has a height of 16 metres with a canopy spread of 8 metres and is mature in age. The has a health rating of 5 out of 5 and a structure rating of 3 out of 5. It is a dominant tree with 50% canopy cover. The trunk has inclusions at 6 metre mark and the 10-metre mark. It has a TPZ of 7.2 metres.

Tree 13 – *Eucalyptus microcorys*. Trunk inclusion at 6 metres.

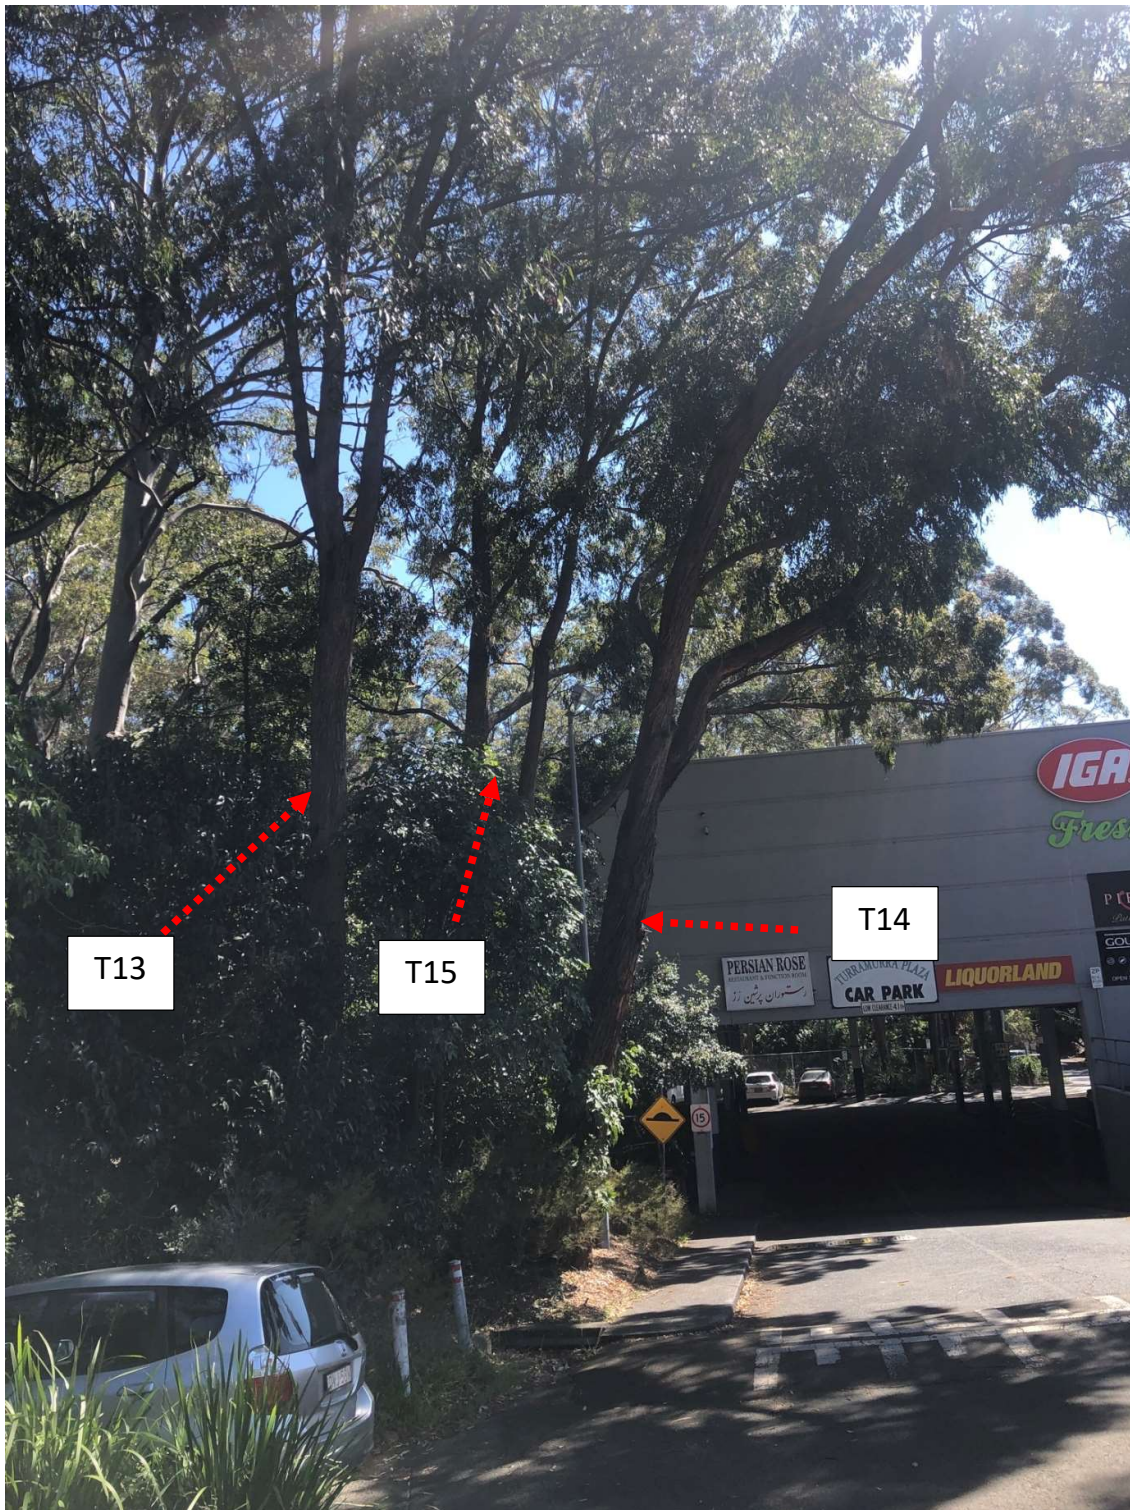
PHOTO 25 (C)

Trees 13, 14, 15- *Eucalyptus microcorys* - Tree 15 is predominantly growing over existing roadway.

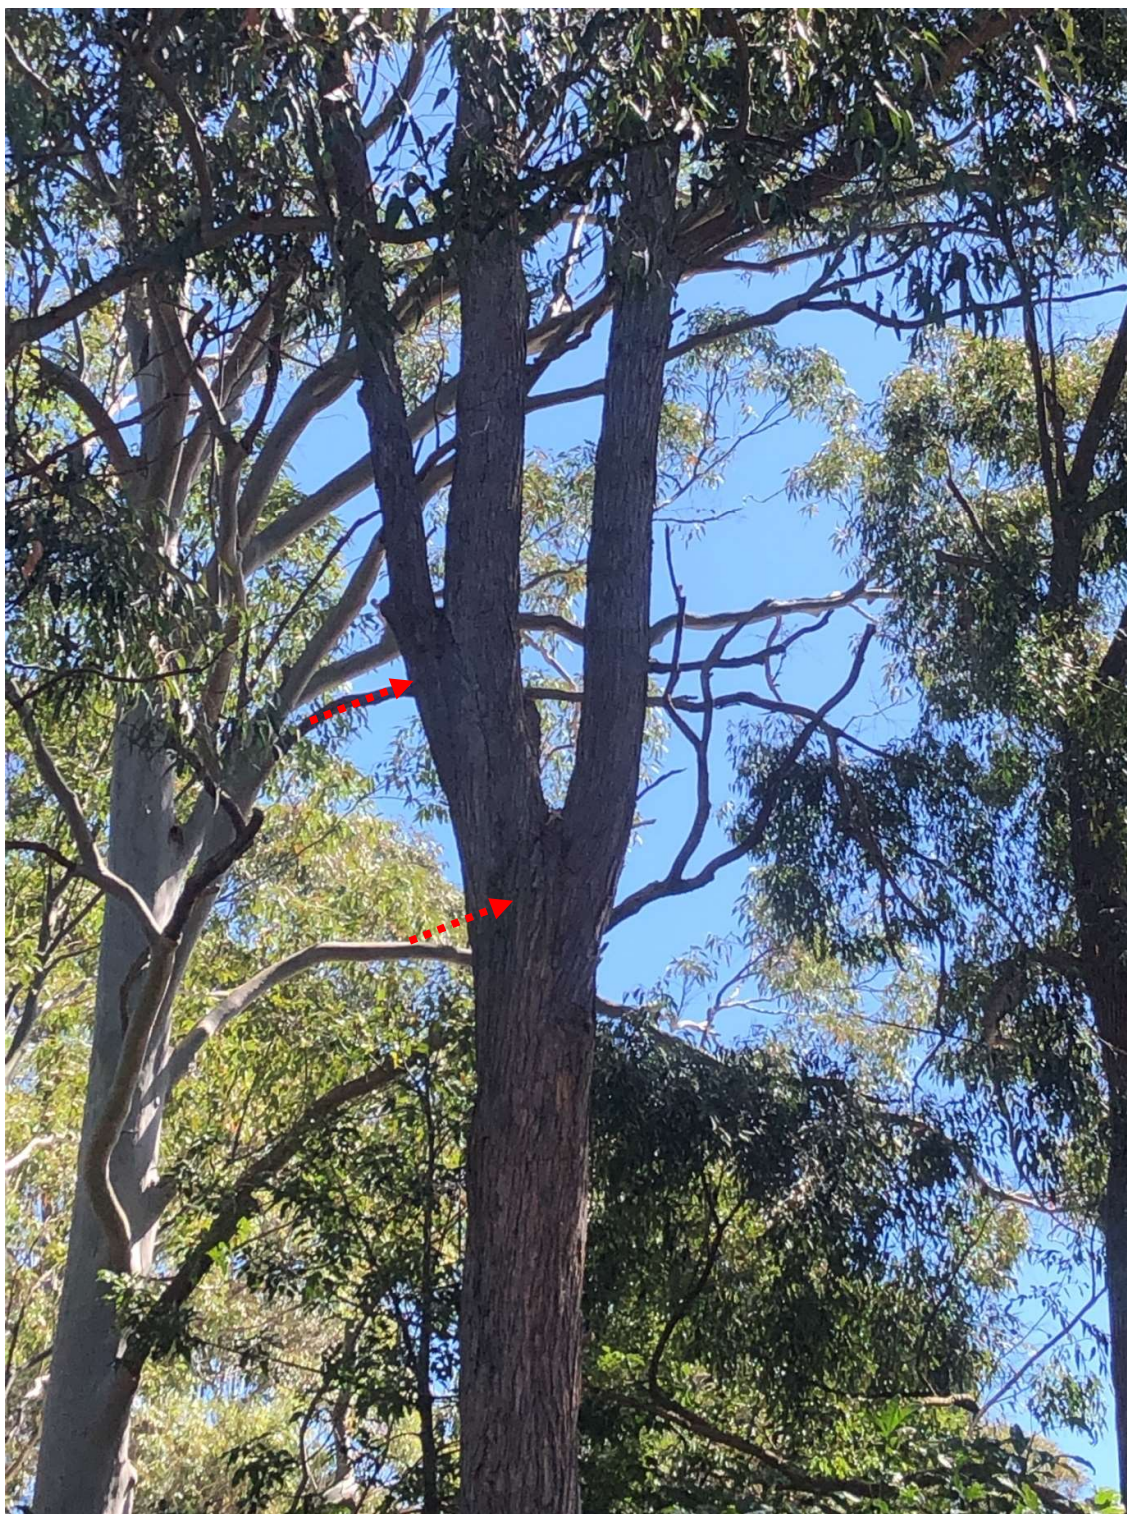
PHOTO 26 (D)

Tree 13 – Eucalyptus microcorys - Trunk inclusion at 6 metres.

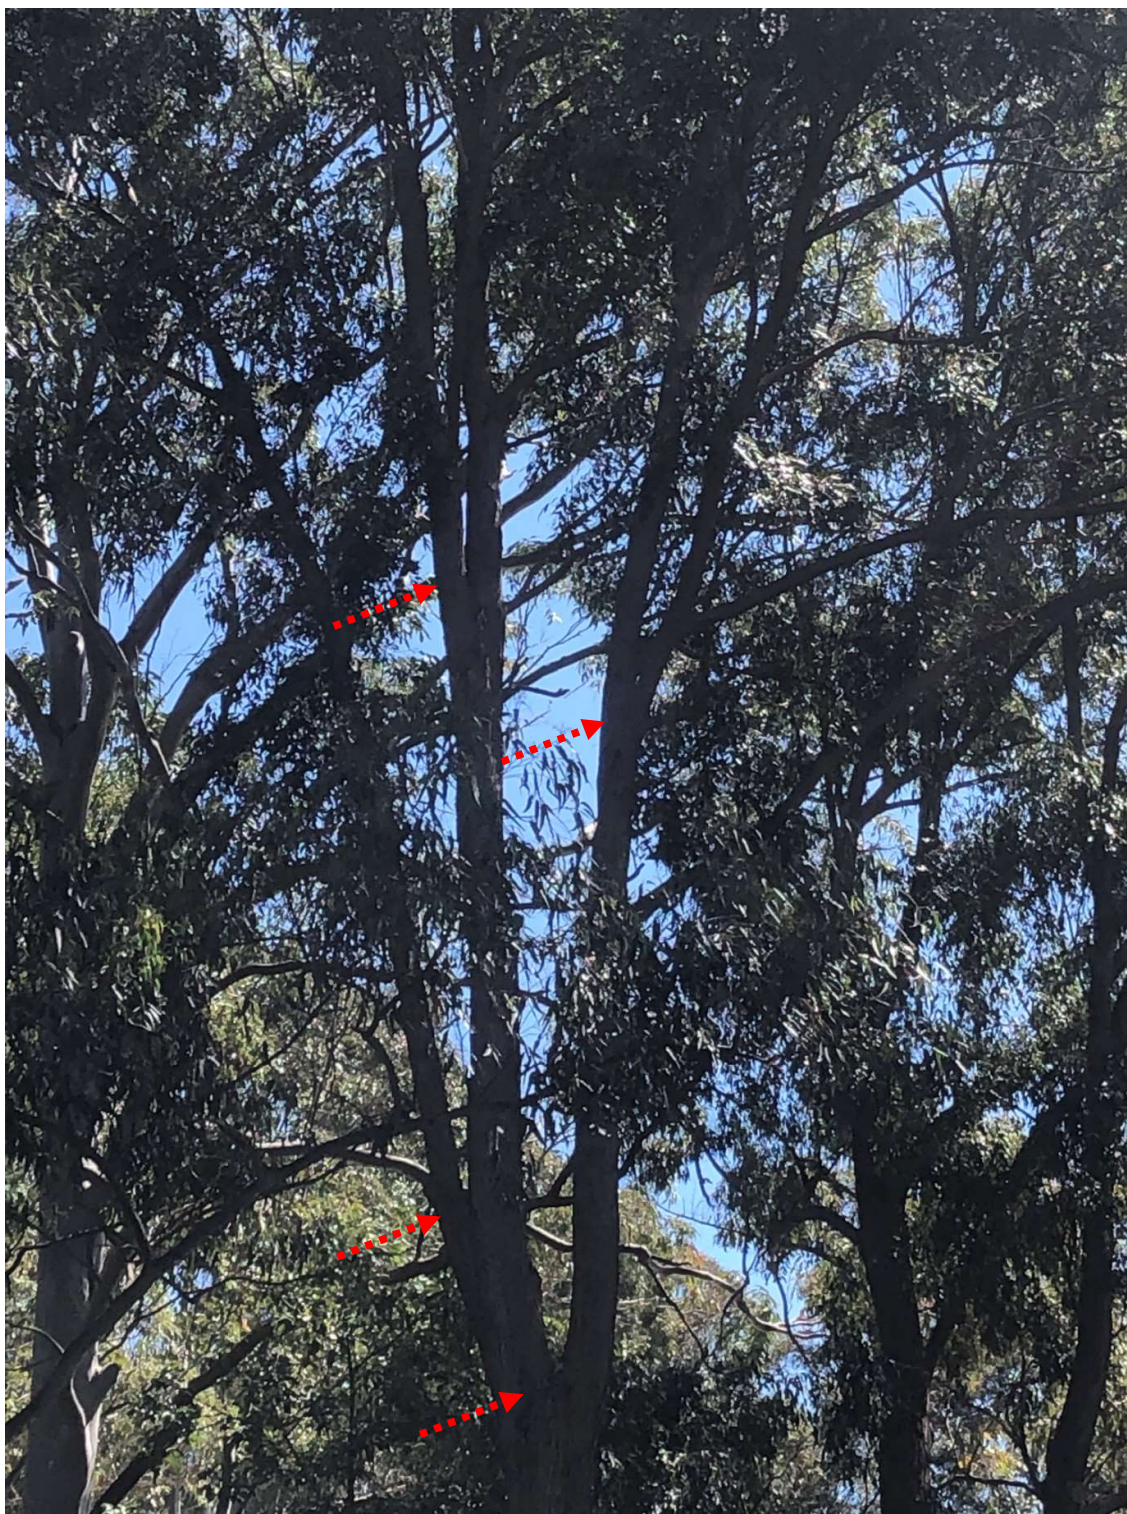
PHOTO 27 (E)

Tree 13 - Eucalyptus microcorys - trunk inclusions at 6 metres and 10 metres.

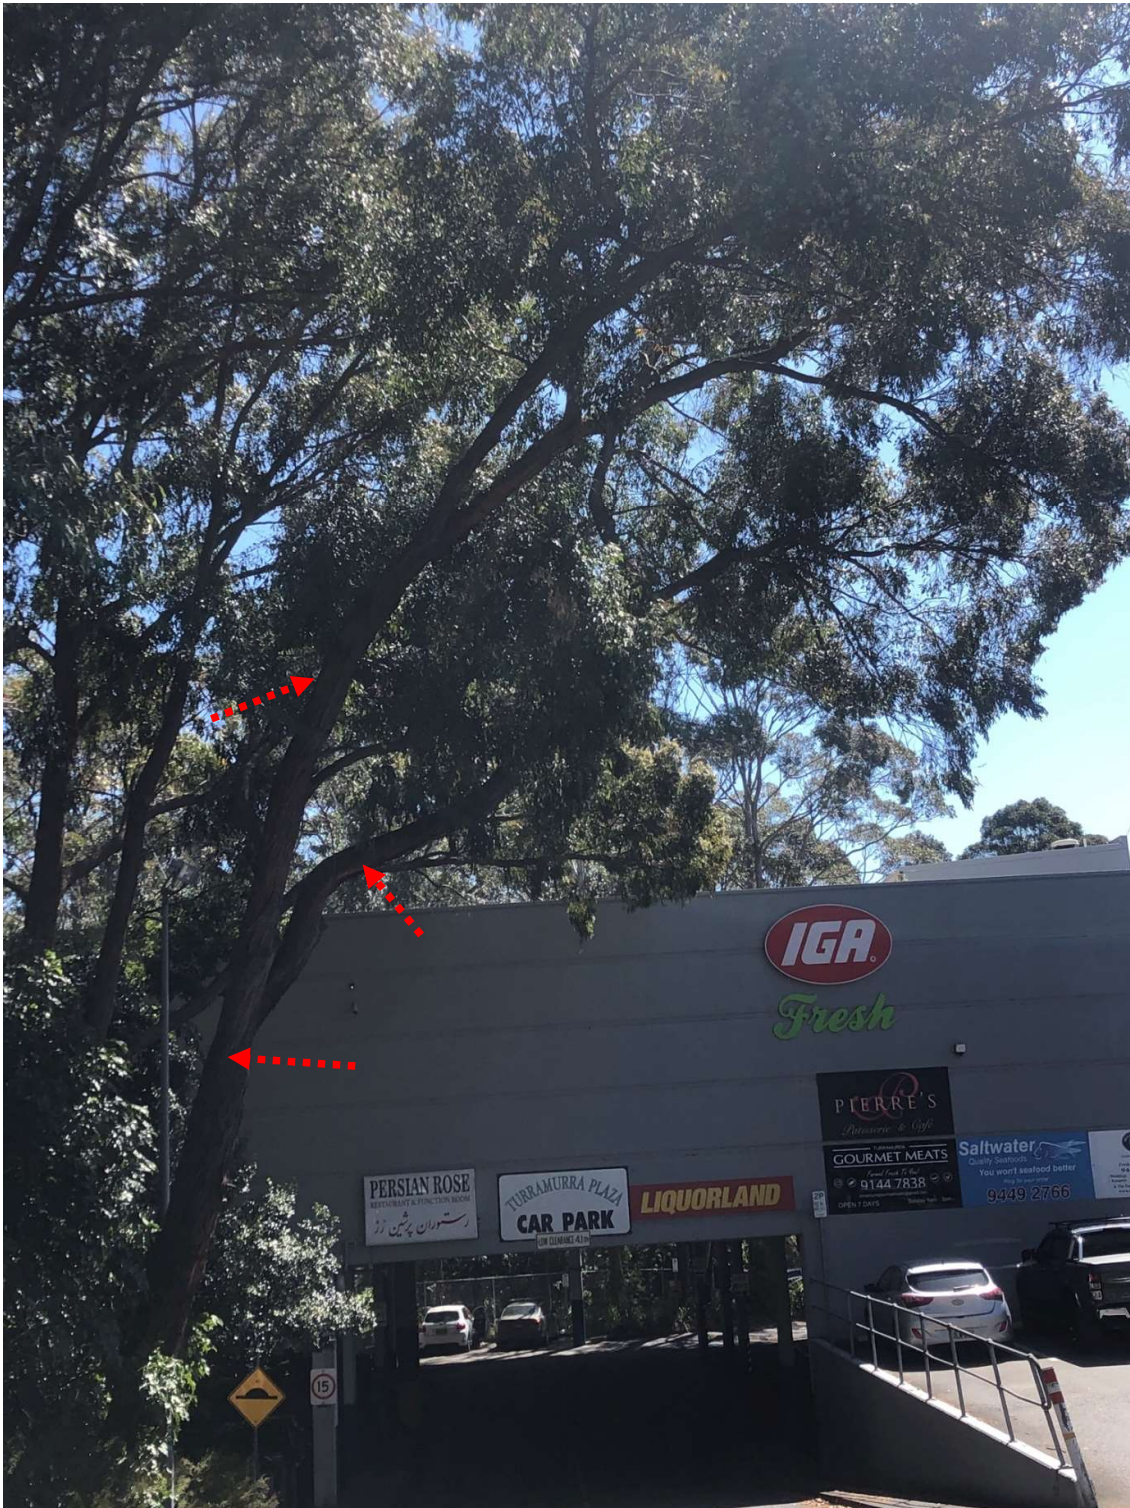
PHOTO 28 (F)

Tree 13 – Eucalyptus microcorys - major lean over road.
