PRELIMINARY CONTAMINATED SITE INVESTIGATION

Stratheden Project Area

777 to 815 Manilla Road, Tamworth NSW 2340

March 2024

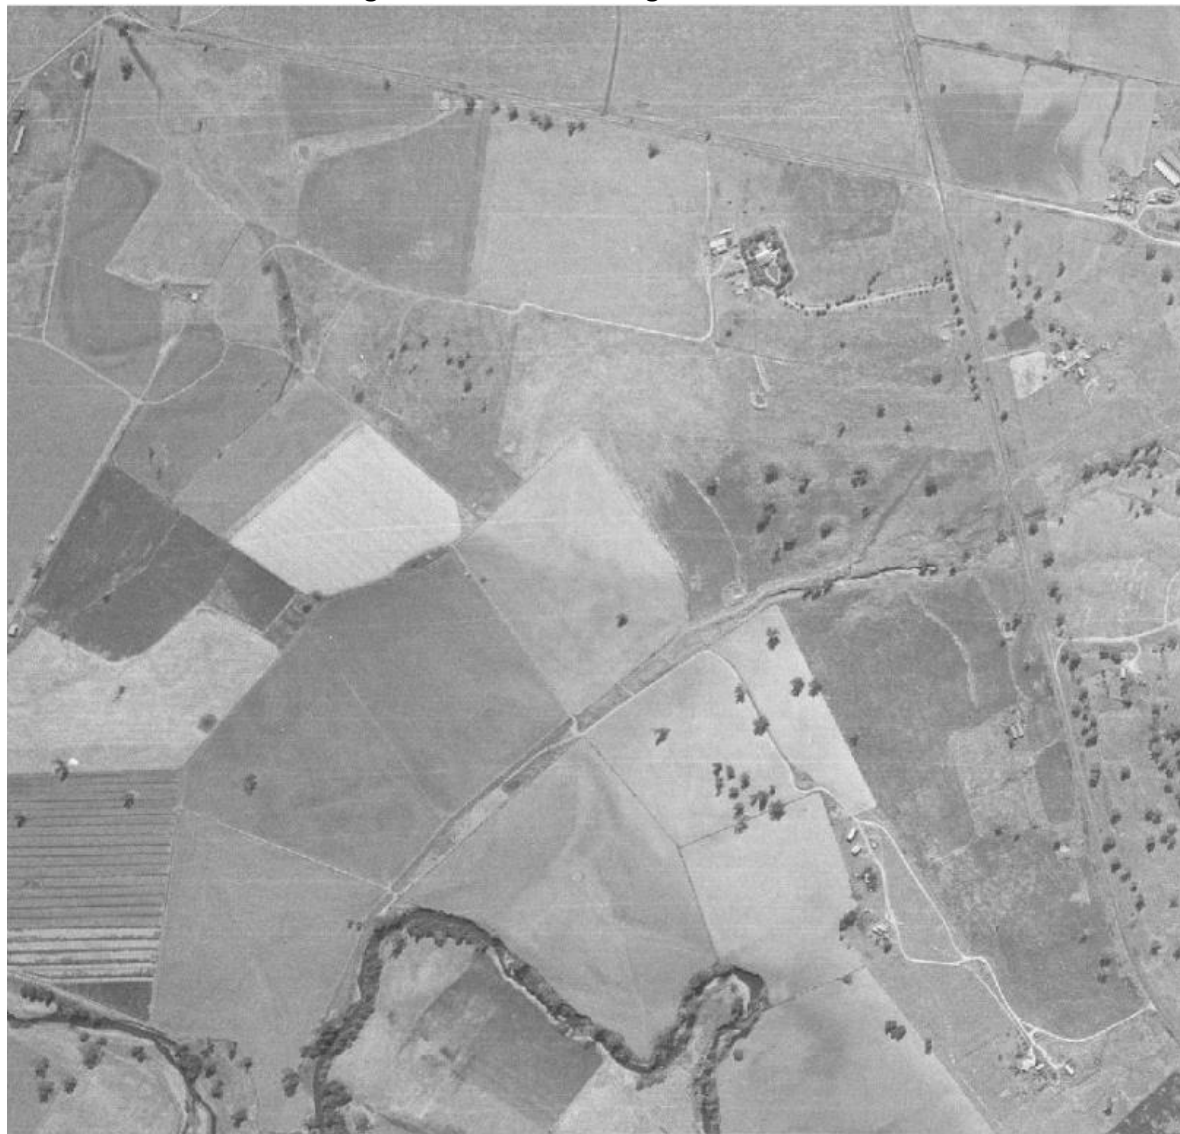
Figure 2: 1976 Aerial image of Stratheden.

Historical aerial images were accessed to review historical development on the property. The images available start in 1976. This image presented in figure 2 shows the main homestead and surrounding horse related infrastructure. Paddocks contain a few horse shelters and self-

feeders. Only one small shed is present in the western part of the property. Approximately one third of the property was cultivated. The remainder appears as natural or improved pasture. The buildings in this photo remain in place. There is no residence at 783 Manilla Road or sheds on 777 Manilla Road in this 1976 aerial image.

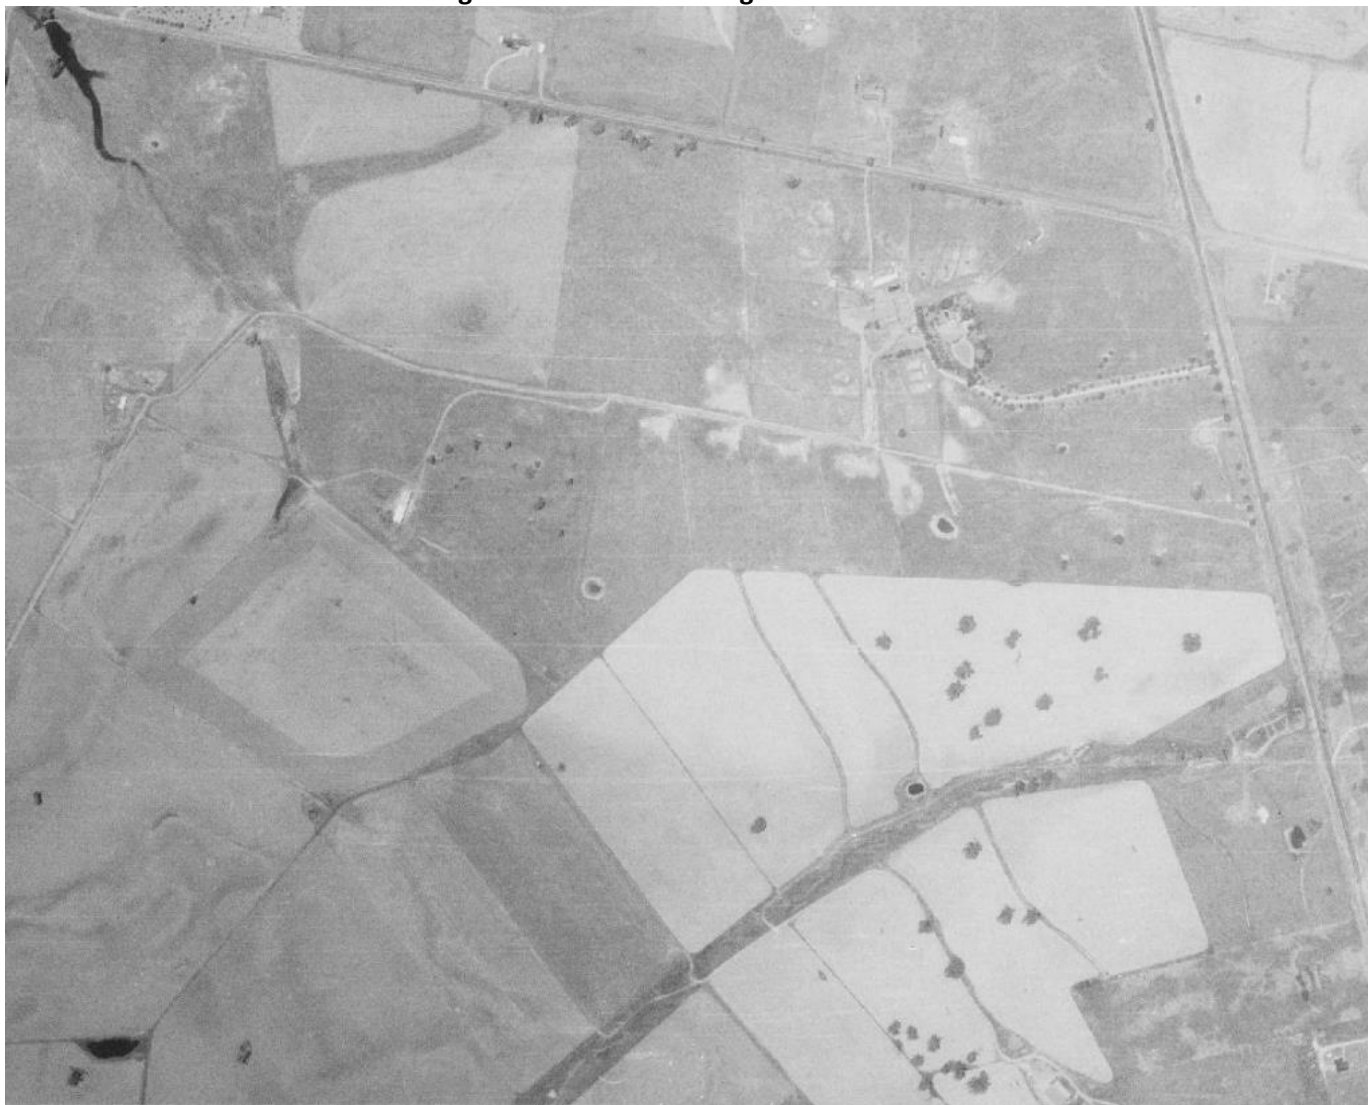
Figure 3: 1984 Aerial image of Stratheden.

A 1984 aerial image presented in figure 3 shows some minor expansion of the horse facilities and hay storage on Stratheden. The second house and main hay shed appear in this image. No buildings are present on 777 or 783 Manilla Road. All ground disturbance can be related to grazing animals, roads, cultivation and old stock dams. No structures of concern are present.

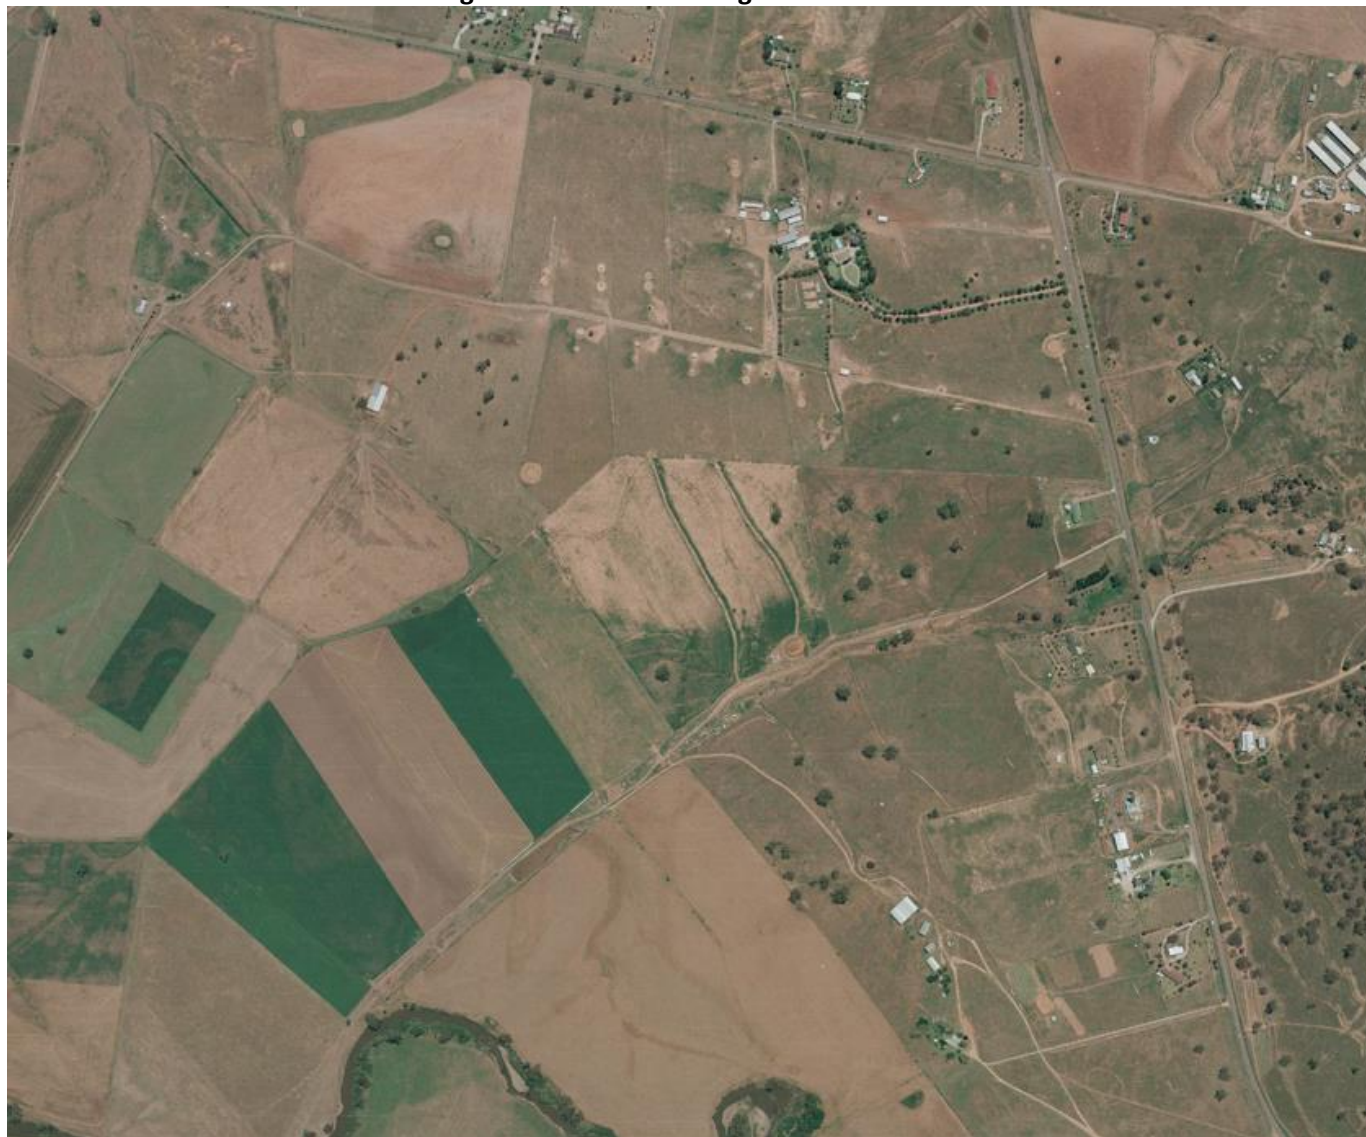
Figure 4: 1993 aerial image of Stratheden.

The 1993 aerial image presented in figure 4 shows further expansion of the horse related infrastructure on Stratheden including additional stables, horse shelters and self-feeders. All additions relate to the horse enterprise. The house at 783 Manilla Road appears in this image. The sheds on 777 Manilla Road appear in the image.

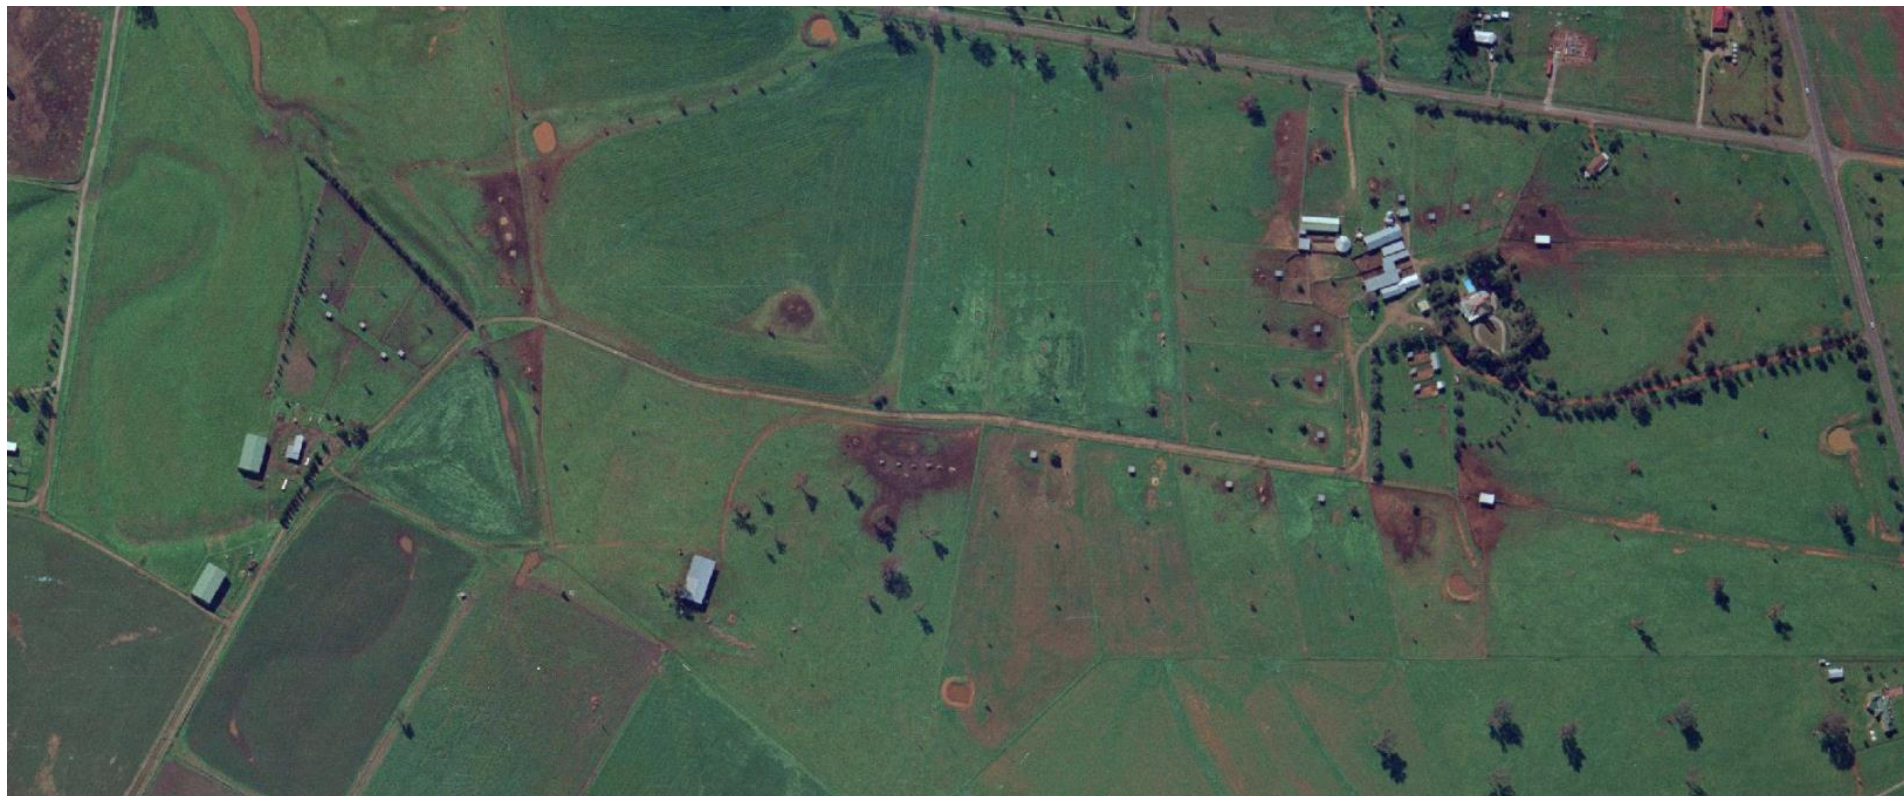
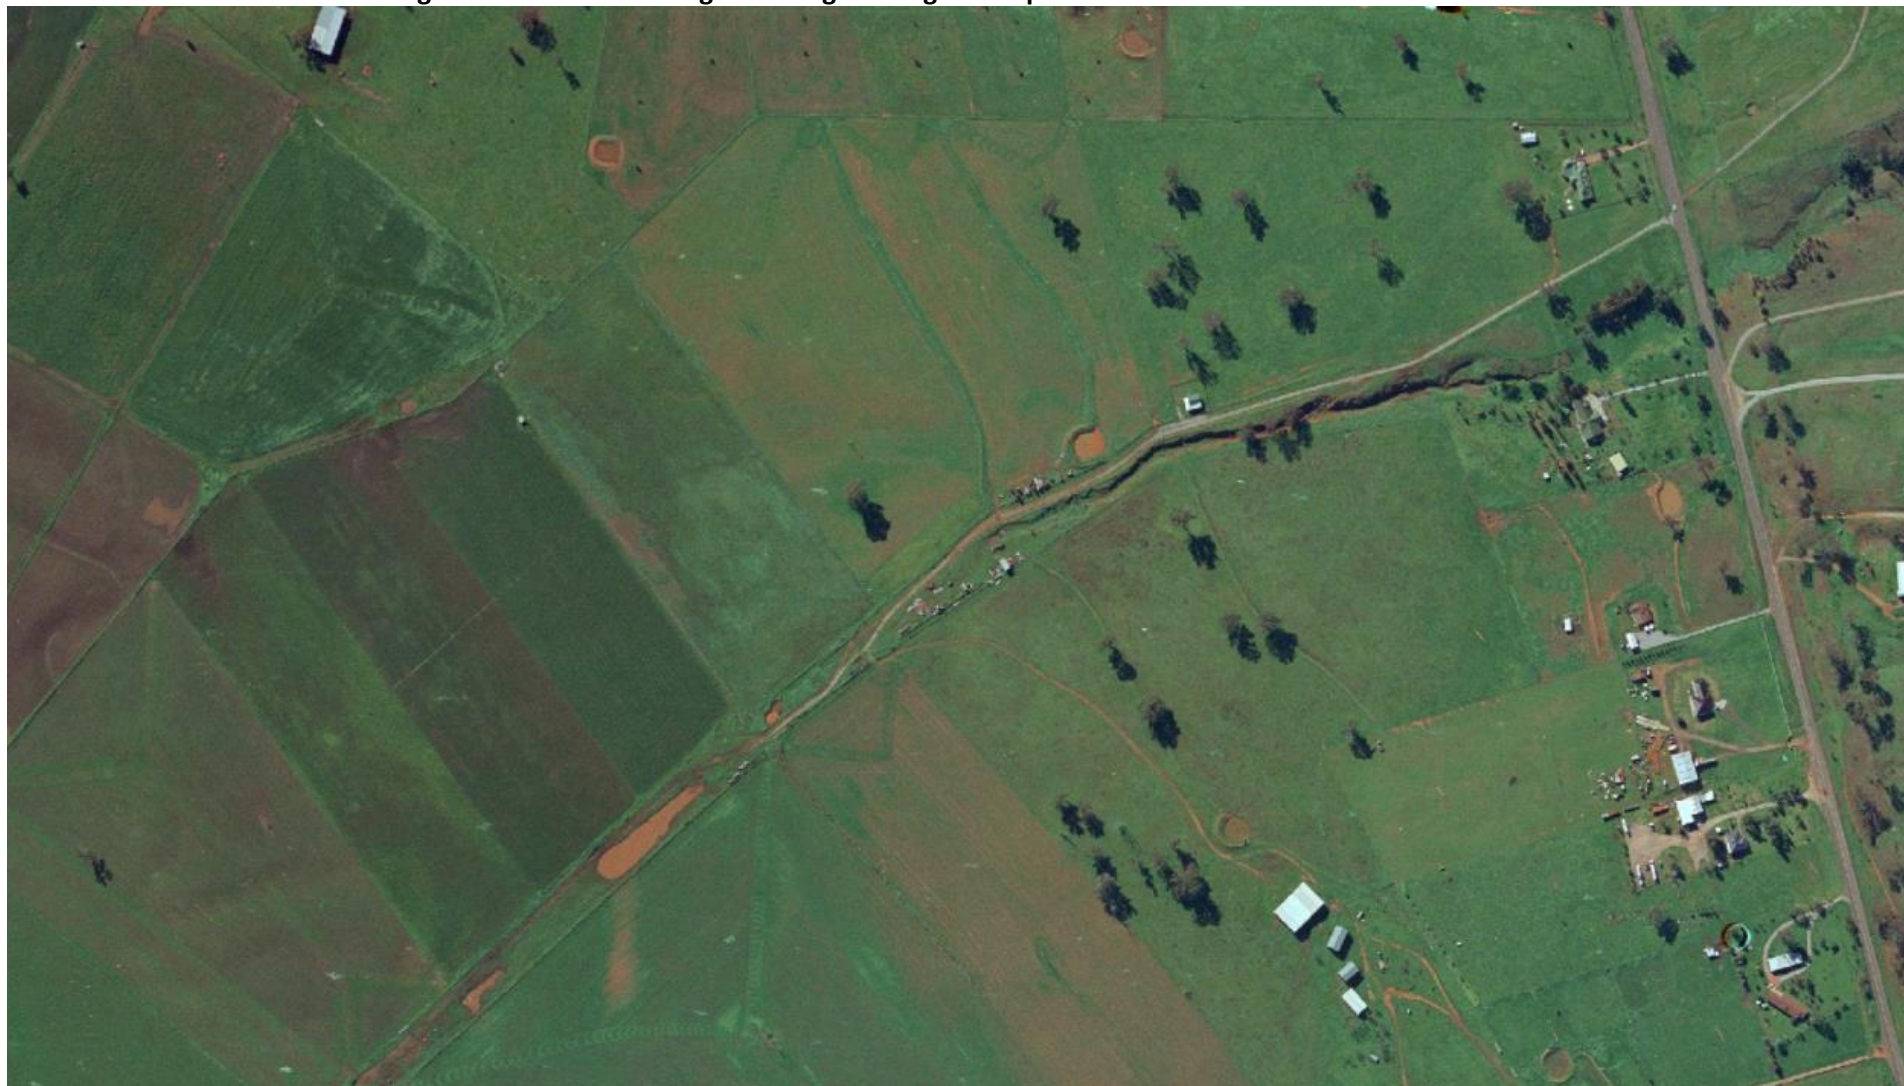
Figure 5 and 6 provide aerial images of the northern and southern sections of the investigation area from 1998. These images show similar development to 1993 under a wet season where grass and crop is present. Minimal additional buildings are present other than a worker's cottage and additional hay storage sheds associated with the irrigated cropping area.

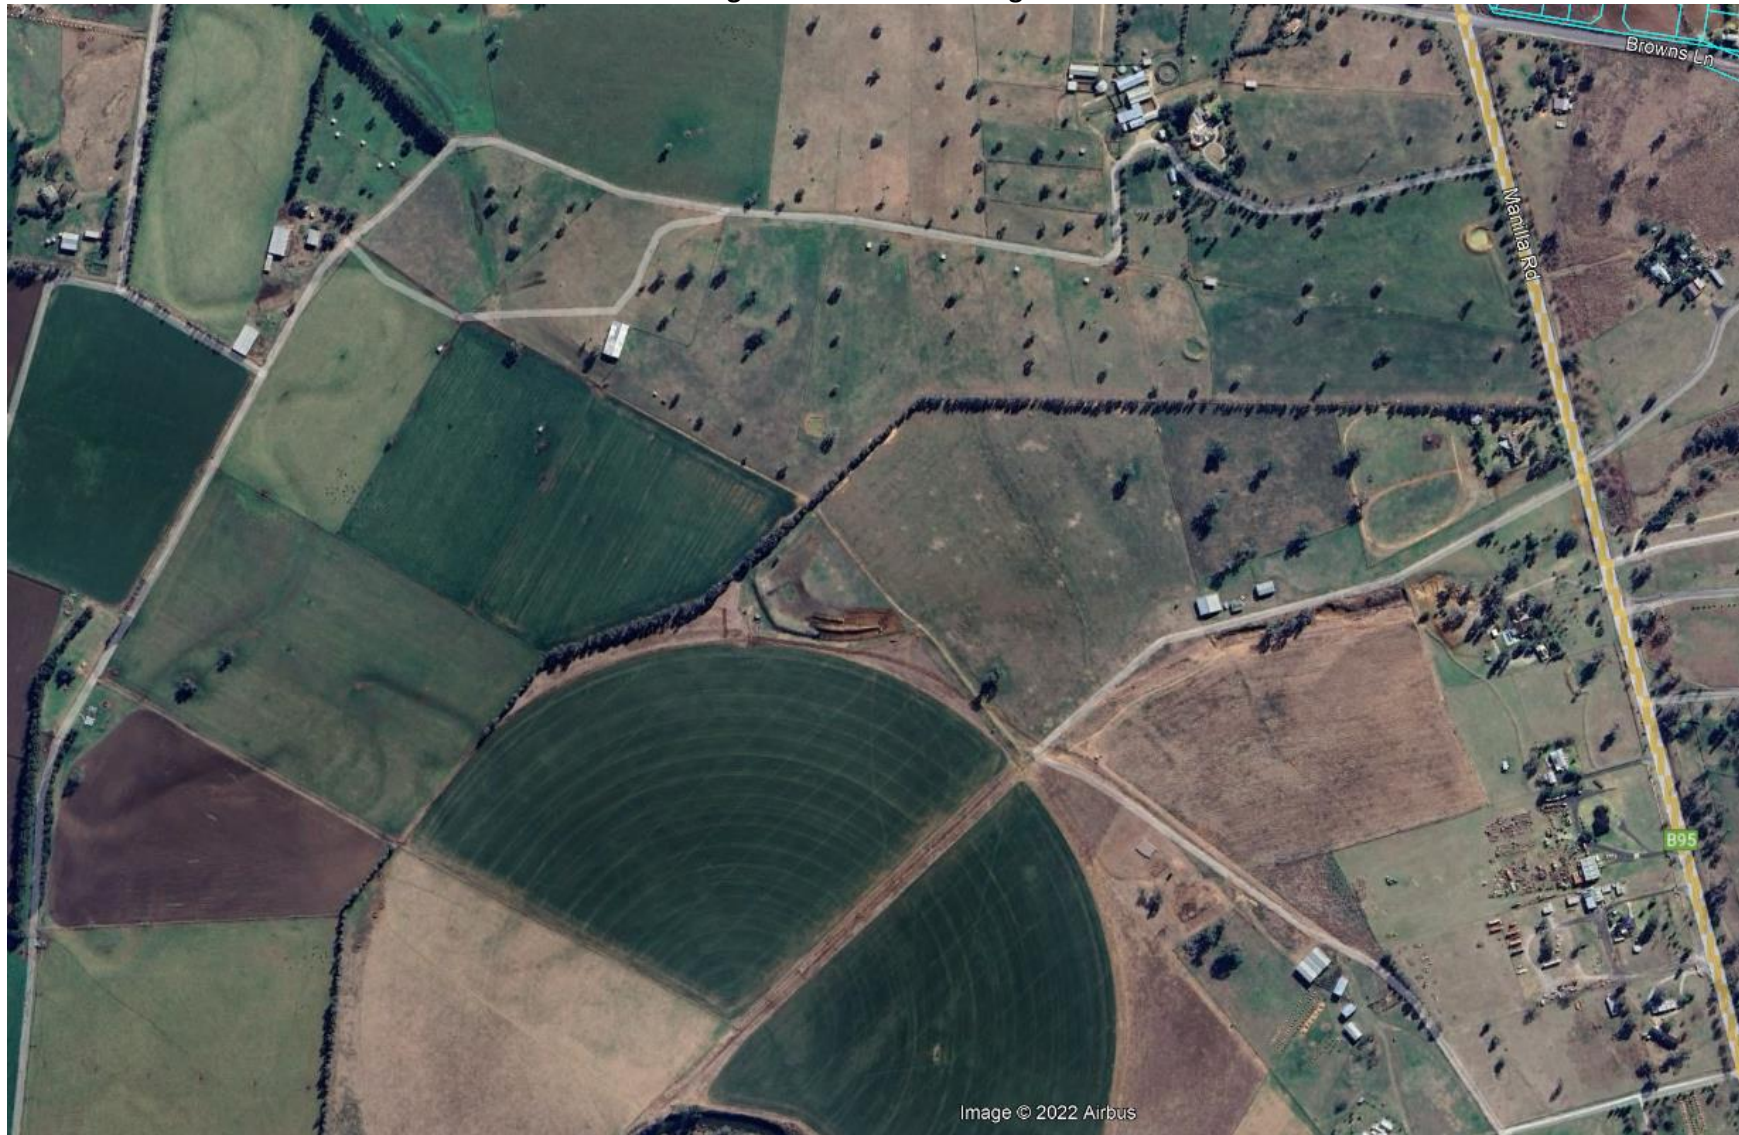
Figure 7: 2022 Aerial image.

A 2022 image shows minor changes. Additional training facilities have been added to the structures around the Stratheden homestead.

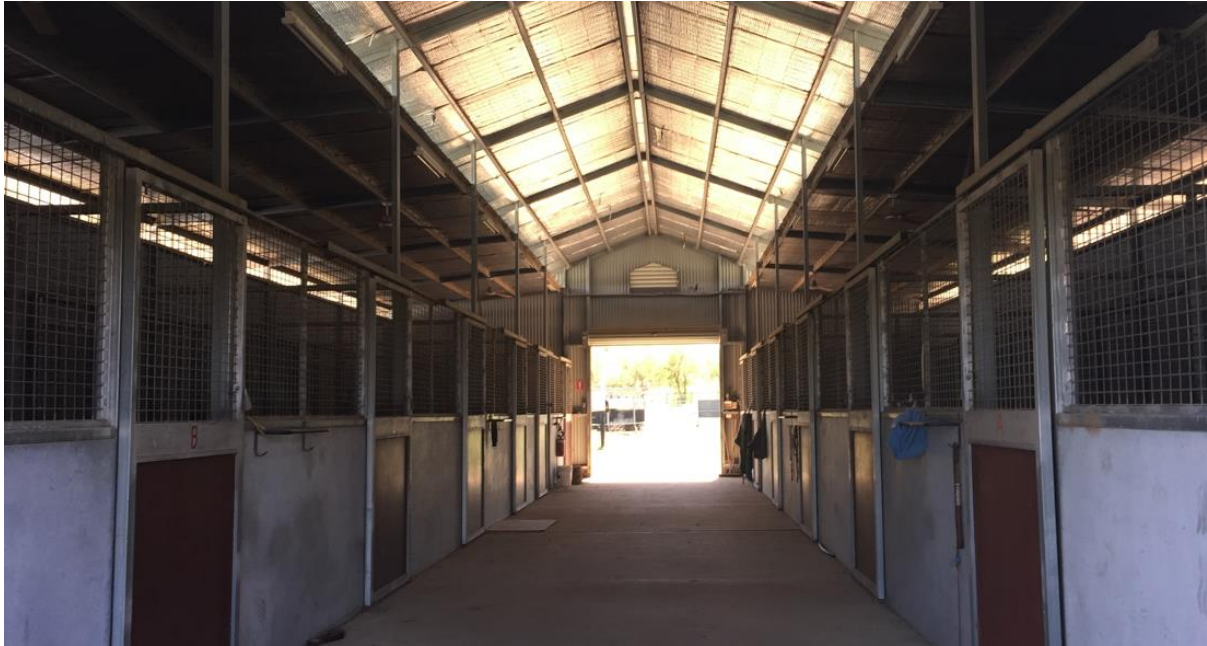
Figure 8: Existing horse stables adjacent to main homestead.

The breeding of horses does not require the use of chemicals that may present a long-term risk of ground contamination.
