30 August 2024

**Re: Riparian Assessment, 27 North Marshall Mount Road, Marshall Mount, 2530**

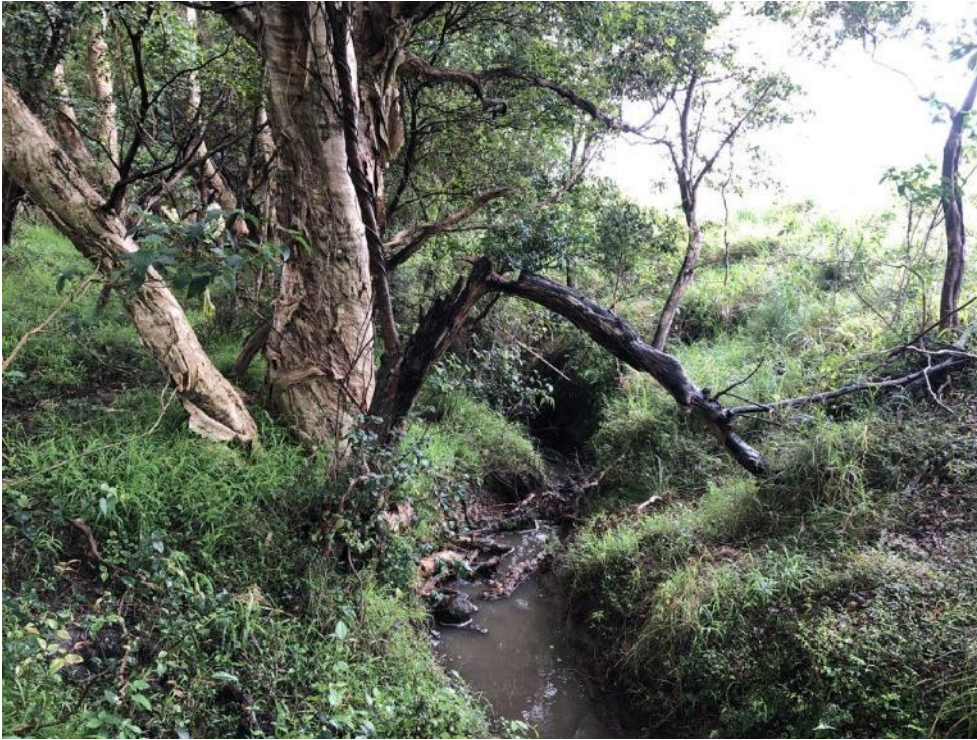
A small section of bed and bank was identified in Reach 2. The bed and bank is located in an area of native vegetation and mapped as C2 under the WLEP (**Figure 7**). No bed and bank was evident upstream or downstream of this location (**Figure 8** and **Figure 9**). The mapped watercourse on the Statewide topographic map has been dammed in the past, and the overflow diverted into the bushland where the bed and bank are now observable due to erosion. The location of this watercourse is not the natural state of the overland flowpath, and presently (in high flow periods) is eroding the substrate below the extant vegetation in this part of the property.

**Figure 7: Eroded bed and bank, with bank slumping – Reach 2.**

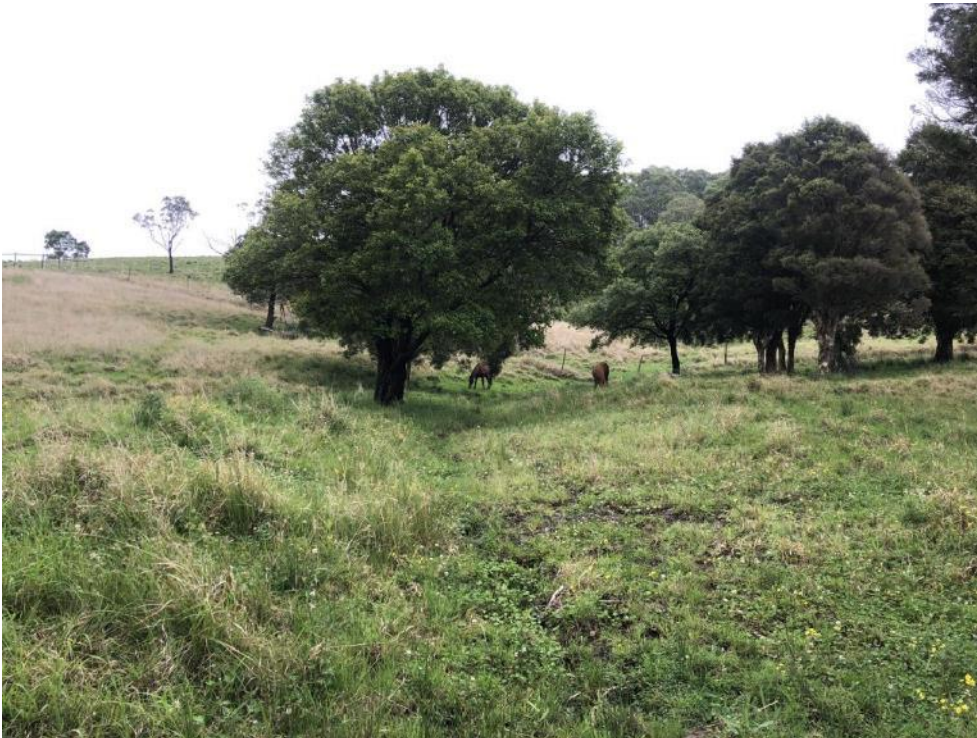
**Figure 8: No bed and bank - downstream of Reach 2**

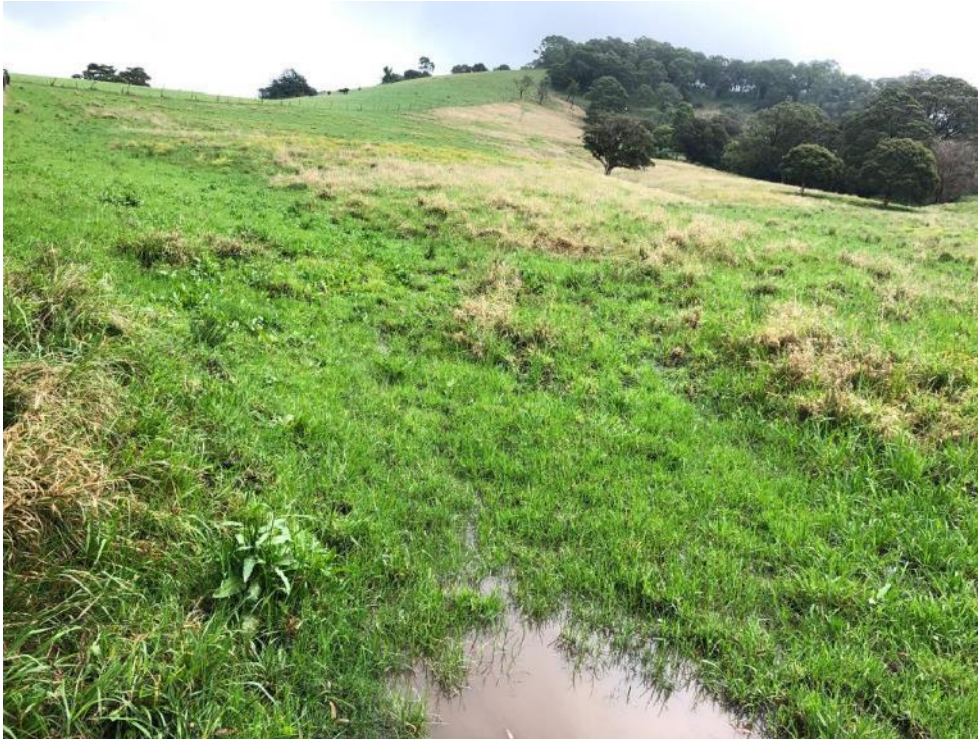
**Figure 9: No bed and bank - upstream of Reach 2**

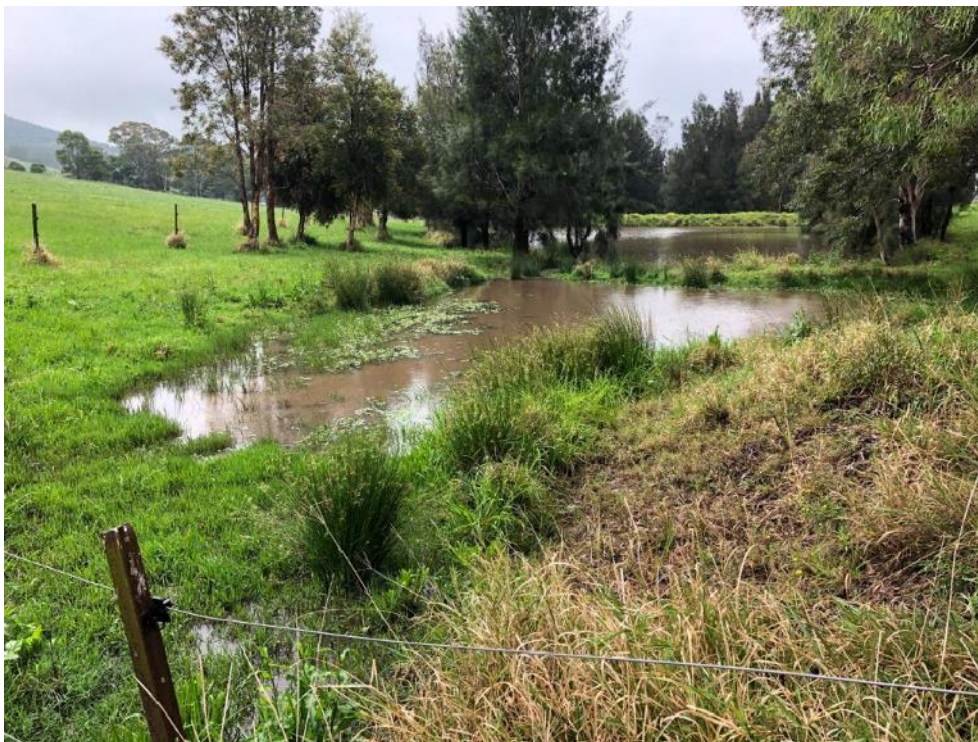
Reach 3 is comprised of several dams in degraded condition. Some vegetation is present adjacent to the most downstream of the dams (**Figure 10**). Directly upstream of Reach 3 (Reach 2) shows no discernible bed and bank (**Figure 8**). ToB was not mapped for Reach 3 due to the size of the dams present, however a nominal centre line was used to map riparian corridor widths.

**Figure 10: Reach 3 dams**

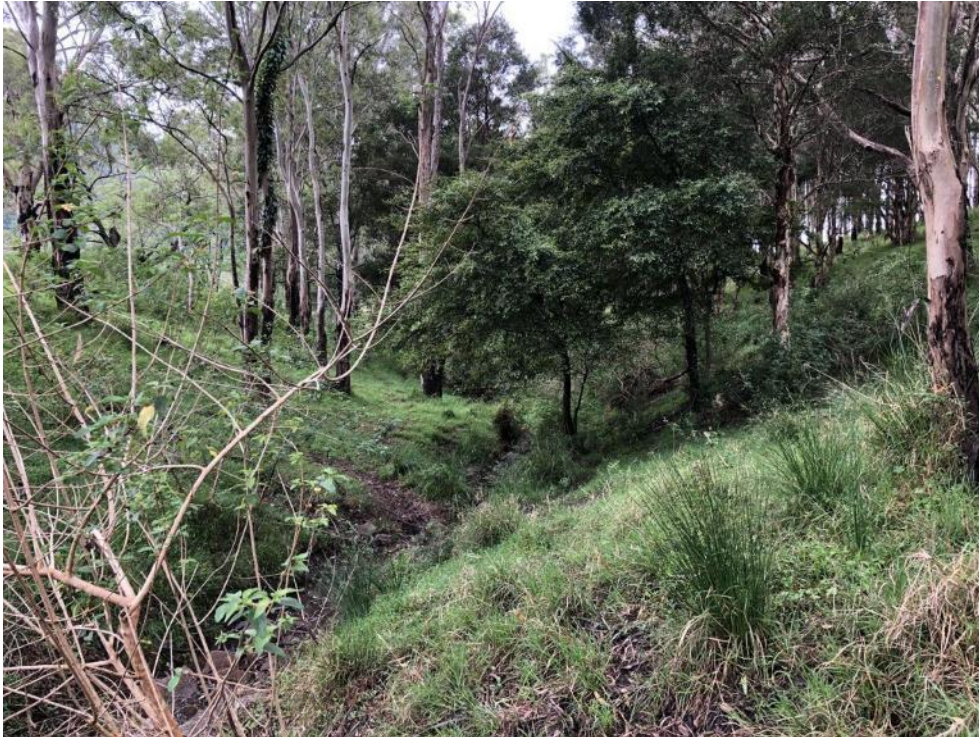
Reach 4 had confirmed bed and bank along much of the mapped watercourse length (**Figure 11** and **Figure 12**); however, bed and bank was not identified in the far upper stream component of Reach 4. Bed and bank was also evident in Reach 5; however, as with Reach 4, the upper component of Reach 5 had no mapped bed and bank (**Figure 13**). The confluence of Reach 4 and Reach 5 was confirmed to be further north than previously mapped, with Reach 5 also lying further west than previously identified.

**Figure 11: Bed and bank - Reach 4**

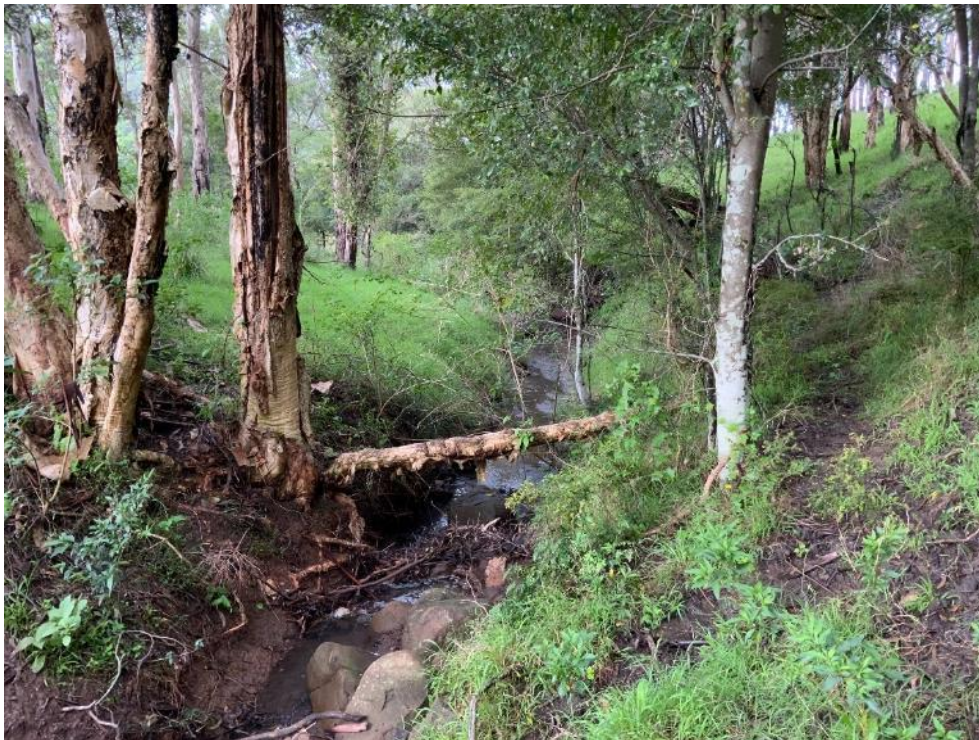
**Figure 12: Bed and bank - Reach 4**

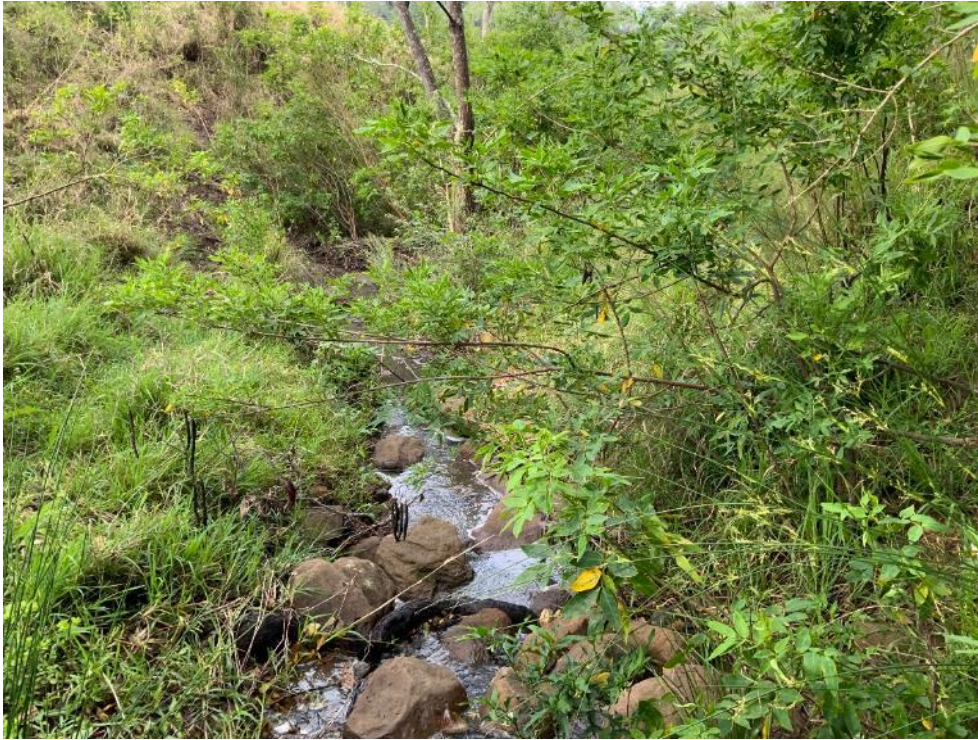
**Figure 13: Bed and bank - Reach 5**

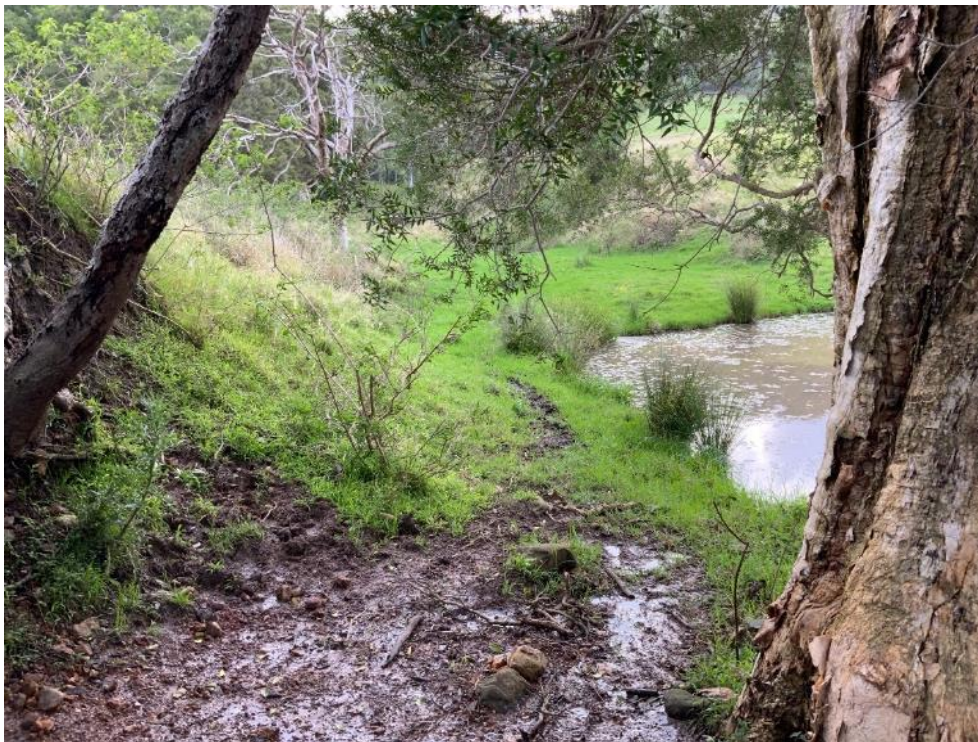
Bed and bank was confirmed in Reach 6, with the reach terminating in a dam on North Marshall Mount Road (**Figure 14**). The results of the ToB mapping within the study area are displayed in **Figure 15**.

**Figure 14: Dam - Reach 6**

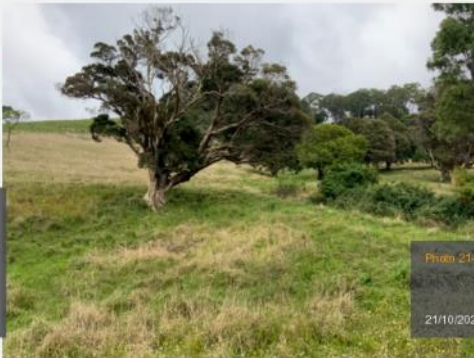
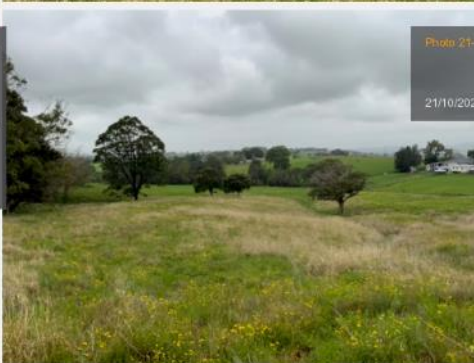
The site is in poor condition, with a raw score of -31.9 (49%) overall. The bed type is grass - G. The bank type is grass - G.

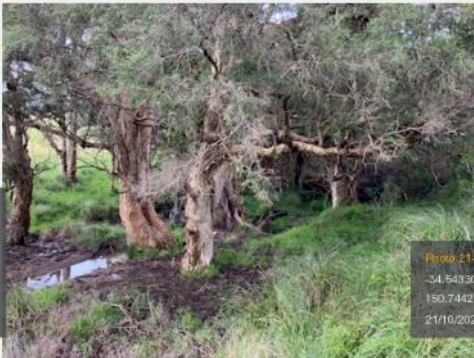
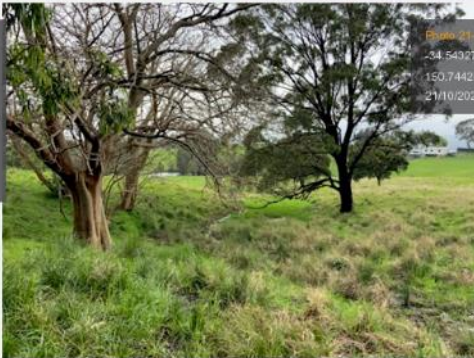
The site is in poor condition, with a raw score of -28.5 (50%) overall. The bed type is grass overflow - Go. The bank type is grass - G.

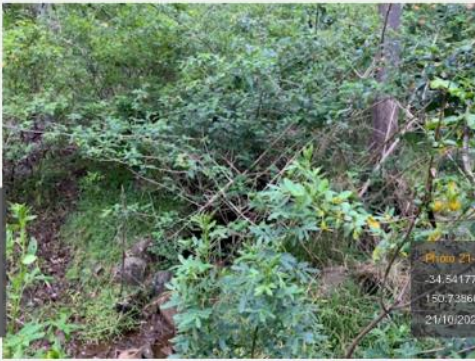
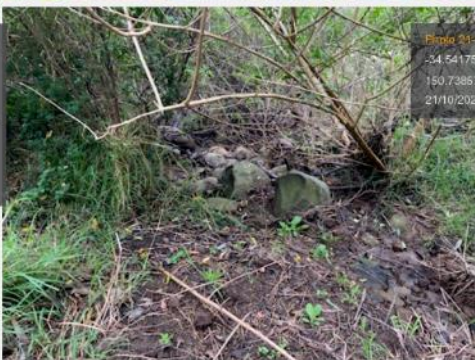
The site is in very poor condition, with a raw score of -42.45 (44%) overall. The bed type is natural bed mud - Nvm. The bank type is grass - G.

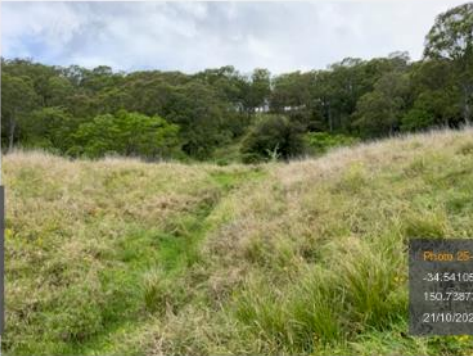
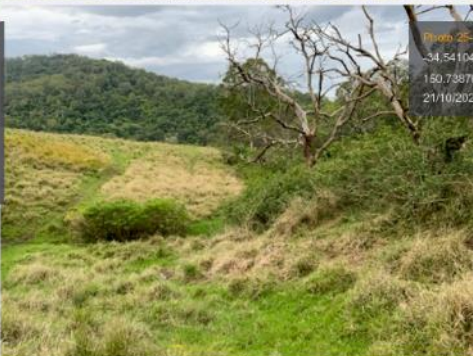
The site is in very poor condition, with a raw score of -44 (44%) overall.

Within the 50 metre assessment radius, left bank vegetation structure is 60% weed/exotic, 40% pasture grassland, approximately. Right bank vegetation structure is 60% pasture grassland, 40% weed/exotic, approximately. This is reflected in the vegetation structure subtotal.

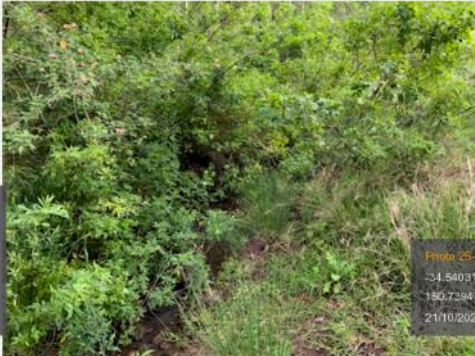
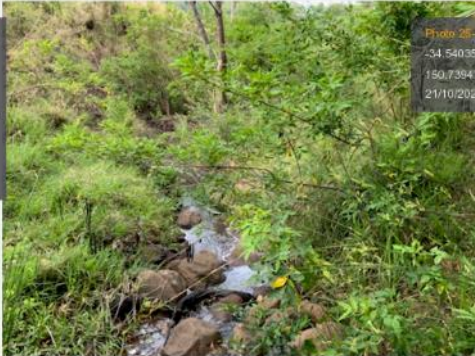
The site is in poor condition, with a raw score of 0 (61%) overall. The bed type is natural bedrock. The bank type is grass - G.
