**Proposed Mixed Development  
11-15 Deane St & 20 George St, Burwood**

Report on  
Preliminary Geotechnical Investigation

1623-A  
19 February 2011

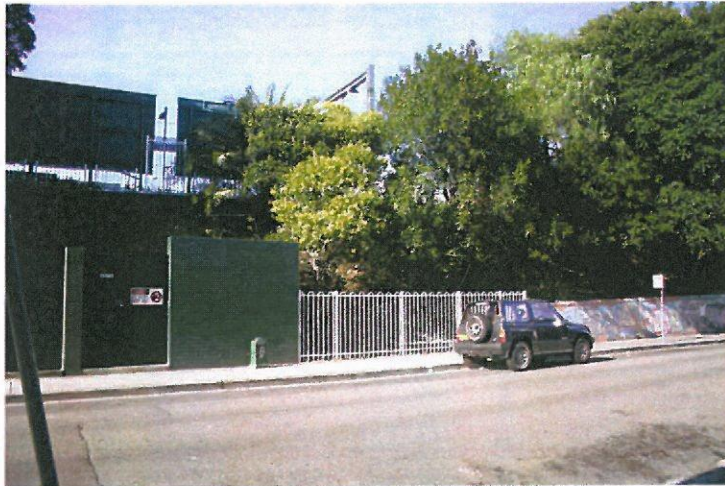
embankment between the platform and the retaining wall appears to comprise soil filling. The brick retaining wall is in overall moderate condition with some cracking observed.

**Plate 2 - view of railway corridor showing electricity substation and brick retaining wall**

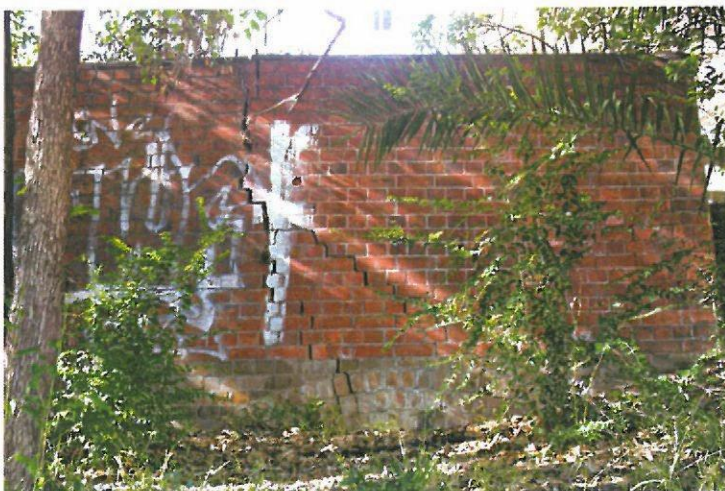
A brick wall located within the corridor just north of the platform is in poor condition with significant cracking observed (see Plate 3). The brick work at the base of the wall indicates an archway which may have been subsequently buried or backfilled.

**Plate 3 - view of damaged brick wall within railway corridor adjacent to railway platform**

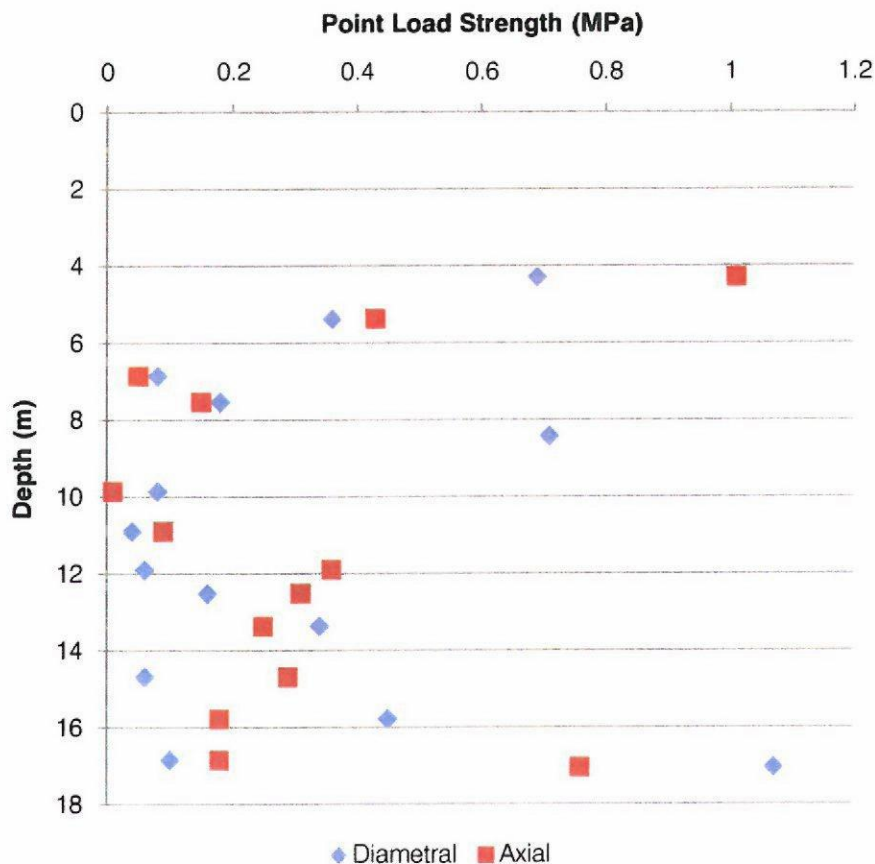
The point load strength index test results are attached and indicate values ranging from 0.01 MPa to 1.07 MPa (i.e. extremely low to medium strength). It should be noted that the diametral tests typically (but not always) failed along bedding planes and the axial tests failed through the rock fabric. The axial tests are therefore considered more representative of the rock substance strength.
