ROAD SAFETY AUDIT REPORT

Stage 5 (Existing Road)

GREENDALE ROAD, GREENDALE
(The Northern Road to Park Road)

JULY 2012

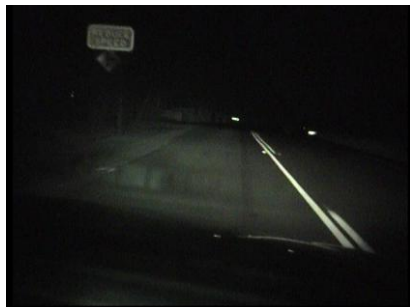
No.	Location	Description of deficiency	Photographic Record	Priority (L/M/H)	Accept	Response
1	General	For the whole length of Greendale Rd there is a general lack of consistency in the application of pavement markings (centre line, edge-lines and RRPM's), guideposts and signposting (curve warning and hazard boards).		H		
2	General	Apart from the junction with Wolstenholme Ave which is "Stop" controlled, there is no control at side streets i.e. Tyson, Dwyer, Vickery, Matingara, Davenport, Murroobah, Roma, Peter Pan, Eagle and Byron.		M		
3	General	<p>A number of signs have lost reflectivity, probably due to age, and are therefore not visible at night. These include:</p> <ul style="list-style-type: none"> • "Road narrows" sign at Ch.0.44 southbound; • T-junction sign at Ch.6.92 southbound (pictured – located under the Reduce Speed sign); • Hazard boards at Ch.14.14 southbound.

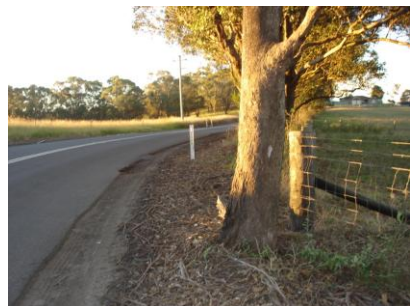
L		
4	General	<p>There are non-frangible objects in the clear zone. RTA/Pub.11.097 Fig 6.1 shows clear zone for roads with <1000 AADT at 80kph is 4m.</p> <p>Example: tree at Ch.5.40 looking north is 2m from the pavement edge. Also note, vehicles have been travelling off the pavement.</p>

H

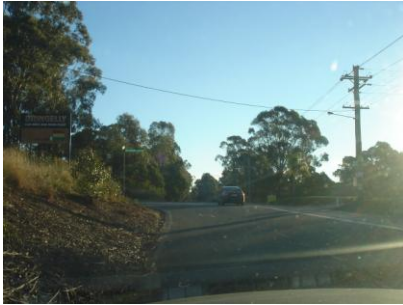
No.	Location	Description of deficiency	Photographic Record	Priority (L/M/H)	Accept	Response
5	Approach to Medway Rd (Ch.0.60)	Slip lane markings are very worn and are not visible at night.

L		
6	From Ch.1.04 to Ch.8.85	There are no edge-lines to provide driver guidance. This is particularly a hazard under night conditions and likely to contribute to run-off-road incidents. Photos show transition at Ch.8.85.

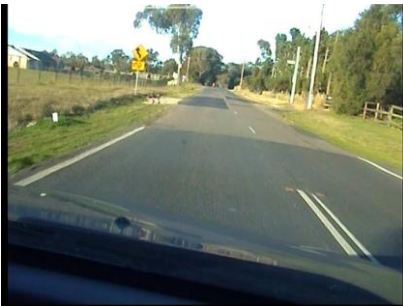
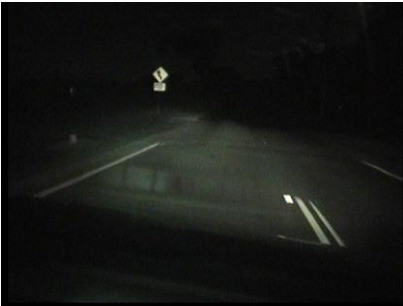
H

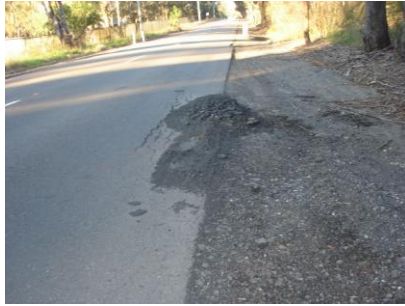
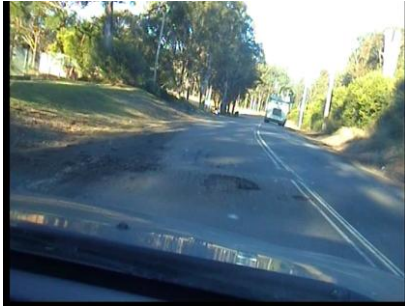
No.	Location	Description of deficiency	Photographic Record	Priority (L/M/H)	Accept	Response
7	From Ch.1.20 to Ch.8.85	<p>There is intermittent pavement failure, including pot-holing and pavement edge failure. Pot-holes are a particular hazard for motorcycles.</p> <p>Examples: Photo 1 at Ch.1.20 looking south; Photo 2 at Ch.7.18 looking south.</p>

H

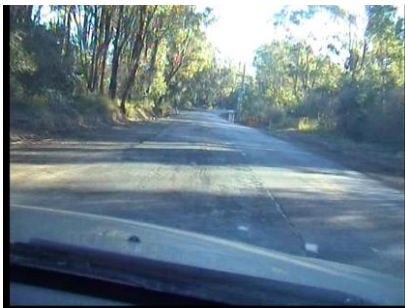
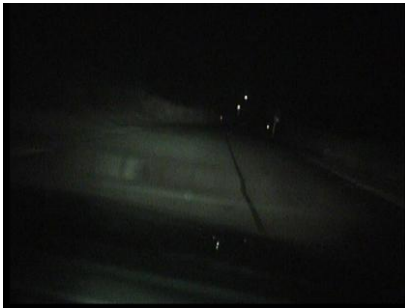
No.	Location	Description of deficiency	Photographic Record	Priority (L/M/H)	Accept	Response
8	From Ch.1.33 to Ch.8.85	<p>Some pavement remediation has been undertaken but centre line markings have not been reinstated resulting in loss of pavement definition, particularly at night.</p> <p>Examples: Photo 1 at Ch.1.90 northbound. Photo 2 at Ch.7.12 northbound at night.</p>

H		
9	Tyson Rd (Ch.1.74)	There are no advance T-junction signs in either direction.		L		
10	Tyson Rd (Ch.1.74)	Greendale Rd signposting is damaged.

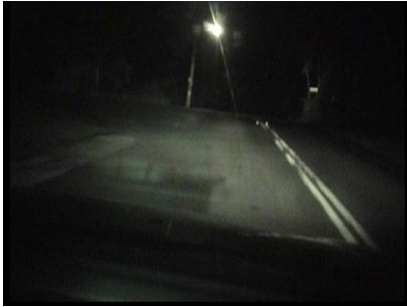
No.	Location	Description of deficiency	Photographic Record	Priority (L/M/H)	Accept	Response
11	Dwyer Rd (Ch.3.06)	There is no advance T-junction sign in the southbound direction. There is a wide expanse of uncontrolled pavement. Driver perception of place on roadway would be assisted by a continuity line.

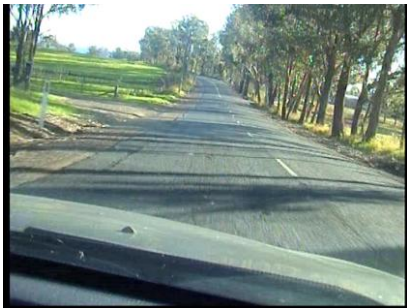
L		
12	Ch.4.58	The pavement northbound narrows without warning.

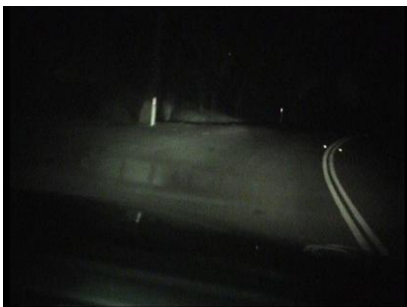
L		
13	Ch.5.12	There is no warning of the curve in southbound direction and it is not properly delineated in either direction.

H

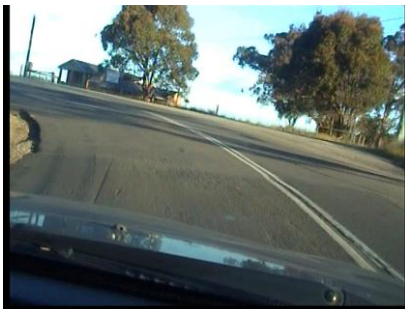
No.	Location	Description of deficiency	Photographic Record	Priority (L/M/H)	Accept	Response
14	Ch 5.30	Curve is not delineated in southbound direction for daylight conditions although there is overhead lighting at night.

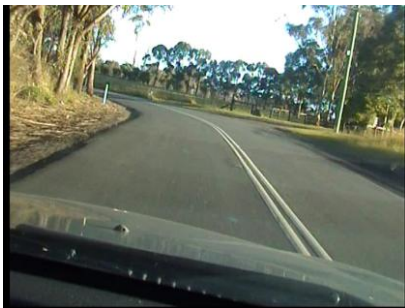
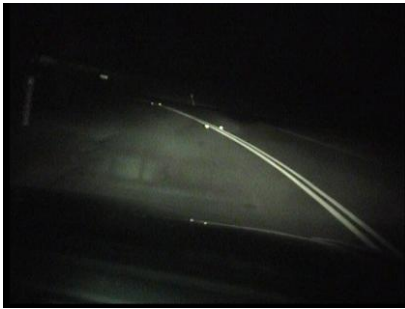
L		
15	Ch.5.40	Curve is not delineated in southbound direction. As it leads into the curve at Ch.5.30 it is considered that advance warning of curve and advisory speed of 35kph should commence here.

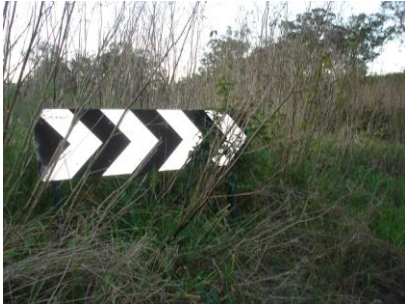
No.	Location	Description of deficiency	Photographic Record	Priority (L/M/H)	Accept	Response
17	Ch.11.50	Visibility of chevron board is obscured by grasses.

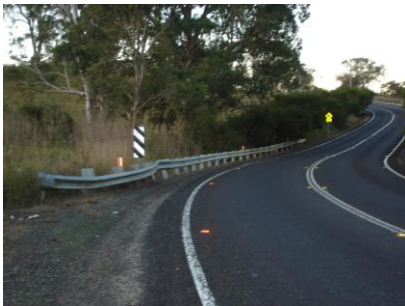
L		
18	Ch.11.50	Guardrail has been damaged. End terminals are redundant type.

M		
19	Ch.11.50 eastern side	Hazard marker has been damaged.

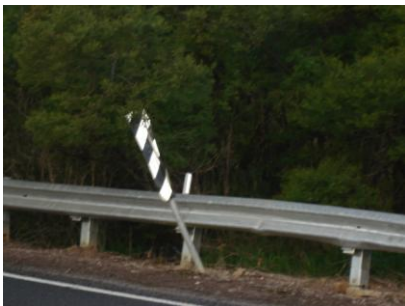
L

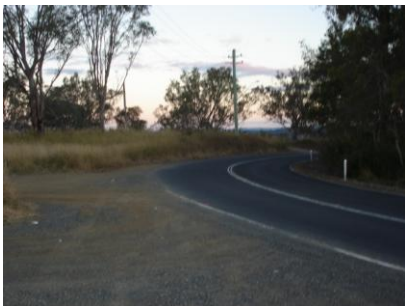
No.	Location	Description of deficiency	Photographic Record	Priority (L/M/H)	Accept	Response
20	Ch.12.88 (property #723)	There is no advance warning in the southbound direction. Curve has no delineation in either direction. Edge-line has been lost on curve.

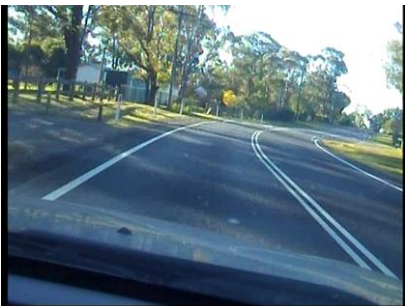
H		
21	Ch.13.88	In northbound direction 50kph regulatory signs are around curve without advance warning of the change in speed limit.		H		
22	Matingara Way (Ch.15.16)	This intersection is part of Bus Route 759 to Warragamba. Night delineation is good but in daylight there is no advance warning of the turning lanes and it is a surprise around the curve.

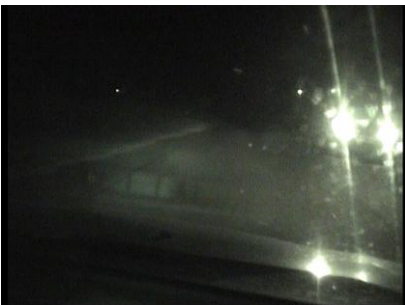
M		
23	Ch.15.27 to end.	Centre and edge-line markings terminate abruptly at 15.27. Overhead lighting is poor and at night a driver is not confident about vehicle position in the roadway, particularly with on-coming vehicle headlights. It is believed this area is within the administrative boundaries of Penrith Council. The road is in a residential precinct and a high non-compliance to the regulated 50kph speed was observed.

H
