Tree Report

**West Pymble Indoor Pool Facility
Ku-ring-gai Bicentennial Park, West Pymble
Revision 3**

For Colston Budd Hunt & Kafes Pty Ltd

December 2010

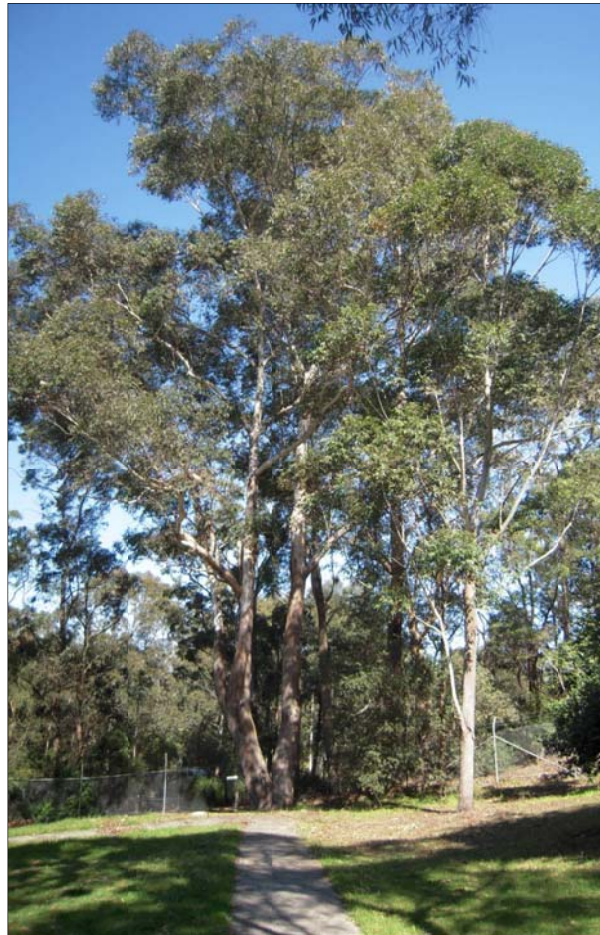
Plate 1: Tree 1 (left)
and Tree 6 *Eucalyptus pilularis*
(Blackbutt)

Tree 1 *Eucalyptus pilularis* (Blackbutt) is a mature specimen in good health and in fair structural condition, with a codominant junction between the subtrunks. It is located immediately to the south of the proposed building. The footing would be located approximately 6m to the north of the trunk, within the theoretical tree protection zone radius of approximately 12m (for a tree with a combined trunk diameter of 1m as defined in Australian Standard AS 4970 *Protection of trees on development sites*). Accordingly a root investigation by means of hand excavation was undertaken to ascertain whether root injury would occur, and the results are noted below.

The Bushfire Report recommends that a 5m clearance is maintained between buildings and tree crowns. Most of the trees concerned have a relatively high branch habit so that much of the crown which may overhang a roof is over 5m above the roof. Pruning required for clearance has not been specifically assessed but for this reason it is likely that any pruning required would not be drastic. Tree 1 *Eucalyptus pilularis* (Blackbutt) for example has few low branches to the north side of the trunk and achieving a 5m vertical clearance would not be difficult (Plate 1).

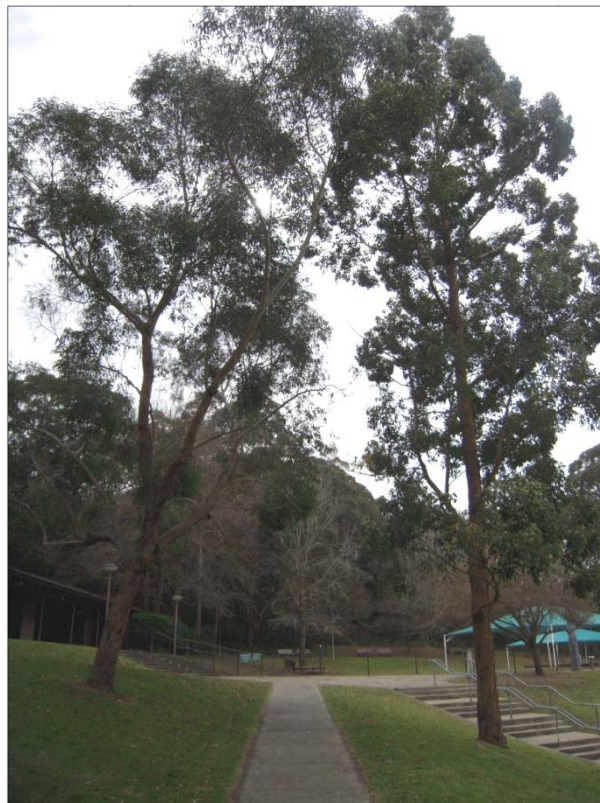
Plate 2: Tree 14 *Eucalyptus pilularis* (Blackbutt) left and
Tree 36 *Eucalyptus microcorys*
(Tallowwood)

Trees 21A and 36 *Eucalyptus microcorys* (Tallowwood) although in good health and condition are semimature examples of a native species which is not indigenous to the area.

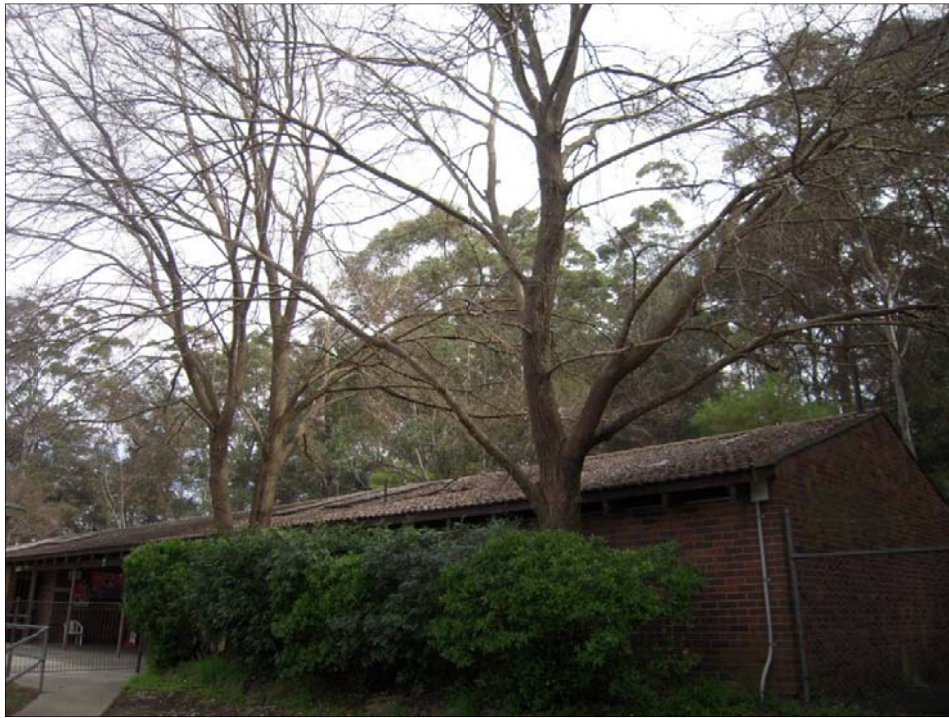
Plate 3: Trees 19 and 20 *Ulmus glabra* (Wych Elm)

Trees 17, 19, 20, 26 and 27 have some landscape significance, being semimature to mature specimens of the commonly planted deciduous species *Ulmus parvifolia* (Chinese Elm), *Ulmus glabra* (Wych Elm) and *Koelreuteria paniculata* (Golden Rain Tree) (Plate 7).

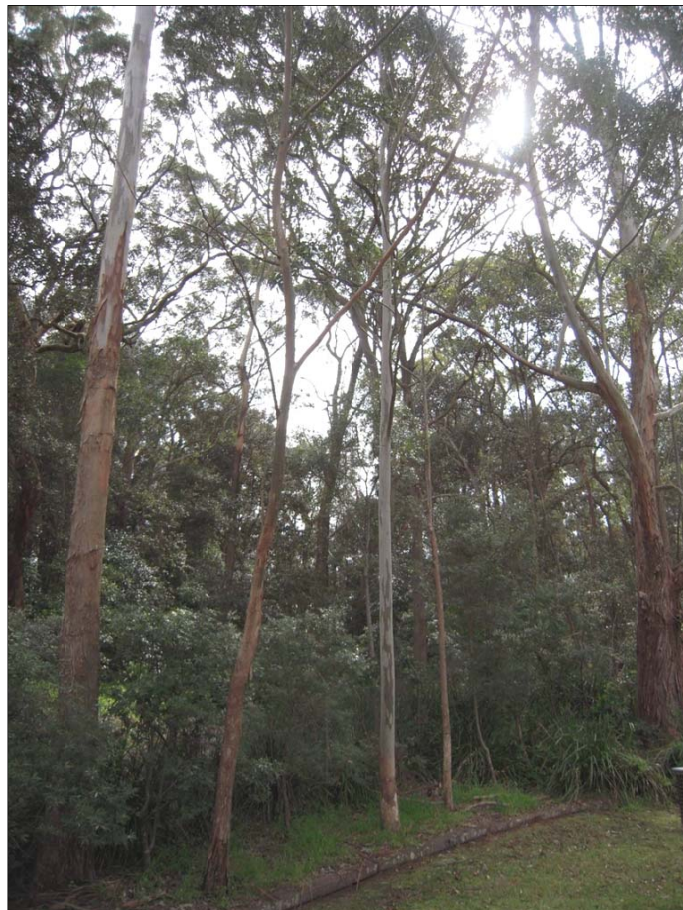
Plate 4: Trees 20A-20C and Tree 25 (right) *Eucalyptus saligna* (Sydney Blue Gum)

Of the twelve indigenous trees proposed for removal, some are semimature and not of large dimensions although Trees 2, 3, 6 and 14 *Eucalyptus pilularis* (Blackbutt) and Trees 20A and 25 *Eucalyptus saligna* (Sydney Blue Gum) have trunk diameters of over 300mm. Tree 25 *Eucalyptus saligna* (Sydney Blue Gum) is the largest tree proposed for removal, with a trunk diameter of 1050mm (Plate 5).

Most of the indigenous trees proposed for removal are in good health and condition although some lower branches of Tree 25 *Eucalyptus saligna* (Sydney Blue Gum) have been injured by storm.

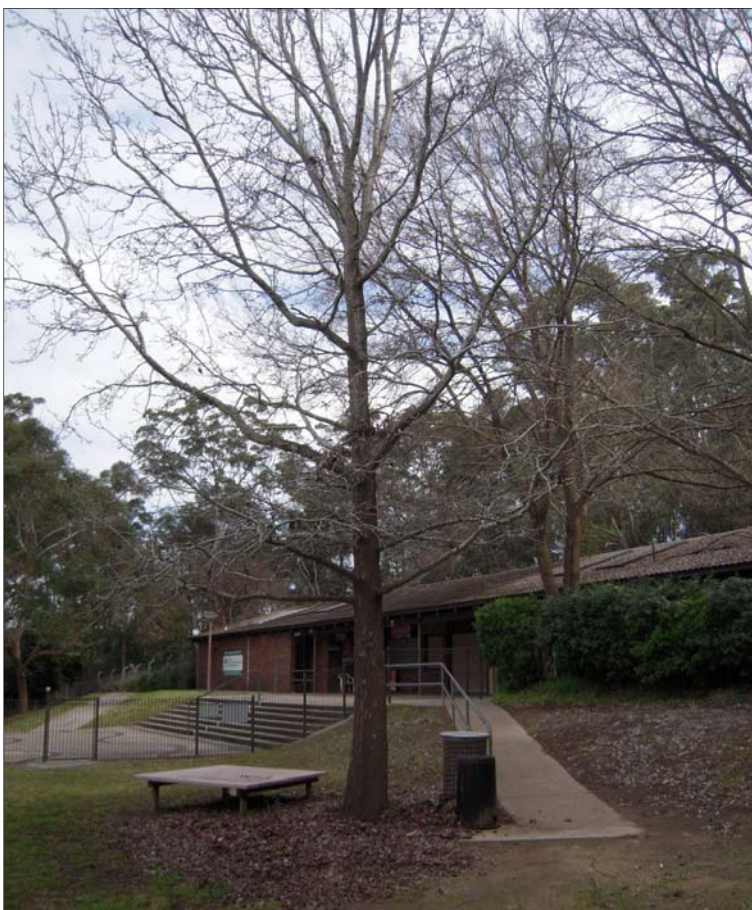
Plate 6: Tree 21 *Liquidambar styraciflua* (Liquidambar)

Trees 21 and 28 *Liquidambar styraciflua* (Liquidambar) are of a species regarded as nuisance due to its potential for very large eventual size and its vigorous root system; specimens up to 12m in height are exempt from the provisions of the Ku-Ring-Gai Council Tree Preservation Order. However these subject trees are greater in height and not exempt.

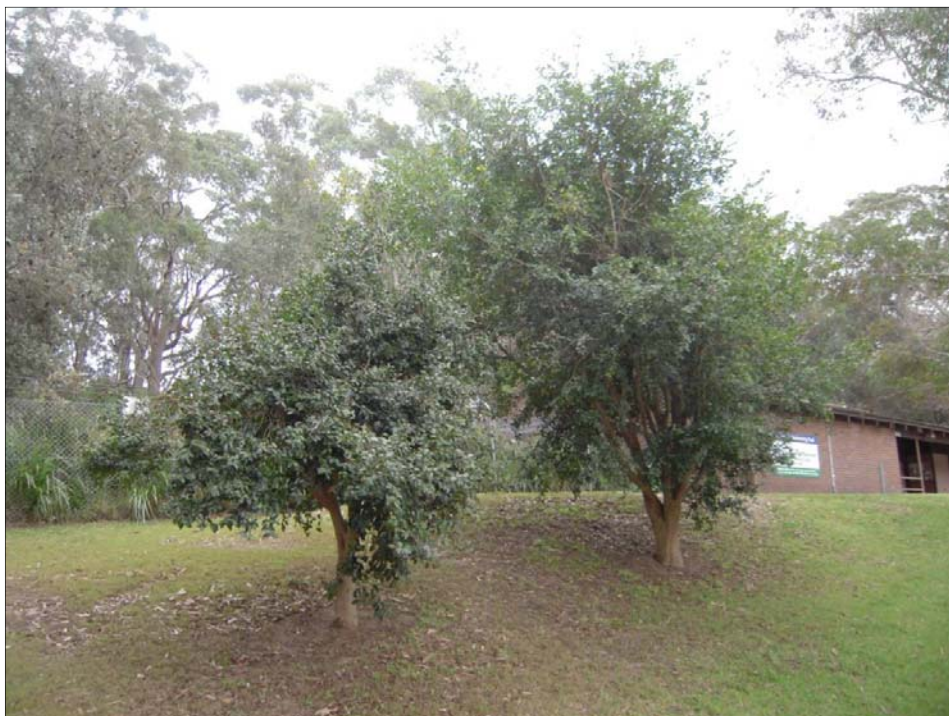
Plate 8: Trees 12 and 13
Camellia sasanqua (Camellia)

Trees 8, 12 and 13 *Camellia sasanqua* (Camellia) are large shrubs and not of great landscape prominence (Plate 8). If required, they could be relocated to other parts of the site.

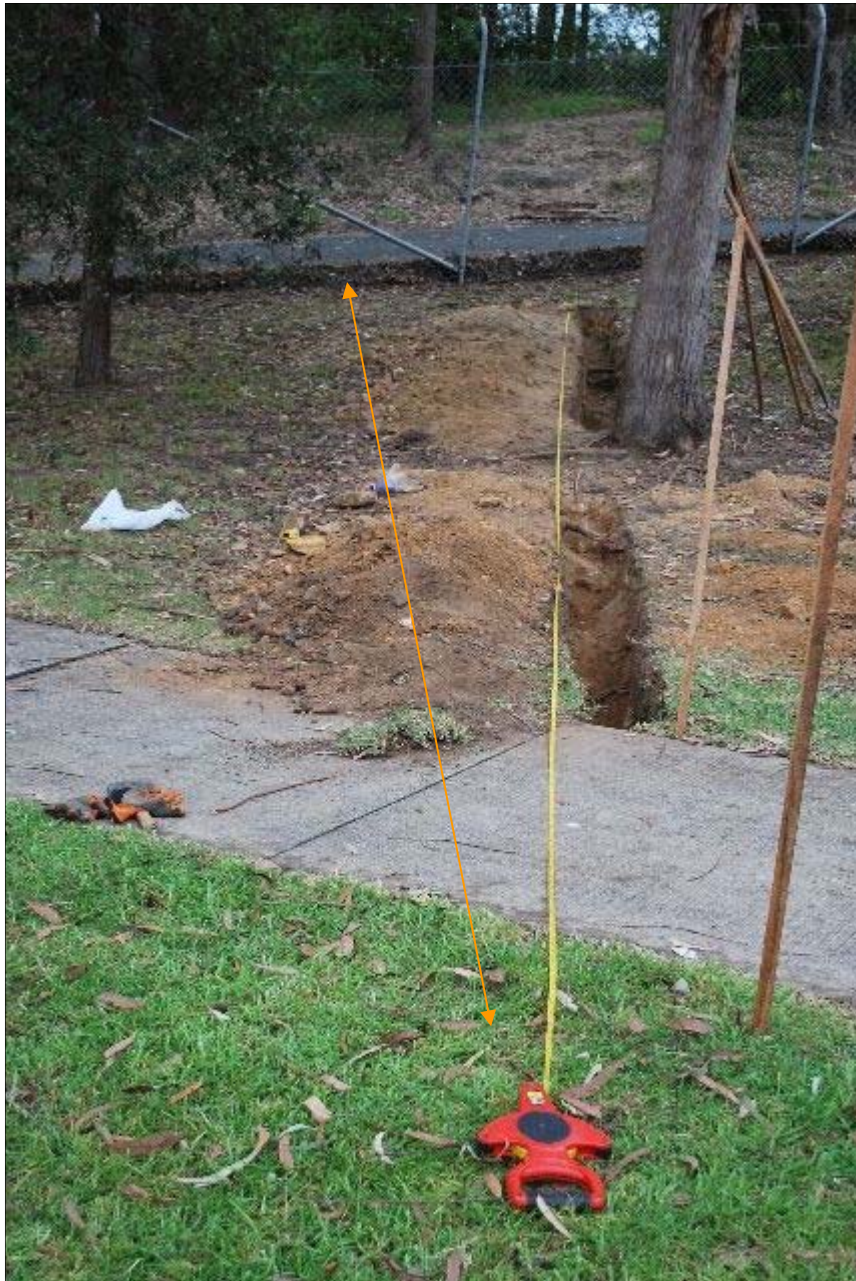
Arrow indicates extent of proposed excavation; Tree 6 is near the trench and Tree 1 out of picture is to the right

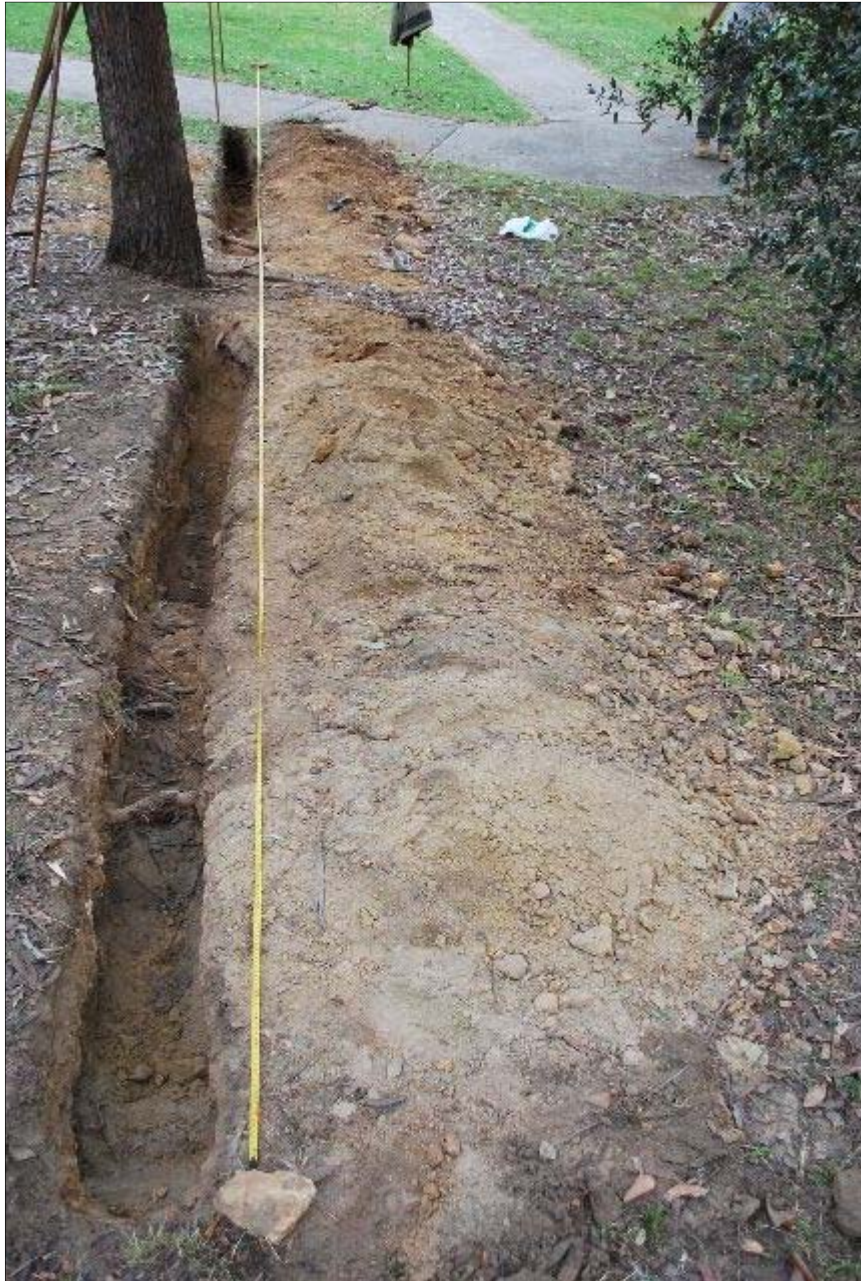
A trench was excavated by hand along the approximate line of the building footprint and to the level of the hard compacted clay subsoil at approximately 600mm depth. The trench was approximately 9.3m in length. The trench was discontinued in the vicinity of Tree 6 *Eucalyptus pilularis* (Blackbutt) to avoid root injury.

Root mapping trench viewed from the west

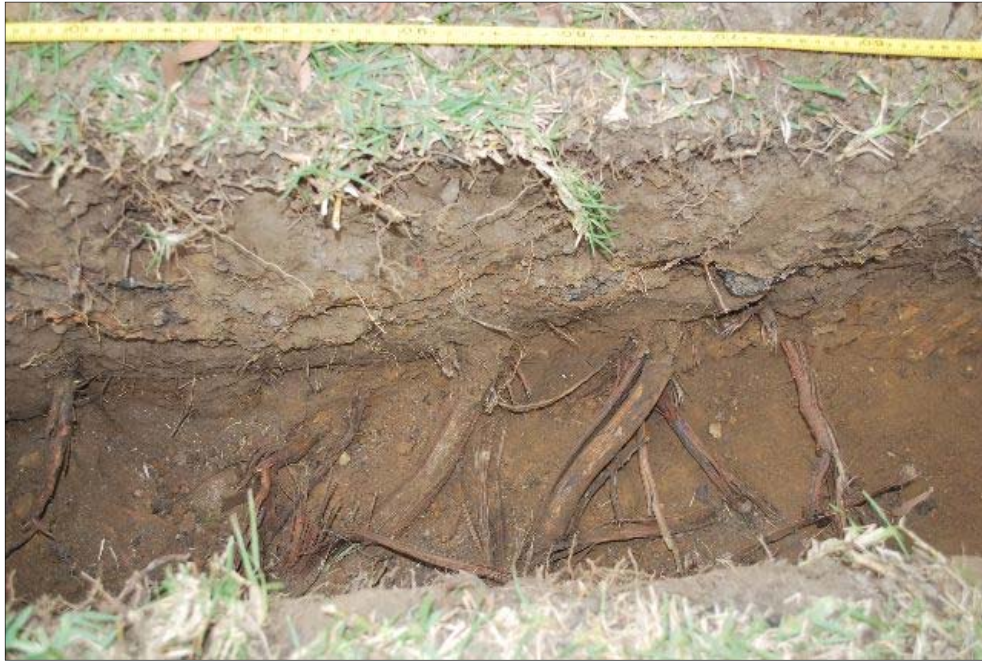
Eight small roots to a maximum diameter of 45mm were found in the trench. Other roots were smaller, with diameters between 15mm and 35mm. Roots were found at depths between 290mm and 400mm. See root investigation plan below.

The loss of the eight roots encountered in the trench would not have an adverse impact on the stability, vigour or life expectancy of the tree. The roots are small and

not structurally important for anchorage. They appear to be small roots extending towards open soft soil landscape area which are not essential for the continuing vigour of the tree.

Roots located at 7.9m – 9.0m along trench.
Low numbers of small diameter (<10mm) roots were also present in the trench.

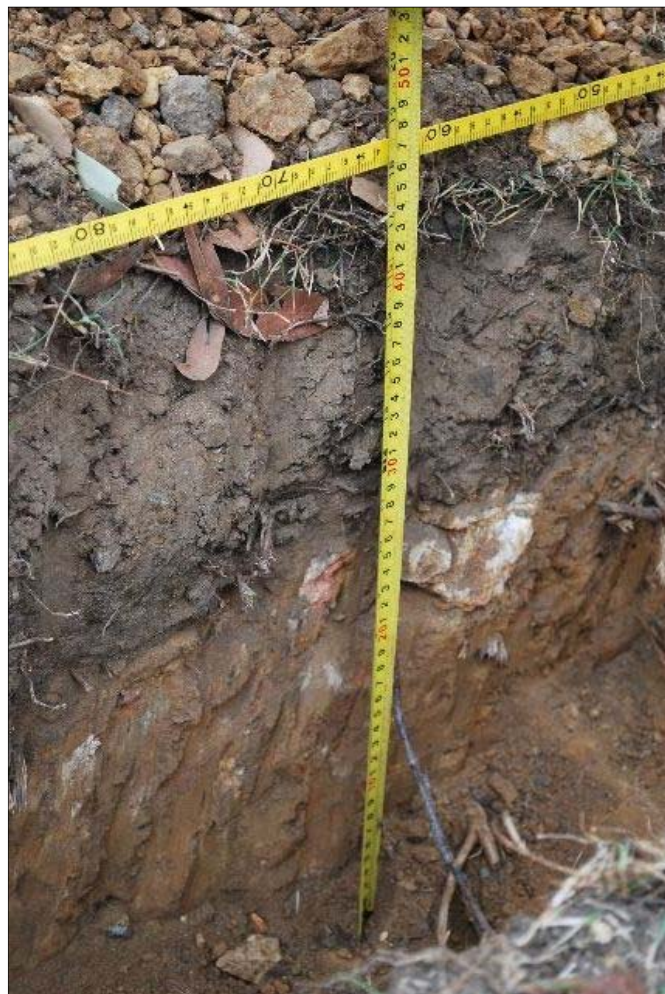
Trench depth to 500mm. The clearly visible lower soil horizon comprises of hard compacted clay sub soils containing large sand stone boulders.
