SITE CONCEPTUAL MODEL

Milperra, NSW

Flower Power Pty Ltd – March 2012

479 Henry Lawson Drive Milperra NSW 2214

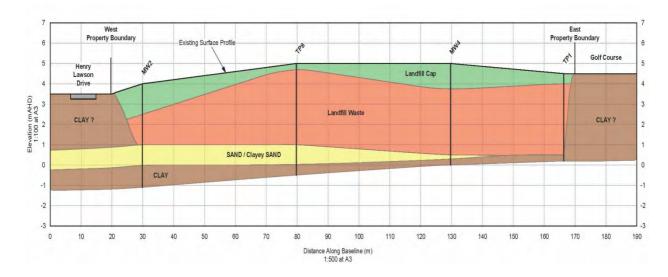
Characteristics	Landfill Cap	Landfill Waste
Composition	Mostly sandy Clay, sandy Silt, Clay with gravel, clayey Sand. Some areas with silty Sand and crushed sandstone used as capping material.	Mixture of Silt, Clay, plastic bags, packing strap, ceramic and plastic pots, scrap metal, paper, timber, bricks, tiles, glass, ash, fabric, foam, rocks, aluminium cans, tyres, insulation bats, sawdust.
Thickness	0.45 - 1.50m (Figure 5)	1.2 – 3.75m (Figure 6)
Estimated Volume Material	23,500m ³	81,000m ³
Comments	Landfill cap was not engineered, is of variable thickness and constructed with variable materials. Cap thickest at margins of landfill.	Waste is mostly inert, poorly compacted, cap is hummocky and evidence of differential settlement. Methane has been detected emitting from cap.

A schematic cross section of the landfill is presented below;

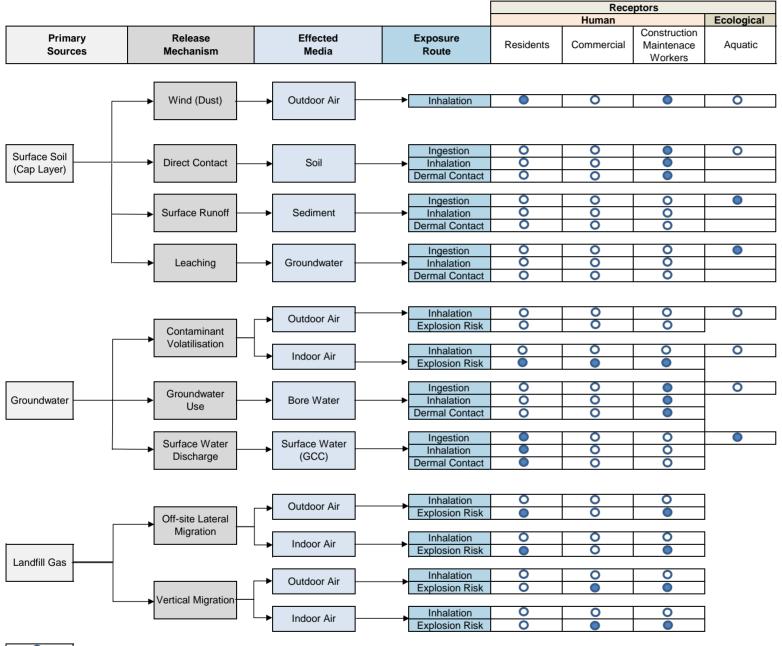
SITE CONCEPTUAL MODEL 26.3.12 - Former Landfill 479 Henry Lawson Drive, Milperra, NSW

Explosion risk from offsite methane gas impacts upon neighbouring residential properties considered to be low. Explosion risk to utilities and utility workers considered to be moderate for utilities in proximity to landfill. Further assessment of gas migration necessary.

Given landfill is emitting methane the exposure path is considered complete. Future works to focus on gas mitigation for commercial use of the site.
