Arborist Report

Client: Health One

Address: Corner Jacaranda Avenue &
Swan Street Raymond Terrace N.S.W 2324

Date: 14th March 2011

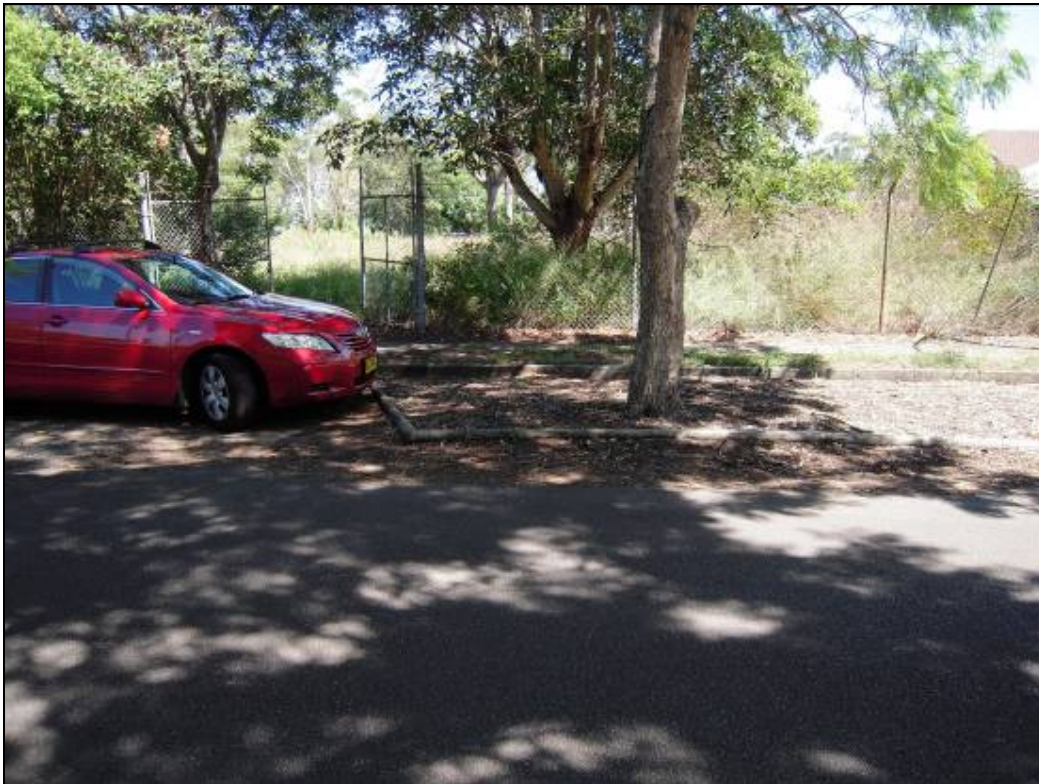
Figure 4 - Location of Tree 1 near the entry point into the subject property.

- It is recommended to erect tree protection measures to Trees 1 & 2 in accordance with Australian Standards 4970 2009 before commencement of any trucks entering the site. Tree guards are to be installed to minimise damage to the trees during the construction phase. Tree protection measures are to consist of 2 metre (or similar size) wooden beams installed to the trunk of the tree. Hessian or a similar non abrasive material is to be placed behind the planks to ensure minimal damage occurs to the tree. It is recommended to allocate a different entry point for trucks and heavy machinery if feasible away from the Jacarandas. If this is not feasible than protection measures outlined will need to be adopted for Trees 1 & 2.

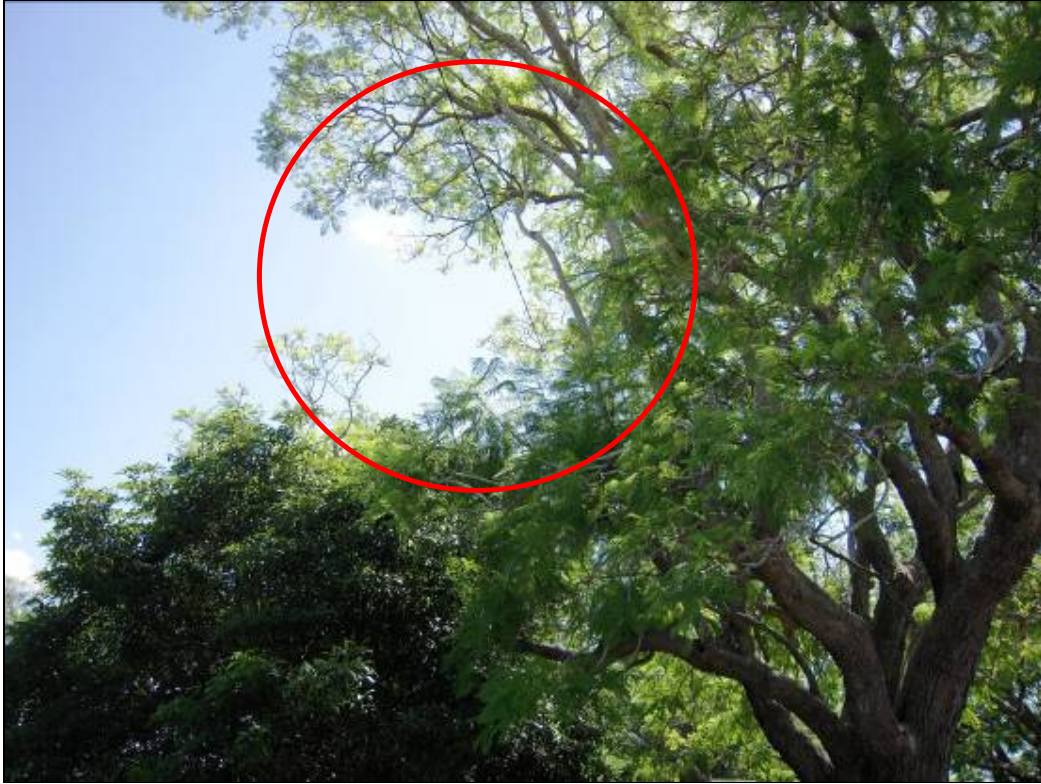
Tree 4 has been directionally pruned to the west over wires in the past that has resulted in epicormic leaders forming at the wound. The tree will require moderate pruning works in the medium term as the tree continues to grow near the service wires.

Figure 5 – Showing the area highlighted in red that has been directionally pruned to minimise damage to the service wires.

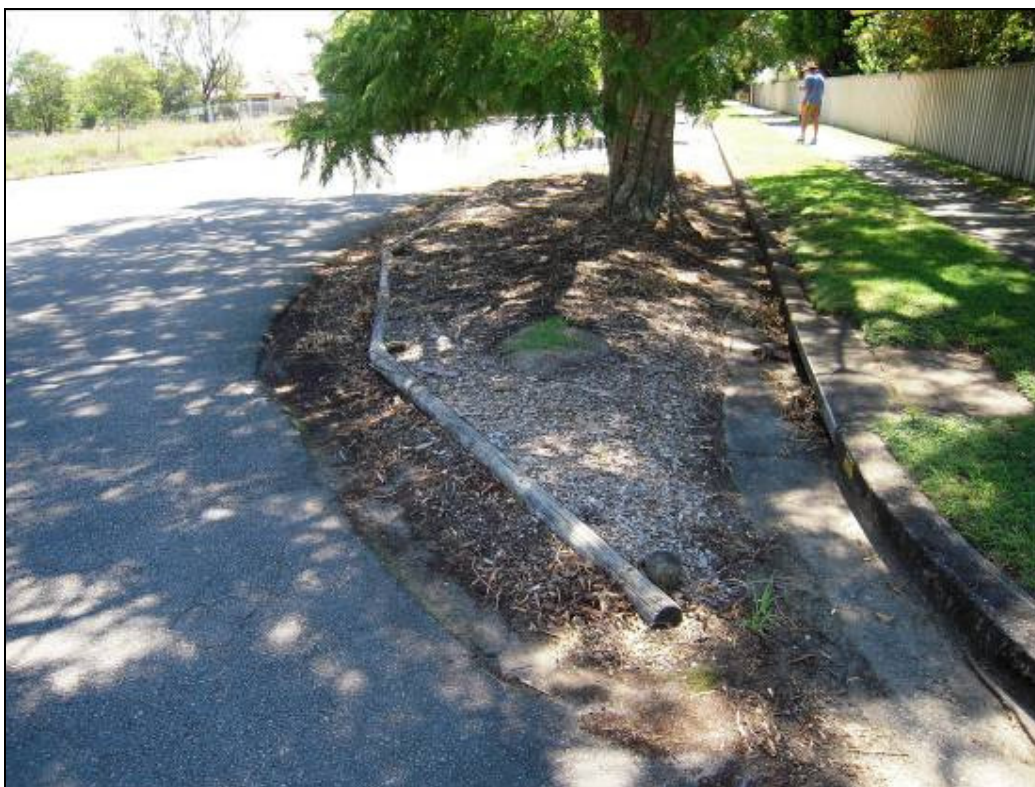
Tree 5 has three main leaders at 1.6 metres above ground level. The tree is located in a mulched garden bed in a familiar pattern to the other *Jacaranda mimisifolia*. The tree requires no work in the short term and could be retained and incorporated into the design.

Figure 6 – Location of Tree 5 within a mulched garden bed on the corner of Jacaranda Avenue.

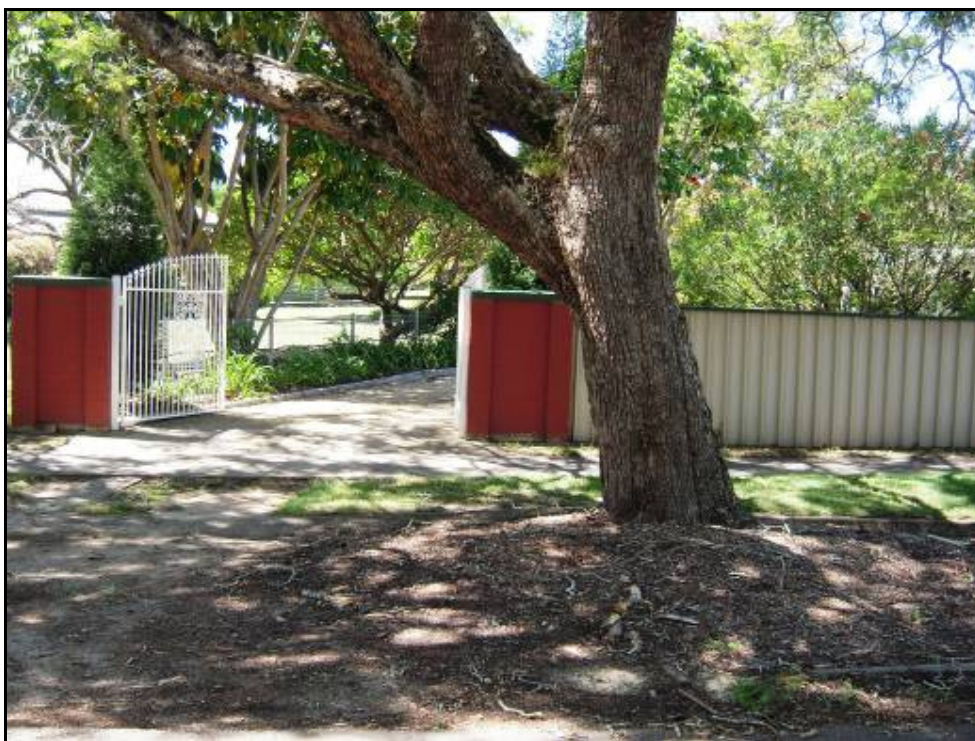
Tree 9 is located on the eastern side of Jacaranda Avenue within close proximity to an existing driveway. The tree is within an existing garden bed that has previously been mulched. The tree would benefit from a bollard to prevent mechanical damage from cars hitting the trunk of the tree & minimising compaction within the SRZ.. The tree requires no work in the short term and could be retained and incorporated into the design.

Figure 7 – showing the close proximity of Tree 9 to an existing driveway

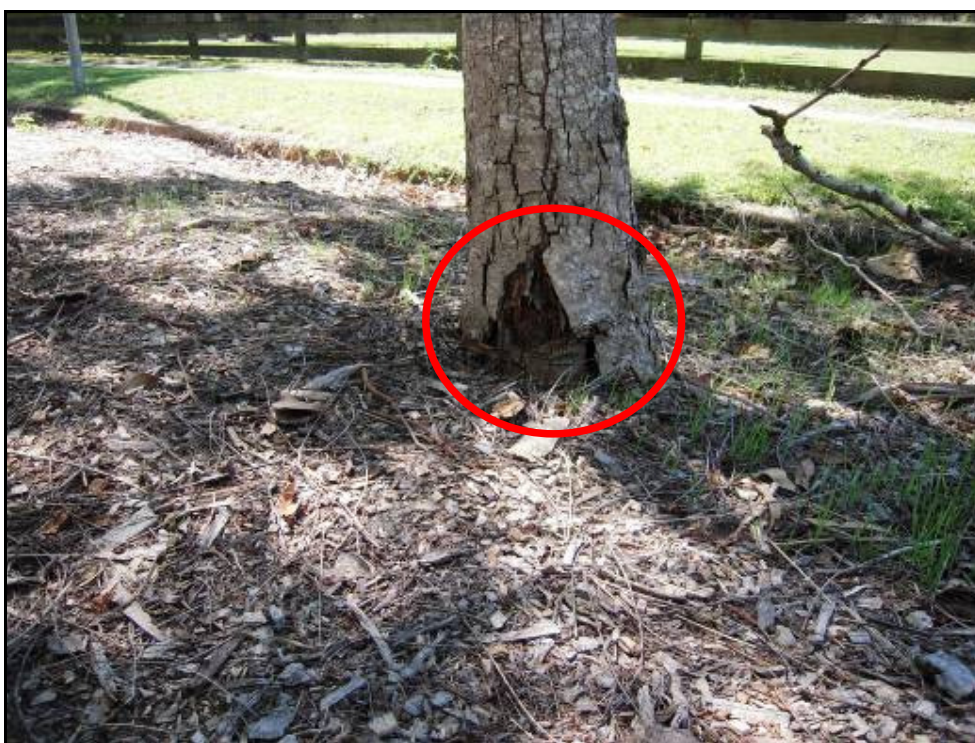
Tree 10 located on the eastern side of Jacaranda Avenue is located in a 1.6 metre garden bed. The tree has previous mechanical damage to the western side of the trunk. The tree could be retained and incorporated into the development.

Figure 8 – showing the mechanical damage that has occurred to Tree 10

- It is recommended to monitor the mechanical damage to Tree 10 within a two year period.
- It is recommended to provide an area where no works are undertaken set aside as the SRZ. An SRZ should be set aside to Trees near proposed buildings or hardstand areas. This includes SRZ to trees 1 – 4, 36 – 39, 41 & 42. These have been tabulated in the table below -

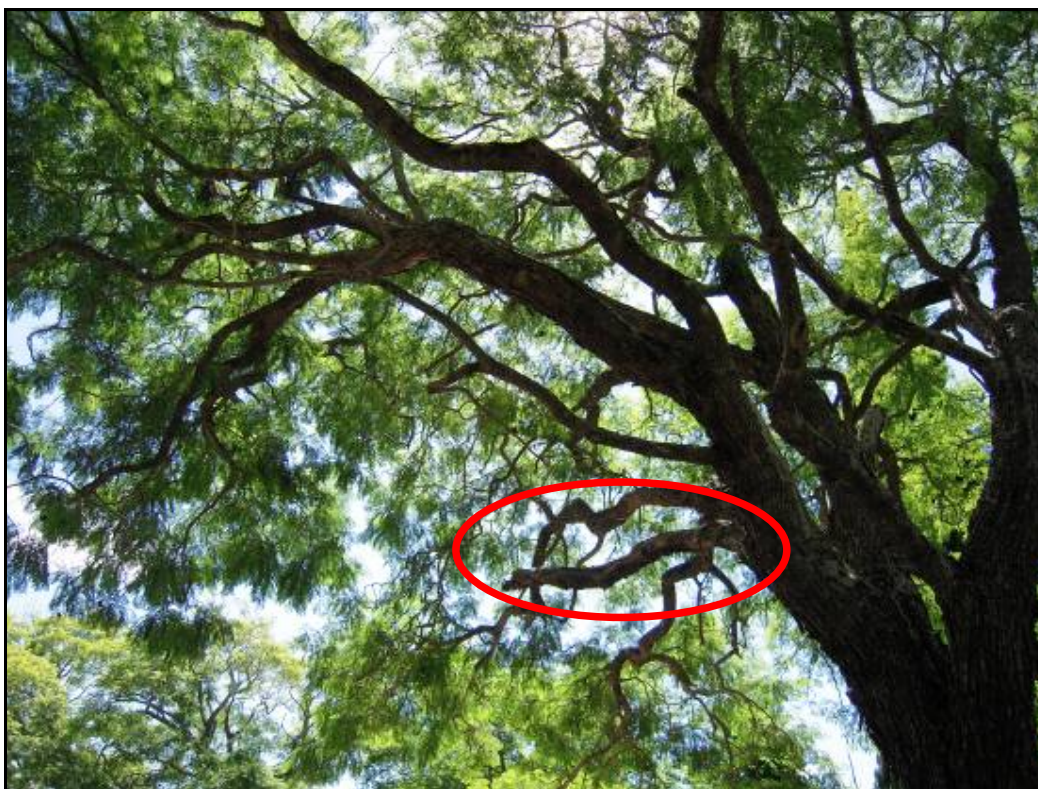
Tree 11 is located on the eastern side of Jacaranda Avenue. The tree has co dominant leaders at 1.8 metres with major deadwood over road and garden bed areas. The deadwood could be accessed by a scissor lift to minimise damage to the tree.

Figure 9 – An example of a 2nd order scaffold tear (Tree 11) out that is overhanging the road way.

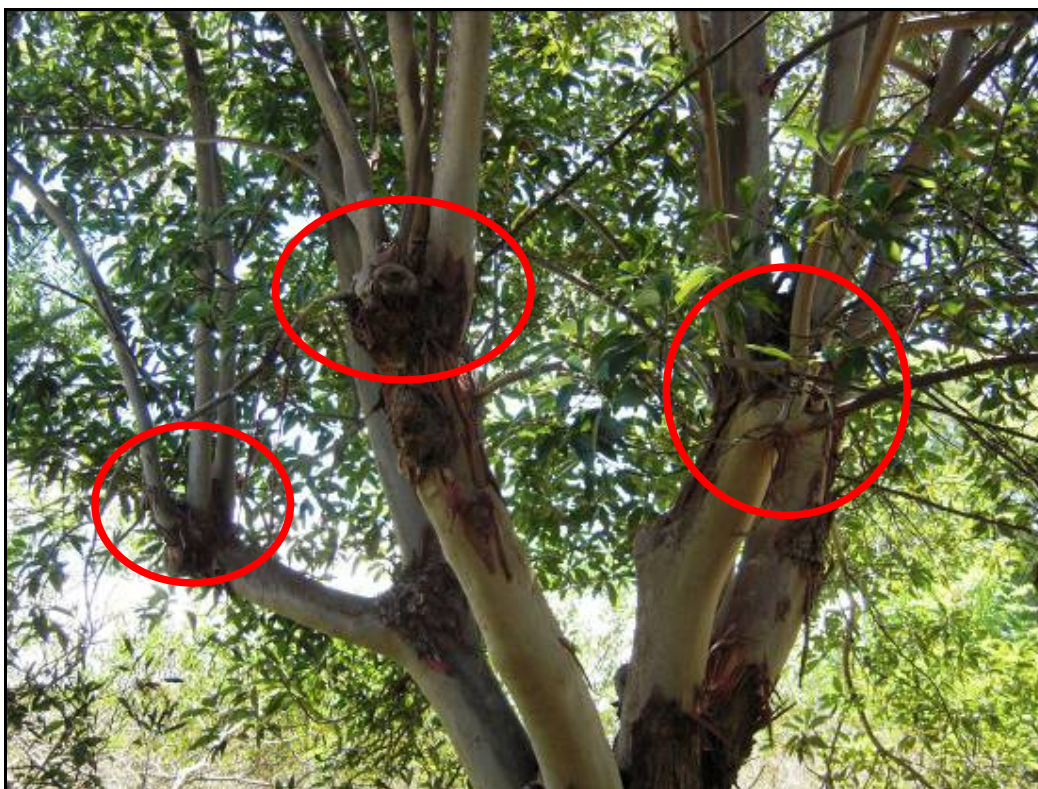
Trees 13 – 18 & 20 have been identified as *Lophostemon confertus* that were planted at the same time. The tree heights vary from 5 – 14 metres and overall are in good health. The entire row of trees has been topped previously and as a result several main leaders have formed on all the trees. The topping points vary however most were topped at 2.0 – 2.5 metres above ground level. As a result the trees are not growing true to form with multiple attachments. Trees 13, 15 – 18 will be within the proposed car parking areas to the north east and Tree 14 will be within the driveway entry/exit area off Jacaranda Avenue.

Figure 10 – Showing the topped points on the cluster of *Lophostemon confertus* identified as trees 13 – 18, 20 & 22 on the north eastern side.

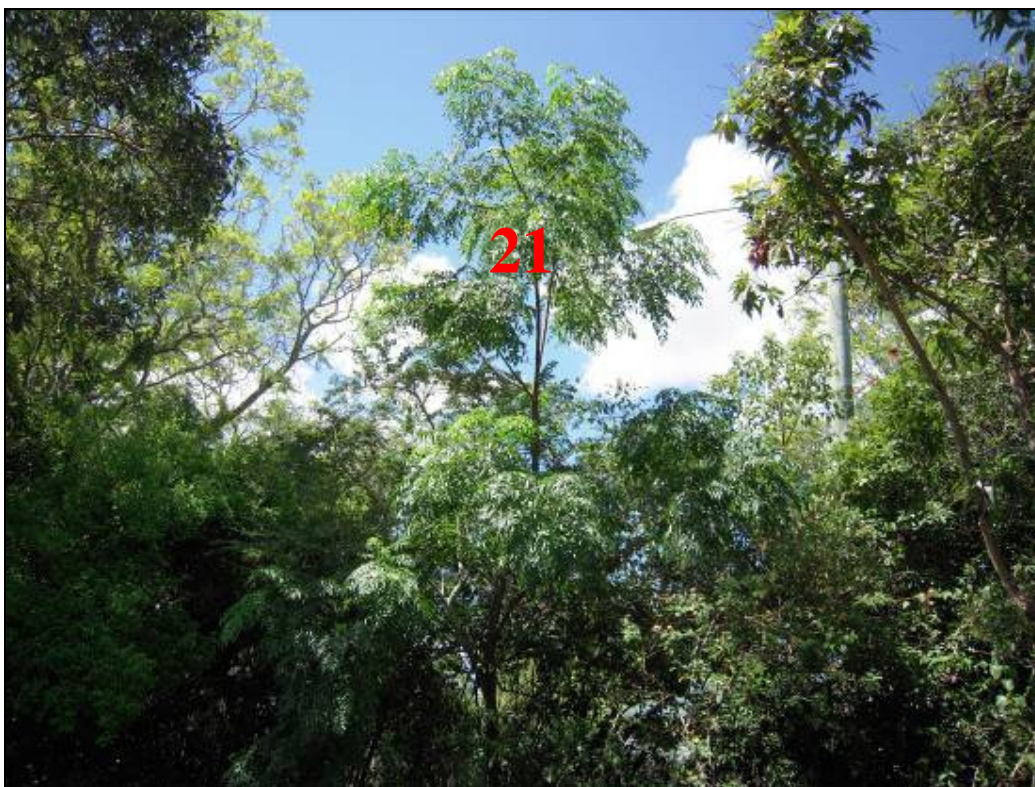
Trees 20, 21 & 22 have been identified as *Lophostemon confertus*, *Melia azedarach* & *Lophostemon confertus*. Trees 20 & 22 have been topped previously and are not growing true to form. The trees are akin to the tree depicted in Figure 10. The trees due to their position will be just outside the proposed building. Trees 20 & 22 would require 35 – 40% of the canopy removed in order to accommodate the building. These trees have been earmarked for removal in order to accommodate the proposed building. Tree 21 would require minor pruning works of no more than 10% however is only semi mature and would impede on the building as the tree continues to grow. The tree has a SRZ of 1.40 metres that will increase over time as the tree continues to grow. The tree has been earmarked for removal before commencement of works.

Figure 11 – showing the semi mature Tree 21 that is earmarked for removal due to its location to the proposed hardstand area.

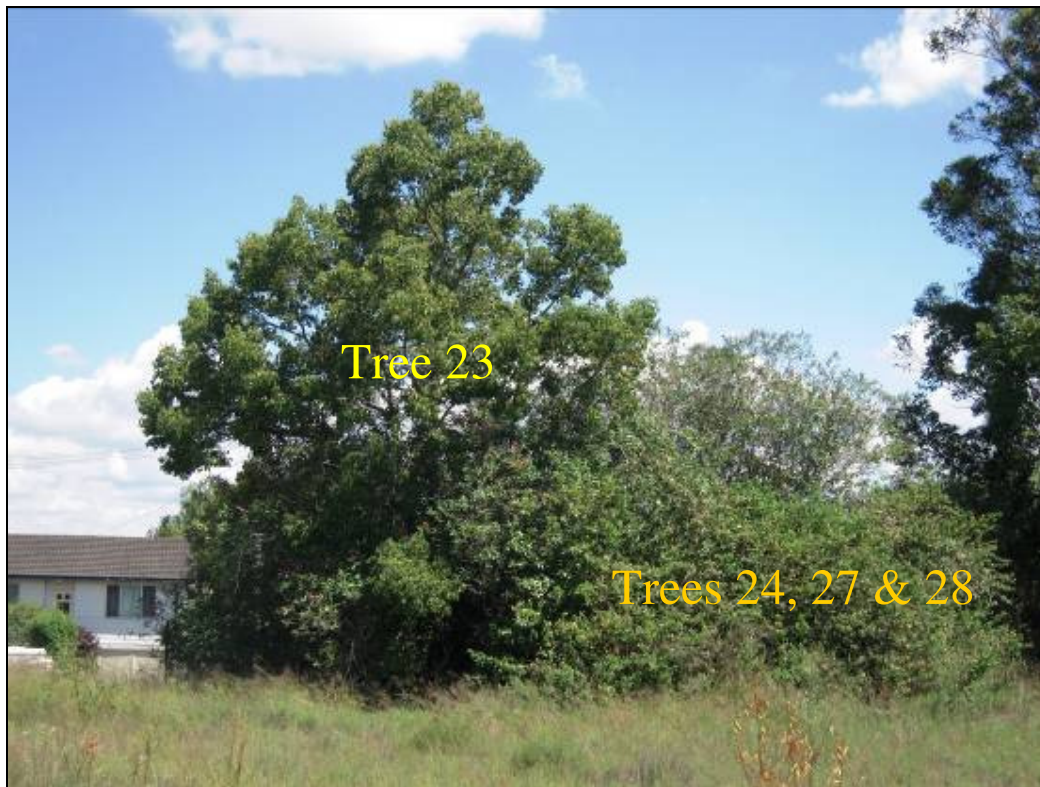
Trees 23, 24, 26 – 28, 30 & 31 are located on the south western side of the property. The trees have been identified as *Cinnamomum camphora* and *Nerium oleander*. Both species have been checked against the tree preservation order and are classified as exempt species and can be removed without further permission from council. These trees would require removal due to their location being within a metre or within the proposed building and hardstand area.

Figure 12 – Showing the location of exempt species within the subject property.

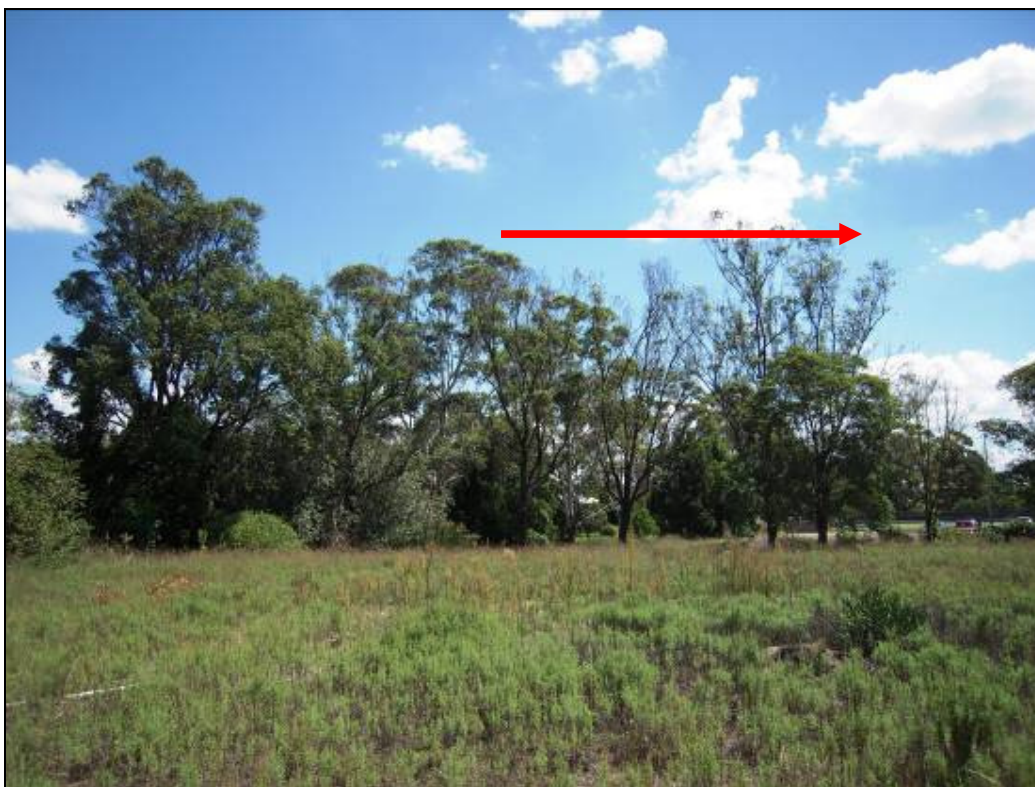
Trees 32 -35 have been identified as *Eucalyptus robusta* that have been earmarked for retention in accordance with the landscape plan. The trees are all in poor form with live crown ratio being 30 – 35% for the cluster of trees. The trees display major dieback and extensive epicormic growth (see Figure 13). The trees have short life spans and would be beneficial to remove and replace with native trees.

Figure 13 – Showing the row of over mature *Eucalyptus robusta* located on the western boundary of the subject property.

- Trees 32 – 35 have been identified as *Eucalyptus robusta* that are in a declining condition with extensive epicormic growth. The trees have a life span less than 5 years and have been earmarked for removal.

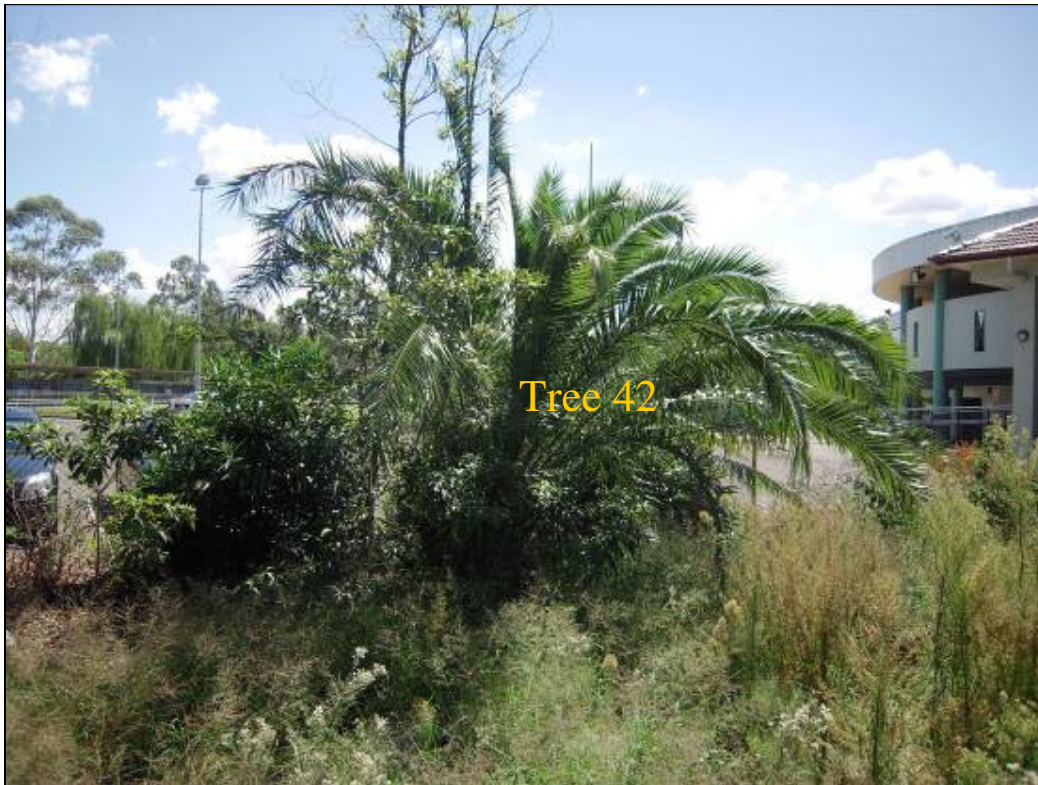
Tree 42 has been identified as a young *Phoenix canariensis* that is 4 metres tall. The tree comes under the requirements of Port Stephens tree preservation order. Tree 42 is in good health and condition and has a long life span. The tree could be retained and incorporated into the development.

Figure 14 - Showing the location of Tree 42 located in the north western corner of the subject property.

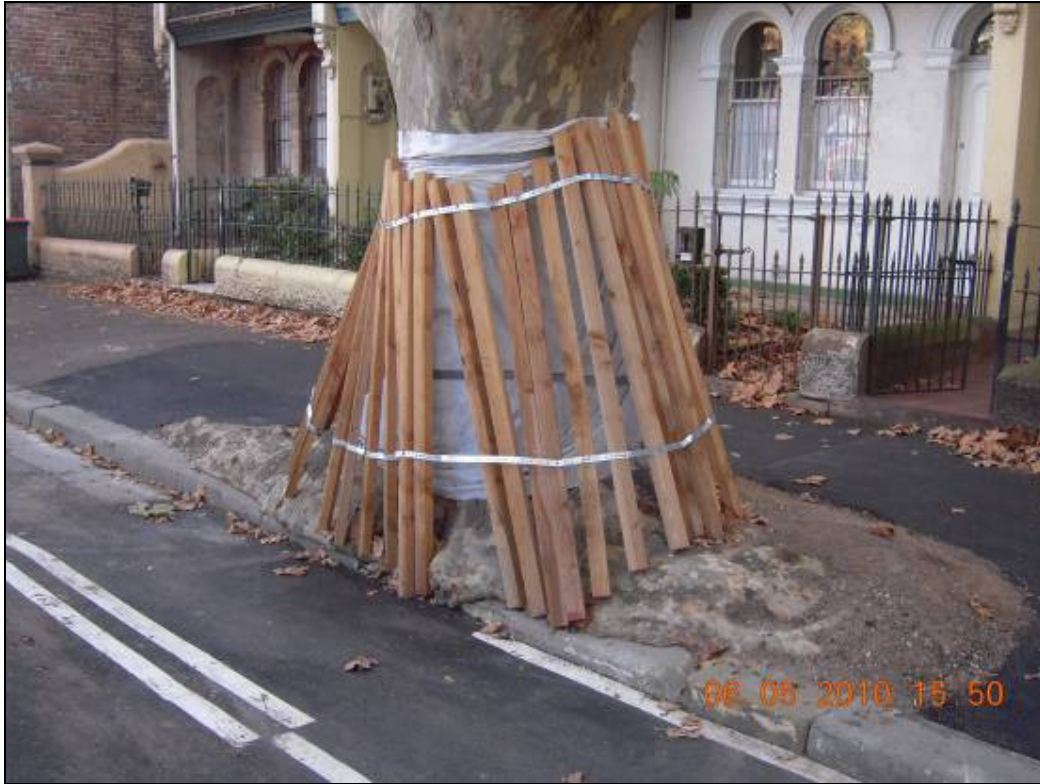
Figure 15 – Tree protection measures (for Trees 1 & 2) as indicated by the photo above will minimise damage by trucks and cars entering the site and protect against accidental damage by such vehicles.
