**From:** Catriona Mackenzie <cat@urbanforestryaustralia.com.au>  
**Sent:** Tuesday, 29 May 2012 7:30 AM  
**To:** David Gazzoli  
**Cc:** Ryan Fury  
**Subject:** Further information.

Re – Trimming of tree H18:158

Following the recent resubmission of additional documentation for the Killara Golf club D.A. 0147/11 the landscape officer requested some additional clarification on four trees and the landscape planting plans in an email dated 24<sup>th</sup> May 2012. This letter relates to tree H18: 158 and is to be viewed in conjunction with the Arborist, Catriona Mackenzie's updated information dated Tuesday 29<sup>th</sup> May 2012 which is attached. Below is the photo of the tree and the crown reduction while maintaining the trunk with any cavities as fauna habitat.

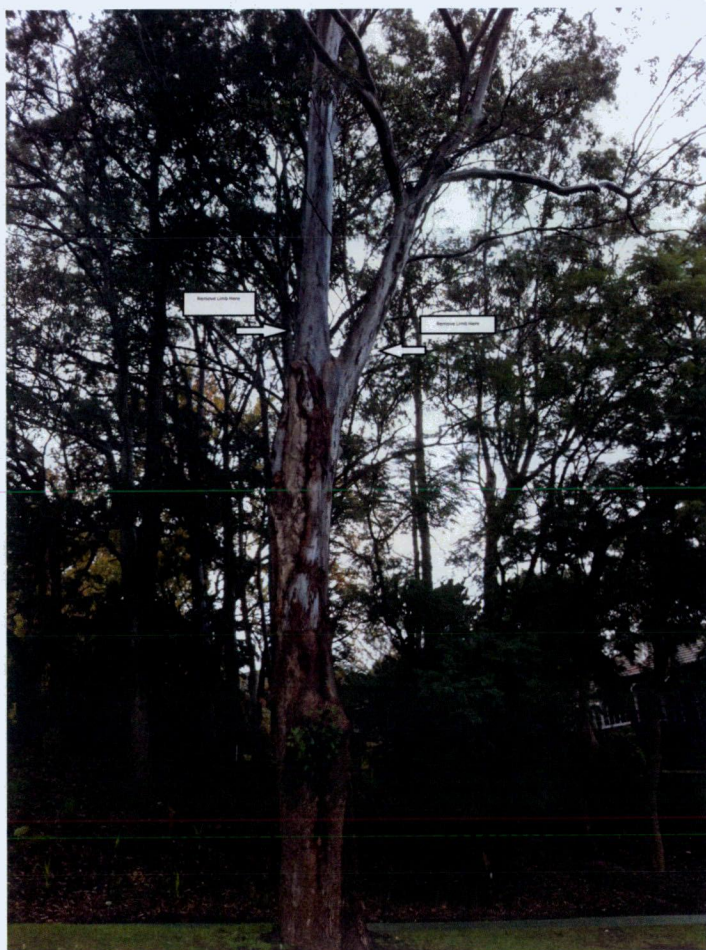
- H18-158 – My main concern with this tree is the evidence pointing to the likely existence of an internal column of decay in the trunk - from the cavity in the southside lower trunk, the depressed vertical section arising from this cavity area and extending up to the decayed trunk section to the southwest side of the stem. The presence of extensive reaction wood to the east side of the lower stem indicates the tree has grown this area to 'shore up' a weakened stem. The large scaffold branches and crown above the stem appear to be sound, although my concern is with the weight of these parts bearing down on a structurally weakened trunk. This feature is akin to placing a heavy brick on top of a section of hosepipe – there is considerable risk of the stem buckling under the weight of the parts above it.  
The extent of decay and its impact on stem wood strength can be measured by diagnostic decay testing (e.g. Resistograph® or Sonic Tomograph testing), although it needs to be understood this testing does not treat the disease and only provides information to determine whether the tree must be removed entirely or can be retained for a specified period and subject to routine re-testing, pruning, etc.

Given the obvious extent of decay affecting the lower stem right up to the top of the stem, it is my opinion diagnostic testing is not warranted and that substantial removal of the crown is the only way to remove the weight on this weakened stem. It is the tree's poor condition and location that increases the risk to the golf club's staff and players, and that despite any testing, the tree needs to undergo some reduction of the weight above the obviously compromised stem.  
The tree should have the crown reduced at, or within 1m of the stem bifurcation to significantly reduce the weight issue. Any subsequent re-growth should be managed according to arboricultural assessment and advice.

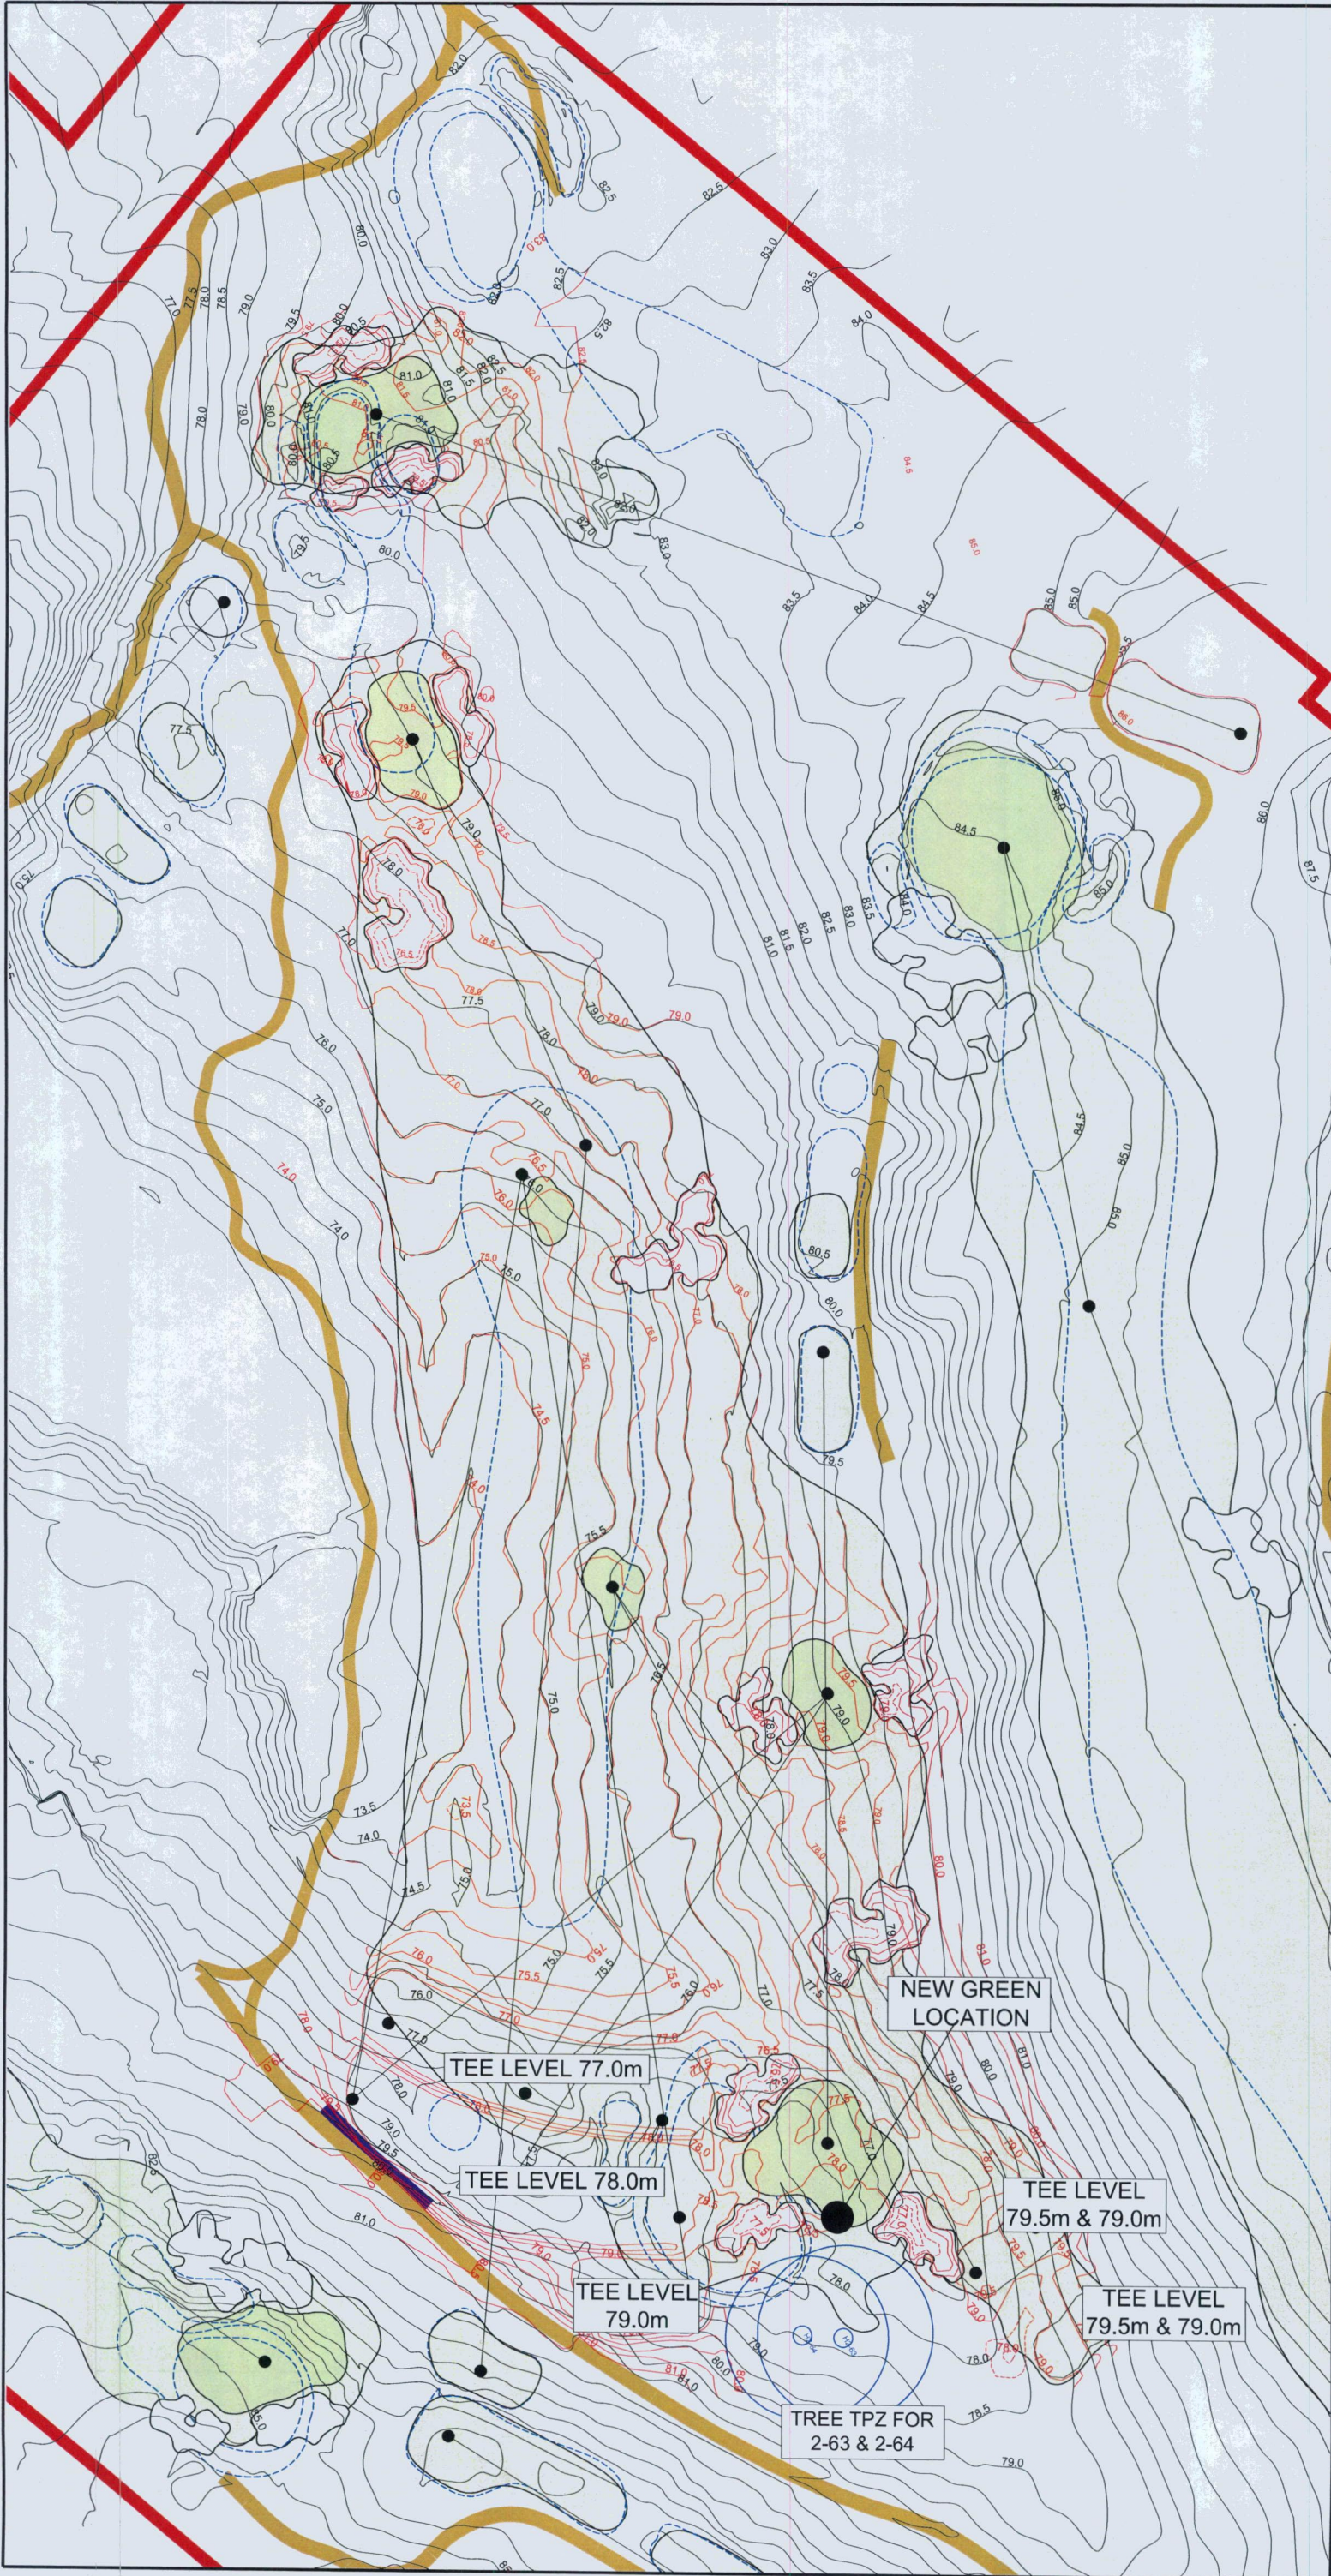
**Practice Fairway  
Grading Plan**

- I've reviewed the Amended Grading Plan, dated May 2012, forward by Cashmore Design, and note the Tree Protection Zone ("TPZ") offsets applied to H2-64 (13m radius) and H2-63 (14m radius), are generous and greater than the 11m nominated in the tree schedule by Australian Tree Consultants.

- Grading is not proposed within the TPZ of the trees, and I am satisfied the tree's can be adequately protected during construction of the new green.
