**173 - 179 PENNANT HILLS ROAD, THORNLEIGH**

**URBANLINK PTY LTD**

**NEW RESIDENTIAL UNITS**

**TREE LOCATION PLAN**

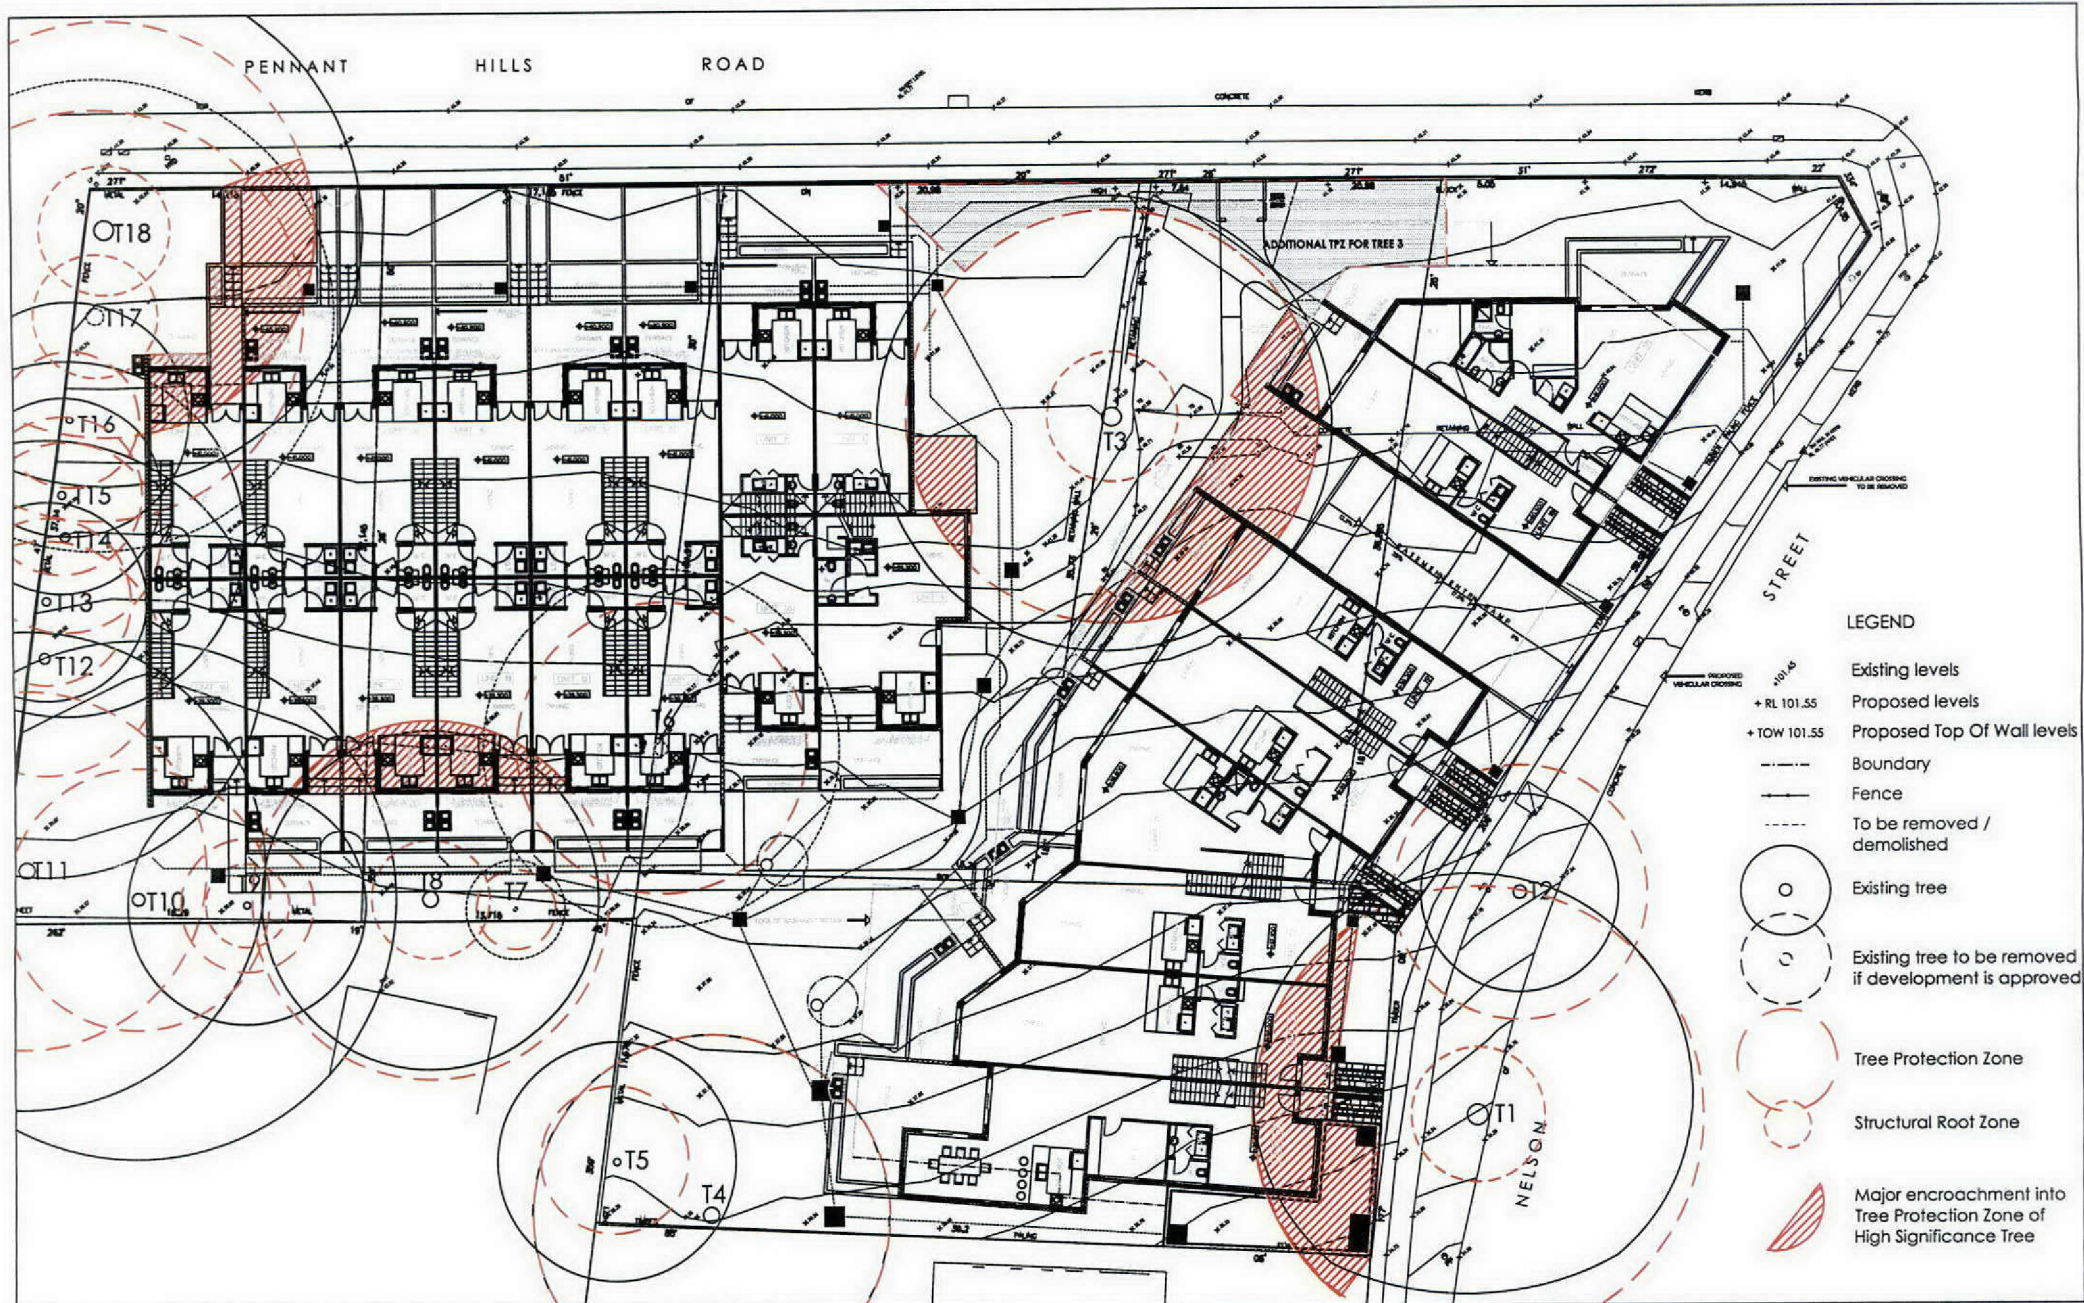
NO#	Genus	Species	Common Name	Height	Spread	Trunk Dia	Trunk Dia 2	DBH	DRB	Age	Health	Crown	Signifi- cance	Am	Eco	Form	Defects	SRZ	TPZ	Development	Seiback	Comments
1	<i>Eucalyptus</i>	<i>pitularis</i>	Blackbutt	30	23	950		950	1050	M	G	G	H	H	H	U,S,D	P, B, Cr, DW,E	3378	11400	4.4m from proposed OSD tank, 6.7m from proposed stormwater pipe - 18% encroachment within TPZ		Bulge in trunk. On nature strip. Cracking gutter. Mounded base. Large DW, dead stubs. Pruned for road clearance. Epicormics. Cracks in upper branch. Large codom stem pruned from base decaying. Termite remnant in stump and on ground.
2	<i>Corymbia</i>	<i>gummifera</i>	Red Bloodwood	11	10	280	455	535	670	M	AV	P	M	M	H	U	DB, BW, FB	2797	6420	4m from proposed stormwater pipe - 10% encroachment within TPZ		2 main stems - column of decay in both. Dieback, deadwood. Foliar insect damage. Cavity from base of main stem. Dead main leaders. Termite evidence. Gross growing under bark.

3	<i>Eucalyptus</i>	<i>pitularis</i>	Blackbutt	32	23	870		870	1000	M	G	AV	H	H	H	B,S,D	DW, DB, E, R, W	3309	10440	5.4m from proposed building and basement - 21% encroachment within TPZ. 6.6m from proposed terrace courtyard - additional 4% encroachment within TPZ. Stormwater line within TPZ - additional 11% encroachment. Total: 36% (25% without stormwater pipe)		Insect or bird wounds on branches. Dead stubs. Deadwood, small dieback on West side. Epicormics. Large epicormics on South side. Bark rubbed off or sunburnt on West side. Level change @ base. Large exp root south side - along top of wall/bank & damaged
4	<i>Eucalyptus</i>	<i>pitularis</i>	Blackbutt	28	18	750		750	810	M	G	G	H	H	H	B,S,D	DW, DB, E, W	3029	9000	8.6m from proposed planter & stormwater pit - 8% encroachment within TPZ		Large deadwood. Some dieback. Small epicormics. Wound on trunk 5-6m. Adjacent fence, buttress root through fence. Low branches from 6m

5	<i>Araucaria</i>	<i>cunninghamii</i>	Hoop Pine	14	12	310		310	350	SM	G	F	M	M	M	CS-T4	P, DW	2129	3720	No impact		Lower branches recently pruned to 6m H. Branch collars slightly torn. Small deadwood. 0.3m from fence. Branches left under tree
6	<i>Eucalyptus</i>	<i>saligna</i>	Sydney Blue Gum	27	18	610		610	660	M	G	G	H	H	H	U,S,D	DW, R, W,P	2779	7320	Within proposed building		Large wound with exposed heartwood obscured by geotech fabric around trunk. Lower branches pruned. Dead stumps. Hanging deadwood. Epicormics. Broken branches. Level change @ base - excavation.
7	<i>Corymbia</i>	<i>gummifera</i>	Red Bloodwood	8	5	150		150	200	SM	P	P	L	L	H	U	E, PD,DW	1683	2000	2.6m from proposed path - major encroachment within TPZ & SRZ		Mostly dead. Some epicormics. Insect damage. Privet @ base
8	<i>Eucalyptus</i>	<i>saligna</i>	Sydney Blue Gum	26	17	750		750	780	M	AV	AV	H	M	H	U,S	DW, E, P	2981	9000	3.8m from proposed terrace, 5m from proposed building, adjacent proposed path & stormwater pipe - major encroachment within TPZ & SRZ. 14% encroachment within TPZ from building.		Adjacent fence - leaning away. Deadwood, epicormics, lower branches pruned, partly occluded. Somewhat sparse

9	<i>Grevillea</i>	<i>robusta</i>	Silky Oak	17	12	280		280	340	SM	G	AV	M	M	M	C, CS- T10	DW, P	2104	3360	0.5m from proposed path (within SRZ), 1.2m from proposed stormwater pipe (within SRZ), 2.5m from proposed planter (minor encroachment)		Wound on trunk. Crown lifted. Deadwood. Crownshy to T10
10	<i>Eucalyptus</i>	<i>saligna</i>	Sydney Blue Gum	28	26	550		550	620	M	G	G	H	H	H	U,S,D	DW, W, E	2707	6600	4.5m from proposed building - minor encroachment within TPZ		Large hanging deadwood. 1 low branch @ 5m over property. Phoenix @ base and Privet - Codominant @ 8m - with wound at junction. Large epicormics

NO#	Genus	Species	Common Name	Height	Spread	Trunk Dia	Trunk Dia 2	DBH	DRB	Age	Health	Crown	Signifi- cance	Am	Eco	Form	Defects	SRZ	TPZ	Development Setback	Comments
11	<i>Eucalyptus</i>	<i>saligna</i>	Sydney Blue Gum	30	24	750		750	800	M	G	AV	H	H	H	U,S	DW	3013	9000	7.5m from proposed building - minor encroachment within TPZ	Liquidambers @ base. Codominant with T10 & T12. Deadwood, hanging deadwood. Tridominant @ 3m. Weeds @ base. Leaf debris @ base. Driveway on other side of fence
12	<i>Eucalyptus</i>	<i>tereticornis</i>	Forest Red Gum	24	22	490		490	530	M	G	G	H	H	H	U,S,D	DW, E	2535	5880	5.8m from proposed building - minor encroachment within TPZ	Large deadwood. Small insect wounds on trunk. Epicormics, broken branches
13	<i>Grevillea</i>	<i>robusta</i>	Silky Oak	20	10	350		350	410	M	G	F	M	M	M	CS - T12 +14	-	2276	4200	5.5m from proposed building - no impact	Sparse - codominant @ 12m
14	<i>Quercus</i>	<i>robur</i>	English Oak	20	18	400		400	490	M	AV	G	M	H	L	B,S,D	P,E, PD	2453	4800	4.9m from proposed building - minor encroachment within TPZ	Lower branches pruned, epicormics. Pest/disease - leaves speckled.

15	<i>Grevillea</i>	<i>robusta</i>	Silky Oak	19	10	335		335	400	M	G	AV	M	M	M	CS	P	2252	4020	4.8m from proposed building - no impact	Root damage. Lower branches pruned. Crownshy to T14
16	<i>Araucaria</i>	<i>cunninghamii</i>	Hoop Pine	12	12	290		290	330	M	AV	AV	M	M	L	B,C	P	2077	3480	4.1m from proposed building - no impact	Recent lower branches pruned and left @ base. Low branches from 4m. Broken branches. Growing over bricks @ base, below small wall.
17	<i>Eucalyptus</i>	<i>saligna</i>	Sydney Blue Gum	31	24	870		870	870	M	F	AV	H	H	H	U,S	DW, PD	3121	10440	3.1m from proposed building - major encroachment (23%) within TPZ	Weeds @ base. Large deadwood. Codominant @ 4m. Damp wood in wound @ base - possible soft rot. Wound on trunk. 3 large <i>Phellinus</i> or similar fungus on trunk. Decay column. Borer in heartwood and bark.
18	<i>Eucalyptus</i>	<i>saligna</i>	Sydney Blue Gum	30	26	880		880	980	M	G	G	H	H	H	B,S,D	DW, P, E	3281	10560	5m from proposed retaining wall - major encroachment (17%) within TPZ or 11% if path at ex. grade	Large deadwood, and hanging deadwood. Leaning away from fence. Pruned. Epicormics.
