Arborist Report

Client: Health One

Address: Corner Jacaranda Avenue &
Swan Street Raymond Terrace N.S.W 2324

Date: 12th December 2011

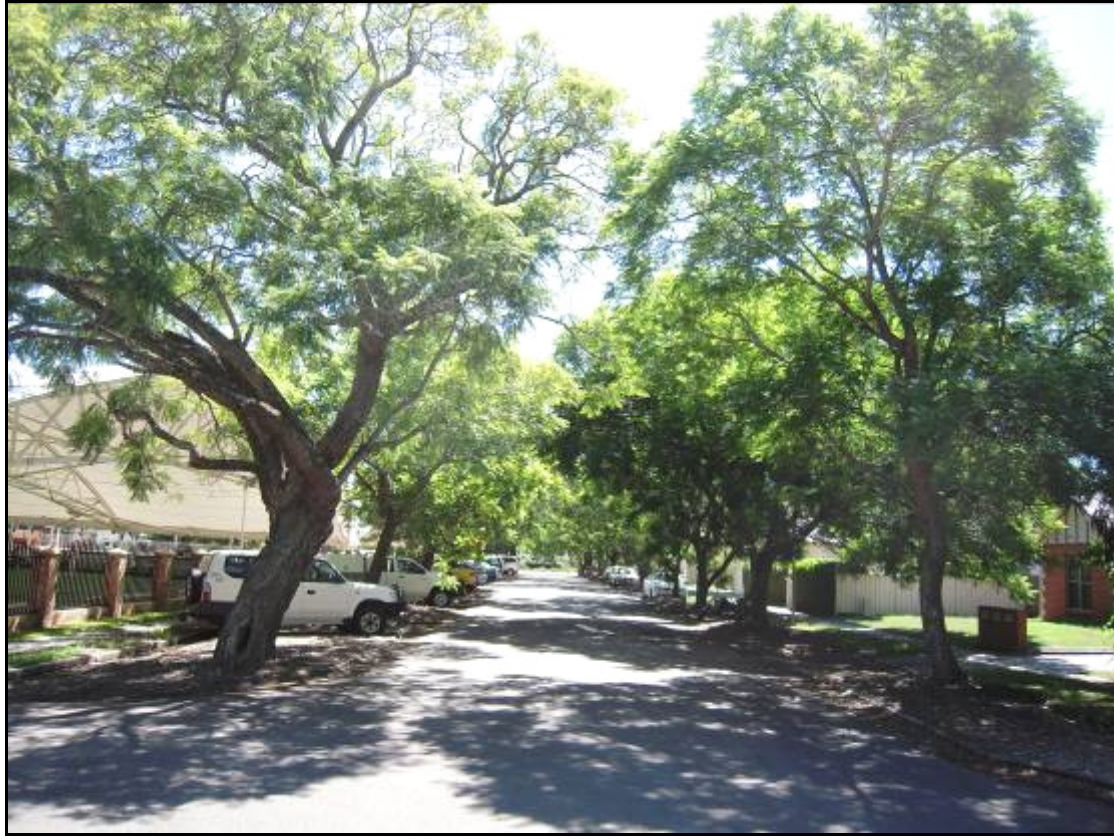
Figure 2 – Looking north along Jacaranda Avenue showing the avenue of Jacaranda mimosifolia. These trees are earmarked for retention and will be protected during the construction phase.

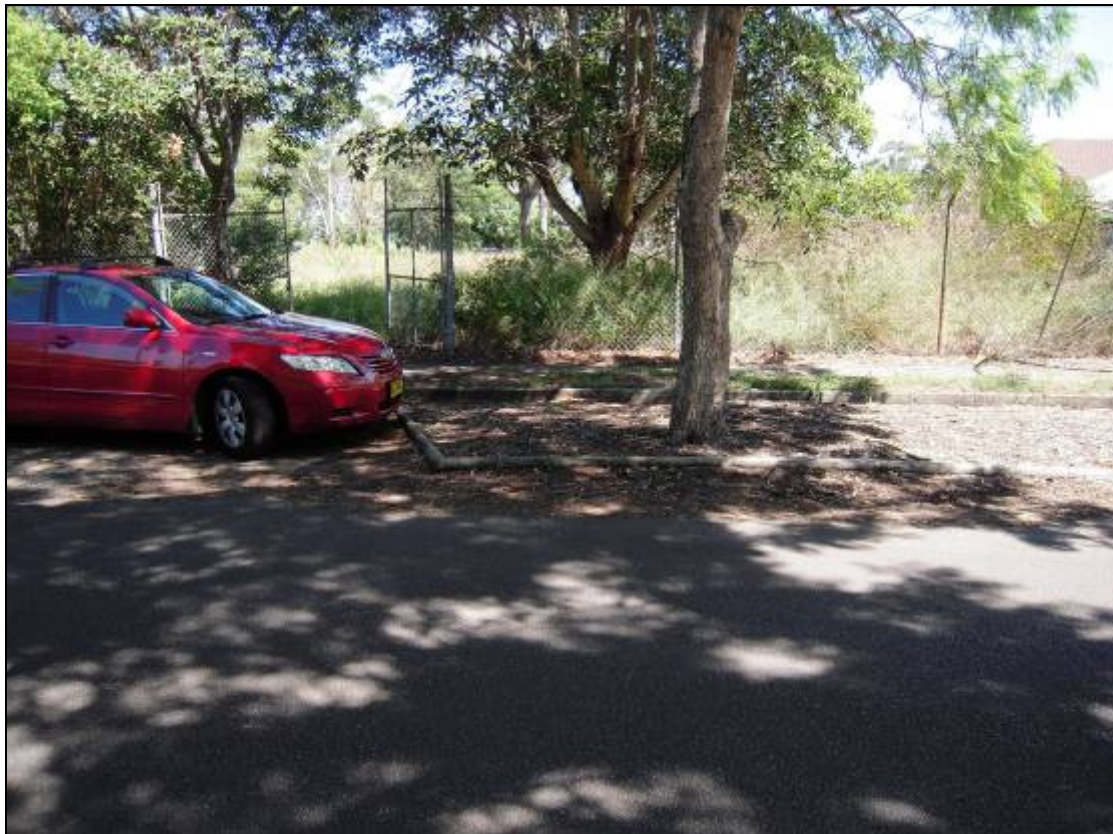
Figure 4 - Location of Tree 1 near the entry point into the subject property.

- It is recommended to erect tree protection measures to Trees 1 & 2 in accordance with Australian Standards 4970 2009 before commencement of any trucks entering the site. Tree guards are to be installed to minimise damage to the trees during the construction phase. Tree protection measures are to consist of 2 metre (or similar size) wooden beams installed to the trunk of the tree. Hessian or a similar non abrasive material is to be placed behind the planks to ensure minimal damage occurs to the tree. A temporary layer of mulch is to be applied to the area to a depth of 200mm. Rumble boards are to be placed over the mulch to minimise compaction to the Trees. It is recommended to allocate a different entry point for trucks and heavy machinery if feasible away from the Jacarandas. If this is not feasible than protection measures outlined will need to be adopted for Trees 1 & 2.

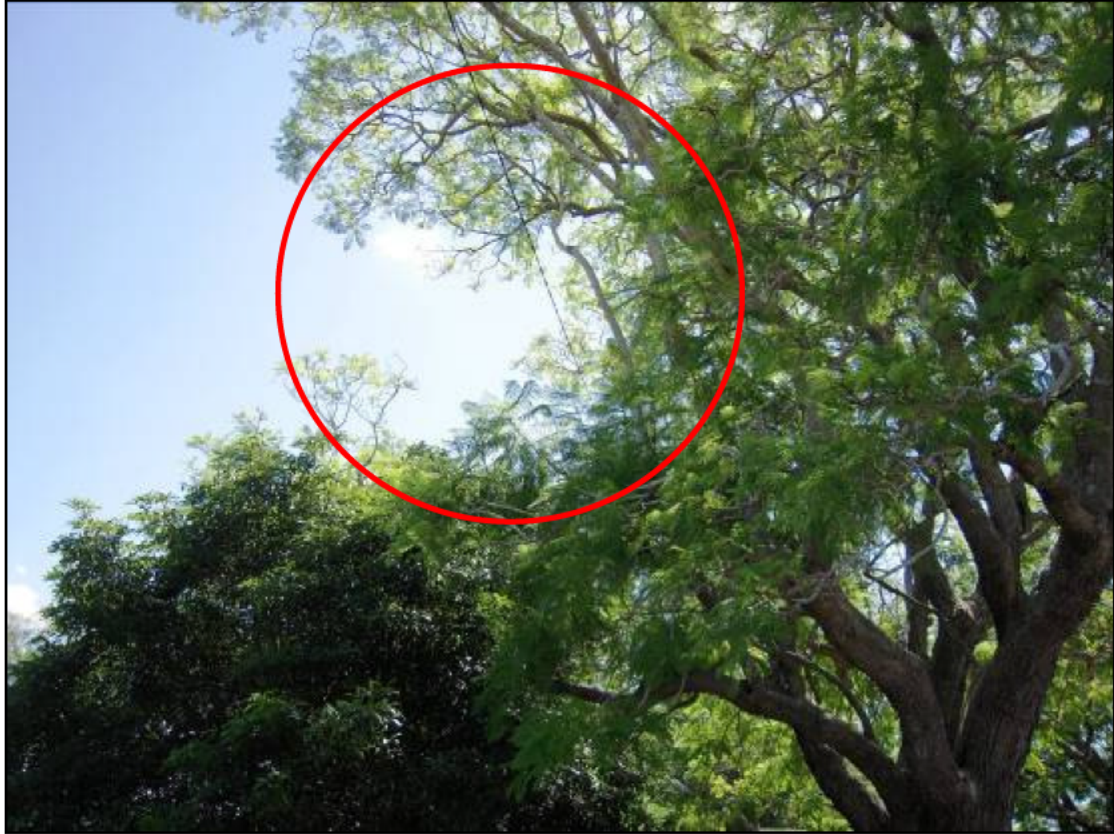
Tree 4 has been directionally pruned to the west over wires in the past that has resulted in epicormic leaders forming at the wound. The tree will require moderate pruning works in the medium term as the tree continues to grow near the service wires.

Figure 5 – Showing the area highlighted in red that has been directionally pruned to minimise damage to the service wires.

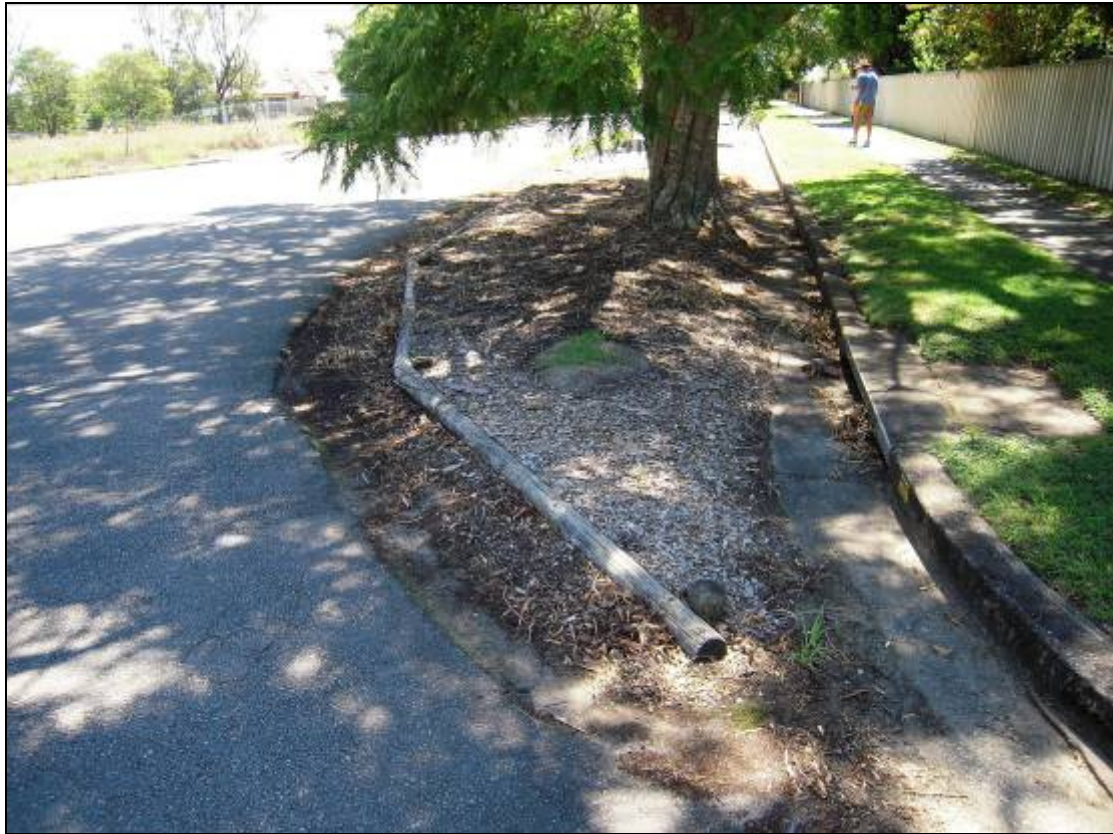
Tree 5 has three main leaders at 1.6 metres above ground level. The tree is located in a mulched garden bed in a similar pattern to the other *Jacaranda mimosifolia*. The tree requires no work in the short term and could be retained and incorporated into the design.

Figure 6 – Location of Tree 5 within a mulched garden bed on the corner of Jacaranda Avenue.

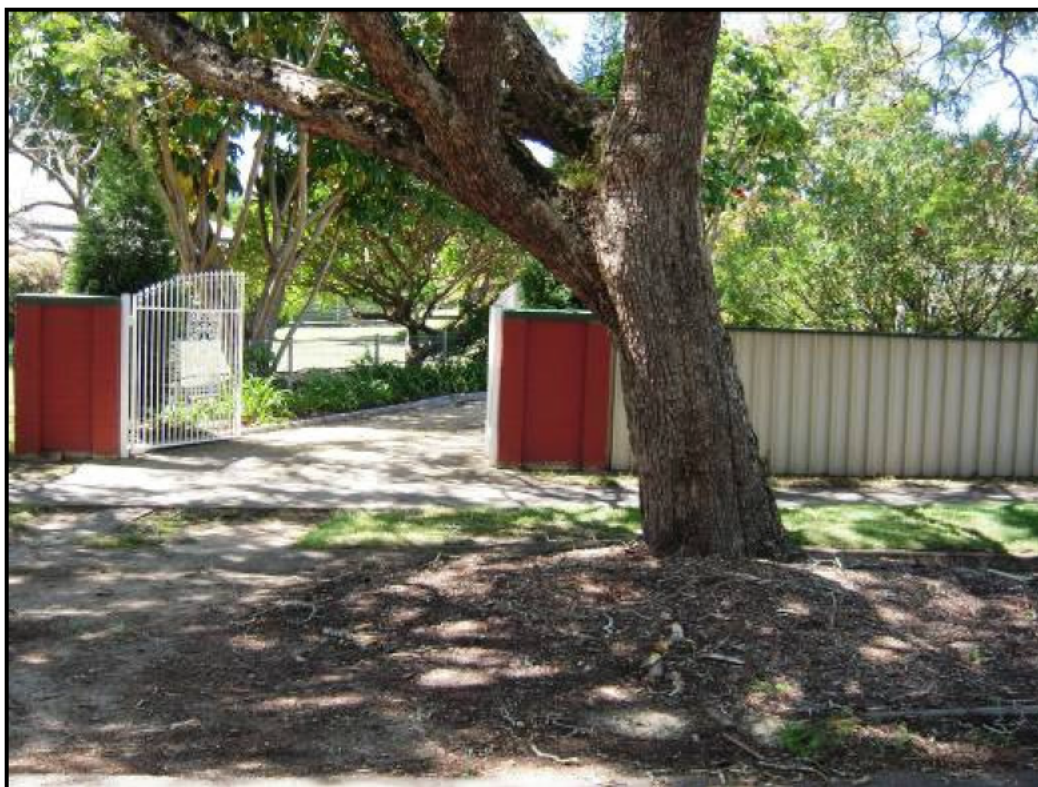
| Tree No | Scientific Name | Common Name | DBH (MM) | Height (M) | AGE CLASS | Vigour | SPREAD N.E.S.W. | UL E | Comments |
|---|---|---|---|---|---|---|---|---|---|
| 9 | Jacaranda mimosifolia | Jacaranda | 730 | 14 | M | G | 10,6,5,6 | 2d | Driveway 1.5 metres from the tree. Bollard could be installed to minimize damage from cars. Retain tree and incorporate into the development. |

Tree 9 is located on the eastern side of Jacaranda Avenue within close proximity to an existing driveway. The tree is within an existing garden bed that has previously been mulched. The tree would benefit from a bollard to prevent mechanical damage from cars hitting the trunk of the tree & minimising compaction within the SRZ. The tree requires no work in the short term and could be retained and incorporated into the design.

Figure 7 – showing the close proximity of Tree 9 to an existing driveway

Figure 17 – erection of a bollard in a similar location to the red line will minimise compaction issues and minimise car movement within the SRZ.

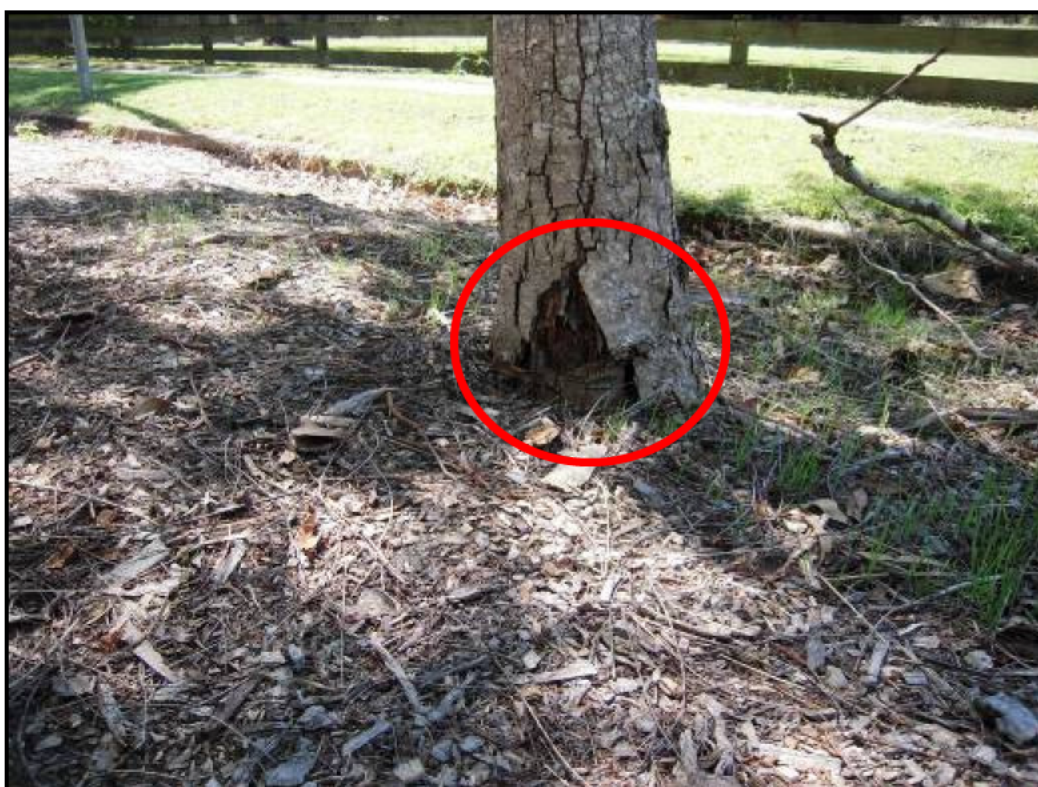
| Tree No | Scientific Name | Common Name | DBH (MM) | Height (M) | AGE CLASS | Vigour | SPREAD N.E.S.W. | UL E | Comments |
|---|---|---|---|---|---|---|---|---|---|
| 10 | Jacaranda mimosifolia | Jacaranda | 190 | 6 | SM | G | 3,2,2,2 | 2d | Mechanical damage on the western side of trunk at the base. Retain tree and incorporate into the development. |

Tree 10 located on the eastern side of Jacaranda Avenue is located in a 1.6 metre wide garden bed. The tree has previous mechanical damage to the western side of the trunk. The tree could be retained and incorporated into the development.

Figure 8 – showing the mechanical damage that has occurred to Tree 10

- It is recommended to monitor the mechanical damage to Tree 10 within a two year period.
- It is recommended to provide an area where no to minimal works are undertaken, set aside as the SRZ. An SRZ should be set aside to Trees near proposed buildings or hardstand areas. This includes the SRZ's to trees 1 – 4. These have been tabulated in the table below -

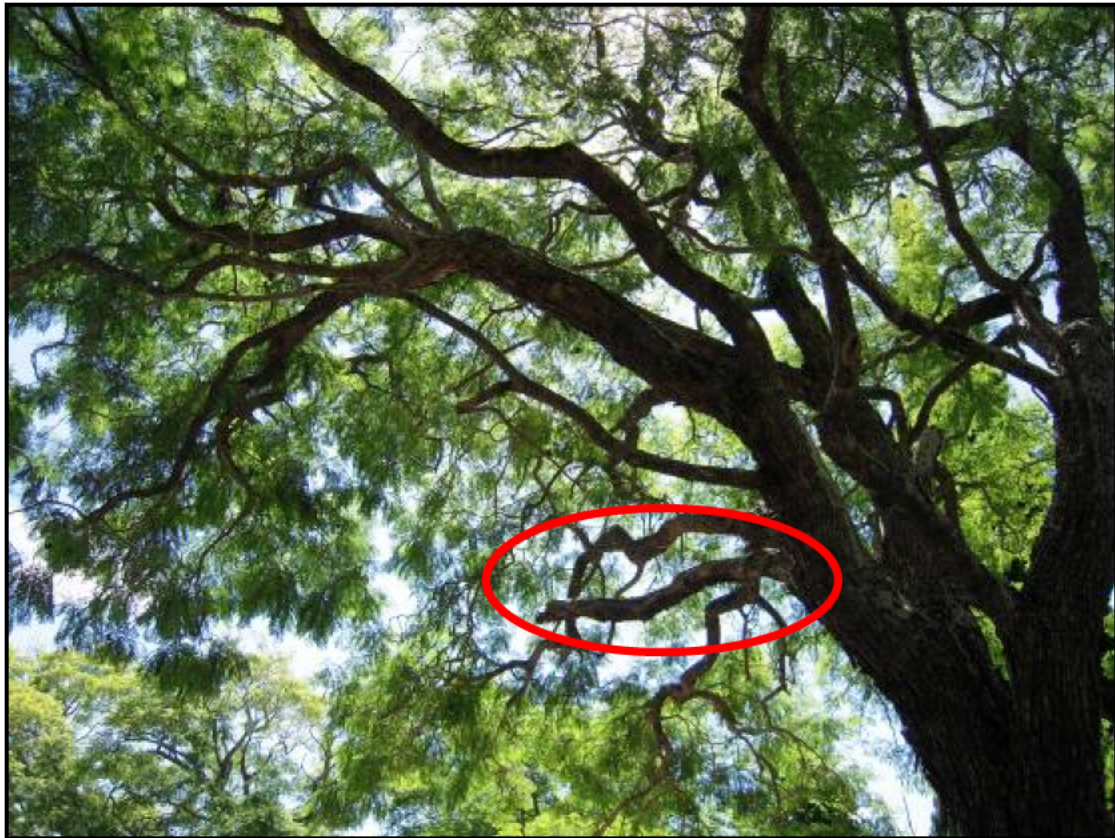
Tree 11 is located on the eastern side of Jacaranda Avenue. The tree has co dominant leaders at 1.8 metres with major deadwood over road and garden bed areas. The deadwood could be accessed by a scissor lift to minimise damage to the tree.

Figure 9 – An example of a 2nd order scaffold tear (Tree 11) out that is overhanging the road way.

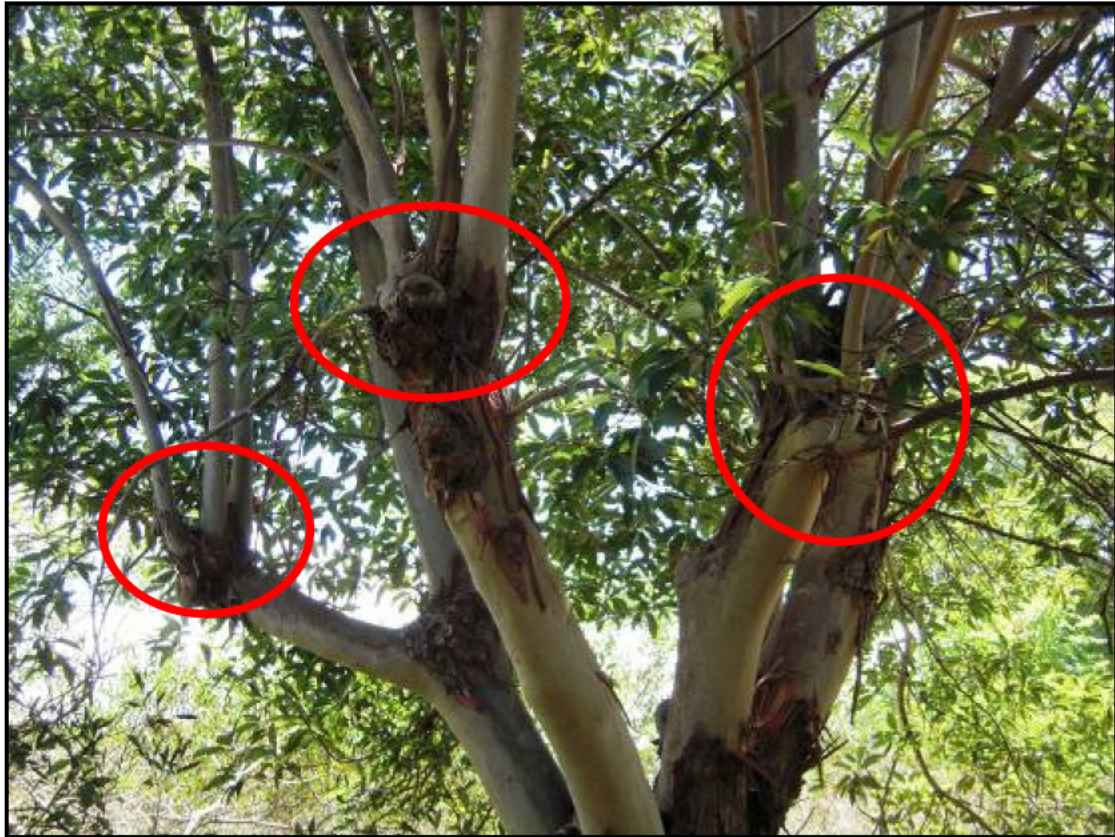
Trees 13 – 18 & 20 have been identified as *Lophostemon confertus* that were planted at the same time. The tree heights vary from 5 – 14 metres and overall are in good health. The entire row of trees has been topped previously and as a result several main leaders have formed on all the trees. The topping points vary however most were topped at 2.0 – 2.5 metres above ground level. This pruning technique contravenes Australian Standards 4970 – 2009. As a result the trees are not growing true to form with multiple attachments. Trees 13, 15 – 18 will be within the proposed car parking areas to the north east and Tree 14 will be within the driveway entry/exit area off Jacaranda Avenue. Trees 19 & 20 will be severely damaged by the excavation works due to the proposed car parking and building. The western root plate (TPZ) of Trees 19 & 20 would be severed by 35 – 40%.

Figure 10 – An example of the topped points on the cluster of *Lophostemon confertus* identified as trees 13 – 18, 20 & 22 on the north eastern side.

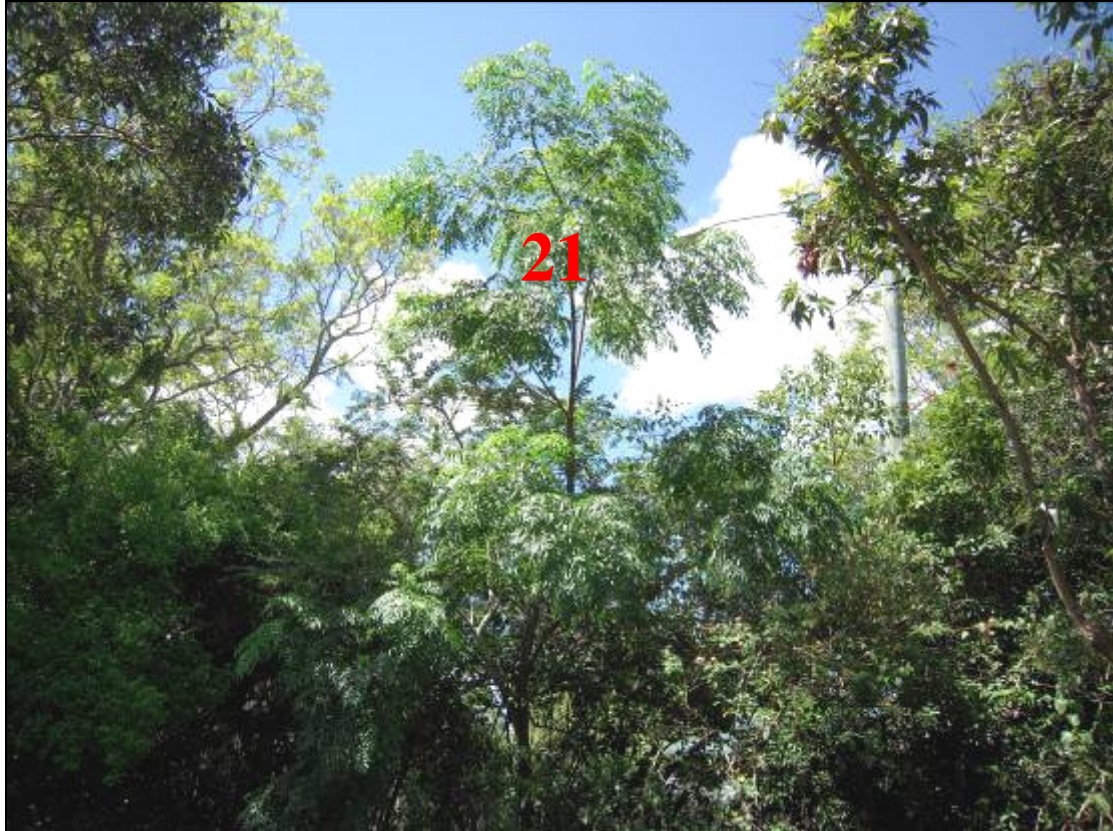
Trees 20, 21 & 22 have been identified as *Lophostemon confertus*, *Melia azedarach* & *Lophostemon confertus*. Trees 20 & 22 have been topped previously and are not growing true to form. The trees are akin to the tree depicted in Figure 10. The trees due to their position will be just outside the proposed building. Trees 20 & 22 would require 35 – 40% of the canopy removed in order to accommodate the building. These trees have been earmarked for removal in order to accommodate the proposed building. Tree 21 would require minor pruning works of no more than 10% however

is only semi mature and would impede on the building as the tree continues to grow. The tree has a SRZ of 1.40 metres that will increase over time. This type of species when mature can grow to 12 – 15 metres in height. This species would not be suitable in the long term. The tree has been earmarked for removal before commencement of works.

Figure 11 – showing the semi mature Tree 21 that is earmarked for removal due to its location to the proposed hardstand area.

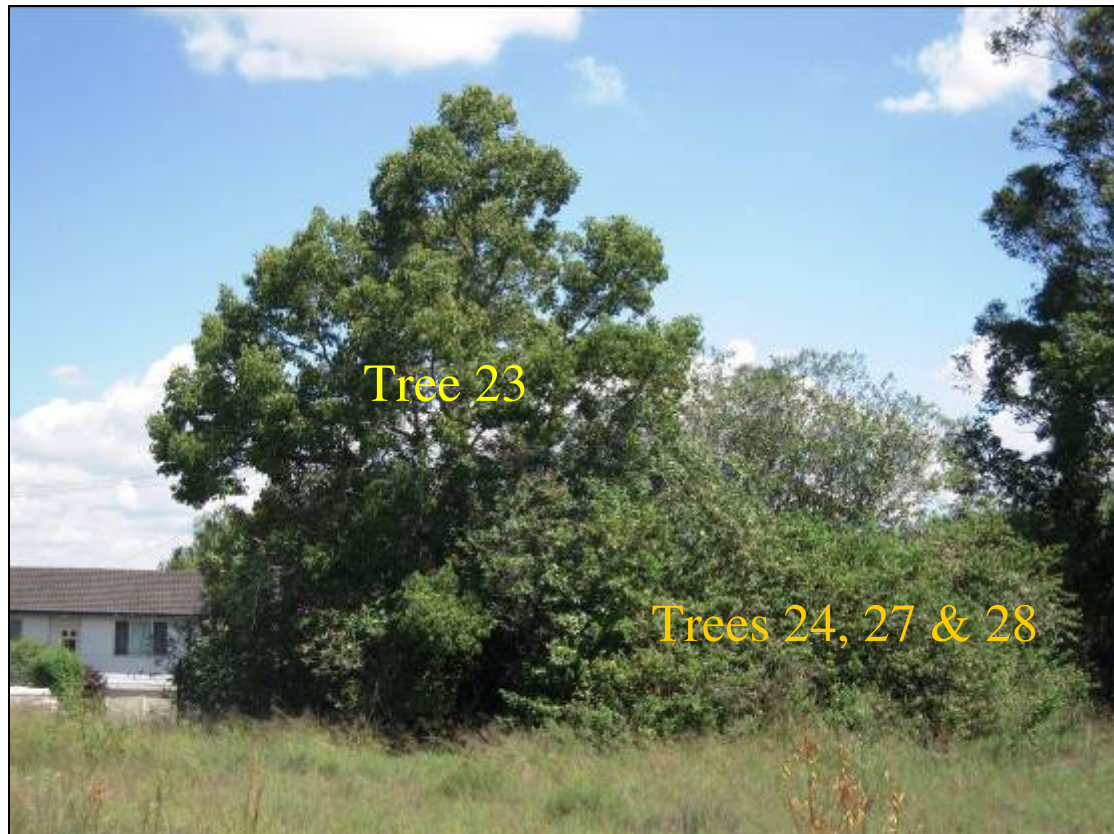
Trees 23, 24, 26 – 28, 30 & 31 are located on the south western side of the property. The trees have been identified as *Cinnamomum camphora* and *Nerium oleander*. Both species have been checked against the tree preservation order and are classified as exempt species and can be removed without further permission from council. These trees would require removal due to their location being within a metre or within the proposed building and hardstand area.

Figure 12 – Showing the location of exempt species within the subject property.

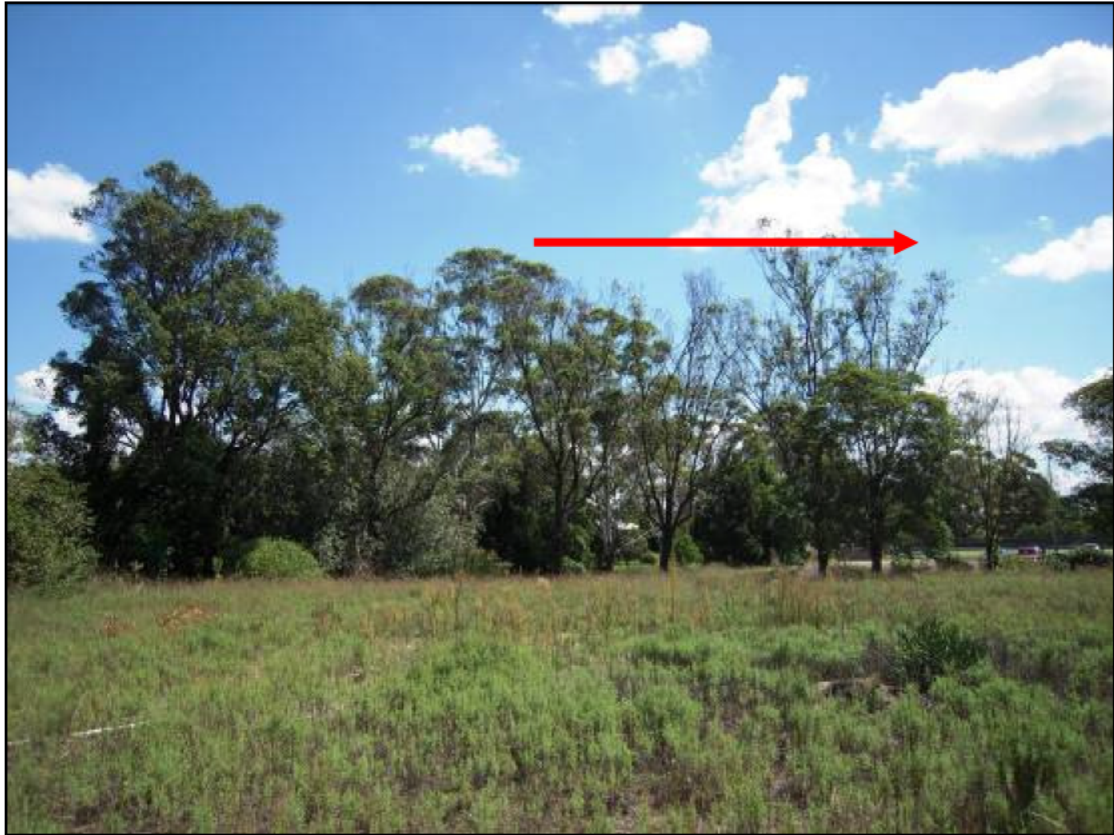
Trees 32 -35 are located on the western boundary of the subject property. These trees have been identified as *Eucalyptus robusta*. The trees are all in poor form with a live crown ratio of 30 – 35% for the cluster of trees. The trees display major dieback and extensive epicormic growth (see Figure 13). The trees have short life spans and would be beneficial to remove and replace with native trees.

Figure 13 – Showing the row of over mature Eucalyptus robusta (Trees 32 – 35) located on the western boundary of the subject property.

- Trees 32 – 35 have been identified as *Eucalyptus robusta* that are in a declining condition with extensive epicormic growth. The trees have a life span less than 5 years and have been earmarked for removal.

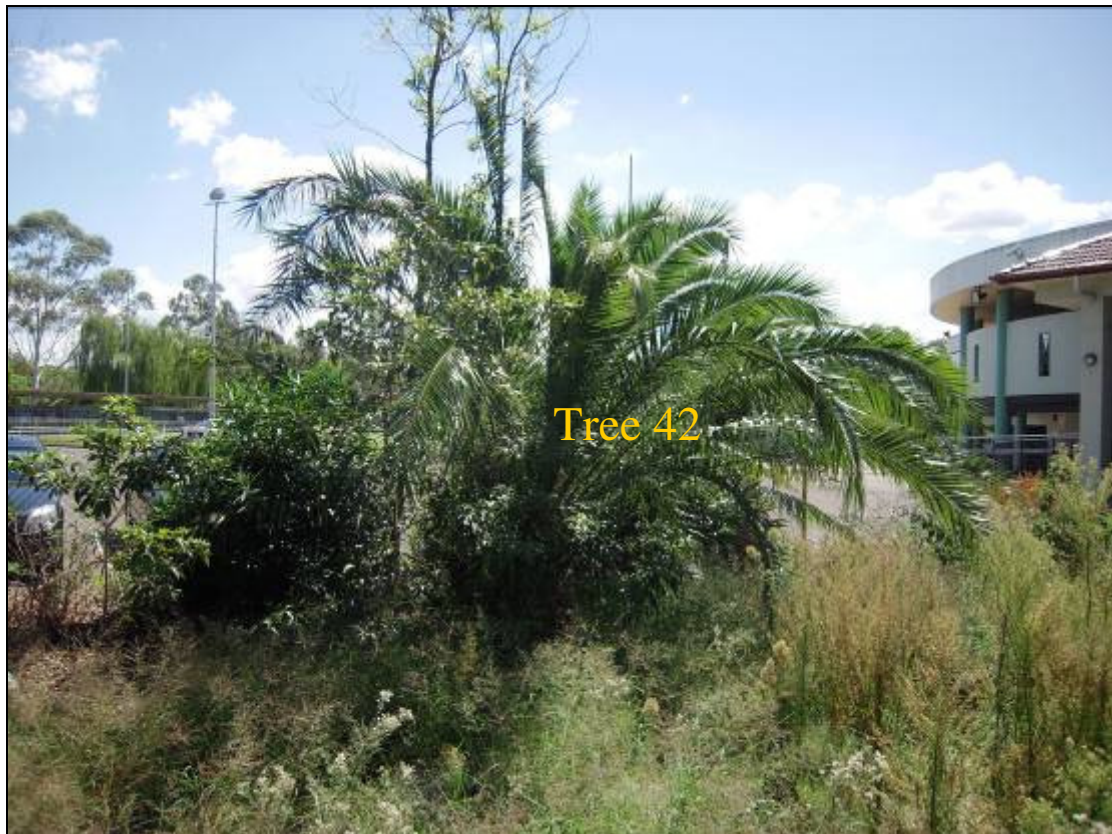
Tree 42 has been identified as a young *Phoenix canariensis* that is 4 metres tall. The tree comes under the requirements of Port Stephens tree preservation order. Tree 42 is in good health and condition and has a long life span. The trees root plate would be within the proposed car parking area by 60 – 65%. This is considered a major encroachment into the TPZ and therefore has been earmarked for removal.

Figure 14 - The location of Tree 42 is within the north western corner of the subject property.

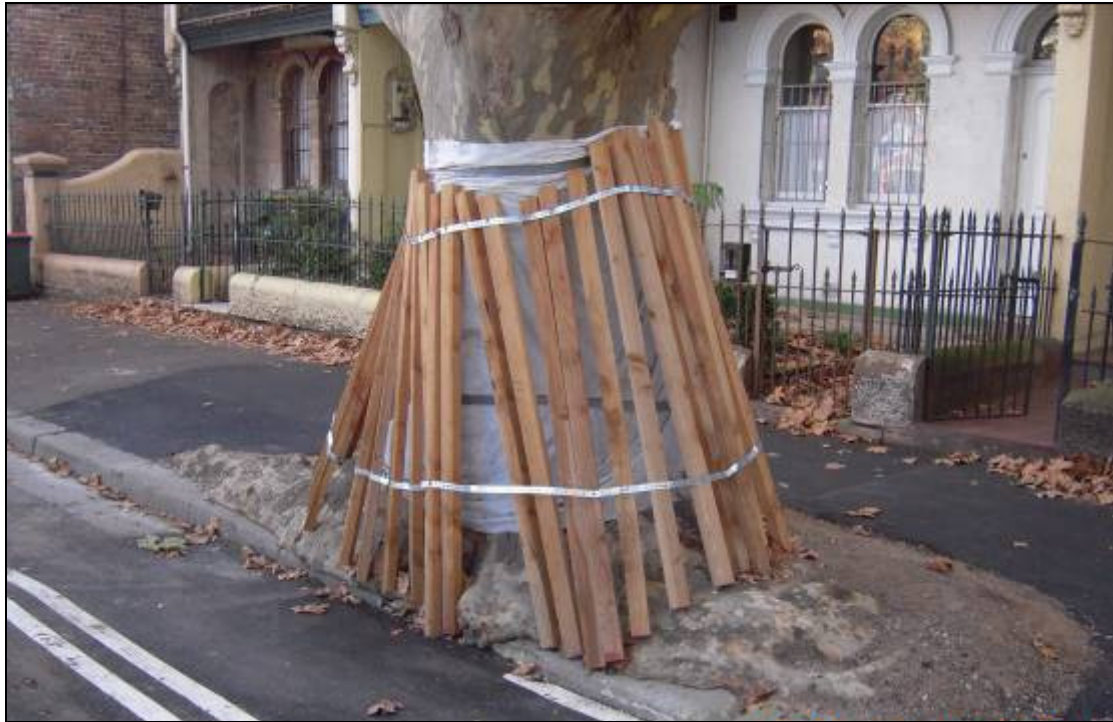
Figure 15 – Tree protection measures (for Trees 1 & 2) as indicated by the photo above will minimise damage by trucks and cars entering the site and protect against accidental damage by such vehicles.
