## **Asbestos Survey of Tamworth Depot Goonoo Goonoo Road, Tamworth NSW**

2 June 2010

**TransGrid**

Ref: HAZ07907\_Tamworth\_ASB\_RPT\_020610

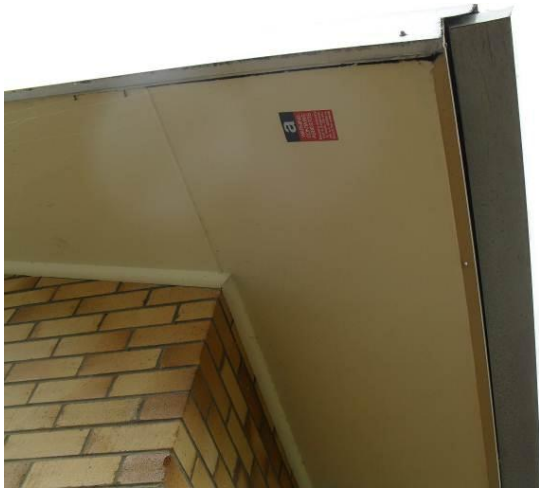
- The paintwork to the eave and ceiling linings throughout the site has deteriorated and is peeling from the surface. There are numerous cracks appearing in the eave linings. These areas should be resealed if the ACM is to remain in situ.*

***Photo 1: Flat AC sheet linings to eaves of Administration Building (Chrysotile Asbestos).***

The flat AC sheet ceiling and eave linings require repainting and repair if they are to remain insitu as the current paintwork has deteriorated and peeling badly.

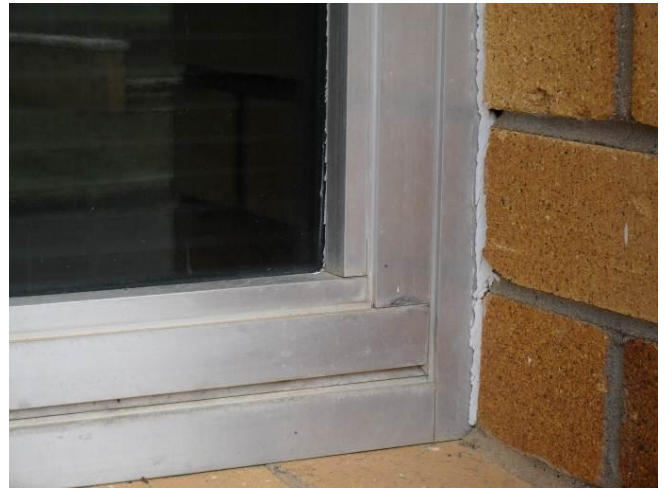
***Photo 2: Mastic containing asbestos to windows – Typical (Chrysotile Asbestos).***

Tamworth Depot	Office and Administration	Exterior	Mastic to windows	Mastic containing asbestos	HLA (2007-1)	Chrysotile	Fair condition, some weathering	16 = 2(2x2x2x1)	P3 - Low	No

2	Affix labels. Maintain and review in 2012	2-Jun-10	Glenn Watterson - Hazmat Services Pty Ltd									
	Tamworth Depot	Office and Administration	Exterior	Coating to Western entry verandah	Galbestos	HLA (2007-2)	Chrysotile	Fair condition, some weathering	16 = 2(2x2x2x1)	P3 - Low	No	-	-	Seal with paint. Affix labels. Maintain and review in 2012	2-Jun-10	Glenn Watterson - Hazmat Services Pty Ltd									
	Tamworth Depot	Office and Administration	Exterior	Ceiling lining to Western entry verandah	Flat AC sheet	HLA (2007-3)	Chrysotile, Amosite & Crocidolite	Good condition	2 = 2(1x1x1x1)	P4 - Negligible	Yes	-	-	Maintain and review in 2012	2-Jun-10	Glenn Watterson - Hazmat Services Pty Ltd									
	Tamworth Depot	Office and Administration	Exterior	Coating to South-Eastern entry Verandah roof sheeting and fascia panel	Presumes Galbestos	-	Presumed asbestos	Fair condition, some weathering	16 = 2(2x2x2x1)	P3 - Low	No

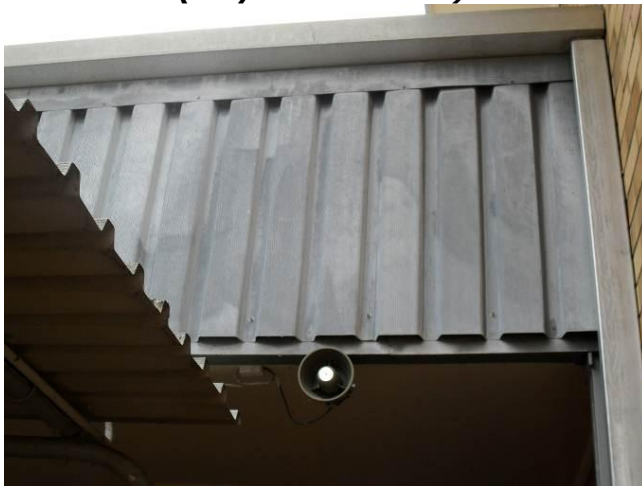
***Photo 3: Galbestos cladding to south/eastern entry to Control / Mains Building.***

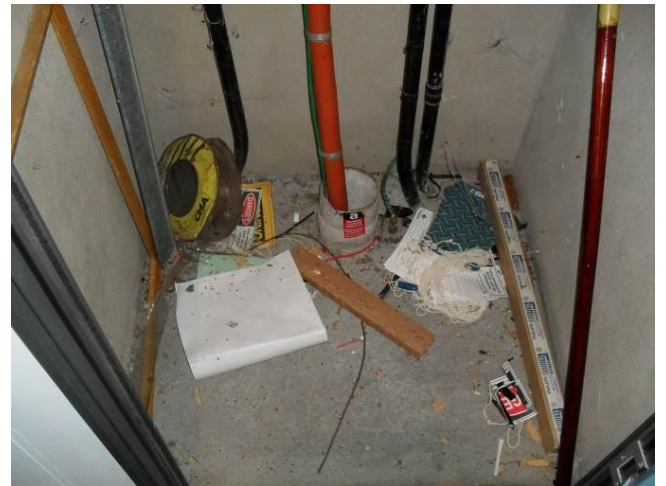
***Photo 4: Conduit to distribution cupboard of Administration Building (Chrysotile, Crocidolite & Amosite Asbestos).***

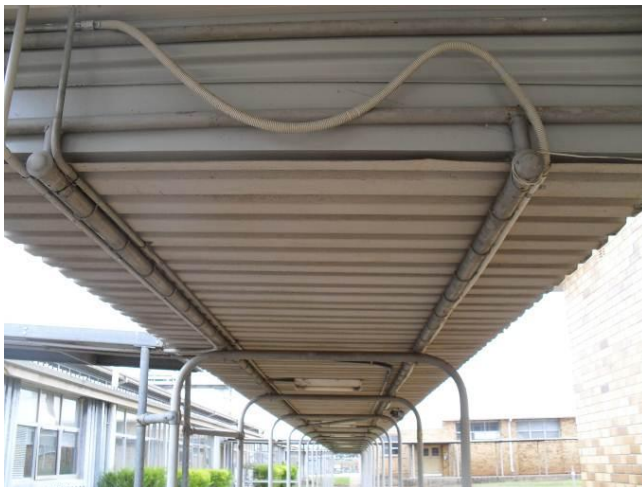
***Photo 5: Galbestos coating to all walkways.***

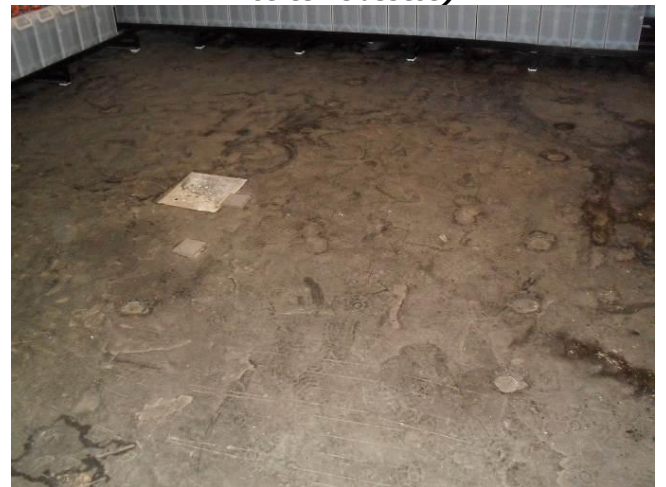
The bituminous type floor covering to the Battery Charge Room that contain asbestos is in poor condition with damage to the surface. This should be removed under controlled asbestos conditions and replaced with a non-asbestos alternative.

***Photo 6: Malthoid to floor of Battery Charge Room. (Chrysotile Asbestos).***

ID	Site	Building	Exterior/ Interior	Item	Description	Sample Number	Type	Condition	Hazard Level	Priority Level	Labelled	Photograph	Photograph No	Recommendation	Date Raised	Raised By (Competent Person)	Owner	Target Date	Risk Response	Residual Risk	Status	Progress	Reference	Close Date	Comments
	Tamworth Depot	Control and Stores	Interior	Distribution board to Battery Room	Backing board presumed to contain asbestos	-	Presumed asbestos	Good condition	2 = 2(2x1x1x1)	P4 - Negligible	Yes	-	-	Maintain and review in 2012	2-Jun-10	Glenn Watterson - Hazmat Services Pty Ltd									
	Tamworth Depot	Control and Stores	Interior	Conduits to Battery Room	Presumed moulded AC	-	Presumed asbestos	Fair condition, minor damage, unpainted	8 = 2(2x2x1x1)	P3 - Low	Yes	-	-	Seal with paint. Maintain and review in 2012	2-Jun-10	Glenn Watterson - Hazmat Services Pty Ltd									
	Tamworth Depot	Control and Stores	Interior	Floor covering to Battery Room	Bitumous floor covering	Hyder 2001 (85-4)	Chrysotile	Poor condition, extensive damage	48 = 2(3x2x2x2)	P2 - Medium	No

6	Remove and replace with non-asbestos alternative as soon as possible	2-Jun-10	Glenn Watterson - Hazmat Services Pty Ltd

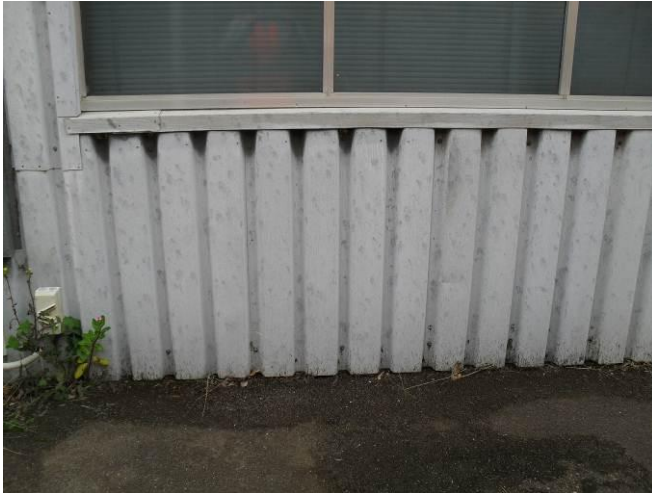
***Photo 7: Galbestos coating to Workshop walls  
(Chrysotile Asbestos).***

Tamworth Depot	Workshop	Exterior	Coating to metal wall cladding	Galbestos	HLA (2007-9)	Chrysotile	Fair condition, some weathering	16 = 2(2x2x2x1)	P3 - Low	No

7	Seal with paint. Affix labels. Maintain and review in 2012	2-Jun-10	Glenn Watterson - Hazmat Services Pty Ltd									
	Tamworth Depot	Workshop	Exterior	Coating to roof sheeting	Presumed Galbestos	-	Presumed asbestos	Fair condition, some weathering	16 = 2(2x2x2x1)	P3 - Low	No	-	-	Seal with paint. Affix labels. Maintain and review in 2012	2-Jun-10	Glenn Watterson - Hazmat Services Pty Ltd									
	Tamworth Depot	Workshop	Exterior	Eave linings	Flat AC sheet	HLA (2007-10)	Chrysotile, Amosite & Crocidolite	Good condition	2 = 2(1x1x1x1)	P4 - Negligible	Yes	-	-	Maintain and review in 2012	2-Jun-10	Glenn Watterson - Hazmat Services Pty Ltd									
	Tamworth Depot	Workshop	Exterior	Seal to combination fuse switch boxes	Asbestos rope	HLA (2007-11)	Chrysotile	Fair condition, easily damaged on opening.	48 = 3(2x2x2x2)	P2 - Medium	No

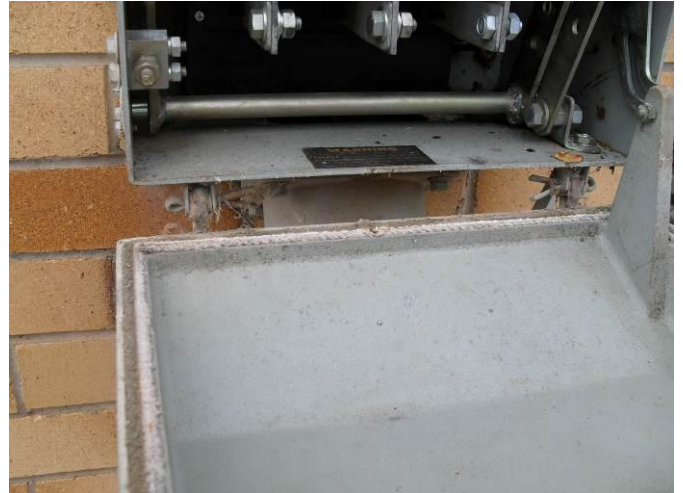
The seal to the combination fuse switch is in poor condition and is easily damaged on opening. The seal should be removed under controlled asbestos conditions as soon as possible and replace with a non-asbestos alternative.

***Photo 8: Seal to combination fuse switches  
containing asbestos (Chrysotile Asbestos).***

8	Remove and replace with non-asbestos alternative as soon as possible	2-Jun-10	Glenn Watterson - Hazmat Services Pty Ltd

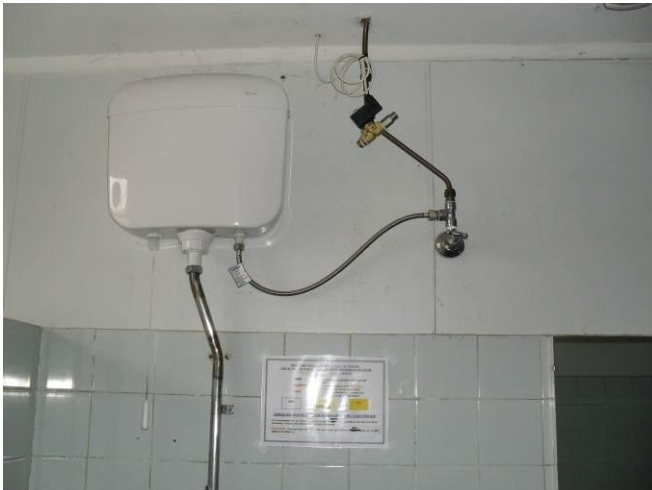
***Photo 9: Flat AC sheet linings to Technical  
Services Amenities (Chrysotile, Crocidolite &  
Amosite Asbestos).***

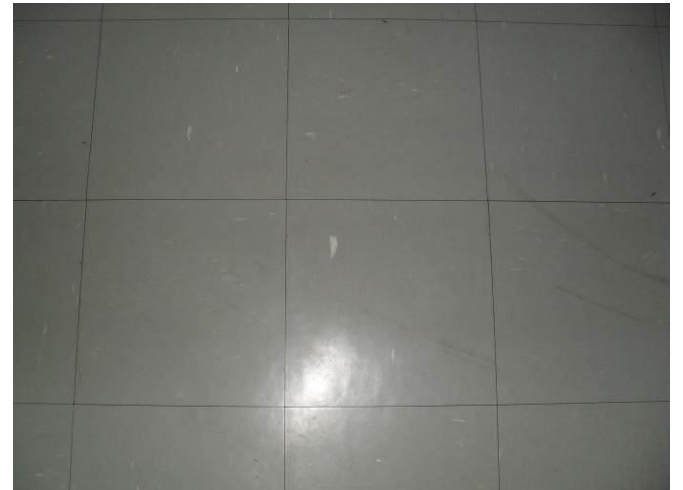
The vinyl tiles to the office of the plant section room that contain asbestos are in a poor condition with damage to the surface. These should be removed under controlled asbestos conditions and replaced with a non-asbestos alternative.

***Photo 10: Vinyl tiles to Plant Section Office  
containing asbestos  
(Chrysotile Asbestos).***

Tamworth Depot	Workshop	Interior	Floor covering to Plant Section Office	Vinyl tile containing asbestos	HLA (2007-16)	Chrysotile	Fair condition, some damage	16 = 2(2x2x2x1)	P3 - Low	No

10	Remove and replace with non-asbestos alternative when capital allows. Affix labels, maintain and review in 2012.	2-Jun-10	Glenn Watterson - Hazmat Services Pty Ltd									
	Tamworth Depot	Workshop	Interior	Floor covering to Sub Station Workshop Office	Vinyl tile containing asbestos	HLA (2007-17)	Chrysotile	Good condition	2 = 2(1x1x1x1)	P4 - Negligible	No

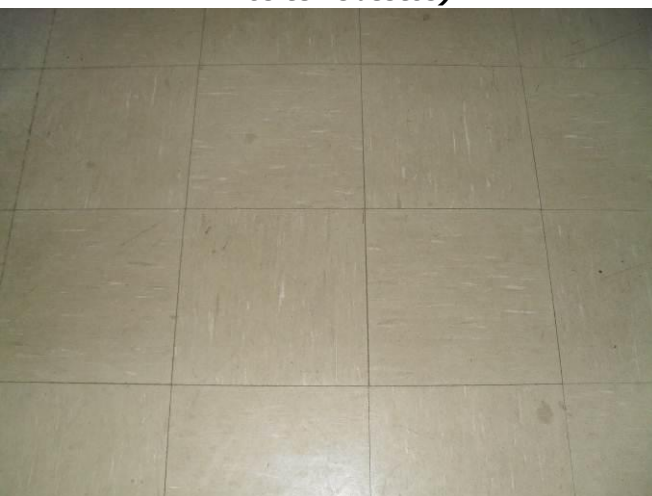
***Photo 11: Vinyl tile to Sub Station Office  
containing asbestos (Chrysotile Asbestos).***

11	Affix labels. Maintain and review in 2012	2-Jun-10	Glenn Watterson - Hazmat Services Pty Ltd									
	Tamworth Depot	Stores Area (Yard)	Exterior	Coating to metal cladding of sheds (2 of)	Presumed Galbestos	-	Presumed asbestos	Fair condition, some weathering	16 = 2(2x2x2x1)	P3 - Low	No

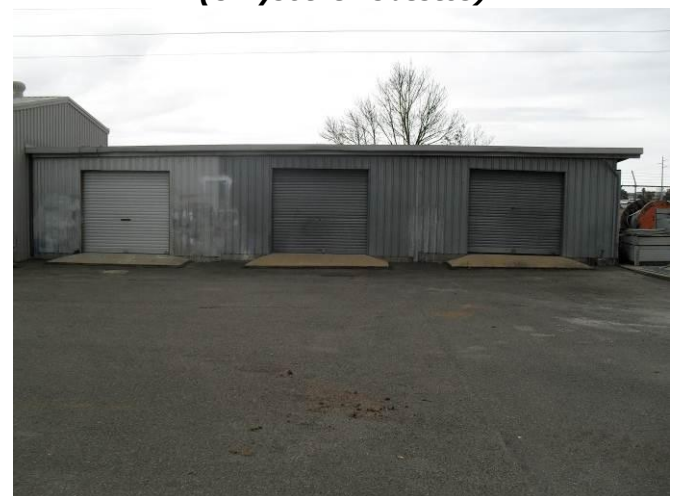
The Galbestos coatings of the Storage Area are starting to peel and deteriorate due to weathering. This should be rectified when capital allows.

***Photo 12: Yard Stores Area Storage Shed  
Galbestos coating (Presumed to contain  
asbestos).***

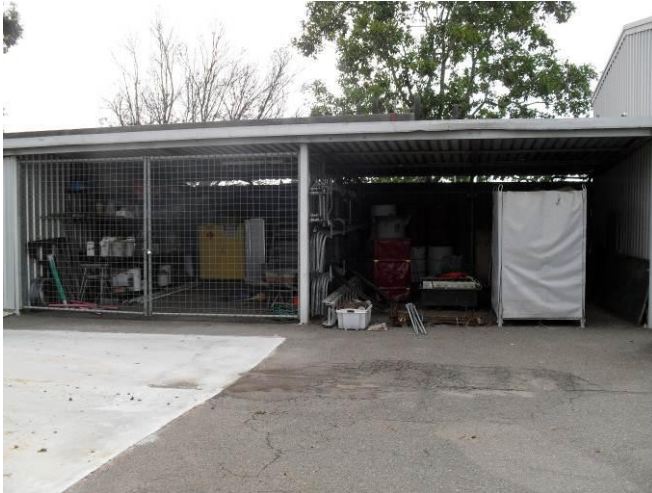
***Photo 13: Yard Stores Area Storage Shed with Galbestos coating (Presumed to contain asbestos).***

13	Seal with paint. Affix labels. Maintain and review in 2012	2-Jun-10	Glenn Watterson - Hazmat Services Pty Ltd									
	Tamworth Depot	Flammable Liquids	Exterior	Coating to roof sheeting	Presumed Galbestos	-	Presumed asbestos	Fair condition, some weathering	16 = 2(2x2x2x1)	P3 - Low	No	-	-	Seal with paint. Affix labels. Maintain and review in 2012	2-Jun-10	Glenn Watterson - Hazmat Services Pty Ltd									
	Tamworth Depot	Flammable Liquids	Exterior	Eave lining	Presumed flat AC sheet	-	Presumed asbestos	Good condition	4 = 2(1x1x1x1)	P4 - Negligible	Yes

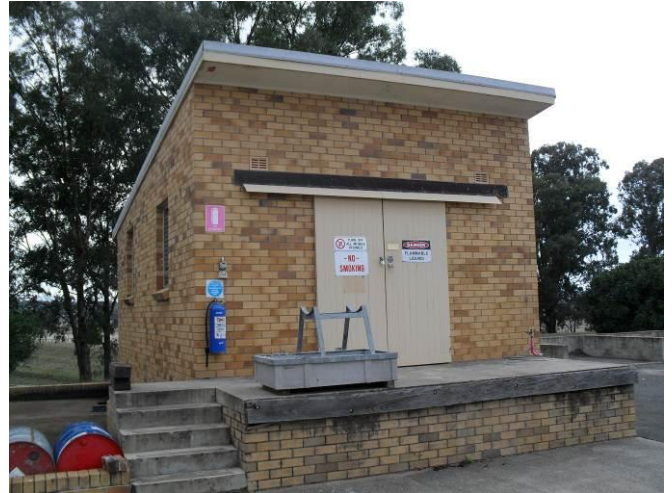
***Photo 14: Flammable Liquids Shed – Galbestos coating to roof presumed to contain asbestos and presumed flat AC sheet eave lining.***

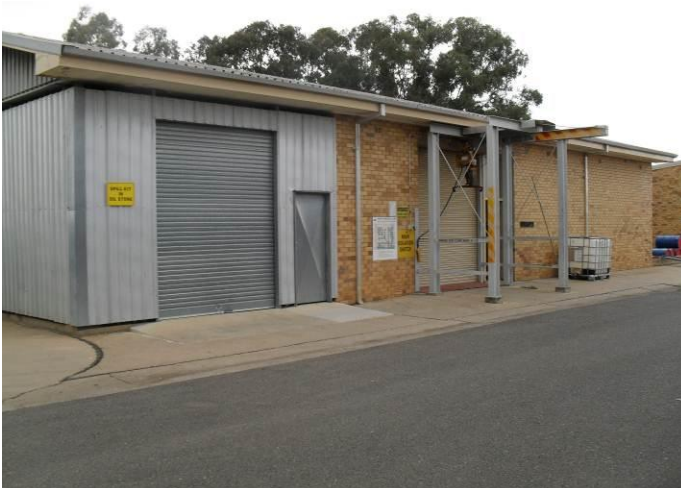
***Photo 15: Oil Stores Building - Galbestos coating to roof and gable ends presumed to contain asbestos.***

15	Seal with paint. Affix labels. Maintain and review in 2012	2-Jun-10	Glenn Watterson - Hazmat Services Pty Ltd									
	Tamworth Depot	Oil Stores	Exterior	Eave lining	Presumed flat AC sheet	-	Presumed asbestos	Good condition	2 = 2(1x1x1x1)	P4 - Negligible	Yes	-	-	Maintain and review in 2012	2-Jun-10	Glenn Watterson - Hazmat Services Pty Ltd

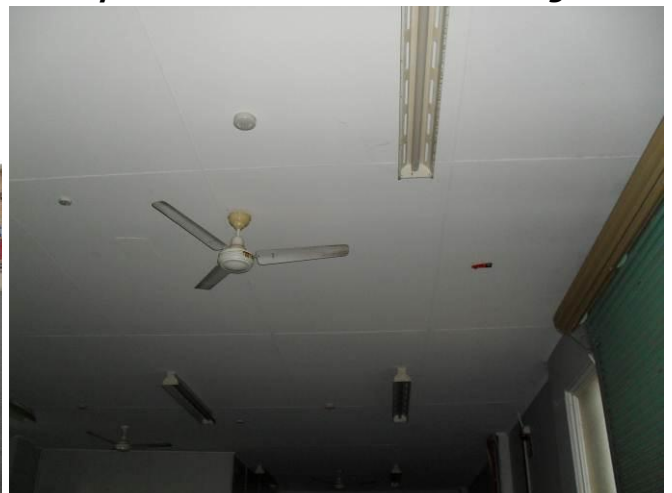
***Photo 16: Flat AC sheet ceiling lining to Oil Store Building (Chrysotile, Crocidolite & Amosite Asbestos).***

16	Affix labels. Maintain and review in 2012	2-Jun-10	Glenn Watterson - Hazmat Services Pty Ltd									
	Tamworth Depot	Oil Stores	Interior	Distribution board to wall	Backing board presumed to contain asbestos	-	Presumed asbestos	Good condition	2 = 2(1x1x1x1)	P4 - Negligible	Yes	-	-	Maintain and review in 2012	2-Jun-10	Glenn Watterson - Hazmat Services Pty Ltd									
	Tamworth Depot	Oil Stores	Interior	Seal to combination fuse switch	Presumed asbestos rope	-	Presumed asbestos	Fair condition, easily damaged on opening	48 = 3(2x2x2x2)	P2 - Medium	No	-	-	Remove and replace with non- asbestos alternative as soon as possible	2-Jun-10	Glenn Watterson - Hazmat Services Pty Ltd

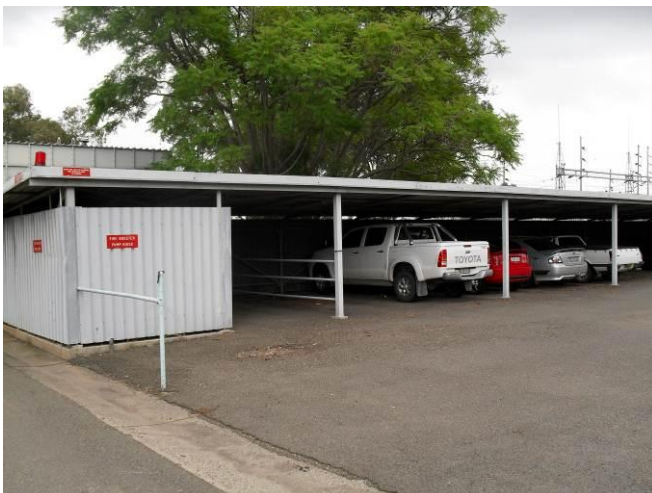
***Photo 17: Main Staff Carport with Galbestos coating (Presumed to contain asbestos).***

Tamworth Depot	Main Staff Carport	Exterior	Coating to metal cladding	Presumed Galbestos	-	Presumed asbestos	Fair condition, some weathering	16 = 2(2x2x2x1)	P3 - Low	No

17	Seal with paint. Affix labels. Maintain and review in 2012	2-Jun-10	Glenn Watterson - Hazmat Services Pty Ltd									
	Tamworth Depot	Main Staff Carport	Exterior	Coating to roof sheeting	Presumed Galbestos	-	Presumed asbestos	Fair condition, some weathering	16 = 2(2x2x2x1)	P3 - Low	No	-	-	Seal with paint. Affix labels. Maintain and review in 2012	2-Jun-10	Glenn Watterson - Hazmat Services Pty Ltd									
	Tamworth Depot	Pump house	Exterior	Cladding to walls	Flat AC sheet	Hyder- 2001 (85-14)	Chrysotile	Fair condition, areas of damage, Exposed edges	32 = 2(2x2x2x2)	P2 - Medium	Yes

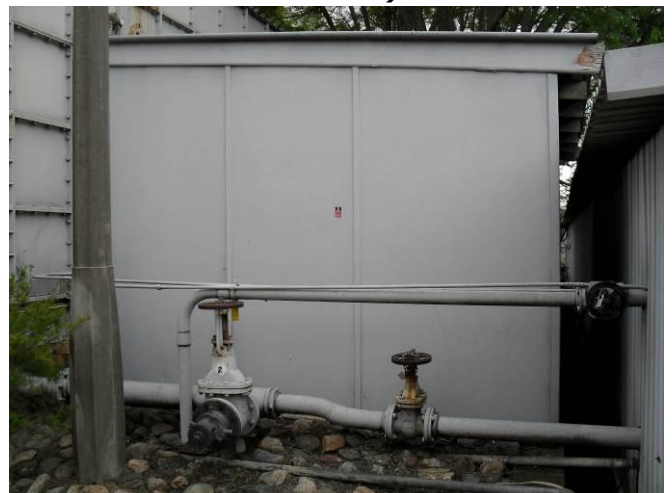
The flat AC sheet wall cladding to this building has sustained some damage to the surface exposing fibres. This cladding should be sealed with paint or removed under controlled asbestos conditions replaced with a non-asbestos alternative under controlled conditions.

***Photo 18: Flat AC sheet wall cladding to Pump House Building (Chrysotile Asbestos).***

18	Sealed damaged areas with paint or remove under controlled conditions. Maintain and review in 20112	2-Jun-10	Glenn Watterson - Hazmat Services Pty Ltd
