Preliminary Arborist's Report

Site Address: 4B South St Windale NSW 2306

Date: 20 October 2014

Prepared by Ian Hills - Assoc. Dip Hort., Cert III Arboriculture,
Diploma Arboriculture

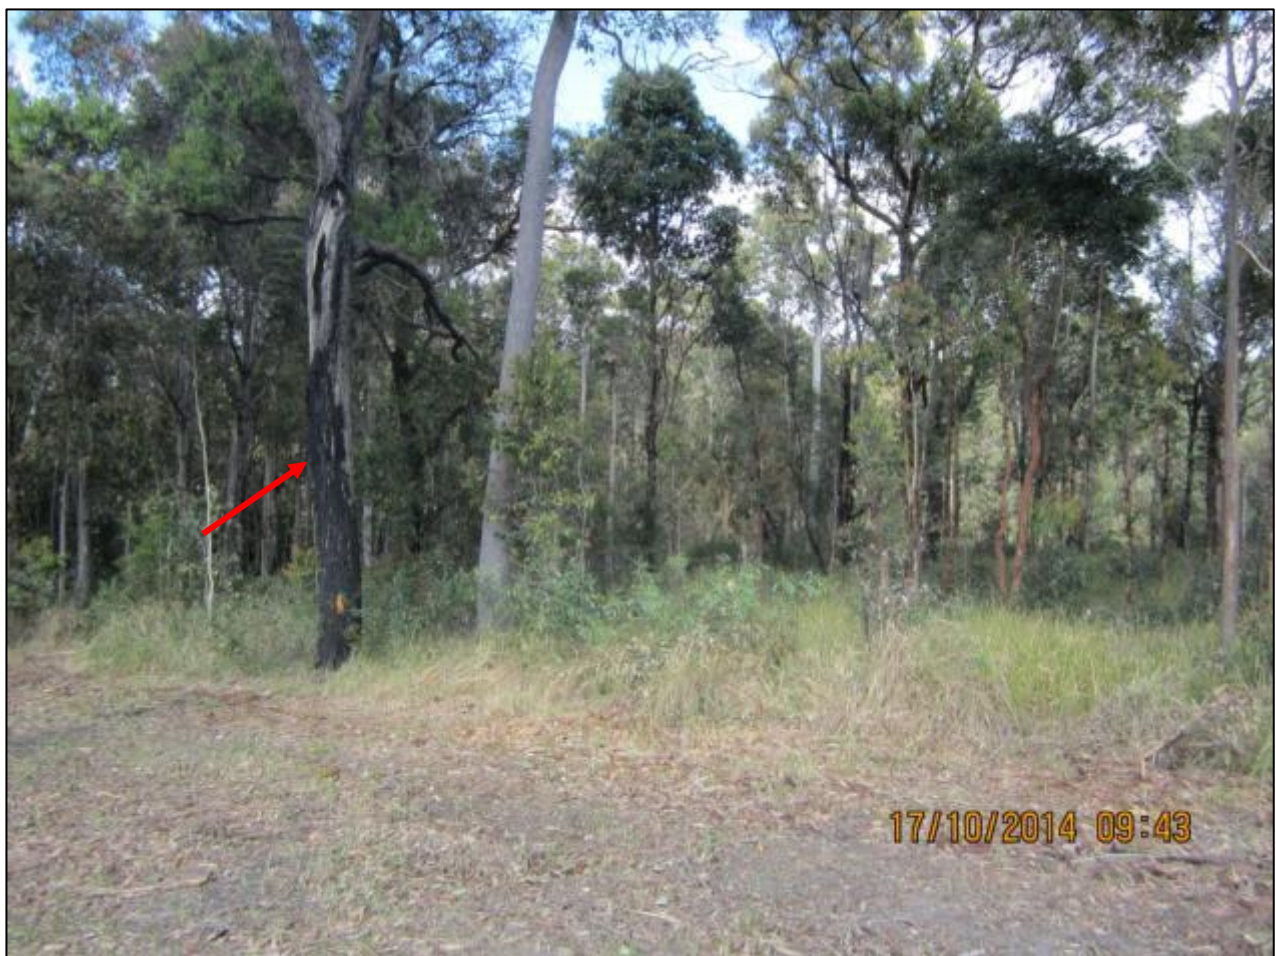
Figure 1 Hollow bearing tree at the Southern end of Pacific Hwy frontage

Two trees in this group appear in an advanced state of decline and are recommended for removal, they are marked with red paint. Another three trees close to the easement are suitable for retention and have been marked with green paint. One hollow bearing Eucalypt, marked with yellow paint will require further investigation to determine if there is any habitation by fauna.

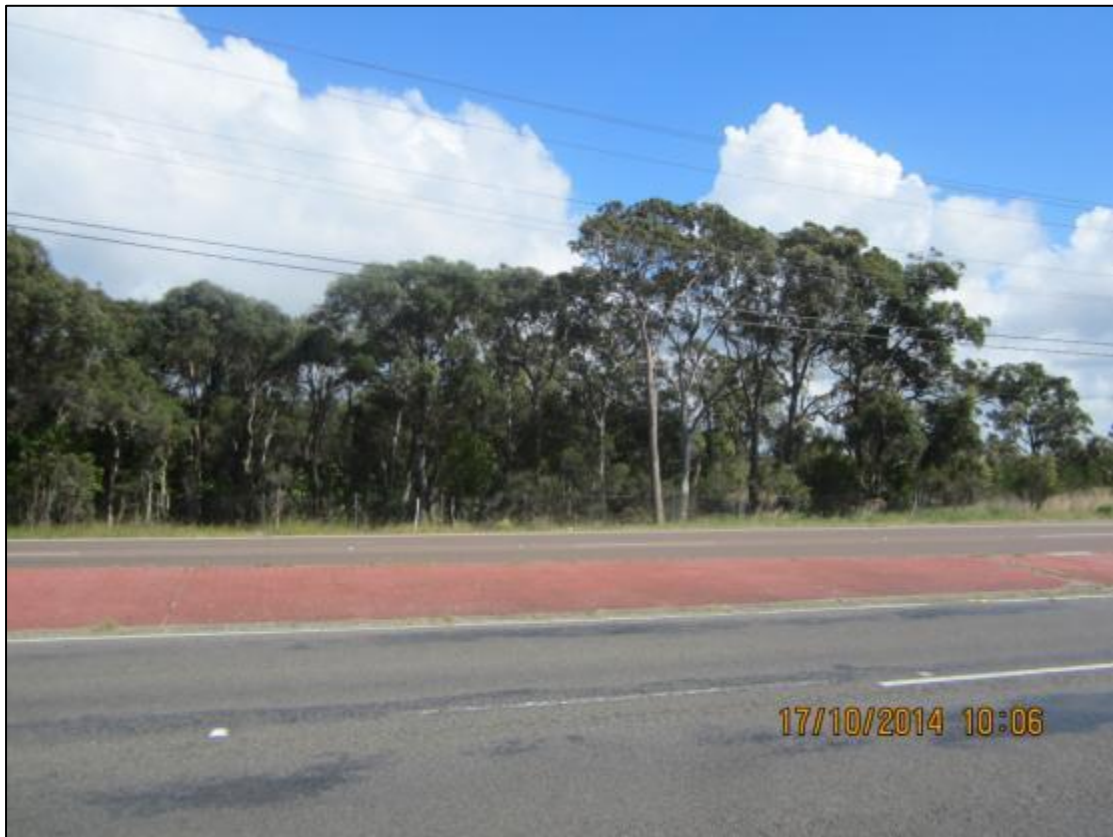
North of the proposed secondary entry to the site the road reserve widens and the vegetation community improves to become a near natural woodland landscape comprising *Eucalyptus* and *Angophora* in the canopy with an understorey of *Glochidion* and native grasses.

Figure 2 Vegetation North of the proposed main Pacific Hwy entrance

The quality of the vegetation in this area forms a good basis for a bush regeneration project which will require little work to achieve a useful screen planting from the highway.

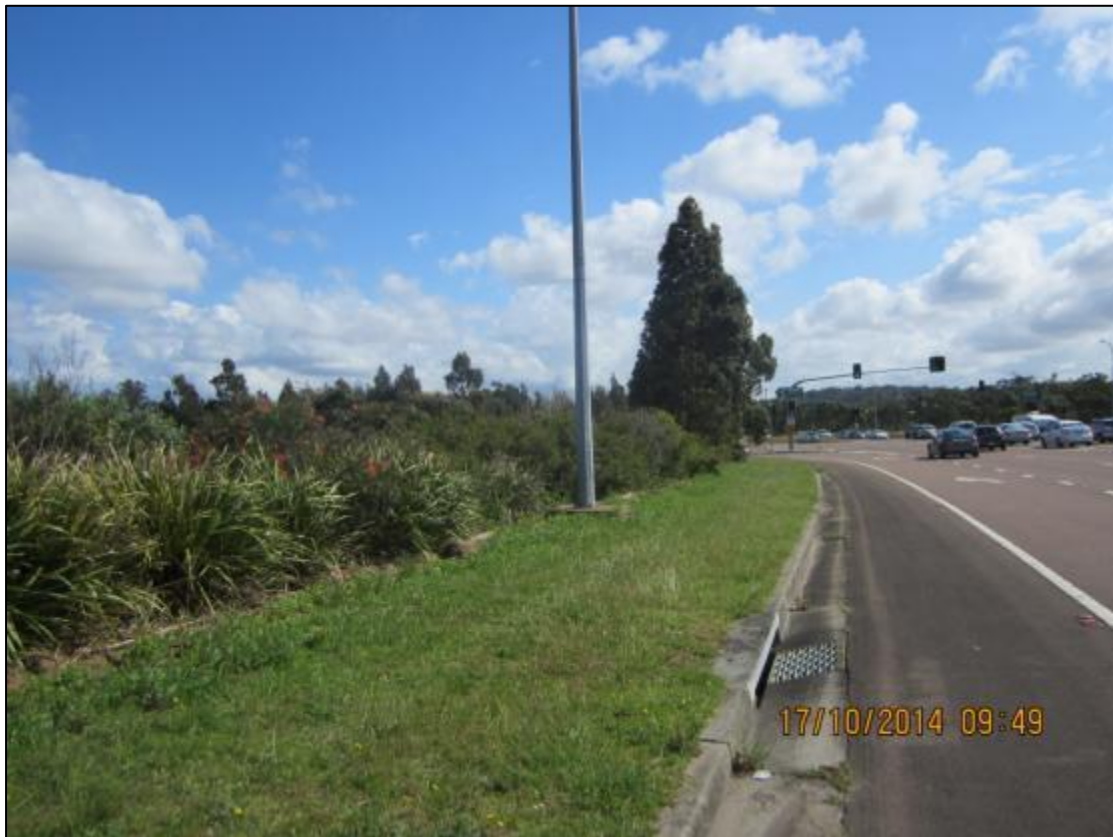
The area approaching the main entry to the site and extending North to Lake Rd has already been subject to remediation planting and drainage works. Retention and extension of this landscaping will assist in providing screening to the Pacific Highway frontage of the proposed development.

The use of non-indemic native species creates a pleasant streetscape between the highway and the easement. Between the easement and the property boundary it is expected that retention of all trees is achievable.

Figure 3 Landscaping near the junction of Lake Rd

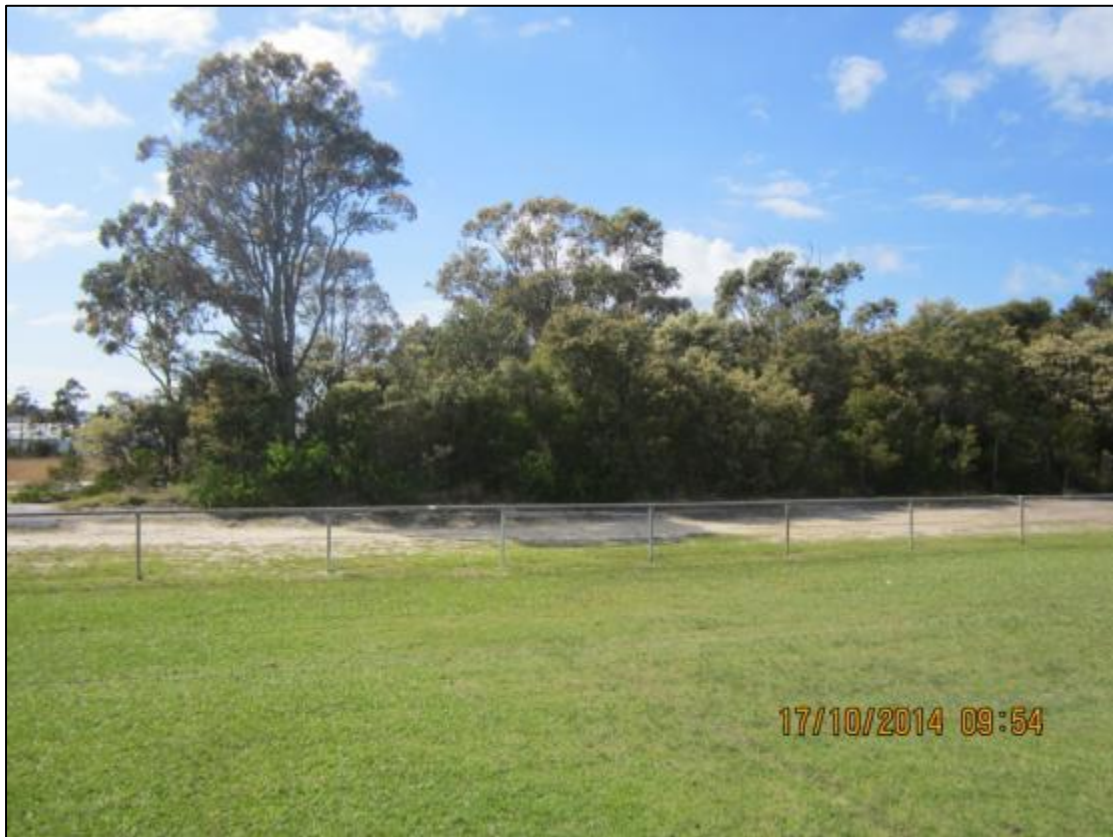
West of the proposed main entrance from Pacific Highway is a group of approximately 50 Prickly Leaved Paperbark (*Melaleuca nodosa*) which form a dense copse with an area of approximately 400sq/m at the Northern end of the group is a semi-mature Red Bloodwood (*Corymbia gummifera*).

Although the vegetation appears in good health and suitable for retention, there is a conflict with the design of the proposed service road and entry round-about, making it implausible to retain this area of vegetation.

Figure 4 Vegetation in Area 2

The opportunity exists to replicate this element of the landscape with new planting within the round-about and the entry landscaping.

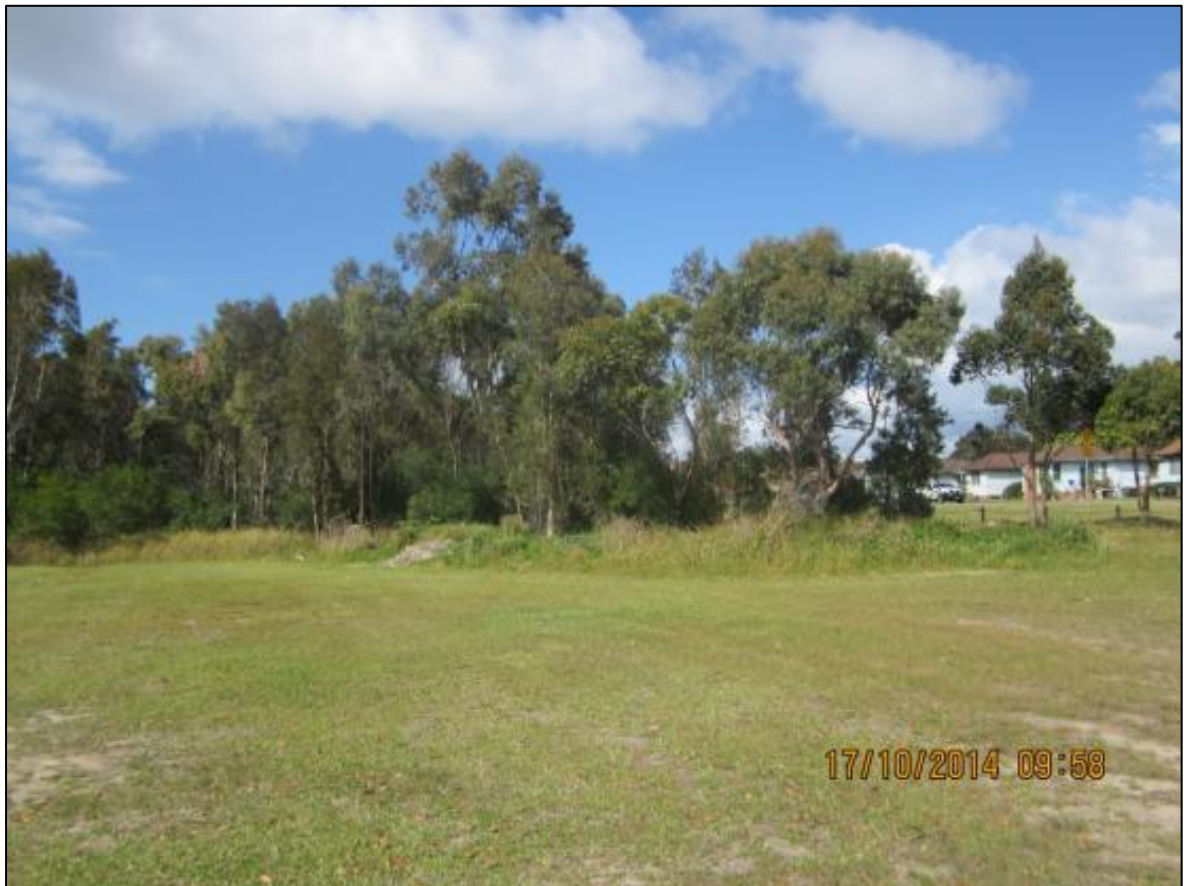
This area divides the proposed main car-park area from the playing fields and is currently vegetated with a thick canopy of *Eucalyptus*, *Angophora* and *Melaleuca*. The retention of vegetation within the boundary will conflict with the proposed car-parking which extends to the boundary.

Outside of the boundary it appears feasible to retain approximately 38 trees which have been marked using green paint while there two trees marked in red appear unsuitable for retention due to their poor health and condition.

Figure 5 Vegetation in Area 3 near South St

There is adequate space to provide buffer planting on the sports-field site without impacting upon the field, this would however need to be negotiated between the property owners as the required land is outside the development property boundary.

Planting that uses the local *Eucalyptus*, *Angophora* and *Melaleuca* species with an understory of native grasses and shrubs is suggested to gain a natural looking landscape.

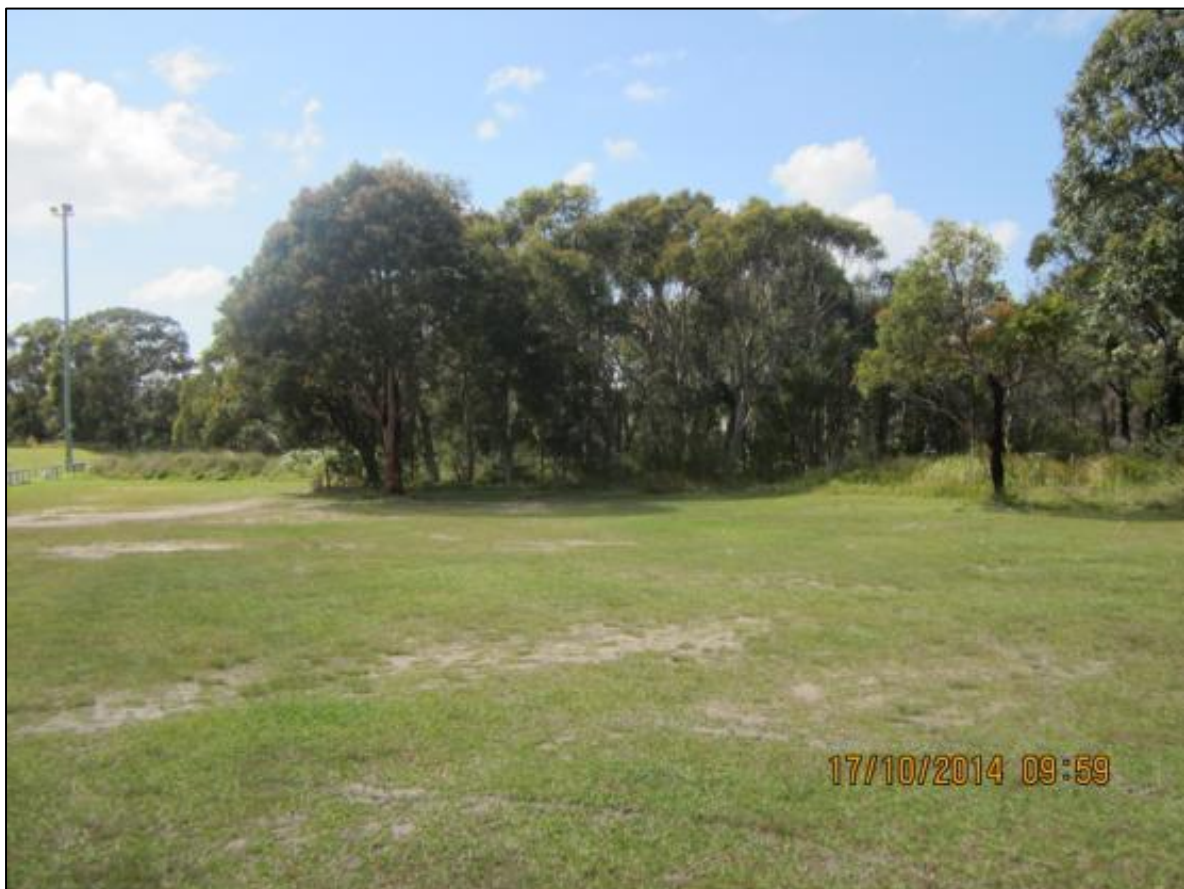
Figure 6 Vegetation in Area 3 near playing field

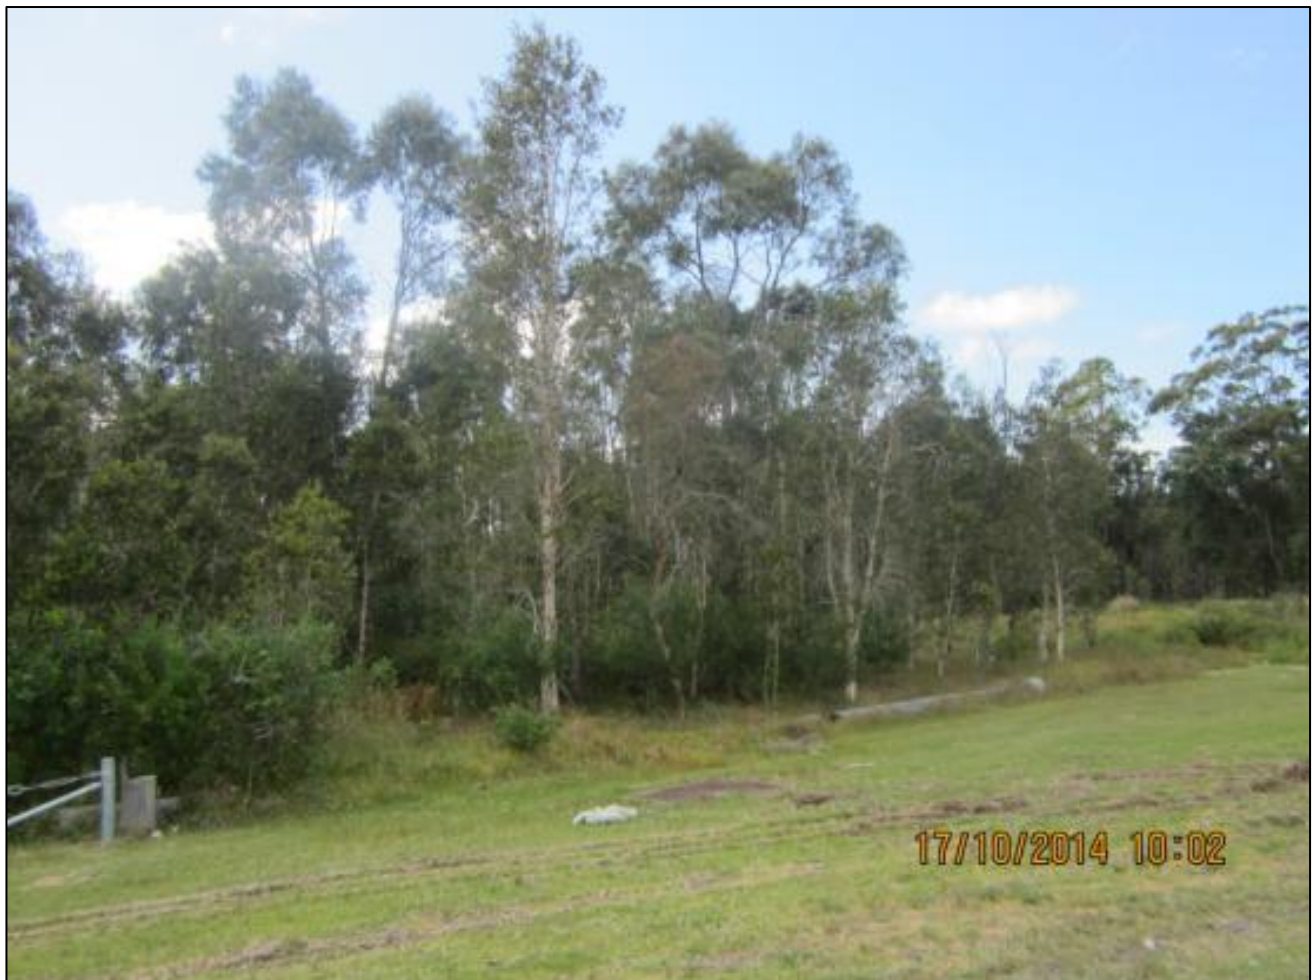
At the proposed site entry from South St there is a recent planting of 80-100 *Eucalyptus* and *Melaleuca* this will be bisected by the road necessitating the removal of approximately 60 small trees.

Figure 7 *Melaleucas* at the proposed entry from South St

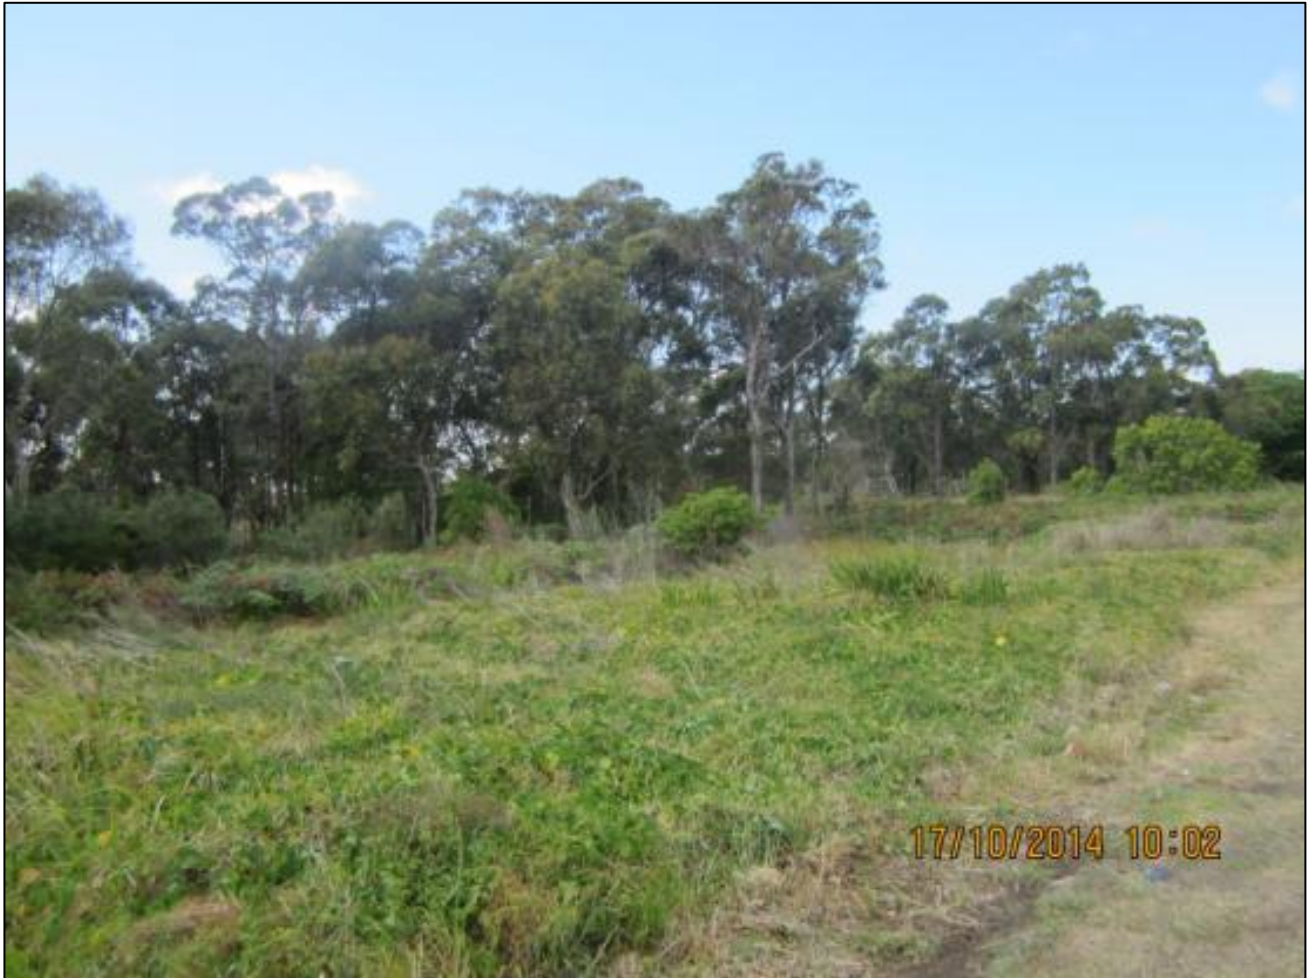
The area is sparsely vegetated, and the landscape disturbed with a dense understory of weed species. Bush regeneration techniques could be employed to return the area to a near native landscape and provide screening to the South St frontage of the site.

Figure 8 Understory vegetation along South St is mainly weed species
