# Arborist Report

## **Eleebana Shores Retirement Village**

Issue B

date: 2/06/2014  
project no: 9861.5  
site: 40 & 48 Burton Road, Eleebana  
council: Lake Macquarie City Council  
proposal: Demolition of two existing residential dwellings and construction of a retirement village.

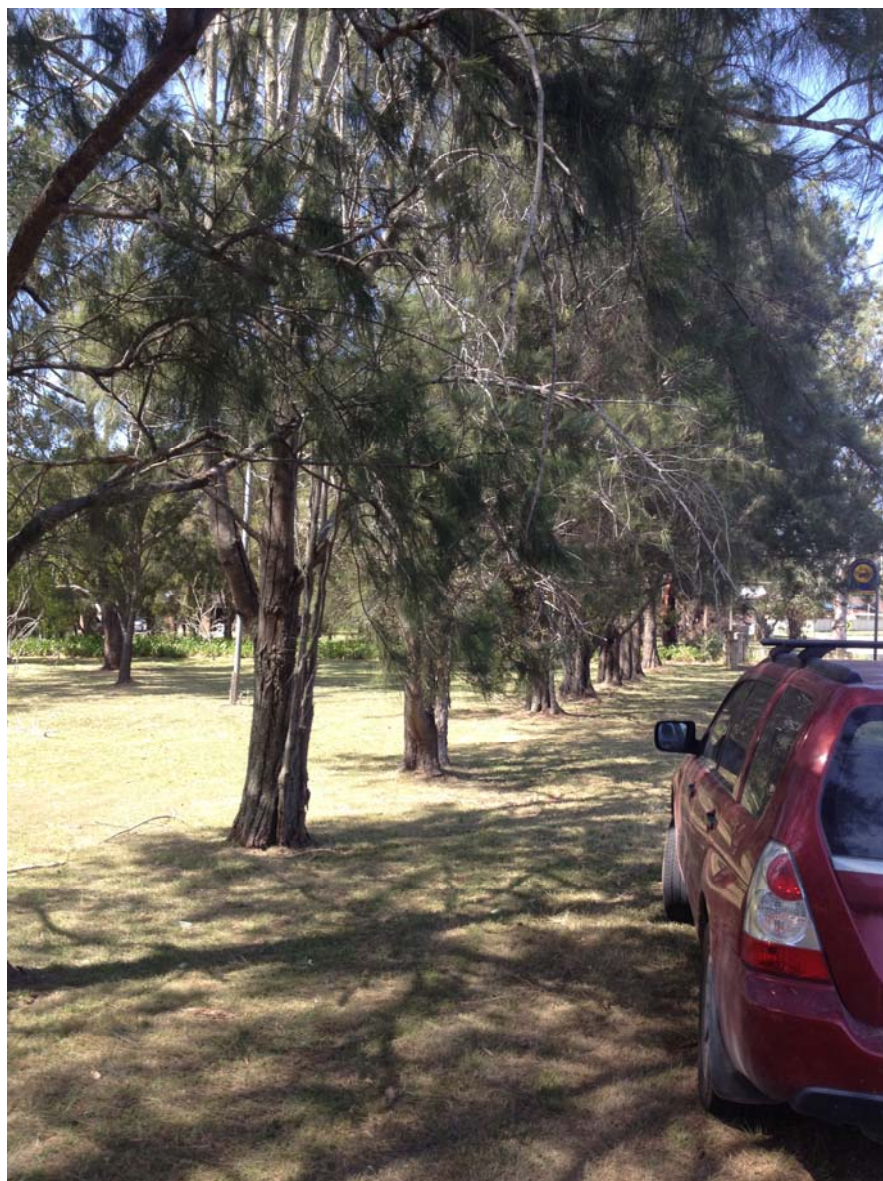
**Figure 2:** Trees 2 to 15 along the Burton Road frontage.

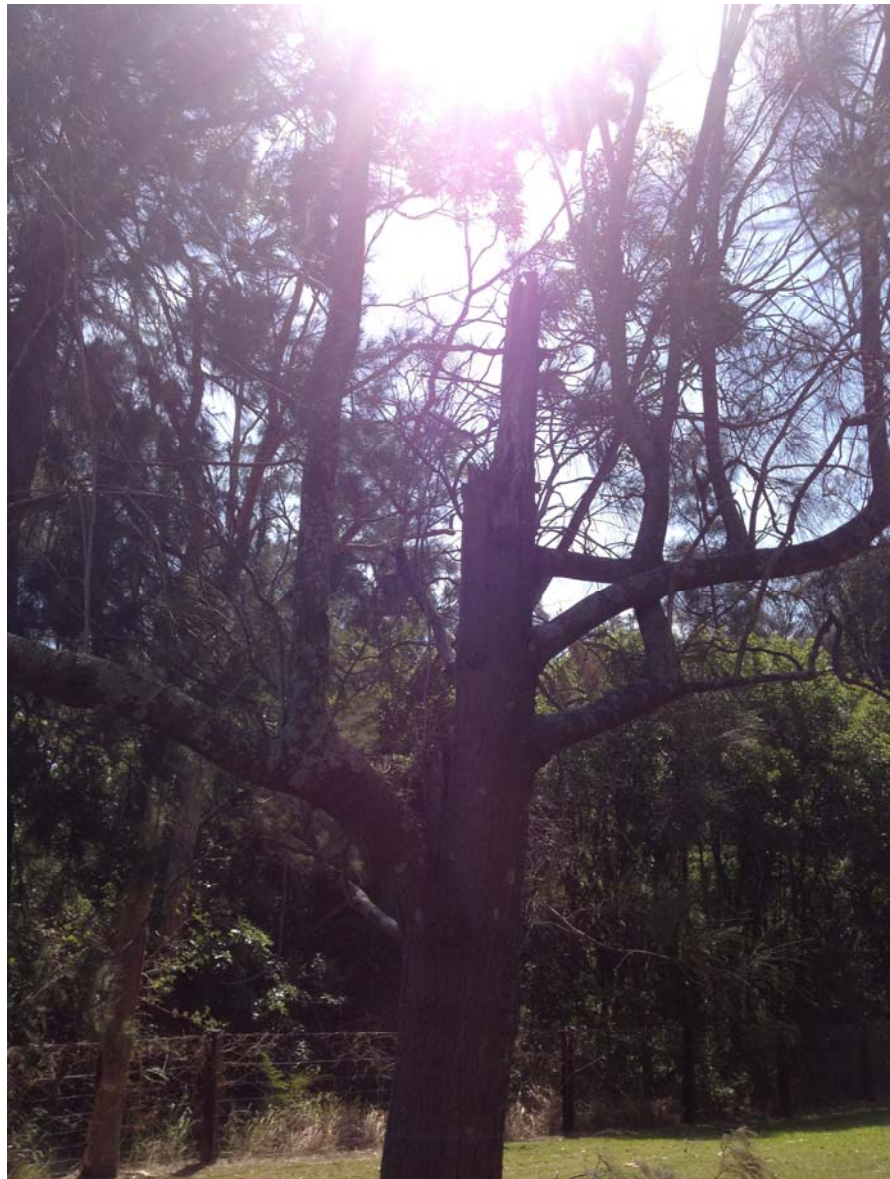
Main trunk failure at 3m. This has led to poor form.

**Figure 3:** Tree 3 with trunk failure.

| No | BOTANICAL NAME | COMMON NAME | AGE CLASS | HEIGHT [M] | DBH [MM] | SPREAD [M] | | | | ULE | TREE AZ | STRUCTURE | HEALTH | COMMENTS |
|---|---|---|---|---|---|---|---|---|---|---|---|---|---|---|
| 3 | <i>Casuarina cunninghamiana</i> | River She Oak | M | 12 | 310 | 2 | 4 | 4 | 4 | 4B | Z4 | P | P | FAILED TREE, FAILURE LOCATED 3 METRES UP TRUNK |

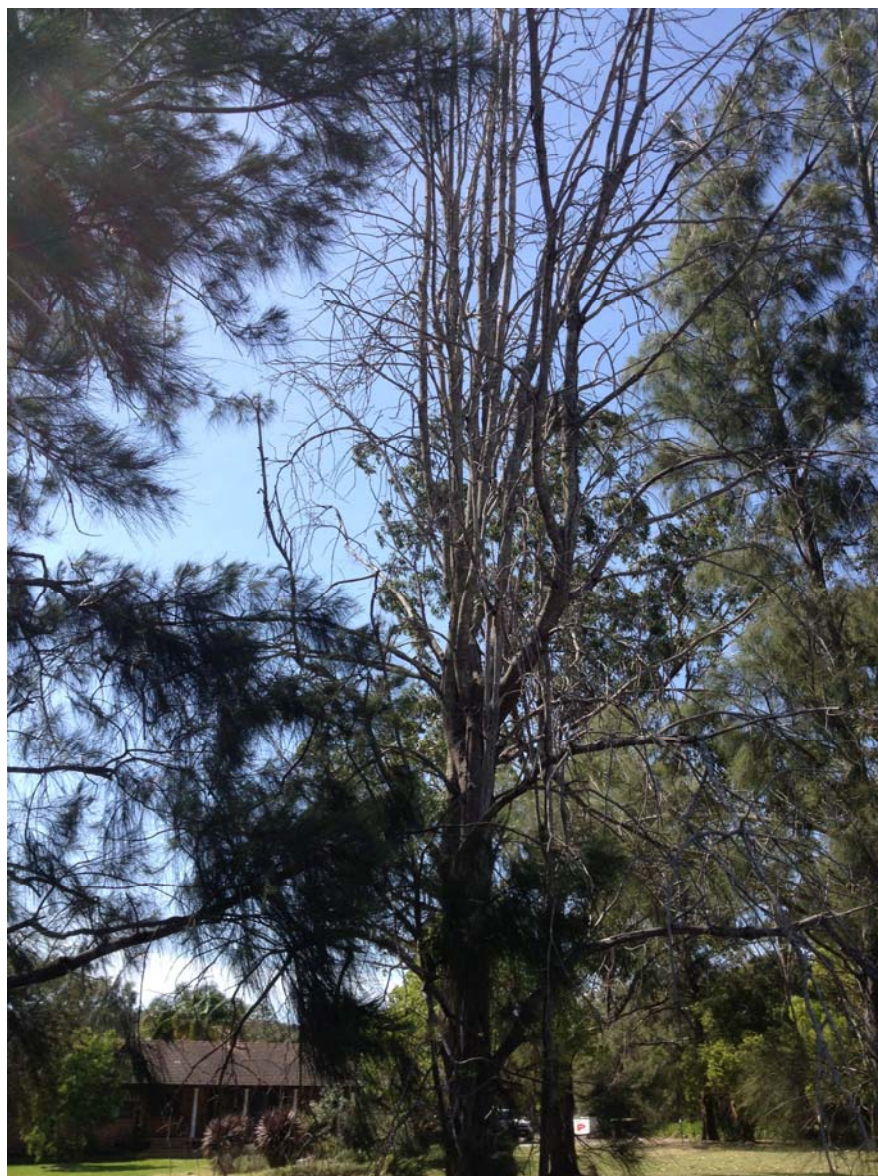
**Figure 4:** Tree 7

**Tree 7 *Casuarina cunninghamiana* River She Oak ULE Rating 4A Tree AZ Rating Z4**  
Dead tree. Tree should be removed and replaced.

| No | BOTANICAL NAME | COMMON NAME | AGE CLASS | HEIGHT [M] | DBH [MM] | SPREAD [M] | | | | ULE | TREE AZ | STRUCTURE | HEALTH | COMMENTS |
|---|---|---|---|---|---|---|---|---|---|---|---|---|---|---|
| 7 | <i>Dead Tree</i> | | | | | | | | | 4A | Z4 | | | DEAD TREE |

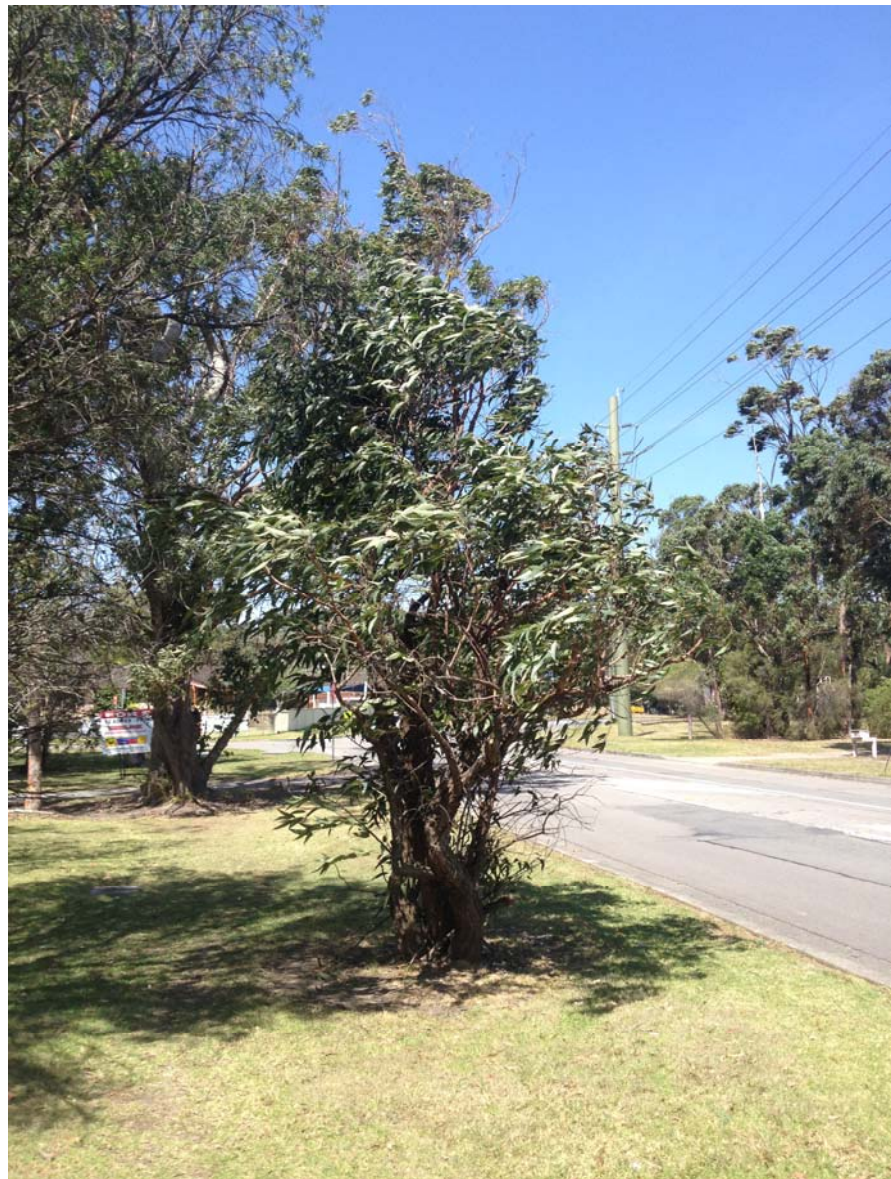
**Figure 5:** Tree 23

Located in street verge. Small stunted tree of very poor form.

| No | BOTANICAL NAME | COMMON NAME | AGE CLASS | HEIGHT [M] | DBH [MM] | SPREAD [M] | | | | ULE | TREE AZ | STRUCTURE | HEALTH | COMMENTS |
|---|---|---|---|---|---|---|---|---|---|---|---|---|---|---|
| 23 | <i>Eucalyptus umbra</i> | Broad Leaved White Mahogany | M | 4 | 210*<br>220*<br>250* | 1 | 2 | 1 | 1 | 4B | Z10 | P | P | LOCATED IN STREET VERGE, SMALL STUNTED TREE. |

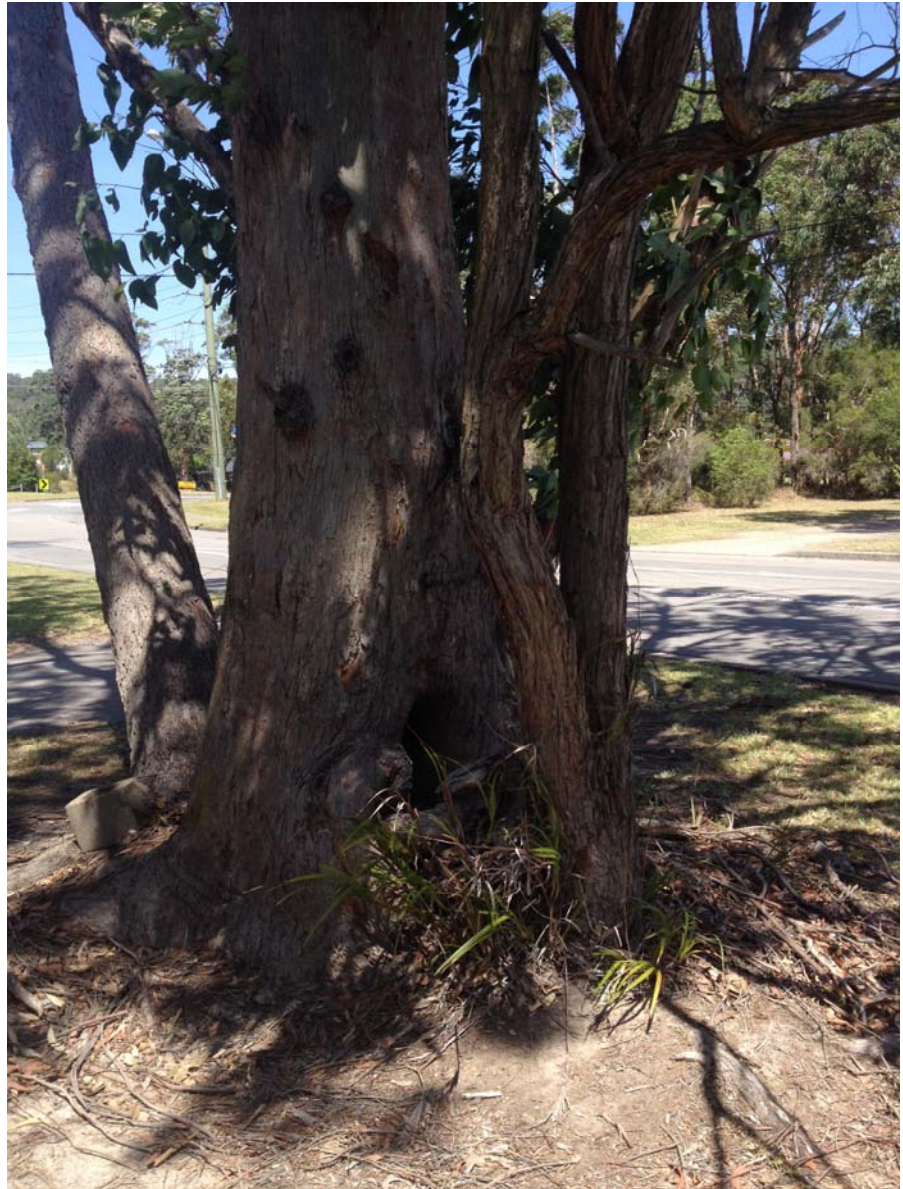
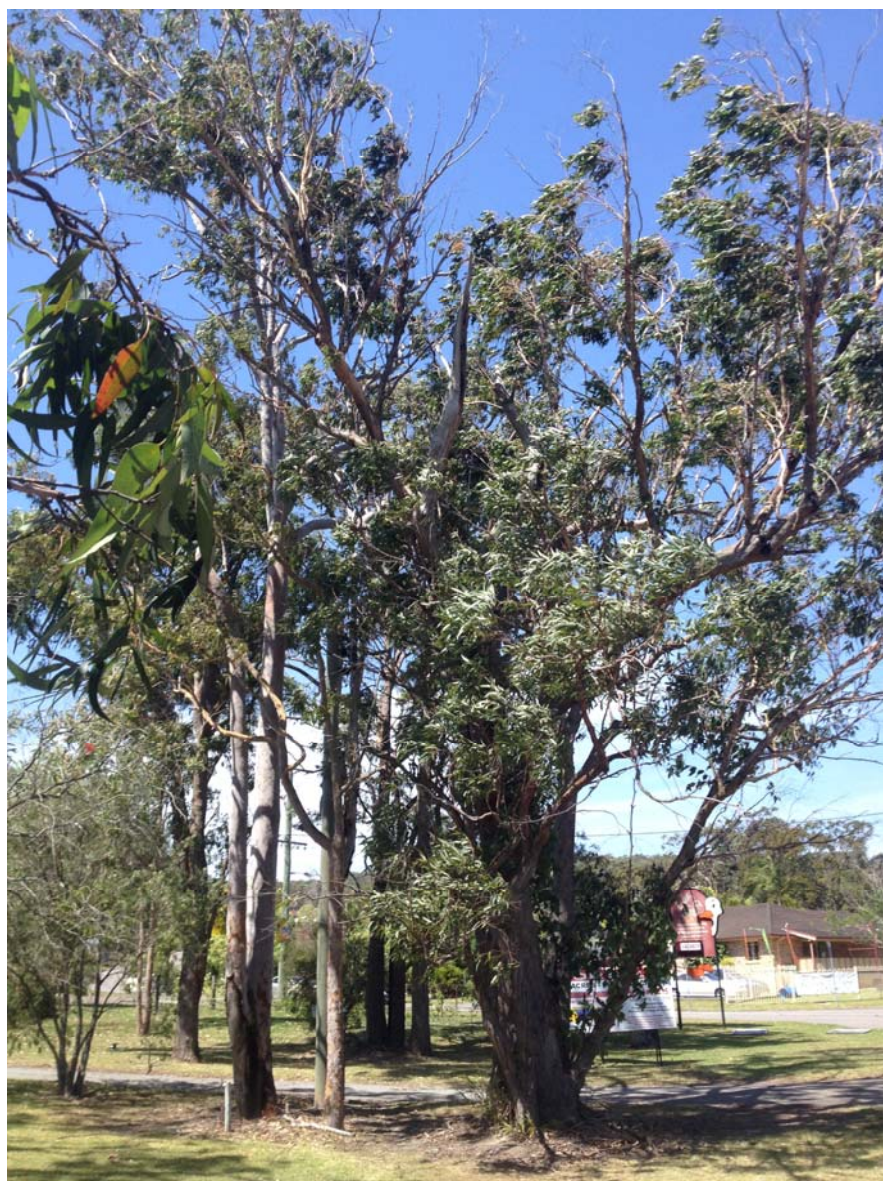
Trees 24, 25 and 26 are growing against each other. All 3 trees require removal. Tree 24 is suppressed and has a poor structural form.

**Figure 6:** Trees 24, 25 and 26 all growing in nvery close proximity.

Over mature tree in decline. Large amount of decay throughout the tree. Many past branch failures evident. Hollow present in branch failure wound. This tree should be removed.

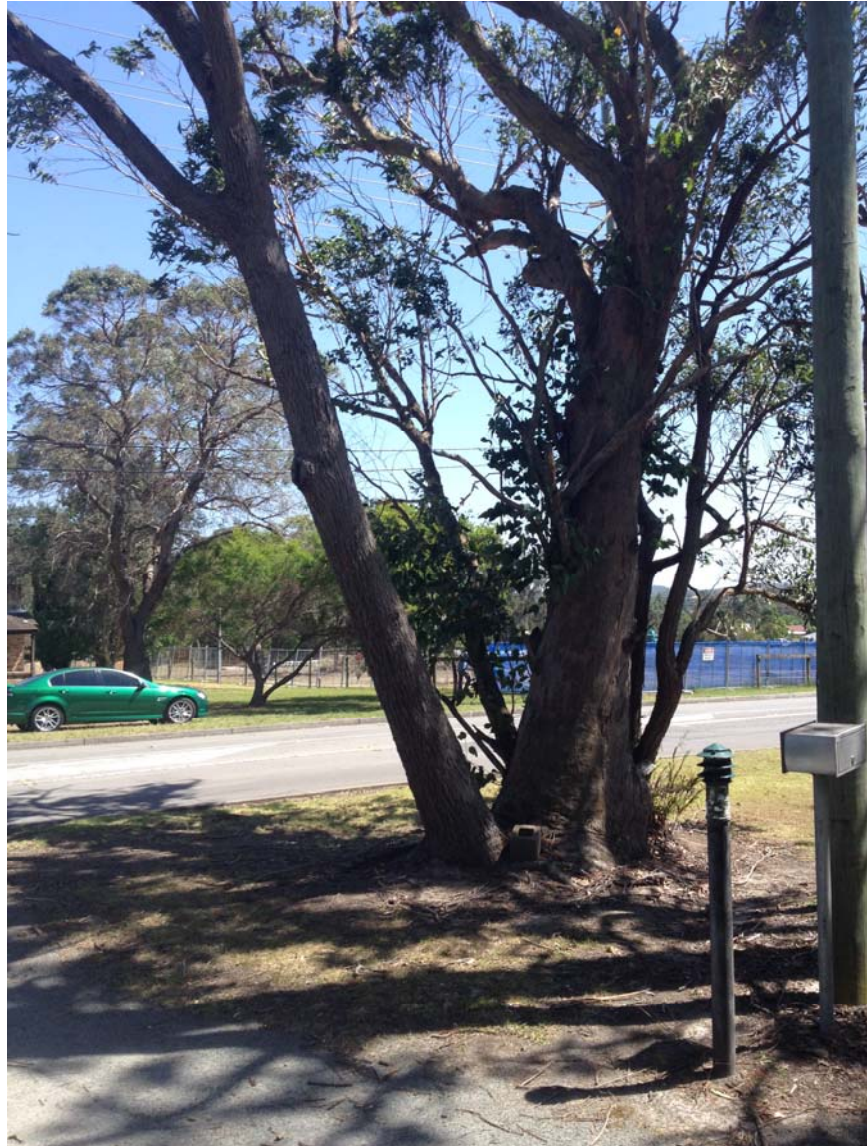
Growing against tree 25, has a severe lean to the south developed through phototropism. Lean overhangs residential power supply lines. Tree should be removed.

**Figure 8:** Tree 26 leaning to the south over powerlines.

| No | BOTANICAL NAME | COMMON NAME | AGE CLASS | HEIGHT [M] | DBH [MM] | SPREAD [M] | | | | ULE | TREE AZ | STRUCTURE | HEALTH | COMMENTS |
|---|---|---|---|---|---|---|---|---|---|---|---|---|---|---|
| 26 | <i>Corymbia gummifera</i> | Red Bloodwood | M | 14 | 430 | 0 | 2 | 10 | 10 | 4D | ZZ | P | F | AGAINST TREE 25, SEVERE LEAN TO THE SOUTH OVER POWER LINES |

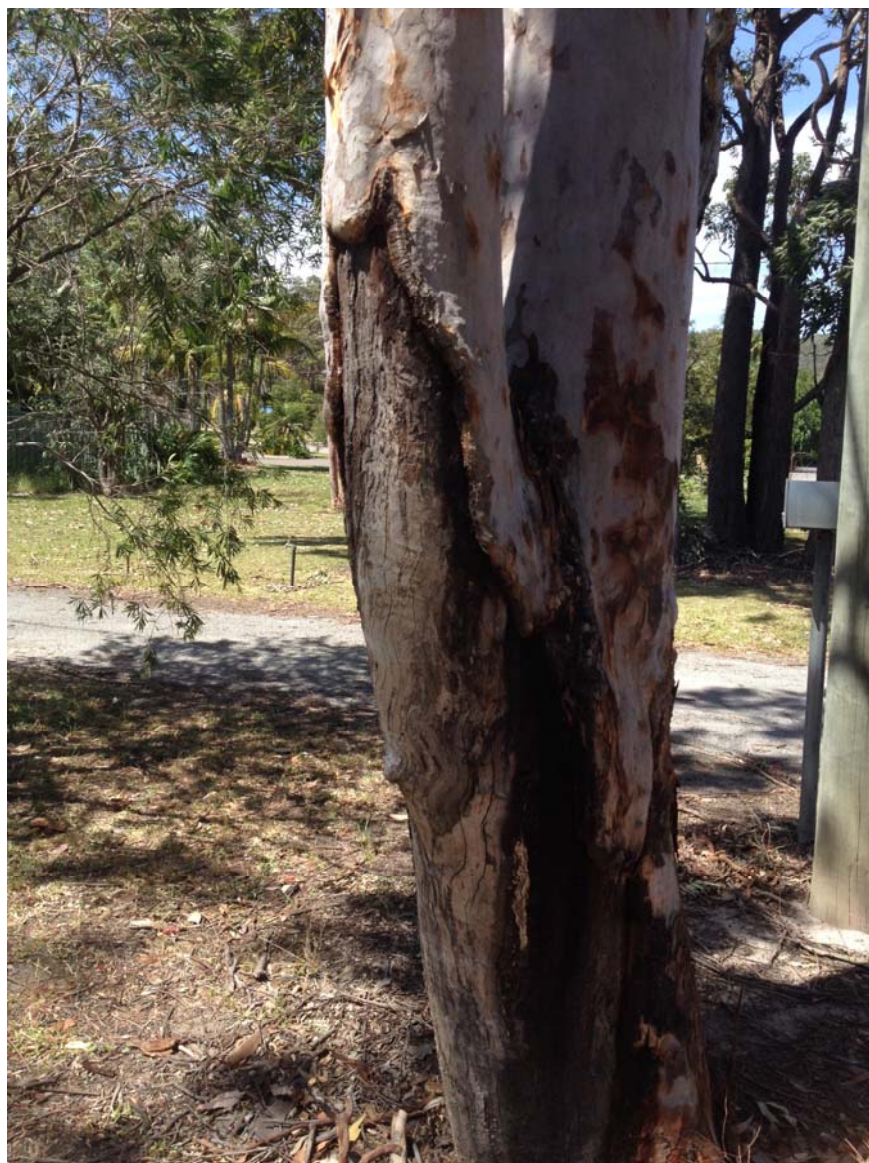
**Tree 28** *Angophora costata* Smooth Barked Apple ULE Rating 3D Tree AZ Rating Z10  
Large wound located at the base of the trunk. Co-dominant leaders.

**Figure 9:** Tree 28 large wound to lower trunk.

| No | BOTANICAL NAME | COMMON NAME | AGE CLASS | HEIGHT [M] | DBH [MM] | SPREAD [M] | | | | ULE | TREE AZ | STRUCTURE | HEALTH | COMMENTS |
|---|---|---|---|---|---|---|---|---|---|---|---|---|---|---|
| 28 | <i>Angophora costata</i> | Smooth Barked Apple | M | 19 | 620 | 4 | 4 | 10 | 5 | 3D | Z10 | F | F | LARGE WOUND IN THE BASE OF THE TRUNK, CO-DOMINANT LEADERS |
