**Re: Section 89 Referral to the JRPP re: Proposed Refusal of a Crown DA
LUA12/0921 - Demolition of Existing Structures and 2 Lot Subdivision
Lot 61 DP 114602 – 82 Bong Bong Road, Renwick**

BUILDING DEFECT & COST ESTIMATE REPORT

61 BONG BONG ROAD MITTAGONG

13TH MARCH 2013 @ 9AM

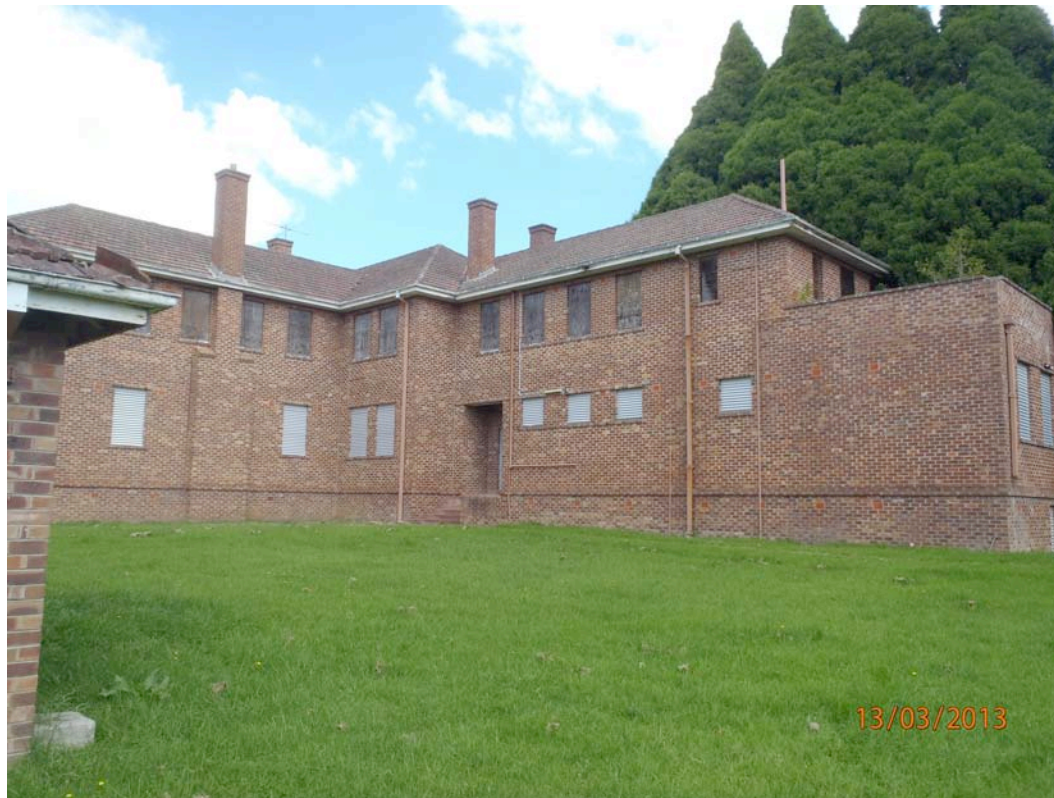
The building structurally is sound, however some footing movement has occurred. The internal areas to the property have been extensively vandalised and have also deteriorated due to water entry through roofing and general age.

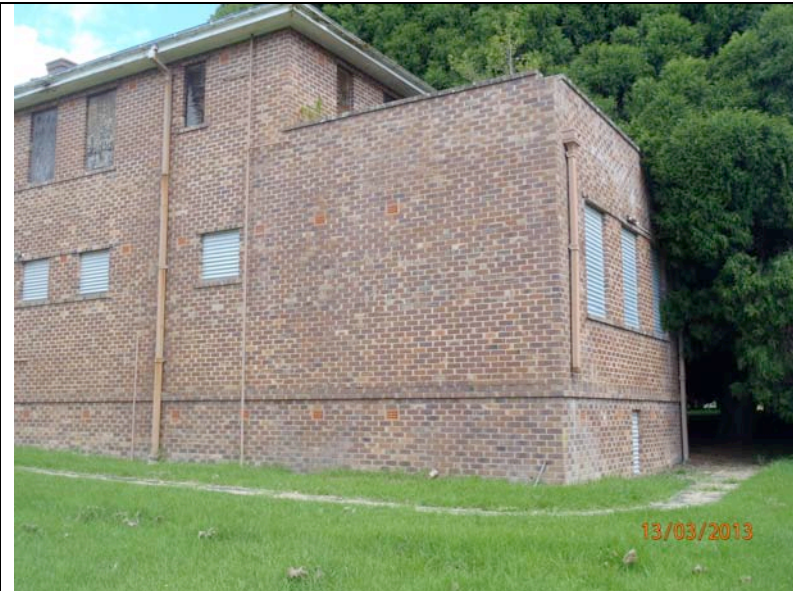
Some of the many trees to be removed

| | | Removal of large number of pine trees close to buildings footings. | | \$40,000.00 | | |

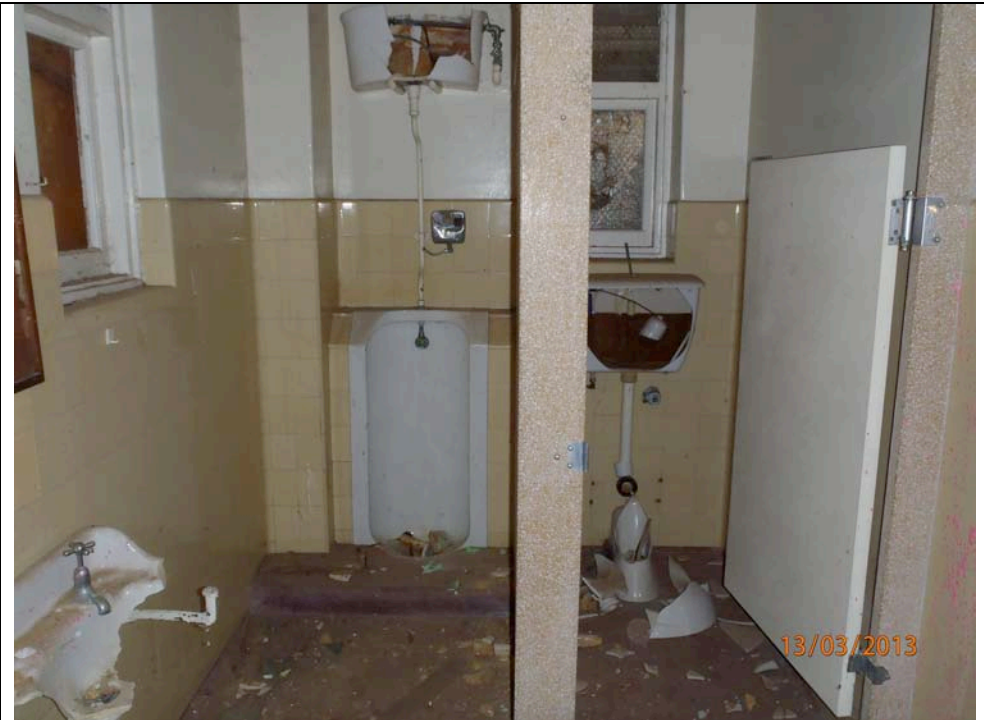
Damaged bathroom areas

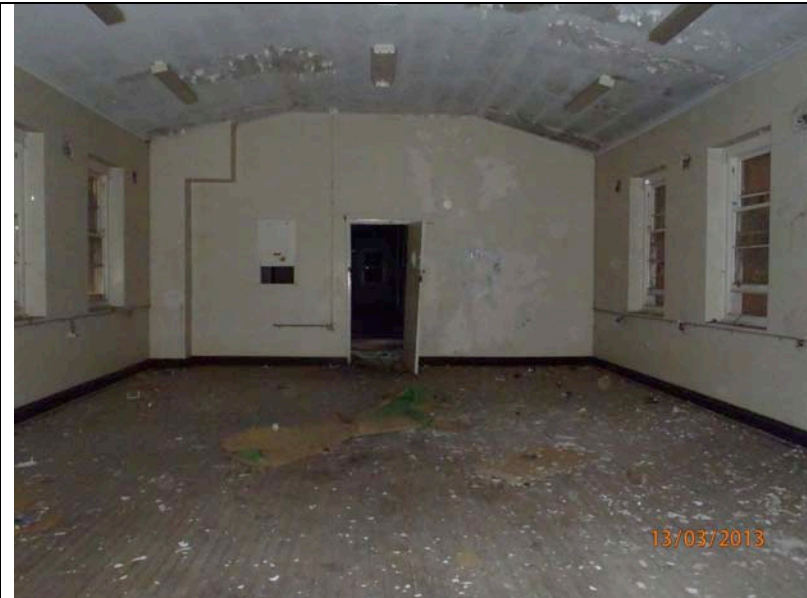
Photo shows damaged walls, windows and ceilings to upper level dormitory

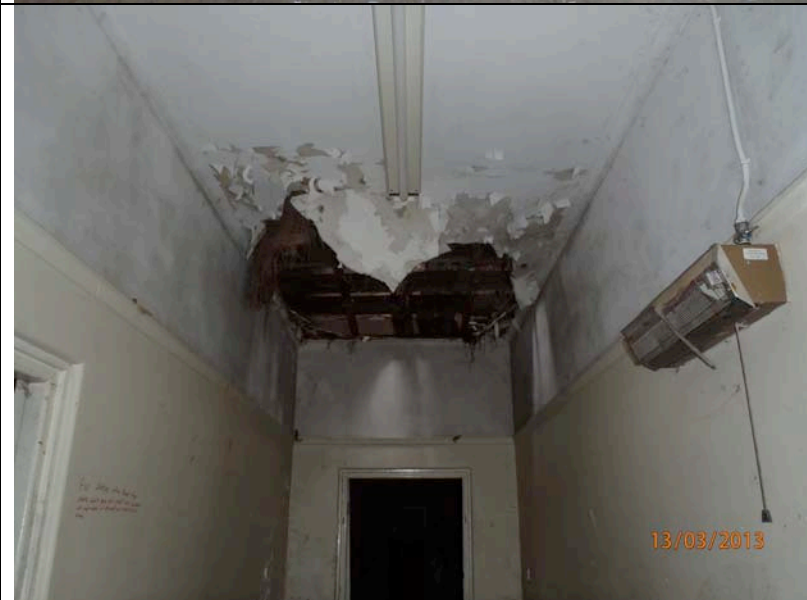
Example of damaged ceilings

| | COST CENTRES | DESCRIPTION | DESCRIPTION | TOTAL QUANTITY | COST CENTRE TOTALS | RUNNING TOTAL |
|---|---|---|---|---|---|---|
| | | Damaged ceiling removal | | \$12,000.00 | | |

| | | Install new ceilings where required and repair where possible. | | \$40,000.00 | | |
