Statement of Environmental Effects

Demolition of Existing Structures and
Two Lot Subdivision
82 Bong Bong Road, Renwick

Prepared for: Landcom
Project No: 6946A
Date: October 2012

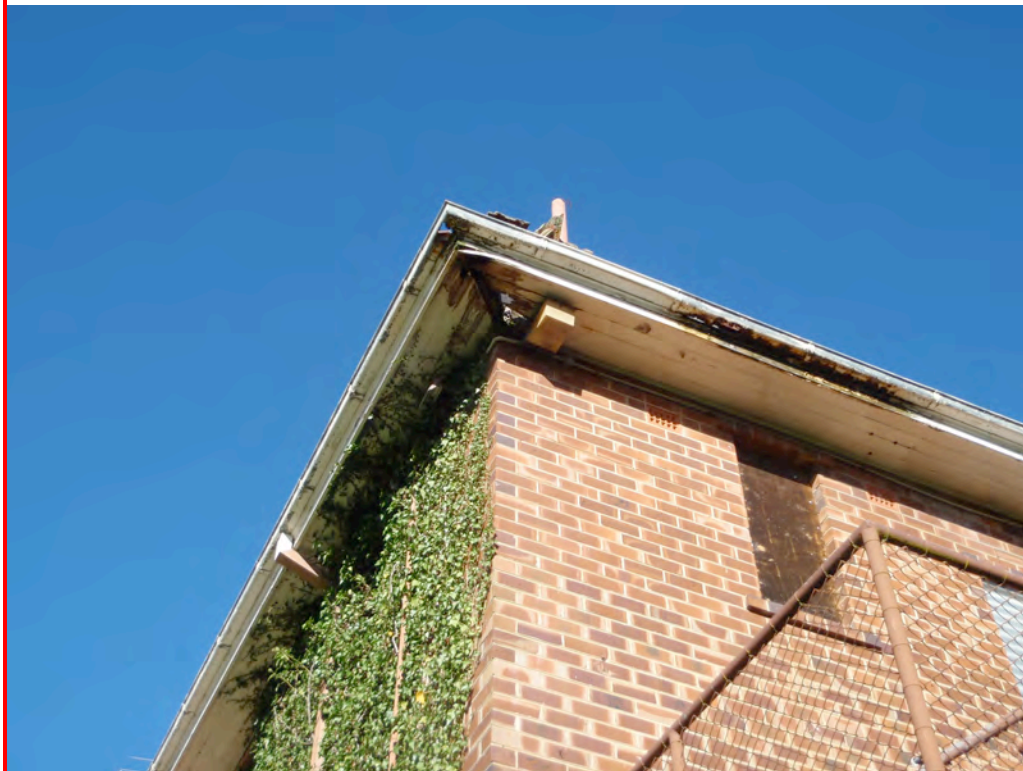
The external timbers to the property have aged and weathered in areas, including the windows. These timbers should be painted immediately to prevent decay.

\$21,000.00

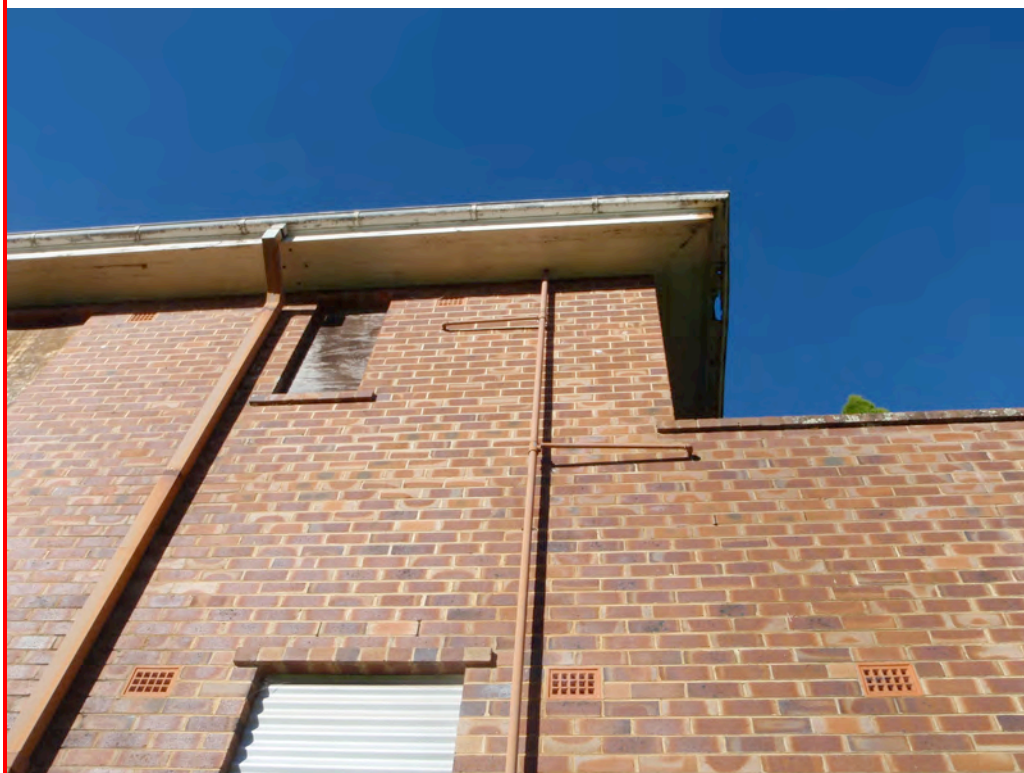
Roof valley metal to all areas has rusted and replacement will be required immediately.

Replace the rusting downpipes to all areas throughout the property.

\$3,000.00

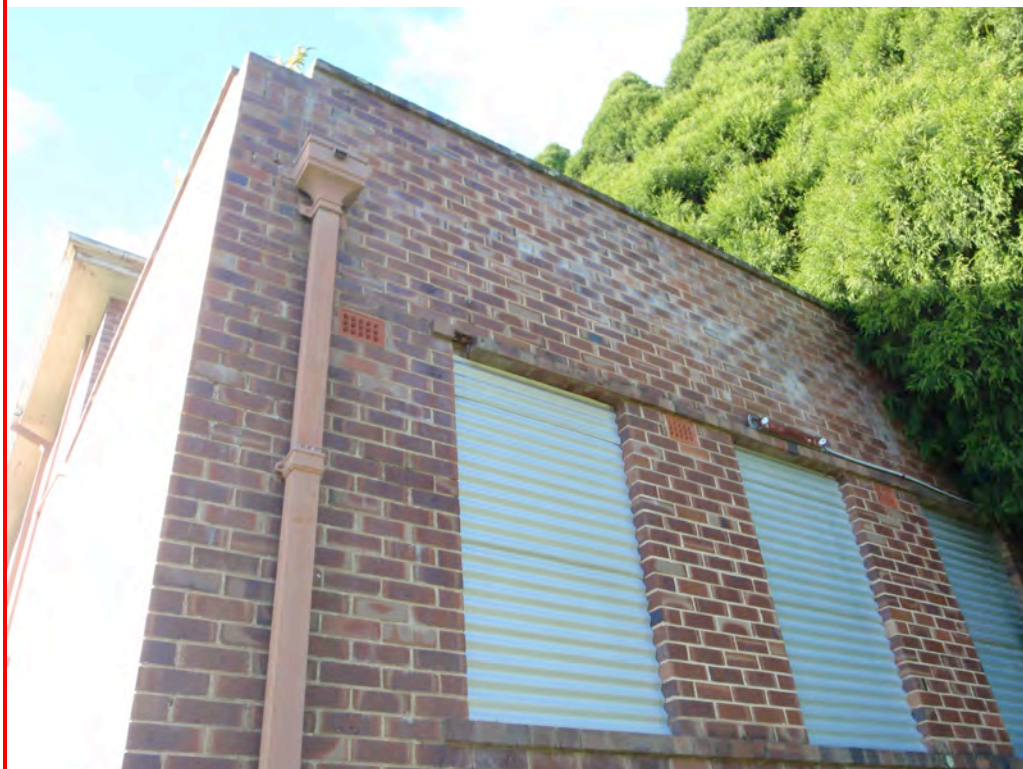
Repair the deteriorated mortar joints to the rear left corner brickwork. Moisture from the leaking verandah area above has contributed to this situation.

\$300.00

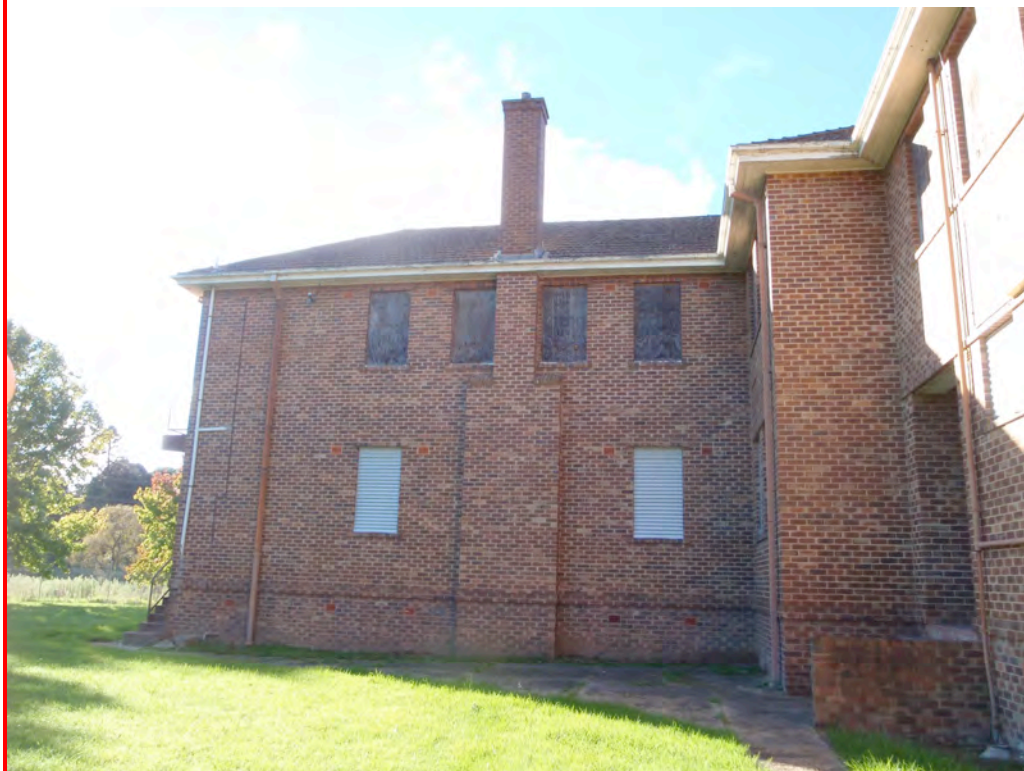
Leaks are occurring from the first floor verandah into the surrounding brickwork and internal walls and ceiling in the locker room below. Access to this area will be required to fully assess, however, it will require re-waterproofing to the floor, walls and wall capping.

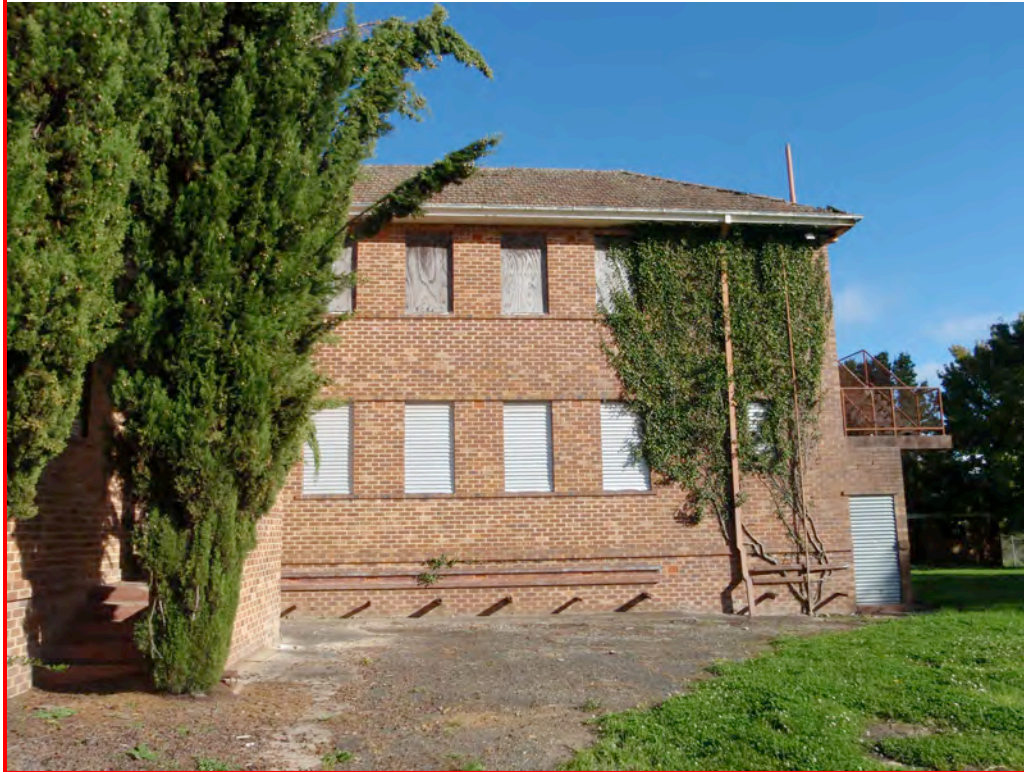
Remove large pine trees growing directly against the external walls at the rear access steps and front of the building in several areas. These trees are damaging the brickwork and causing footing problems.

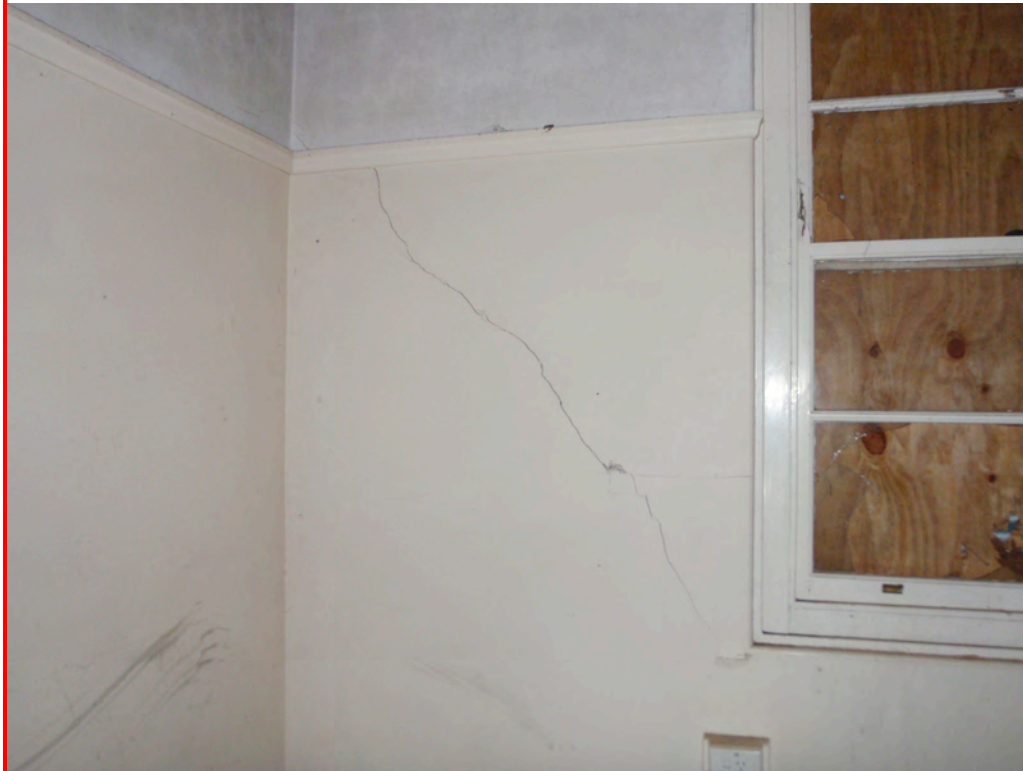
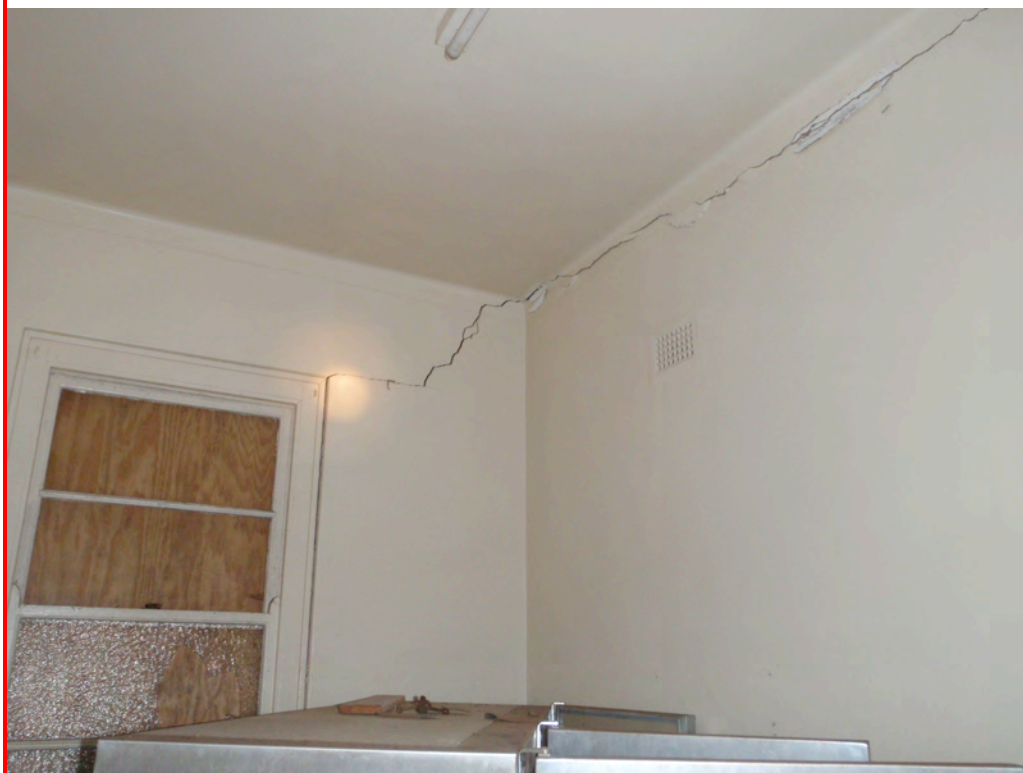
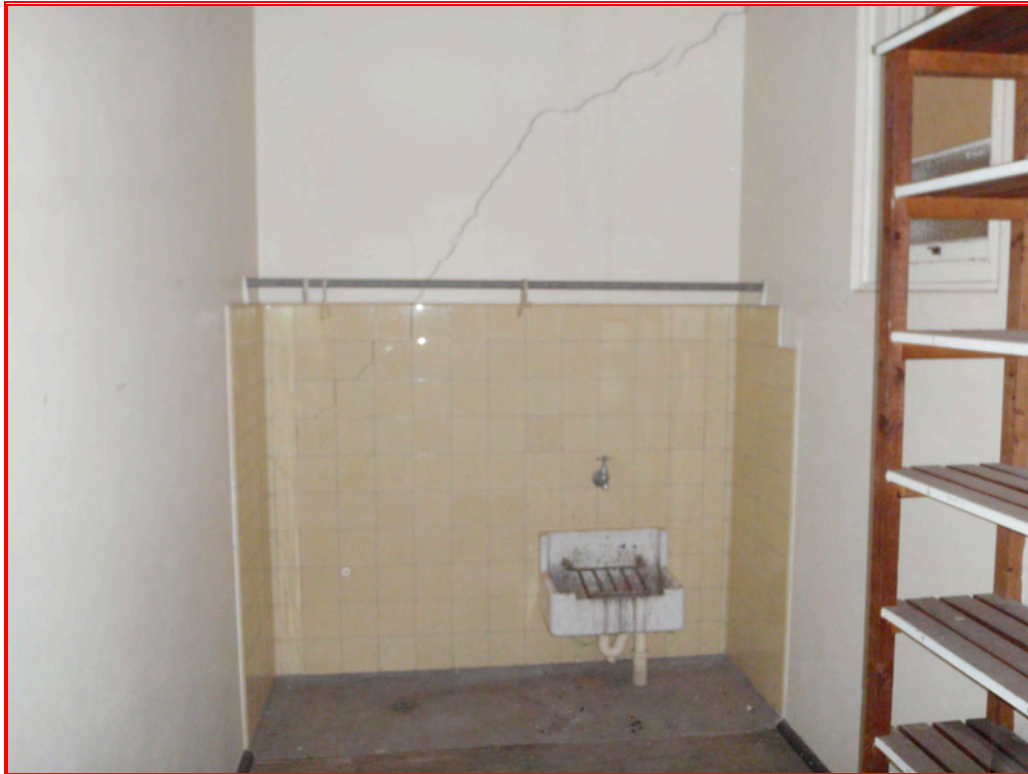
Ceilings throughout the upper level have been damaged by water entry or have cracked and sagged due to general age. Ceilings will require either complete replacement or extensive repair.

\$15,000.00

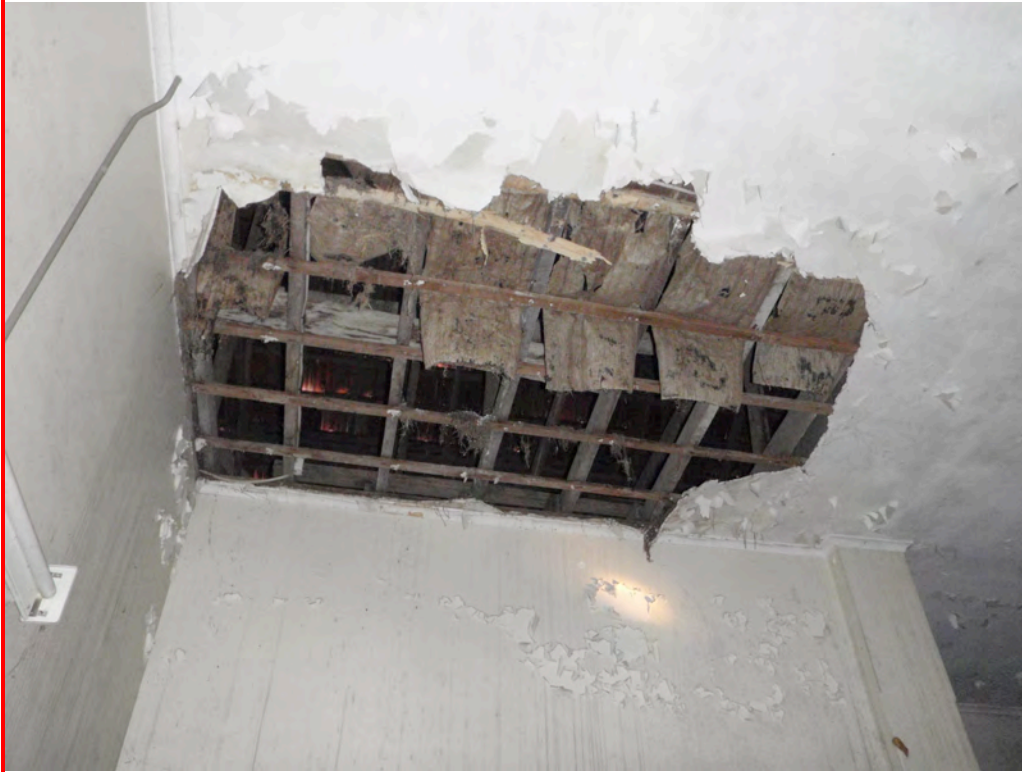
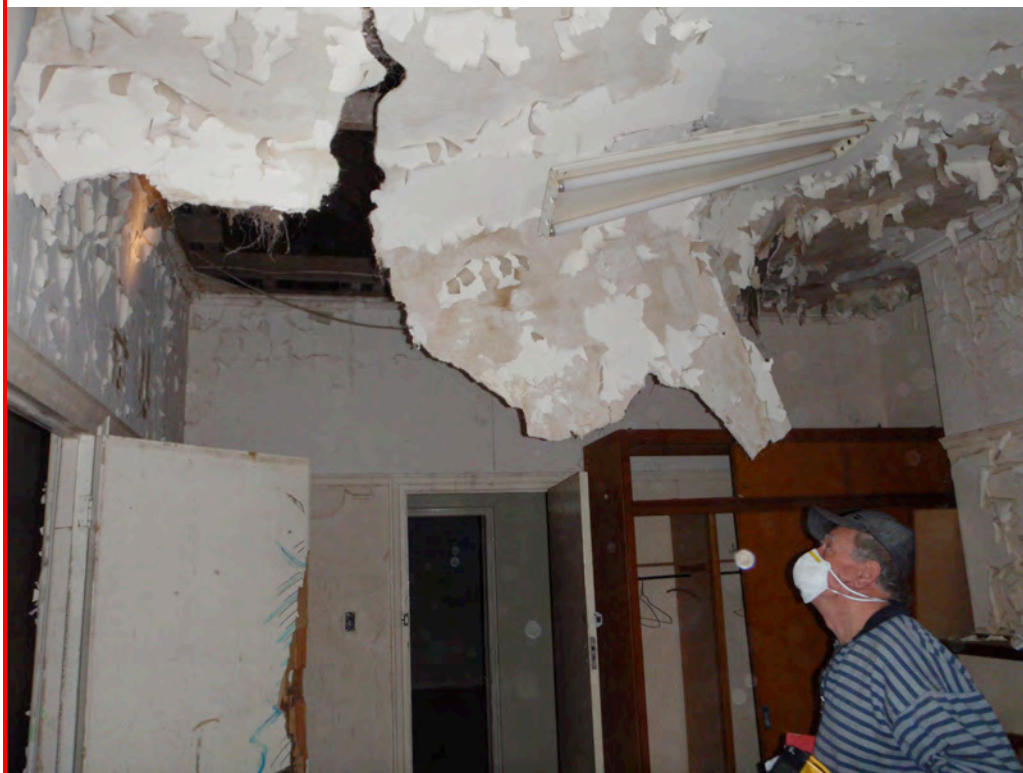
Ceilings to the lower level have been damaged by age and general wear and some moisture entry. Repairs will be required to restore these ceilings.

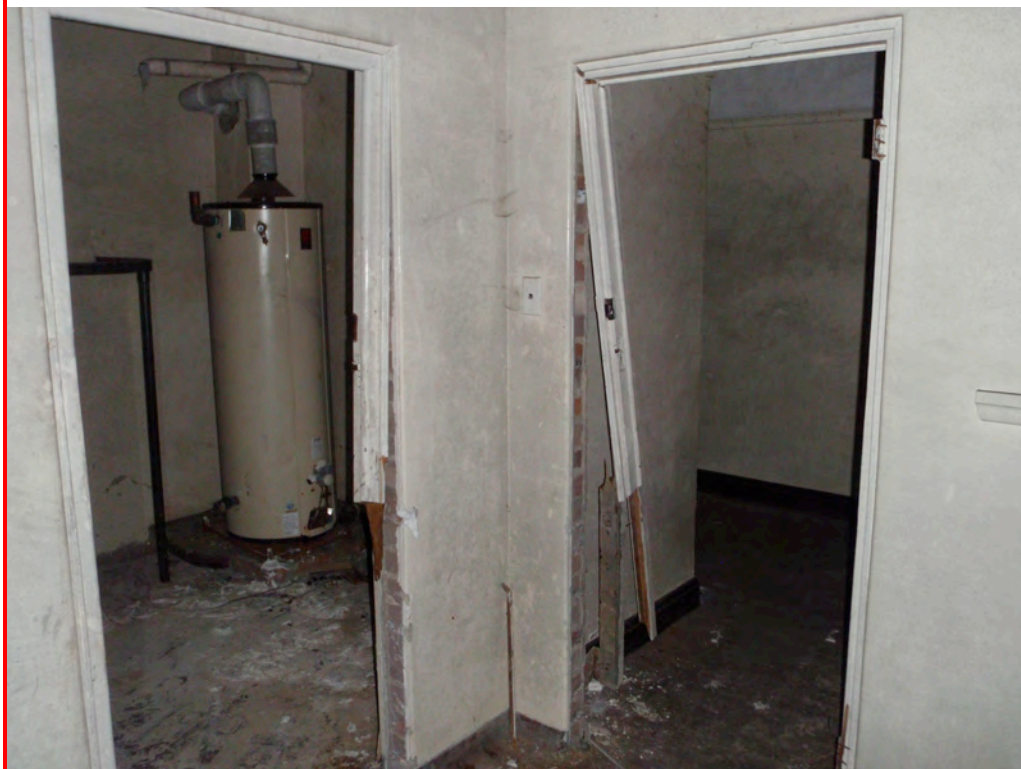
Replace all doors throughout the property. Doors have been damaged by vandals.

\$7,000.00

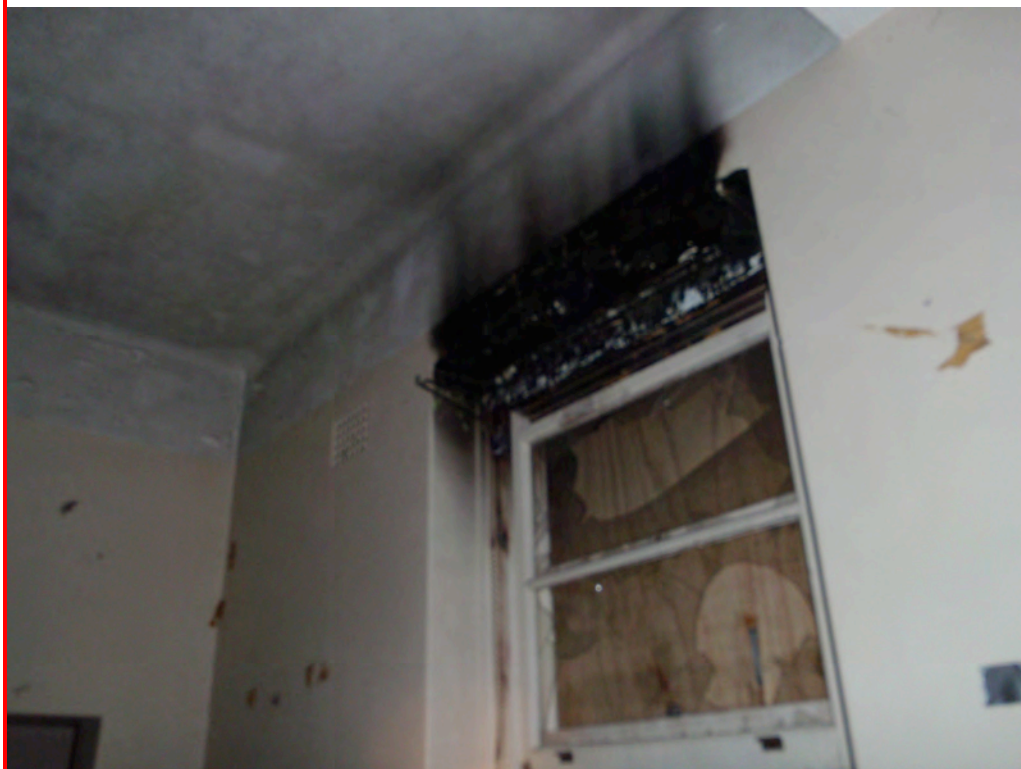
Glazing to all windows has been broken and will require replacement.

\$18,000.00

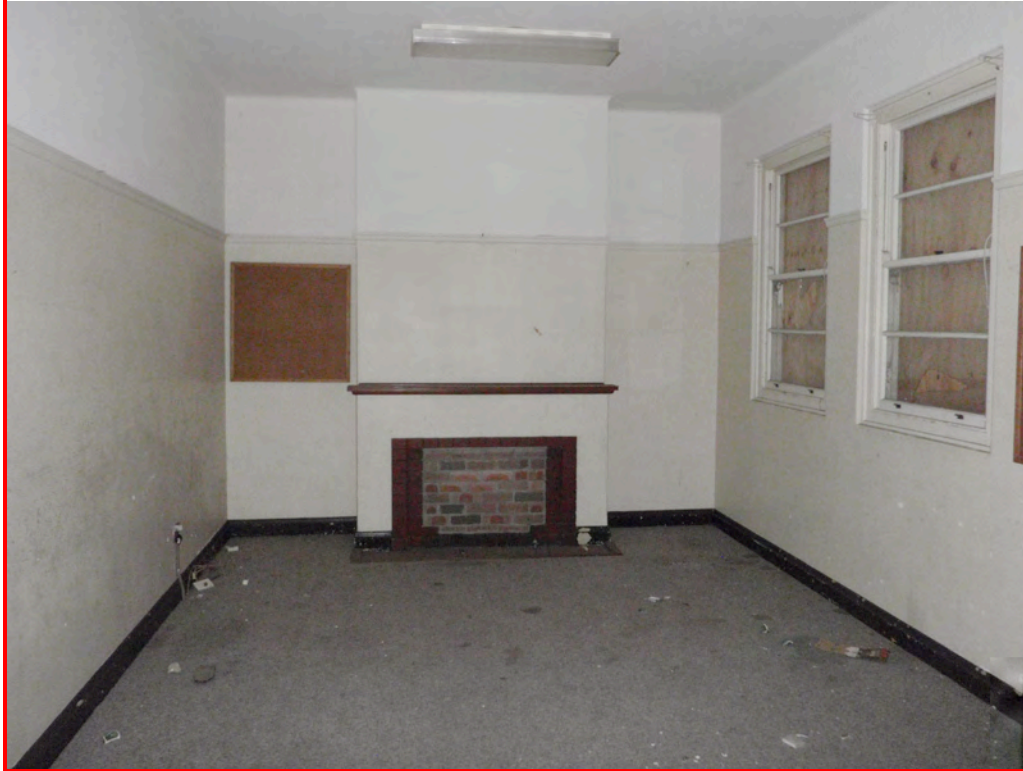
Remove the deteriorated vinyl floor tiling to several areas throughout the property including the kitchen and stair landing and other rooms. It is likely this material contains asbestos.

\$3,000.00

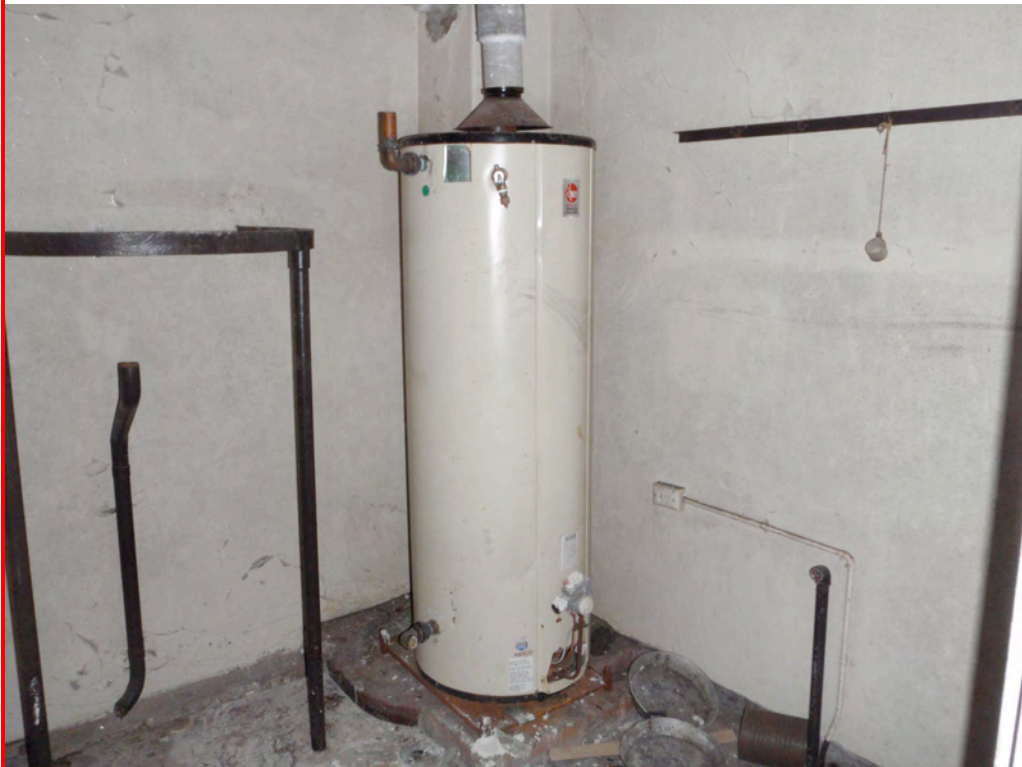
Broken/loose asbestos lagging was noted to the flooring in several areas throughout the property particularly to the laundry area. A thorough clean of the entire buildings floor internally will be required to ensure safety for workers and people viewing the property

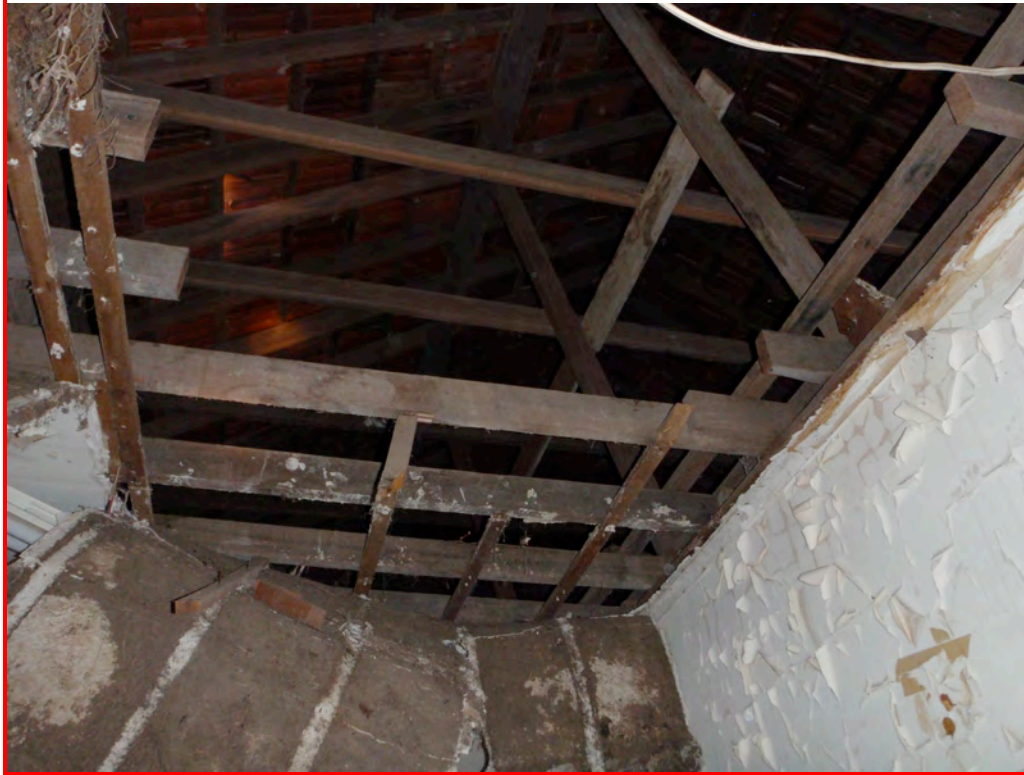
A number of areas of the roof tiling have broken open and have allowed water entry which has extensively damaged the ceilings. The roof tiling to these areas will need to be repaired.

\$5,000.00

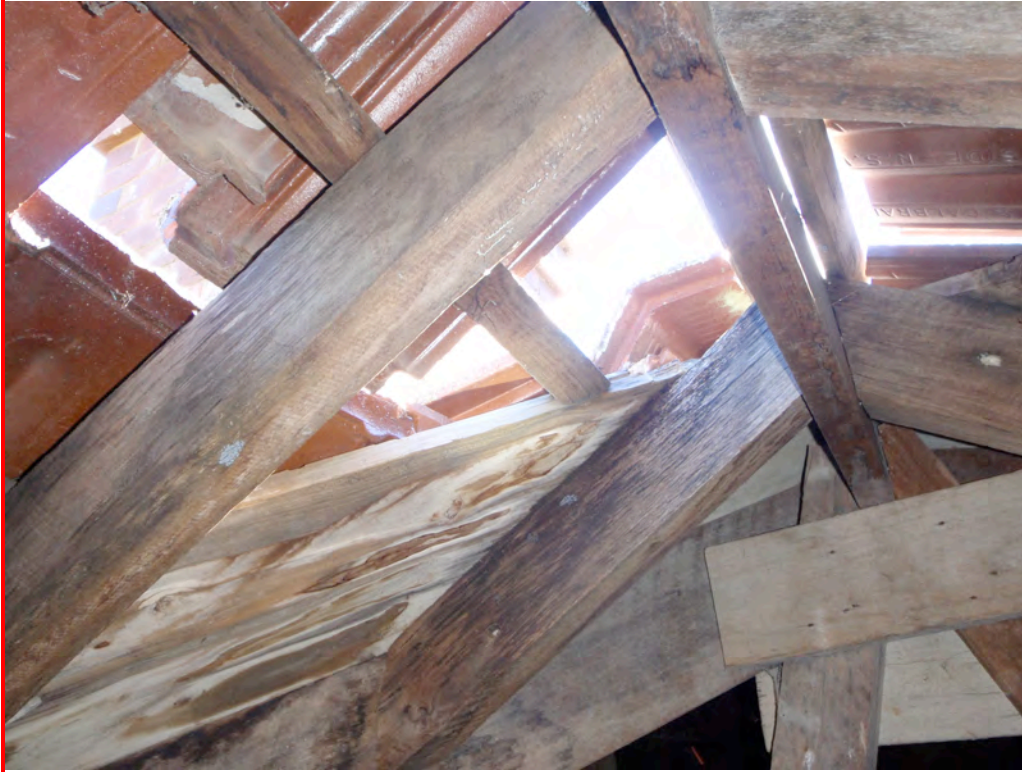
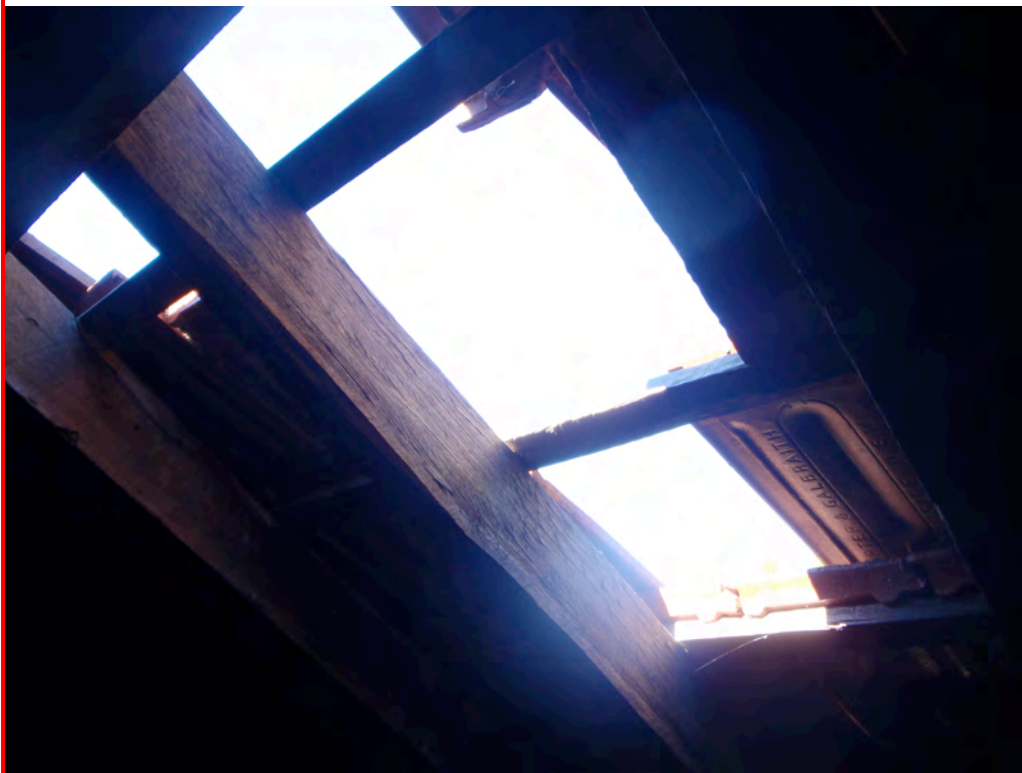
Access to the roof will be required externally using long ladders and harnesses, however, the following defects are likely to be found:

1. cracked ridge cappings
2. faulty/deteriorated flashings to chimneys
3. deteriorated flashings to plumbing penetrations

Some of the above defects were viewed through the openings in the roof tiling.

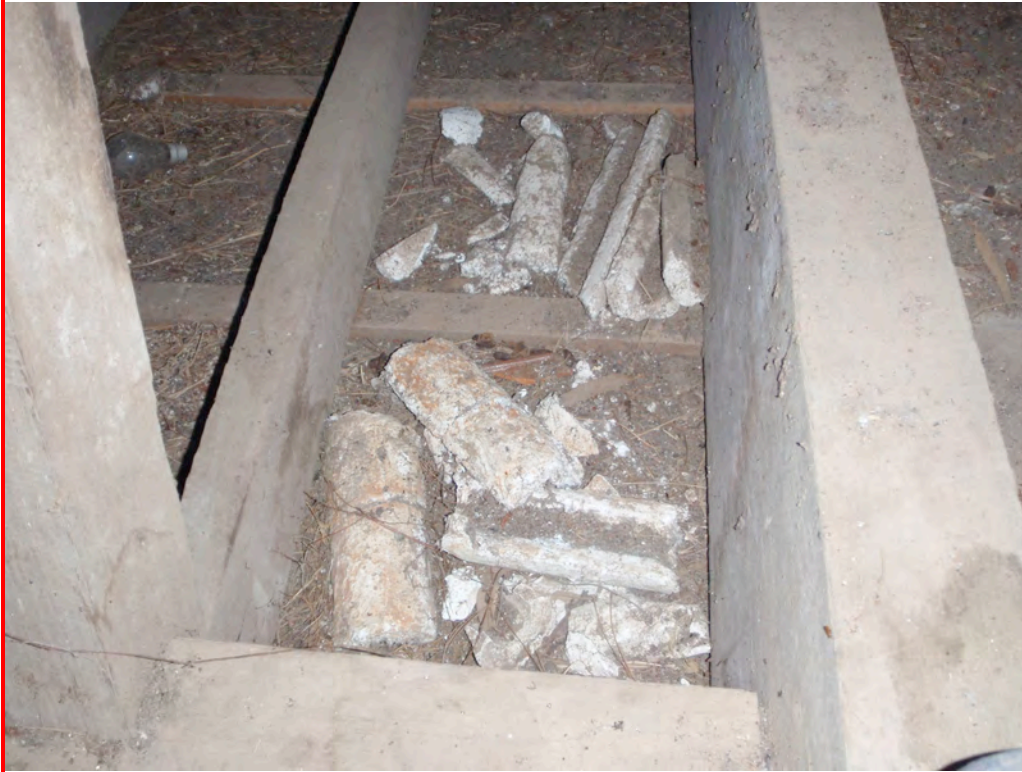
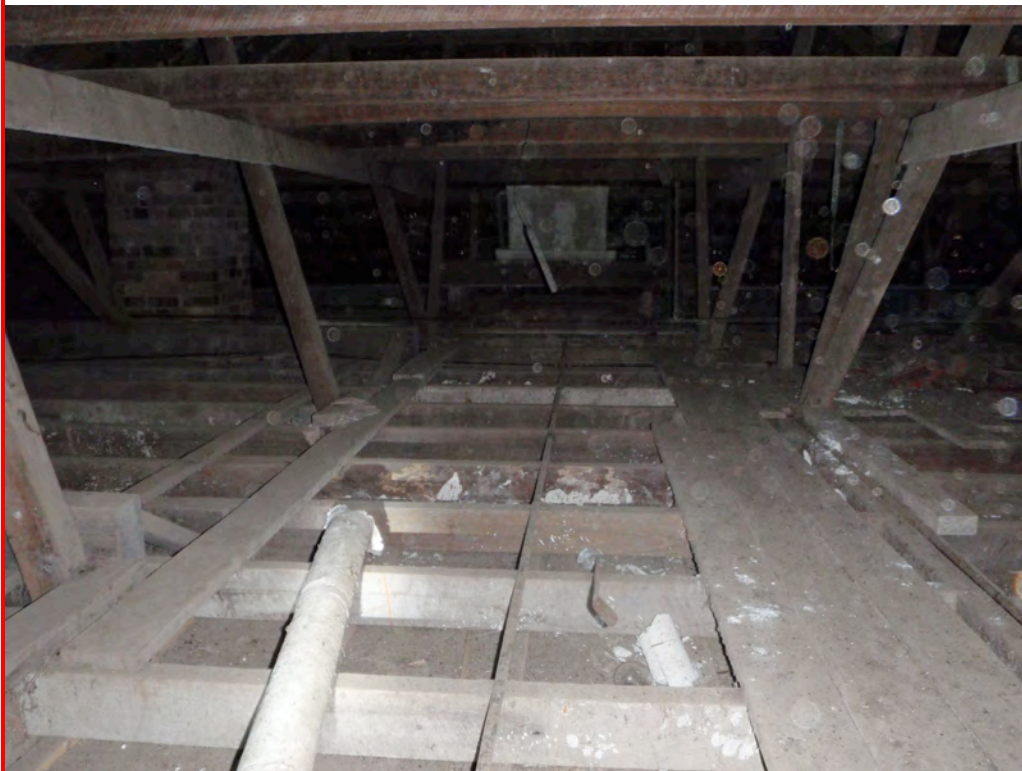
Remove bird nest debris from the roof void in several areas.

\$500.00

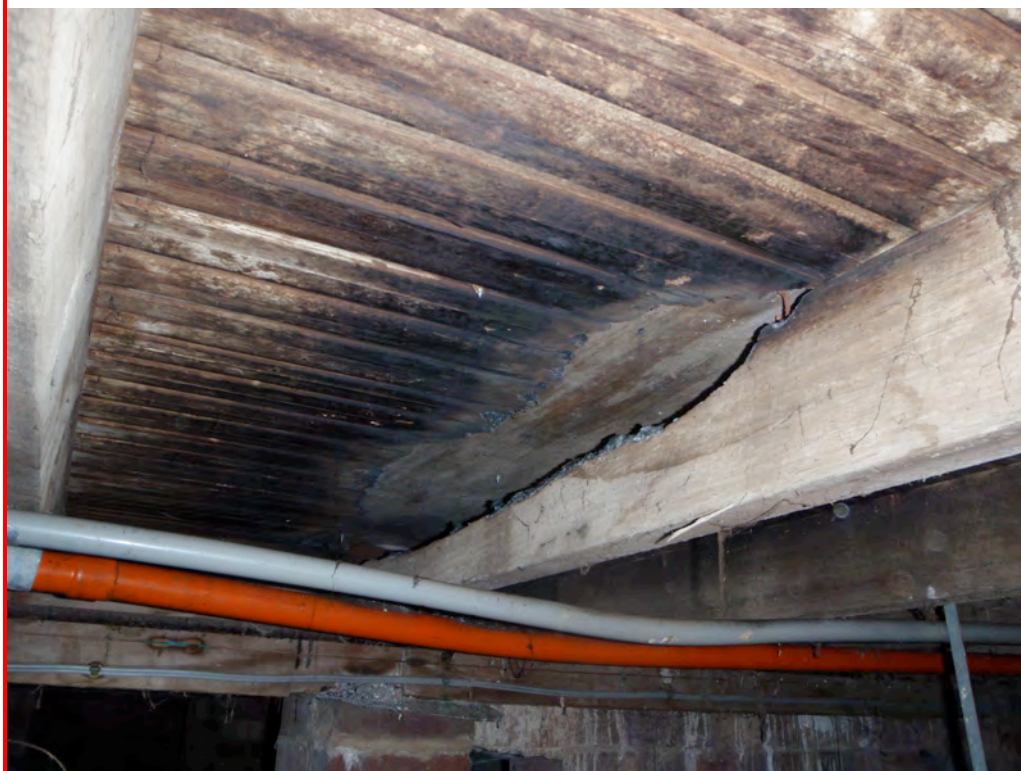
Moisture staining was noted to the underside of the flooring to the locker room. Replacement of timber is not essential at this stage, however, the leak from the verandah above should be repaired immediately.

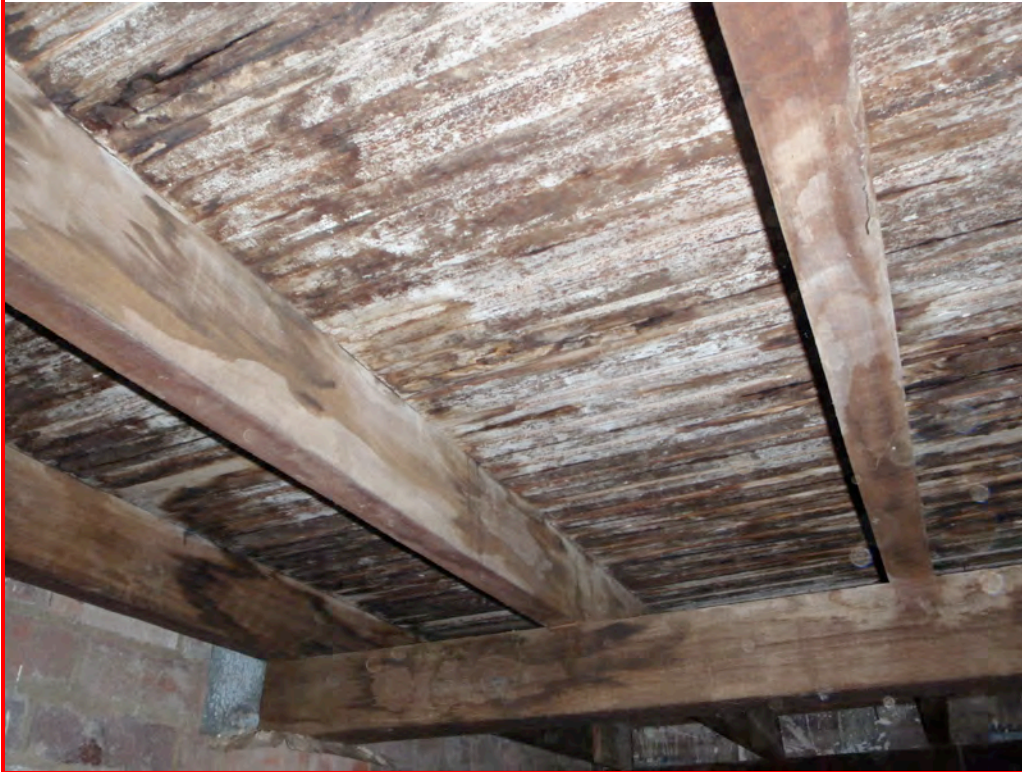
Much of the copper water pipes throughout the subfloor have been removed by vandals.

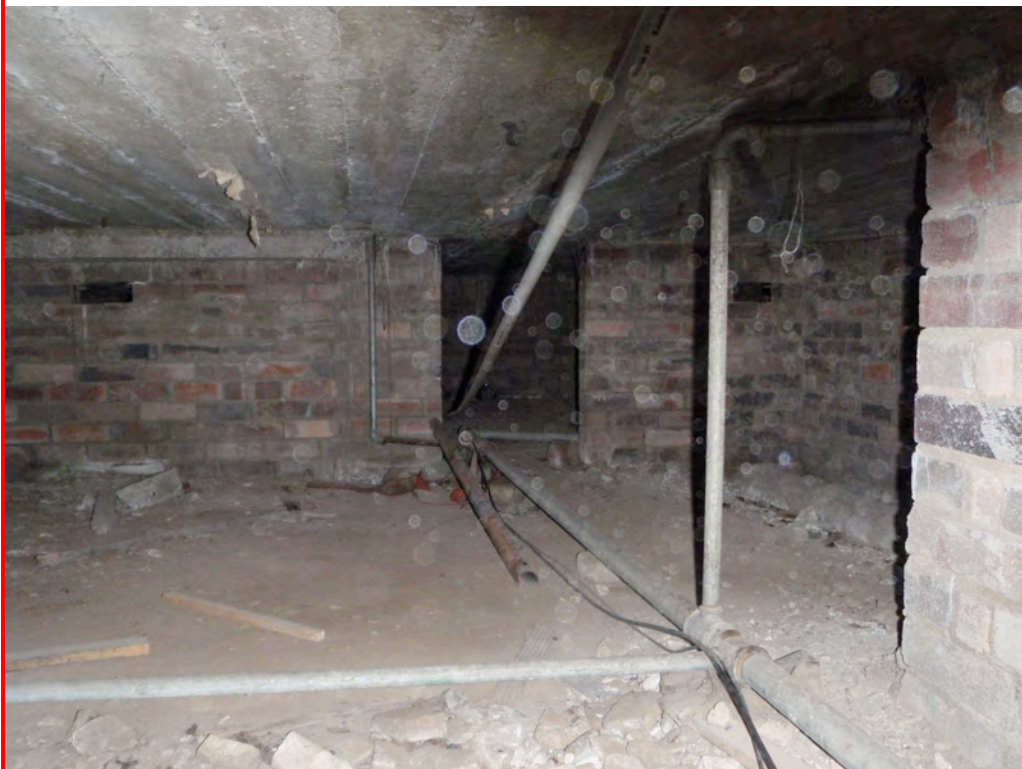
Replace the corroded galvanised steel water pipes throughout the subfloor with copper water pipes.

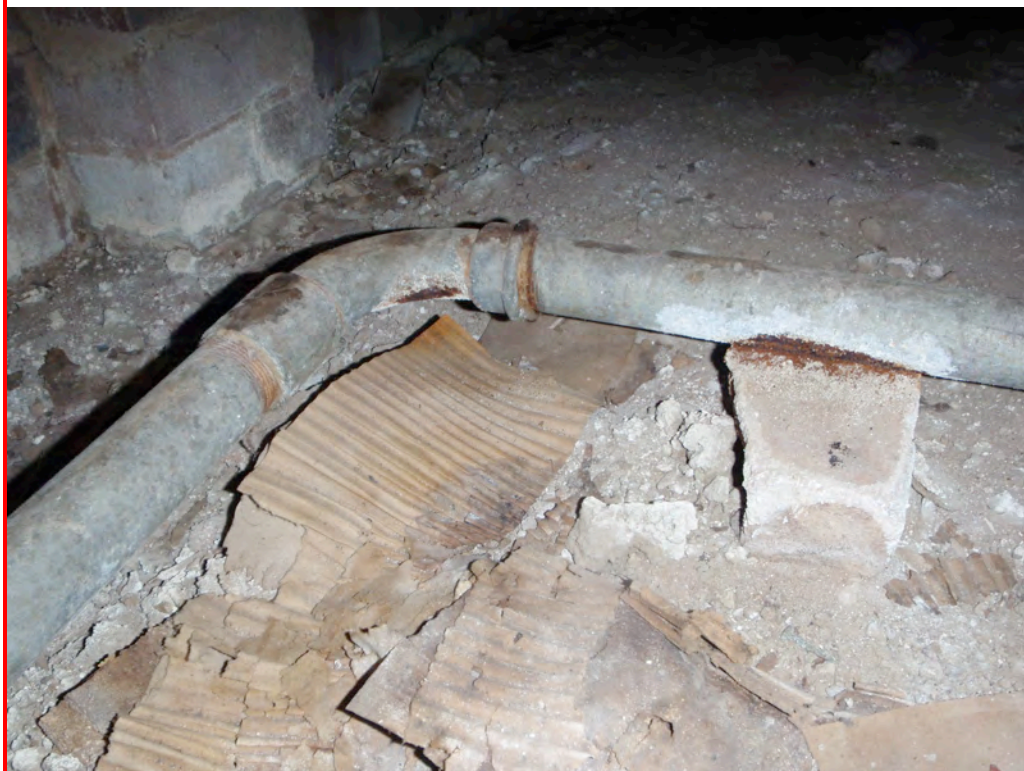
Broken asbestos should be removed from the subfloor area. Small asbestos off-cuts were found in several areas and possible unbonded asbestos was identified to several areas. Samples should be taken to confirm this material is asbestos. Possible unbonded asbestos was mainly found near the hallway manhole.

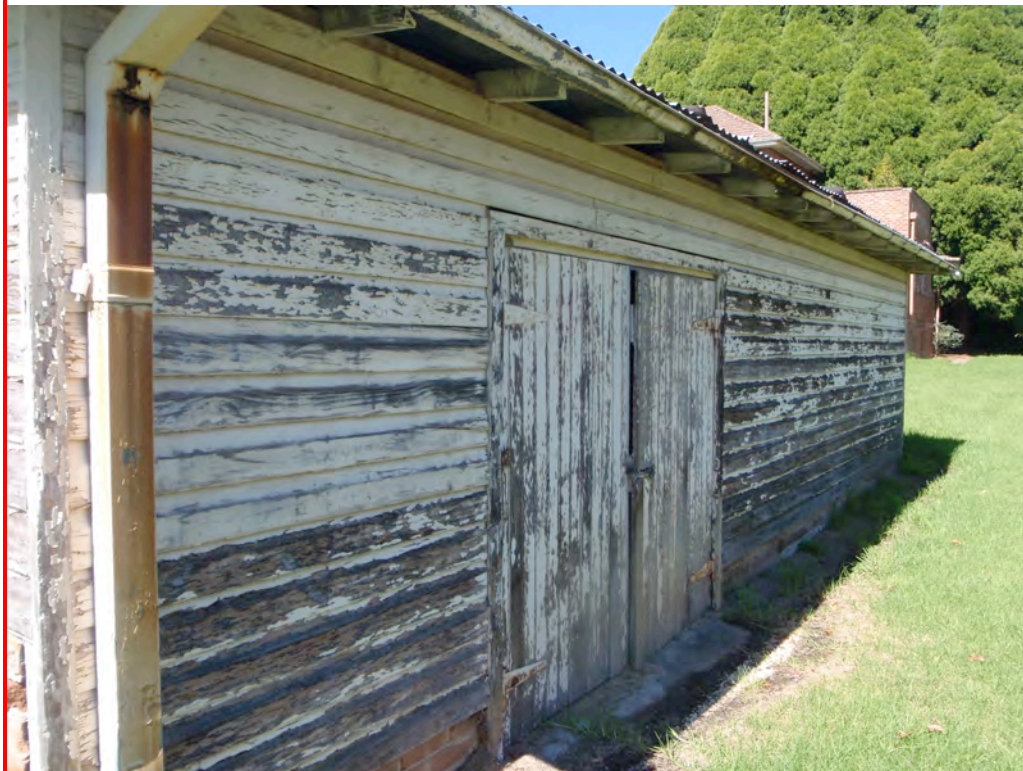
Paint all weathered external timbers.

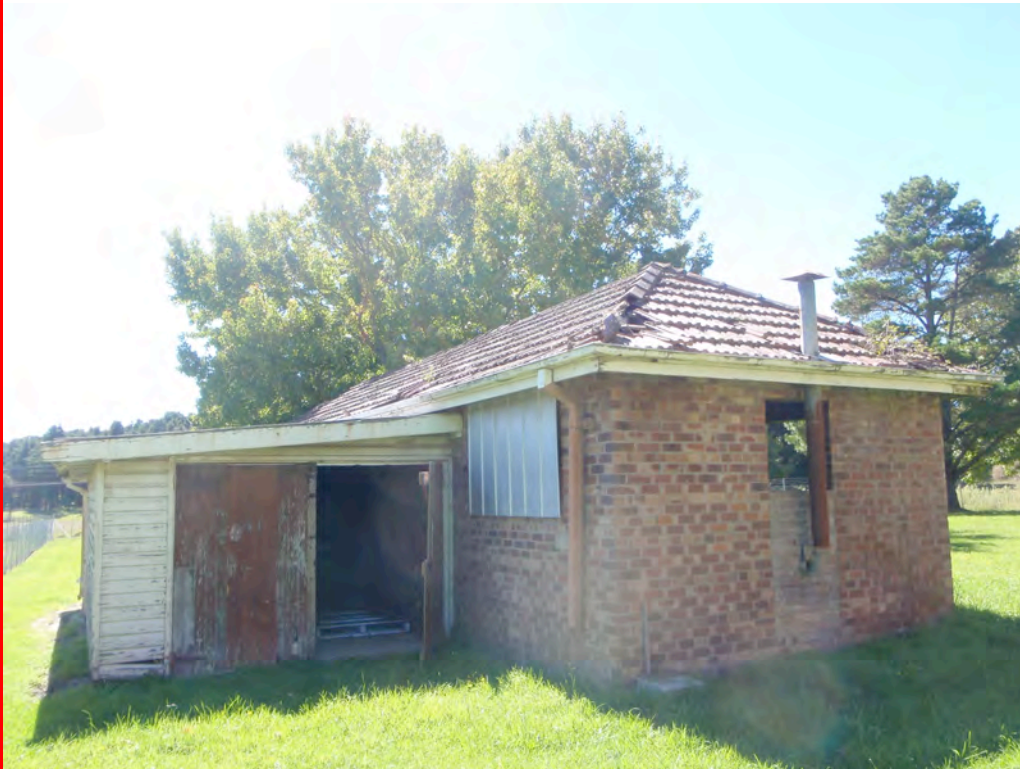
Replace rusted corrugated steel roof sheeting to the rear skillion area.
