Re: Fire Engineering Letter in support of Development Application
Project: New Classroom and Library Building
Address: Harbord Public School, Freshwater

TREE SURVEY PLAN TSP-01

Harbord Public School New Development Geotechnical Investigation

Limited Destructive Hazardous Materials Survey Report

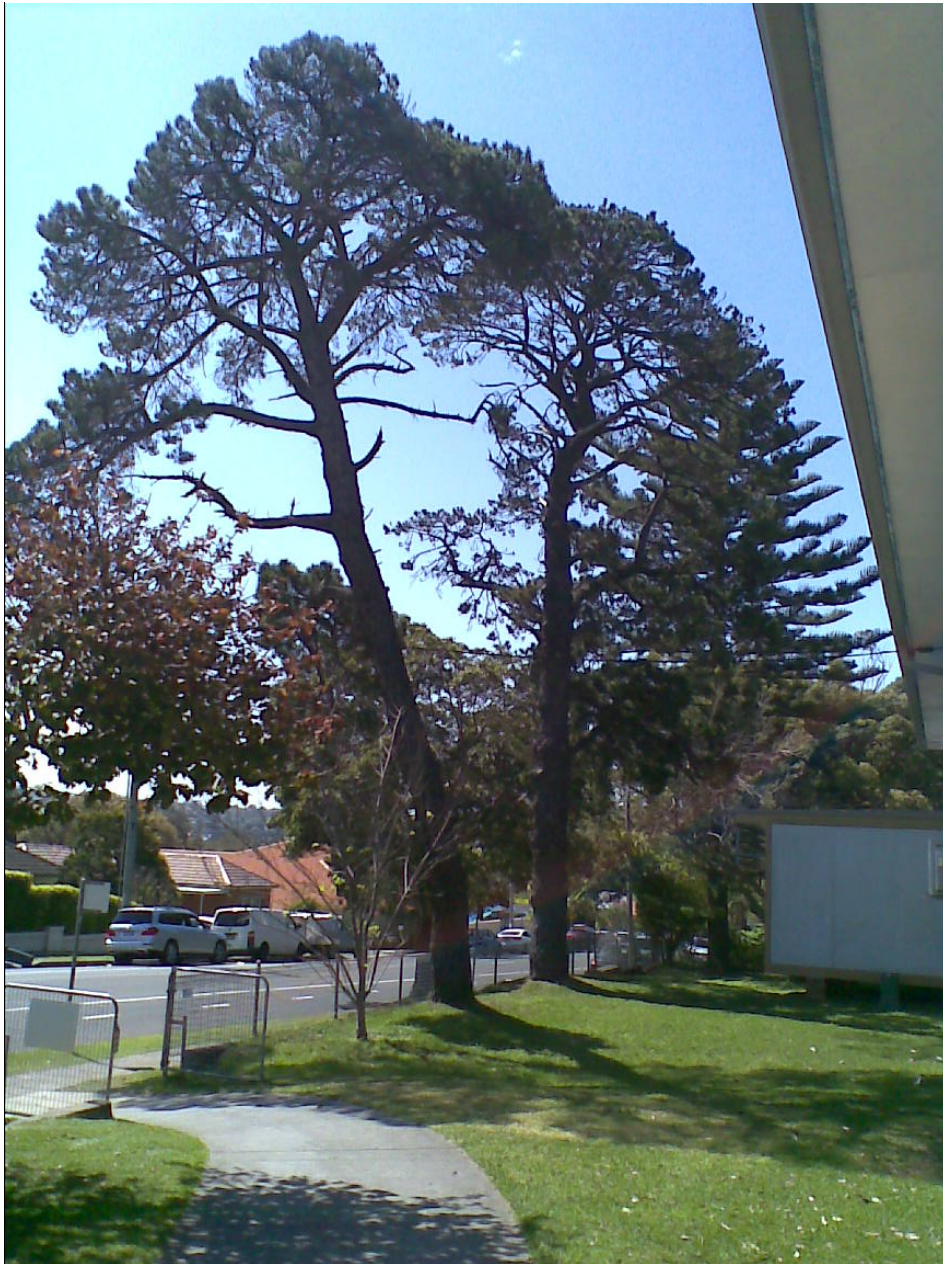
Image 1: Shows canopy form of trees numbered #5 and 6, overhanging the council footpath along Oliver Street, looking north west.

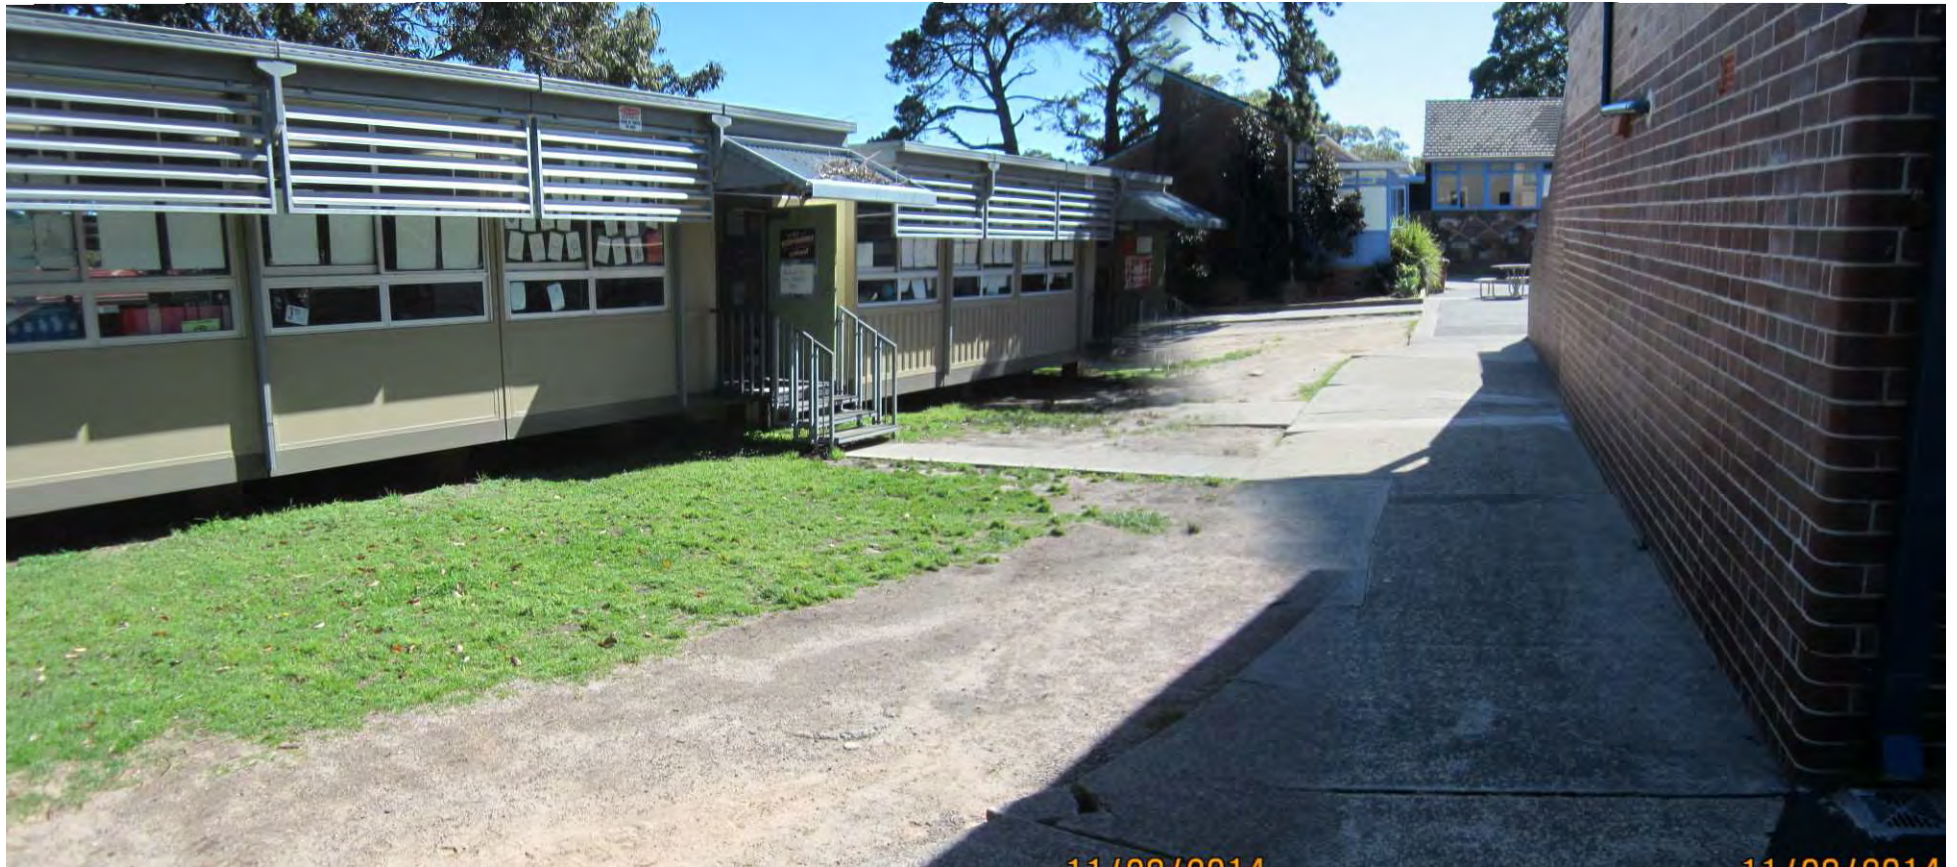
PLATE 1 : View towards the North of the Investigation Area. The proposed new building will be located to the north (the area on the far side) of the demountables. Block Q is on the right. Block A is visible in the background to the right.

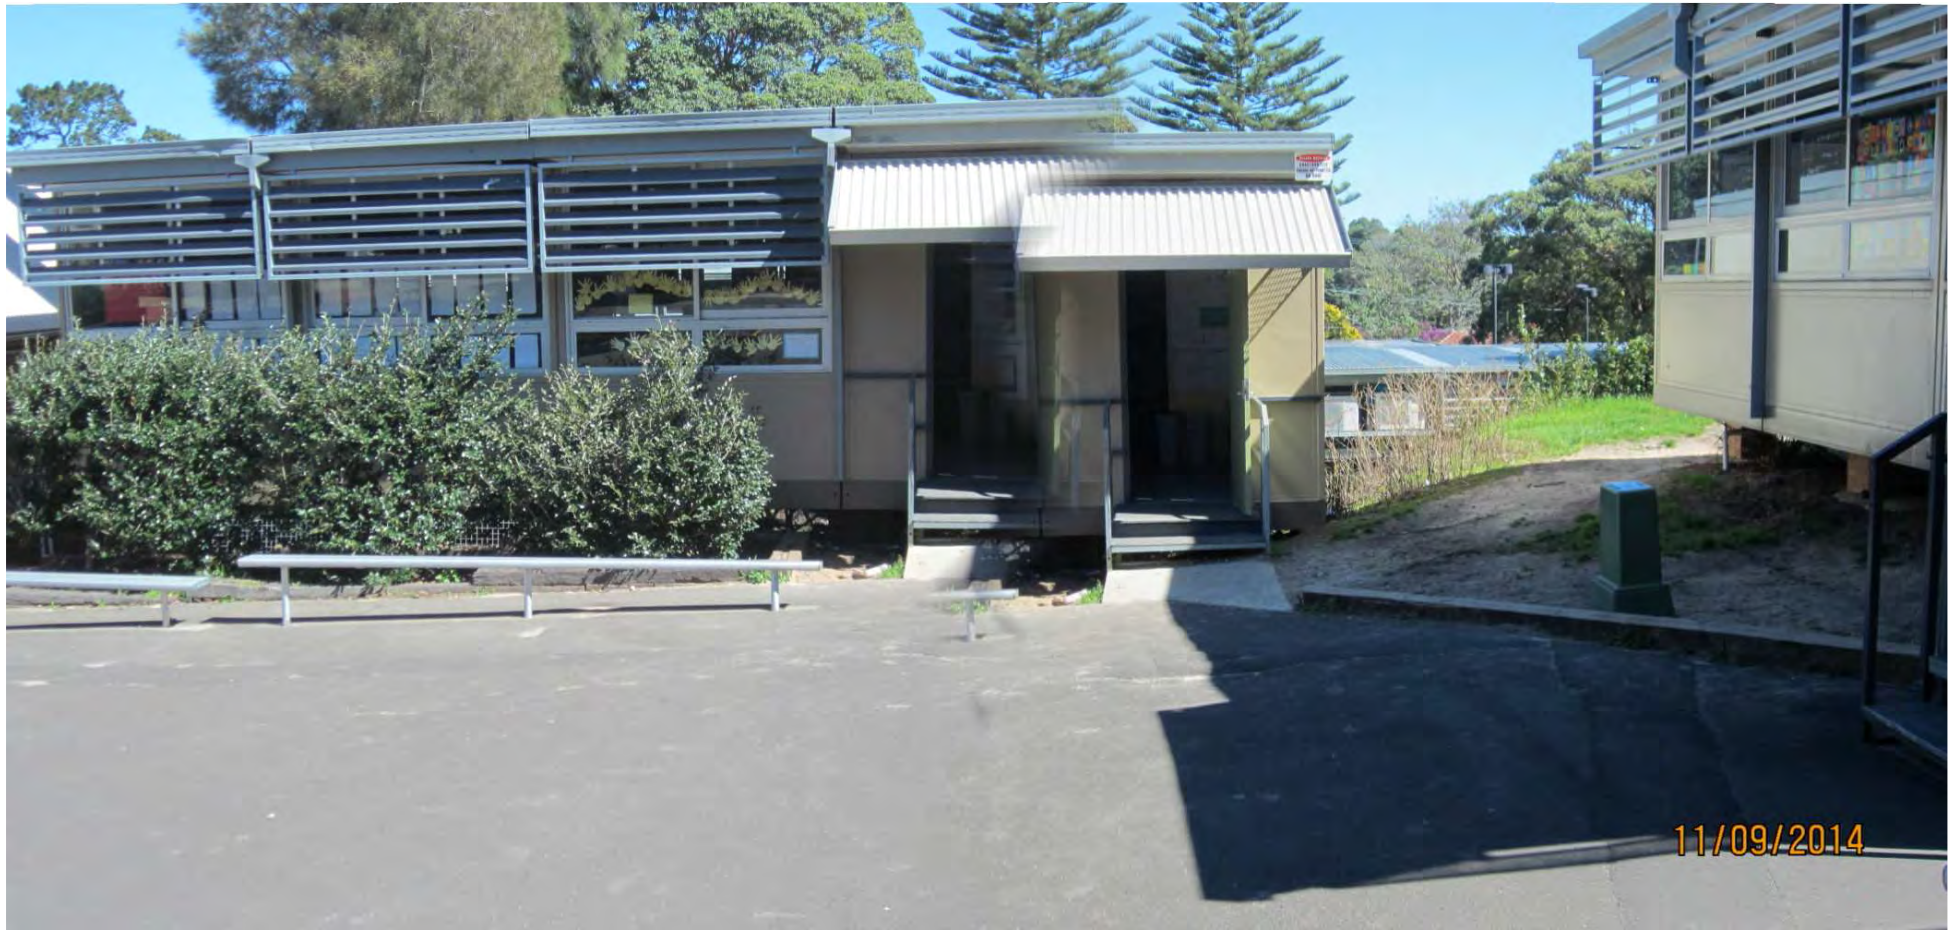
PLATE 3 : View towards the west of the Investigation Area. The demountable in the middle appears to be supported on sandstone outcrop.

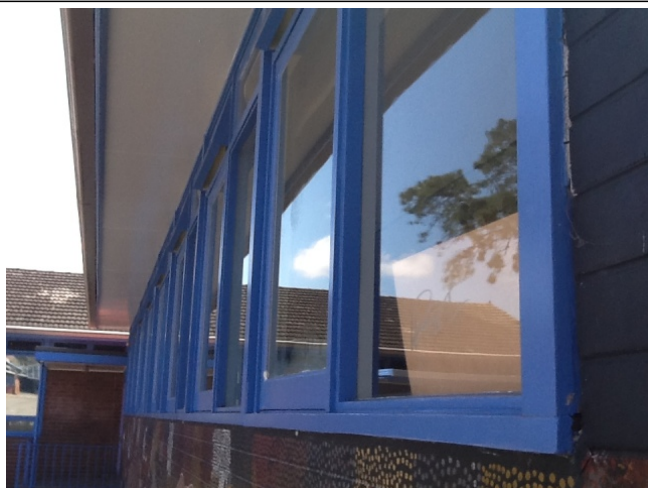
Photo No: J128920-003-Photo041
Result: Lead (Paint) - Positive
Building/Level: Building A-Ground Level
Room/Location: Exterior-North & West
Feature/Material: Window Frame-Lower Paint System/s

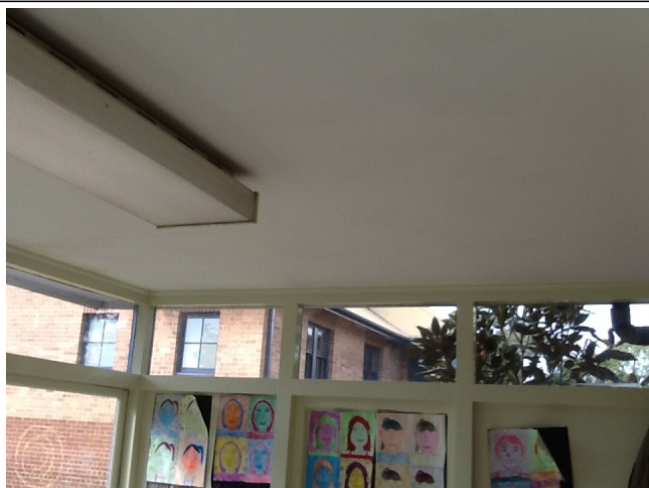
Photo No: J128920-003-Photo002
Result: Asbestos - Previously Sampled Positive
Building/Level: Building A-Ground Level
Room/Location: R0002-Throughout
Feature/Material: Ceiling-Fibre Cement Sheetting

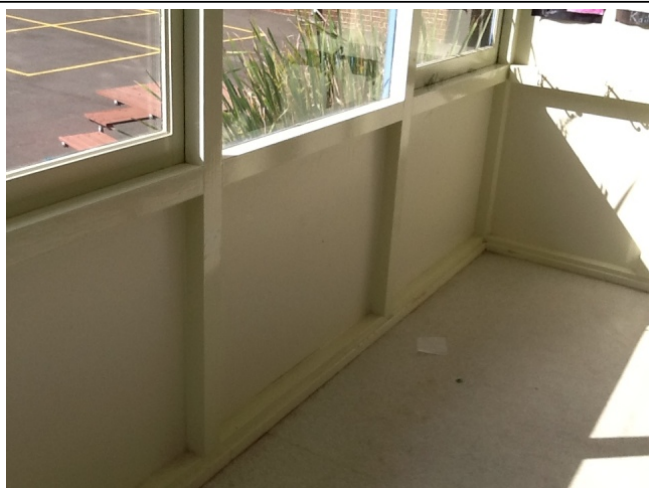
Photo No: J128920-003-Photo003
Result: Asbestos - Previously Sampled Positive
Building/Level: Building A-Ground Level
Room/Location: R0002-Throughout
Feature/Material: Wall Lining-Fibre Cement Sheetting

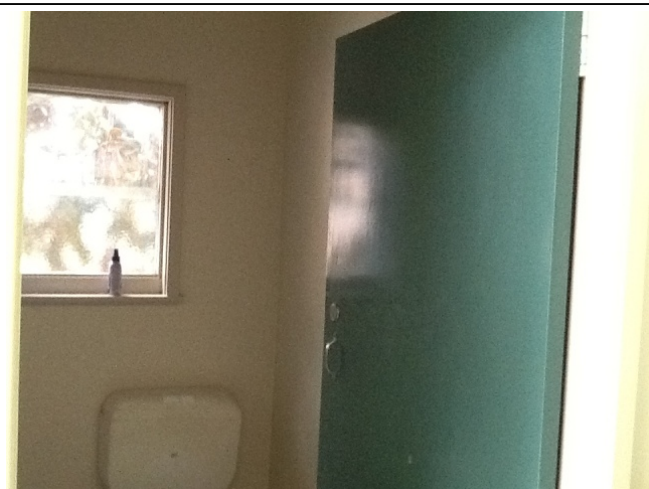
Photo No: J128920-003-Photo009
Result: Lead (Paint) - Presumed Positive
Building/Level: Building A-Ground Level
Room/Location: R0004-North
Feature/Material: Wall-Paint System/s

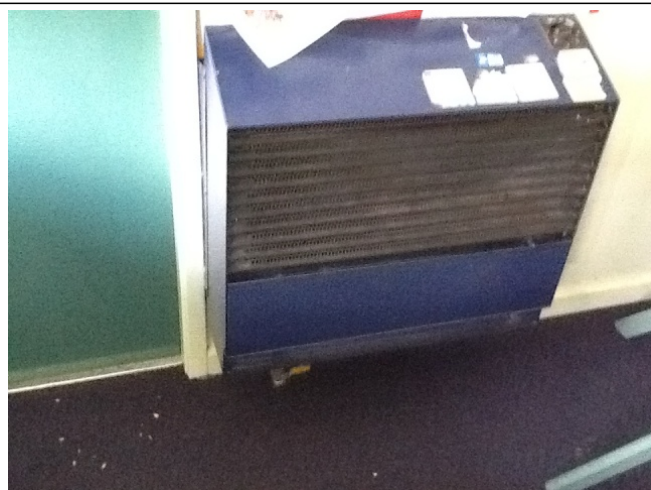
Photo No: J128920-003-Photo014
Result: Asbestos - Presumed Positive
Building/Level: Building A-Ground Level
Room/Location: R0006-North
Feature/Material: Heater-Insulation

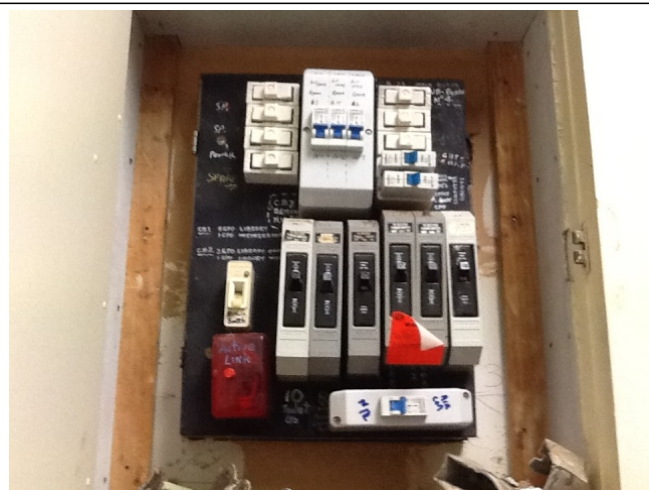
Photo No: J128920-003-Photo017
Result: Asbestos - Presumed Positive
Building/Level: Building A-Ground Level
Room/Location: R0008-West
Feature/Material: Electrical - Switch Board-Compressed Bituminous Electrical Panel

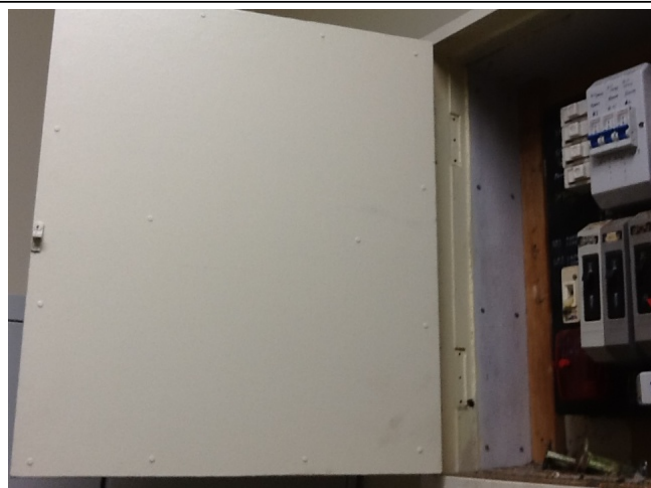
Photo No: J128920-003-Photo018
Result: Asbestos - Previously Sampled Positive
Building/Level: Building A-Ground Level
Room/Location: R0008-West
Feature/Material: Electrical - Switch Board-Fibre Cement Sheetting

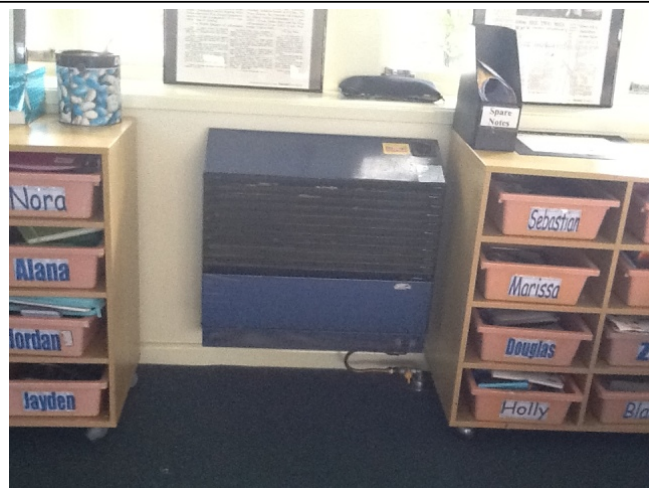
Photo No: J128920-003-Photo033
Result: Asbestos - Presumed Positive
Building/Level: Building A-Ground Level
Room/Location: R0010-North
Feature/Material: Heater-Insulation

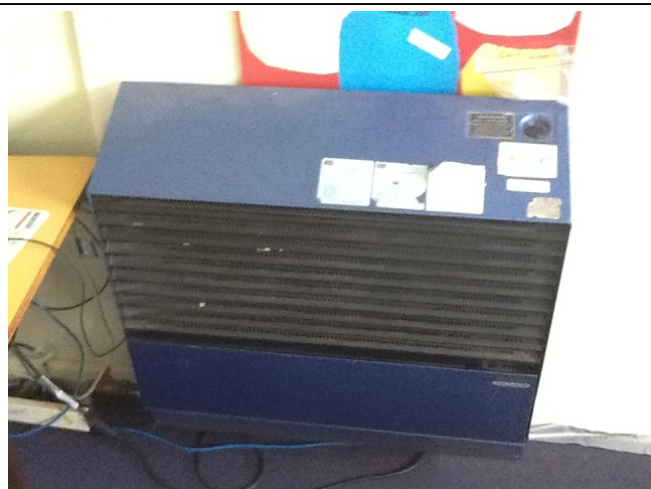
Photo No: J128920-003-Photo025
Result: Asbestos - Presumed Positive
Building/Level: Building A-Ground Level
Room/Location: R0010-South
Feature/Material: Heater-Insulation

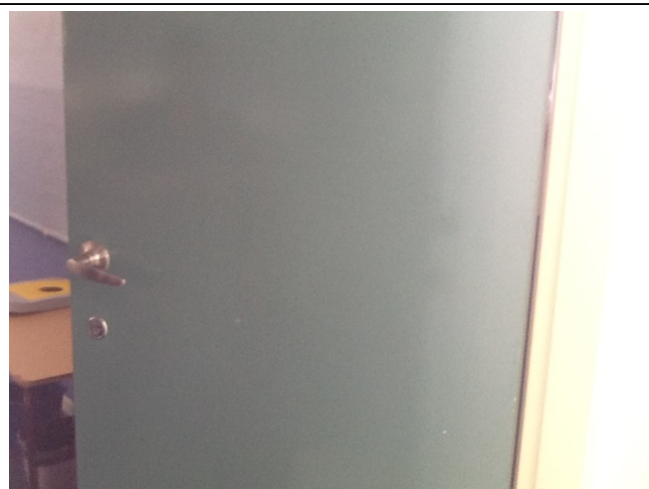
Photo No: J128920-003-Photo032
Result: Lead (Paint) - Presumed Positive
Building/Level: Building A-Ground Level
Room/Location: R0020-East
Feature/Material: Door-Paint System/s

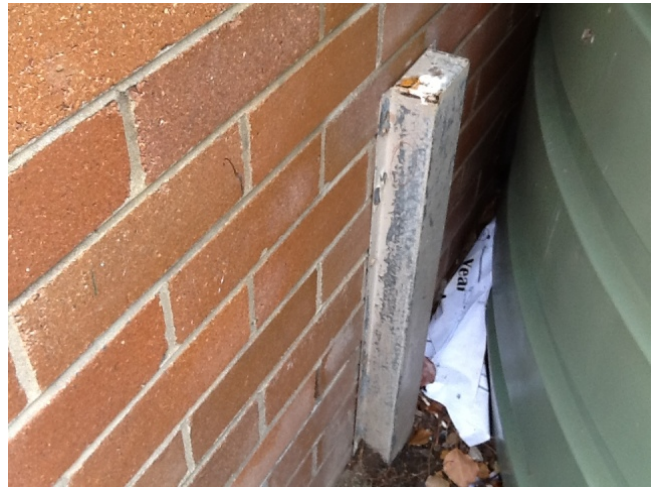
Photo No: J128920-003-Photo049
Result: Lead (Paint) - Positive
Building/Level: Building B-Ground Level
Room/Location: Exterior-South & East
Feature/Material: Metal Work-Paint System/s

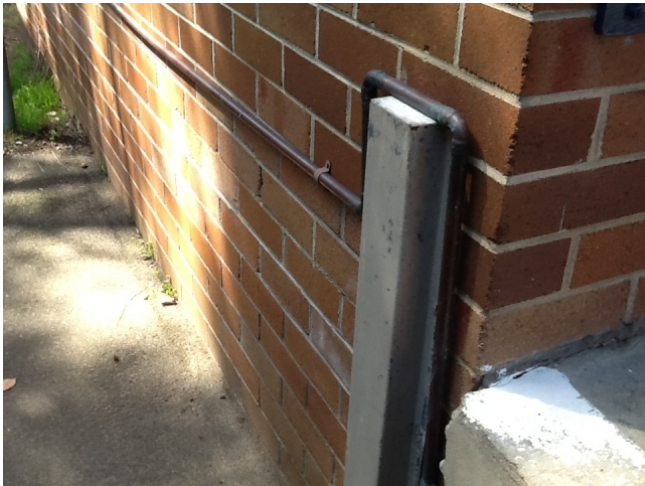
Photo No: J128920-003-Photo058
Result: Lead (Paint) - Positive
Building/Level: Building C-Ground Level
Room/Location: Exterior-West
Feature/Material: Metal Work-Paint System/s

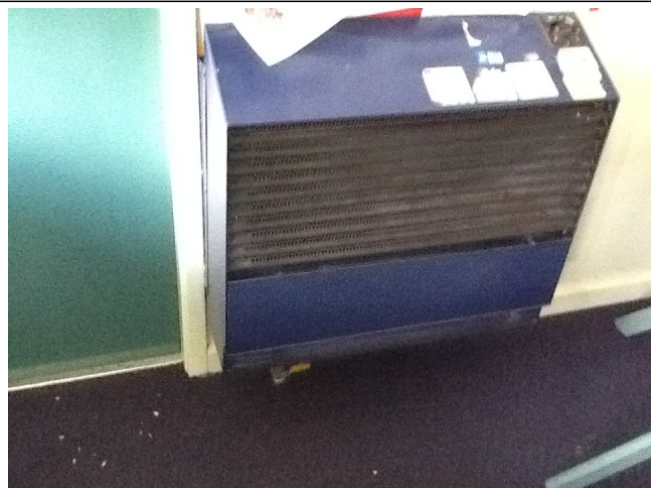
Photo No: J128920-003-Photo014
Result: Asbestos - Presumed Positive
Building/Level: Building A-Ground Level
Room/Location: R0006-North
Feature/Material: Heater-Insulation

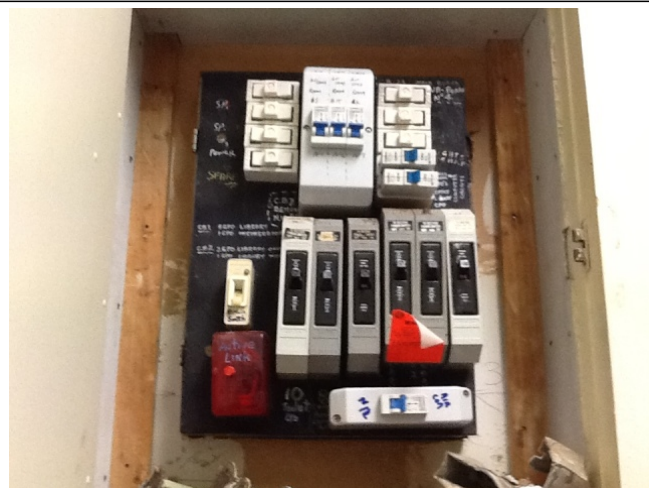
Photo No: J128920-003-Photo017
Result: Asbestos - Presumed Positive
Building/Level: Building A-Ground Level
Room/Location: R0008-West
Feature/Material: Electrical - Switch Board-Compressed Bituminous Electrical Panel

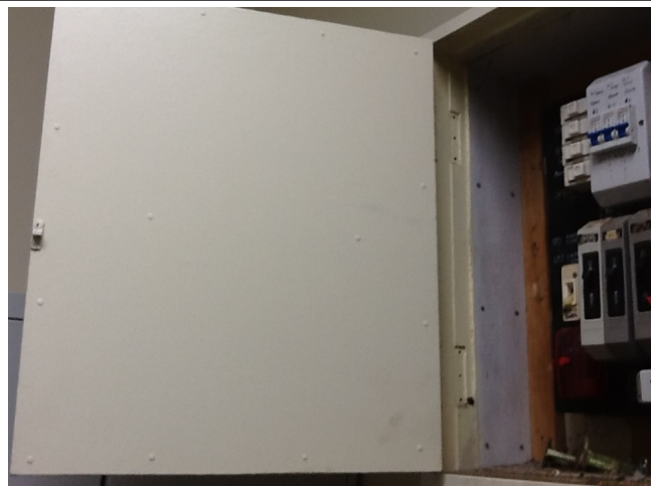
Photo No: J128920-003-Photo018
Result: Asbestos - Previously Sampled Positive
Building/Level: Building A-Ground Level
Room/Location: R0008-West
Feature/Material: Electrical - Switch Board-Fibre Cement Sheetting

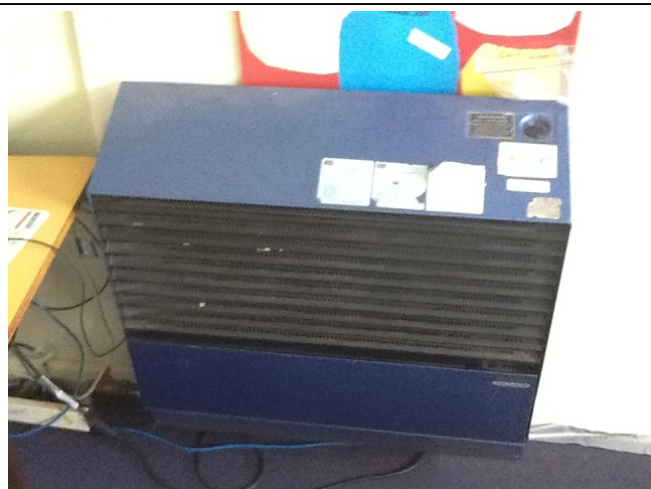
Photo No: J128920-003-Photo025
Result: Asbestos - Presumed Positive
Building/Level: Building A-Ground Level
Room/Location: R0010-South
Feature/Material: Heater-Insulation

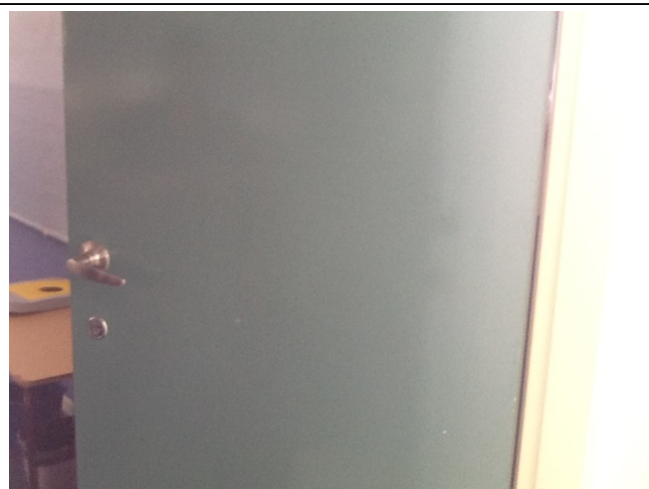
Photo No: J128920-003-Photo032
Result: Lead (Paint) - Presumed Positive
Building/Level: Building A-Ground Level
Room/Location: R0020-East
Feature/Material: Door-Paint System/s

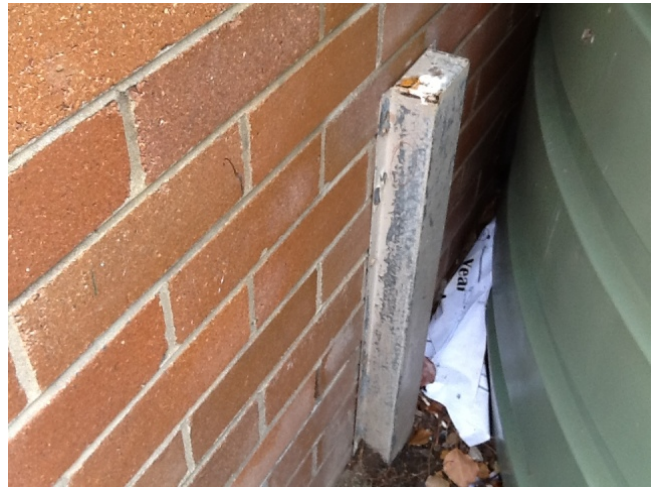
Photo No: J128920-003-Photo049
Result: Lead (Paint) - Positive
Building/Level: Building B-Ground Level
Room/Location: Exterior-South & East
Feature/Material: Metal Work-Paint System/s

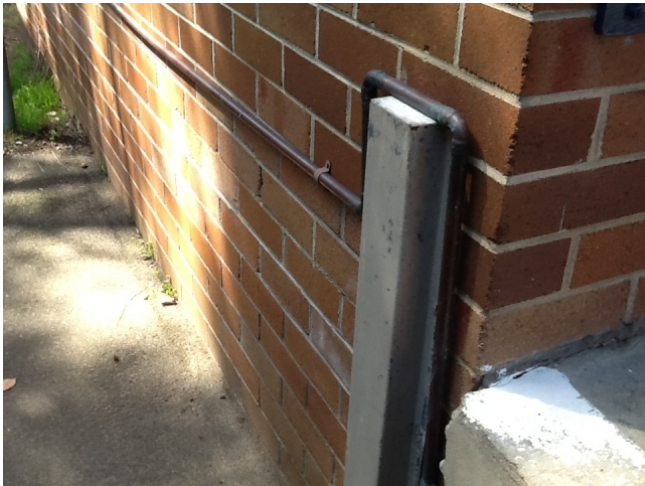
Photo No: J128920-003-Photo058
Result: Lead (Paint) - Positive
Building/Level: Building C-Ground Level
Room/Location: Exterior-West
Feature/Material: Metal Work-Paint System/s
