# WEBSTER STREET AND HENRY LAWSON DRIVE, MILPERRA

## PRELIMINARY DESIGN ROAD SAFETY AUDIT

DOLTONE HOUSE

Issue date: 2 September 2014

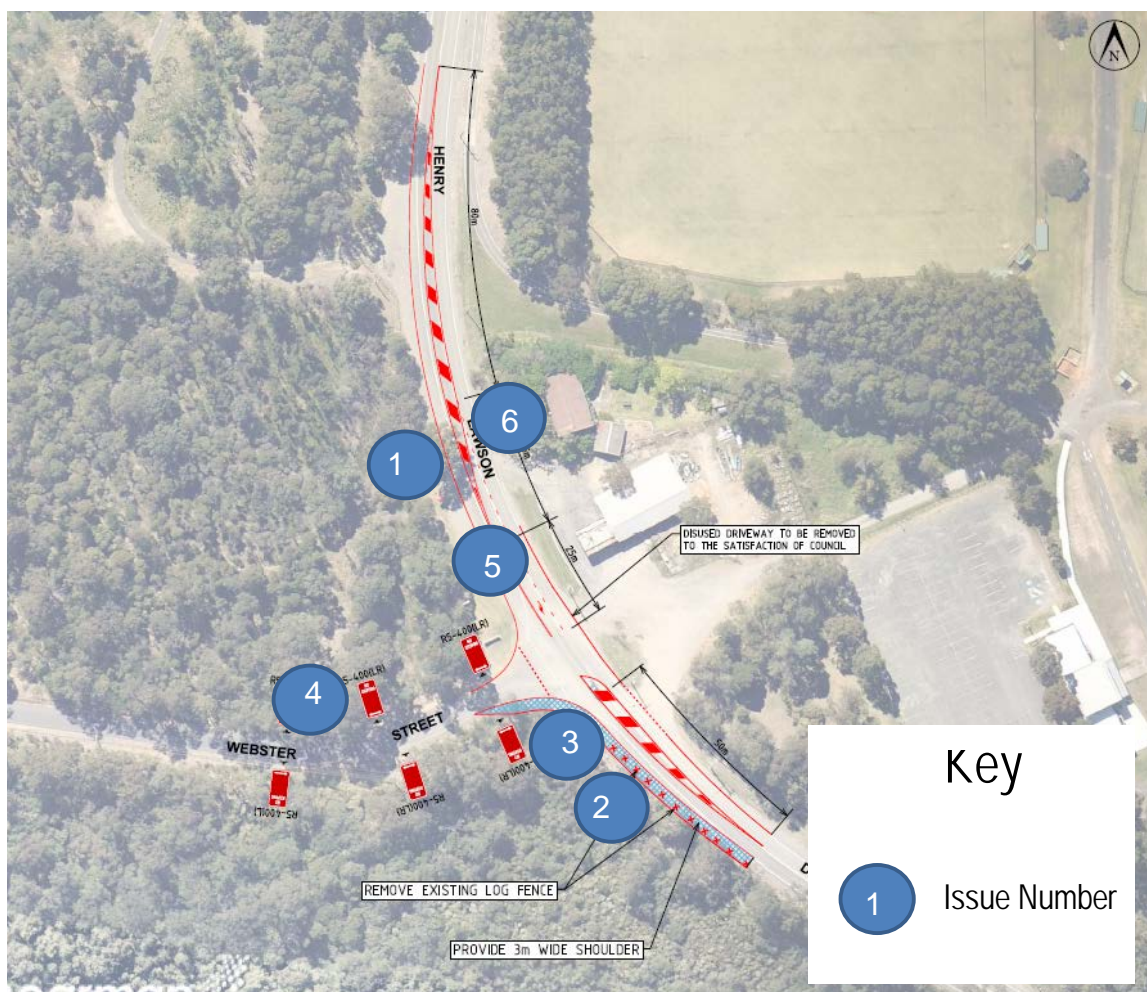
Figure 3.1: Location of Identified Issues

The key findings of the audit related to objects in the clear zone including a mature tree, log fence and an existing culvert. Many of the issues raised relate to existing hazards and all issues can be addressed in the detail design of the intersection.

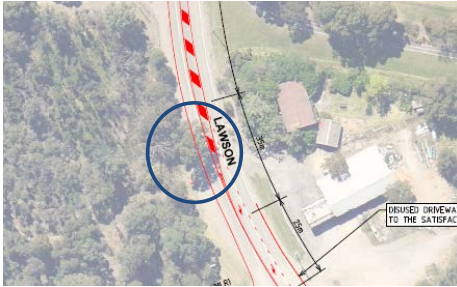
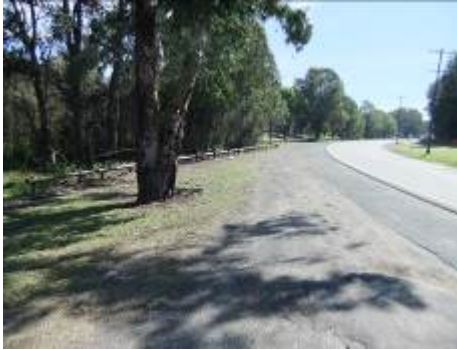
Item	Plan No.	Risk Priority	Issues	Site Illustration	Audit Response
1	1	High	<p>The widening of the road will make the travel lane closer to a mature tree. It is estimated that it will be located some 3m from the nearest travel lane on the outside of a horizontal curve.</p> <p>There is a risk that an errant vehicle could collide with the tree.</p>

<p>The location of the tree relative to the nearest travel lane shall be considered during detail design of the intersection.</p> <p>Should the location of the tree be within the 3m zone then mitigation measures such as barrier controls or tree removal shall be considered.</p>
2	1	Medium	<p>There is a batter slope located on the outside of the bend on the eastern approach to the intersection. The slope will be unprotected and there is a risk that an errant vehicle may overturn.</p>

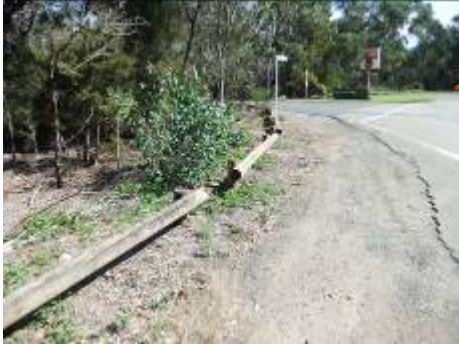
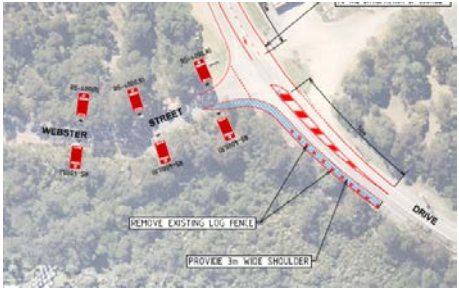
Item	Plan No.	Risk Priority	Issues	Site Illustration	Audit Response
3		High	The plan indicates that the log fence will be removed only part way to the intersection as indicated by the x's . The remaining log fence near the intersection is located on the outside of a horizontal curve and would be a hazard for errant vehicles that may collide head on into the fence.

It is recommended that the extent of the log fence removal be extended around the curve into Webster Street.
4		Low	There is an unprotected drainage culvert located on the Webster Street approach to the intersection. An errant vehicle could strike the concrete structure. Further, there is poor delineation of the object with an unreflective white post that would be hard to see in low light conditions.

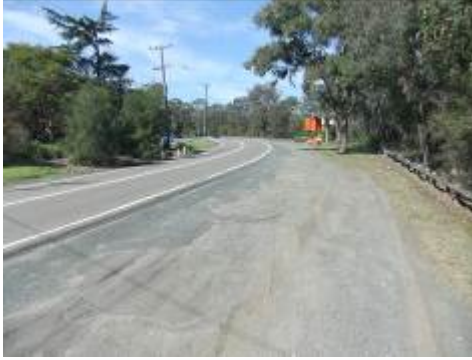
Item	Plan No.	Risk Priority	Issues	Site Illustration	Audit Response
5		Medium	<p>The exiting road has a super elevation on the curve. At this stage in the design it is unclear whether the super elevation will be maintained or a crown introduced in the road.</p> <p>(i) If the super elevation is maintained for widened section then the road shoulder will slope away from the road reducing the chance of recovery or directing vehicles toward road side objects.</p> <p>(ii) If not maintained then vehicles will have less grip while negotiating the turn.</p>

<p>Super elevation and in particular the associated issues identified in this audit shall be considered during detail design of the intersection.</p>

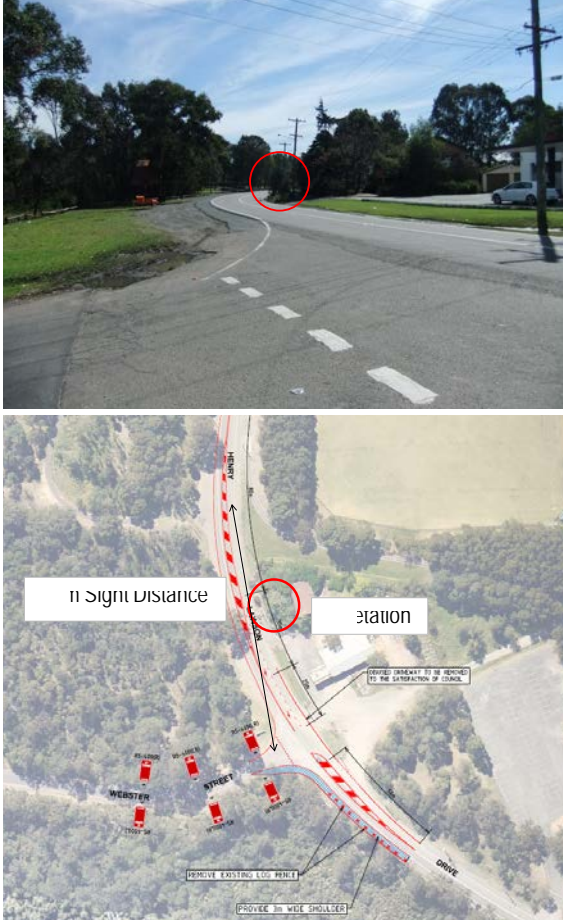
Item	Plan No.	Risk Priority	Issues	Site Illustration	Audit Response
6		High	<p>Sight distance to the intersection is restricted by vegetation on inside of the curve. There is a potential for a vehicle on the main road to collide with a vehicle turning right from Webster street.</p> <p>Austrroads Guide to Road Design part 4A recommends a Safe Intersection Sight Distance of 123m. We estimate that from the existing hold line there is some 95m. From the future hold line sight distance will be 110m. Removing the vegetation would provide adequate sight distance.</p>

<p>It is recommended that the vegetation which is located within the road reserve be trimmed / removed such as to provide appropriate sight distances.</p> <p>It is noted that these works are required to address an existing situation and should be undertaken with or without approval of the Deepwater Motor Boat Club DA.</p>
