Arborist Report

Warners Bay Private Hospital

project no: 10738.5
date: Thursday, 25 August 2016
revision: F

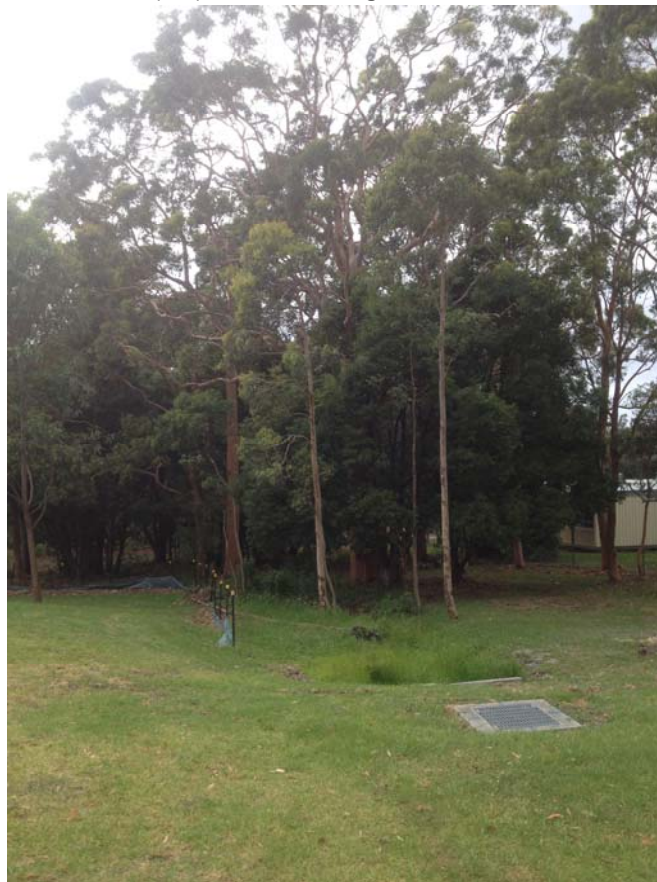
FIGURE 5: TYPICAL VEGETATION OCCURRING ON SITE CLOSE TO EXISTING BUILDINGS.

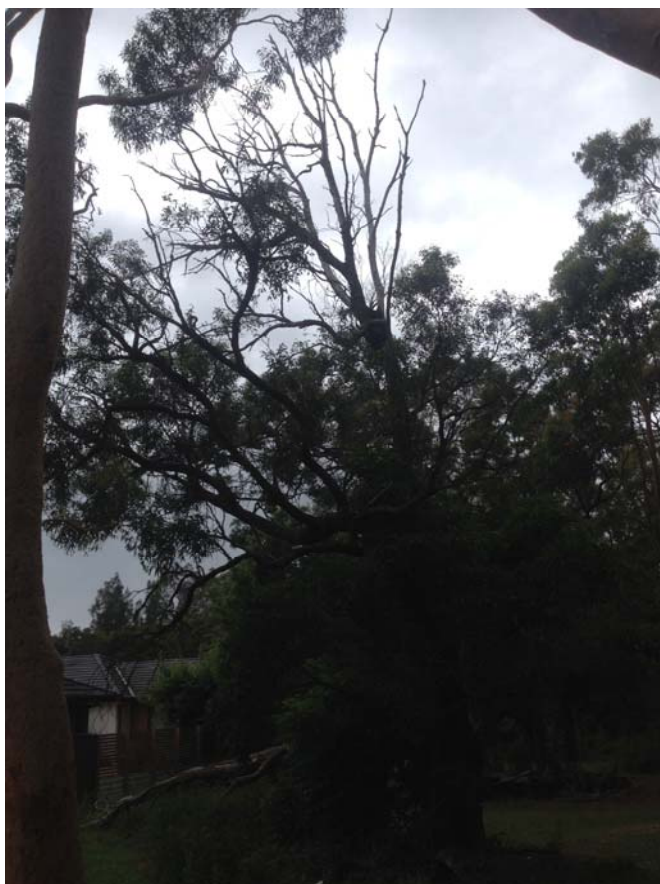
The dominant native tree species consist of *Angophora costata*, *Eucalyptus acmenoides* and *Eucalyptus piperita*. Many of the trees are in a poor state having reached over maturity and a number of these are dead.

FIGURE 3: MANY OF THE TREES ASSESSED ARE OVER MATURE.

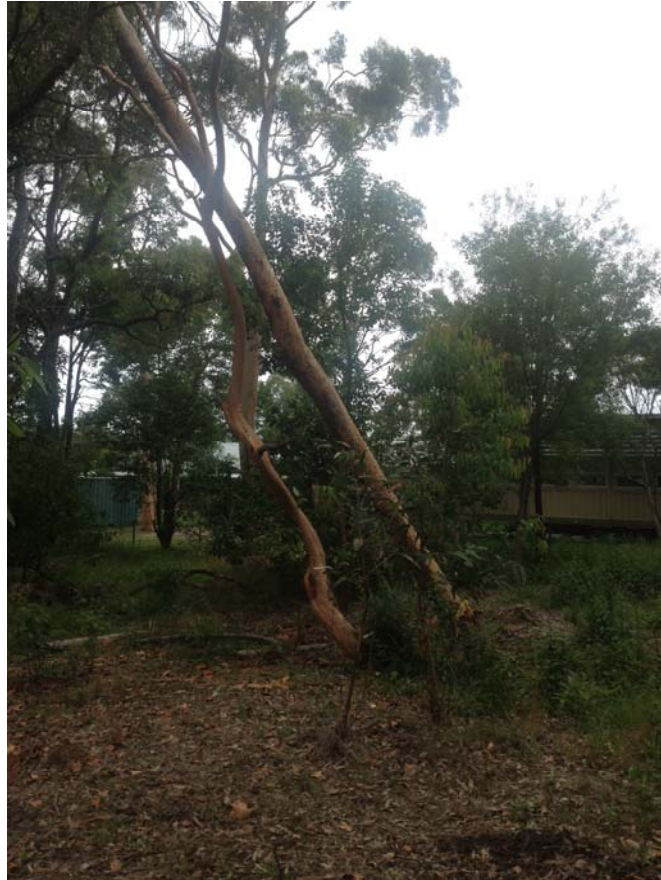
FIGURE 4: TREE 32 ROOT PLATE FAILURE.

30	Dead Tree									4A	Z4			
31	<i>Eucalyptus acmenoides</i>	White Mahogany	OM	19	460	4	4	3	3	4B	Z4	P	P	DECLINING TREE WITH MASSES OF DEAD WOOD. LARGE HANGING BRANCHES AND TERMITE NEST.
32	<i>Angophora costata</i>	Smooth Barked Apple	M	18	300					4C	Z6	P	P	ROOT PLATE FAILURE LEANING INTO ADJACENT TREE.
33	Dead Tree				250					4A	Z4			
34	<i>Eucalyptus acmenoides</i>	White Mahogany	M	15	240	2	2	2	2	1A	A1	AV	AV	
35	<i>Angophora costata</i>	Smooth Barked Apple	M	18	460	6	4	6	5	1A	A1	AV	AV	
36	<i>Eucalyptus acmenoides</i>	White Mahogany	OM	18	1000	10	5	0	4	4B	Z4	P	P	DECLINING TREE ON A LEAN TO THE NORTH, LARGE AMOUNT OF DEAD WOOD AND CANOPY DIEBACK.
37	<i>Eucalyptus species</i>	Gum Tree	OM	18	400	6	5	6	6	4B	Z4	P	P	LARGE AMOUNT OF DEAD WOOD AND CANOPY DIEBACK.
38	<i>Eucalyptus piperita</i>	Sydney Peppermint	M	17	930	12	10	0	3	3D	Z9	P	F	POORLY STRUCTURED, LEANING TO THE NORTH WITH END WEIGHT ISSUES ON BRANCHES, MODERATE AMOUNT OF DEAD WOOD.

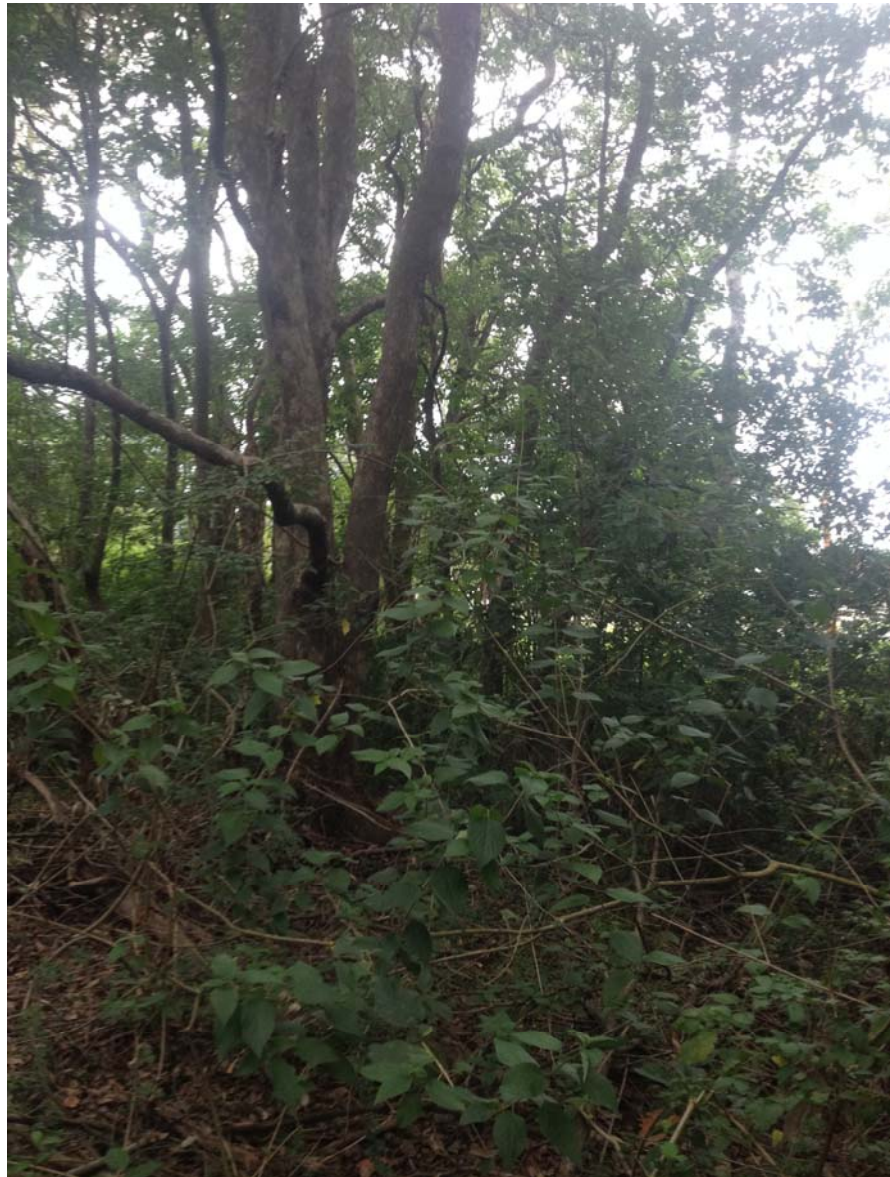
The eastern portion of the study area is dominated by Camphor Laurel, which has formed dense thickets. A small number of native trees (*Melaleuca sp*) are mixed throughout the Camphor Laurels, however trying to distinguish which tree is which on the survey is impossible due the close nature of the thickets. This area is shown as orange on appendix A 'Site Plan'. It is suggested that during site clearing works that a consulting arborist

is present to enable the retention of any worthy native trees in this area outside of the development footprint.

FIGURE 5: TYPICAL VEGETATION WITHIN THE EASTERN PORTION OF THE SITE DOMINATED BY CAMPHOR LAUREL.

- A consulting arborist should be on site during clearing works to identify any trees worthy of retention located within the Camphor Laurel thickets and outside of the development footprint.

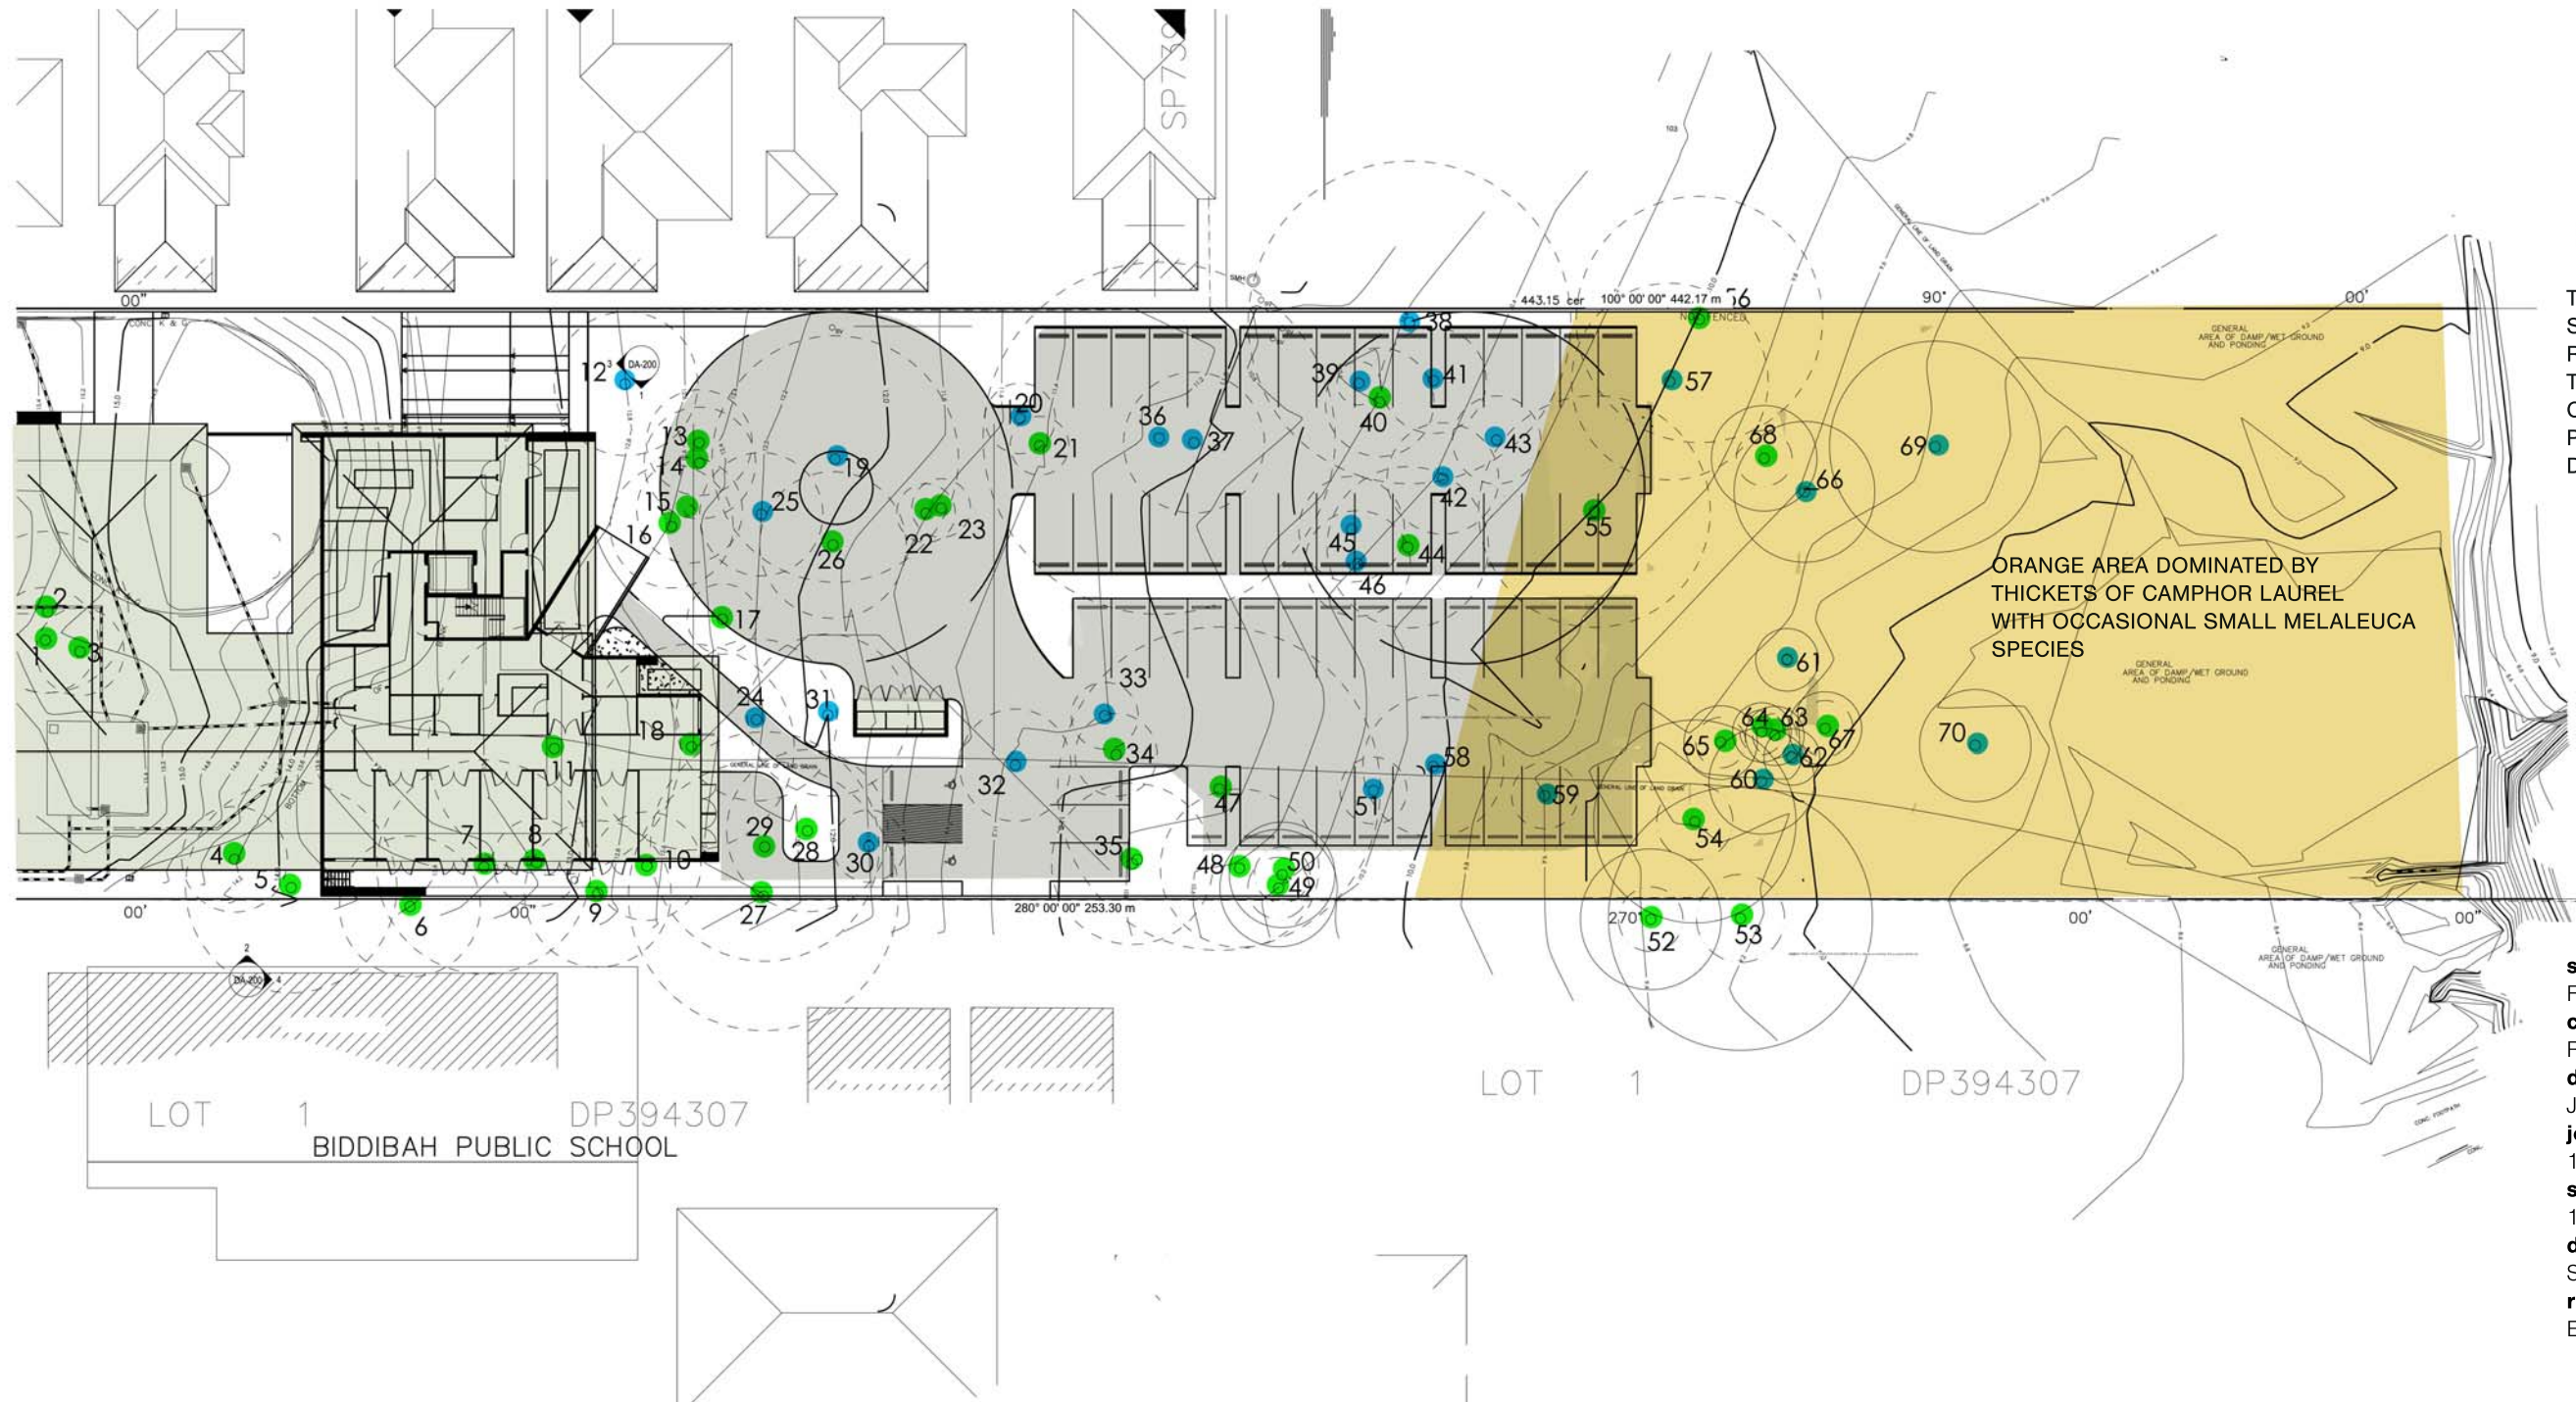
site plan

Based on the proposed development footprint it was determined that 1 tree located on the school grounds and 55 trees within the site would need to be removed applying the requirements of AS 4970 *Protection of trees on development sites*.

Tree 6, located within the school grounds requires removal. Tree 6 will lose approximately 50% of its TPZ due to the building footprint.

- Undertake appropriate replacement plantings on site to replace lost canopy cover and amenity trees.
- Seek approval from the ajoining school for the removal of tree 6 located within their property.
