Preliminary Site Investigation

Macquarie Centre Redevelopment
Stage 1 Concept Development Application
Macquarie Park NSW

Prepared for
AMP Capital
c/- Lend Lease

Project 85160.01 Rev 3
October 2016

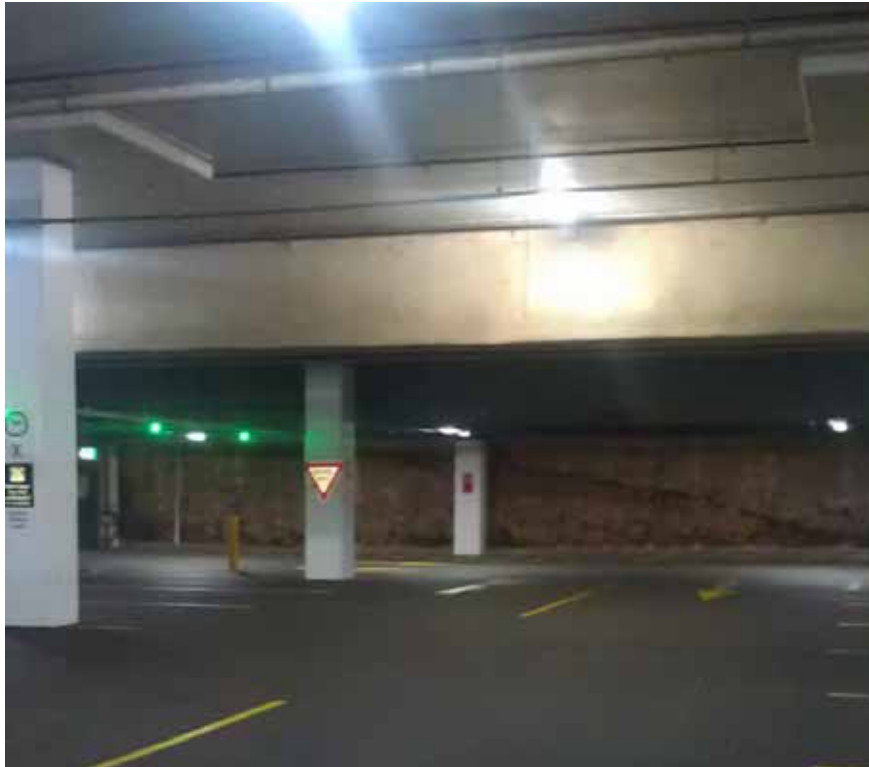
- Hardstand cut into sandstone in basement (Photo 1);
- Ultratune mechanical workshop, which is located in the southern portion of the express car park, is likely to store chemicals (e.g. oils, degreasers), and grease traps are likely (Photo 2);
- A grease trap was observed in the northern end in compactus area (Photo 3);
- Usual stormwater and sewer pits were observed, as well as fire hydrants; and
- There was a ramp to the upper car park/loading dock which leads up to Big W parcel pick up area which may have been filled (Photo 4).

Photo 1 - Express carpark - basement cut into sandstone

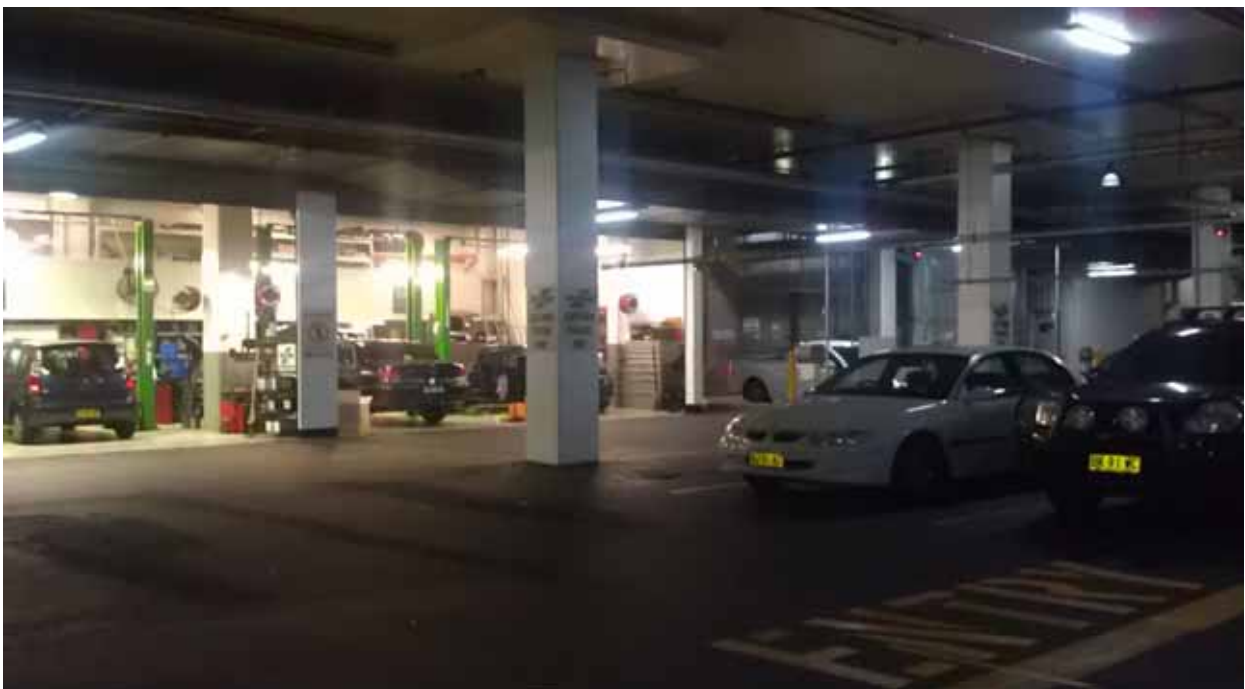
Photo 2 - Express car park - Ultratune workshop

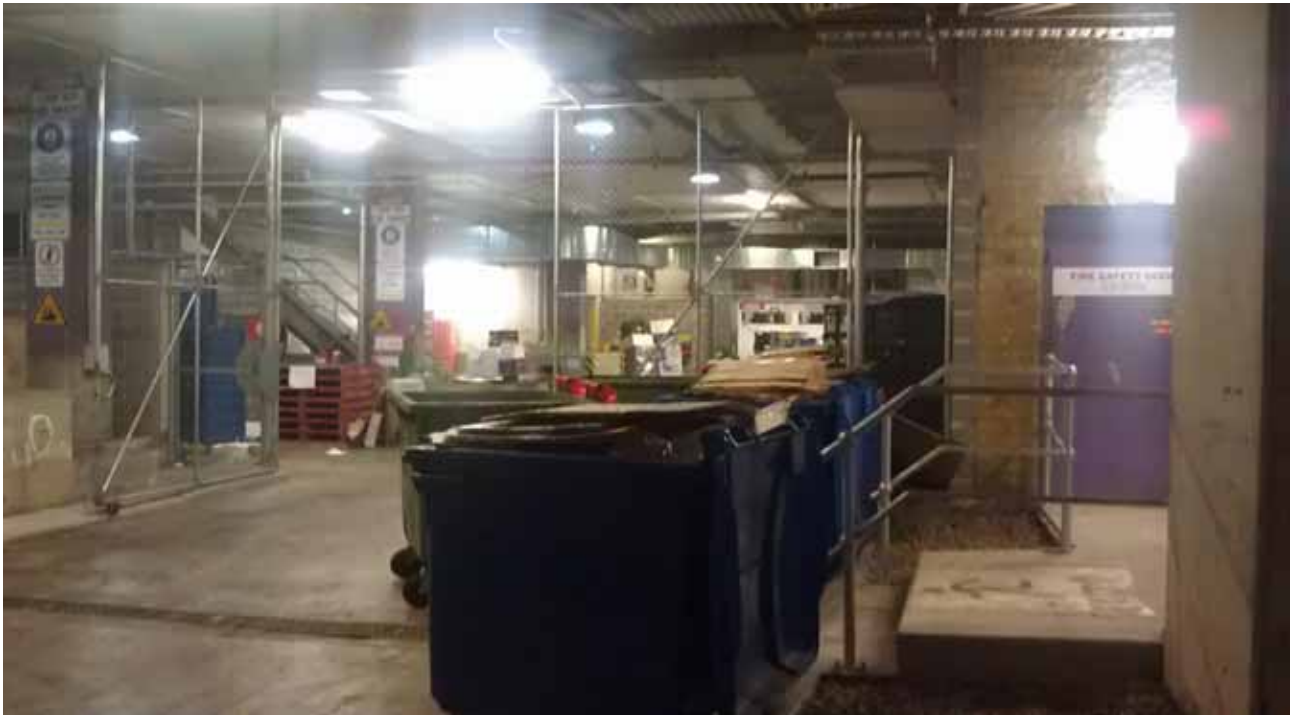
Photo 3 - Compactus with grease trap

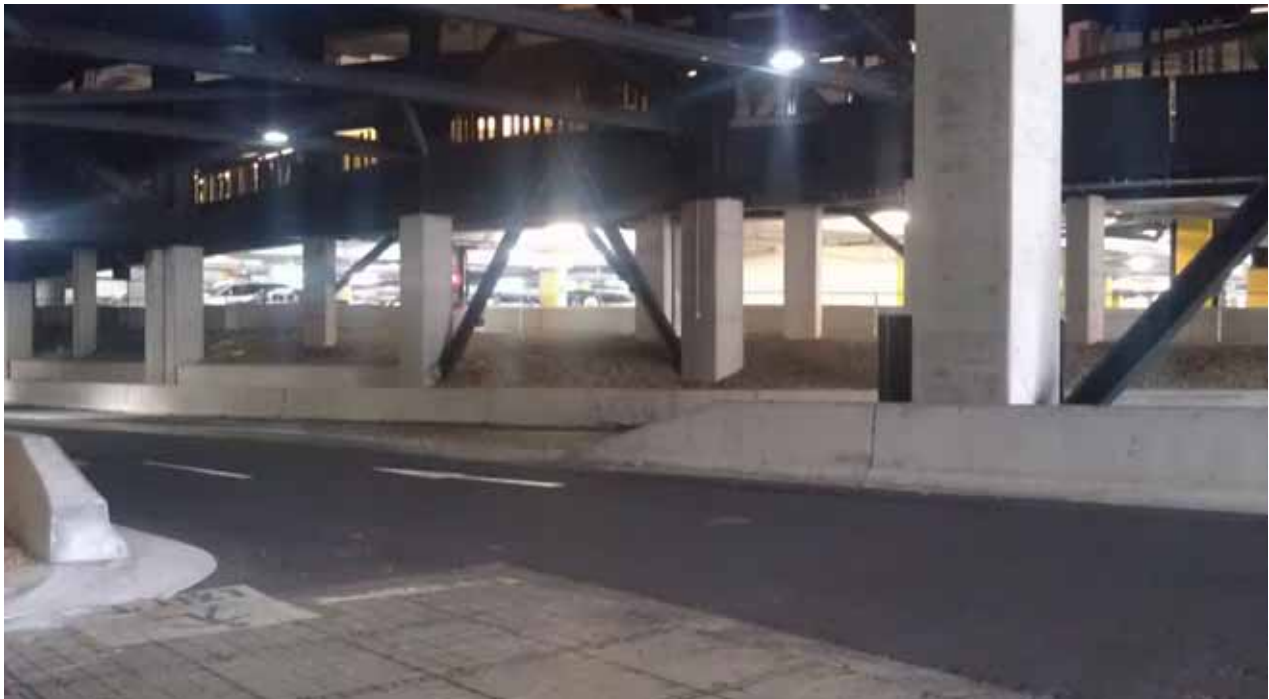
Photo 4 - Potentially filled ramp to loading dock

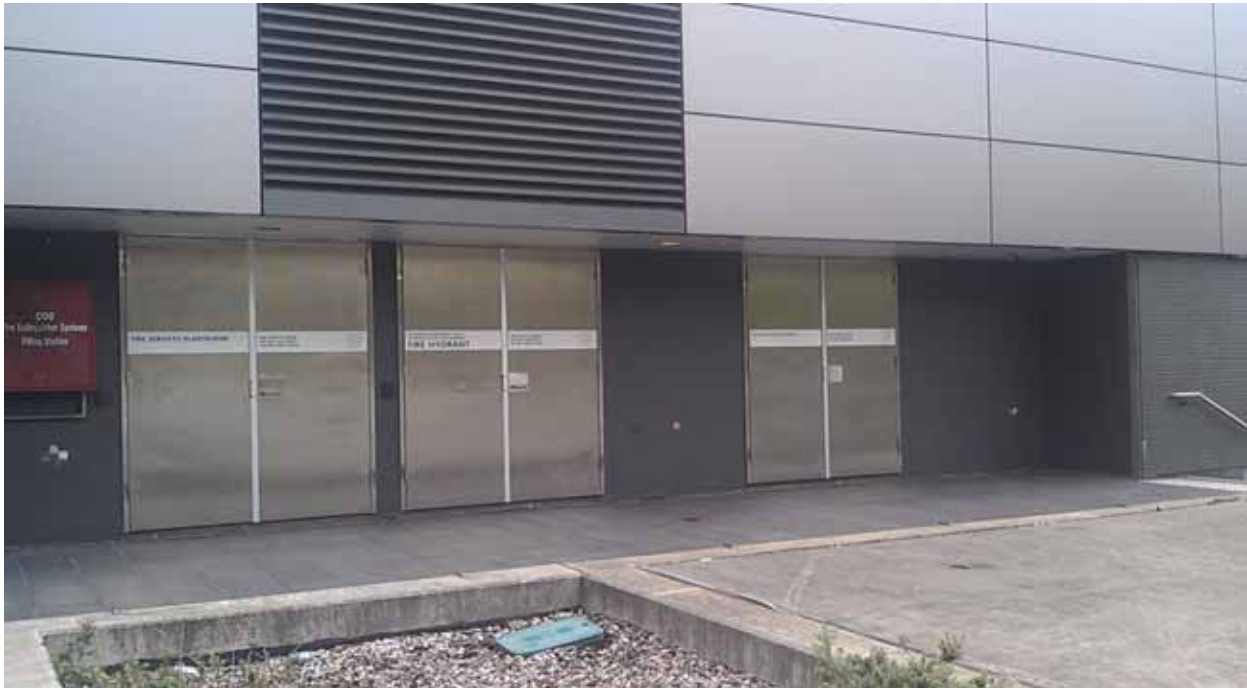
- A fire hydrant plant on the hill was observed and may be filled in some sections along the entrance to the train station (Photo 5).

Photo 5 - Fire hydrant plant area off Waterloo Road

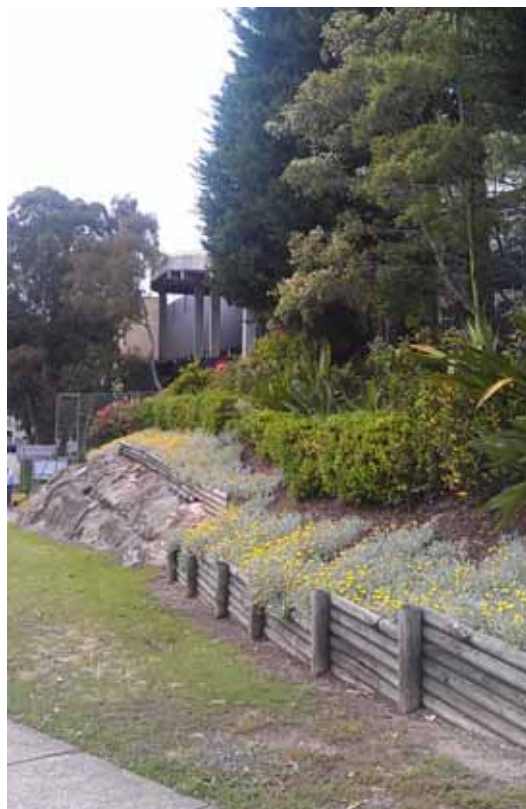
Photo 6 - Sandstone and garden beds along Talavera Road
