# *Arborist Report*

**Client:** Aveo Pty Ltd

Address: Vale Street,  
Shortland N.S.W 2287

Project: Vale Street, Shortland NSW 2287 (Shortland Waters Golf Club)

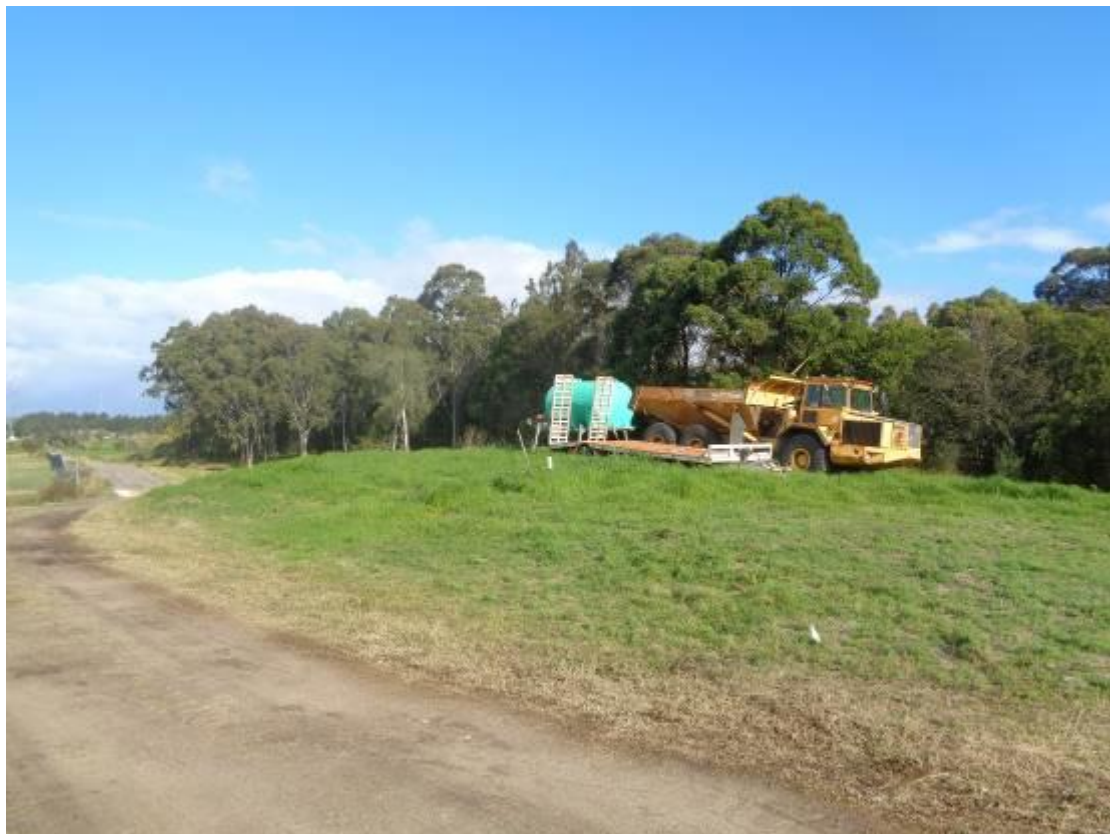
Figure 7 – showing the location of the second area inspected by Abacus Tree Services that included Trees 16 – 86. This area had five (5) trees that were in poor health and condition. Majority of the trees in this area are semi mature with Trees 33, 63, 78, 81 & 86 in poor condition and have been given an ULE rating of 4a.

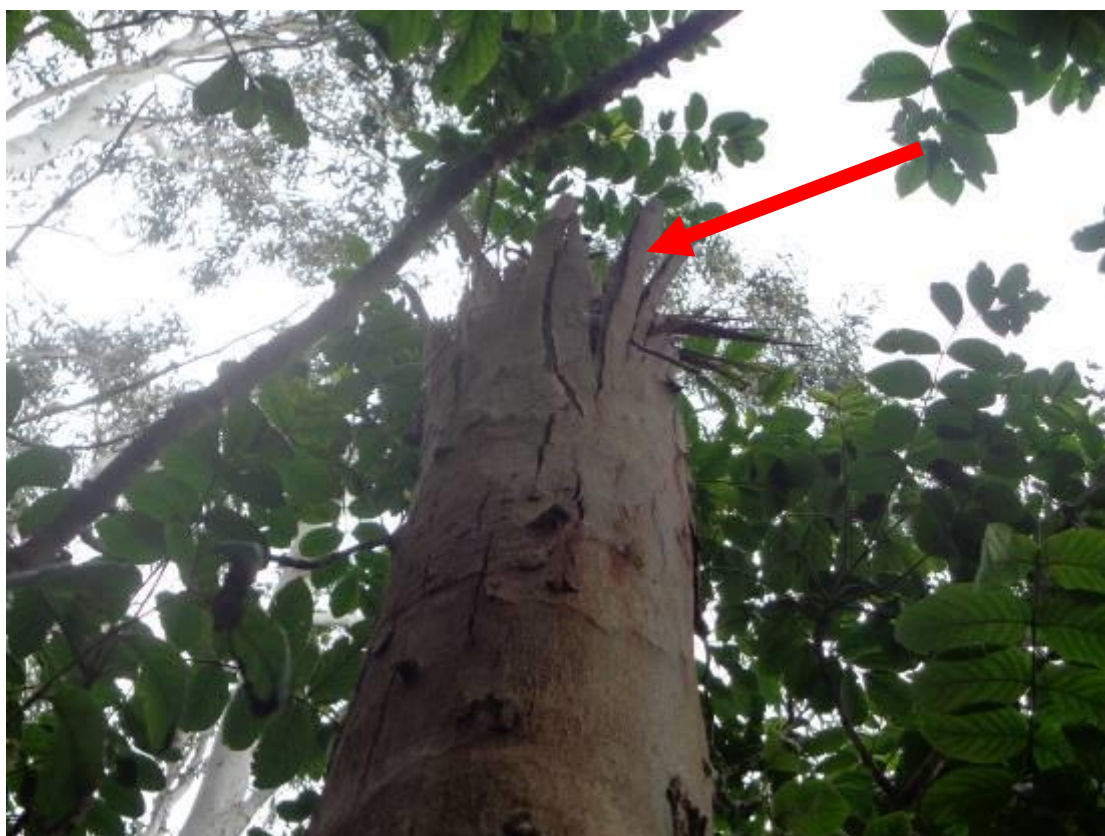
Figure 8 – showing the location of Tree 33 that has lost its main leader at 4 metres above ground level. The apical leader has snapped out and there is only 1 quadrant that has live canopy to the northern quadrant. This species has been given an ULE rating of 4a.

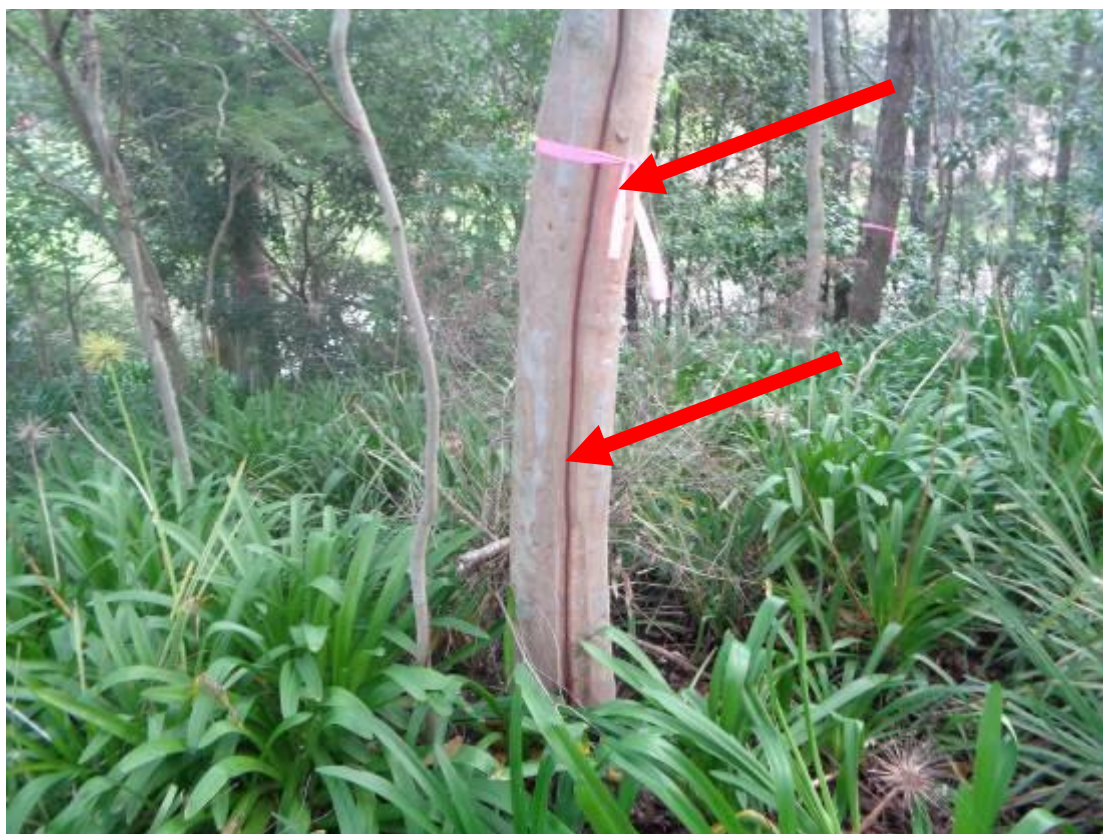
There are several trees with noted water cracks as indicated in Figure 6. These type of cracks are not structural cracks but are noted as water cracks when the xylem swells leading to the outer bark cracking as noted in red in Figure 6. These cracks will heal over time and are not major structural faults and therefore Tree 68 is not given an ULE rating of 4a. This species and majority of the Trees 16 – 87 are semi mature to young mature trees and therefore have moderate canopy sizes.

Figure 9 – showing the location of the water crack associated with Tree 68. The water crack is evident at the base and extends for 5 metres up the trunk on the south eastern side of the tree to five metres above ground level.

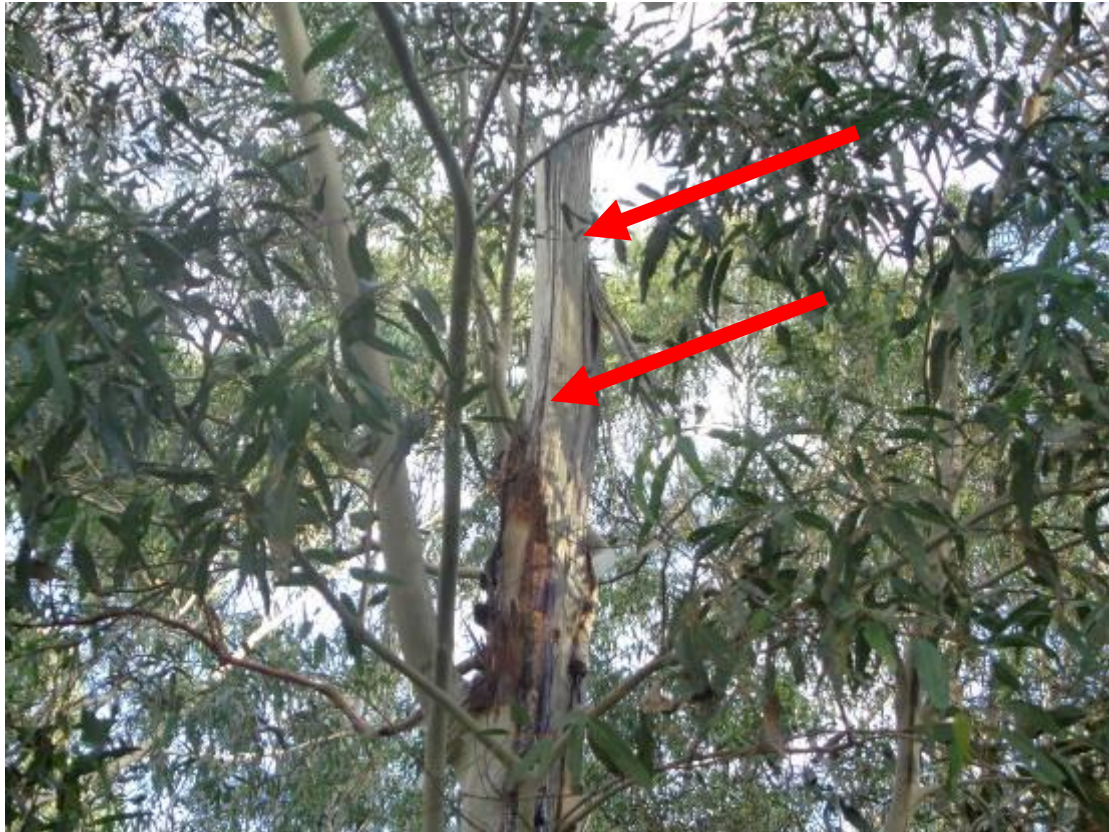
Tree 78 is in poor health and condition with its apical dominant leader failing in a wind storm event as indicated in Figure 7. The leader has snapped out at 5 metres above ground level and is not growing true to form. This has reduced the ULE of Tree 78 to a 4a. This species is not growing true to form as shown in Figure 7.

Figure 10 – showing the location of Tree 78 that is in poor health and condition. Tree 78 has lost its apical dominant leader and is not suitable for retention. This species has been given a short ULE of 4a. This species will be located inside the proposed fairway and therefore will require removal.

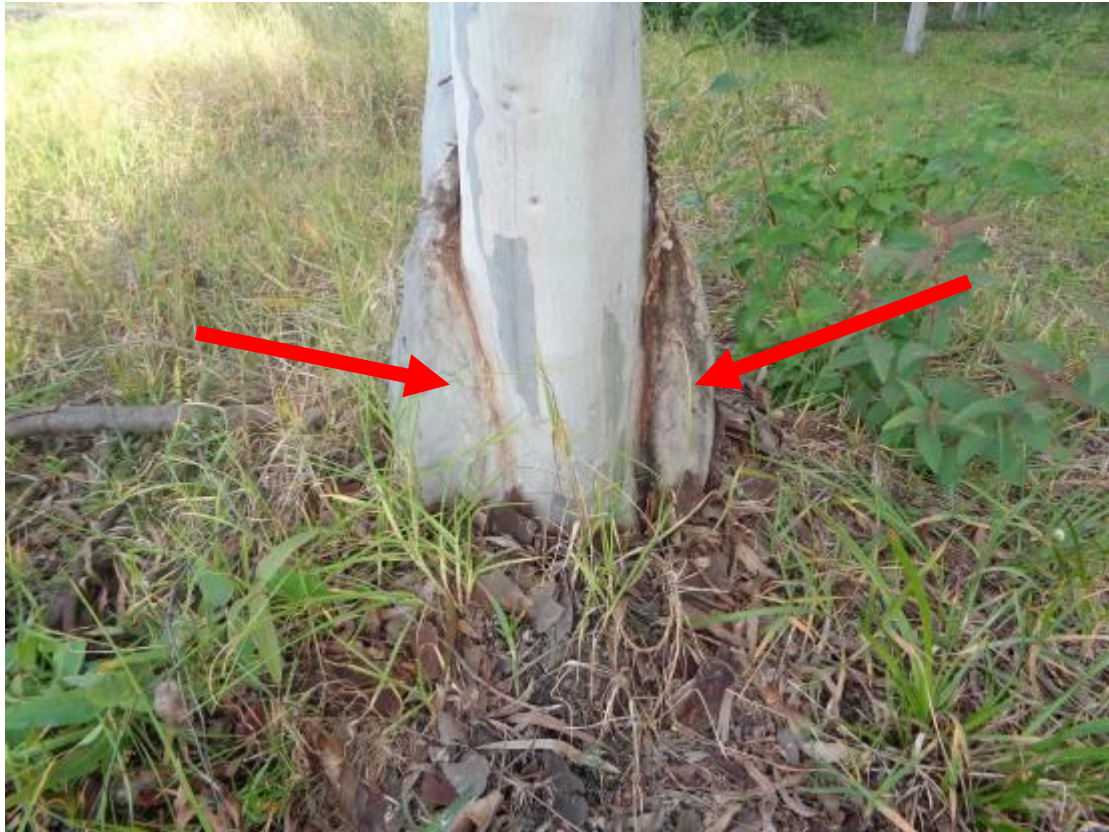
Tree 86 is a young mature tree with an extensive included fork union as shown in Figure 8. This species has an included fork union that extends a minimum 8 – 9 cm from the base. This structural fault will only increase as the tree continues to grow. This species is a young mature tree with potential for extensive future growth. I envisage that the included fork union will grow to a minimum of 12 – 13cm and reduce the life span of Tree 86. The included fork union is on both sides of the tree as indicated in Figure 11.

Figure 11 – showing the location of Tree 86 that has an included fork union at the base as shown in red. This has reduced the life span of Tree 86 and it has been given an ULE rating of 4a.

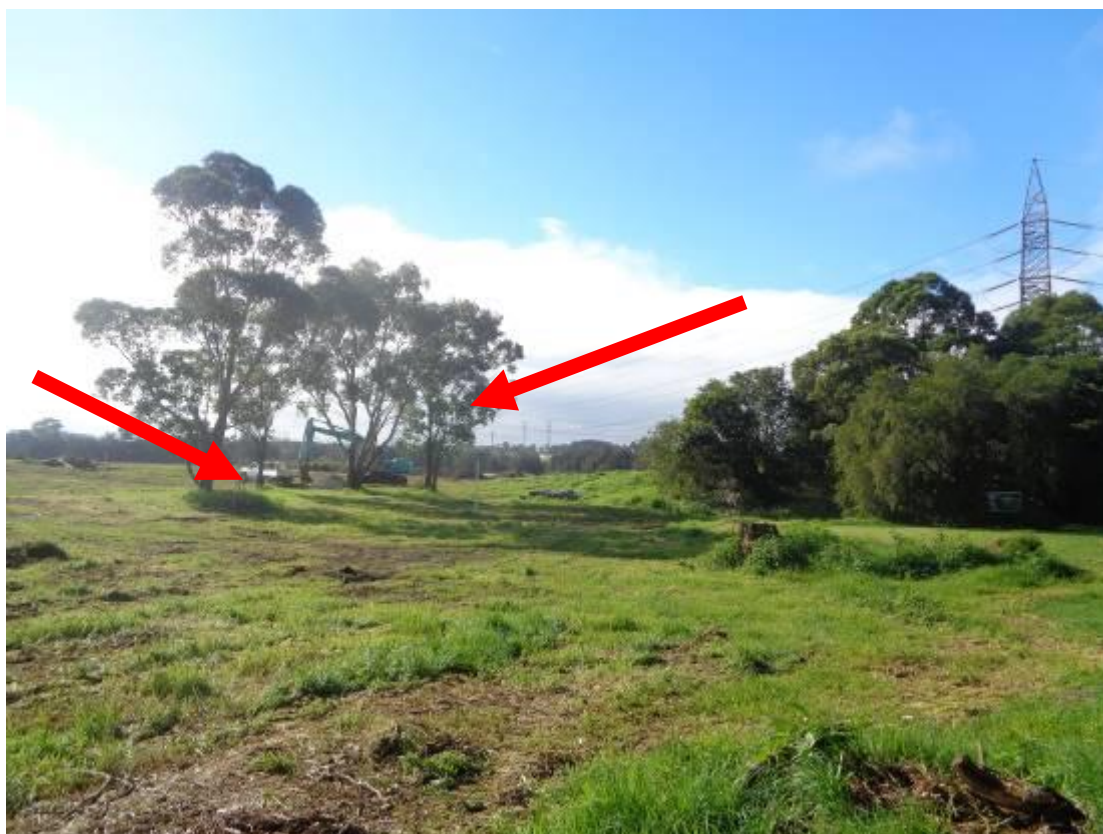
Figure 12 – showing the location of Trees 87 – 90 that will require removal to construct the new fairway.

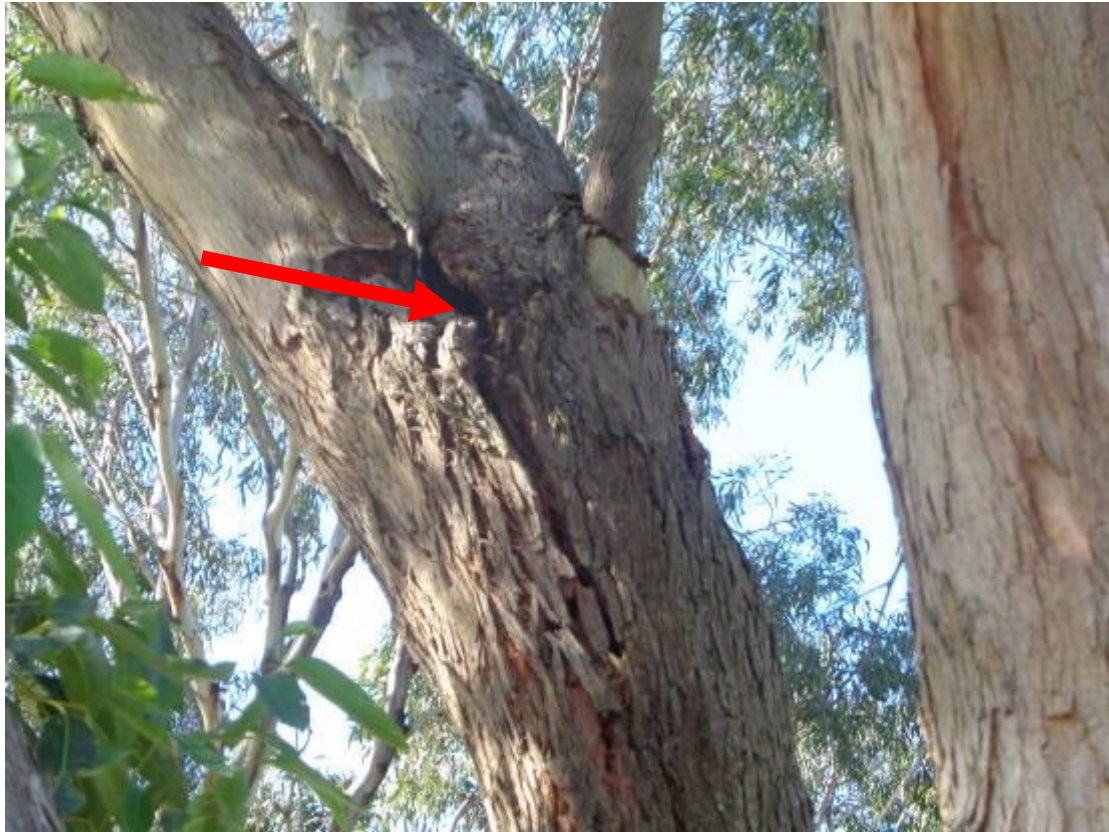
Tree 91 is a young mature tree that has a large structural fault in one of the three main leaders as indicated in Figure 13. Tree 91 has a partial failed leader at 2 metres above ground level to the eastern quadrant. There is an estimated 30 – 35% of the canopy above the cracked area. This species is compromised due to the failed leader and therefore has been earmarked for removal before the commencement of building works. Tree 91 has been given a short life span due to the structural fault.

Figure 13 - showing the structural fault located in the leader to the eastern quadrant at 2 metres above ground level.

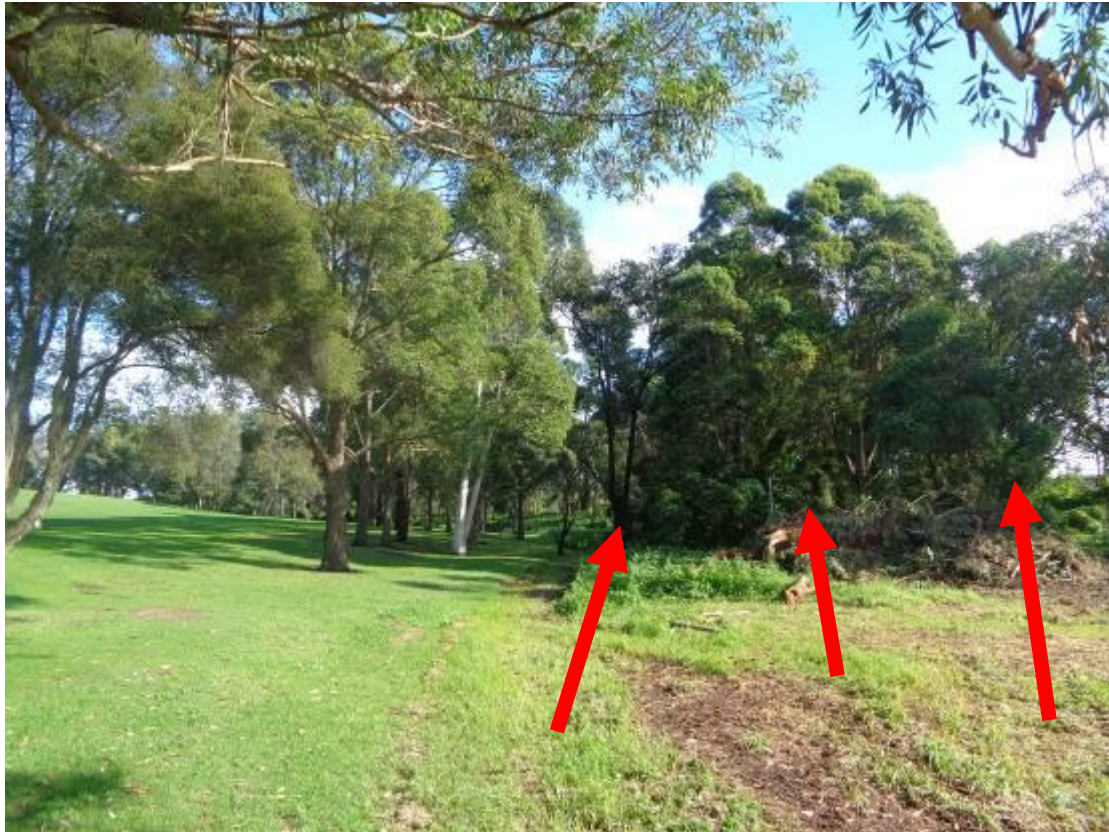
The remainder of the trees are dominated by semi mature and young mature *Eucalyptus microcorys* with a few minor species in the wooded area. The removal of these trees is required to construct the new fairway (No 4). These trees are located and planted close together on a small mound as shown in Figure 14. These trees have all been previously planted over the past 15 – 20 years. There are several of these trees that are being overrun by ivy that will eventually consume the trees & stop them from photosynthesising.

Figure 14 – the remainder of trees are situated along the existing fairway. This cluster of trees will require removal to construct the new fairways that will include excavation works and raised areas. The wooded area as shown in red accommodates Trees 93 – 178. All trees in this area have been previously planted by Shortland Waters Golf Course.

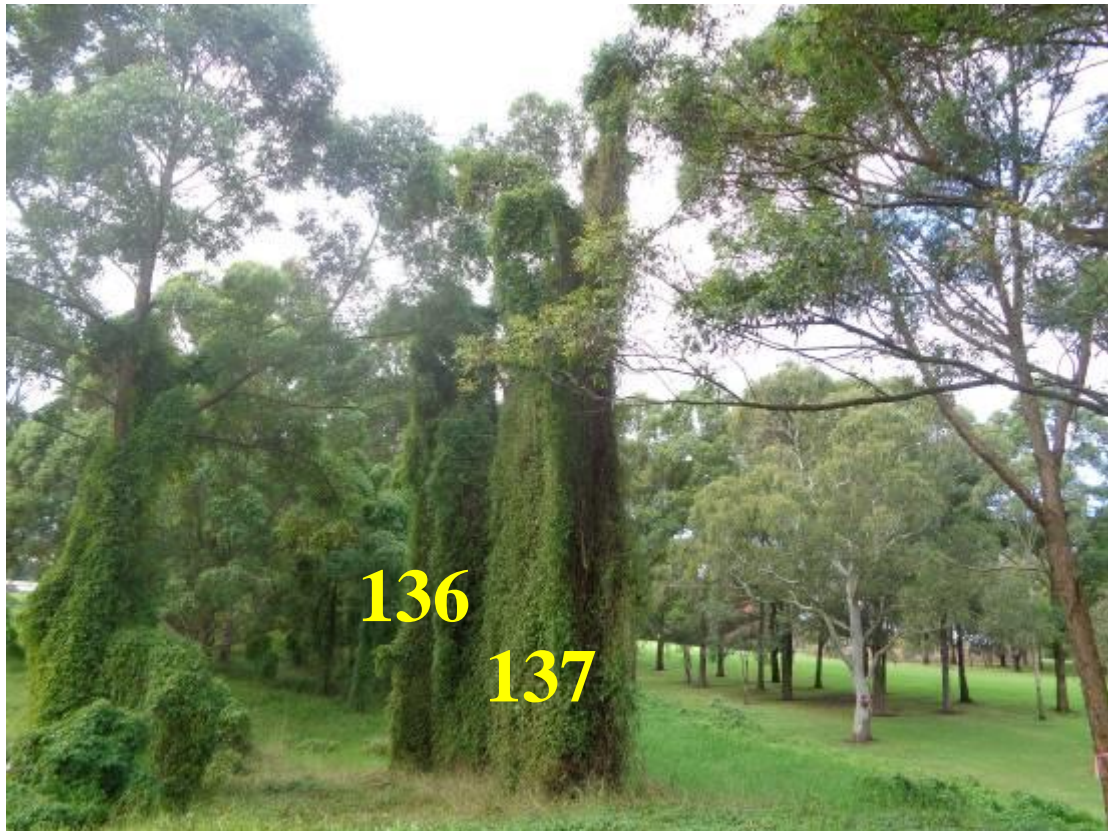
There are several species that are completely vine covered and/or majority of the tree is covered in vines. This has reduced the trees ability to photosynthesis and the trees have lost vigour and reduced the life span. This includes but not limited to Trees 136 & 137 as shown in Figure 12. These trees as well as several others are now given a short life span due to the uptake of vine along the trunk and over the scaffolds.

Figure 15 - showing the location of Trees 136 & 127 that are extensively covered in ivy. The trees have lost their ability to photosynthesis and are in poor condition. Trees 136 is 70 – 75% covered in ivy and Tree 137 is completely covered in ivy as indicated in yellow.

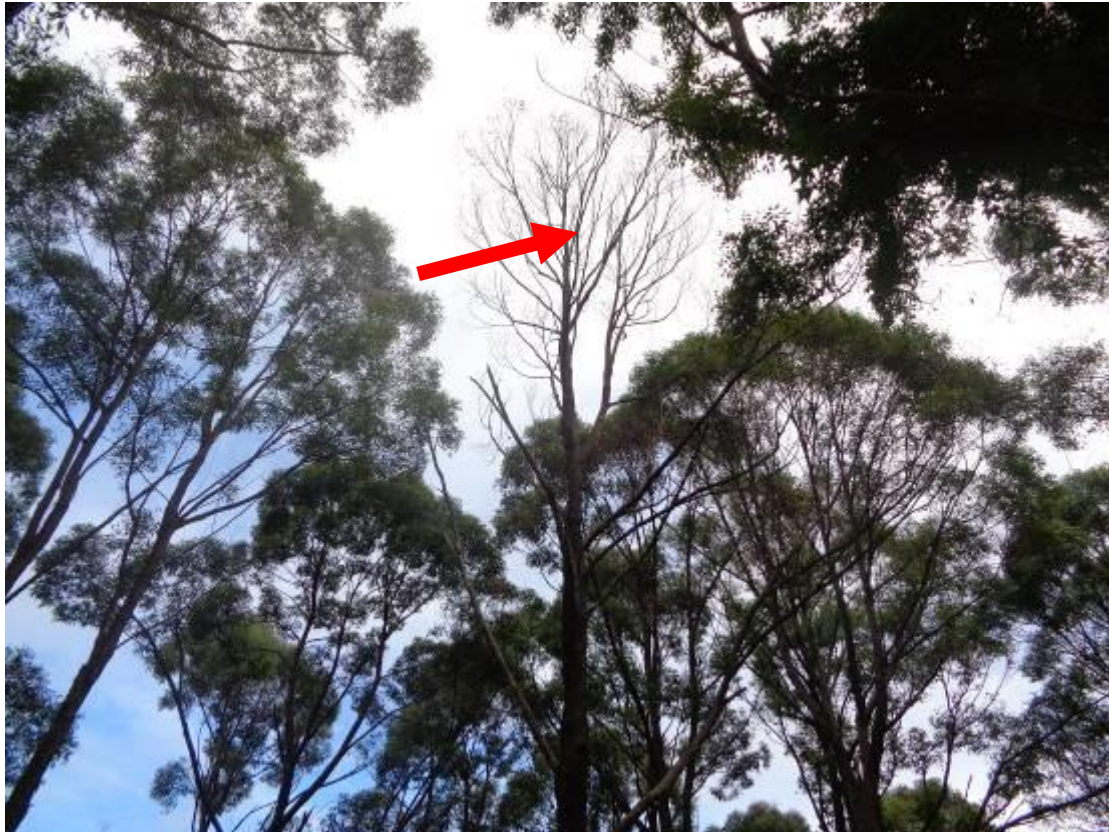
Trees 158 & 172 are dead trees and therefore have been given an ULE rating of 4a. Both these trees have no live crown ratio and no living tissue and therefore are earmarked for immediate removal.

Figure 16 – showing the location of Tree 172 that is dead and therefore requires immediate removal.
