Report on
Geotechnical Assessment and
Preliminary Site Investigation (Contamination)

Aberdeen Valley Fair Retail and Service Centre
172-186 Macqueen Street, Aberdeen

Prepared for
dwp Suters
on behalf of
Noel F Mitchell

Project 91087.00
June 2017

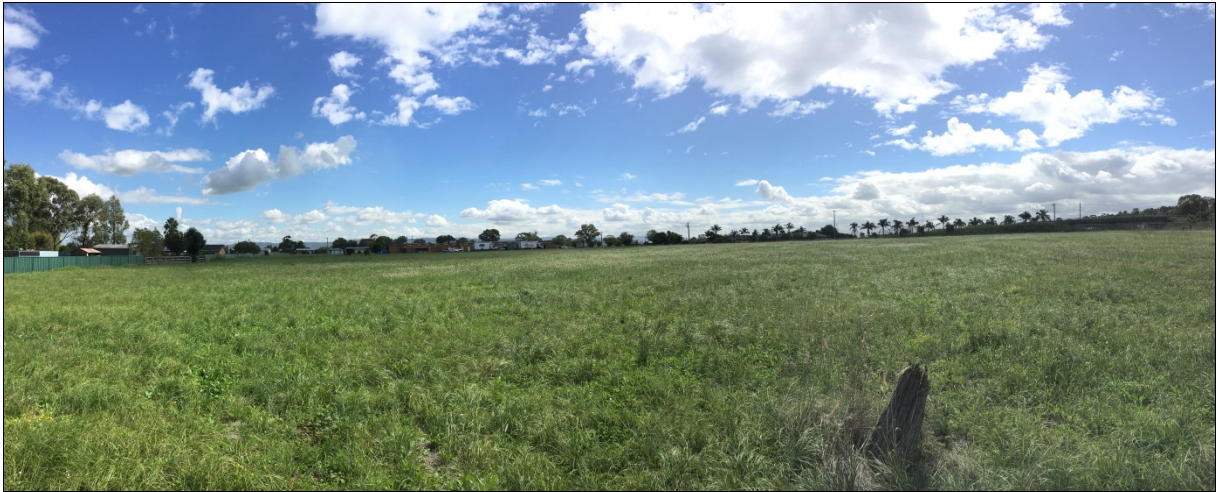
Figure 2: Grass covered paddock, looking north-west from south-east corner of site.

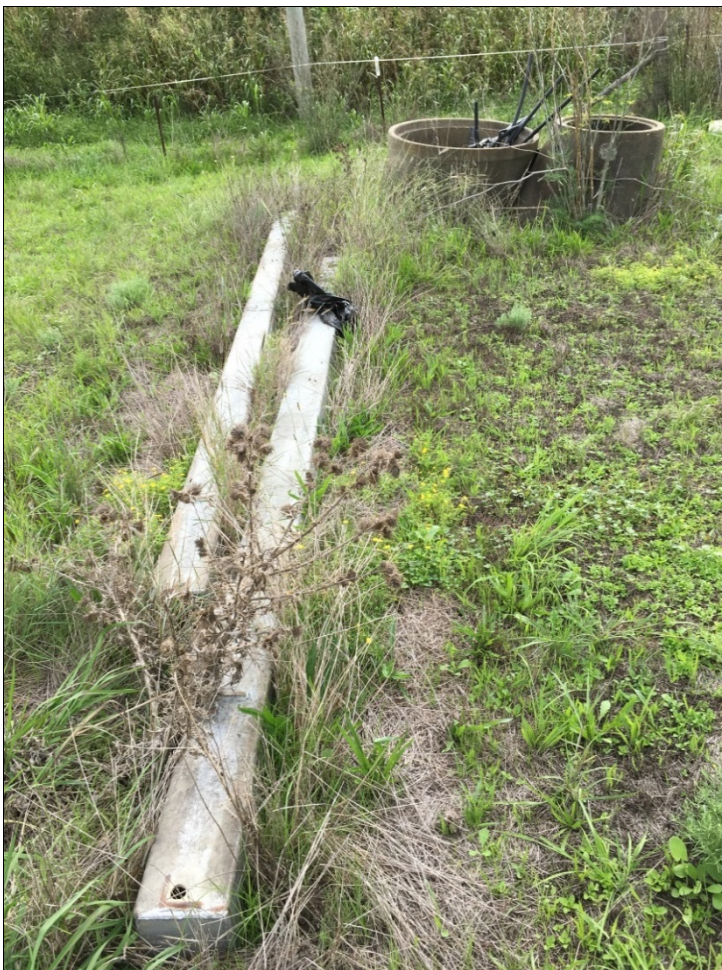
Figure 3: Stockpiled building materials in north-eastern portion of site, looking north.

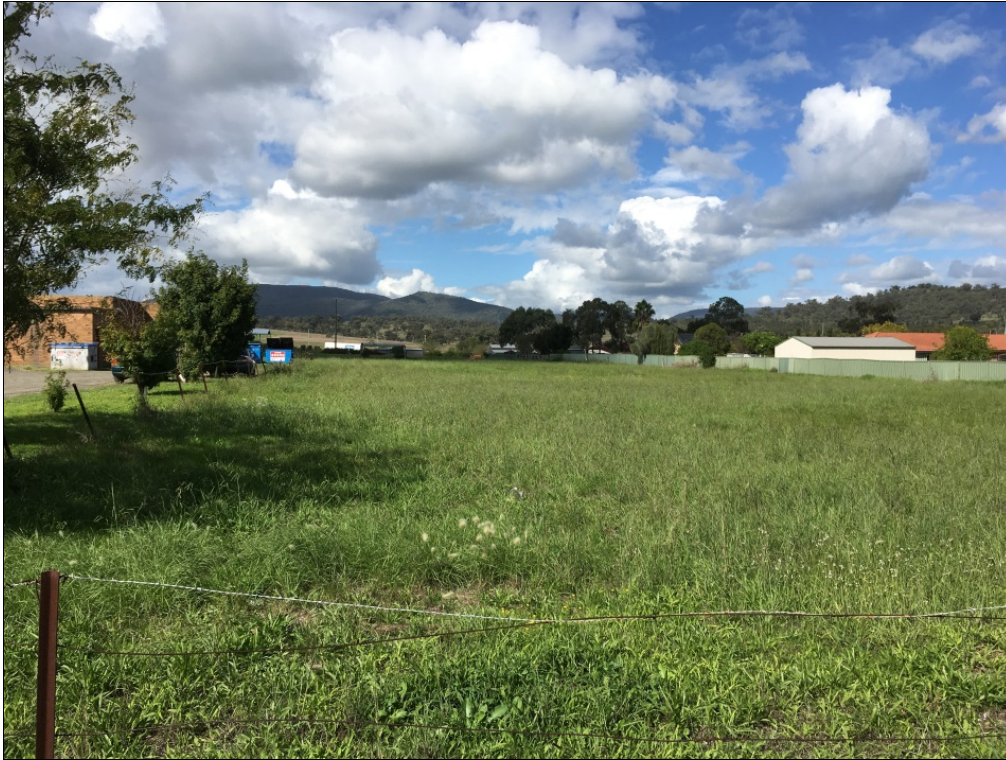
Figure 4: South-western portion of grass covered paddock, looking east from Macqueen Street boundary.

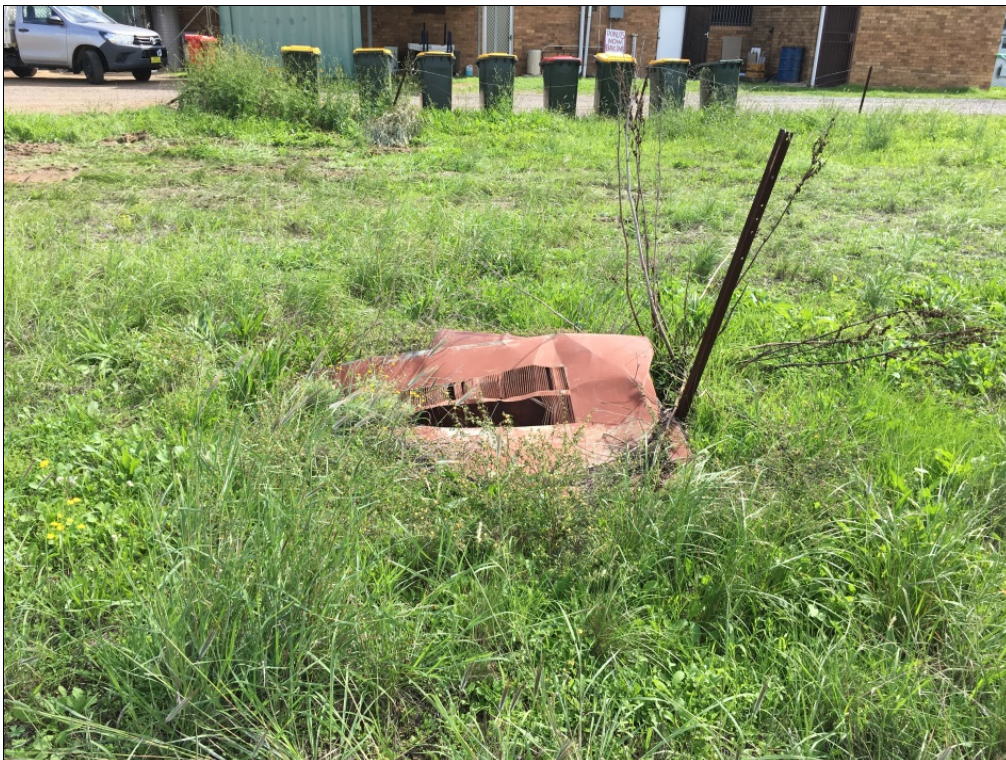
Figure 5: Metal sheeting and drum flush with ground level in central portion of the site, looking west.

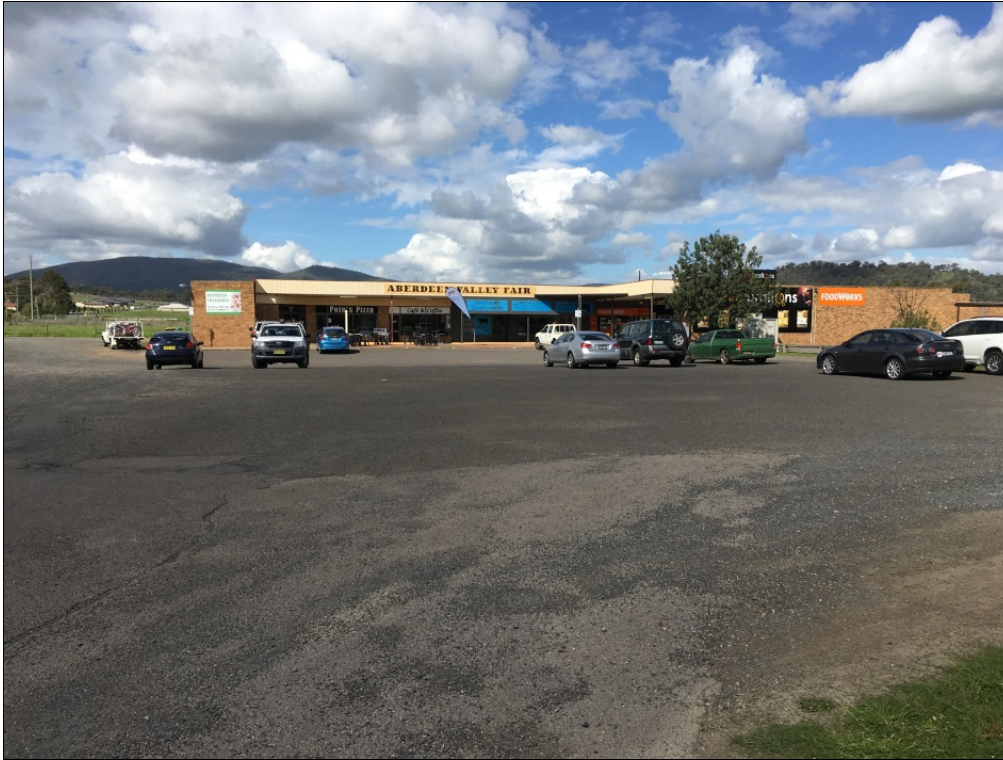
Figure 6: Asphalt and gravel hardstand car park in western portion of the site, looking south-east towards existing building from Macqueen Street boundary.

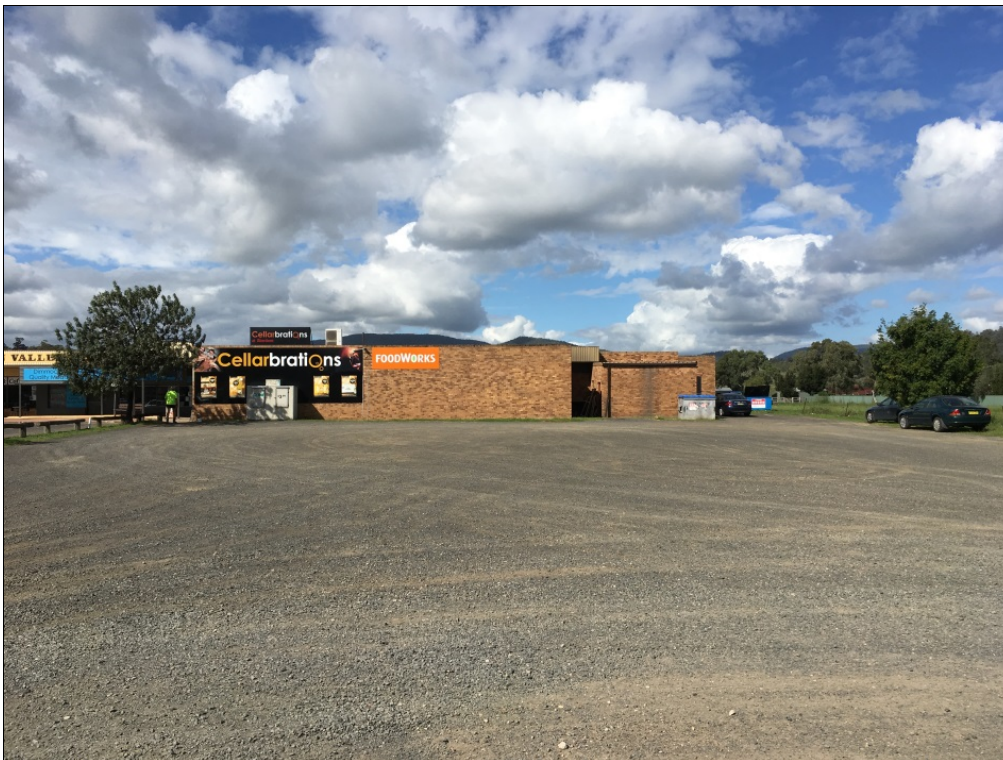
Figure 7: Gravel hardstand car park in western portion of the site, looking east towards existing building from Macqueen Street boundary.

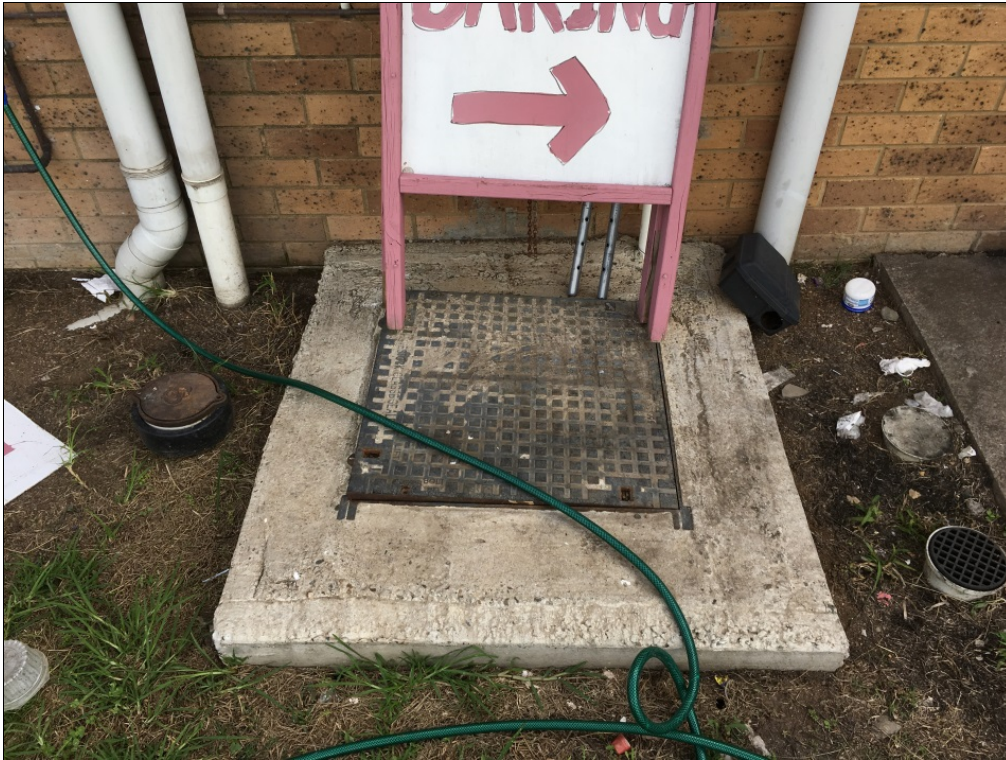
Figure 8: Lid of grease trap located at the rear of building, looking west.

- Imported filling within the carpark and building surrounds which may contain a range of contaminants subject to the source;
- Possible hydrocarbon, heavy metal and nutrient impacts from the grease traps if leakage has occurred;
- Possible presence of asbestos containing materials (ACM) in localised stockpiled comprising building materials (concrete and metal);
- Possible localised hydrocarbon impact within the existing carpark laneway area from drips/spills;
- Possible pesticide, heavy metal, hydrocarbon impacts from pesticide / herbicide application.

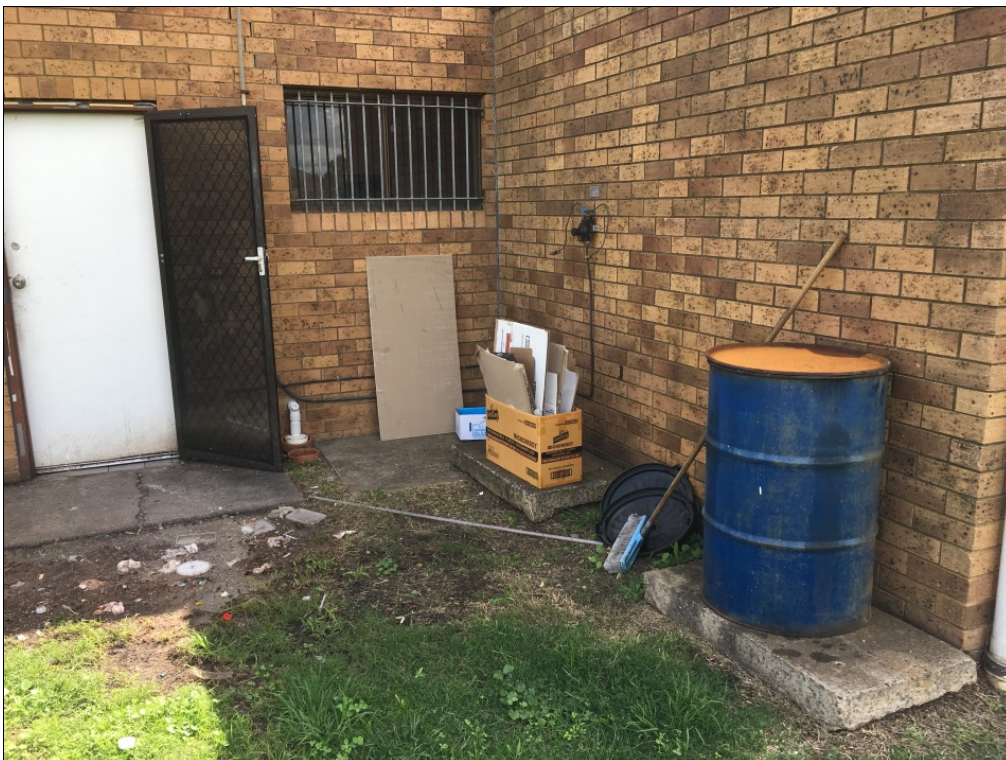
Figure 9: Rubbish and metal drum located to the rear of building, looking north-west.
