Arborist Report

Project No: 11506.54

Location: 48 Brown Street
Newcastle East, NSW 2303

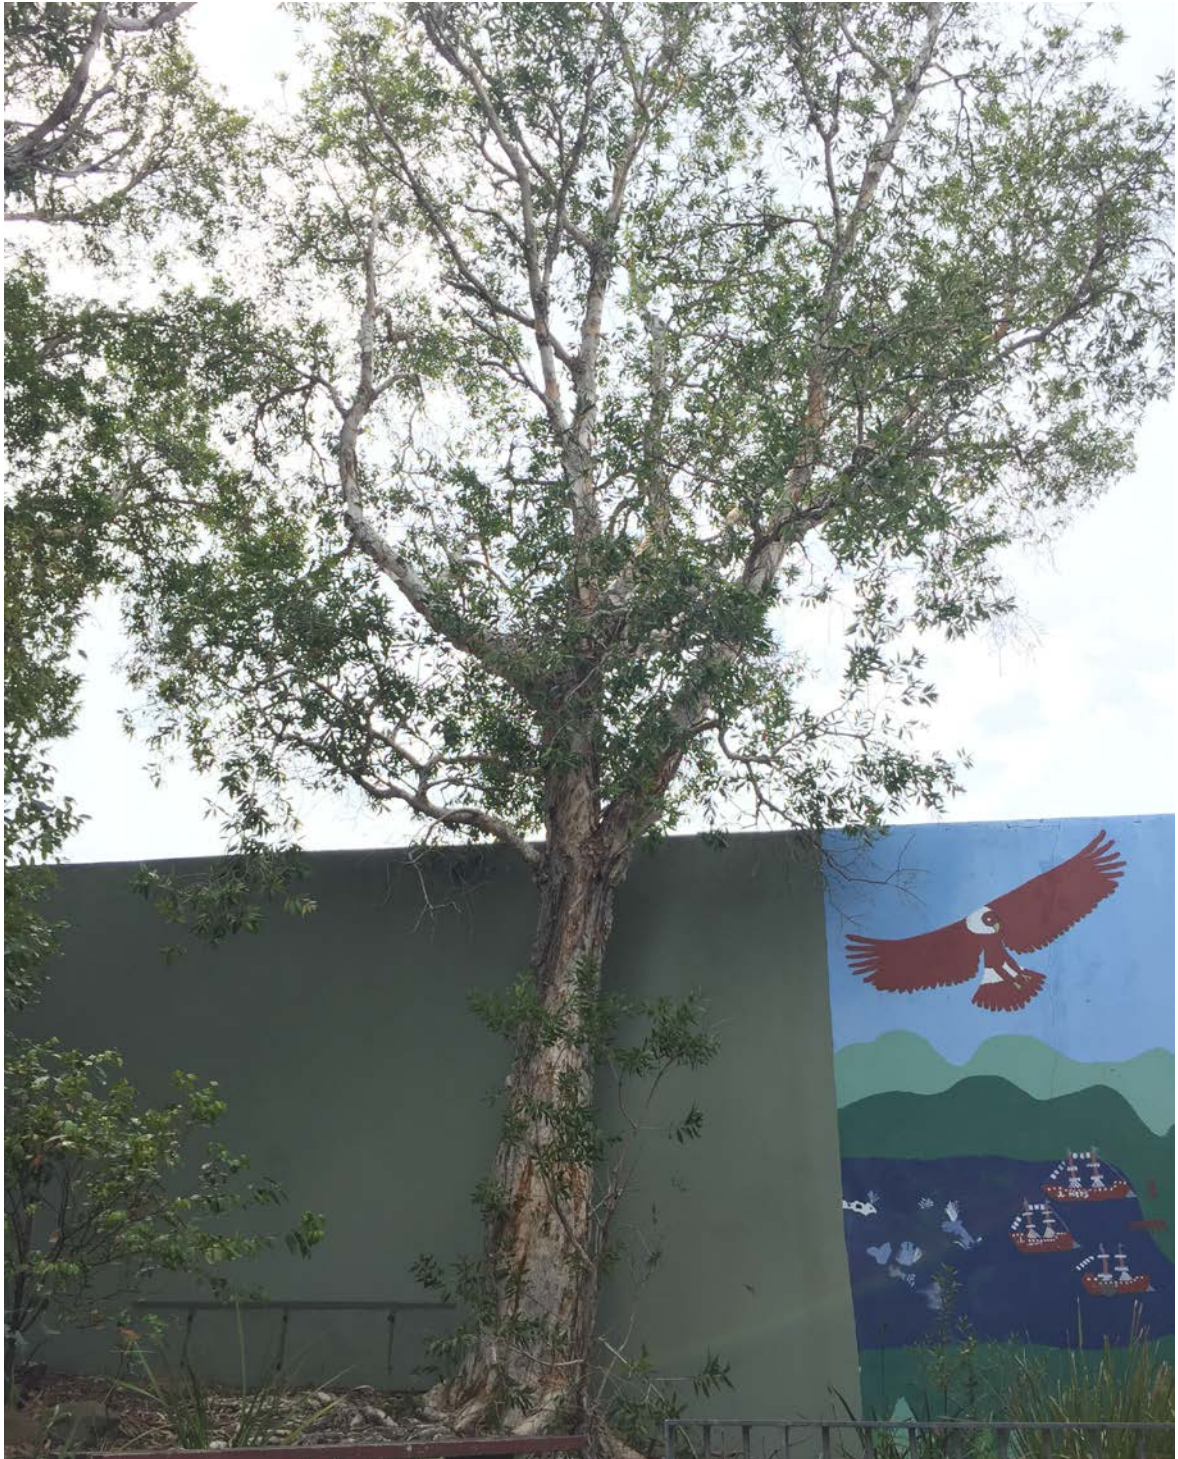
Tree 1: *Melaleuca quinquenervia* [Broad-leaved Paperbark] is a mature tree growing on a sloping gradient in close proximity to a cinder block wall. This tree has a well tapered trunk which supports a co-dominant branch structure.

The top soil zone around the base of the tree has been eroded exposing large buttressing surface roots. There are no visible signs of these surface roots affecting the block wall.

FIGURE 4: TREE 1 WITH CO-DOMINANT CANOPY STRUCTURE AND EXPOSED ANCHOR ROOTS.

RECOMMENDATION (IF RETAINED): Applying mulch around the root zone would benefit the tree by improving vigour and health also protecting the exposed surface roots from damage.

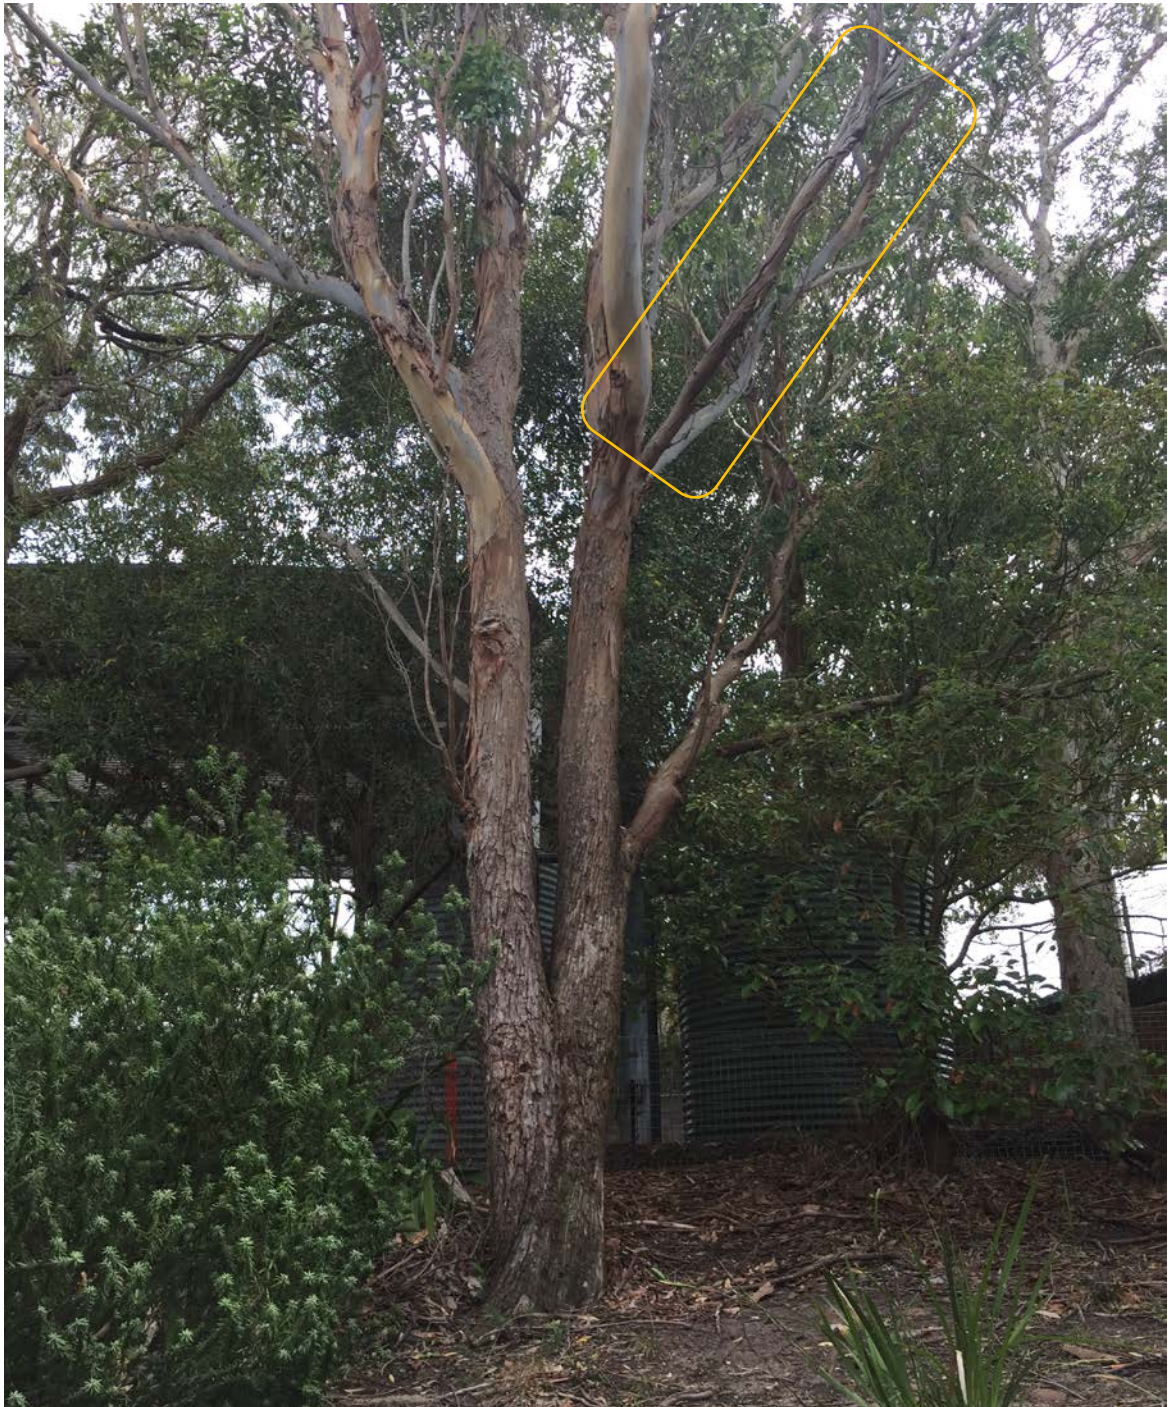
Tree 2: *Eucalyptus botryoides* [Bangalay] is a mature tree with co-dominant structure. The trunk bifurcates at 1.5 metres into two, reasonably tapered first order branch structures.

Second order branches within the upper canopy display signs of minor recession with interior epicormic growth and deadwood <30mm in diameter.

FIGURE 5: TREE 2 WITH LARGE DEADWOOD OVER HANGING SEATING AREA.

RECOMMENDATION (IF RETAINED): This tree would benefit from regulated irrigation, minor branch end weight reduction, dead wooding and detailing. Large deadwood overhanging the seating area should be removed.

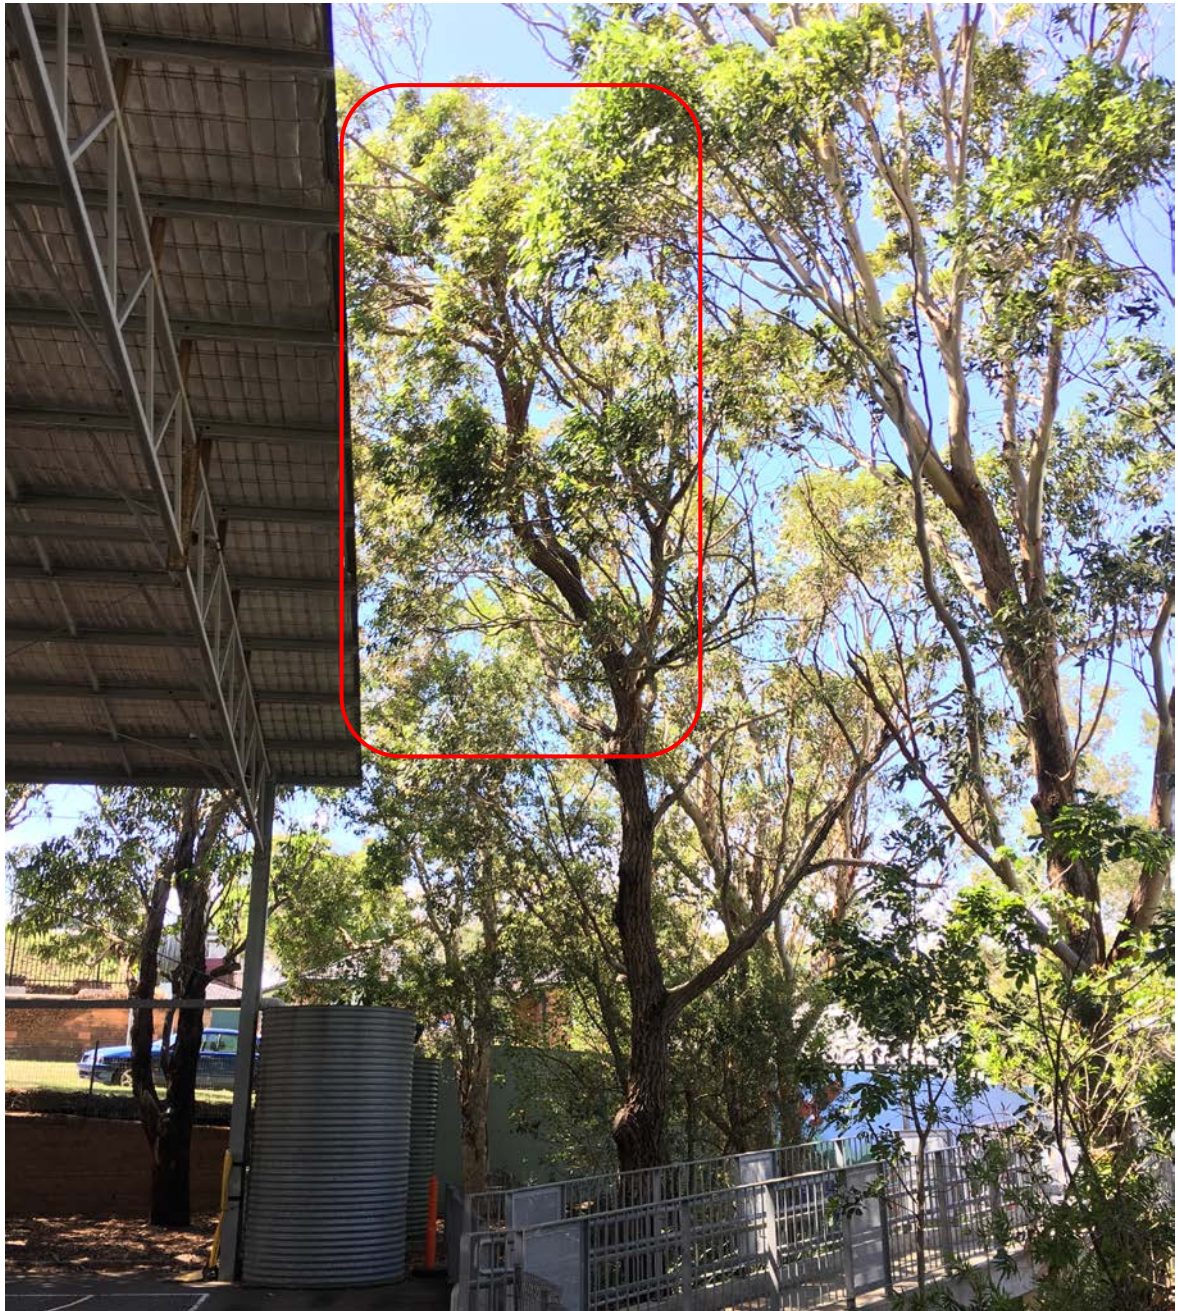
Tree 3: *Eucalyptus paniculata* [Grey Ironbark] is a mature tree with a singular, tapered trunk which supports an asymmetric canopy structure. The upper canopy has first order branches with minor elongation. Second order branches have reasonable taper and minor deadwood <30 mm.

Previous pruning works have been undertaken to remove large branch scaffolds towards the covered play area. Collar cuts which remain from pruning works are occluded by callused wound wood.

FIGURE 6: TREE 3 WITH AN ASYMMETRIC UPPER CANOPY STRUCTURE INDICATED IN RED.

RECOMMENDATION (IF RETAINED): This tree would benefit from canopy works to reduce asymmetry with minor branch end weight reduction and dead wood removal over the classroom walkway.

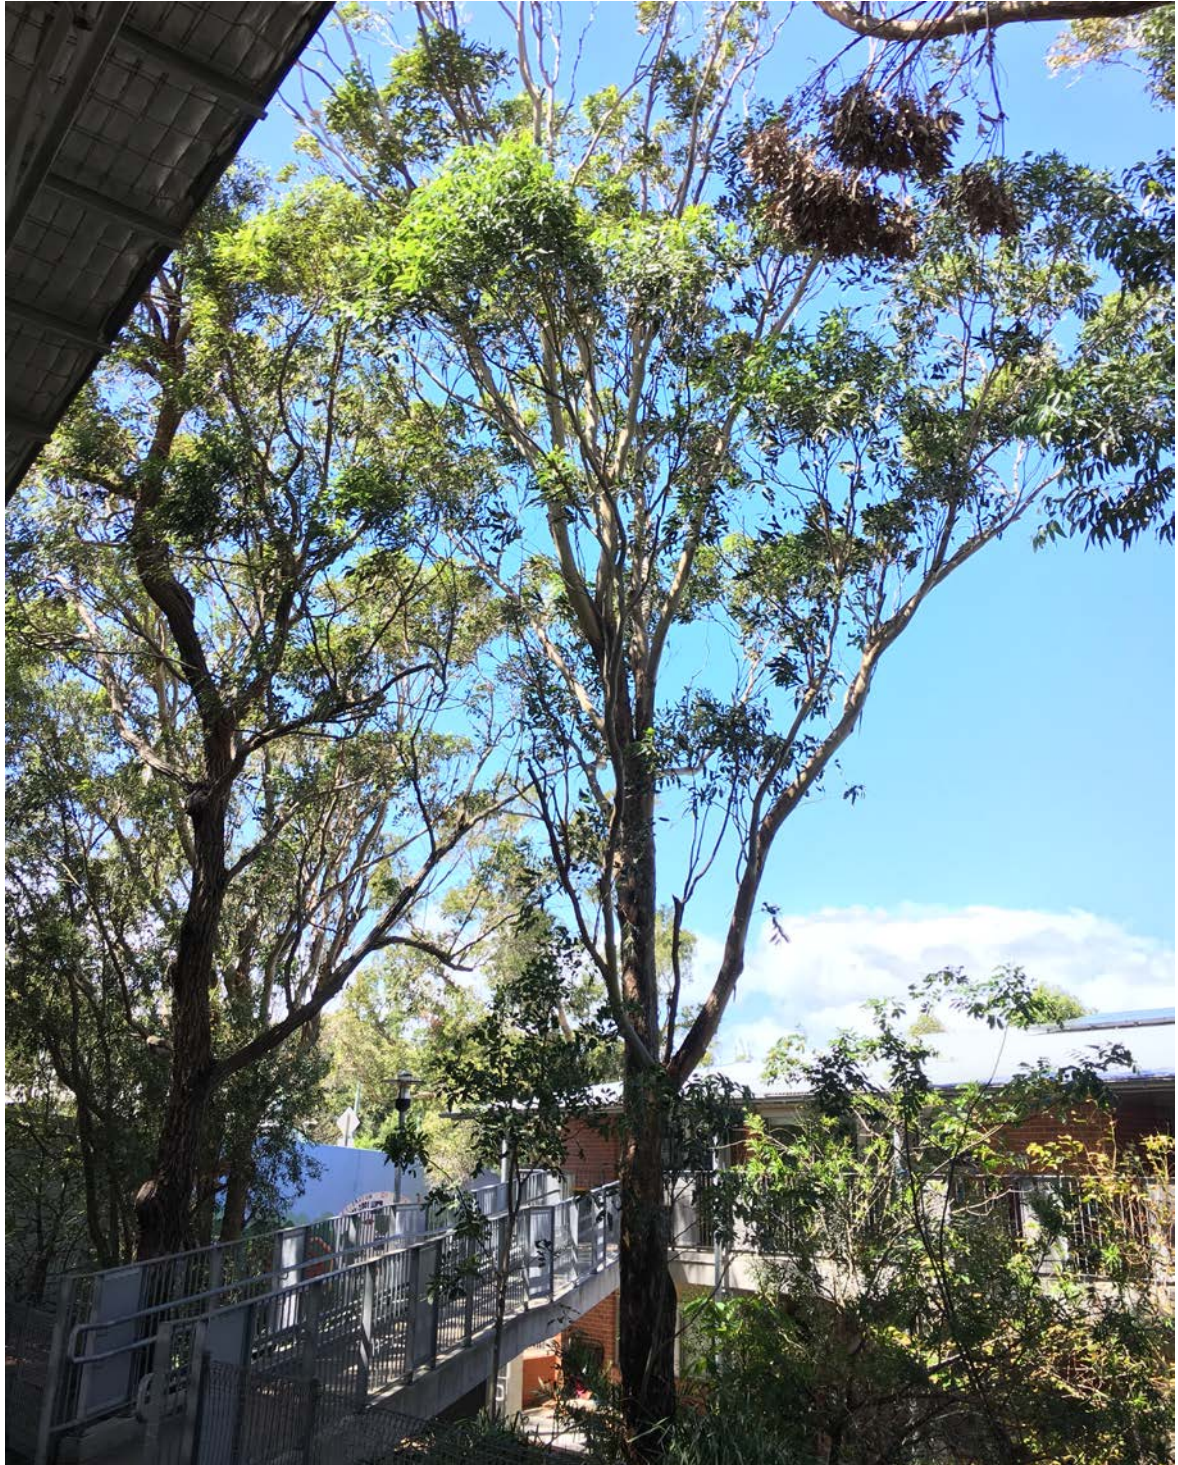
Tree 4: *Eucalyptus botryoides* [Bangalay] is a mature tree with a singular tapered trunk which supports a bi-furcated upper canopy structure.

First and second order branch structures are slightly elongated with selected branches having local wound areas, minor torsion cracks and deadwood <30 mm.

FIGURE 7: TREE 4 WITH A BI-FURCATED CANOPY STRUCTURE.

RECOMMENDATION (IF RETAINED): Branch end weight reduction, deadwood removal and selective target pruning would reduce the likelihood of branch failures.

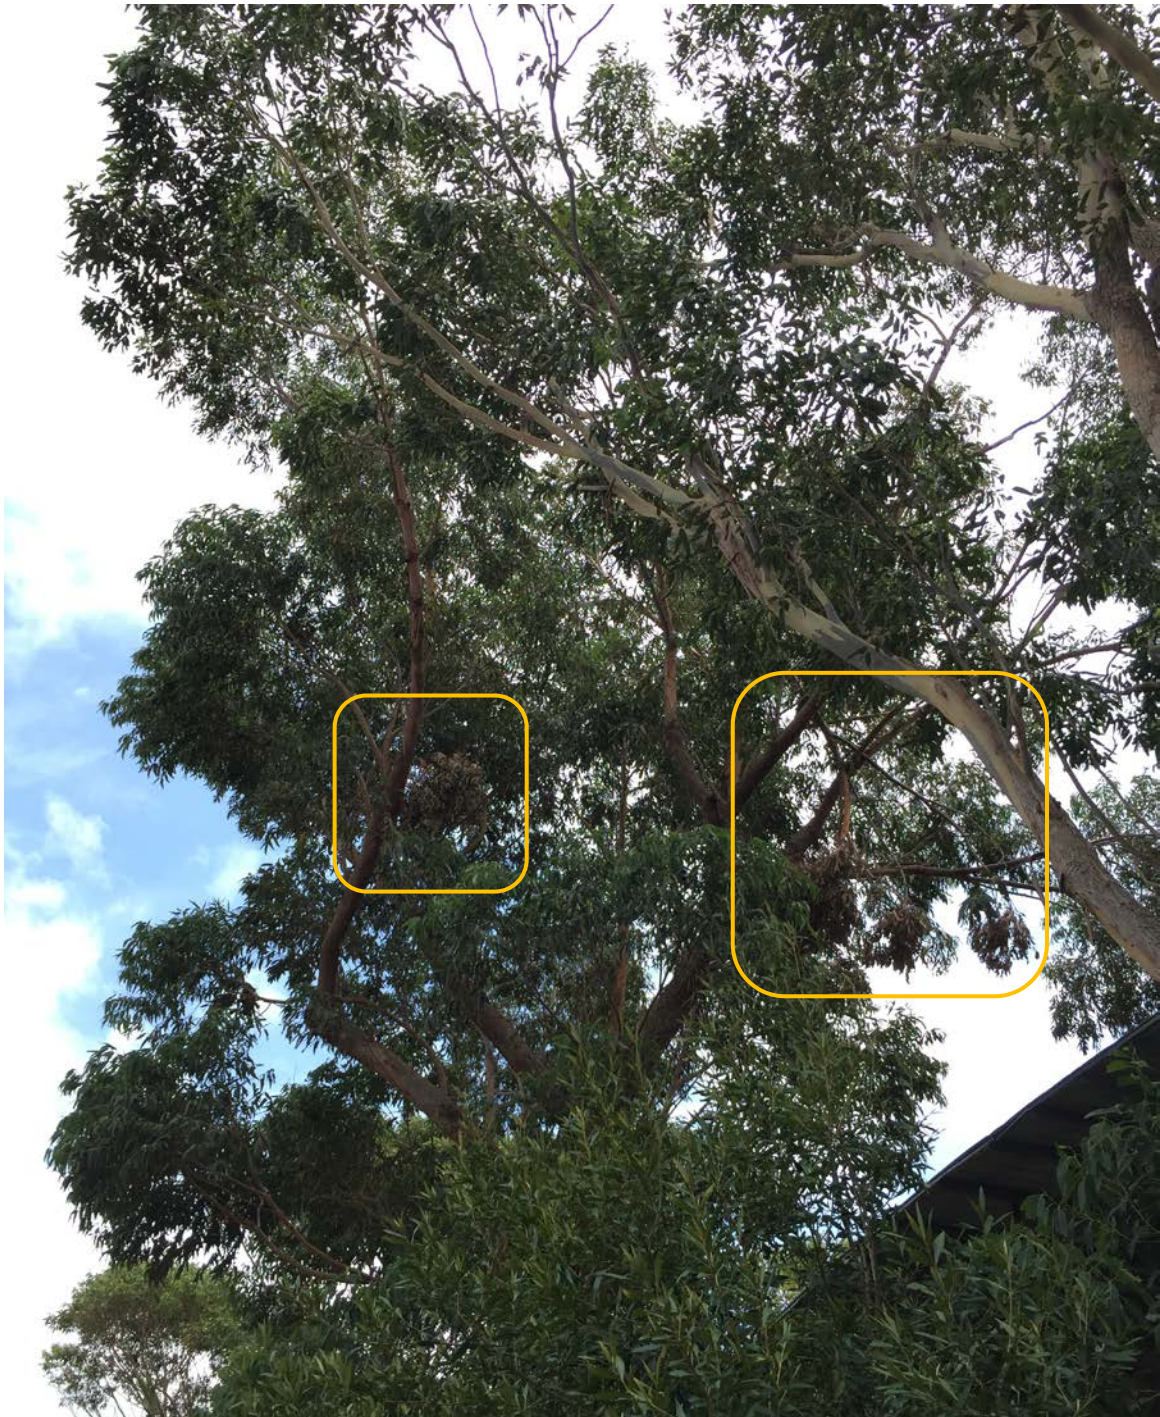
Tree 5: *Eucalyptus botryoides* [Bangalay] is a mature tree with a singular trunk which extends to support an open co-dominant canopy structure.

This tree has large over extended first order branch scaffolds. Recent branch failures have occurred as the result.

FIGURE 8: TREE 5 WITH RECENT BRANCH FAILURES INDICATED IN YELLOW.

RECOMMENDATION (IF RETAINED): Branch end weight reduction, deadwood removal and selective target pruning would reduce the likelihood of further branch failures.

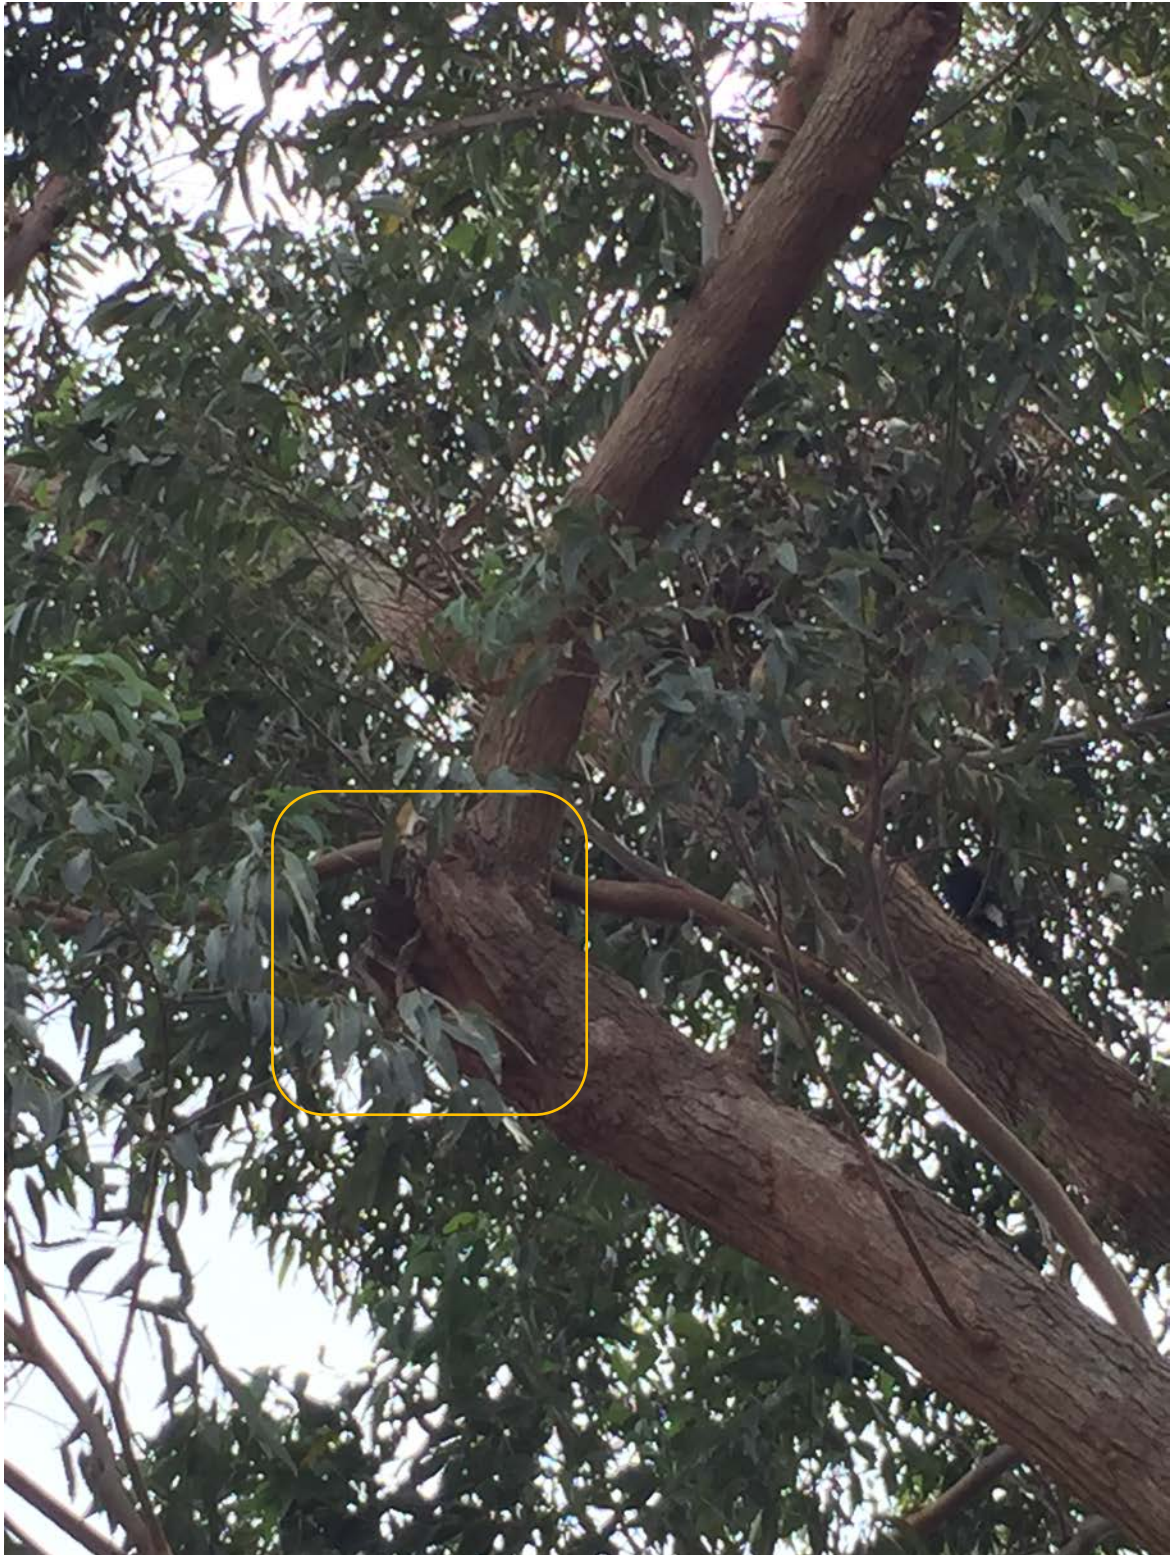
An over extended second order branch has a poor attachment point above a decayed hollow area pictured in Figure 9.

FIGURE 9: TREE 5 WITH AN ELONGATED SECOND ORDER BRANCH EXTENDING ABOVE A DECAYED HOLLOW AREA.

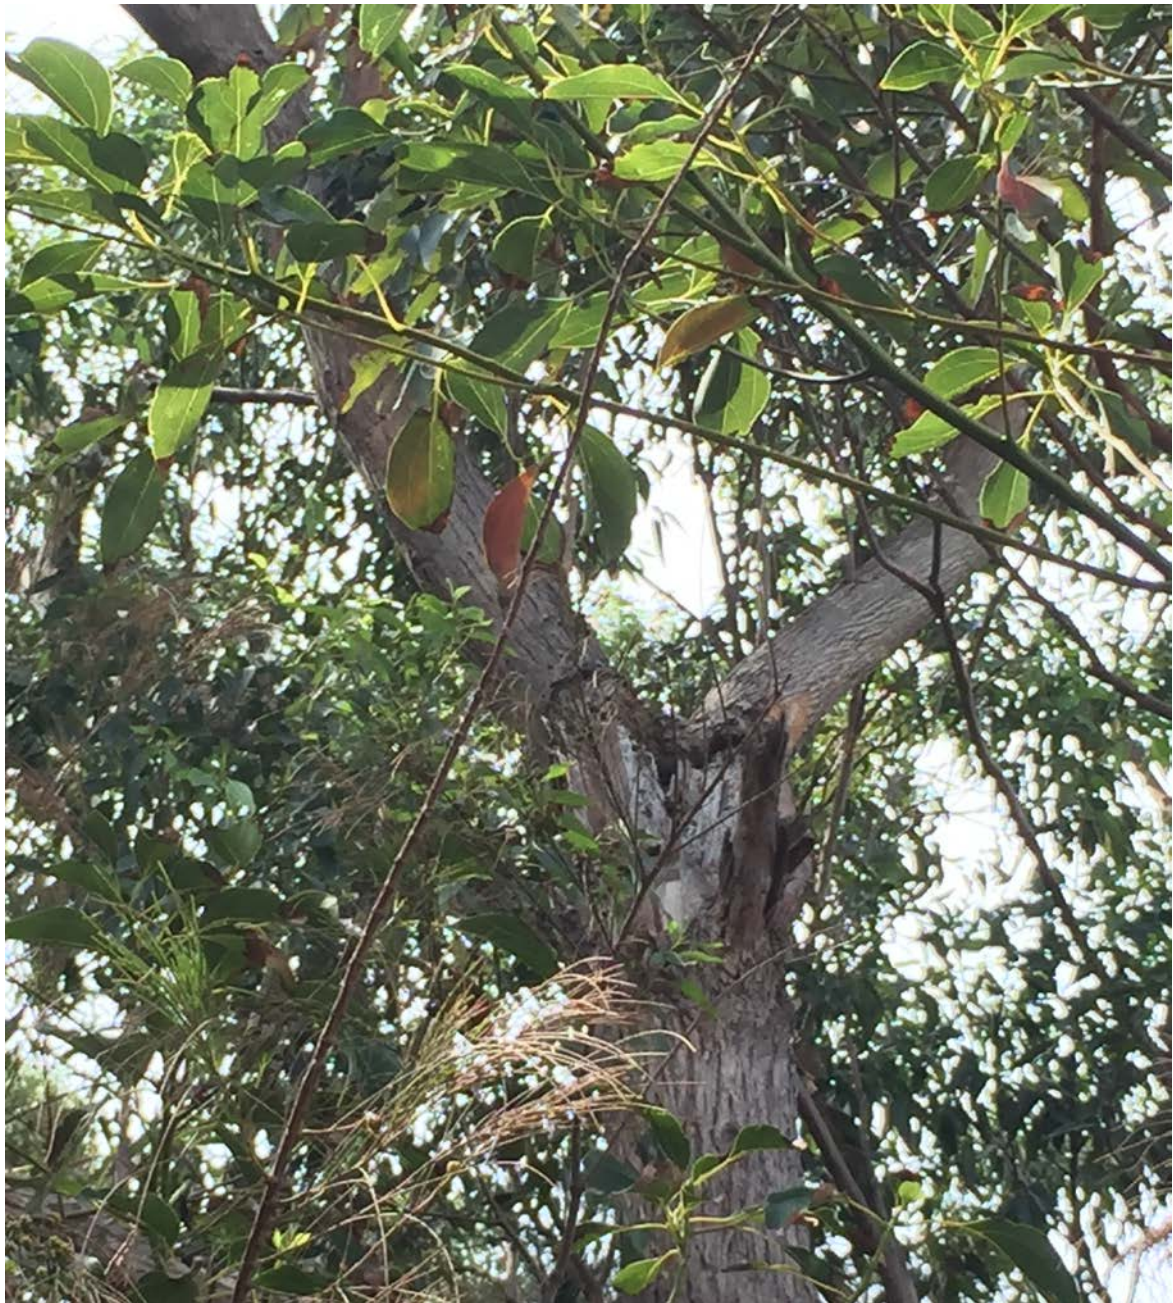
Tree 6: *Eucalyptus botryoides* [Bangalay] is a mature tree with a large trunk diameter which supports elongated, over extended first order branch structures within the upper canopy.

The previous failure of a large terminal leader has left second order branch structures exposed to a decayed wound area as the result.

FIGURE 10: TREE 6 WITH A WOUND AREA RESULTING FROM BRANCH FAILURE.

RECOMMENDATION: Second order branch structures with poor attachment points adjacent to the wound area displayed in Figure 10 should be removed. This tree would benefit from branch end weight reduction, removal of dead wood and canopy sail area reduction to reduce the likelihood of further branch failures.

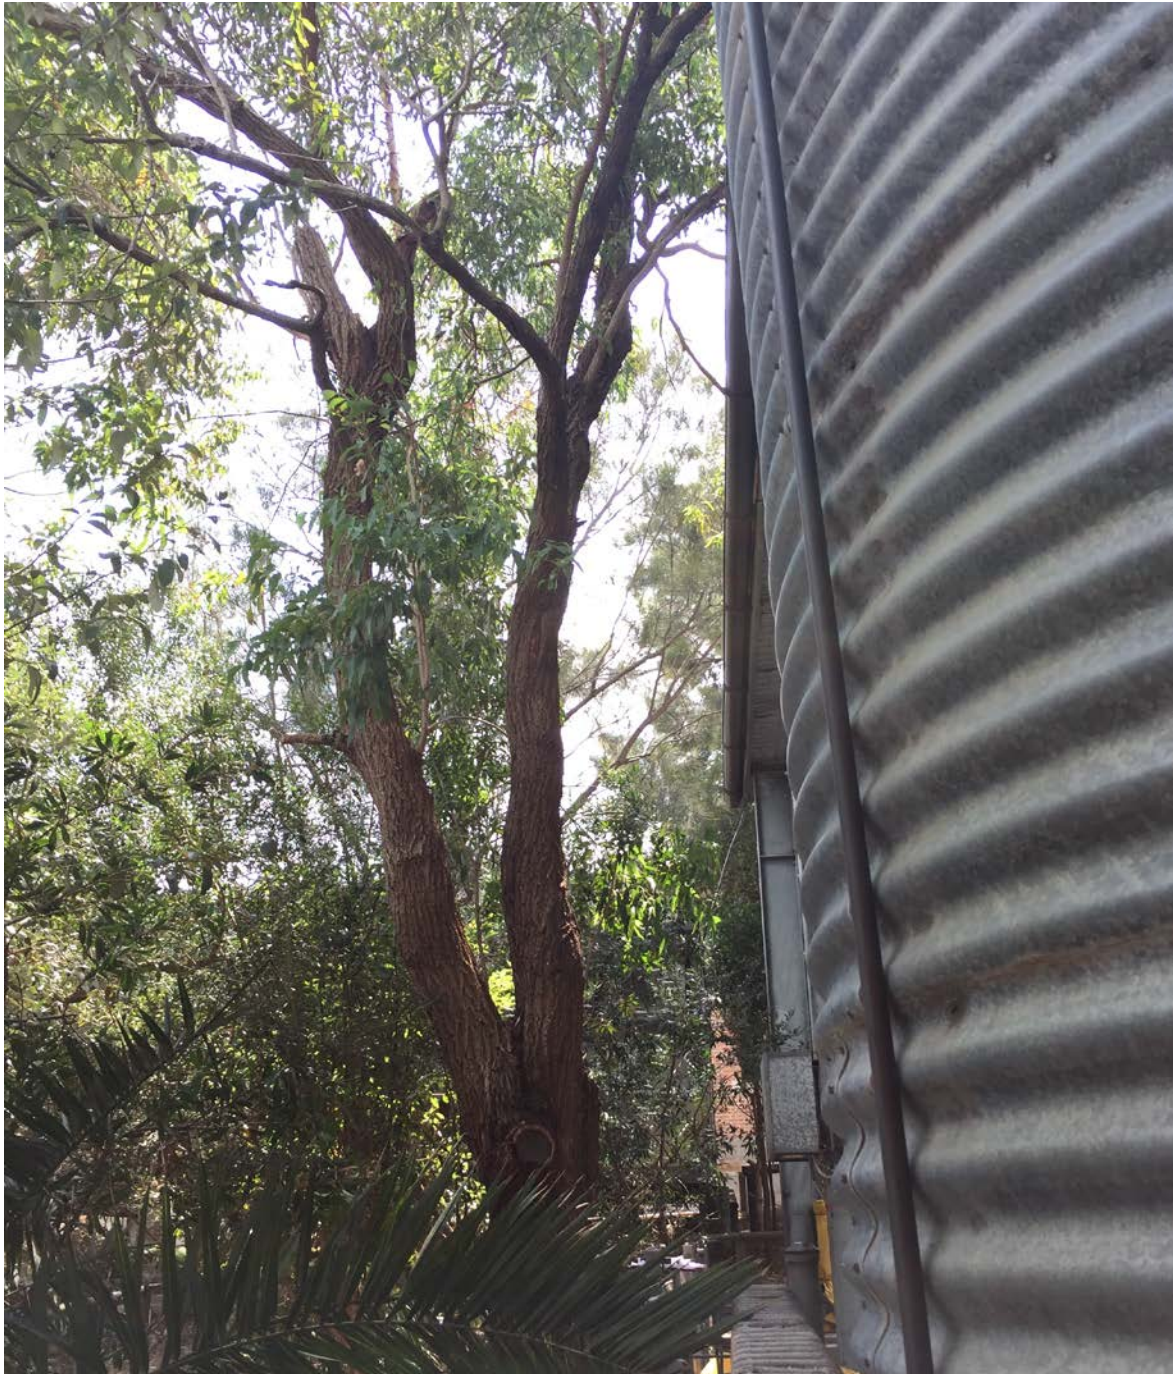
Tree 7: *Eucalyptus paniculata* [Grey Iron Bark] is a mature tree with an open union at 1.6 metres which then bi-furcates into semi-elongated, co-dominant first order branch structures.

An abnormal canopy profile has resulted from suppression of adjacent trees. Second order branches are elongated with deadwood <30mm.

FIGURE 11: TREE 7 WITH CO-DOMINANT STRUCTURE AND CANOPY MASS OVER COVERED PLAY AREA.

RECOMMENDATION (IF RETAINED): This tree would benefit from the corrective pruning of elongated branch scaffolds, branch end weight reduction and the removal of deadwood.

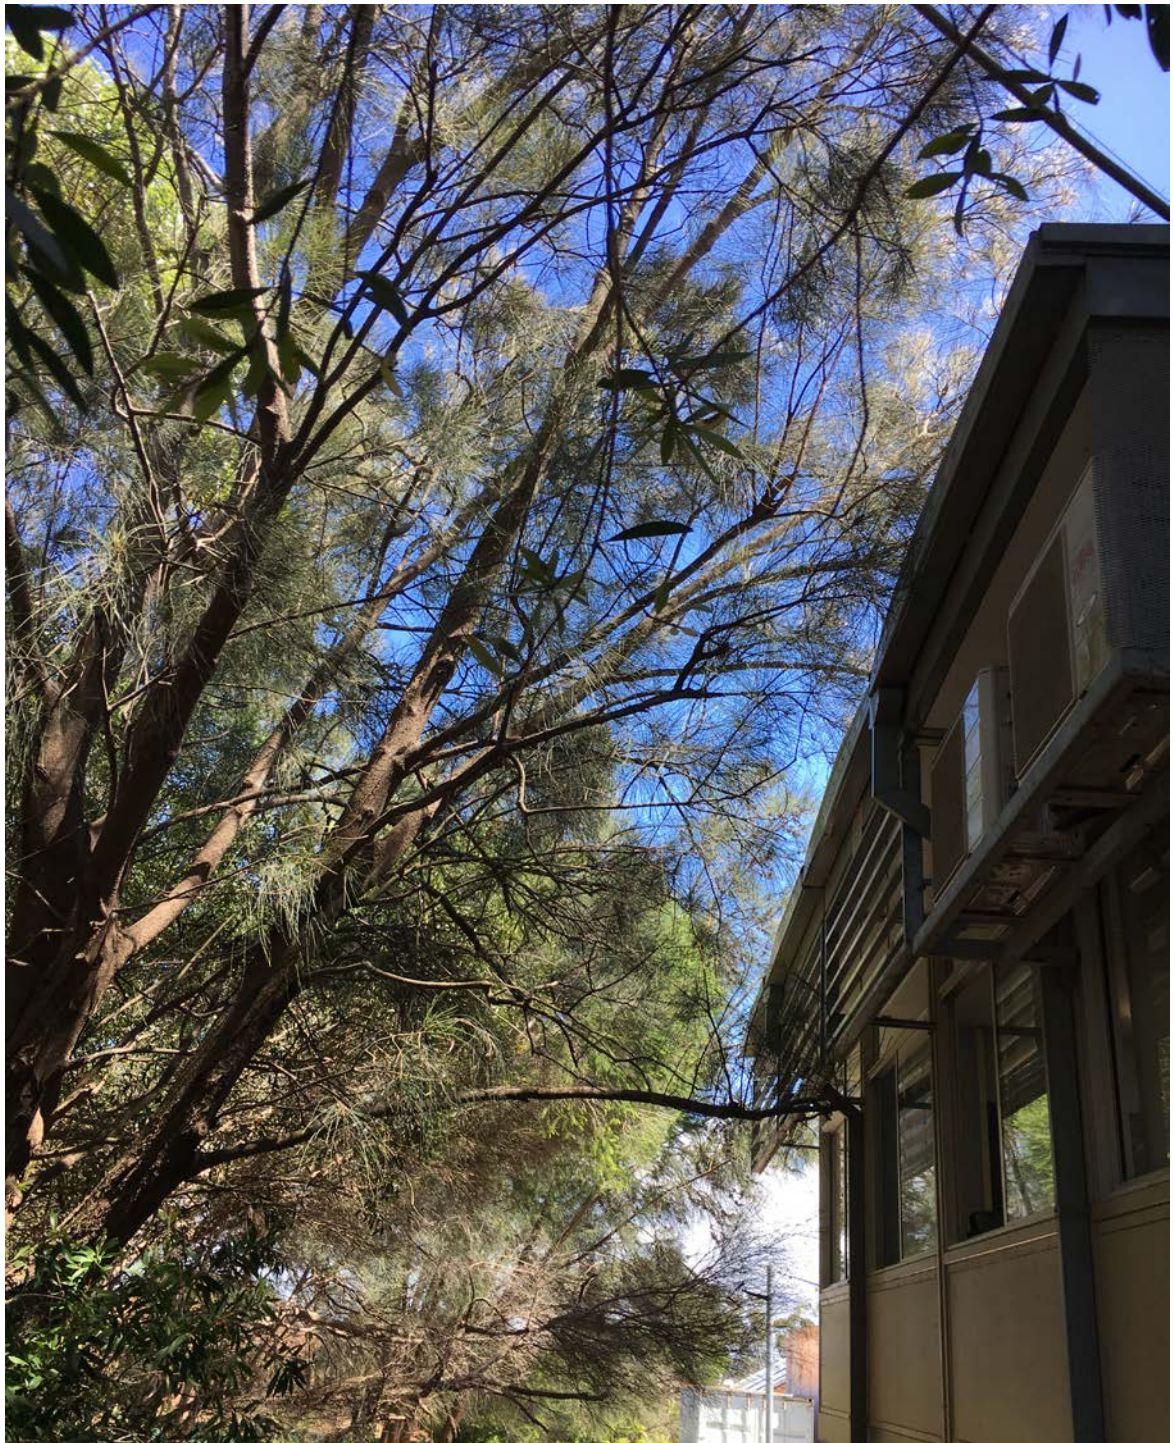
Tree 8: *Casuarina glauca* [Swamp She-oak] is mature tree with a multi-stemmed upper trunk and an asymmetric canopy structure.

Second order branches towards the demountable classroom have been poorly pruned leaving long branch stubs as the result.

FIGURE 12: TREE 8 WITH A MULTI-STEMMED ASYMMETRIC CANOPY.

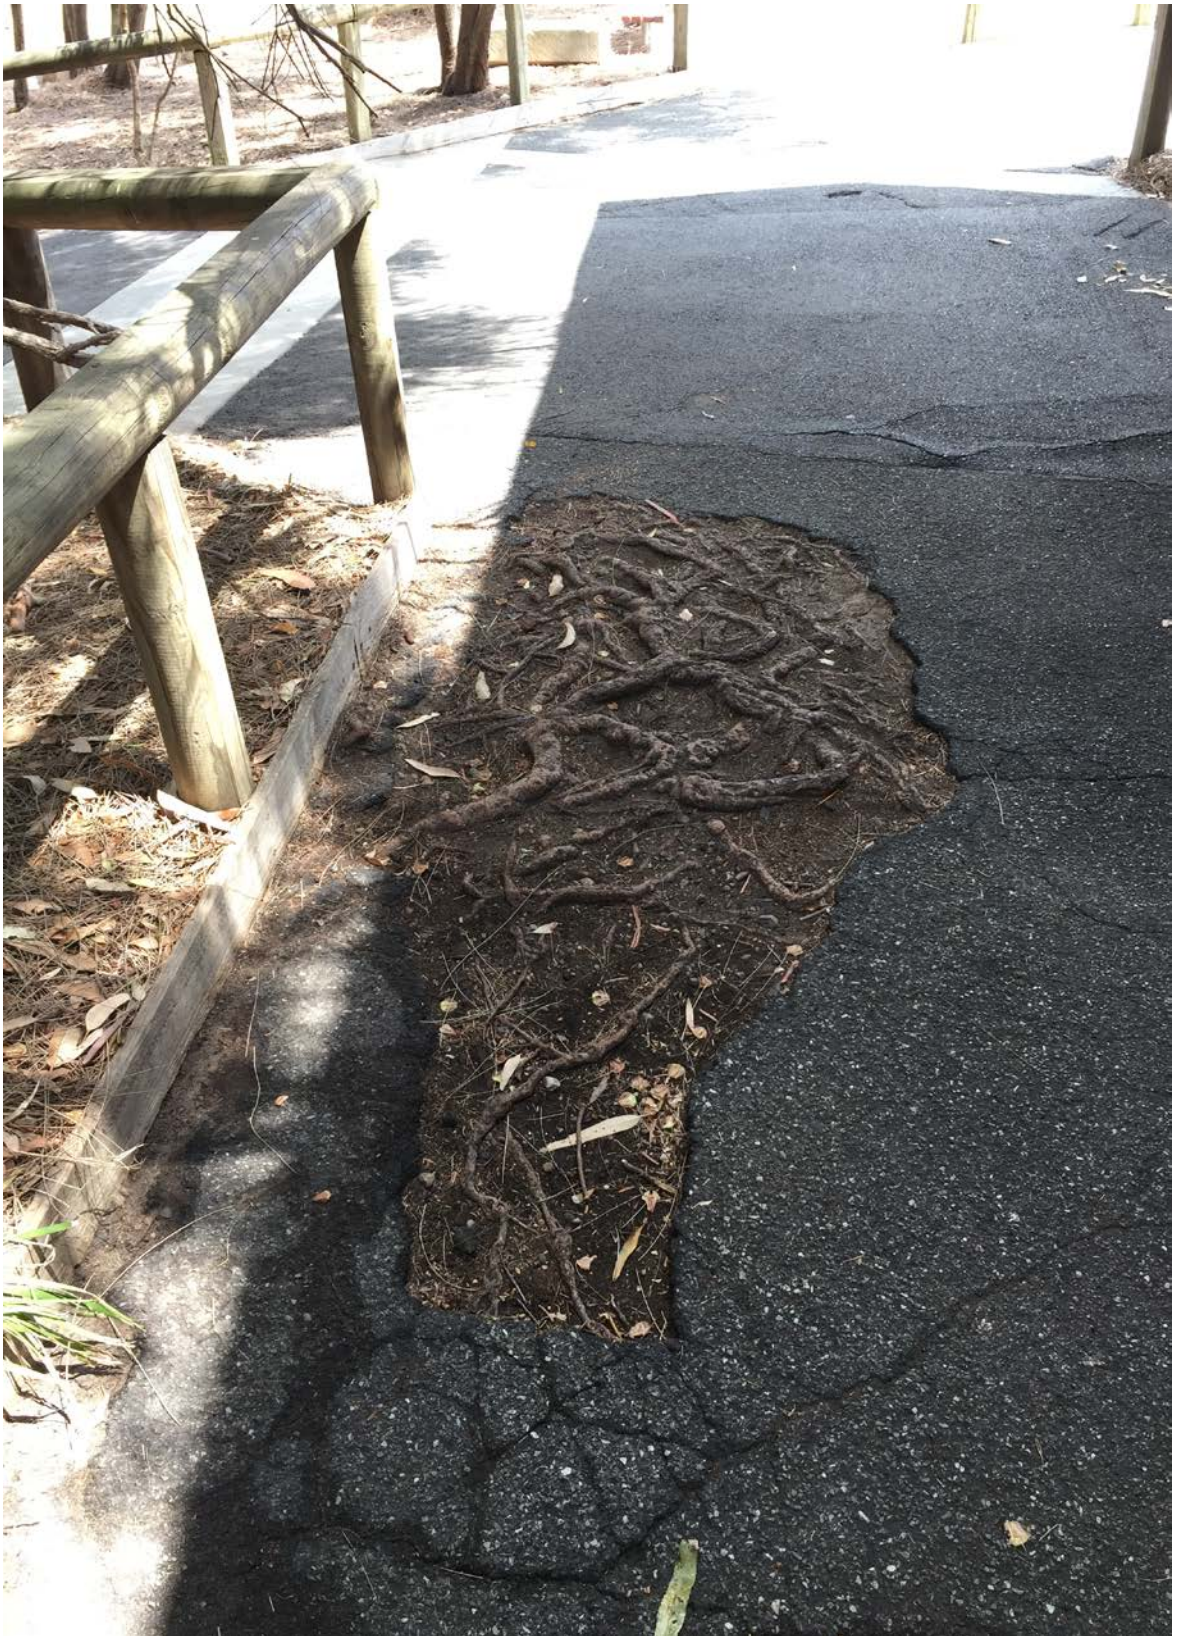
FIGURE 13: TREE 8, EXPOSED ROOTS AND BROKEN PATHWAY SURFACE.

RECOMMENDATION (IF RETAINED): The sealed pathway beneath the canopy has broken away leaving exposed roots and a raised undulated surface. Make pavement safe by patching over roots. Refer to Figure 13

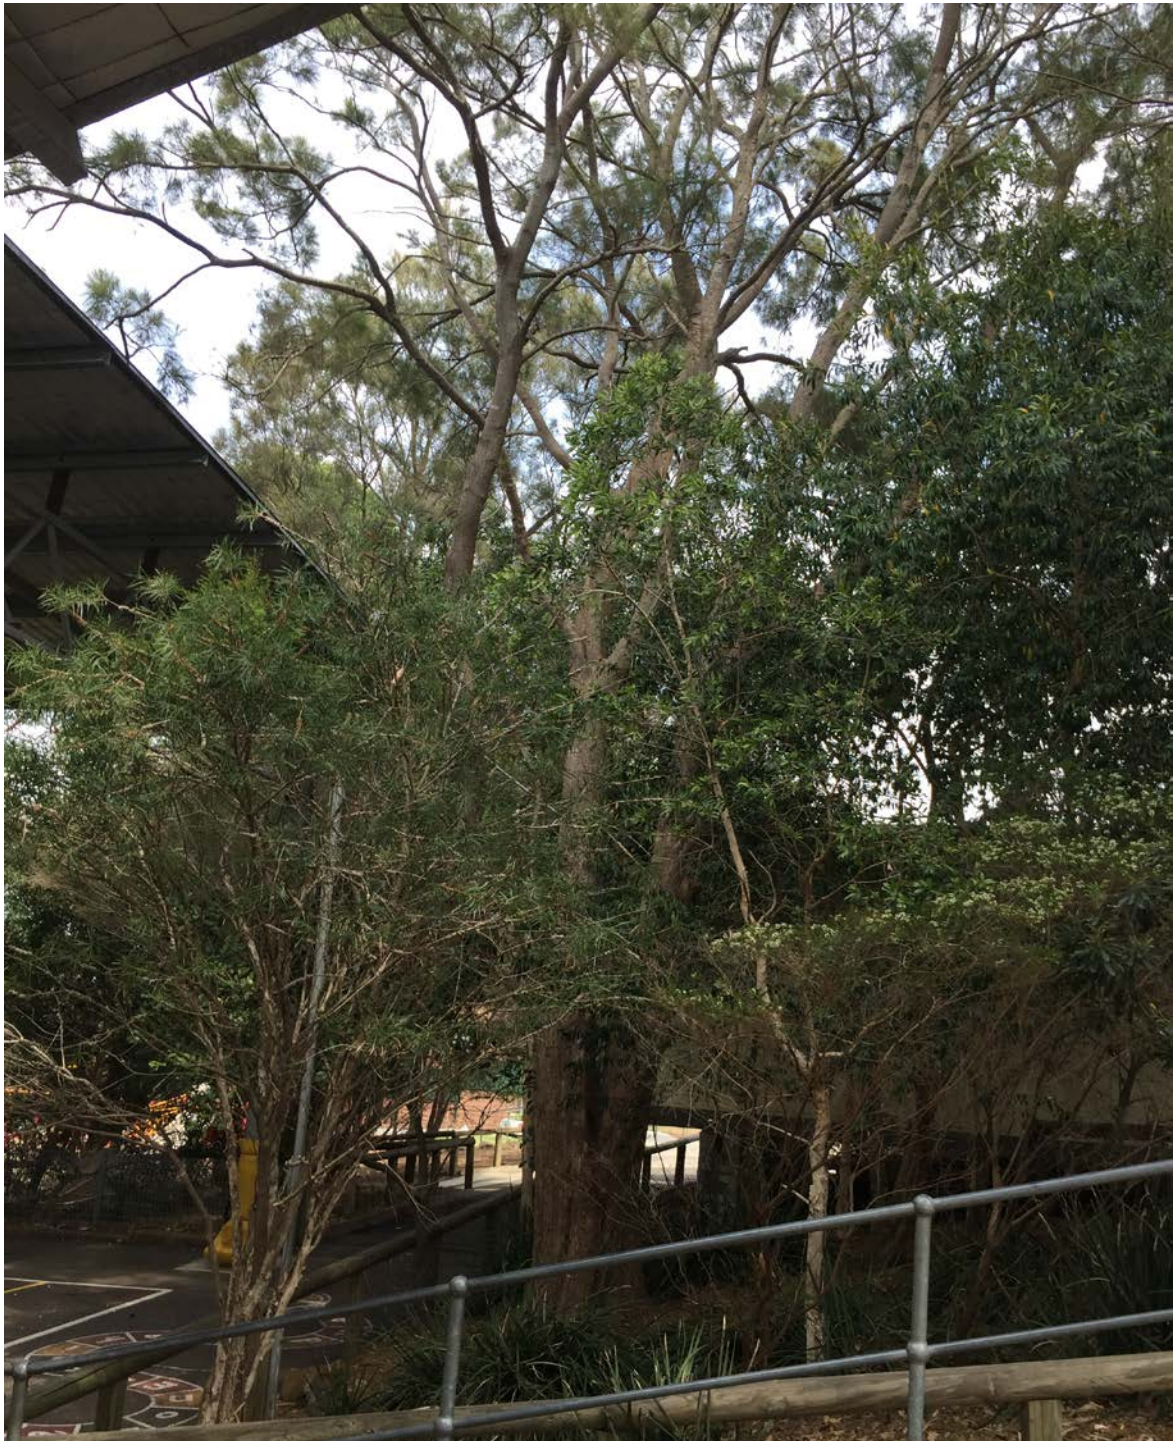
Tree 9: *Casuarina cunninghamiana* [River She-oak] is a large mature tree with a co-dominant trunk which supports a multi-stemmed upper canopy structure.

Second order branch structures have reasonable taper. Minor branch failures have occurred previously leaving long branch stubs as a result.

FIGURE 14: TREE 9 WITH A CO-DOMINANT TO MULTI-STEMMED CANOPY STRUCTURE

RECOMMENDATION: Branch end weight reduction, deadwood removal and selective target pruning would reduce the likelihood of future branch failures.

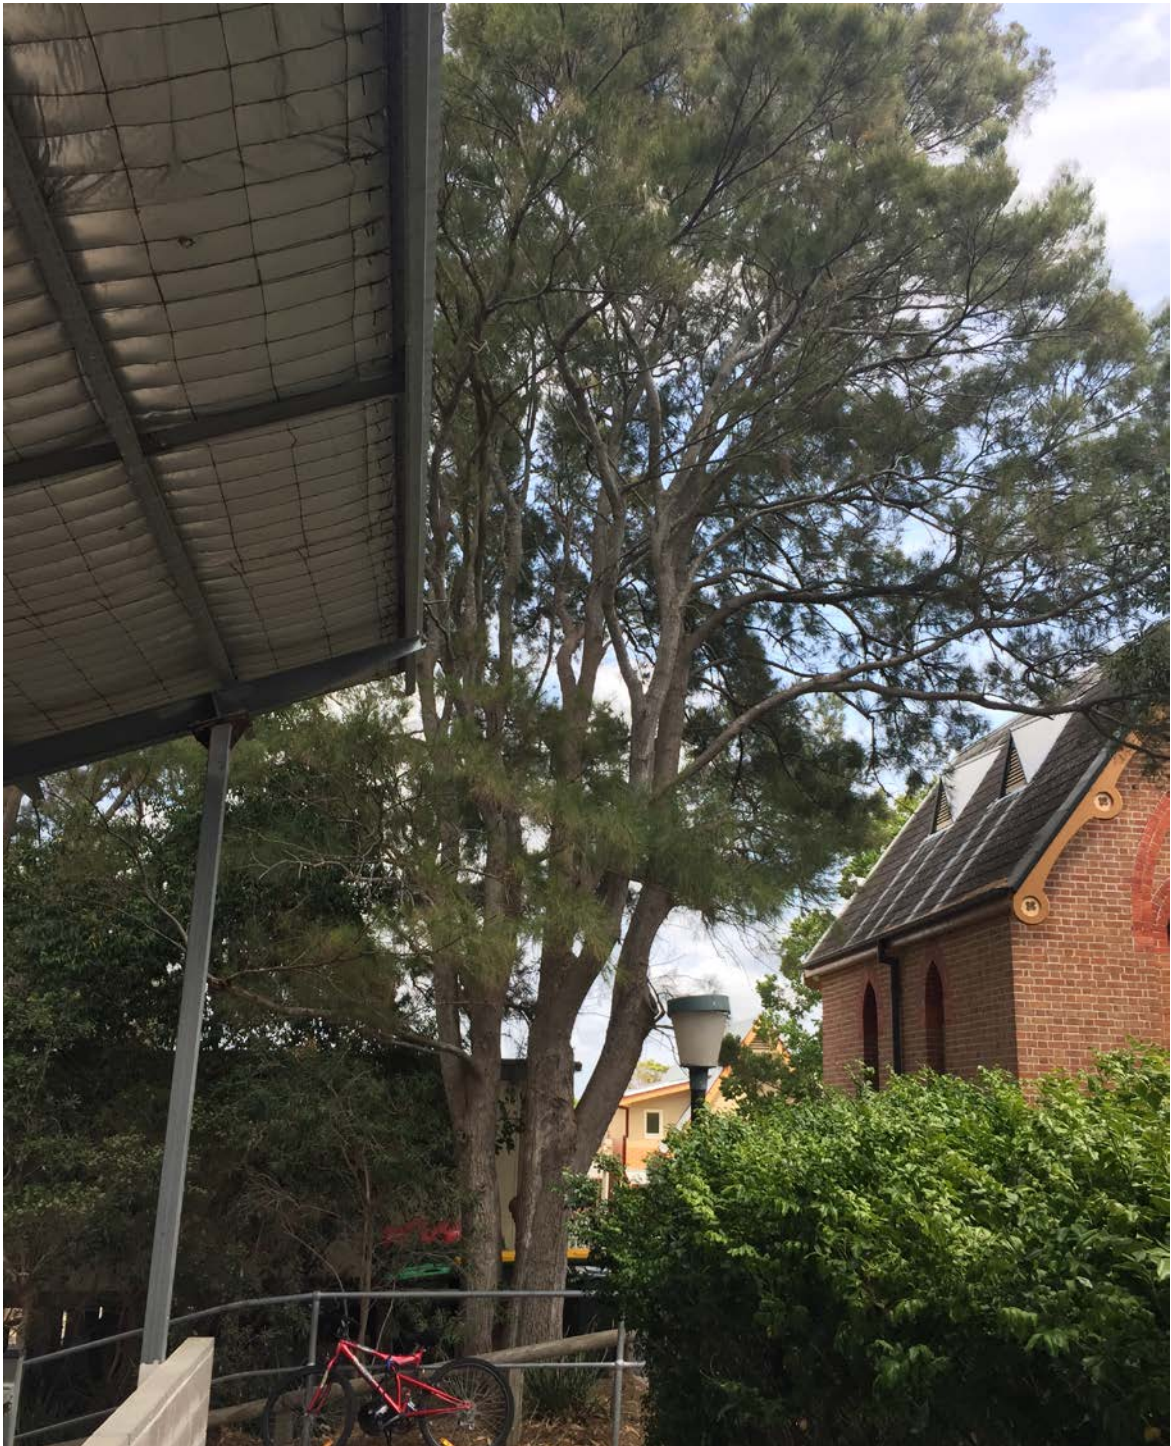
Tree 10: *Casuarina cunninghamiana* [River She-oak] is a large mature tree with a low bi-furcated co-dominant trunk structure.

The upper canopy structure is multi-stemmed with large lateral second order branches which extend outwards over the pathway beneath.

FIGURE 15: TREE 10 WITH A LOW BRANCHING CO-DOMINANT STRUCTURE.
