Arborist Report

Project No: 11506.54

Location: 48 Brown Street
Newcastle East, NSW 2303

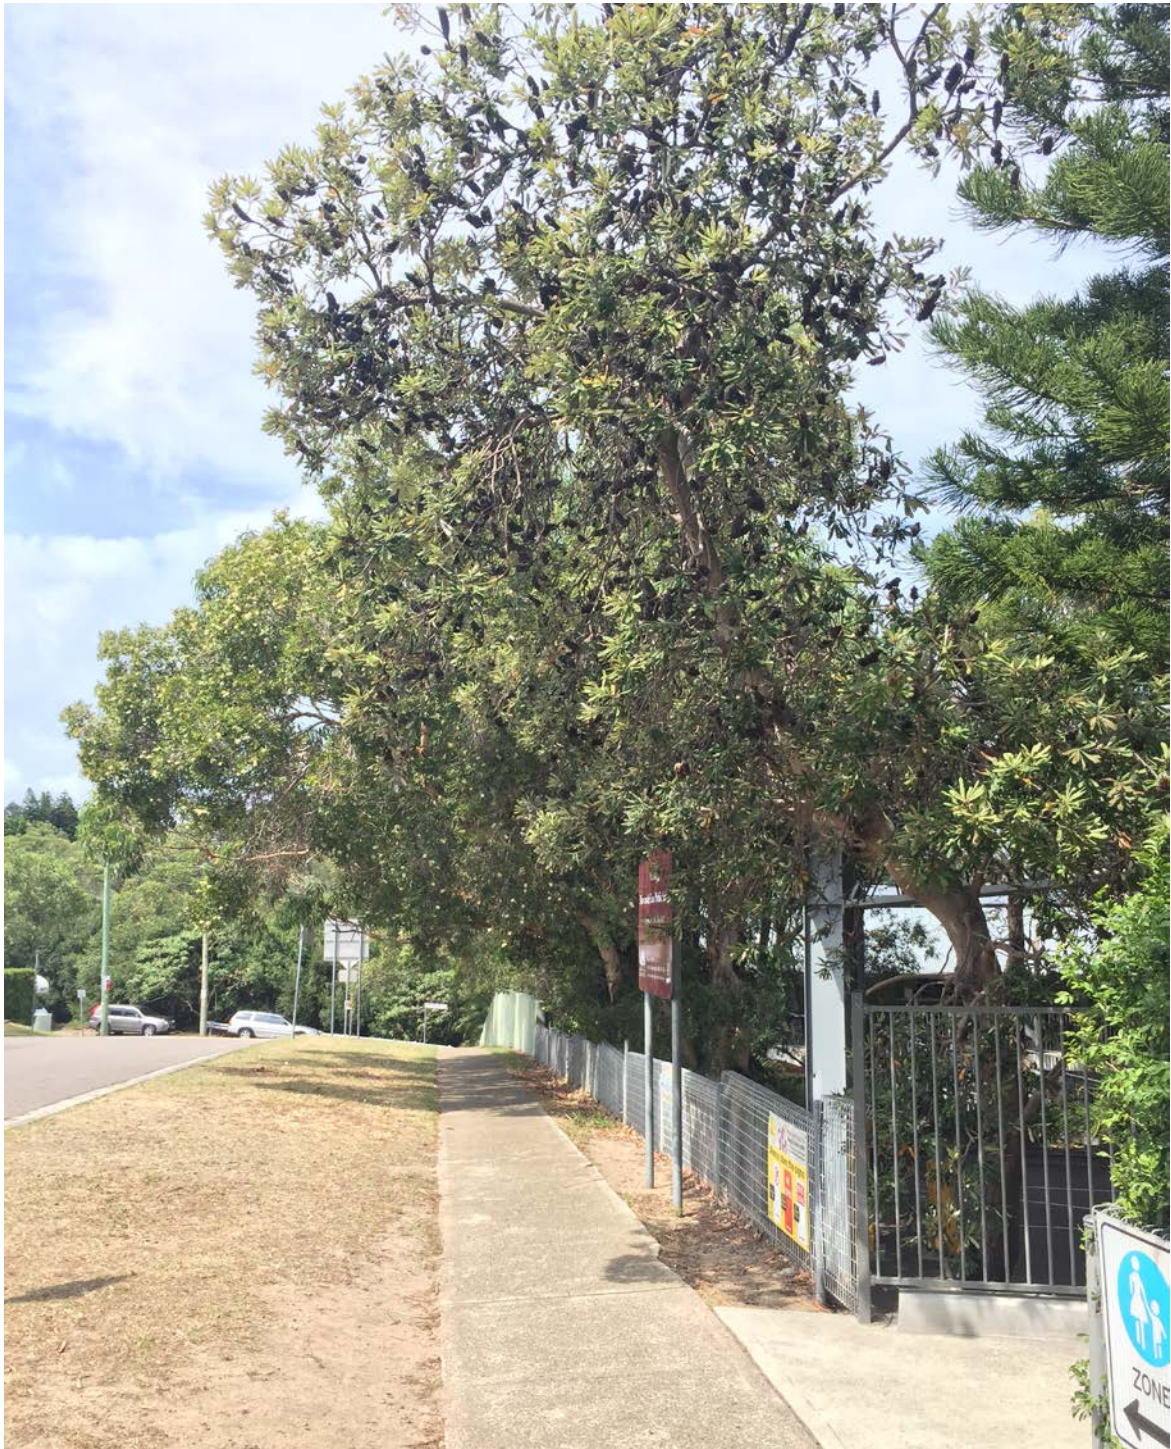
Tree 13: *Banksia integrifolia* [Coastal Banksia] is a mature tree which has a severe lean towards Brown Street and an asymmetric upper canopy structure.

FIGURE 18: TREE 13 WITH ASYMMETRY OVER THE FOOTPATH ON BROWN STREET

RECOMMENDATION (IF RETAINED): This tree would benefit from canopy reduction and thinning of banksia cones to reduce dispersal onto the footpath.

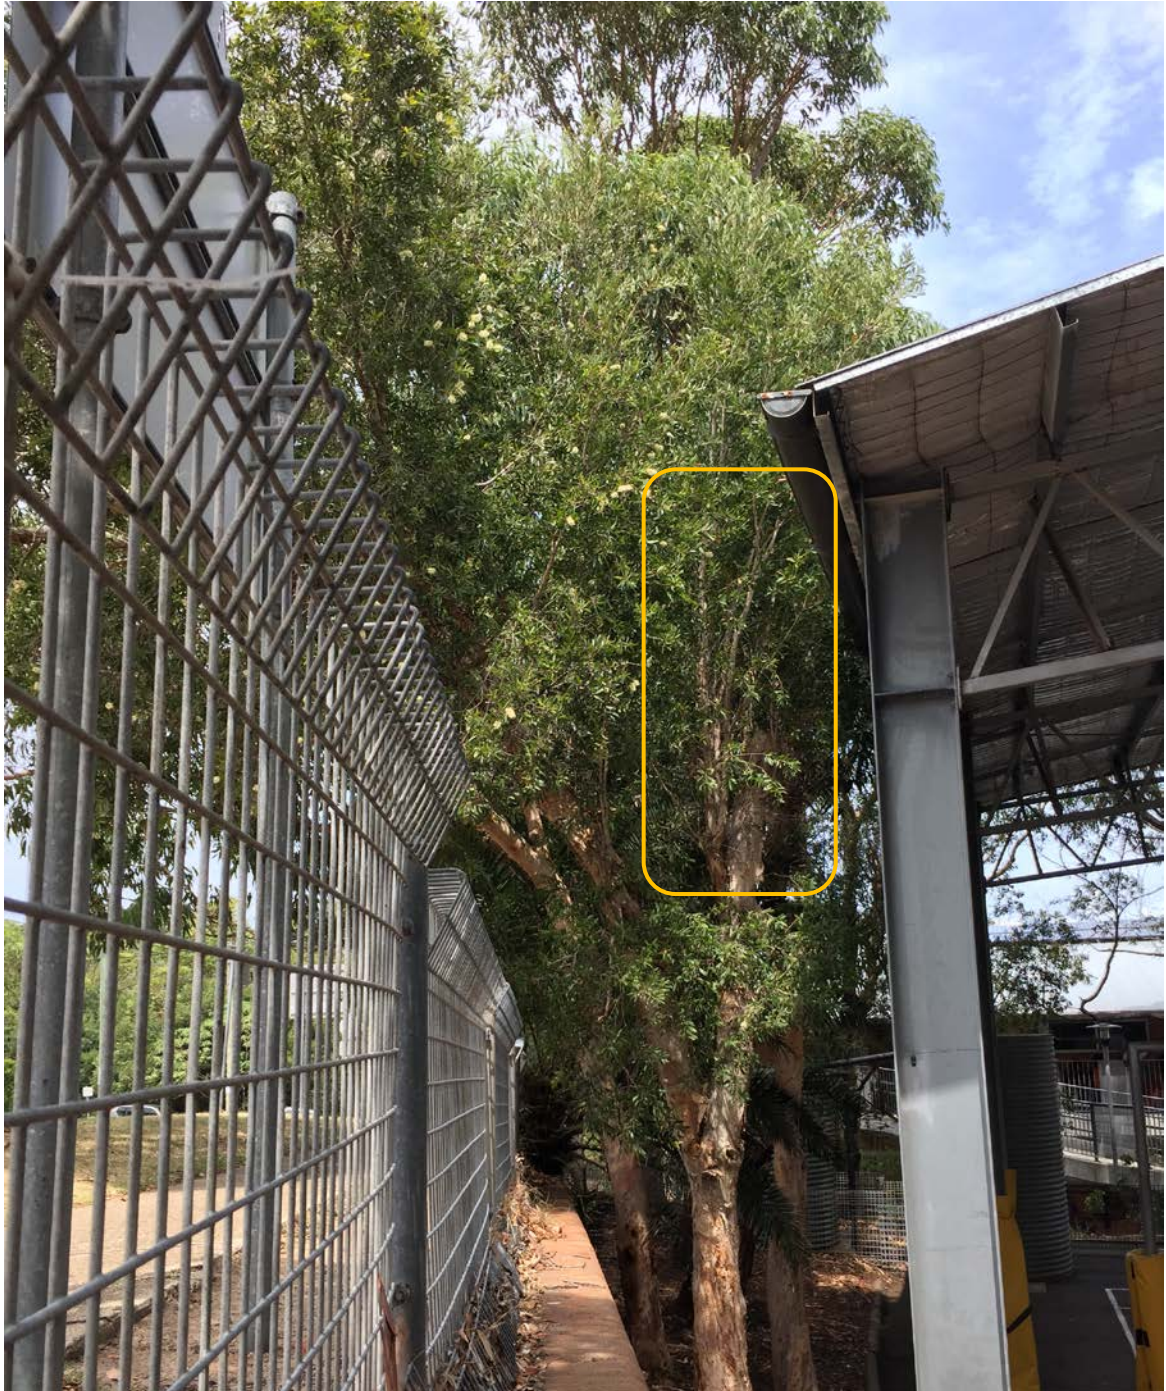
Previous works have been undertaken to clear first and second order branches from the gutter line of the covered play area.

Poor pruning techniques have triggered the regrowth of multiple epicormic shoots with poor attachments. A large first order branch stub remains as a result.

The second co-dominant stem extends over the public footpath which services the Brown Street entry to the school.

FIGURE 19: TREE 14 WITH LOPPED CO-DOMINANT STEM AND EPICORMIC REGROWTH INDICATED IN YELLOW.

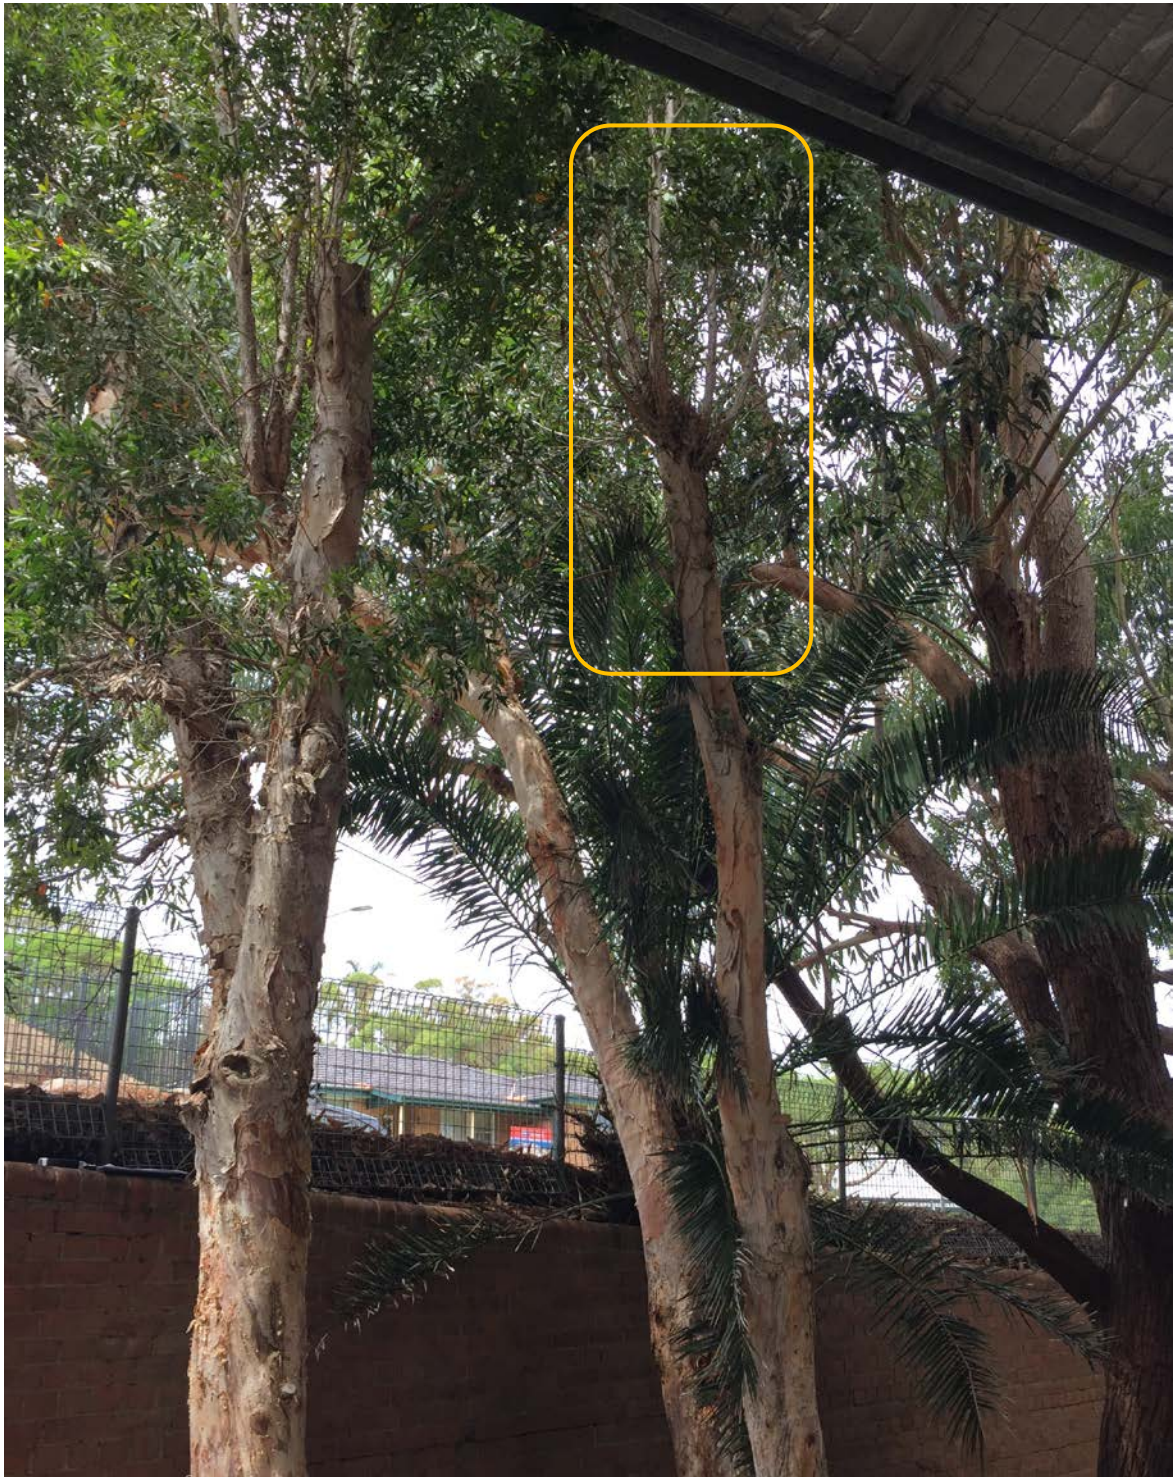
Tree 15: *Melaleuca quinquenervia* [Broad-leaved Paperbark] is a mature tree which has been previously lopped below gutter height.

The remaining epicormic regrowth is structurally unsound as a result of lopping.

FIGURE 20: TREE 15 WITH LOPPED REGROWTH BELOW GUTTER HEIGHT INDICATED IN YELLOW.

RECOMMENDATION (IF RETAINED): Corrective pruning is unachievable and therefore this tree will require removal.

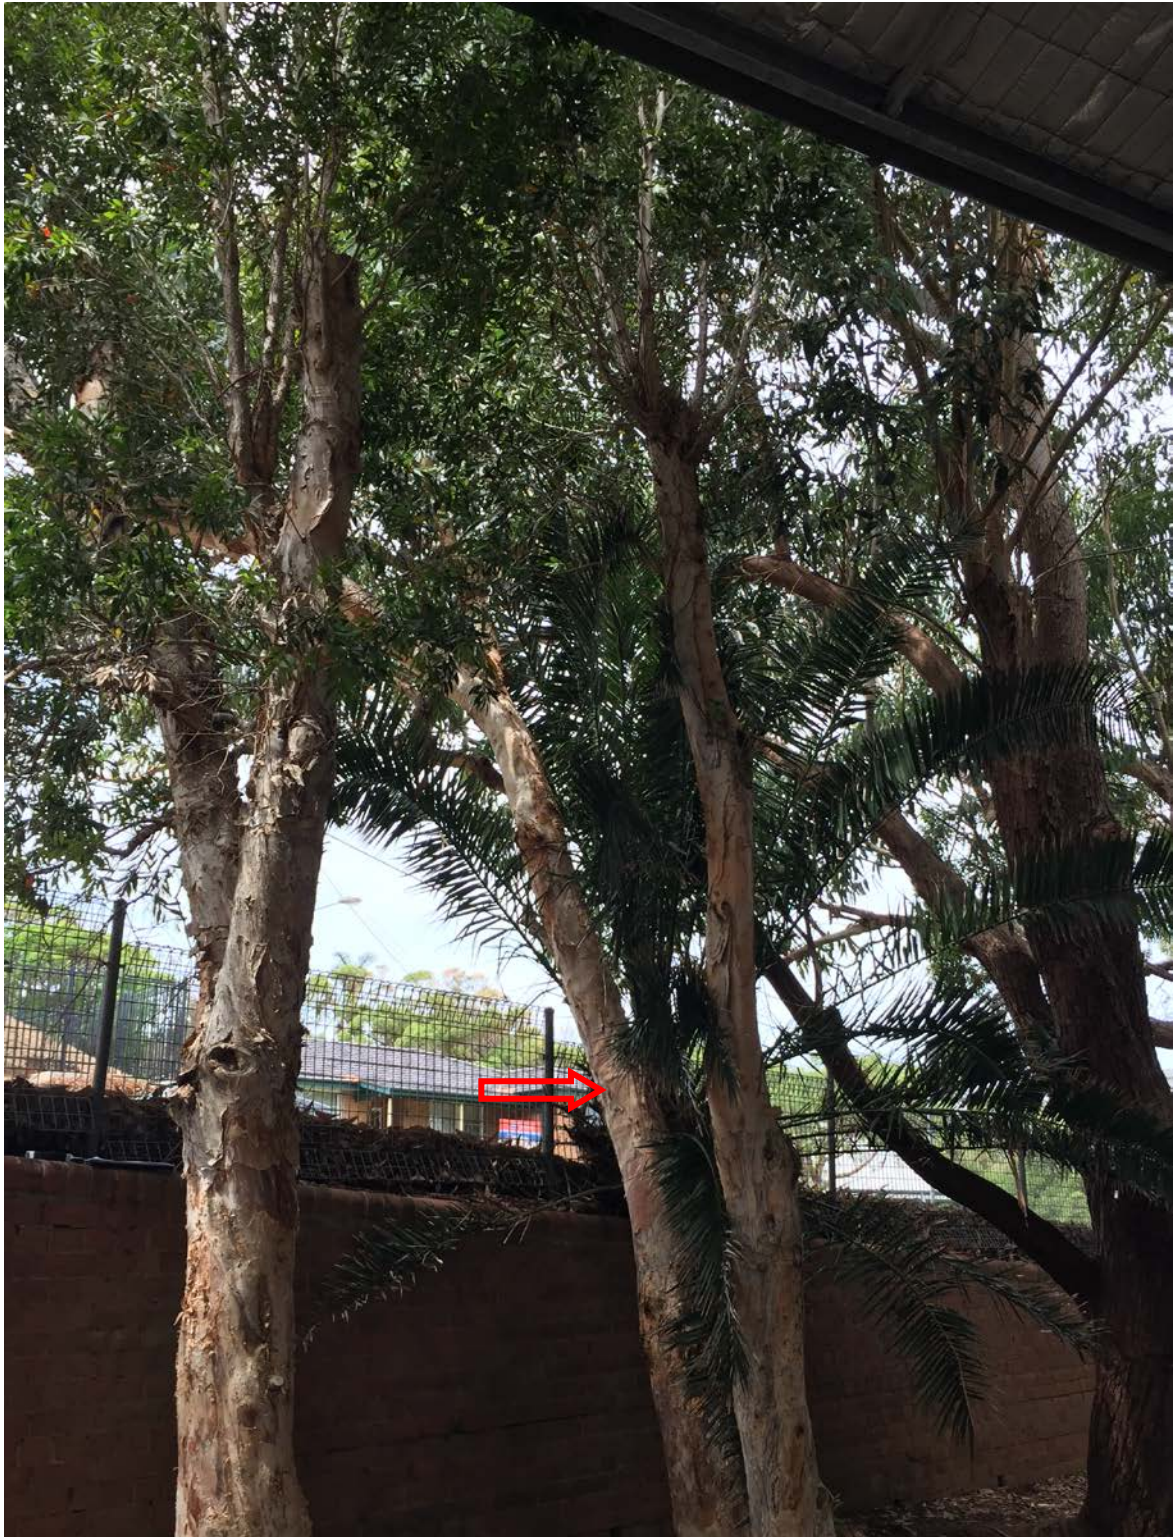
Tree 16: *Melaleuca quinquenervia* [Broad-leaved Paperbark] is a mature tree with poor trunk taper and severe asymmetry over the public footpath which services the Brown Street and the entry to the school.

FIGURE 21: TREE 16 WITH MAJOR ASYMMETRY TOWARDS BROWN STREET (RED ARROW).

RECOMMENDATION (IF RETAINED): Corrective pruning to reduce asymmetry is unachievable and will exceed the allowable annual pruning percentage therefore this tree will require removal.

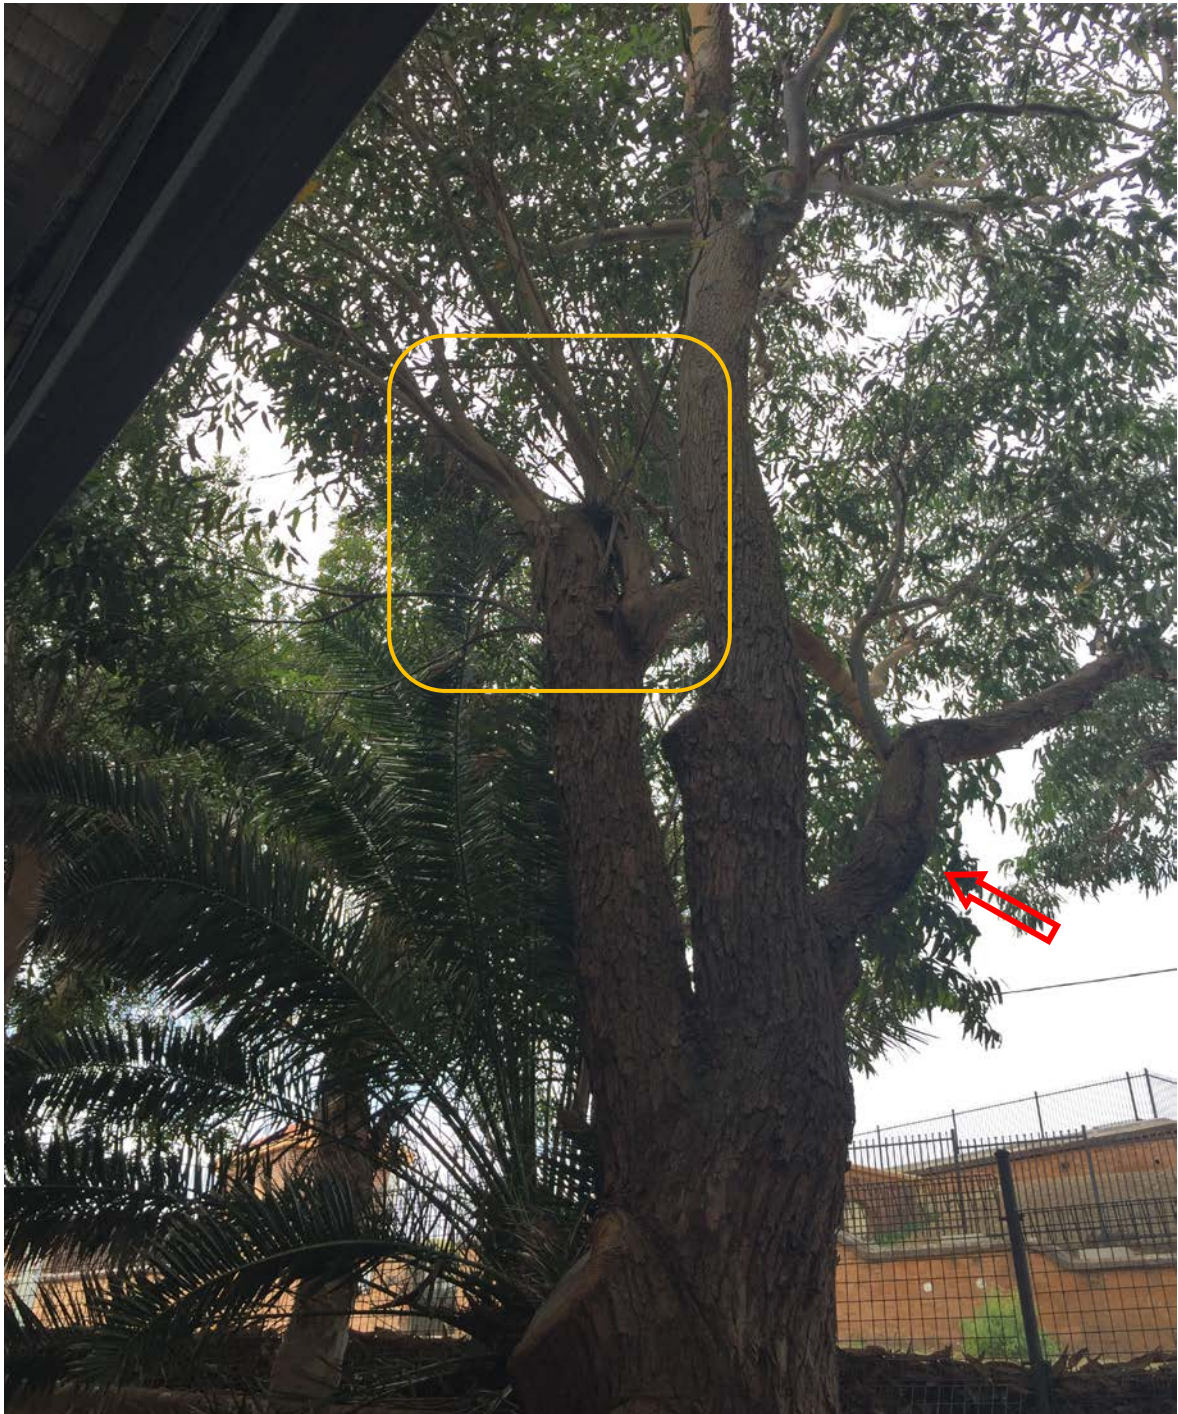
Tree 17: *Eucalyptus botryoides* [Bangalay] is a mature tree with minor asymmetry and over extended first order branch scaffolds towards Brown Street.

Previous works has left a lopped branch scaffold with epicormic regrowth bellow gutter height similar to trees 14 and 15.

This tree has a callused, torsion crack wound area (RED ARROW) which indicates a longitudinal internal stress fracture along an over-extended first order branch scaffold.

FIGURE 22: TREE 17 WITH A TORSION CRACK AND LOPPED LIMB REGROWTH INDICATED IN YELLOW.

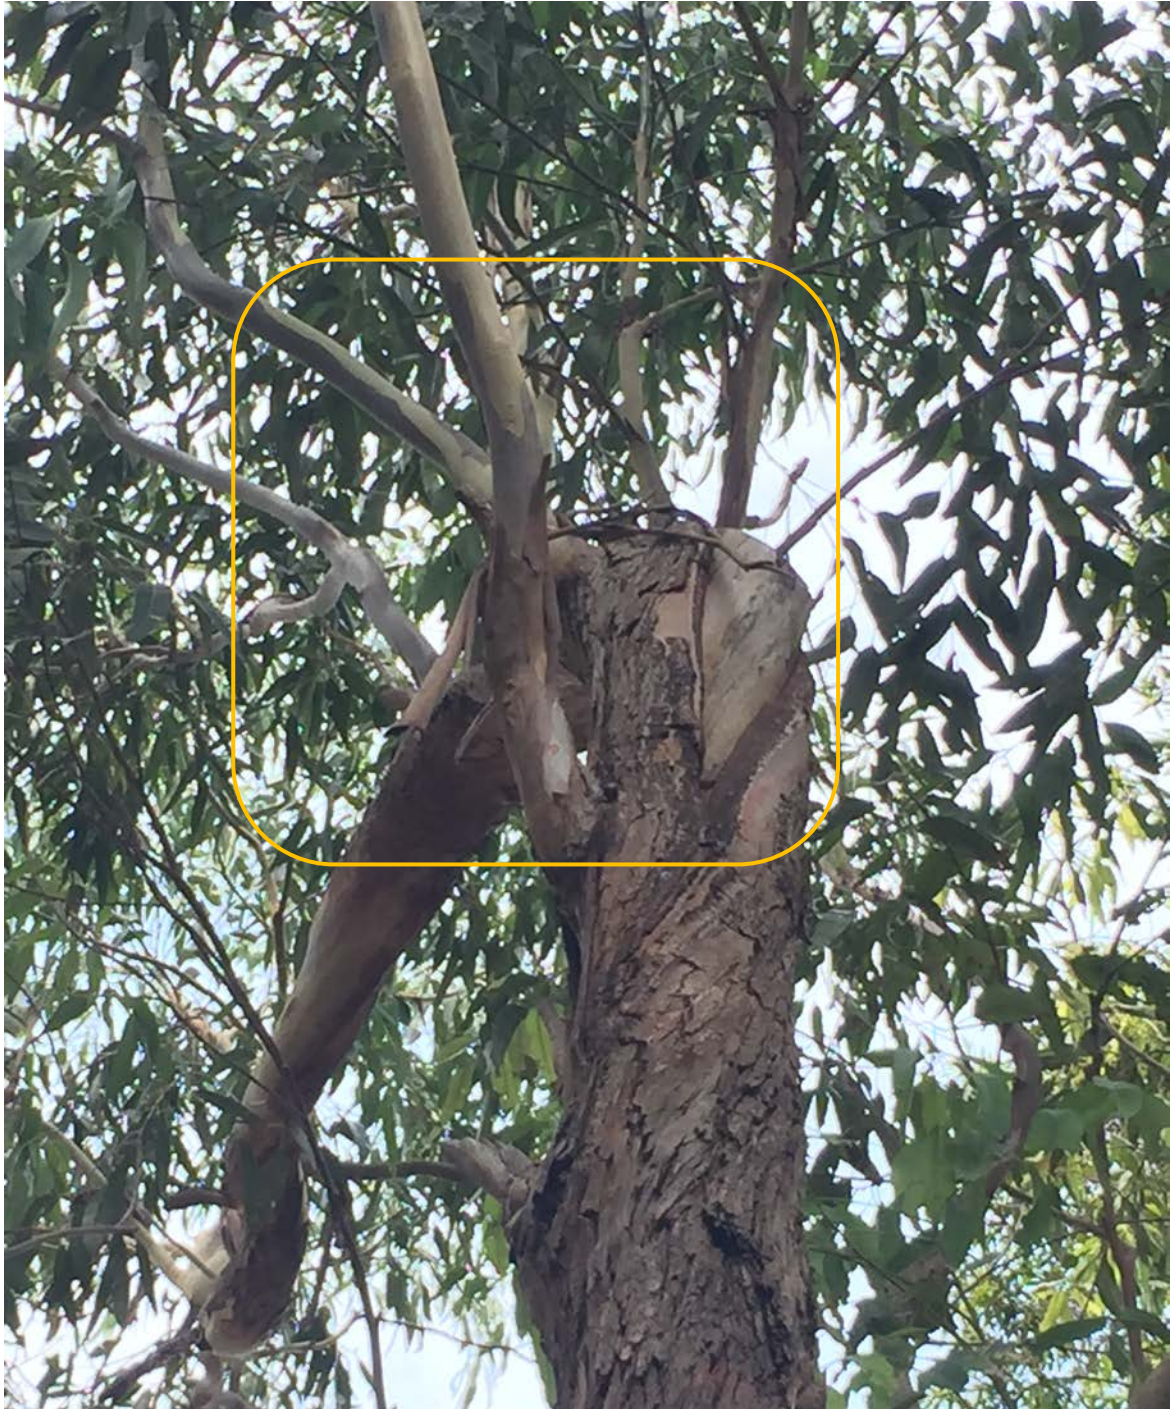
Tree 18: *Eucalyptus botryoides* [Bangalay] is a mature tree with over extended first order branch scaffolds overhanging the footpath of Brown Street.

The combination of a wound area and an over extended branch scaffold has resulted in longitudinal torsion cracking and dormant bud release. Refer to Figure 23.

FIGURE 23: WOUND AREA AND DORMANT BUD RELEASE FROM LONGITUDINAL TORSION CRACKING INDICATED IN YELLOW.

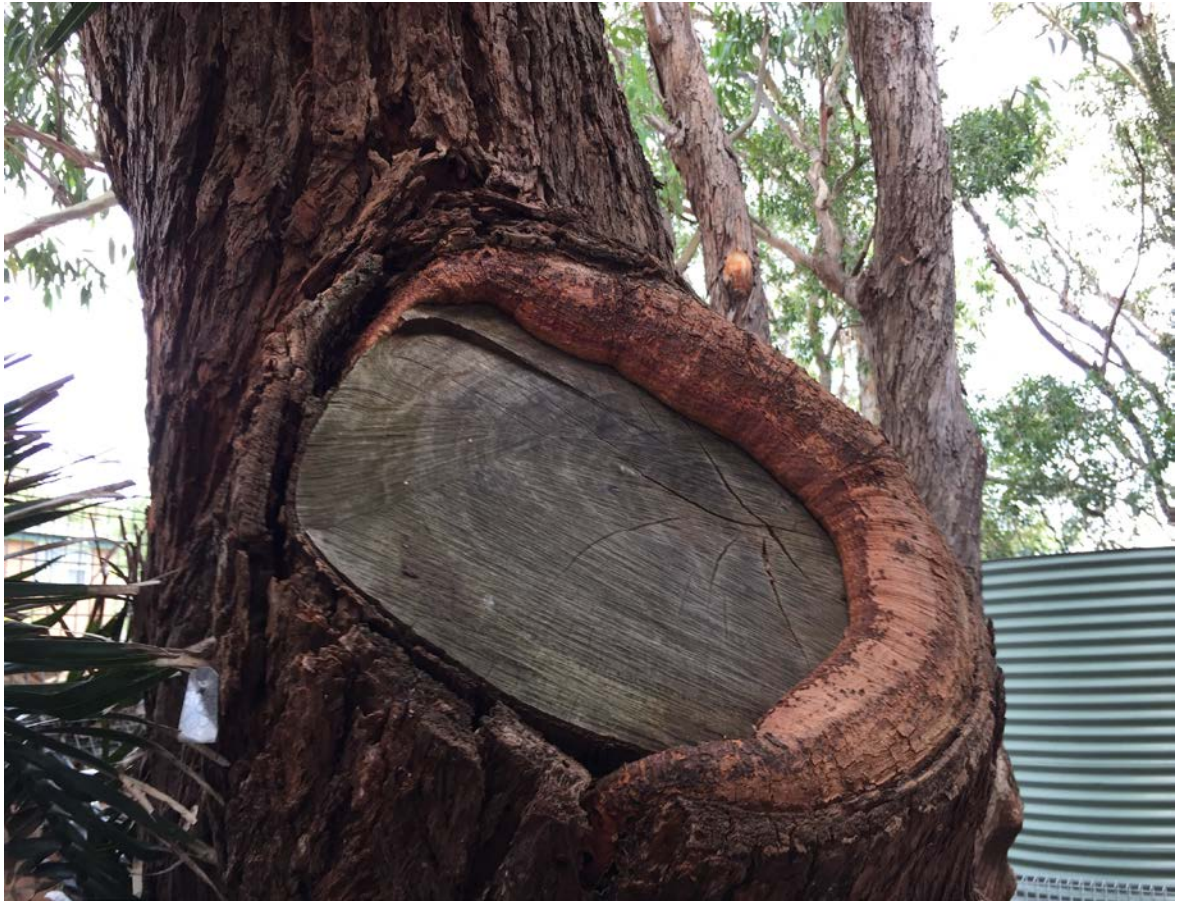
A large first order branch towards the covered play area has been previously removed back to the stem bark ridge. An inaccurate finish cut has resulted in a partial wound occlusion. Refer to Figure 24

FIGURE 24: TREE 18 WITH STEM BARK RIDGE PRUNING FINISH CUT WITH A PARTIAL OCCLUSION.

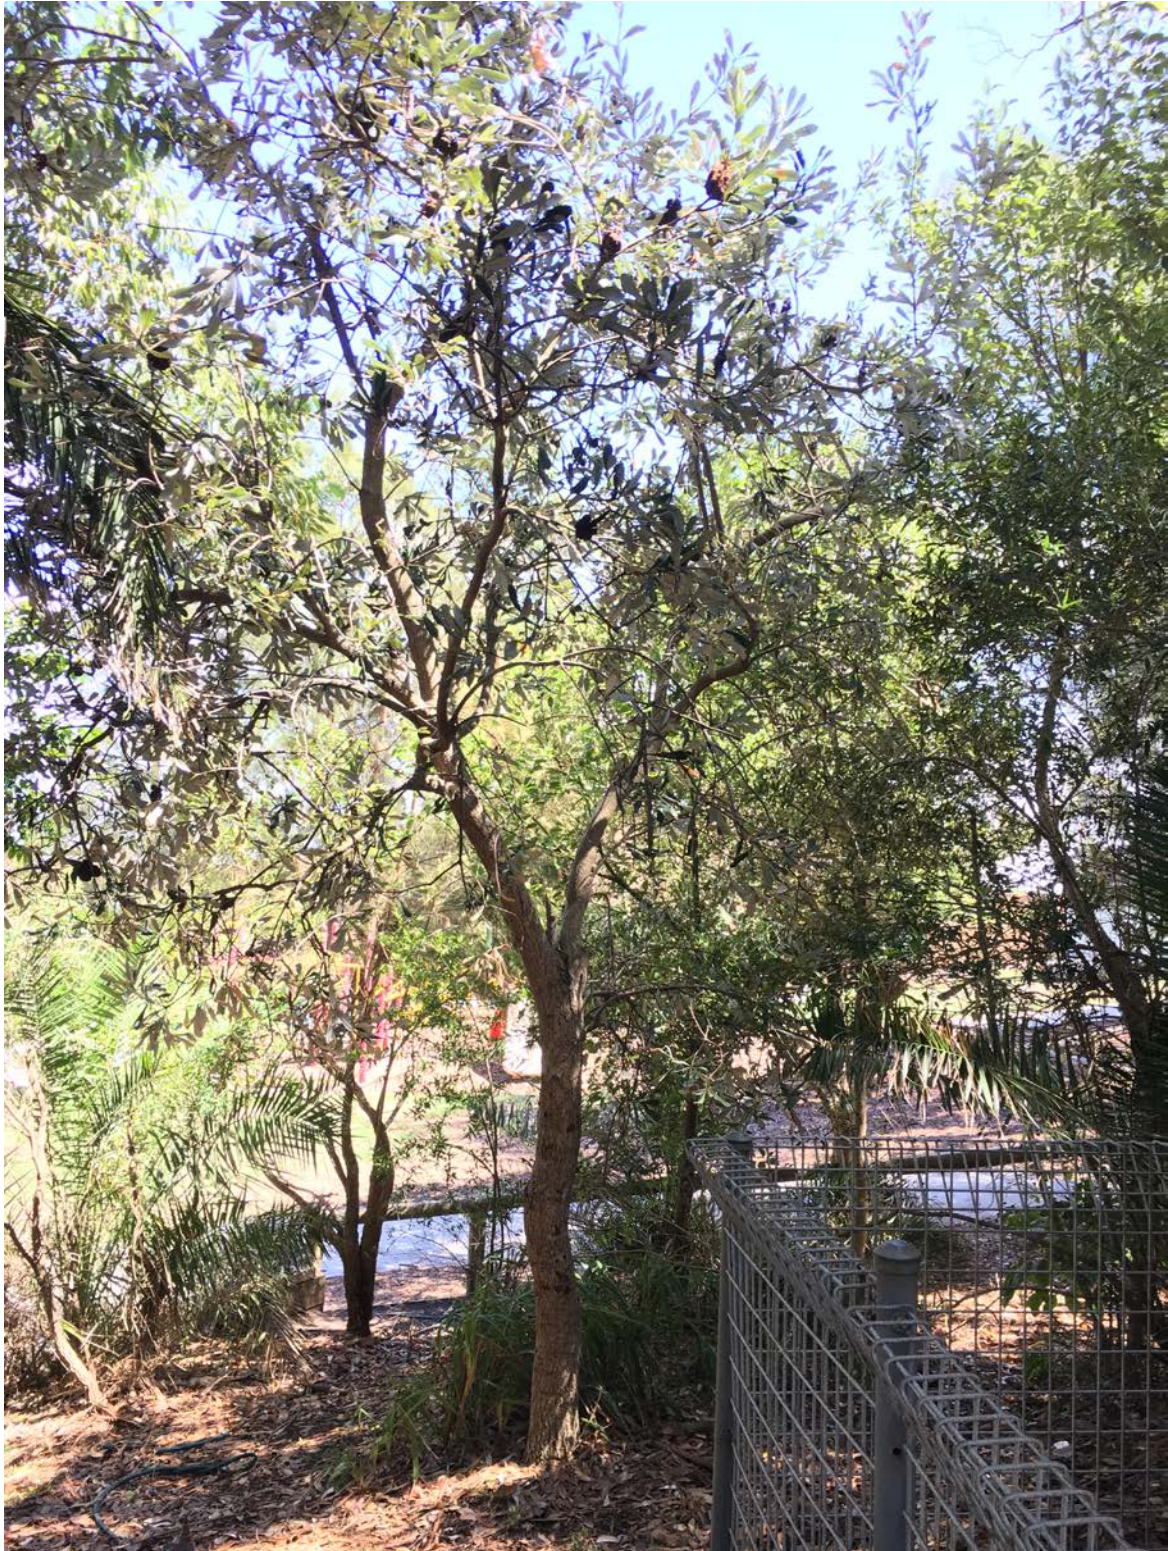
Tree 20: *Banksia integrifolia* [Coastal Banksia] is a semi mature tree with a suppressed sparse canopy structure.

This tree is subject to wasp gall causing distortion in juvenile flower cones of certain Banksia species.

FIGURE 26: TREE 20 WITH A SUPPRESSED CANOPY STRUCTURE

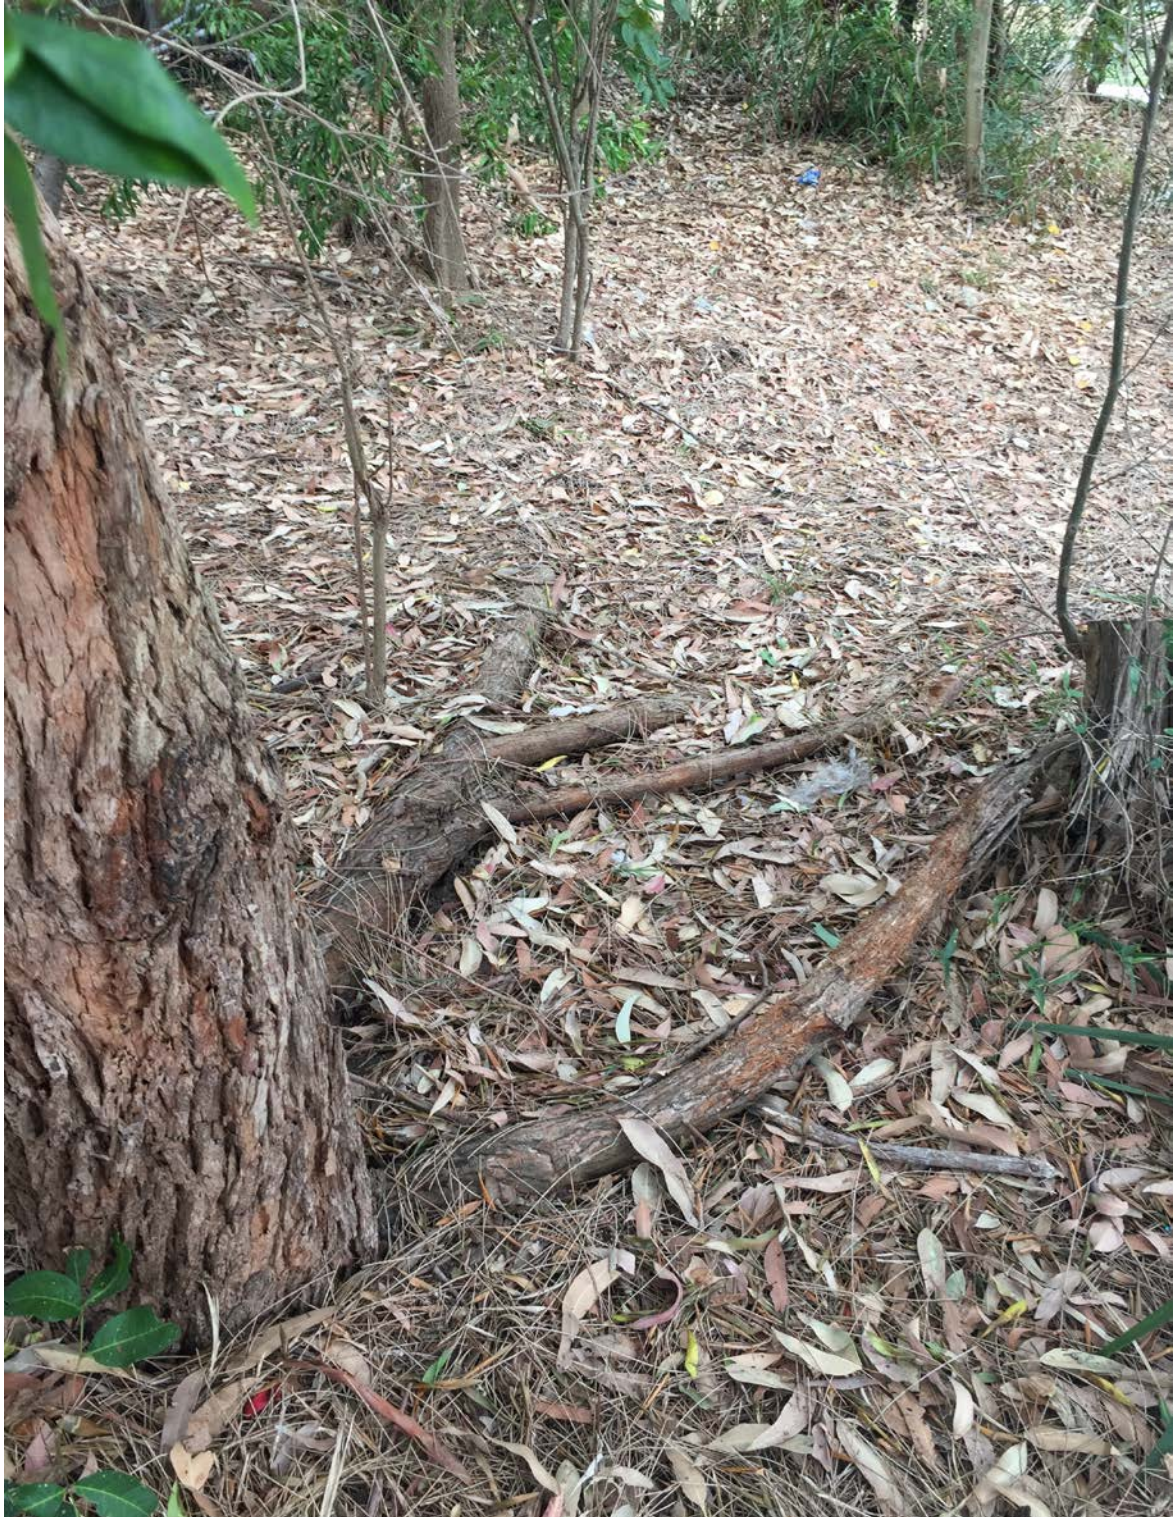
Tree 21: *Eucalyptus botryoides* [Bangalay] is a semi-mature tree with a poor trunk taper and a sparse upper canopy structure.

A previous strong wind event has caused root plate heave resulting in large lifted surface roots.

FIGURE 27: TREE 21 WITH LARGE EXPOSED SURFACE ROOTS RESULTING FROM ROOT PLATE HEAVE.

RECOMMENDATION (IF RETAINED):: This tree cannot be retained and therefore will require removal.

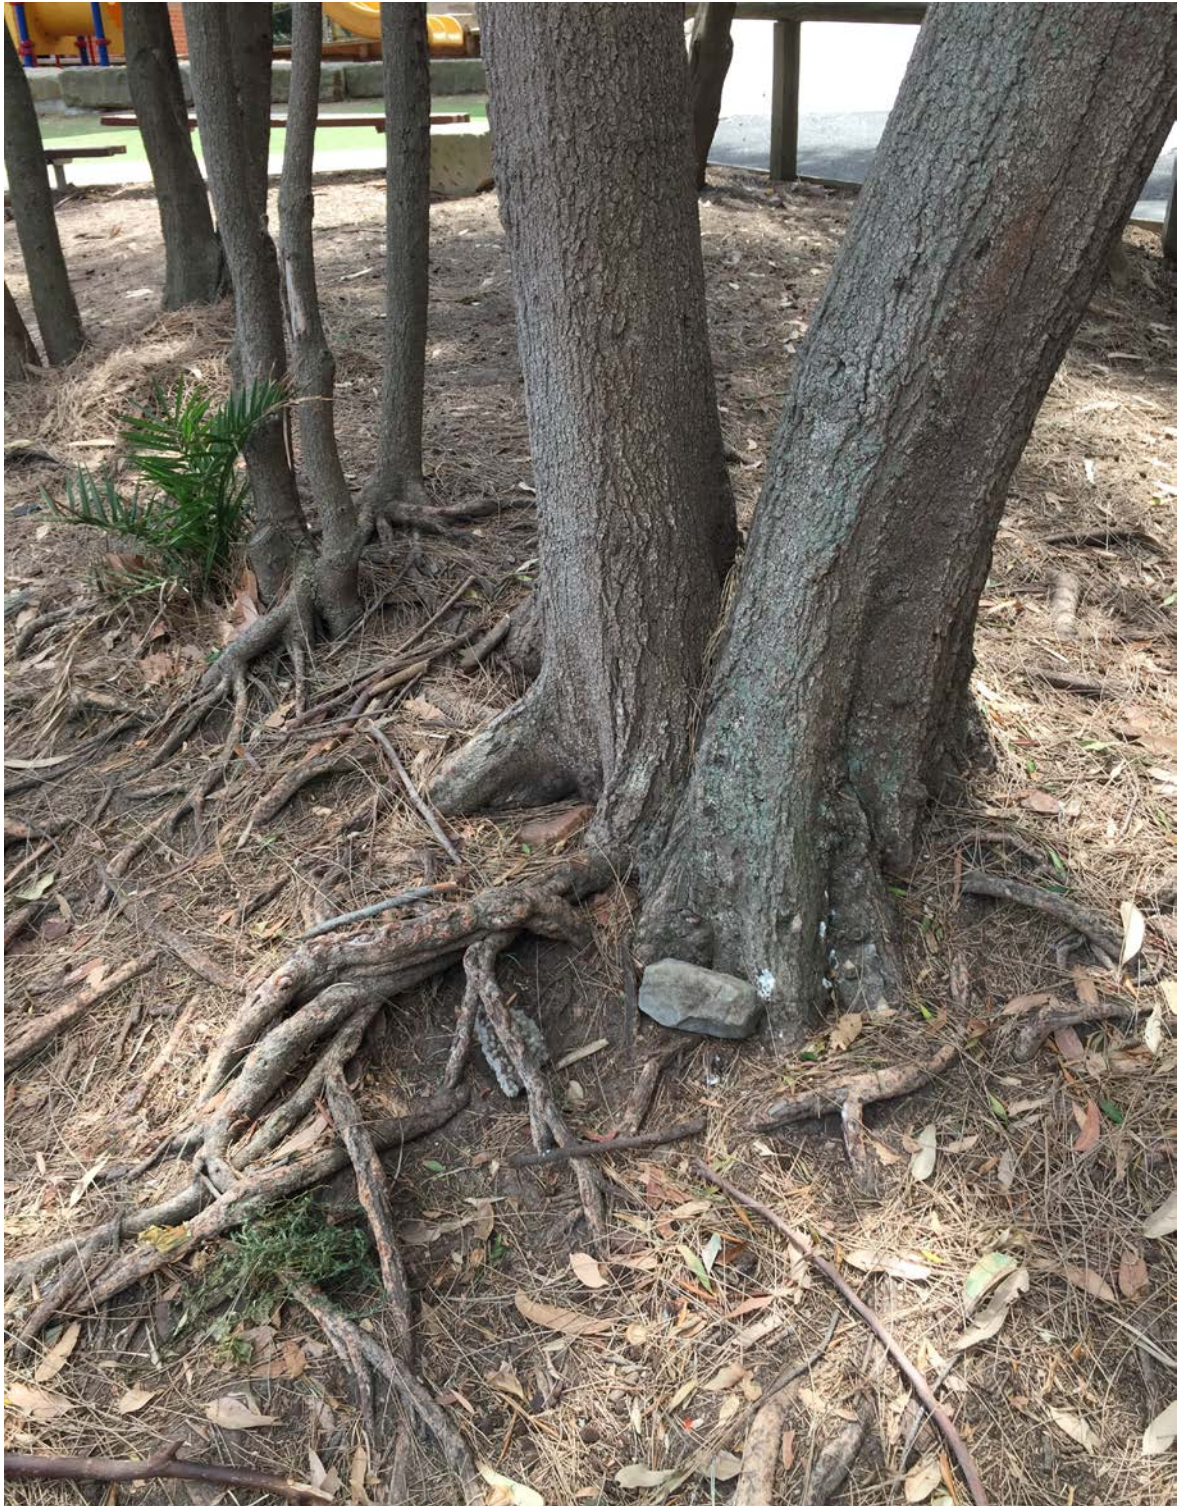
Surface roots have been exposed from soil erosion and foot traffic.

FIGURE 28: TREE 22 WITH EXPOSED SURFACE ROOTS.

RECOMMENDATION (IF RETAINED):: Applying mulch around the root zone would benefit the tree by improving vigour and health also protecting the exposed surface roots from damage.
